Performance of the Flexible and Rigid Lining under Earthquake Impact and Weakness of the New Austrian Tunneling Method (NATM) Principles, a Specific Case Study of the Bolu Tunnel

Ebu Bekir Aygar

Fugro Sial Geosciences Consulting Engineering Ltd., Cankaya 06690, Ankara, Turkey; eaygar@gmail.com

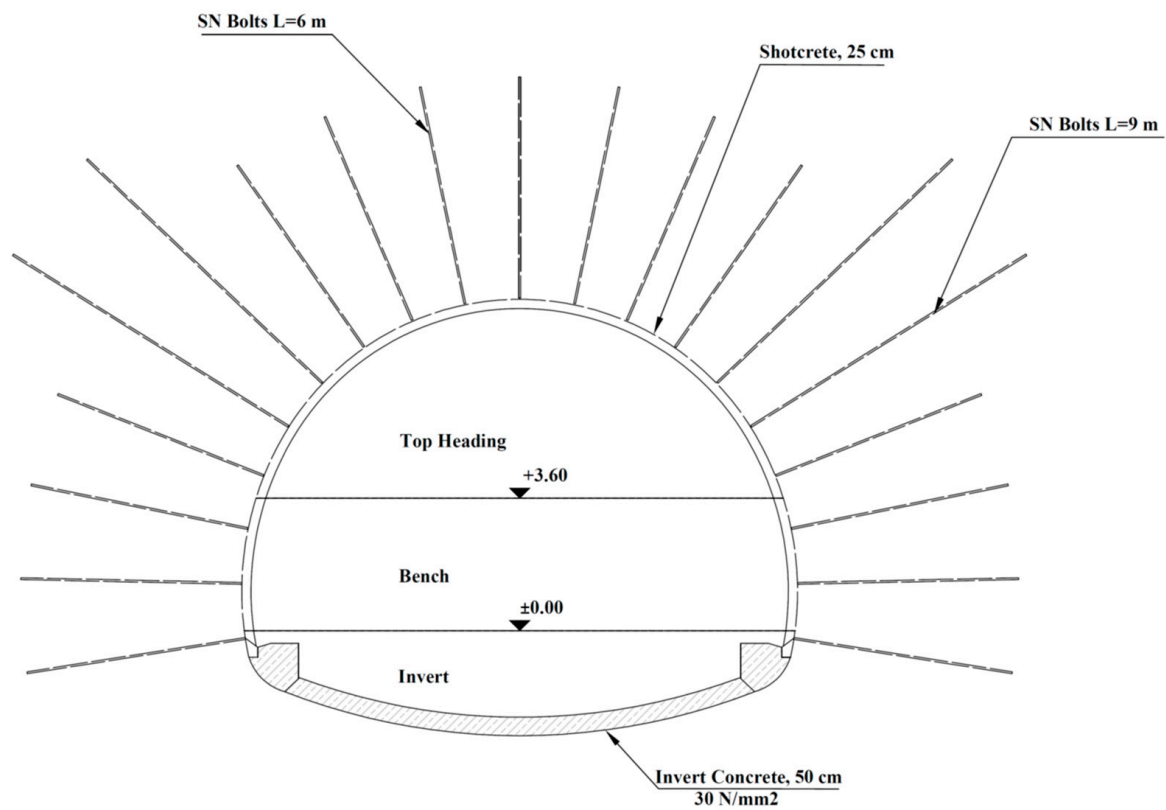
In the first design phase, weak ground condition is accommodated with design consistent with C2 support class according to NATM class [47] sections, with suggested 25 cm shotcrete (Figure 8). However, upon encountering stability problems and extreme deformations in the tunnel, the support systems were revised as C3, C3-M, and intermediate lining (Figures 9 and 10). Intermediate lining, which is called Bernold lining, contains lining between the outer and inner linings. After completing the outer lining (shotcrete, bolts, and steel rib), the intermediate lining (Bernold lining) was installed with a lining thickness of 60 cm (C40 concrete class) to prevent extra loads and deformations before the inner lining was installed (Figures 9 and 10) [45,46]. In the large fault zones, the bench pilot tunnels method was applied to prevent deformation (Figures 11 and 12). The bench pilot tunnels method involves two pilot tunnels in the bench section, which have diameters of 5 m constructed before the top heading excavations. After completing the bench pilot tunnel with reinforced C30 concrete, the top heading excavation was started. As shown in Figures 11 and 12, the bench pilot tunnel method is a very rigid support system.

Figure 8. C2 Support system details proposed in the first design phase [48].

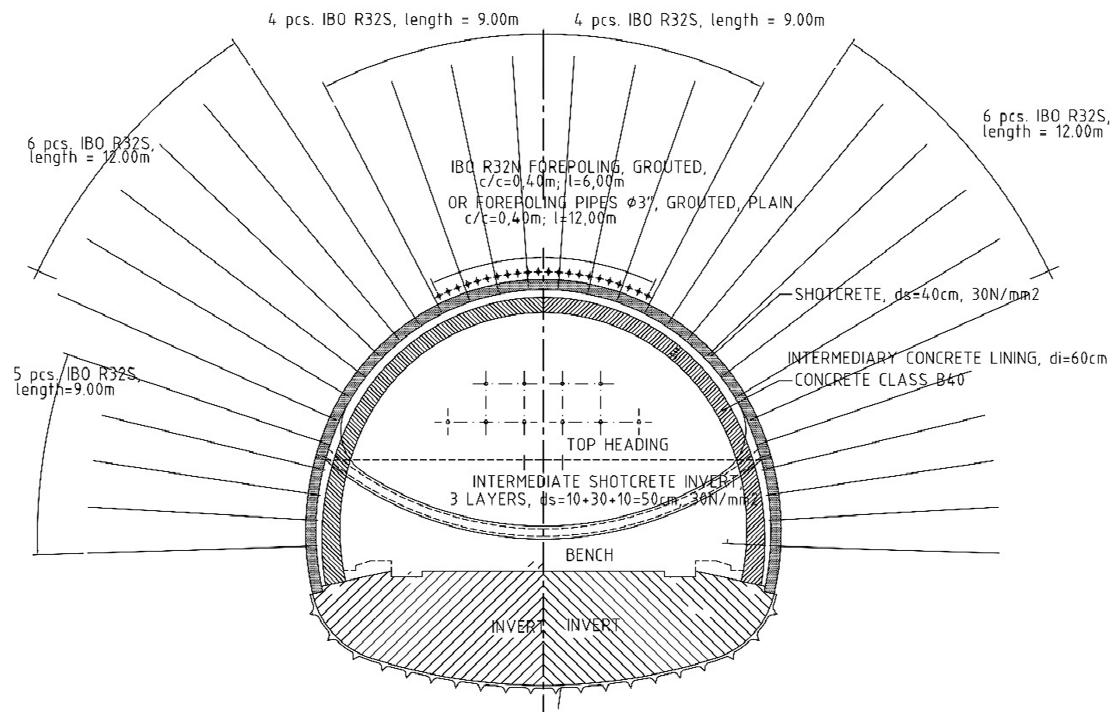
Figure 9. Intermediate lining (Bernold Lining) method implemented at minor fault zone and fly-schoide series [49].

Both methods (the Bernold lining and the bench pilot tunnels) are the opposite of the NATM principles. Both these two lining methods are aiming to mitigate deformations from occurring during the tunnel excavation. Moreover, no collapse or failure occurred in the fault zone or the flyschoid series during the earthquake where these methods were applied. The tunnel support principle should be a rigid system to prevent deformations under the conditions of weak ground and a large cross-section. Otherwise, the displacements could not be stabilized. In the Bolu tunnel applications, it has been seen that the NATM principles failed; therefore, all assumptions and design philosophy were changed. This situation has proved to be a very important point regarding NATM tunnelling and needs to be revised.

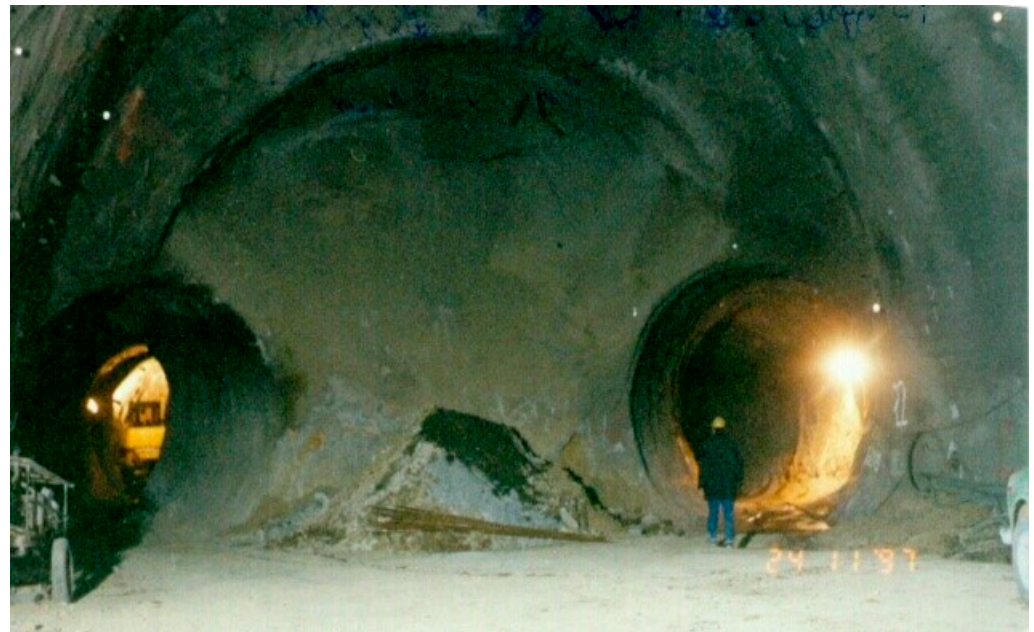
Figure 12. Bench pilot tunnel method applications.

(Figure 16), and, eventually, the tunnel completely collapsed (Figure 17). Afterwards, the section was excavated using the bench pilot tunnel method (Figure 12) [45,46,48].

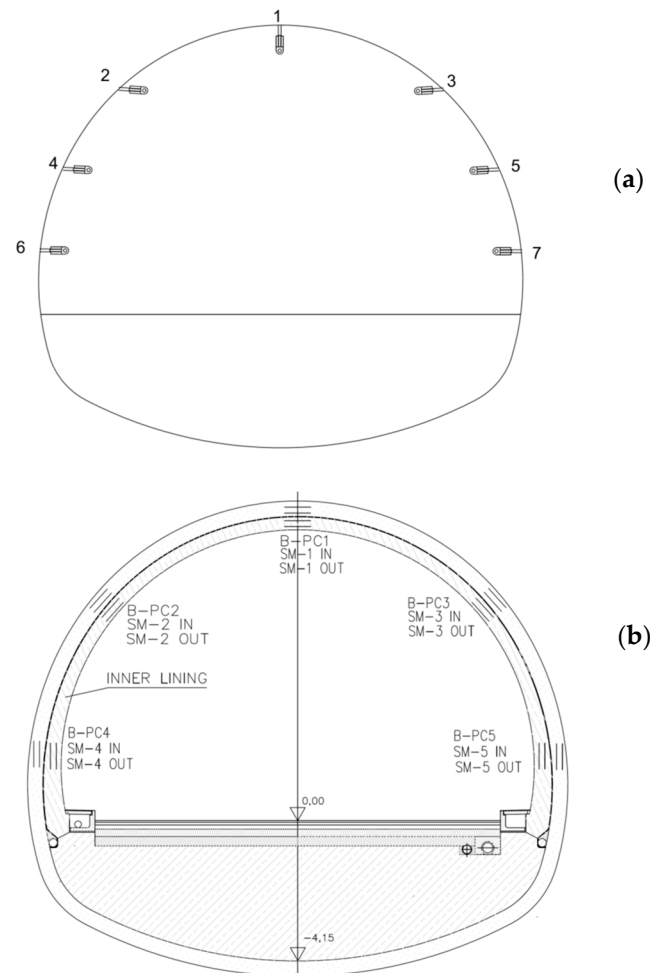
Deformation measurement points were placed every 10 m along the tunnel route. At these points, the soil behavior was examined by measuring the deformations regularly. Extensometer, pressure cell, and strain gauges were placed within the fault zones and flysch series. The geotechnical measurement points in the tunnel are shown in Figure 13.

Figure 13. Geotechnical measurements points: (a) deformation points; and (b) strain gauge and pressure cell measurement points.

Measurements were taken for this section because results could still be obtained as the Düzce earthquake did not cause any damage here. Figure 13 shows the images during the utilization of the geotechnical measurement instruments. The pressure cells are positioned in the tunnel in a tangential and radial manner, while the unit deformation gauges are placed near the two concrete surfaces.

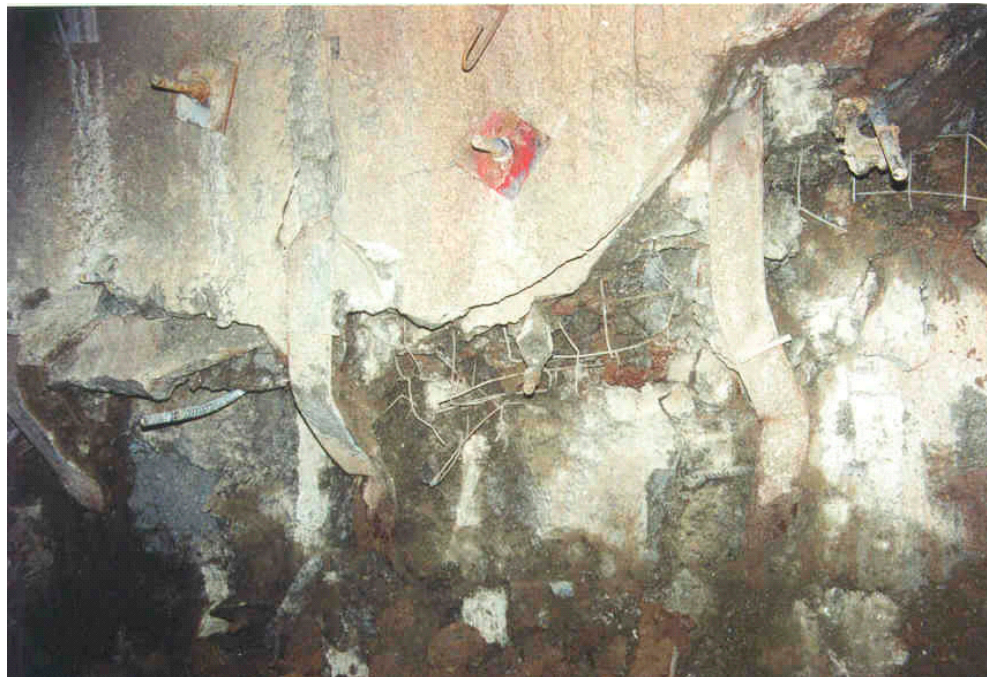
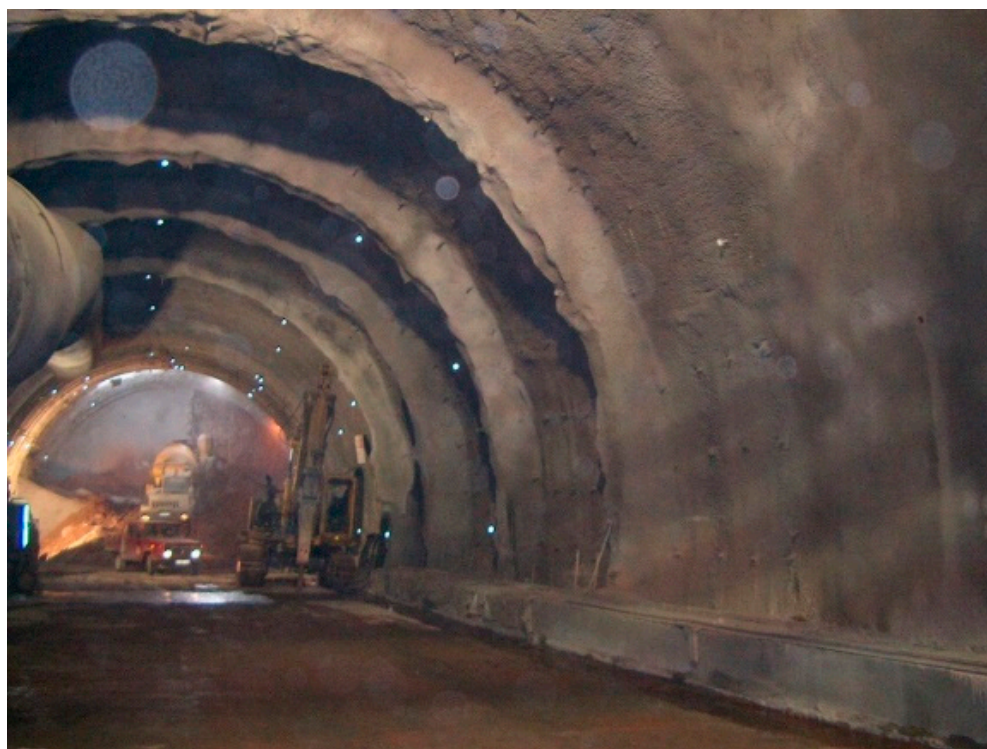
It is determined that the collapse in the Elmalık left tunnel (Figure 15) occurred in the fault zones, and serious problems were experienced in these sections before the earthquake

(Figure 15a). Moreover, deformations up to 100 cm took place in these sections accompanied with continuous strengthening and reinforcement studies (Figure 15b) [45,46,48].

Figure 15. Damage owing to the high deformations in the left tunnel lining (a) and the left tunnel reinforcement works (b) [45].

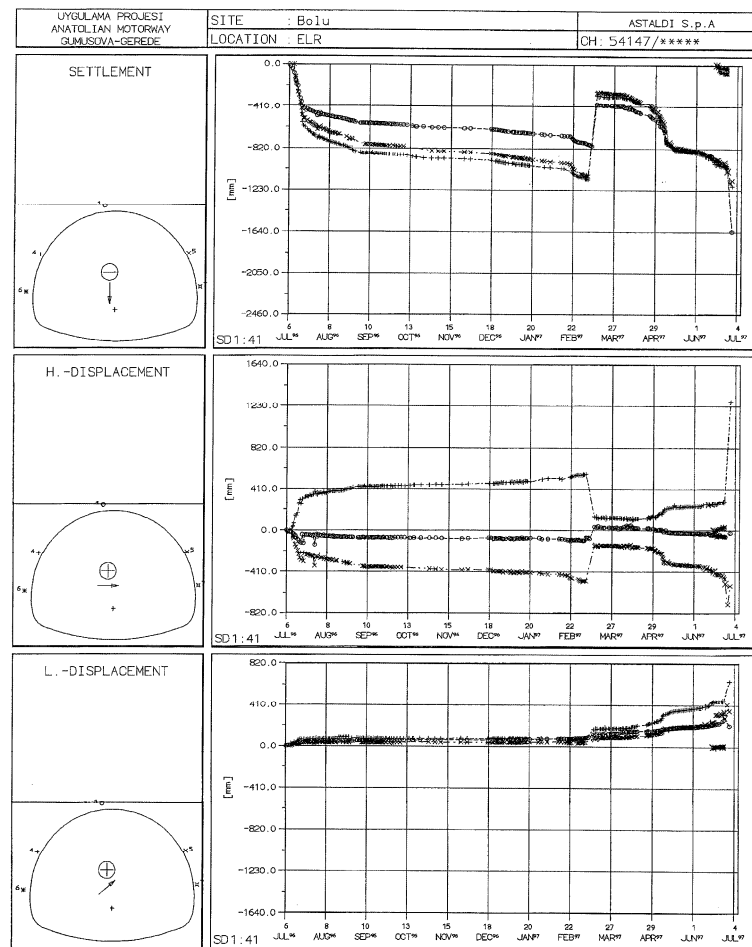
In the Elmalık right tunnel, the collapsed section formed between km: 54 + 060 and km: 54 + 160 was observed in 1996, because of extreme deformations reaching up to 1.3 m

Figure 16. Right tunnel deformations at km: 54 + 147 [52].

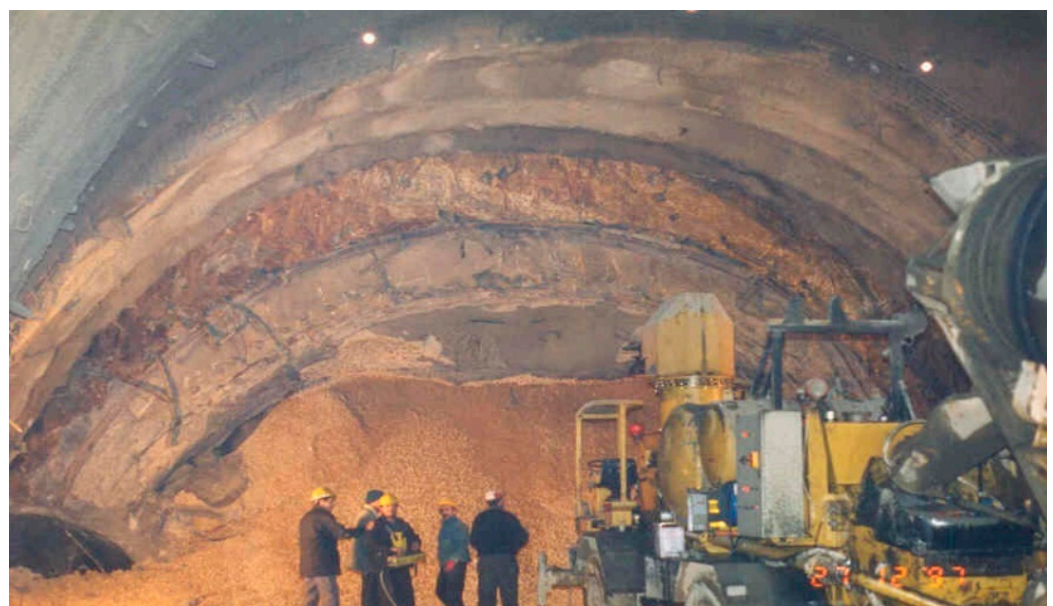
Figure 17. The right tunnel collapse zone between 54 + 147 to 54 + 240 in 1996 (before the Düzce earthquake).

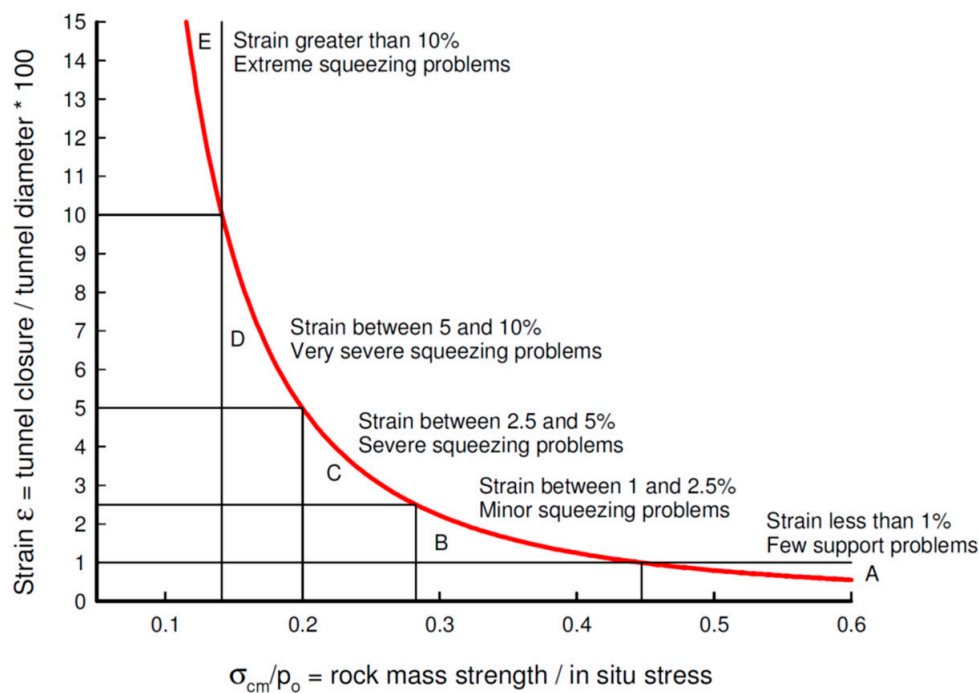
According Jethwa et al. (1984) [54], the Nc value was found to be 0.1, meaning that a high rate of squeezing would occur (Table 4). According to Hoek and Marinos (2000) [53], the \mathcal{E} value is calculated as 18%. As seen in Figure 18, it is stated that very serious stability problems will be encountered in the tunnel.

Figure 18. Squeezing conditions in the unsupported tunnel section [53].

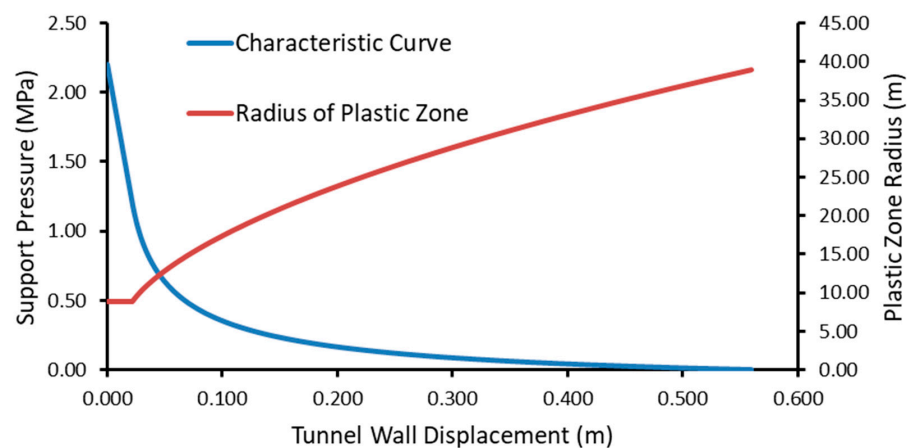
In the analyses, the radius of the plastic zone around the tunnel is 38 m, the σ_{cm}/P_0 ratio is 0.07, the critical pressure P_{cr} 1.20 MPa, and the total deformation is calculated as 55 cm (Table 6) (Figure 19).

**Figure 19.** Characteristic curve and radius of the plastic zone.

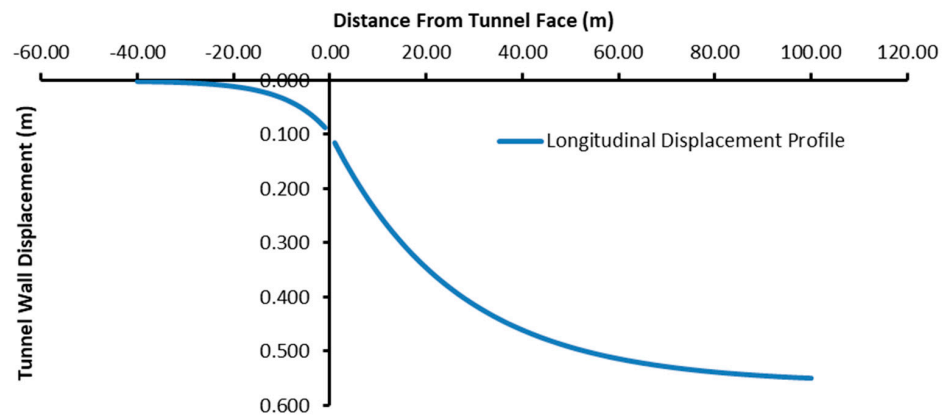
In addition, the equations established by Vlachopoulos and Diedrichs (2009) [57] are used to plot the longitudinal deformation curve of the tunnel. The displacements obtained here increase rapidly towards the back of the tunnel face and reach up to 55 cm (Figure 20).

Figure 20. Longitudinal displacement profile.

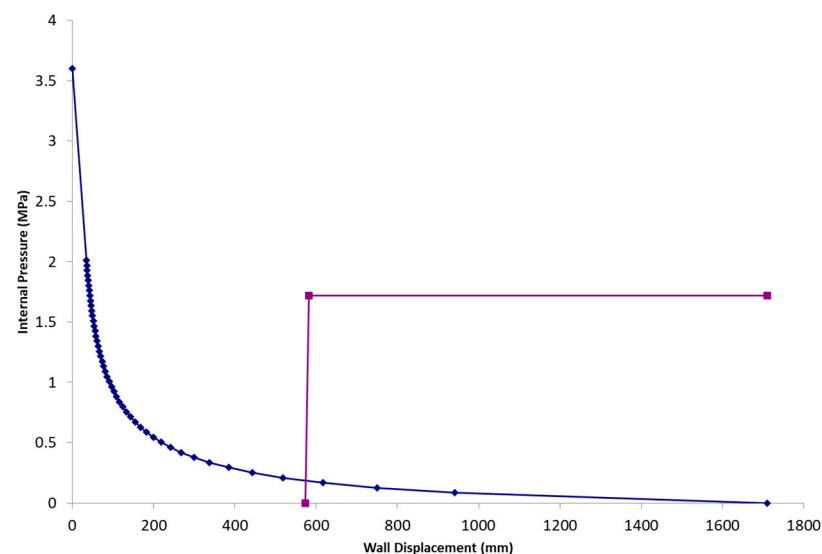
The drawing of the ground and support reaction curves of the tunnel is evaluated in three stages. In the first stage, the situation where the supports were placed from 1 m behind the tunnel face was examined, and, further, it was observed that 526.67 mm deformation occurred in the tunnel face and 574.13 mm deformation in the tunnel (Figure 21). Although the safety factor is calculated as 9.34, it is known that the tunnel will fail because of deformations.

**Figure 21.** Support systems installed 1 m behind, FS:9.34, final wall displacement, 574.13 mm, and displacement at tunnel face, 526.67 mm.

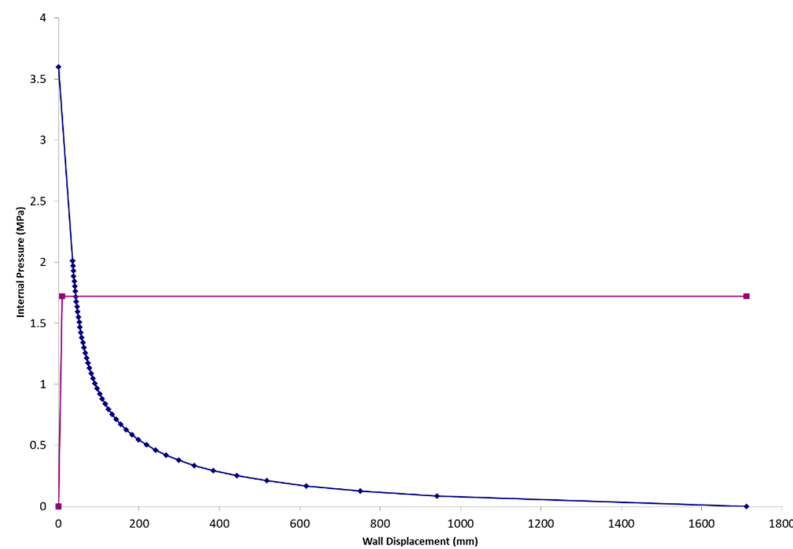
Considering that the supports are placed without deformations in the second stage, the safety factor becomes 0.59, implying that the tunnel is not stable (Figure 22).

Figure 22. Tunnel support systems installed without deformation, FS:0.59, and final wall displacement 49.48 mm.

According to analysis, it was not possible to reach stability with the outer lining made in the tunnel. This fact sheds light on the problems experienced in the tunnel. Stability around the tunnel could not be achieved depending solely on the flexible outer lining. It has been observed that the deformations occurring in the flysch series of the tunnel exceeded 100 cm in places. The reason for these deformations is both insufficient external support and deformations that develop due to squeezing in the long term. After the problems experienced in the Bolu tunnel, intermediate lining (Bernold lining) was begun to be applied to the flysch series. The Bernold lining was begun to be installed from approximately 30 m behind the tunnel face, immediately after the outer lining, and stability was ensured in the tunnel. The properties of the Bernold lining are given in Table 11. The analyses are considered together with the outer lining and the intermediate lining. In this case, since the strength of the outer lining is $P_{\text{outer}} = 1.71$ MPa and $P_{\text{bernold}} = 1.62$ MPa, the total becomes $P_{\text{outer}} + P_{\text{bernold}} = 3.33$ MPa. The ground–support reaction curve is presented in Figure 23. Here, if there is a total deformation of 5 cm in the tunnel, the safety factor is 1.53. In fact, this is an extremely important approach in terms of ensuring the stability of the tunnel. This application was applied in the Bolu tunnel and produced successful results. In addition, no damage occurred in these parts of the tunnel during the 12 November 1999 Düzce earthquake. The sections where damage and collapse occurred were the sections with only the outer lining without the Bernold lining. In a sense, tunnel stability had been ensured with rigid lining. Hence, the main principle of NATM, a flexible outer lining, has failed.

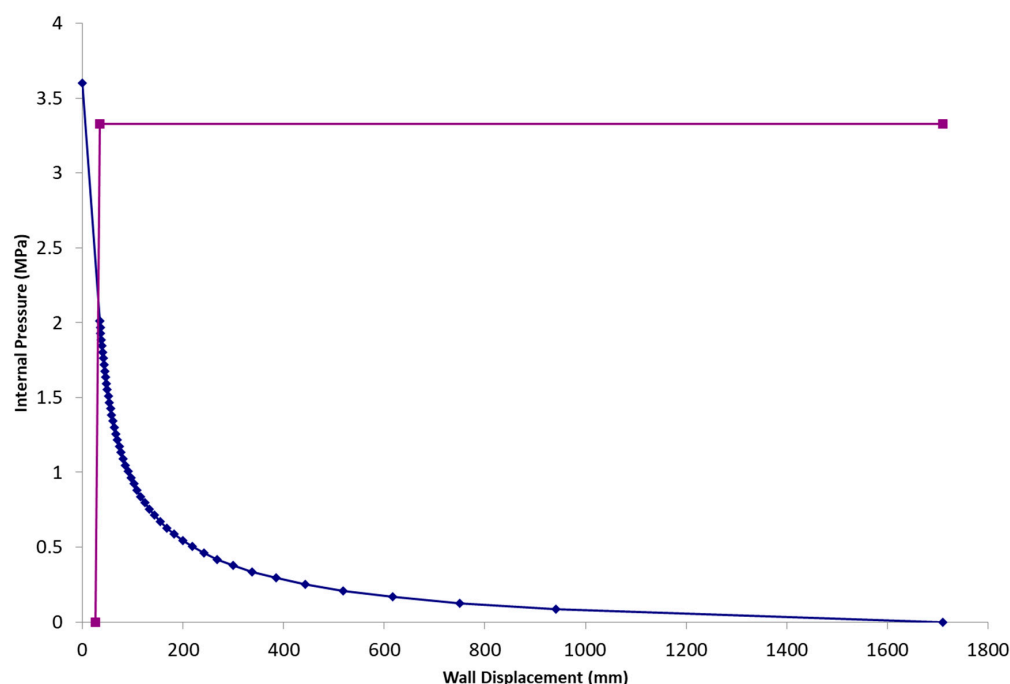
Figure 23. In the case where the support systems are placed before deformations occur in the tunnel, 1 m behind, FS:1.59, and final wall displacement, 30.81 mm.

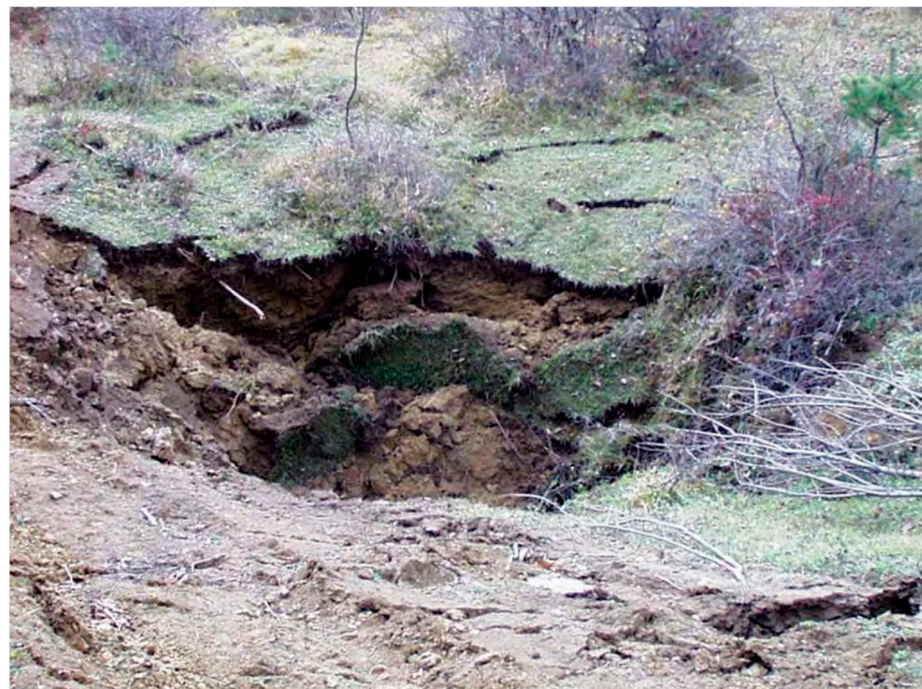
Among those, 2 had a diameter of 20 cm, whereas 9 had a diameter of 12.7 cm. The purpose of the boreholes of 20 cm diameter was to determine the current ground condition and to drain the water in the tunnels. The drillings in the left tunnel at km: 63 + 856.5 revealed the surface settlement occurred at km: 63 + 860 and had turned into a sinkhole formation (Figure 25).

Figure 25. Sinkhole above the tunnel alignment [12].

According to the field studies and horizontal and vertical drillings, it has clearly been seen that a 200 m section of the tunnel had completely collapsed. In addition, a sinkhole was observed at km: 63 + 860 on the left tunnel whose depth reached up to 20–30 m. This sinkhole had widened towards the right tunnel. This sinkhole indicated the existence of another collapse in the tunnel, that is, between km: 63 + 875 and km: 63 + 935.

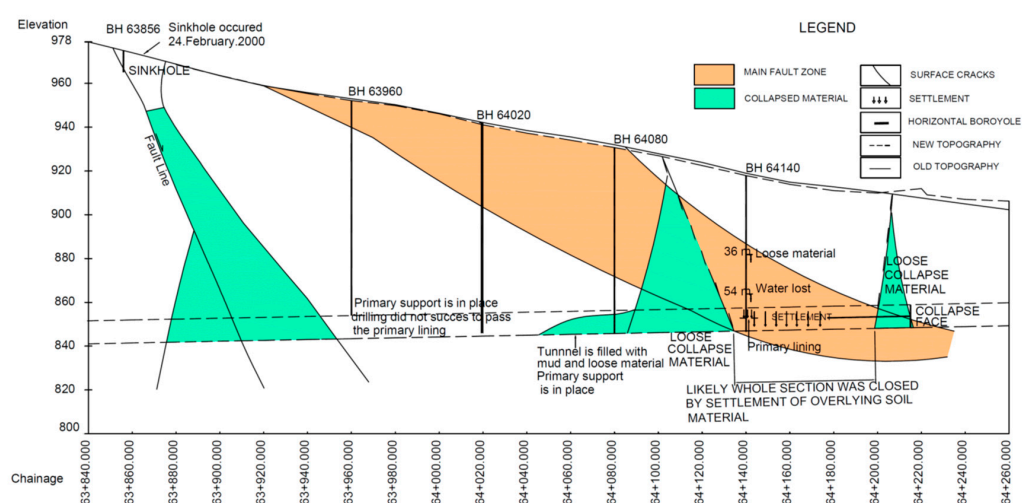
Consequently, this borehole could not be studied. The borehole at km: 53 + 795 in the right tunnel coincided with a collapse [62]. The geometry of the collapse in the tunnel was expected to be identified by using the boreholes in the right tunnel. In the boreholes drilled at km: 53 + 910, a collapse was observed between 94.0 and 104.0 m depths. In the borehole of km: 53 + 980, the collapsed area reached between 70.0 and 82.0 m. At km: 54 + 060, it was identified that the tunnel ceiling was closed for almost 2.0 m while the tunnel entirely filled with collapsed material, and, in turn, settlements were observed in the surface topography. At km: 54 + 110, a collapse was encountered between 39.0 and 58.0 m depth. In the boreholes in the left tunnel, no collapse was observed at km: 63 + 791.5, km: 63 + 960, and km: 64 + 020 drillings. It was observed that inside the tunnel it was filled with loose material at km: 64 + 080. At km: 64 + 140 borehole, a collapse was encountered between 36.0 and 72.0 m depths. In addition to the vertical boreholes, two horizontal boreholes were also drilled in both tubes. As a result of this research and these evaluations, the collapsed sections are modeled and presented in Figures 26 and 27.

Figure 26. Left tunnel longitudinal section after the 12 November 1999 Düzce earthquake [63].

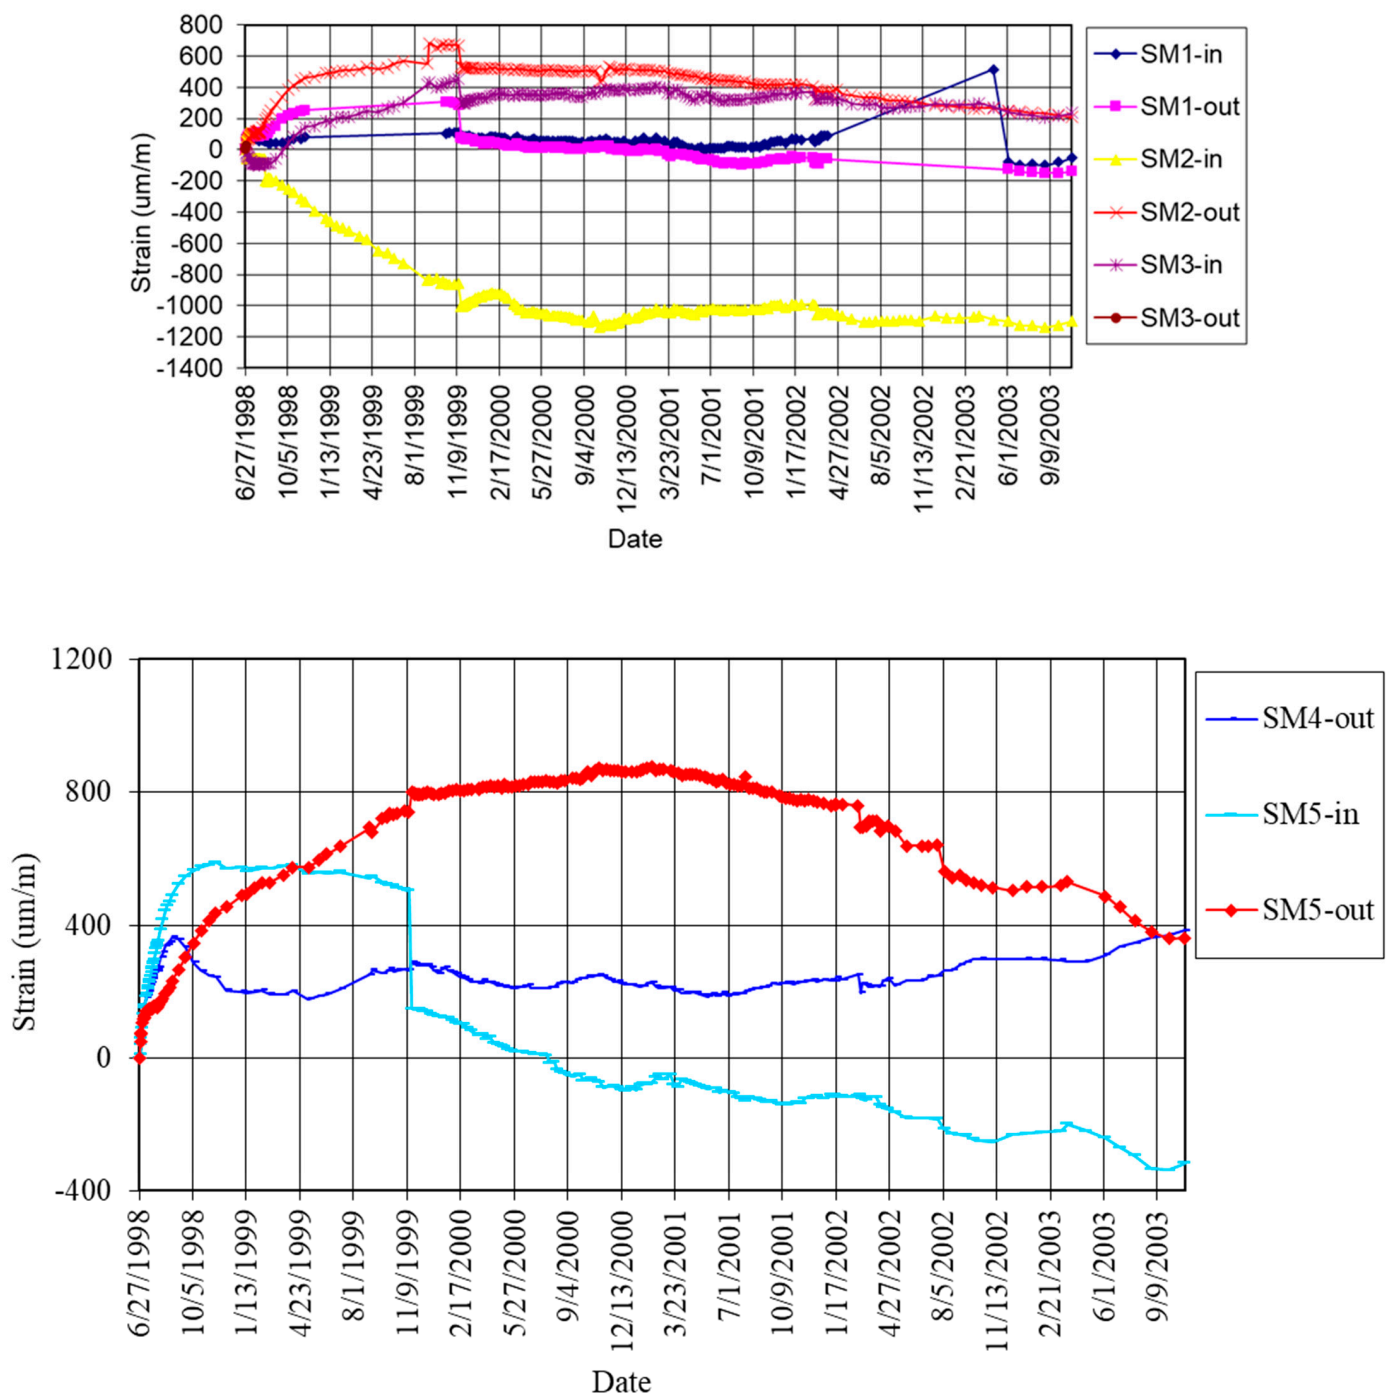
The deformation-related changes that occurred in this section during the earthquake have been summarized, as follows: in Section 1, no significant difference could be noted at the inner part before and after the earthquake, while a decrease of 210 $\mu\text{m}/\text{m}$ was observed in its outer part; in Section 2, a decrease of 140 $\mu\text{m}/\text{m}$ occurred in the inner part, while a decrease of 116 $\mu\text{m}/\text{m}$ occurred in the outer part; in Section 3, a 153 $\mu\text{m}/\text{m}$ decrease was noted in the inner part, while no measurement could be obtained from the outer part; in Section 4, no reading was obtained from the inner part, while an increase of 35 $\mu\text{m}/\text{m}$ was measured in the outer part; and in Section 5, there is a decrease of 355 $\mu\text{m}/\text{m}$ in the inner part and an increase of 60 $\mu\text{m}/\text{m}$ in the outer part (Figure 30).

Figure 30. Unit deformations in the concrete inner lining (points 1, 2, 3, 4, and 5) at the 61st block of the left tunnel of Asarsuyu [66].

Abrupt increases in the level of deformation, tension, bending moment, and force were observed after the earthquake. However, these changes did not cause any significant problems in the tunnel, as the support systems were able to carry the generated loads effectively. The change in deformations, stresses, bending moments, and force remained within limit values, and they normalized to reach inner stability after a period, as can be seen from the obtained results. In the Asarsuyu section of the tunnel, only minor cracks occurred in the inner lining, and these did not have any adverse effect on the tunnel's stability.

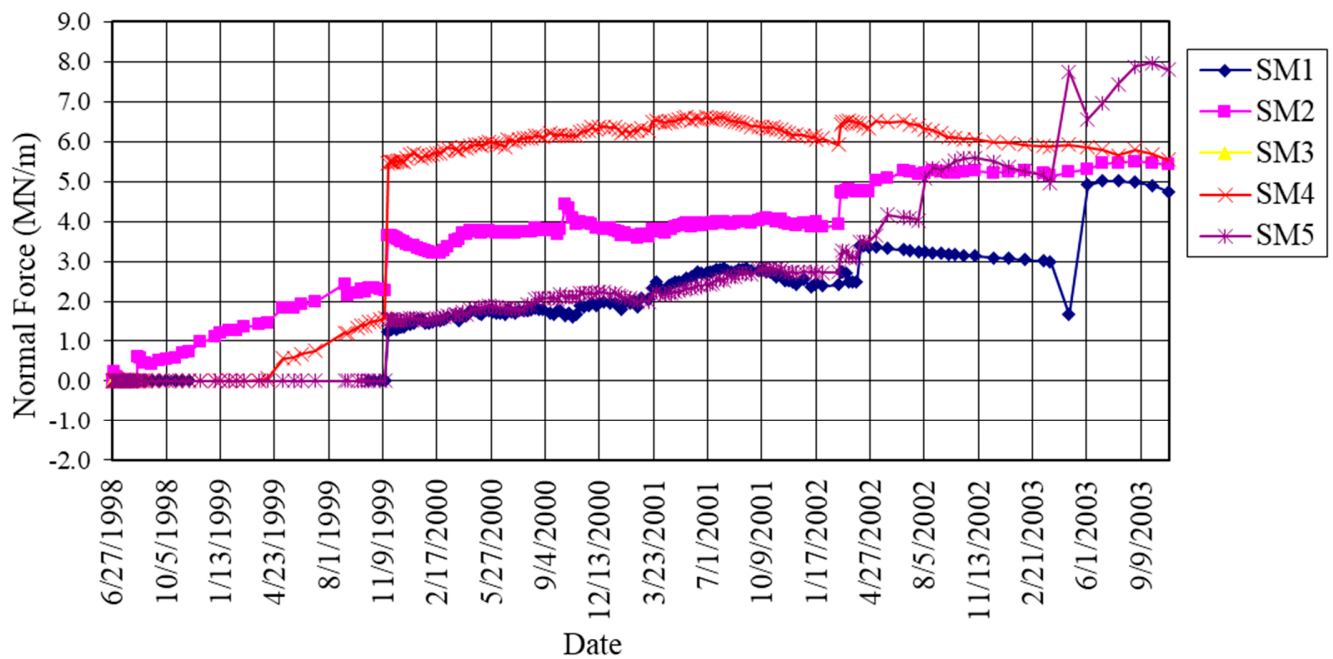
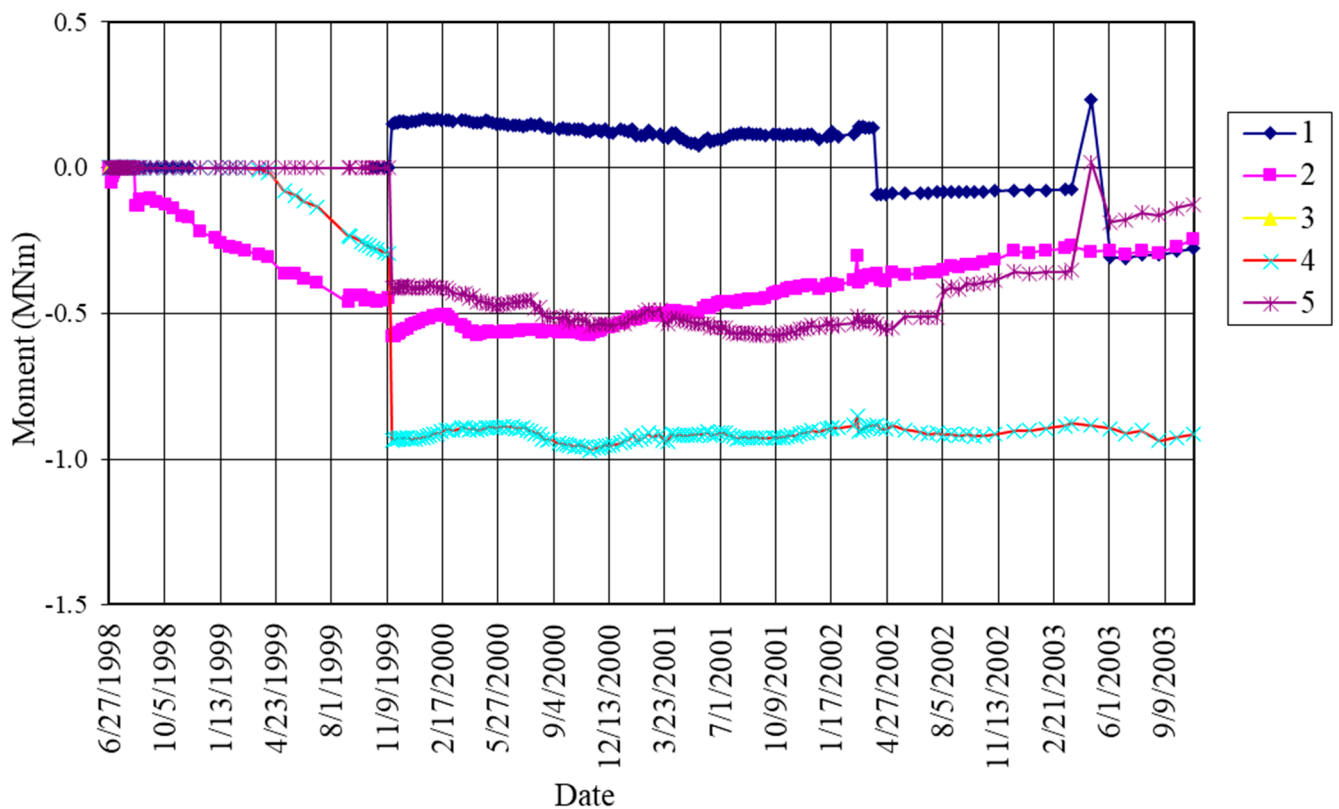
Figure 31. Normal forces and bending moment acting on the concrete inner lining at the 61st block in the left tunnel of Asarsuyu [66].

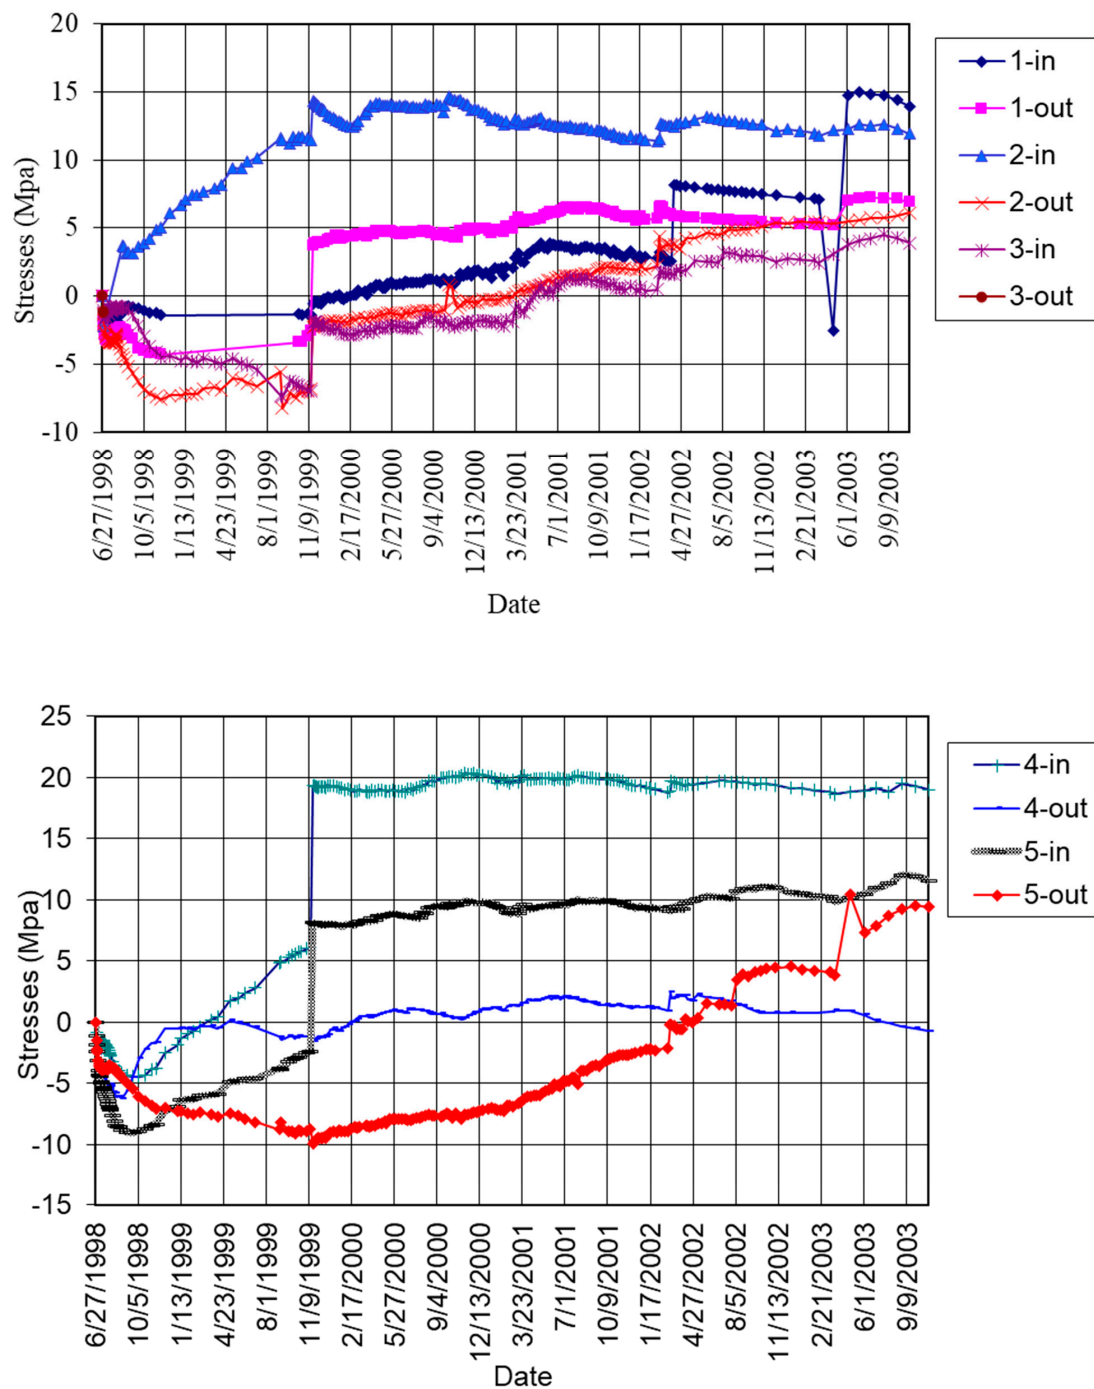
From the monitoring readings obtained from pressure cells placed in Section 1, it was observed that the stresses increased up to 15 MPa around the lining during the earthquake (Figure 32), and the maximum change identified was occurred at the ceiling point. As shown in Figure 32, based on the measurements taken at the intersection of the top-heading and bench, the stress values are determined to be approximately 20 MPa.

Figure 32. Stresses that occurred in the concrete inner lining (point 1, 2, 3, 4, and 5) at the 61st block of the left tunnel of Asarsuyu [66].

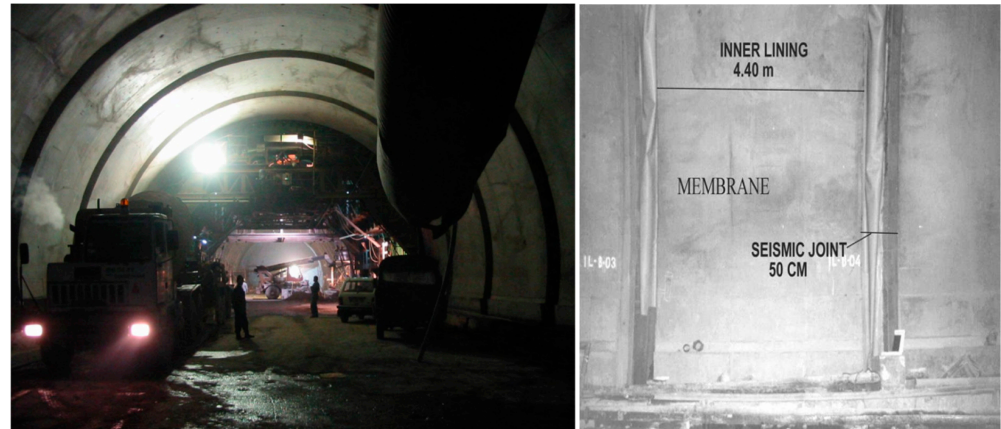
Figure 33. Seismic joints in the inner concrete lining.

After the Düzce earthquake, Letis and Barka (2000) [31] reported that the active Bakacak fault has the potential to create a fault rupture that could cause a 30–50 cm displacement [67]. In order to minimize the damage to the tunnel from this potential displacement, a 50 cm wide gap was left in the inner lining every 4.4 m. These gaps were filled with aerated concrete (Figures 33 and 34), called seismic joints.

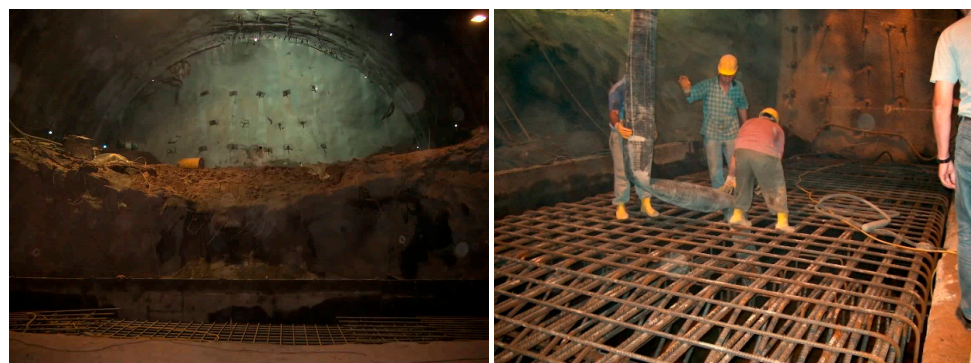
Figure 35. Application of invert with reinforced concrete.

In addition, the ring closure was provided along with the application of a rigid support system by installation of monolithic reinforced invert concrete after the invert excavation (Figure 35).
