Review

The *Vie Cave* Geomorphological Site in Southern Tuscany (Italy): Problems of Decay and Conservation

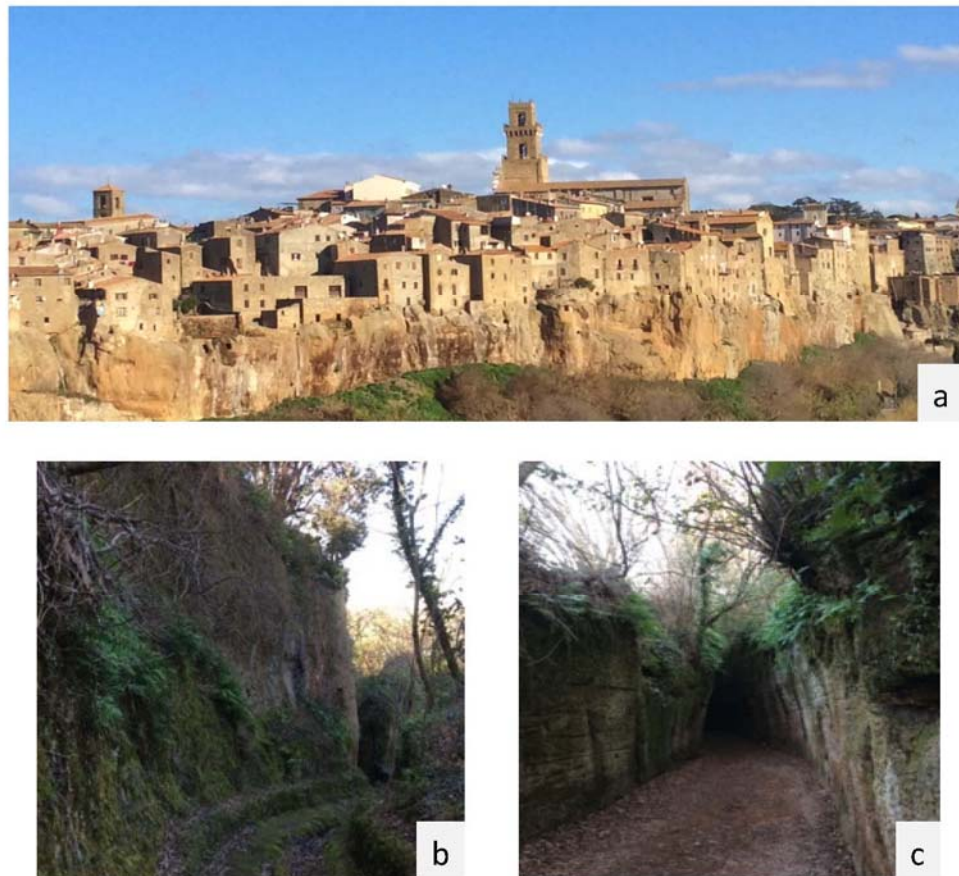
Figure 4. (a) View of Pitigliano town; (b) and (c) Typical aspects of the *Vie Cave*.

The area reached the maximum economic development at the end of the Bronze Age when the most significant settlements were Pitigliano (Figure 4a), Sovana and Sorano. Despite these centers having a good natural defense, they were abandoned at the beginning of the Iron Age when the population moved to the wide plateaus. During the ninth century BC, Pitigliano and Sovana rose again over the natural fortress represented by the plateau of pyroclastic rocks bordered by the steep walls carved by the left tributaries of the Fiora River; this location played an important role in controlling the river valley [12].

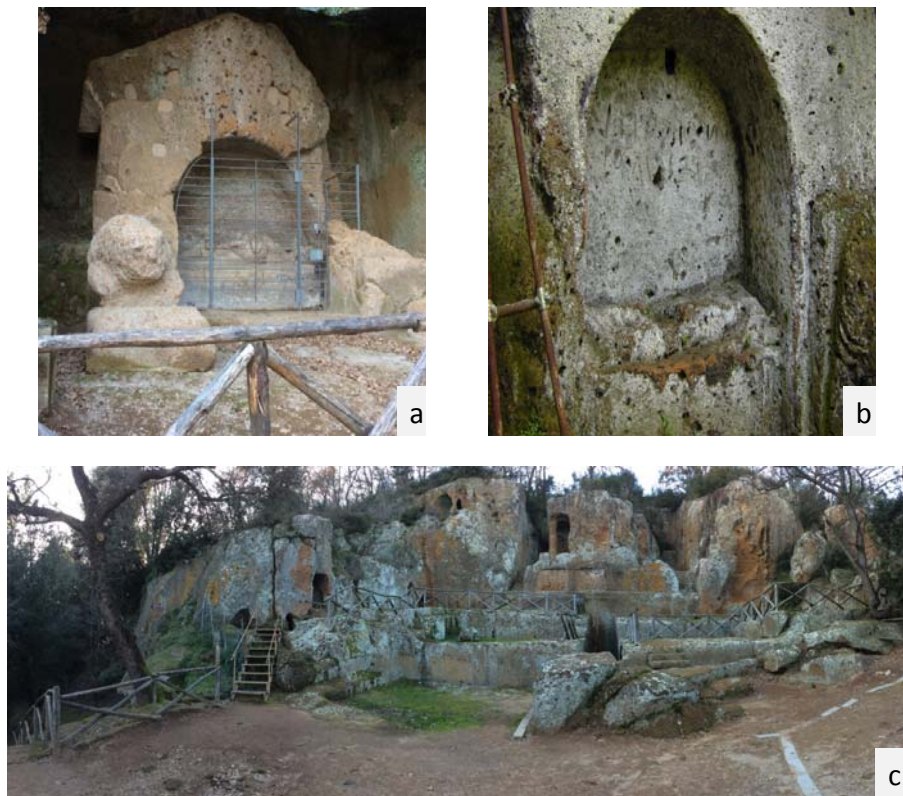
Figure 5. Some examples of funerary architecture in the area of Sovana: (a) Demoni Alati tomb, (b) Sirena tomb, and (c) Ildebranda tomb.

During the Roman period, the entire area underwent several transformations that led to a new territorial setting. Sovana probably survived until the Imperial age as testified by the pottery and oil lamp remains [13]. The most interesting aspect of the archaeological *facies* of the region is certainly made up of its large necropolises connected and crossed by the *Vie Cave* (Figure 4b,c). Pitigliano is surrounded by four major groups of necropolises (S. Giuseppe, Valle delle Fontanelle, S. Giovanni, and Gradone) [14]. Among the various necropolises, those of Sovana, where Canino, Farnese and Sovana Formations outcrop, are particularly important; they display hundreds of tombs, sculpted in the rocks, showing architectural design typical of the Hellenistic period (Figure 5a,b). The necropolises lie all around the plateau where the ancient village of Sovana was located. Some large isolated tombs were also carved on the hill slopes. The area of the necropolises extends across about two kilometers and shows an almost continuous sequence of *dado* and *semidado* tombs. Among these, there are some monumental tombs with colonnade and aedicule with decorated frontage (e.g., Demoni Alati and Ildebranda tombs, Figure 5a,c).

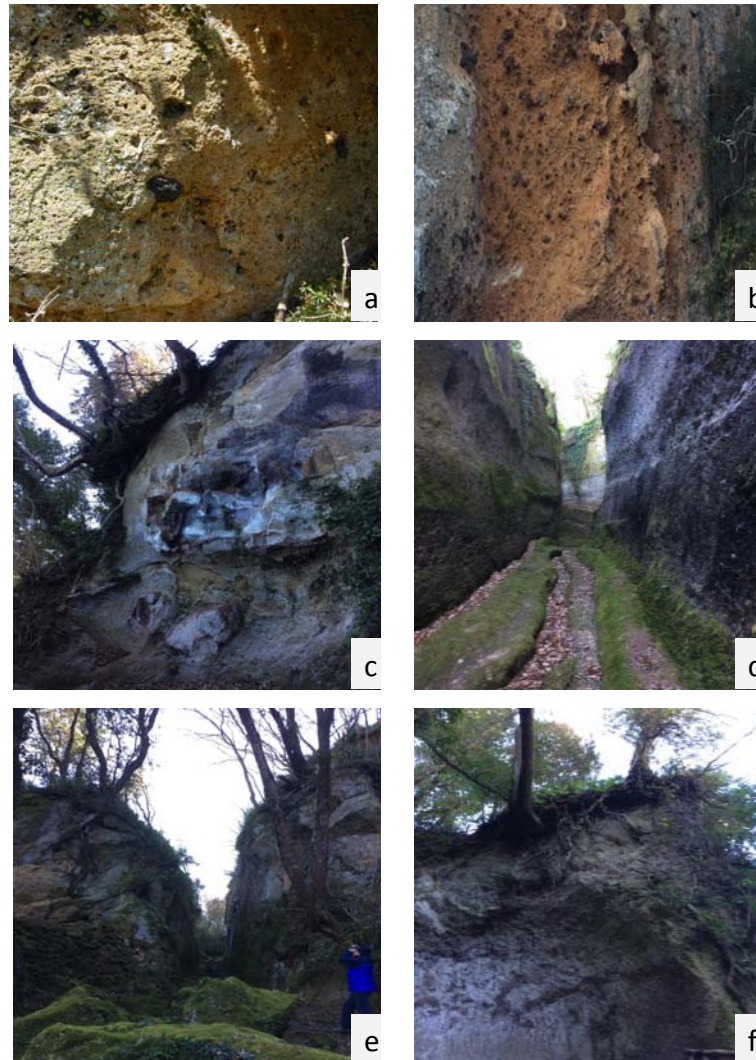
Figure 6. (a,b) Particulars of outcrops of volcanic deposits showing orange colored matrix, and black clasts of pumice; (c) welded grey volcanic deposits in a fractured wall of a *Via Cava*; (d) typical morphological features of a *Via Cava*; and (e) junction of a *Via Cava* with a cliff constituted of ignimbrites. The rock mass is unstable (see the boulders of an ancient fall). (f) Particular of an altered and unstable scarp with vegetal cover.

Volcanic deposits (Figure 6a,b) cropping in the area have mineralogical, physical and textural characteristics influencing the conditions of stability of the structures. The rocks are characterized over all, by a high porosity (variable between 40%–60%) and a high saturation index (variable between 75%–95%) for the presence of zeolites and/or clay minerals having expandable lattice [16]; these characteristics determine an easy decay (e.g., Figure 6b) of the material.

Top flat surfaces are deeply weathered and soil mantle is thick. Vegetation is abundant and usually it consists of evergreen plants. Rainfall is mainly intercepted by leaves and low vegetation and ultimately by soil. Only during very intense storms the runoff is relevant and the *Vie Cave* often act as streams (Figure 6d).

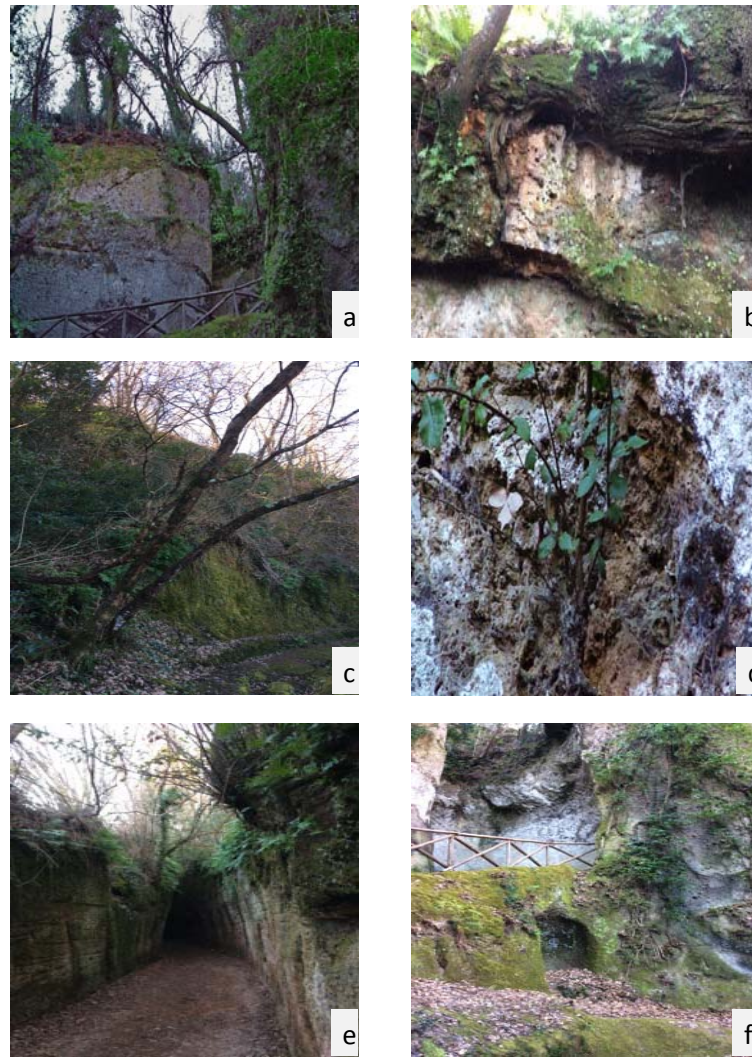
Figure 7. Relationship between vegetation and *Vie Cave* rock walls. (a,c,e) different develop positions of trees and (f) of shrubs; (b) particular jointed root in rock mass; and (d) *Quercus Ilex* growing in a fracture of the rock wall.

- (c) Mixed forests of deciduous and sclerophyllous trees located on the edge of the valley gorges; xeric and thermophilic formations are prevalent, in particular *Quercus ilex* (Figure 7d), which is typically associated with other species such as thermophilic *Acer monspessulanum*, *Quercus pubescens*, and *Fraxinus ornus*.

- (d) Shrubs (Figure 7f), which represent evolutionary stages of abandoned pastures or occupy the edges of meadows, woods and cultivated lands. They are also found in ruderal environments. The composition is related to the different microclimate or soil conditions. Typical species are constituted by *Cornus sanguinea*, *Spartium junceum*, *Cytisus scoparius*, *Prunus spinosa*, *Crataegus monogyna*, and *Erica arborea*.

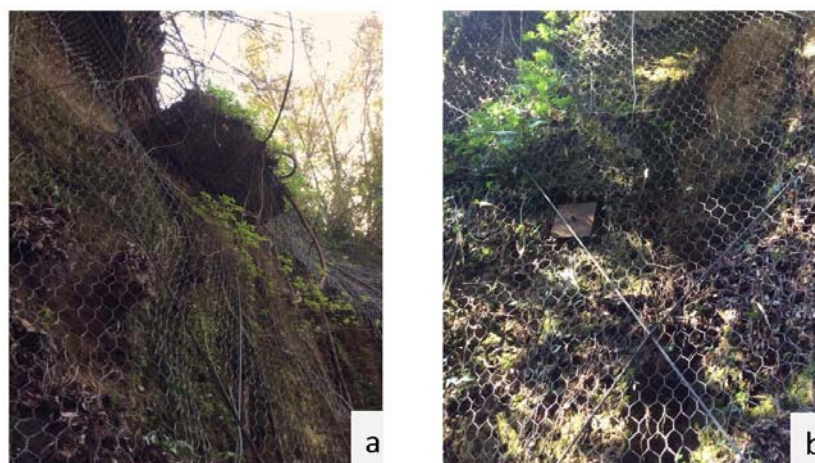
Figure 8. Protection measures used to control rock falls in archaeological sites: (a) cable strands and mesh and (b) particular of mesh blanket.

Finally, the stabilization of the sides of the *Vie Cave* should not be made using wires (Figure 8a,b) as it has been done to date but rather by considering, and trying to limit, the causes that determine the failure.
