# UAV and Structure from Motion Approach to Monitor the Maierato Landslide Evolution

**Abstract:** In February 2010 a large landslide affected the Maierato municipality (Calabria, Italy). The landslide, mainly caused by a period of prolonged and intense rainfalls, produced a mass displacement of about 5 million m<sup>3</sup> and several damages to farmlands, houses and infrastructures. In the aftermath several conventional monitoring actions were carried out. In the current post emergency phase, the monitoring was resumed by carrying out unmanned aerial vehicles (UAV) flights in order to describe the recent behavior of the landslide and to assess residual risk. Thanks to the potentialities of the structure from motion algorithms and the availability of post emergency reconnaissance photos and a previous 3D dataset, the three-dimensional evolution of the area was computed. Moreover, an experimental multispectral flight was carried out and its results supported the interpretation of local phenomena. The dataset allowed to quantify the elevation losses and raises in several peculiar sectors of the landslide. The obtained results confirm that the UAV monitoring and the structure from

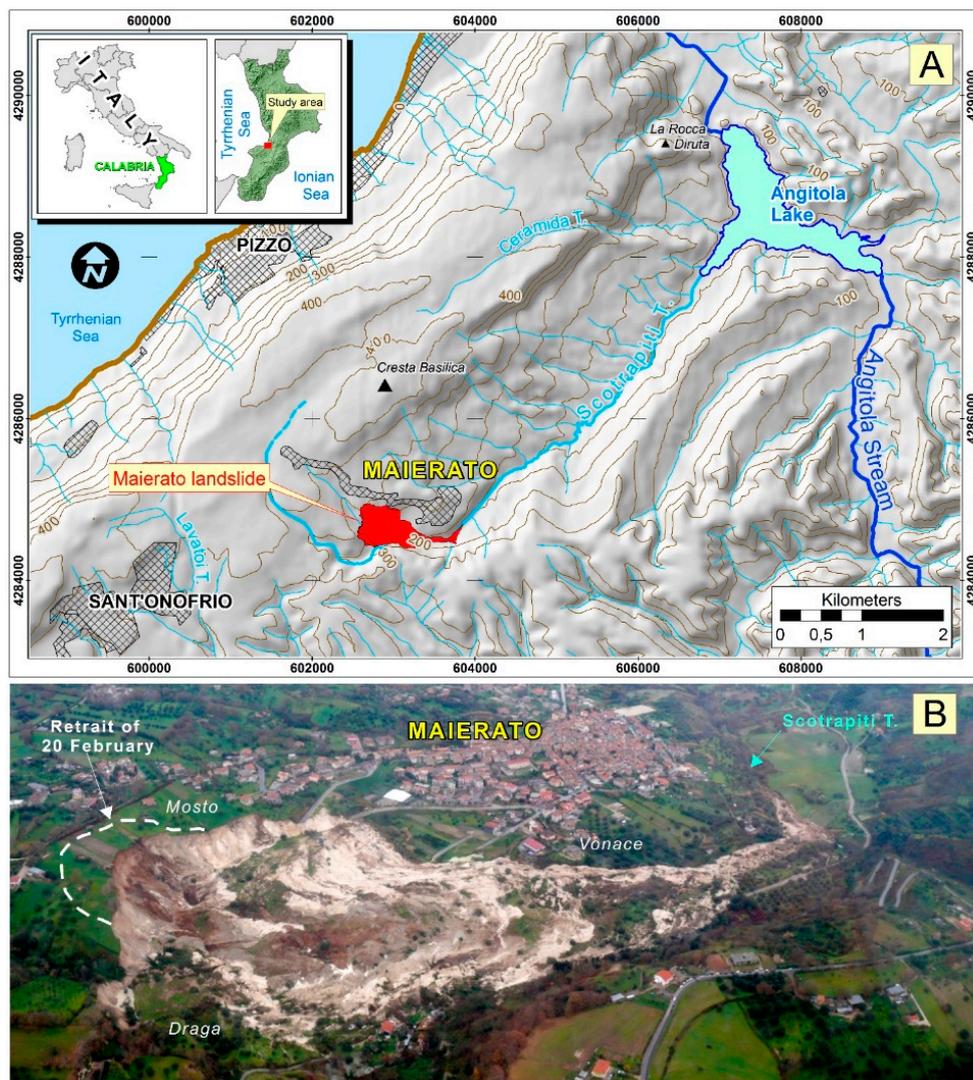
**Figure 1.** Location (A) and panoramic view (B) of Maierato landslide occurred on 15 February 2010 (helicopter photo taken on 16 February 2010, by G.G.).

As explained above, following a rainfall induced landslide event occurred on 15 February 2010 in the Maierato municipality (Calabria, southern Italy; Figure 1A) [35–40] survey campaigns were carried out and a preliminary monitoring network was established [7]. The landslide, that affected the left slope of the Scotrapiti Torrent (Figure 1A), destroyed a part of the S.P. 55 provincial road (about 800 m length) that allow the access to the municipality, moved a building of about 100 m and caused a loss of about 18 ha of farmland. The landslide, that involved a volume of about 5 million cubic meters, represents the reactivation of a preexisting one [35]. It is classified as a complex movement consisting of a very rapid slide of rock and earth and of flow of debris and earth [35]. After the 2010 activation, the landslide showed a subvertical main scarp of about 50 m (Figure 1B) and an overall length of about 1400 m; the main failure surface developed within the hemipelagic marls at a maximum depth of 50 m. During the landslide paroxysmal phase, a significant portion of the Calcare di Base Formation, close to the failure surface, collapsed so changing its mechanical characteristics and assuming a viscous fluid behavior (Figure 1B). This destructured and fluidized limestone allowed a rafting of large rocky blocks without severe disturbance [35].

On 20 February 2010, the main scarp of the Maierato landslide was affected by a retreat of about 80 m (Figure 1B) that affected a surface of about  $2 \times 10^4 \text{ m}^2$  and a volume of about  $4 \times 10^5 \text{ m}^3$ . The landslide, during the 2010 paroxysmal phase, was filmed by an cameraman of a private broadcast company, and is still available online (<https://www.youtube.com/watch?v=oWHjBsvmyLc>).

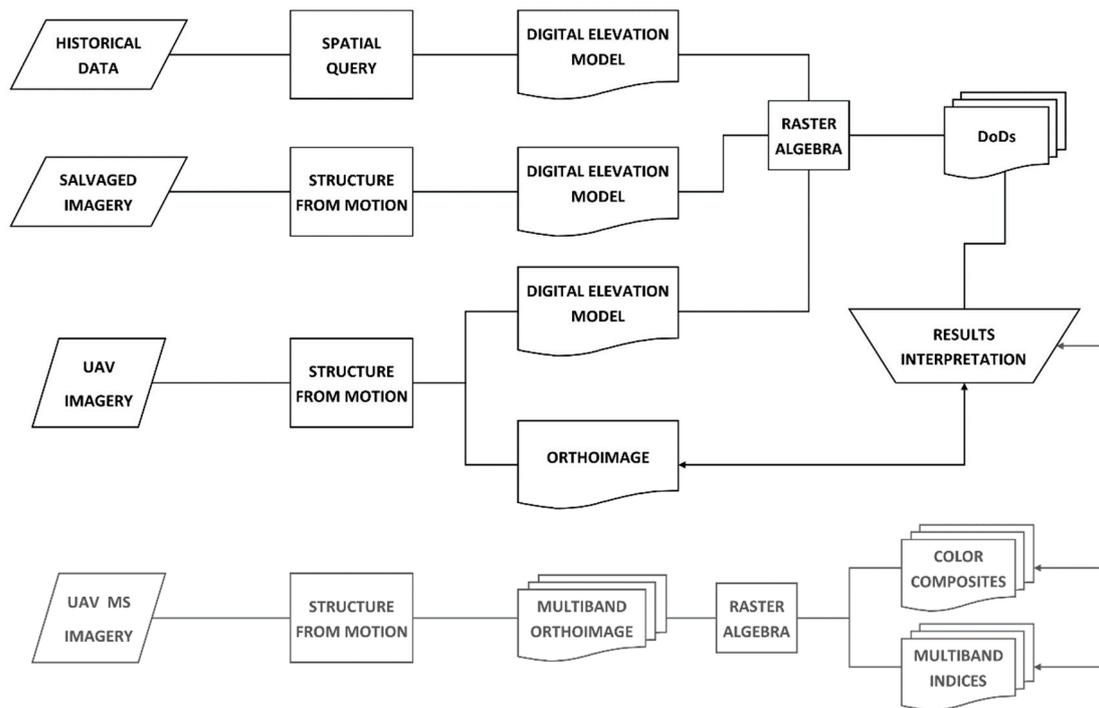
**Figure 2.** Workflow of the proposed methodology, the grey sector was only carried out with an experimental approach.

The workflow of the proposed methodology is shown in Figure 2 and used as main tool a periodic monitoring by UAV [41]. The monitoring of the landslide was initiated after the event with a conventional approach [35,39], particularly the geomorphological study of the area (Figure 1B) was performed through analyses of Google Earth™ multi-temporal high-resolution satellite images and detailed multi-temporal field surveys performed between 2010 and 2019. The updated landslide inventory was mapped on a 1:5000 topographic base map and implemented in a geographic information system (GIS).

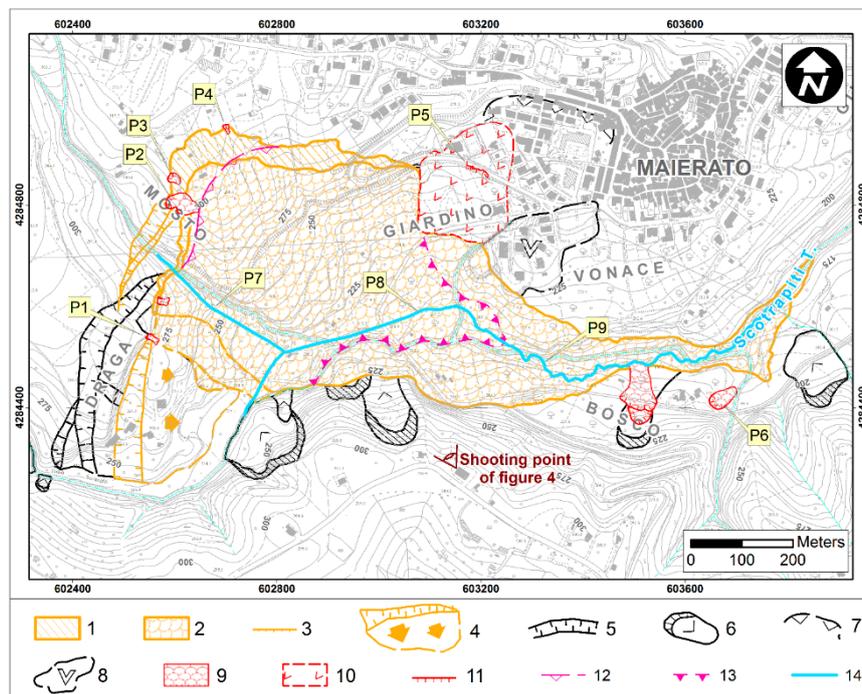
**Figure 3.** Landslide map and locations of the available photographs (shown in Figure 4). Legend: (1) 20 February 2010 landslide scarp; (2) 20 February 2010 landslide body; (3) 20 February 2010 secondary landslide scarp; (4) Draga active block-slide delimited by active graben-like trench; (5) dormant trench; (6) dormant slide; (7) ancient landslide scarp; (8) ancient block-slide with uncertain boundary; (9) 2018 landslide body; (10) active landslide body; (11) 2018 landslide scarp; (12) trace of 15 February 2010 main scarp; (13) toe of the 15 February 2010 sliding surface; (14) Scotrapiti Torrent (present course).

Multitemporal geomorphological field surveys, performed between 2010 and 2019 (whose results are summarized in Figure 3), showed that the Maierato landslide during this period of time has not undergone substantial modifications. Only minor and localized instability phenomena occurred along the main scarp and the margins of the landslide body during the last few years. Specifically, some debris slides of modest size affected the crown of the Maierato landslide (Figure 4, red arrows in photo P1–P4), linked to the attainment of the geostatic balance of the main scarp. Two phenomena typologically related to roto-translational active slides were detected in the Bosco area (Figure 4, photo P6), while a larger slide with an uncertain body, also in a state of activity, was detected in the Giardino area (Figure 4). This slow-moving landslide causes a lowering of the roadway point out by shear or tensile fractures (Figure 4, P5).

The presented results and methodology (Figure 9) showed that the repeated geomorphological surveys (Figure 3) constitute the basis for the next monitoring operations, including UAV flights. The surveys, indeed, highlighted, besides those pointed out by the geomatic monitoring, the absence of remarkable evolutionary phenomena during the investigated time span. Additionally, the helicopter borne reconnaissance photos (February 2010) have provided supplementary data for the processing and the subsequent analyses. In fact, the capabilities of the SfM algorithm have allowed to exploit the availability of images taken immediately after the landslide occurrence and to compute unprecedented 3D data of landslide aftermath. In particular, the availability of previous 3D public dataset allowed to quantify the evolution of the landslide deposit and morphological features, i.e., scarp evolution (Figure 7, DoD 1996–2010). With respect to the aftermath surveys [39,46] the results obtained from the proposed methodology allowed to quantify variations from the original topography ranging from  $-54.8$  m, in the main scarp sector, to  $37.1$  m in the deposit sector. Moreover, the mobile targets combined with the GNSS-VRS allow to register the images in a quick mode optimizing the positioning phase, with the aim of co-registering the survey time series in a repeatable way. Additionally, the adopted method avoids fixed targets installation thus reducing field work and the risk of target damaging. On the other hand, UAV survey is heavily affected by tree canopy cover that can mask ground portion [51,52] thus preventing their measurements, the final 3D model will, in fact, represent, in these areas, the canopy surface instead of the terrain. Concerning the comparison between the first UAV survey (2017) and the 2010 3D model (Figure 7, DoD 2010–2017), the remarkable topographic changes, occurred between 15th and 20th February 2010, are pointed out. In the scarp sector an additional collapse caused a retreat of the crown of up to  $96.7$  m and an elevation reduction of  $54.0$  m. On the other hand, in the central sector a residual deposition of  $18.7$  m occurred. In the southern landslide border an elevation reduction,

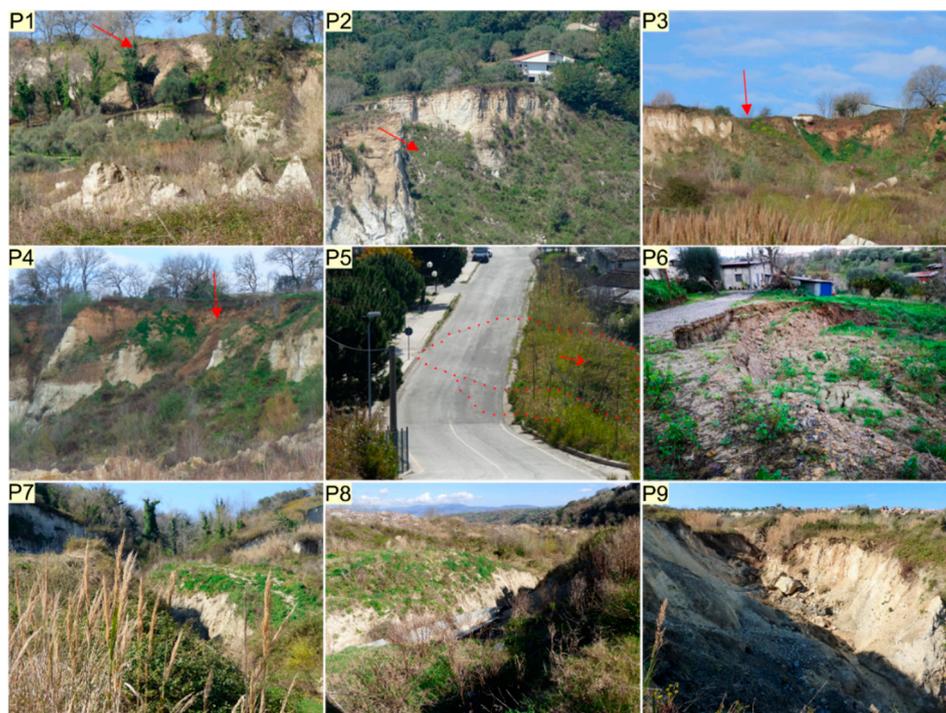
**Figure 4.** Photographs representing landslides (red arrows) activated in 2018 (P1–P6) and the current deepening action with local stream bank erosion along the Scotrapiti Torrent (P7–P9) (photo locations in Figure 3).

In the same period of time, the geomorphological field surveys also show, along the new course of the Scotrapiti Torrent, in the middle and low portion of the 2010 landslide body, a progressive deepening action of the river bed associated with local riverbank erosion phenomena (Figure 4, P7–P9).

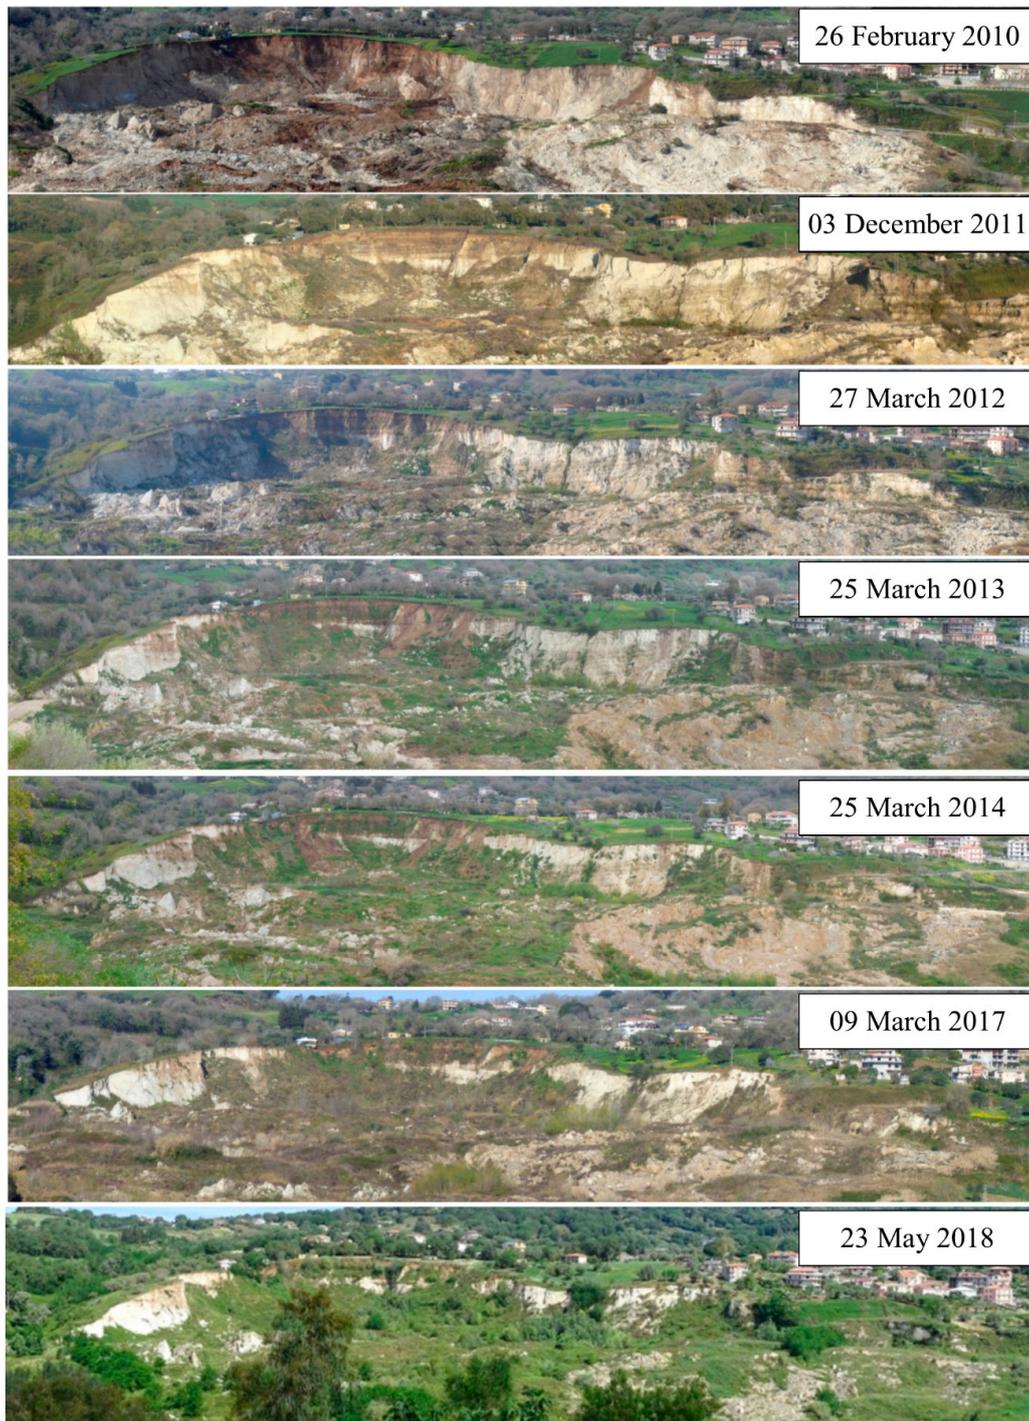
**Figure 5.** Panoramic images time series showing the evolution of the Maierato landslide scarp in the last years.

The multitemporal comparison of panoramic photos (time span from 26 February 2010 to 23 May 2018) of the upper portion of the landslide phenomenon does not show any remarkable retreat of the main scarp and its crown (Figure 5), while it allows to observe a variation of the soil coverage mainly determined by the regrowth of vegetation (trees and shrubs) in the area affected by the landslide. Moreover, in the same time interval, the comparison of the photos shows a generalized lowering of the topographic surface in the landslide body mainly linked to the disintegration and compaction of the lithotypes involved in the mass movement (Figure 5).

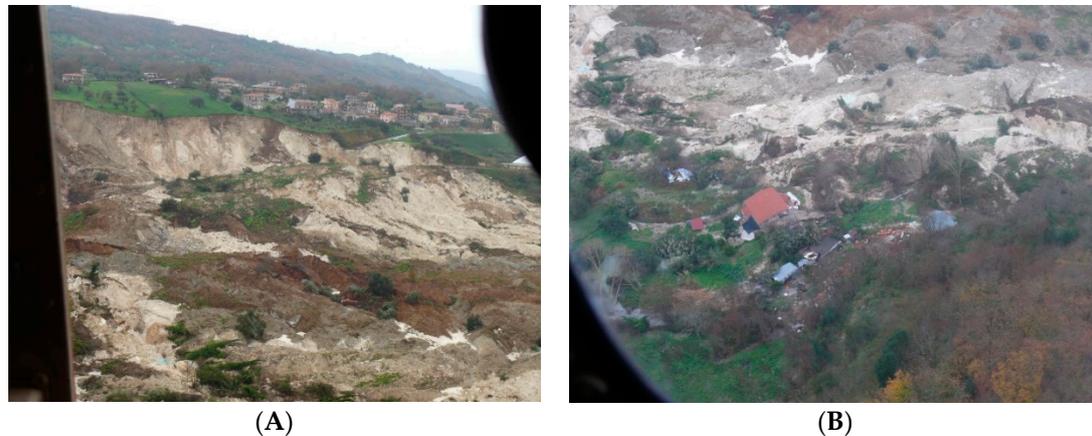
**Figure 6.** Examples of reconnaissance photographs taken from helicopter (on February 16, 2010), characterized by obstacles in the frame (A) or very oblique shot (B).

even of the salvaged dataset, acquired with completely different purposes (Figure 6) and, to compute an unprecedented DEM. The registration and co-registration procedures provided results as much accurate as the SfM performance as shown in Table 3.

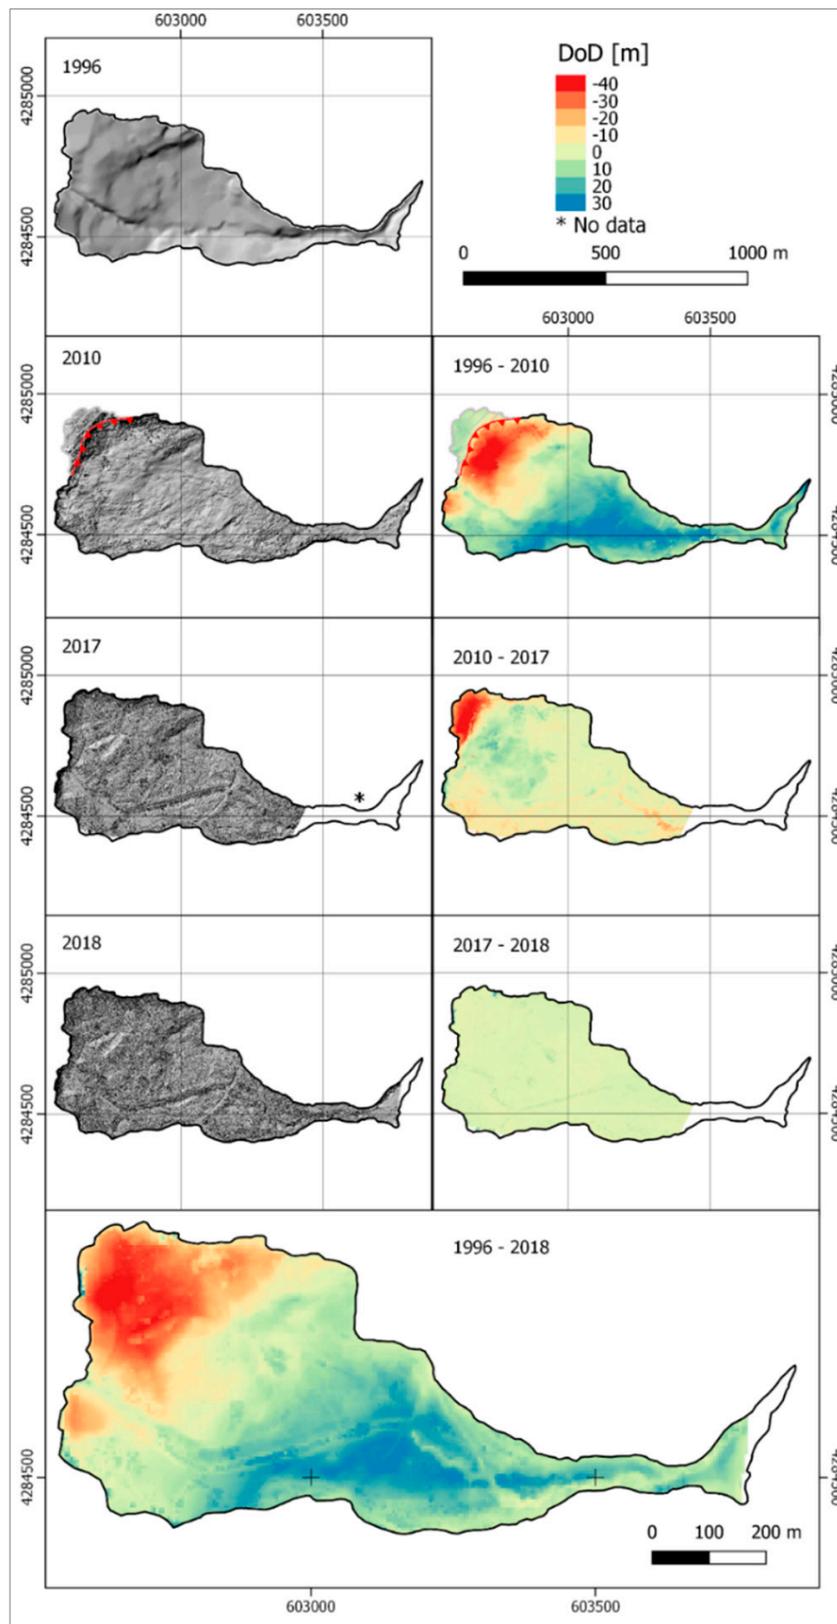
**Figure 7.** Hillshades (left) and DEM of differences (DoDs) (right) of the landslide (RS: UTM WGS84—Zone 33N; EPSG code 32633). The red line in the 2010 hillshade and in the 1996–2010 DoD represent the landslide scarp of 15 February 2010.

By exploiting the pre-failure 1996 DTM, and the 16 February 2010 DTM, it was possible to quantify the variations occurred immediately after the landslide (Figure 7, DoD 1996–2010). The obtained DoD highlighted the formation of a scarp of up to 54 m and of a deposition area of comparable height. The DoD 2010–2017 highlights both the landslide scarp retrogression (which took place on 20 February 2010), which produces a lowering of the topographic surface of about 40 m, and emphasizes several evolution phenomena in the deposit sector of the landslide (Figure 7, DoD 2010–2017); it is, in fact, clearly evident the onset of an erosion process in the riverbed of Scotrapiti Torrent which was channeled through the landslide deposit. The DoD 2017–2018 highlights small topographical variations within the landslide affected area. In particular, the channel sector is characterized by the growth of poplar and willow trees, while the upper part of the deposit sector is characterized by erosion processes that bring to light large rock blocks (where the original stratigraphy is preserved), characterized by higher density, showing an initial onset of pioneer vegetation (Figure 7, DoD 2017–2018). Finally, the overall topographical/morphological changes of the landslide affected area are shown in the DoD 1996–2018 (Figure 7).

The evaluation of the differences between the two UAV 3D models (Figure 7, DoD 2017–2018) at a homogeneous scale color reveals non-substantial changes. However, an additional representation with a customized color scale (Figure 10) has provided insights of the local variations of the investigated areas. Particularly the progress of the erosive processes in the lower stretch of the Scotrapiti Torrent is visible. A diffuse, yet shallow, erosive dynamic can be noticed in the main scarp sector, too. The areas still featuring an elevation increase show the growth of vegetation in the channeled part of the Scotrapiti Torrent and in other sector of the deposit.

Generally, the UAV survey allowed to quantify the modification occurred from the event until the last flight. In the DoD 1996–2018 of Figure 7, the elevation reduction in the crown sector reached values up to  $-46.7$  m, conversely in the deposit sector the maximum increase in elevation resulted as  $35.5$  m.

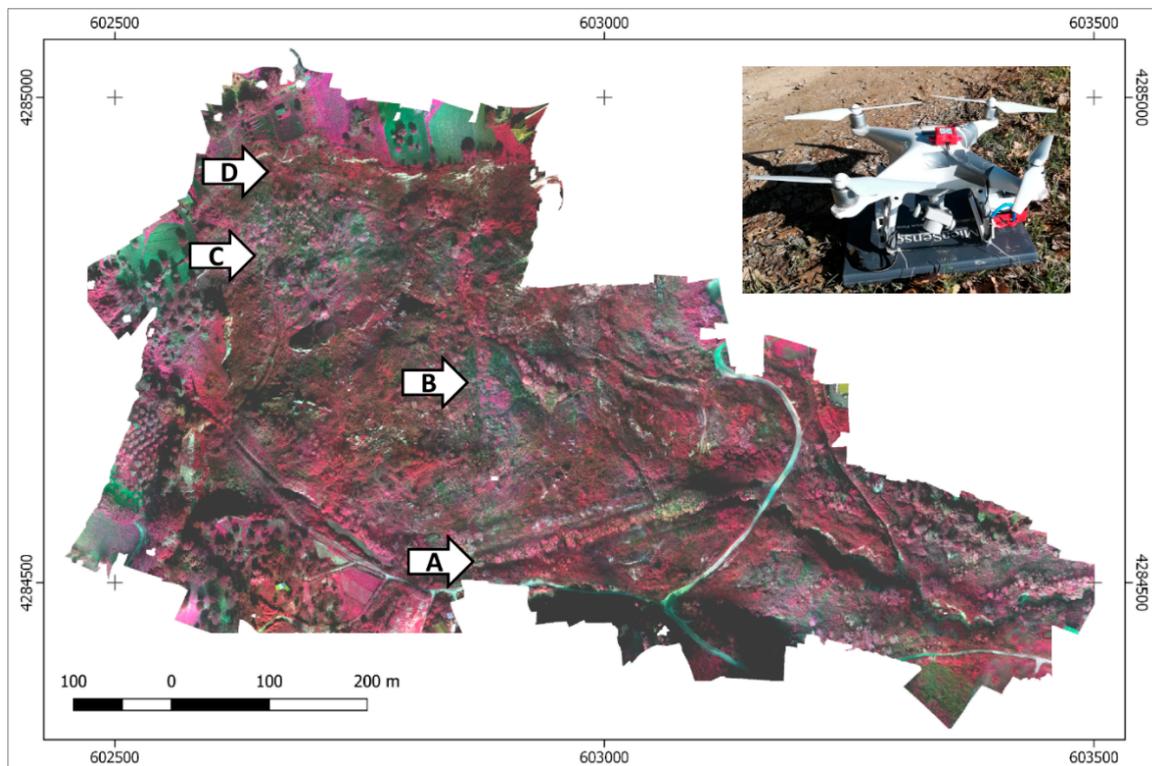
**Figure 8.** CIR orthoimage resulted from the multispectral (MS) flight; in the inset picture: UAV equipped with MS sensor. Arrows indicates peculiar sectors of the orthoimage where vegetation dynamics are interpreted.

To provide additional information in the interpretation of the landslide evolution, the experimental MS flight was successfully carried out [49]. The UAV set-up with customized supports (Figure 8, inset), crafted with a 3D printer, allowed to perform the survey without remarkable influence on UAV flight stability and duration. The preliminary result, a Color-infrared (CIR) composite [50] orthoimage (Figure 8), provided an identification of some sectors characterized by dense tree cover in clear stress (Figure 8A–C) or by several trees in healthy condition (Figure 8D). These results offer the opportunity for additional insights into the interpretation of the current state of the landslide deposit.

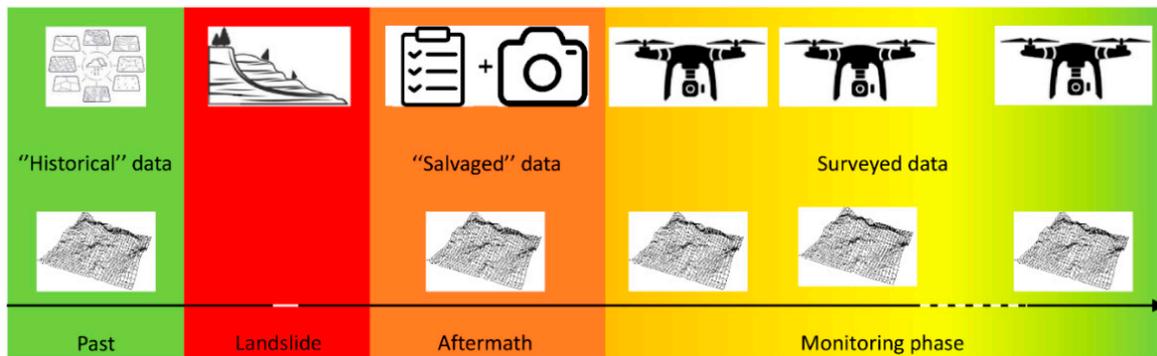
Figure 9. Recapitulatory scheme of the proposed methodology.

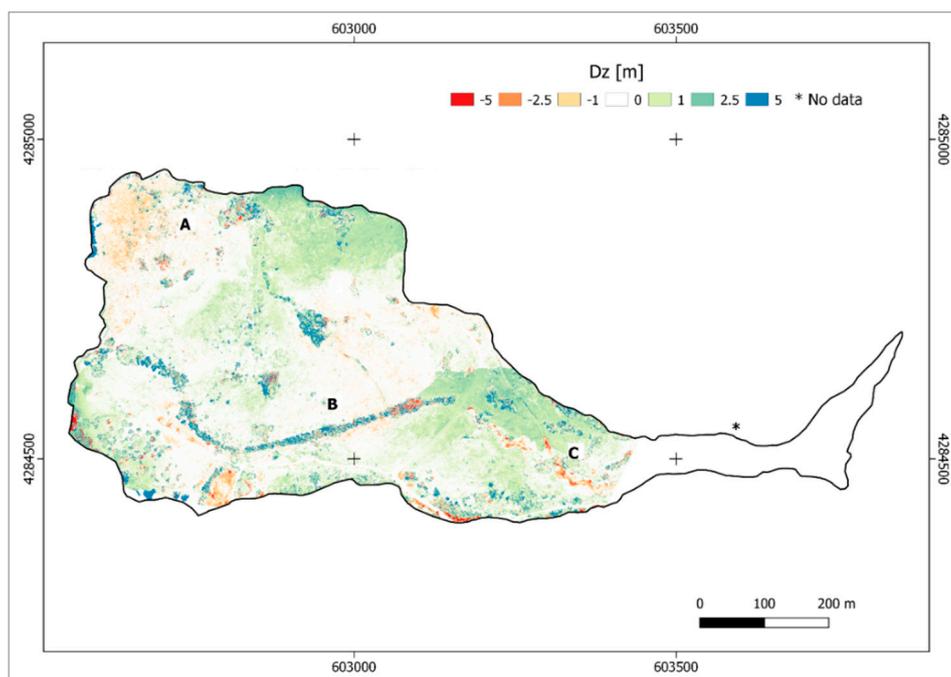
Figure 10. Detail of the 2017–2018 DoD with a customized color scale.

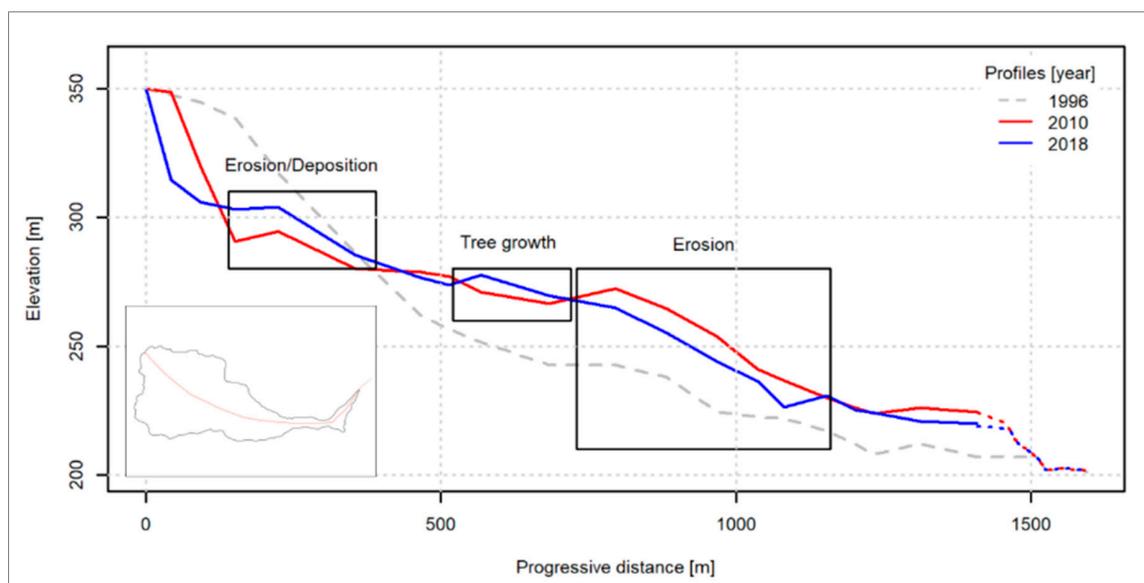
**Figure 11.** Cross section comparison depicting landslide evolution, the dotted lines represents the hypothetical profile outside the landslide border connecting with the undisturbed one.

Definitely, the UAV surveys resulted in an effective spatial representation of the studied area, allowing a continuous analysis of the investigated phenomenon. The repeated survey highlighted, contemporarily, several evolutionary processes dynamics in different landslide sectors (Figure 11), mainly in the scarp and in the main body: (i) retrogressive evolution of the scarp; (ii) erosion of the main body; (iii) onset of pioneer vegetation; (iv) erosion in the non-channeled riverbed of the Scotrapiti.

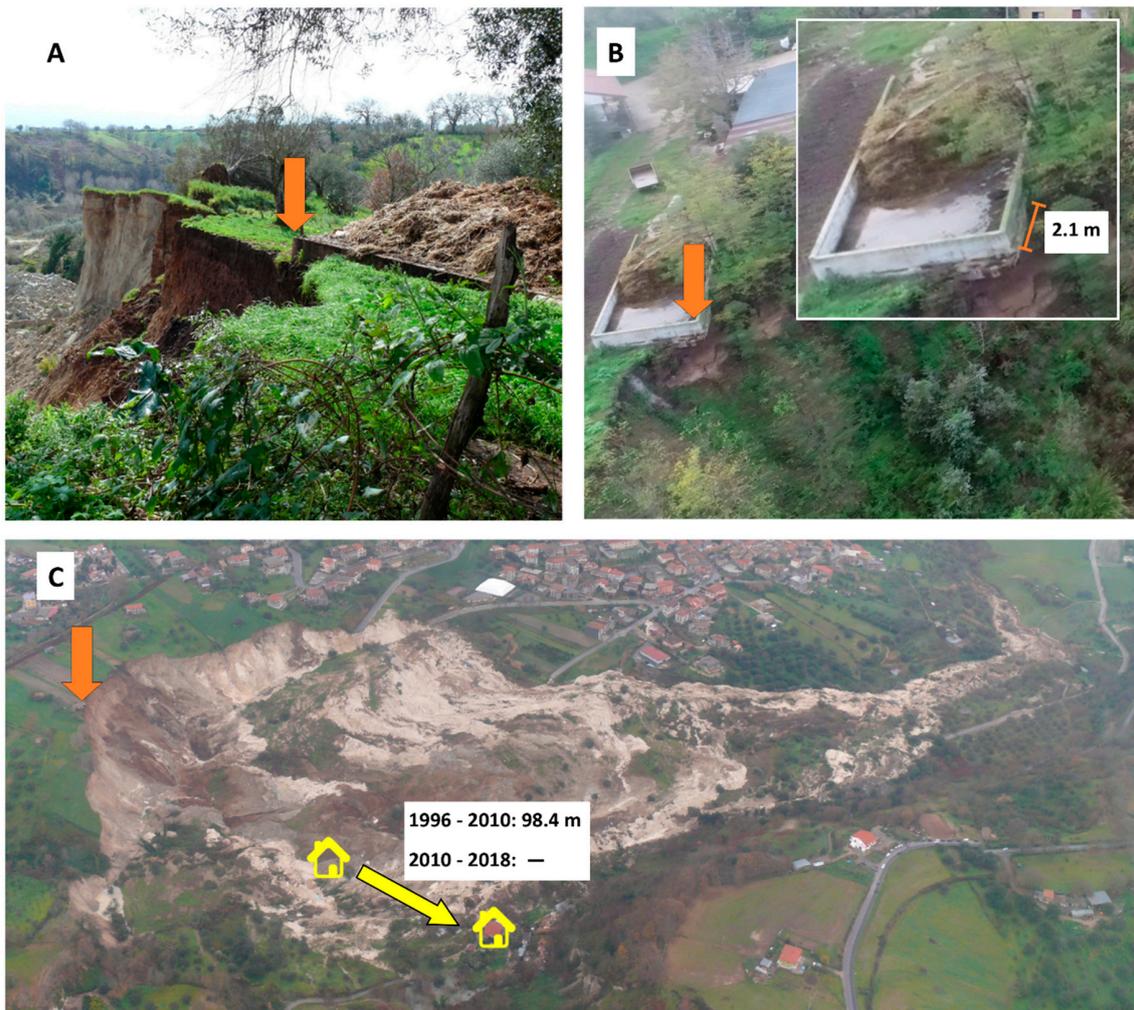
**Figure 12.** Evaluation of retrogressive evolution of the landslide: qualitative comparison between the terrestrial reconnaissance photograph (A) and the UAV survey (B); (C) measurement of the displacement of a building moved by the landslide.

Concerning residual risk assessment, the retrogressive dynamic, that represent the most critical phenomenon, as it can endanger area previously unaffected by the landslide, is also confirmed by qualitative comparison of homologous features recognizable in the reconnaissance image set and in the UAV imagery (e.g., Figure 12 clearly show the scarp evolution in correspondence of a manure-heap located in the crown area). Moreover, Figure 12C shows the pre- and post-landslide position of a building located in the landslide area and the displacement of 98.4 m measured from the comparison between 2010 and 1996 DTMs, confirmed by the same analysis carried out on 2018 and 1996 DTMs which did not highlight further shift.

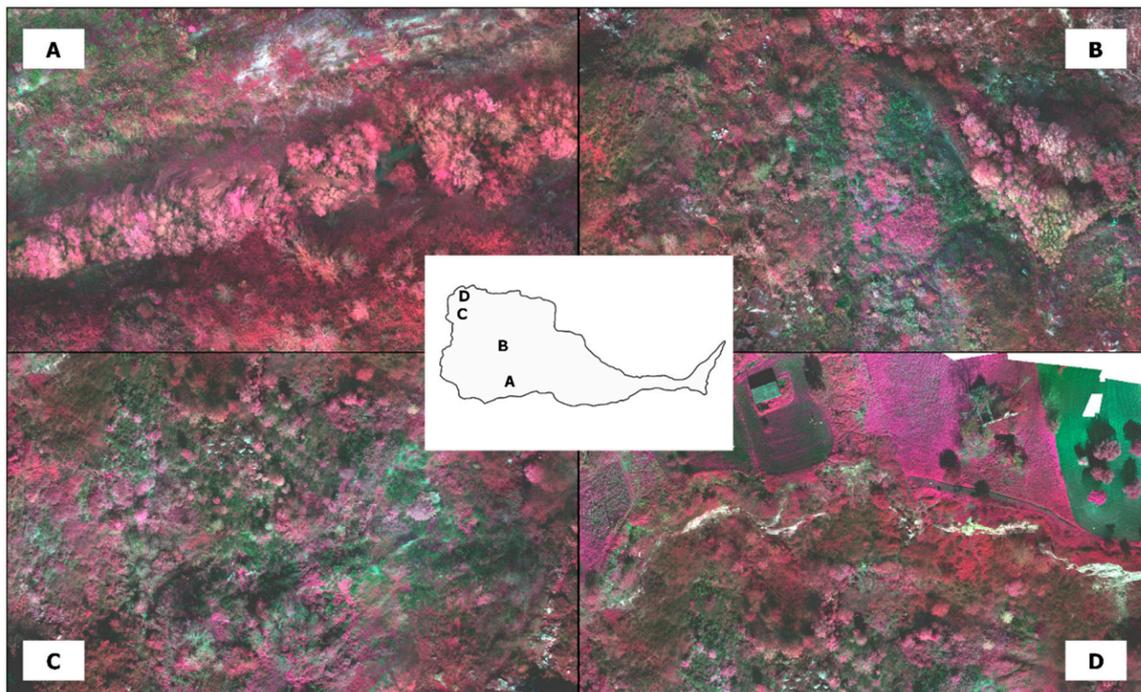
**Figure 13.** Details of four peculiar sectors of the landslide depicting different vegetation behavior that could be related with local dynamics.

The experimental MS survey provided additional hints for the interpretation of the phenomena in the post emergency phase. Particularly (Figure 13), sector A identifies a stretch of Scotrapiti Torrent featuring a dense tree cover in clear stress [55]; the same condition is present in sectors B and C where pioneer vegetation struggle to colonize landslide displaced materials characterized by scarcely evolved soils. On the other hand, in some sectors close to the landslide crown (sector D) there are several trees in healthy condition, due to the translation of large mixed blocks, preserving the integrity of roots and topsoil. The execution of a second flight could add further elements and allow the accomplishment of a change detection analysis for an in deep investigation.
