# Using Keyhole Images to Map Soil Liquefaction Induced by the 1966 Xingtai $M_s$ 6.8 and 7.2 Earthquakes, North China

**Abstract:** In March 1966,  $M_s$  6.8 and 7.2 earthquakes occurred in Xingtai, North China, resulting in widespread soil liquefaction that caused severe infrastructure damage and economic losses. Using Keyhole satellite imagery combined with aerial images and fieldwork records, we interpreted and identified 66,442 liquefaction points and analyzed the coseismic liquefaction distribution characteristics and possible factors that influenced the Xingtai earthquakes. The interpreted coseismic liquefaction was mainly concentrated above the IX-degree zone, accounting for 80% of all liquefaction points. High-density liquefaction zones (point density  $> 75$  pieces/ $\text{km}^2$ ) accounted for 22% of the total liquefaction points. Most of the interpreted liquefaction points were located at the region with a peak ground acceleration (PGA) of  $> 0.46$  g. The liquefaction area on 22 March was significantly larger than that on 8 March. The region of liquefaction was mainly limited by sandy soil conditions, water system conditions, and seismic geological conditions and

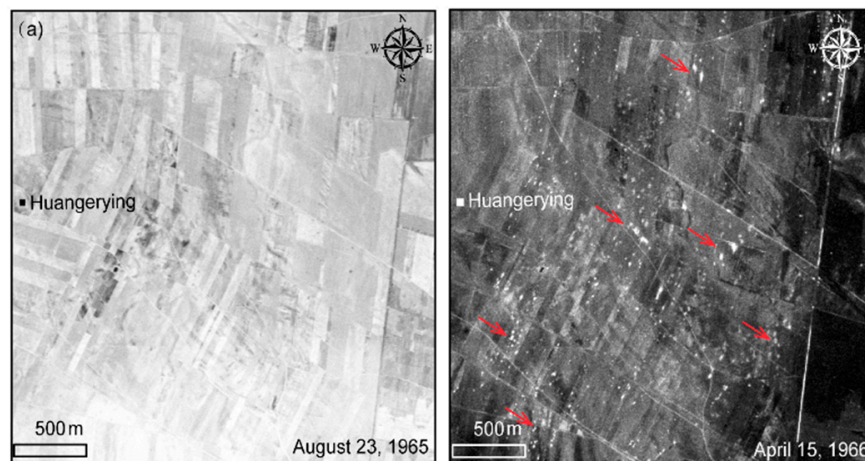
**Figure 9.** Cont.

**Figure 9.** Distribution features of liquefaction points shown on the image. (a) Haphazard and scattered point-like distribution; (b) bead-like and line-like distribution; and (c) block or sheet-like distribution. Red arrows show the locations of coseismic soil liquefaction points during mainshocks.

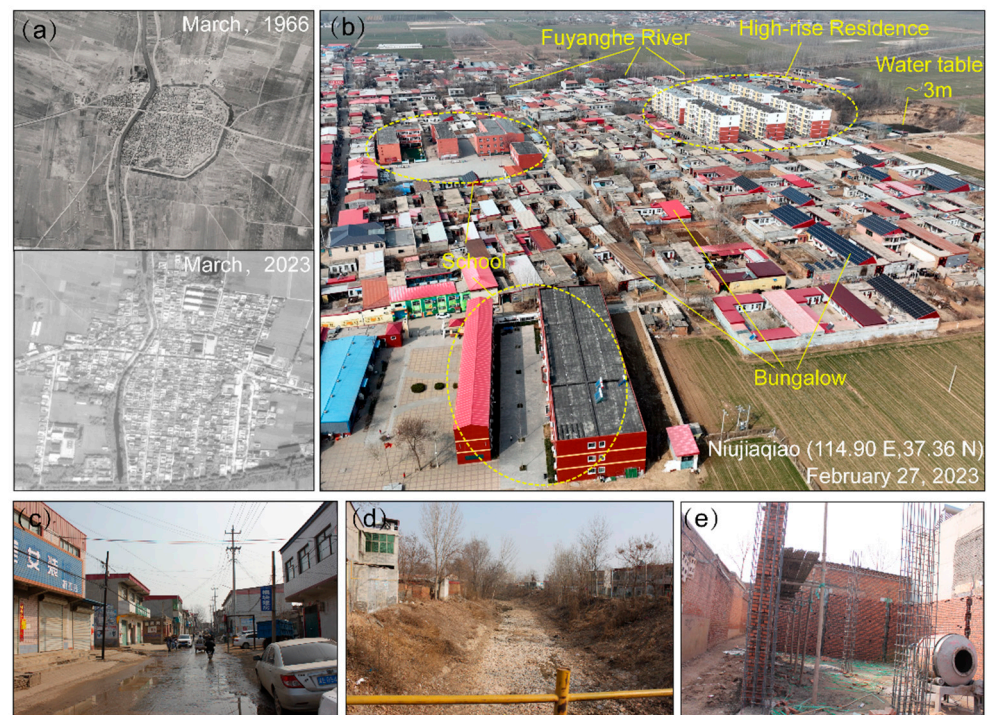
**Figure 15.** (a) Images of the range of buildings in Niujiqiao village in 1966 and 2023 at the locations shown in Figure 14; (b) UAV photo of Niujiqiao village near the epicenter of the earthquake on 8 March 1966 (taken on 27 February 2023), with most of the extended houses built as bungalows with no seismic-resistant measures and few of the school and residential buildings exhibiting seismic-resistant structures; (c) two-story houses next to streets with no seismic-resistant measures; (d) houses built around the adjacent dried-up river channel with no seismic-resistant structures; and (e) new construction of a small number of houses with structural columns.

liquefaction-resistant foundations in rural buildings (Figure 15). Thus, there is a possibility of a situation similar to the 1964 Niigata earthquake in Japan, where an entire building collapsed without damage [72]. Therefore, most newly built houses in the epicenters have safety risks. Seismic damage is frequently repeated, and seismic damage that occurs in a region during a strong earthquake is often repeated during subsequent earthquakes; an example is liquefaction, which occurred continuously and repeatedly in the same place during the 2011 Canterbury earthquake sequence [2]. Luanxian County (now referred to as Luanzhou City) in Hebei Province has experienced repeated sandblasting during multiple earthquakes [73,74]. Governments and relevant departments should learn from the experience of liquefaction damage caused by the Xingtai earthquakes, enact good defensive and mitigation countermeasures, carry out analyses and research on the liquefaction risk of rural sites, and require appropriate seismic reinforcement for already-built houses and seismic defenses for newly built houses in liquefaction-prone areas.
