Article

A Feasibility Study of Thermal Infrared Imaging for Monitoring Natural Terrain—A Case Study in Hong Kong

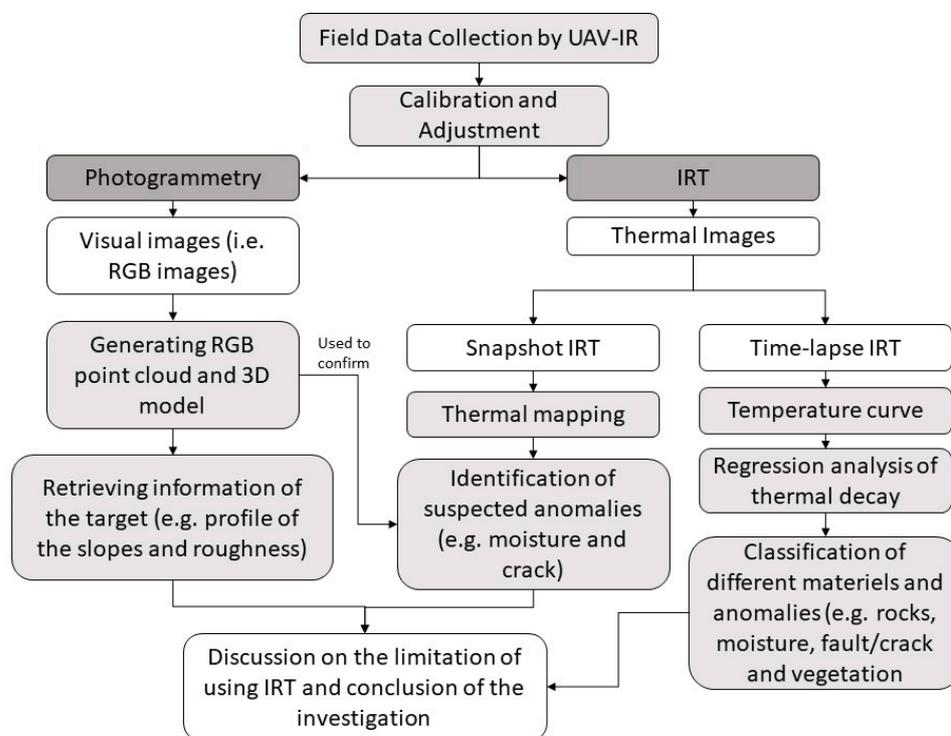
Figure 1. Methodology of the research.

For the characterization of (a) slope features, it is basically due to the difference of thermal diffusivity in rock, soil, crack, and vegetation according to Equation (1), and the difference in emissivity. In Equation (1), it is proposed to measure $\frac{\partial T}{\partial t}$ at any particular locations/geo-referenced coordinates in the course of heat absorption during sunrise and heat dissipation during sunset. Therefore, all field data were collected in the summertime, when the thermal contrast is larger, and time-lapse (within the same day analysis) analysis was applied. Temperature values were extracted from thermal images, then normalization and linear regression of the natural logarithm of time and temperature values were used to perform classification of different materials and anomalies according to the gradient value obtained from regression analysis.

For the characterization of (b) hidden defects such as water seepage/seepage zones/vegetation, all kinds of slope features which are related to moisture (such as water seepage, seepage zones or vegetation) appear as cold spots in the infrared images. This is because of surface cooling caused by water evaporation. Such characterization is also best conducted in

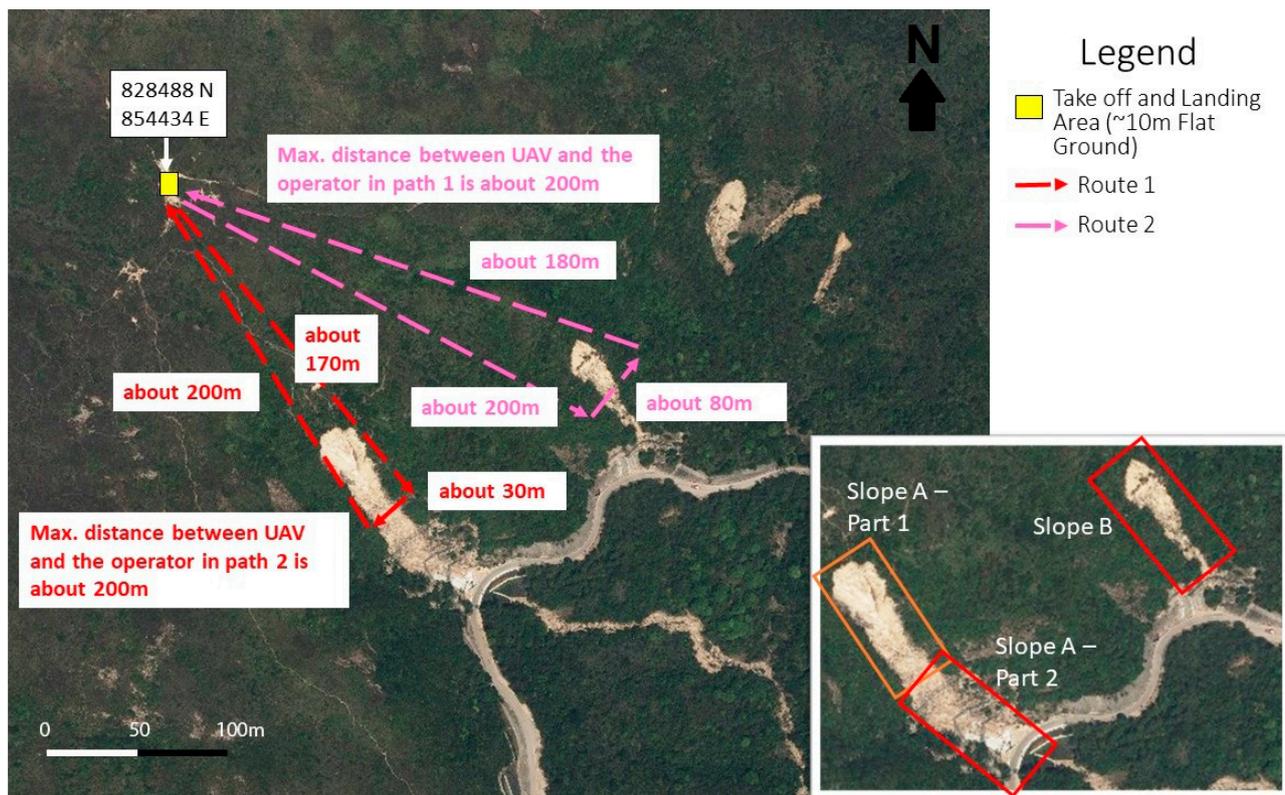
Figure 3. Route 1 and route 2 performed by the UAV to acquire both visible and infrared data. The locations of Slope A and B are indicated in the region in red, which Slope A is separated into 2 parts, part 1 (in orange) and part 2 (in red).

Due to the large size of the whole area, the survey zone was divided into two areas, Slope A (Part 1 and Part 2) and Slope B, where Part 1 of Slope A was identified as the source area of the landslide [33]. Slope A consists of bare rock surface surrounded by vegetation while Slope B consists of soil covered with sparse vegetation, where a relict landslide had occurred [33].

Data were collected on 9 September 2021. Thermal images were captured every 30 min from 11:00 to 18:00 to evaluate the difference in temperature through a time-lapse analysis. The weather on the scheduled survey day was sunny, and the atmospheric temperature recorded was between 26.4 and 33.8 °C. The wind speed on site was around 2 m/s.

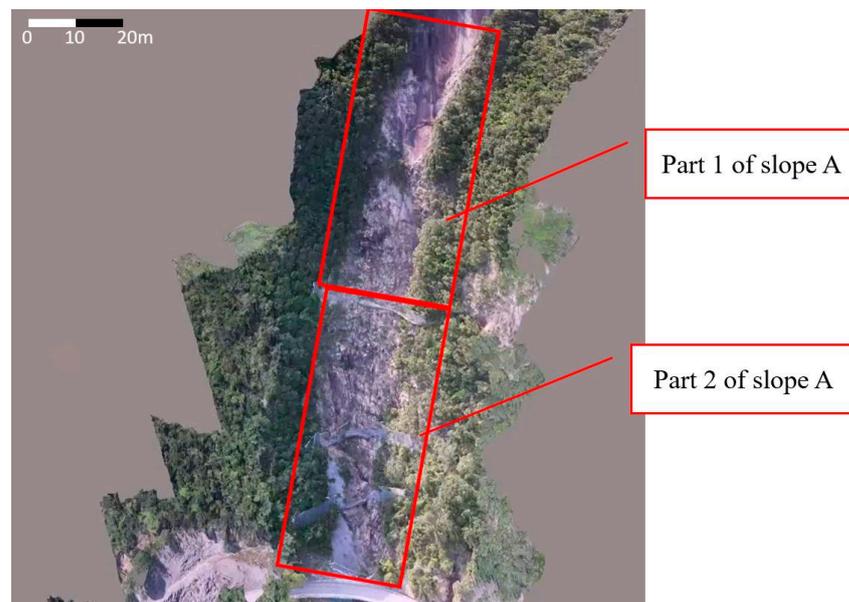
Figure 4. 3D model of the Sai Wan Slope (Slope A).

The 3D model of Slope A (Figure 4) and Slope B (Figure 5) of the Sai Wan Road site were constructed via photogrammetry using high resolution visual images collected using

As shown in Figures 4 and 6a, Slope A is characterized by a steep but apparently flat surface. The average distance from the UAV to the surface was 115 m and the instantaneous field of view (IFOV) was 204.39 cm². A high contrast in temperature was detected between different materials (observed in Figure 6b). The average range in temperature at about 11:00 was 28.1 °C to 45.1 °C, and at about 13:00 was 32.7 °C to 50.7 °C.

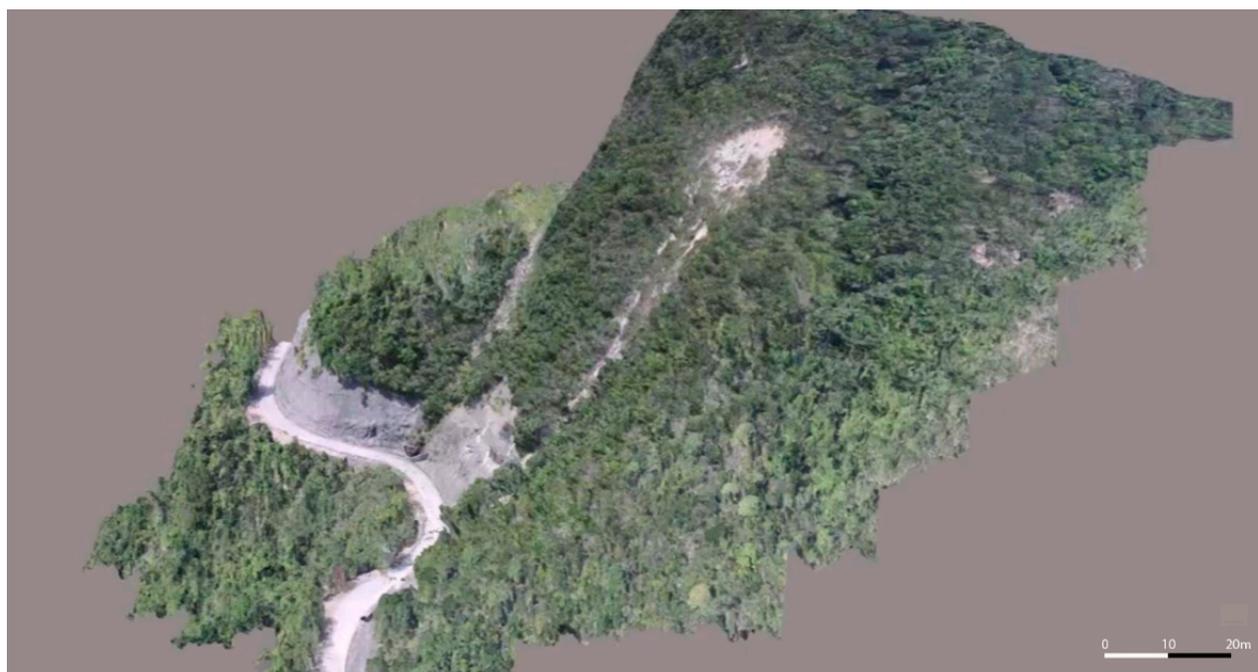
Figure 5. 3D model of the Sai Wan Slope (Slope B).

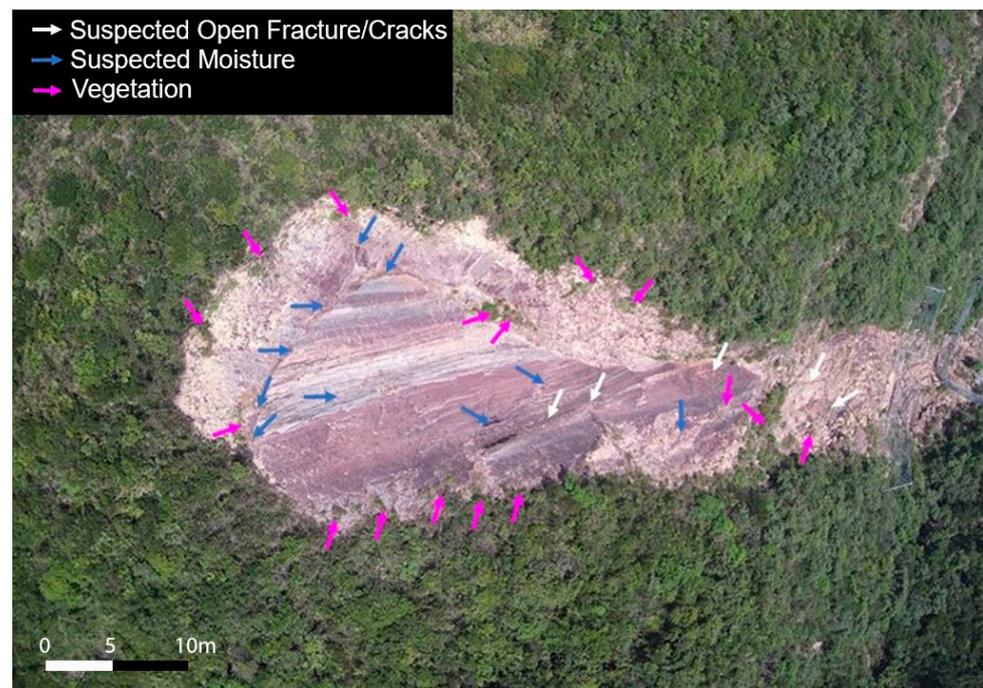
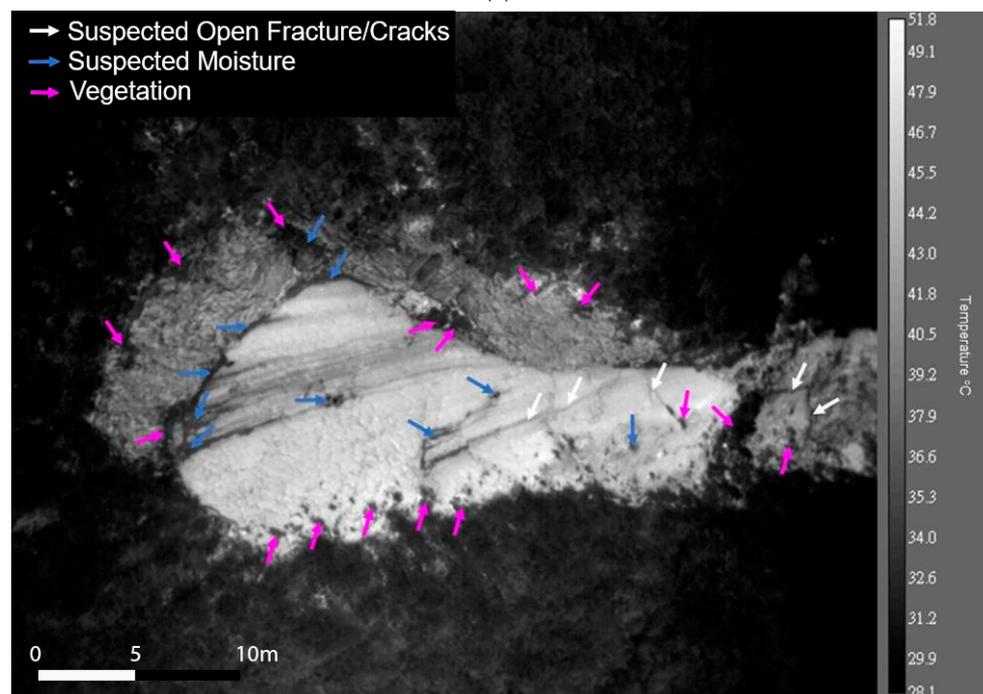
Figure 6. (a) Image acquired at 12:00 (hh:mm) in Slope A (Part 1), Sai Wan: visual image. (b) Image acquired at 12:00 (hh:mm) in Slope A (Part 1), Sai Wan: infrared image (grayscale).

Figures 6 and 7 present the visual and infrared images with identified anomalies acquired at 12:00 and 17:30, respectively. The observed features in both images could be related to open fractures/cracks (white arrows with lower temperature), suspected moisture (blue arrows with lower temperature), and vegetation (magenta arrows with lower temperature). Due to the natural decay of temperature towards sunset, the scale was re-adjusted to the maximum and minimum temperature observed in the region of interest, i.e., the slope, to facilitate the identification of features.

From both Figures 6 and 7, vegetation, which was indicated as magenta arrows, could be identified in the surrounding area while a few scant vegetation were spotted inside the landslide scar. Suspected moisture, indicated as blue arrows, could be identified along the shear zones, where seepage in the same region was reported in [33]. Suspected cracks, indicated as white arrows, could be identified clearly in Figures 6b and 7b, i.e., thermal images. However, in Figures 6a and 7a (i.e., visual images), it could not be easily identified as none or a very pale line could be observed.

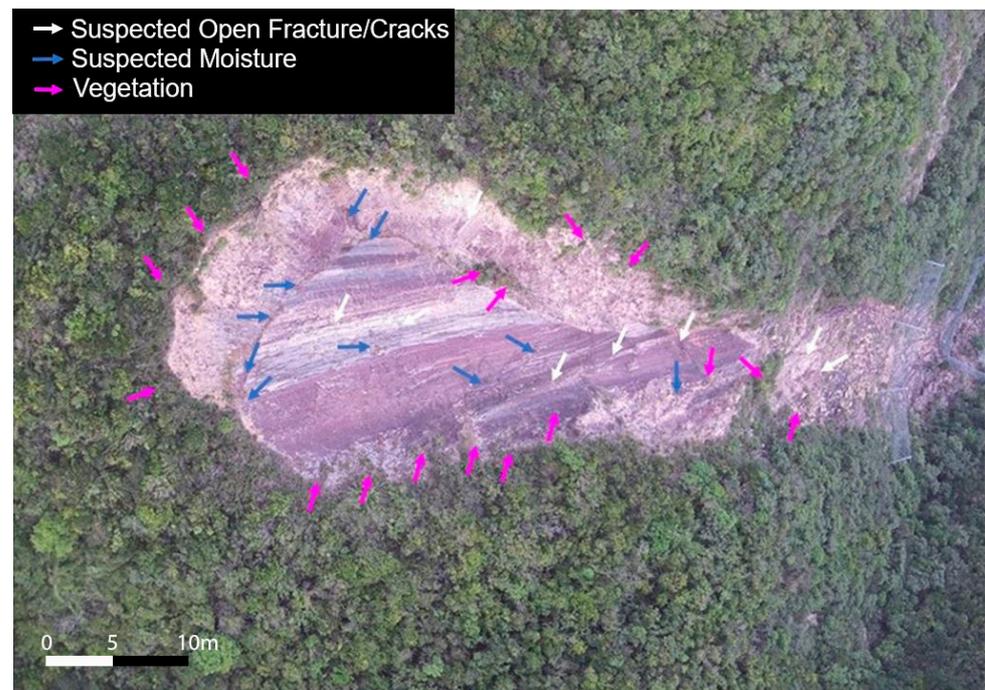
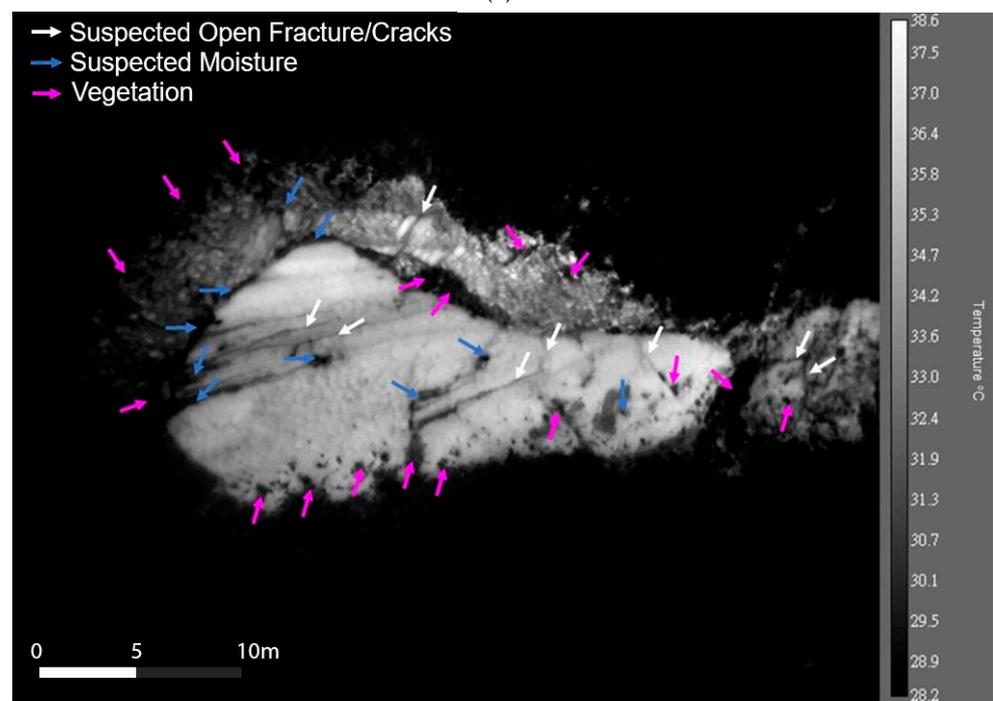
Figure 7. (a) Image acquired at 17:30 (hh:mm) in Slope A (Part 1), Sai Wan: visual image. (b) Image acquired at 17:30 (hh:mm) in Slope A (Part 1), Sai Wan: infrared image (grayscale).

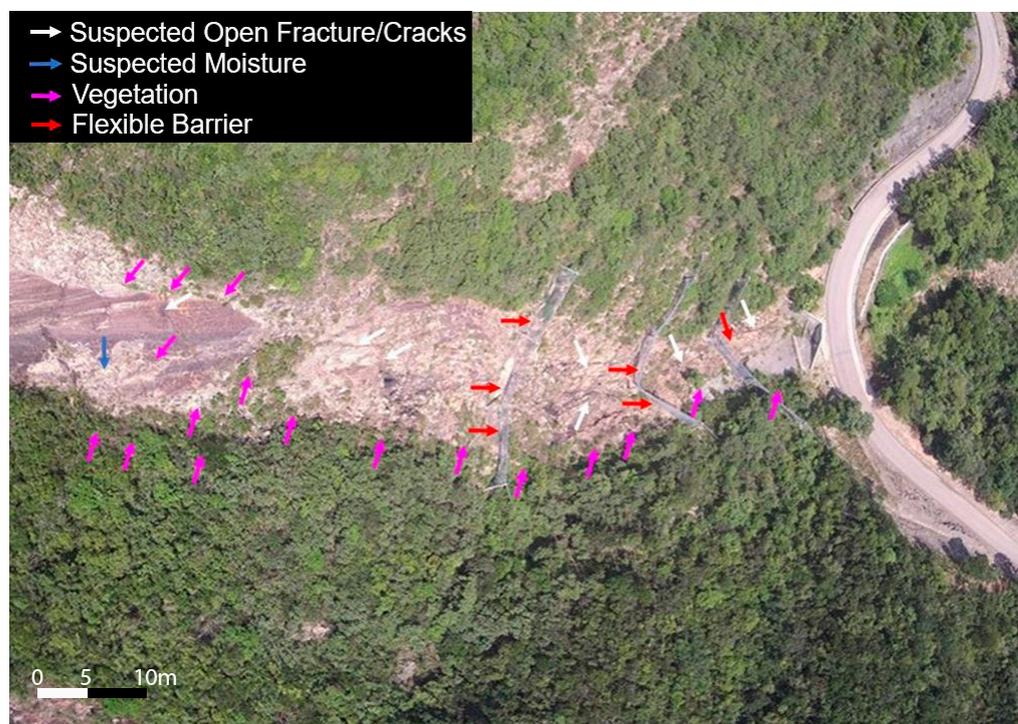
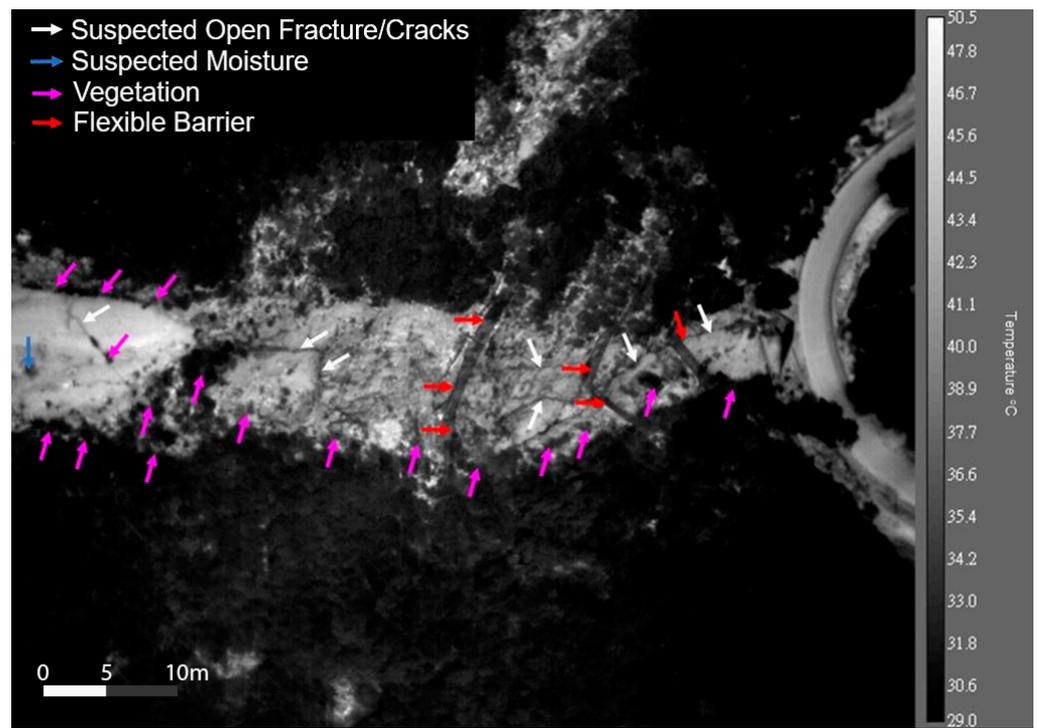
Figure 8. (a) Images acquired at 12:00 (hh:mm) in Slope A (Part 2), Sai Wan: visual image. (b) Images acquired at 12:00 (hh:mm) in Slope A (Part 2), Sai Wan: infrared image (grayscale).

Part 2 is the area below Part 1, as shown in Figure 4. The same procedure was applied to this section. From both visual and infrared images (Figures 8 and 9), again features are related to open fractures/cracks (white arrows with lower temperature), suspected moisture (blue arrows with lower temperature), and vegetation (magenta arrows with lower temperature). Even a flexible barrier (for resisting landslide debris) (red arrows with lower temperature) was clearly identified in both pairs of pictures. It should be noted that the suspected open fractures and moisture identified in the thermal images are not obvious in visual images. This is the merit of using infrared thermography for identifying such kinds of defects not in the visible wavelength.

From both Figures 8 and 9, vegetation, which was indicated as magenta arrows, could be identified along the landslide scar. Suspected moisture, indicated as blue arrows, could be identified on the left and no visible objects could be observed in the same position on the visual image. Suspected cracks indicated as white arrows could be identified clearly in Figures 8b and 9b, i.e., thermal images. However, in Figures 8a and 9a (i.e., visual images), it could not be easily identified as none or a very pale line could be observed. Flexible barriers, indicated as red arrows, could be clearly identified in both thermal and visual images next to the road.

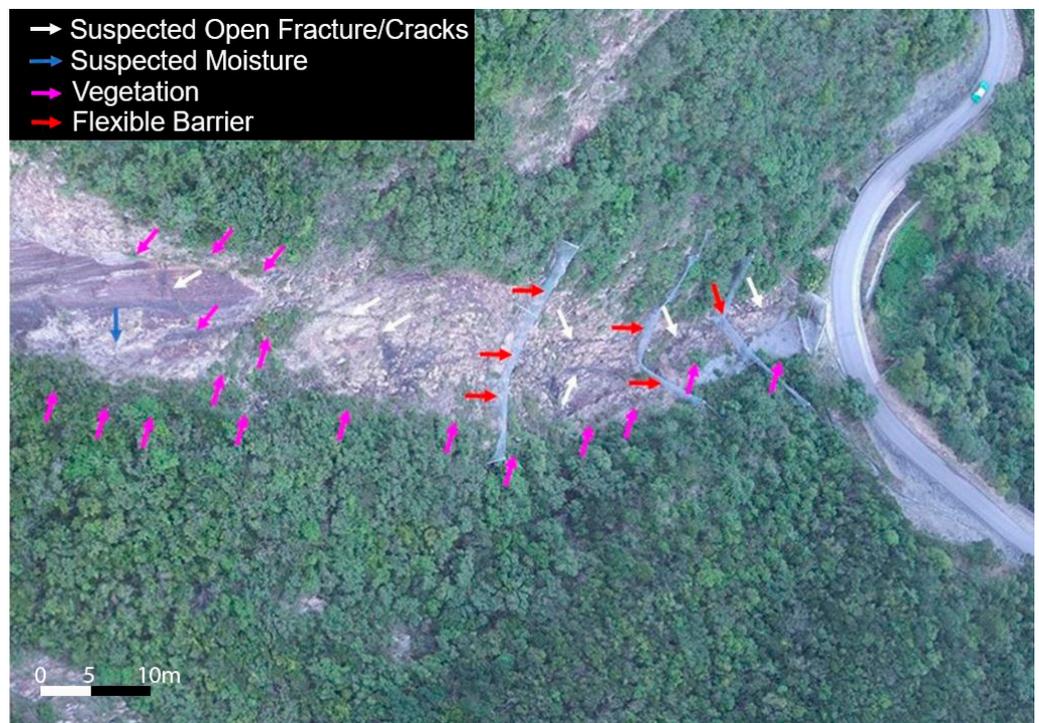
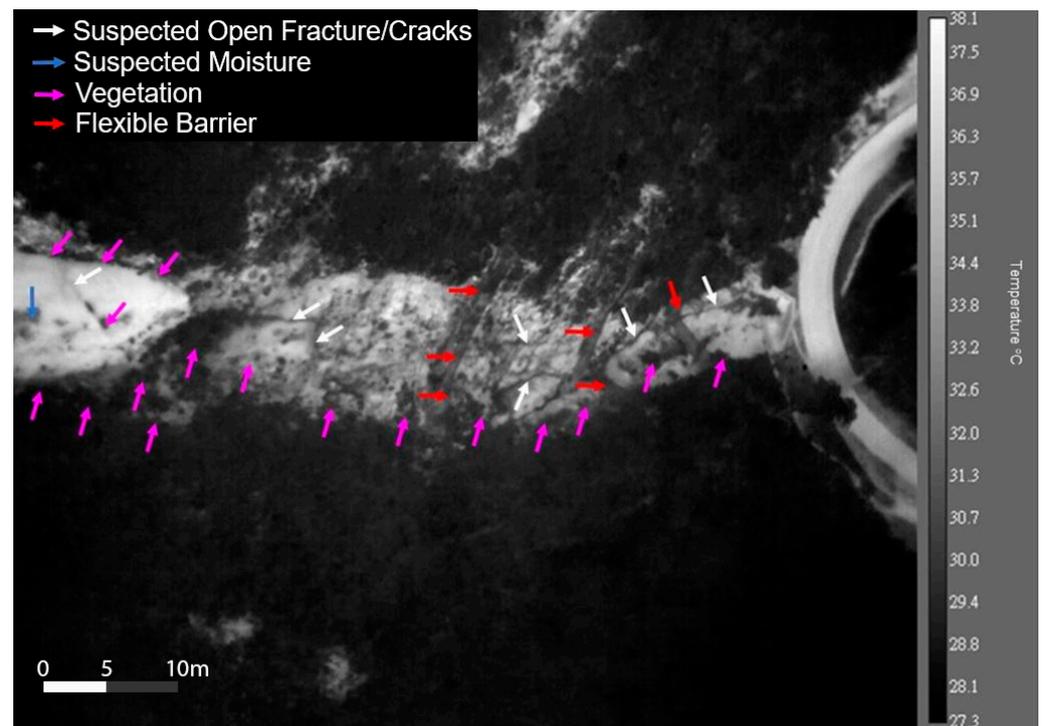
Figure 9. (a) Images acquired at 17:30 (hh:mm) in Slope A (Part 2), Sai Wan: visual image. (b) Images acquired at 17:30 (hh:mm) in Slope A (Part 2), Sai Wan: infrared image (grayscale).

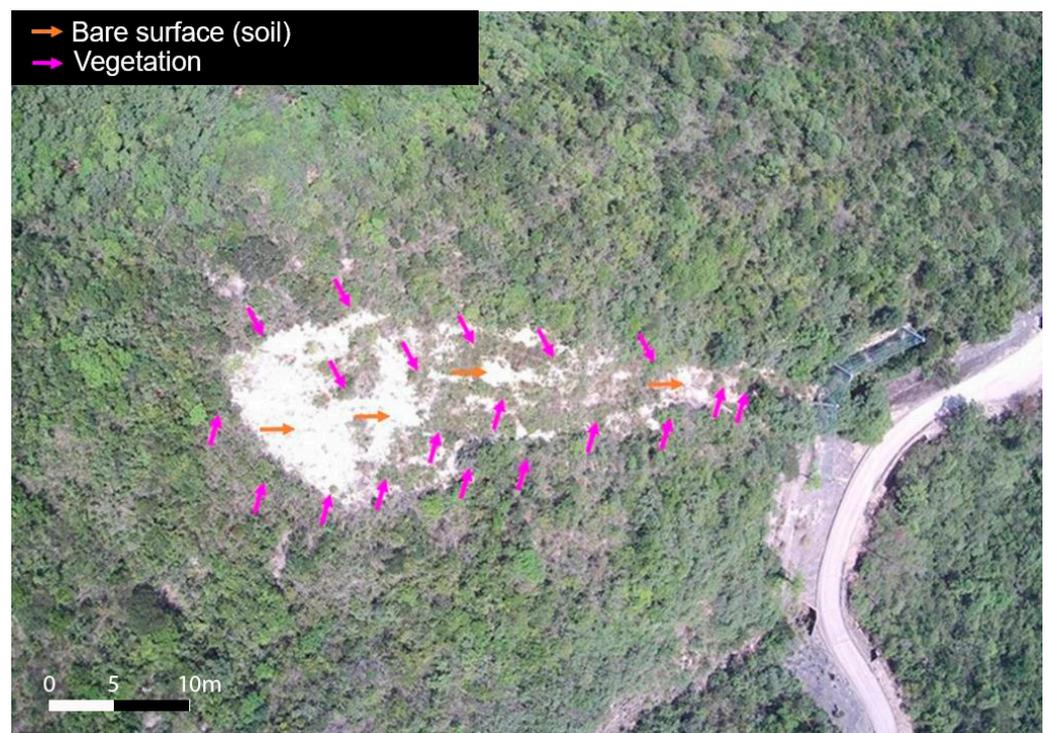
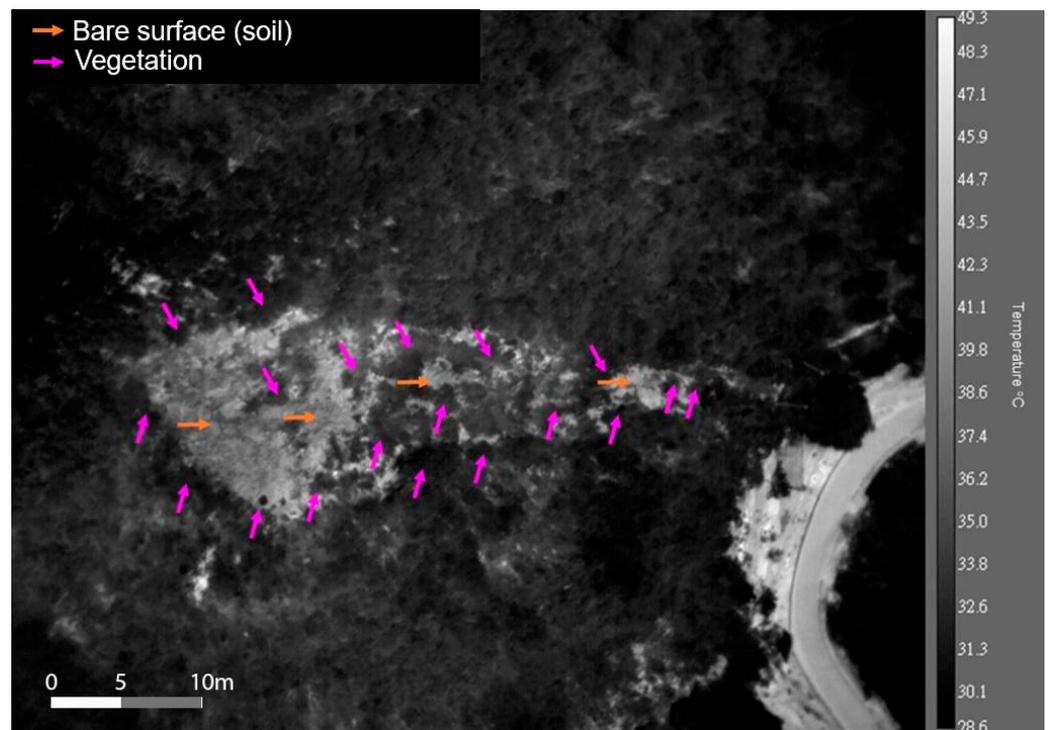
Figure 10. (a) Images acquired at 12:00 (hh:mm) in Slope B, Sai Wan: visual image. (b) Images acquired at 12:00 (hh:mm) in Slope B, Sai Wan: infrared image (grayscale).

From both Figures 10 and 11, vegetation, which was indicated as magenta arrows, could be identified around the landslide scar. Bare soil, indicated as orange arrows, was identified on the left part of the landslide scar, which could be easily observed on both thermal and visual images. However, on thermal images, the temperatures within the bare soil region are uneven, which could be due to the roughness of the surface or uneven moisture content inside.

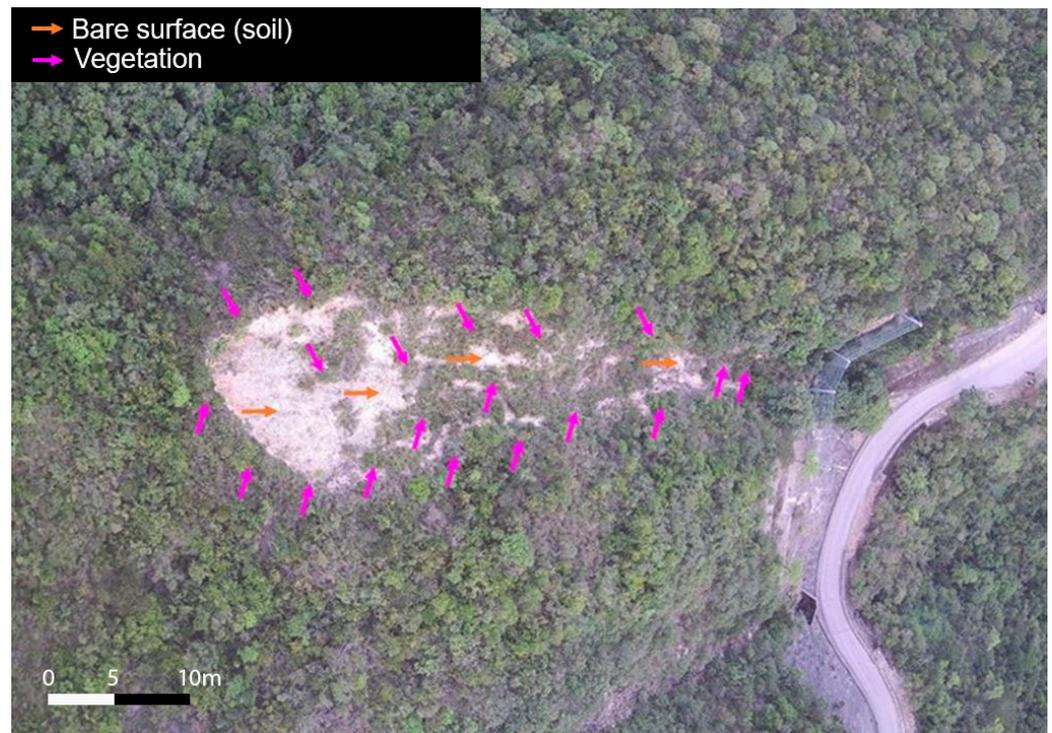
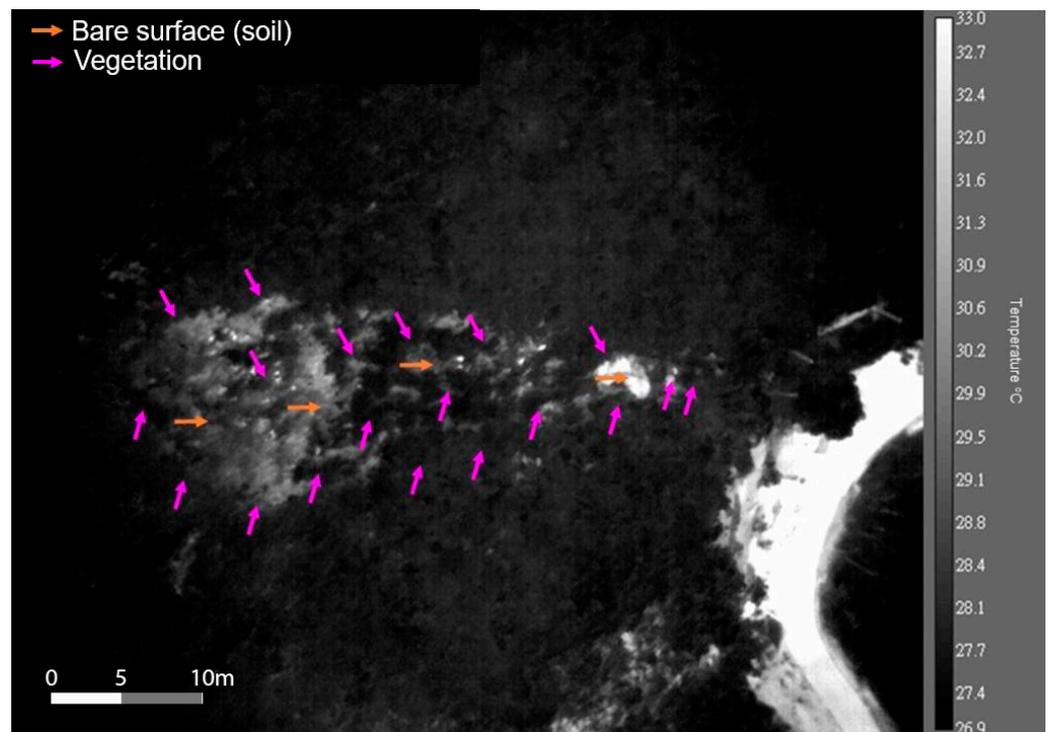
Figure 11. (a) Images acquired at 17:30 (hh:mm) in Slope B, Sai Wan: visual image. (b) Images acquired at 17:30 (hh:mm) in Slope B, Sai Wan: infrared image (grayscale).

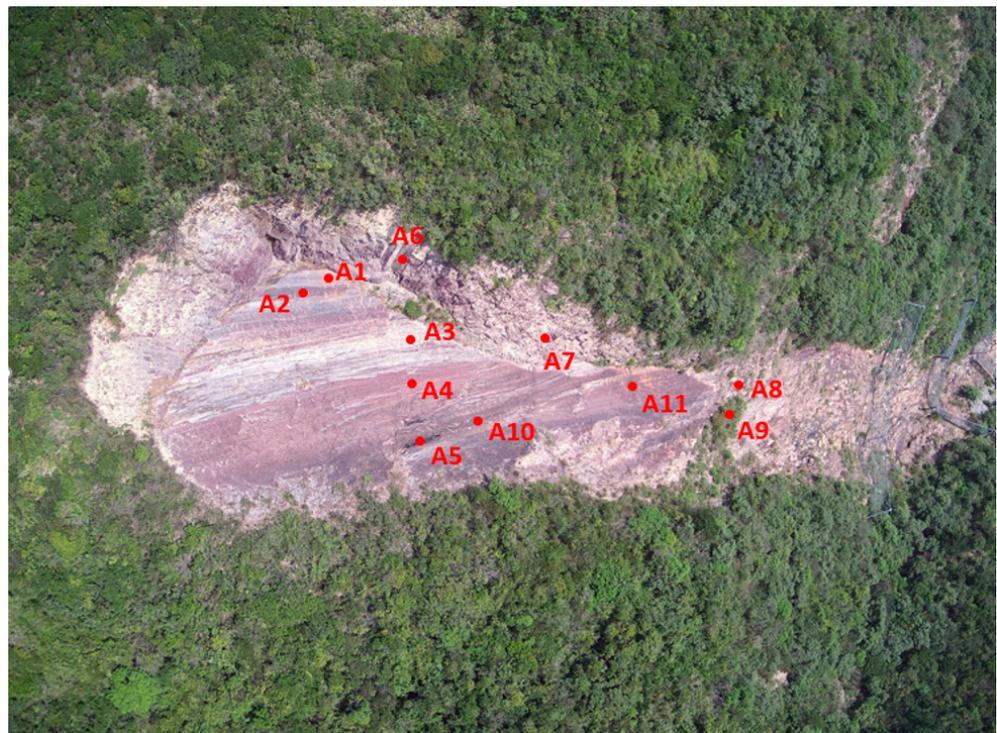
Figure 12. Selected points in the visible spectra (from A1 to A11) to sample different geological materials, suspected cracks, and vegetation in Slope A (Part 1), Sai Wan.

Eleven points of interest were selected in the aerial visible image according to the colour distribution over the inspected slope surface (Figure 12), given the correspondence to different geological materials/elements and associated (possible) cracks or vegetation, for comparison in the infrared image. The evolution of the temperature change at each point in time is expressed in Figure 13. To clearly distinguish the individual features, linear regression was performed on the temperature curves. The values in natural logarithmic base (for both temperature and time) were normalized and plotted (Figure 14) for feature characterization. Figure 14 is divided into Figure 14a for rocks and Figure 14b for suspected moisture, cracks, and vegetation to provide a clearer presentation. The selection of the first point was the highest temperature, from which the temperature started to decay, and which was 13:00 at the time of survey.

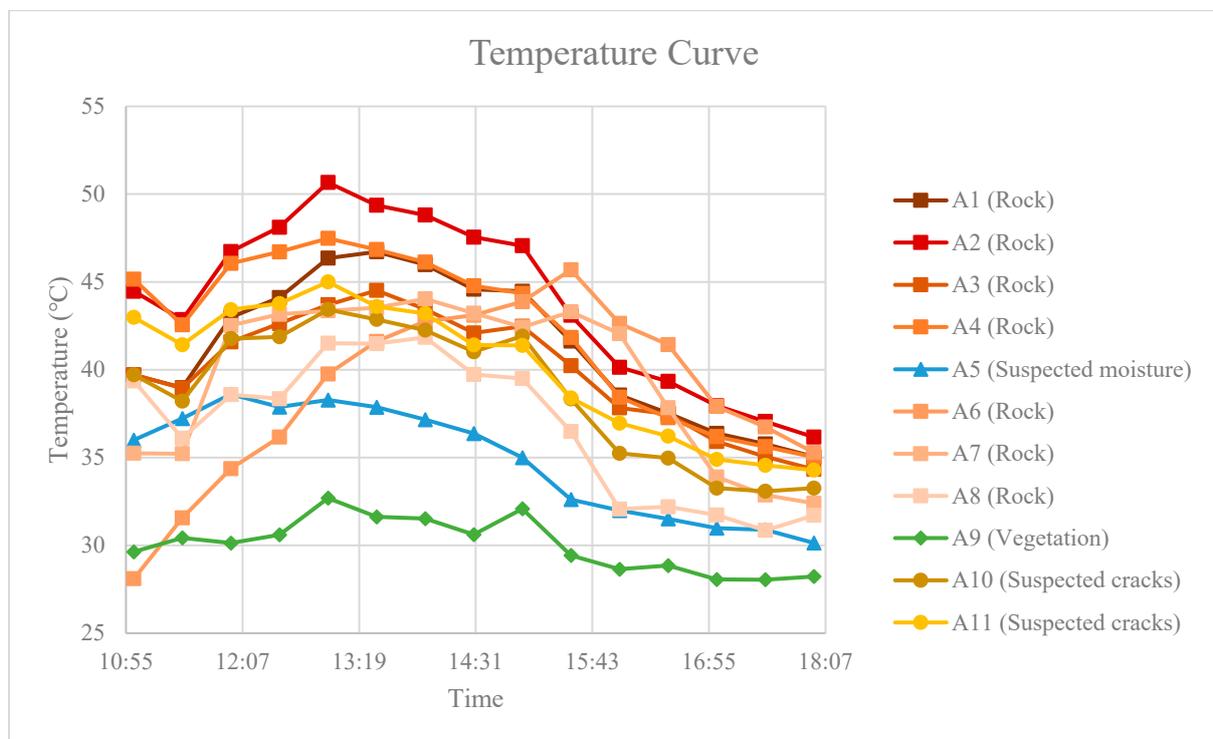
Figure 13. Evolution of temperature throughout the day in 11 selected points in Slope A (Part 1), Sai Wan.

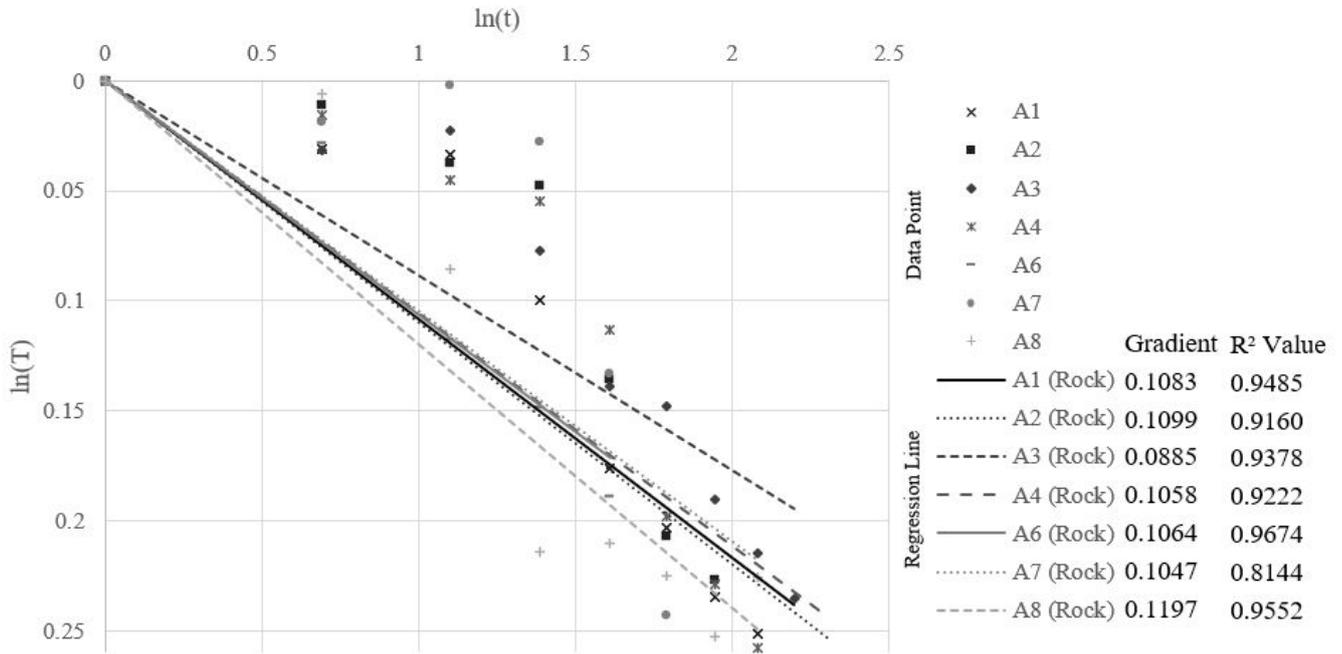
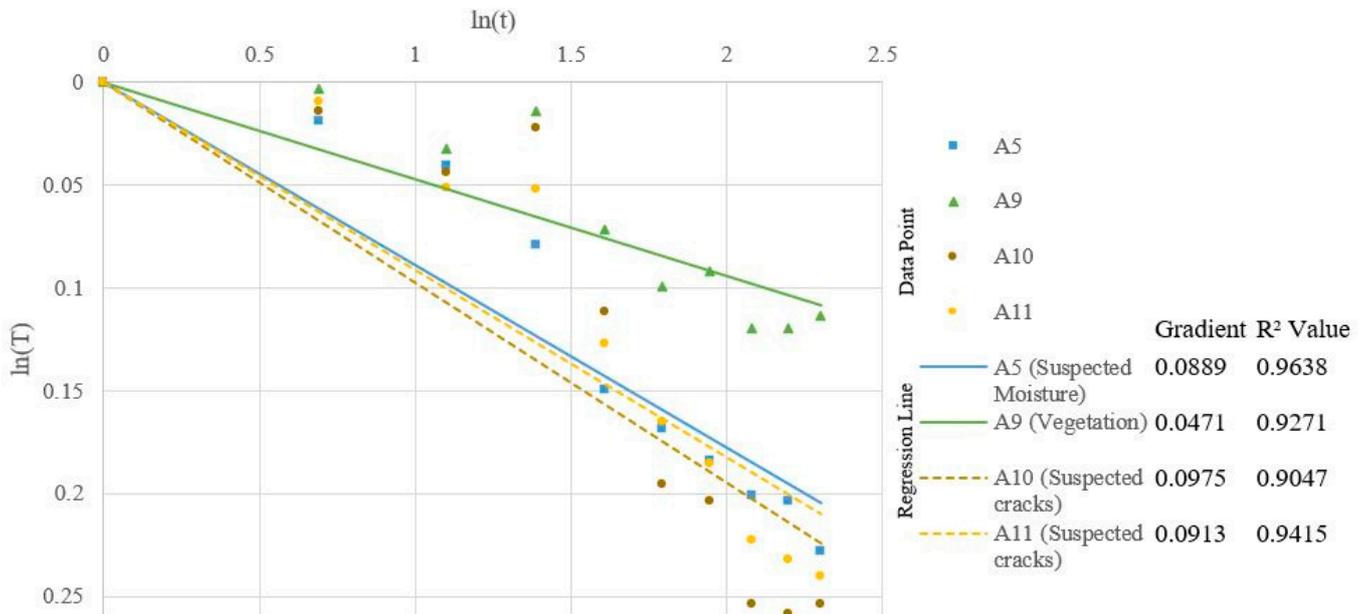
Figure 14. (a) Thermal decay regression in natural logarithmic base in seven selected points (Rock) in Slope A (Part 1), Sai Wan. (b) Thermal decay regression in natural logarithmic base in four selected points (Suspected Moisture, Cracks and Vegetation) in Slope A (Part 1), Sai Wan. The coefficients of determination (R² Values) of the regression are included in both figures.

Moisture (identified as A5 in Slope A, Part 1) exhibits a smaller gradient of temperature decay and definitely less than the majority of the elements classified as rocks [10]. It is probably due to both the high thermal capacity and specific heat (i.e., $4193 \text{ J kg}^{-1} \text{ K}^{-1}$ [6]) that keep the temperature smaller than the surrounding rocks. It is believed that the cracks in question might be filled with loose material, water or even vegetation, reducing the gradient of temperature decay, as demonstrated by A10 and A11 in Figure 14b. If the cracks represent a significantly large gap solely filled with air, then a quicker decay in the region is expected [24], but this is not the case here.

The gradient of thermal decay of rocks greatly depends on their colours. Dark-coloured rocks, which could be the result of the staining of iron oxide and manganese oxide, reach a higher temperature (A2, A8, A12 and A13 in Slope A) and present the highest decay. It is suggested that those darker materials have higher thermal emissivity. When a similar energy was received by both light- and dark-coloured rocks, a higher temperature could be measured in dark-coloured rocks according to Stefan–Boltzmann law, which is due to higher emissivity. The contrary point A3 is located in the light-coloured material and presents the lowest temperature decay, just after the vegetation decay value [20]. When compared with the visual images, the colour difference of rock in the study area is likely affected, at least partially, by the presence of infilling materials on the exposed surfaces.

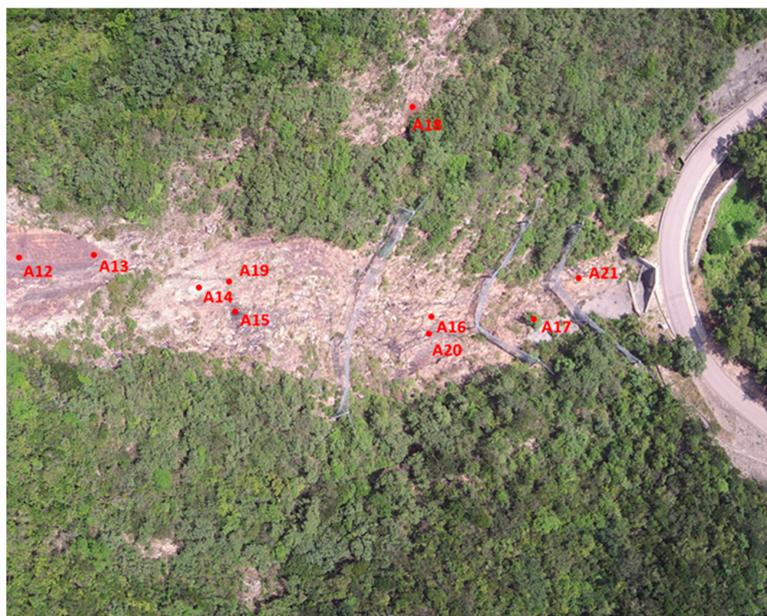
Figure 15. Selected points in the visible spectra (from A12 to A21) to sample different geological materials, suspected cracks, and vegetation in Slope A (Part 2), Sai Wan.

For the lower part, Part 2 of Slope A, ten points of interest (A12–21) were selected in the visible spectra according to the colour (Figure 15), given the correspondence to different geological materials/elements and associated (possible) cracks or even vegetation, for further comparison in the infrared image. The evolution of the temperature at each point in time is expressed in Figure 16. To clearly distinguish the individual features, linear regression was performed on the temperature curves. The values in natural logarithmic base (for both temperature and time) were normalized and plotted (Figure 17) for feature characterization. Figure 17 is divided into Figure 17a for rocks and Figure 17b for suspected cracks and vegetation to provide a clearer presentation.

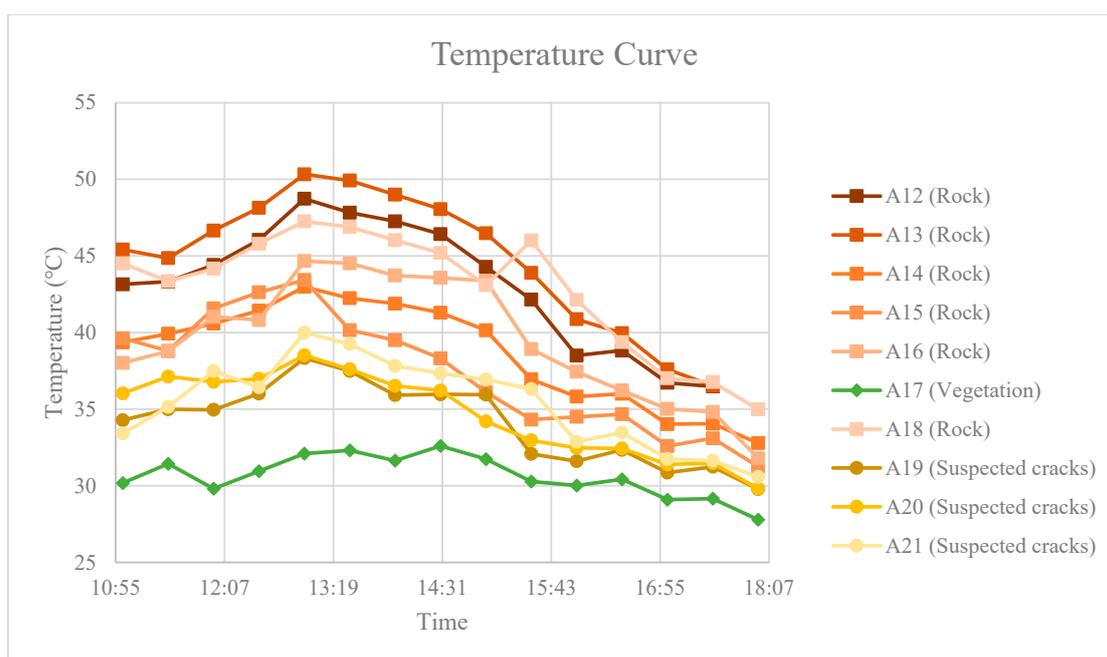
Figure 16. Evolution of temperature along the day in ten selected points in Slope A (Part 2), Sai Wan.

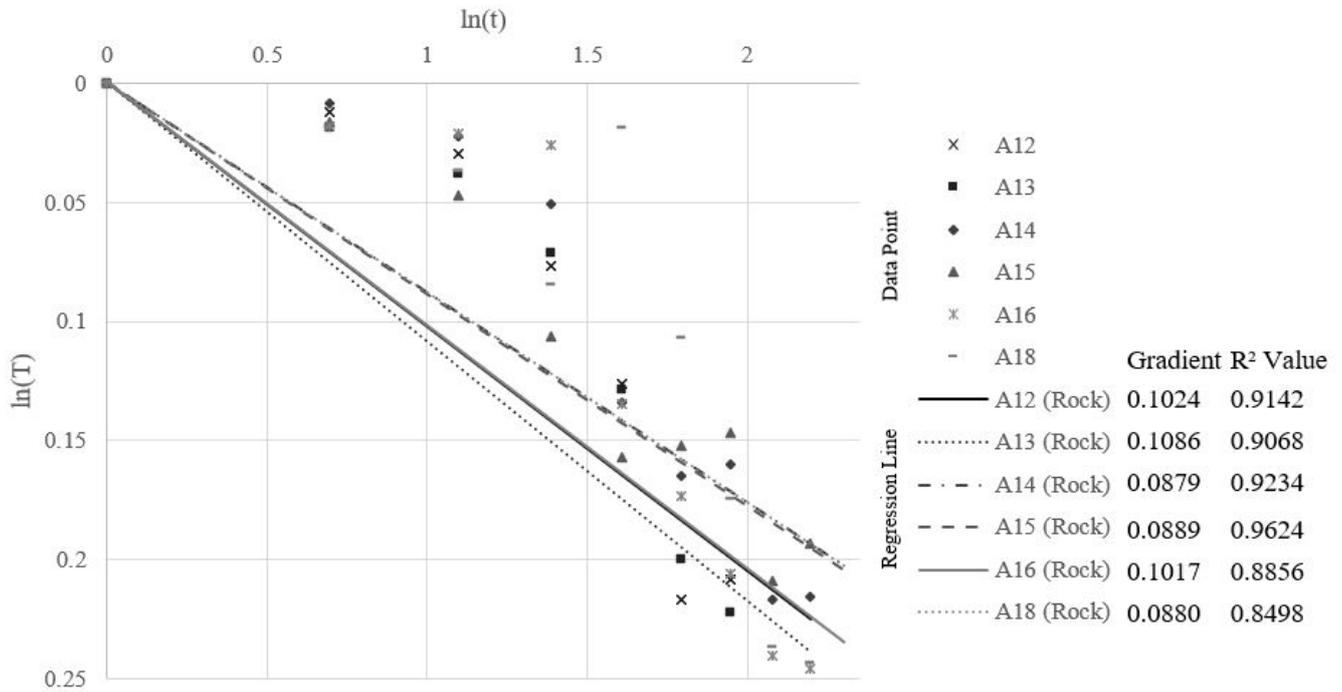
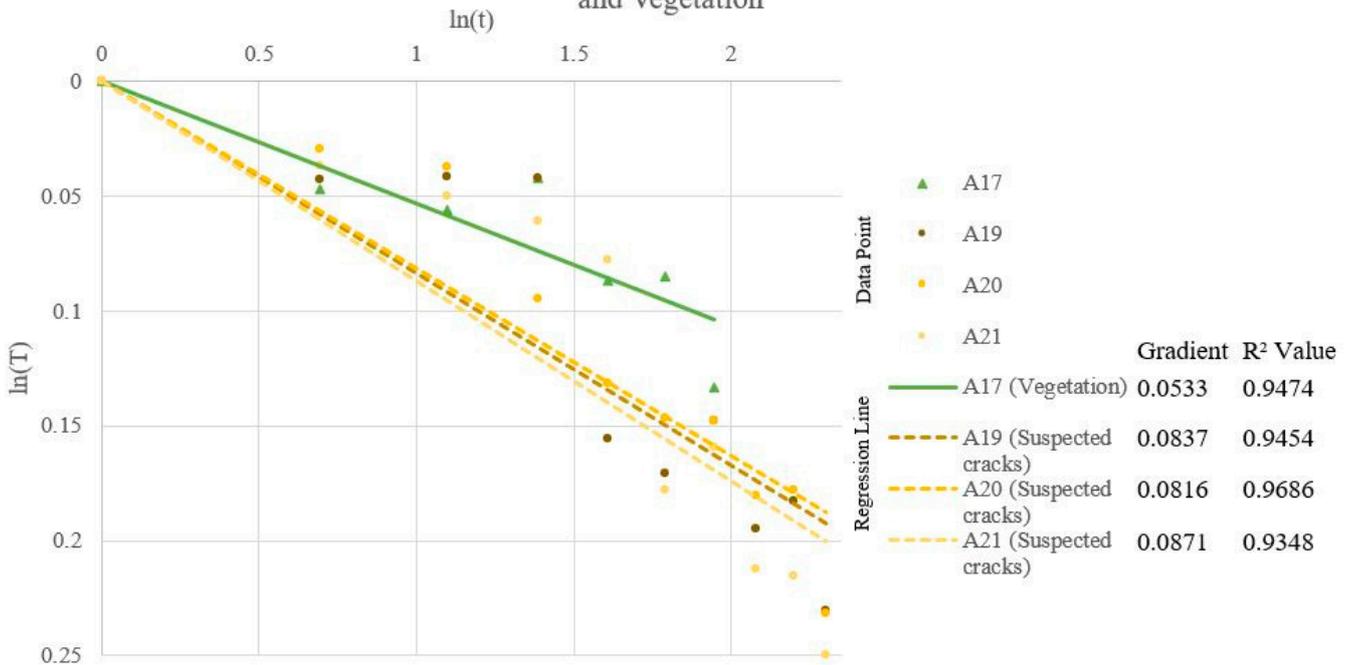
Figure 17. (a) Thermal decay regression in natural logarithmic base in six selected points (Rock) in Slope A (Part 2), Sai Wan. (b) Thermal decay regression in natural logarithmic base in four selected points (Suspected Cracks and Vegetation) in Slope A (Part 2), Sai Wan. The coefficients of determination (R² Values) of the regression are included in both figures.

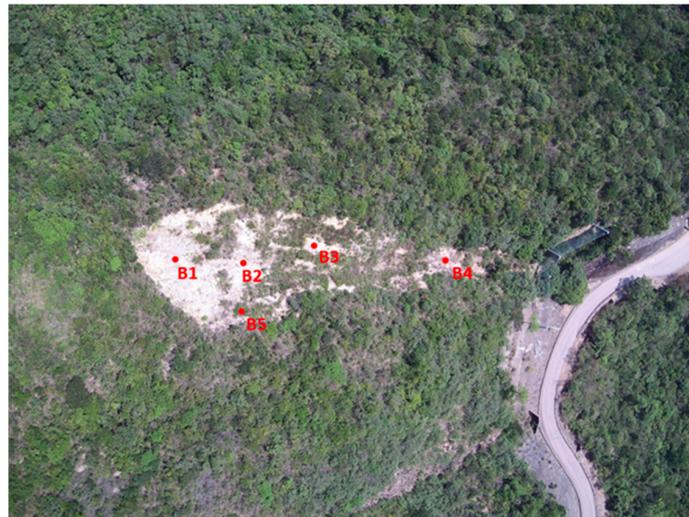
Figure 18. Selected points in the visible spectra (from B1 to B5) on bare soil and vegetation in Slope B, Sai Wan.

A total of five points were selected in the same material (B1 to B4) and in vegetation (B5). The selected locations have different altitudes. The points were selected both in isolated areas and in the middle of the vegetation to appreciate if the nearby surrounding vegetation represents any change (Figure 18). The variation of the temperature throughout the day and the respective normalized regression values in natural logarithmic base are plotted in Figures 19 and 20.
