Article

A Feasibility Study of Thermal Infrared Imaging for Monitoring Natural Terrain—A Case Study in Hong Kong

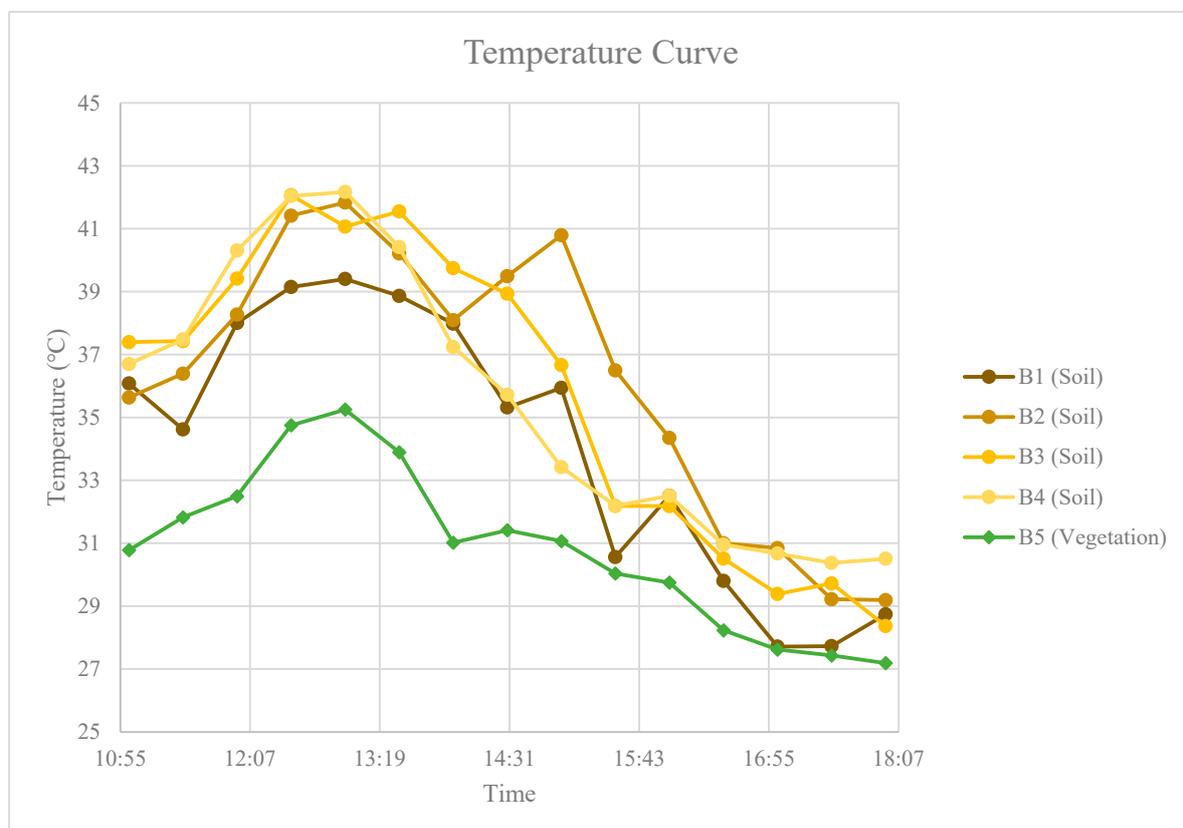
Figure 19. Evolution of temperature throughout the day in five selected points in Slope B, Sai Wan.

A total of five points were selected in the same material (B1 to B4) and in vegetation (B5). The selected locations have different altitudes. The points were selected both in isolated areas and in the middle of the vegetation to appreciate if the nearby surrounding vegetation represents any change (Figure 18). The variation of the temperature throughout the day and the respective normalized regression values in natural logarithmic base are plotted in Figures 19 and 20.

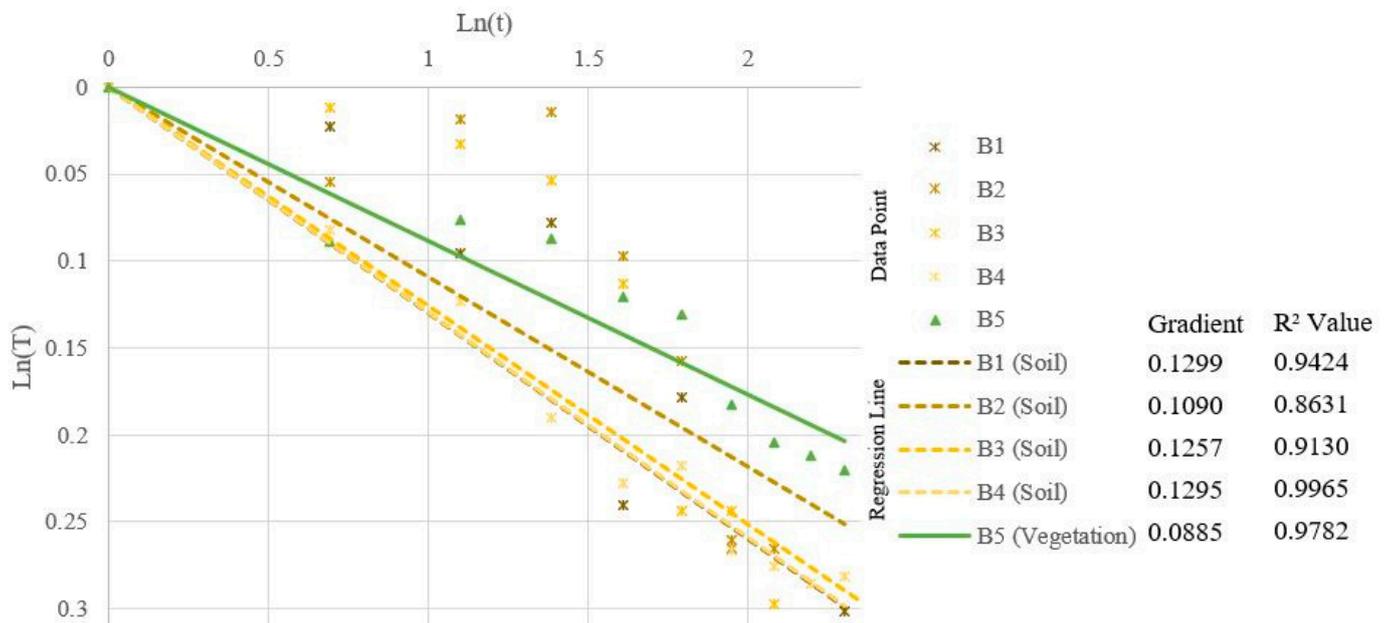
Figure 20. Thermal decay regression in natural logarithmic base in five selected points in Slope B, Sai Wan. The coefficients of determination (R^2 Values) of the regression are included in the figure.

The results obtained in all points from B1 to B4 in Slope B of bare soil proved that no pattern or conclusion can be drawn regarding the effect of altitude and the surrounding vegetation on temperature decay. The difference is minimal and can be neglected. Only point B2 exhibits a lower gradient of thermal decay, probably due to the presence of vegetation.

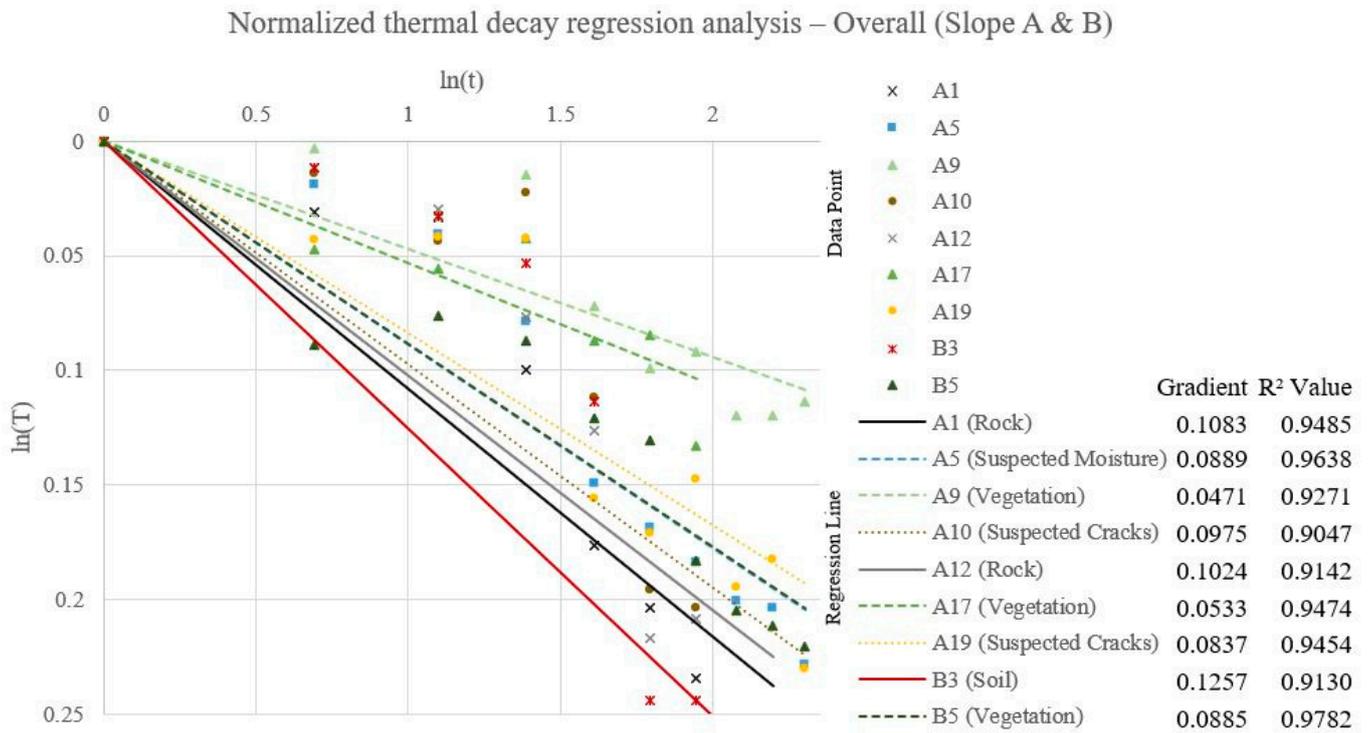
Figure 21. Summary of natural logarithmic decay of temperature in the study site. The coefficients of determination (R² Values) of the regression are included in the figure.

The first simulation was conducted over a high gradient and rough topography (Figure 22). The rate of thermal decay during the heat dissipation period was studied. A sample of the same material with a concavity acting as a crack was stimulated by the same source as the first case. In the initial stage, the temperature of the concavity is lower when compared to the intact area. In the final stage, the temperature in the concavity is higher than the rest, indicating that the concavity acts as heat storage. This suggests the rate of thermal decay of a crack is lower when compared to a flat surface in the same material. Hence, open fractures/cracks could be observed as a straight line in the snapshot IRT survey, and explained why the gradient of thermal decay of open fractures/cracks was lower than intact rock in Figure 21.

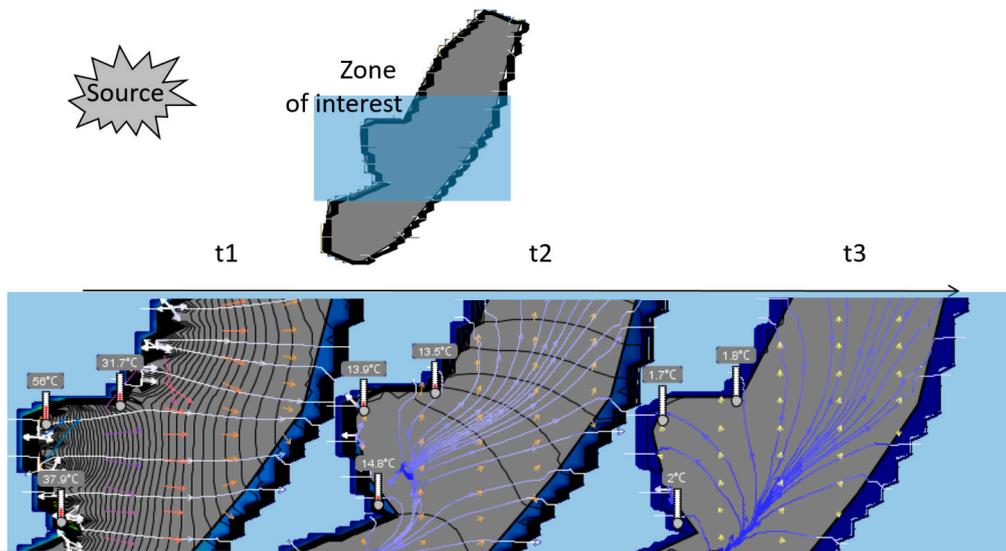
Figure 22. Simulation of flash thermography over a high gradient and rough topography at three different times.

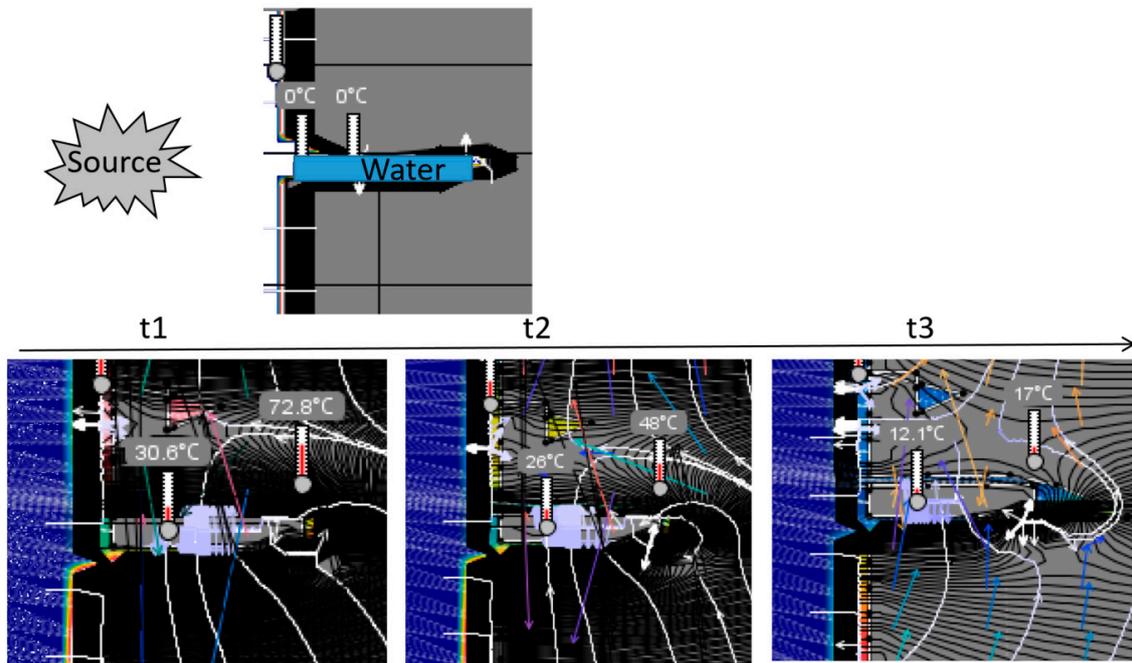
Figure 23. Simulation of flash thermography over a flat surface with a crack filled with water at three different times ($t_1 = 0$ s, $t_2 = 10$ s, $t_3 = 60$ s, with the starting time beginning when the heat source was stopped).

The second simulation scenario was to evaluate the thermal decay of a crack filling with water, since this is a possible case occurring in a real environment, where water could be trapped in the cracks of a natural slope after precipitation. Figure 23 shows the simulation of flash thermography over a flat surface with a crack filled with water. It showed that when water was trapped inside a crack, the temperature inside the crack was lower than the intact area. Due to the high thermal capacity, the water present in a crack lowers the rate of thermal absorption and decay, which explains why the gradient of thermal decay of water seepage was lower than that of intact rock.

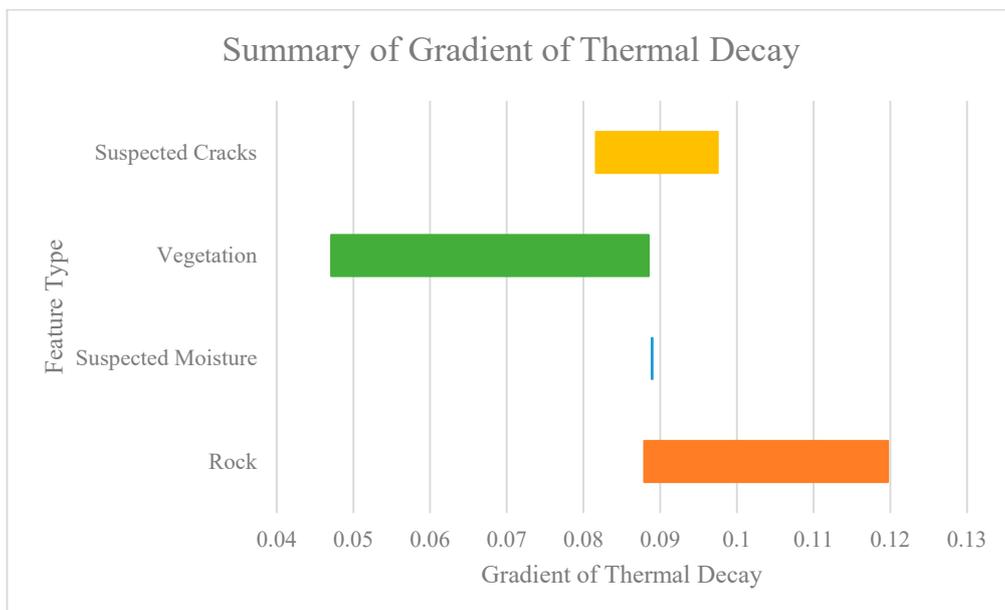
Figure 24. Summary of the gradient of thermal decay of different feature types in the study site.

The behavior of the gradient of the thermal decay of different feature types is summarized in Figure 24. The gradient of vegetation has the lowest range (around 0.046 to 0.0885), with an exemption of 0.0885 expanding the range and hence the range of vegetation overlaps with the range of cracks (around 0.08 to 0.1). The gradient of rocks has the highest range (from 0.086 to 0.12) which overlaps the range of moisture (0.0889). Based on the ranges, cracks, vegetation, and rock can be separated clearly, while moisture needs to be confirmed with the aid of visual images. However, the ranges shown in Figure 24 only represent the gradient values in the selected sites in this study, and it is suggested to include more sites in future studies to develop a more comprehensive range of gradient values for slope/natural terrain feature classification.
