A Recognition and Geological Model of a Deep-Seated Ancient Landslide at a Reservoir under Construction

Abstract: Forty-six ancient Tibetan star-shaped towers and a village are located on a giant slope, which would be partially flooded by a nearby reservoir currently under construction. Ground survey, boreholes, and geophysical investigations have been carried out, with results indicating that the slope consists of loose deposit with a mean thickness of approximately 80 m in addition to an overlying bedrock of micaceous schist and phyllite. Ground survey and Interferometric Synthetic Aperture Radar (InSAR) indicated that the slope is experiencing some local deformations, with the appearance of cracks and occurrence of two small landslides. Through using borehole logs with the knowledge of the regional geological background, it can be inferred that the loose deposit is a result of an ancient deep-seated translational landslide. This landslide was initiated along the weak layer of the bedding plane during the last glaciation in the late Pleistocene (Q₃) period, which was due to deep incision of the Dadu River at that time. Although it has not shown a major reaction since the ancient

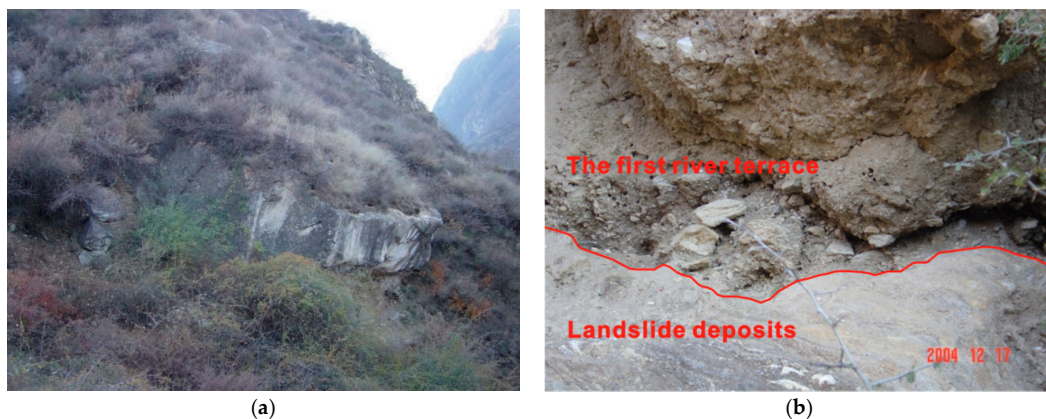
Figure 4. (a) Rock block with size of $10 \times 10 \times 2$ m. (b) The structure of the first river terrace (from site of PH01 in Figure 3).

The investigated slope is almost completely covered by loose deposits, except at its upstream boundary where there is an outcropping of bedrock. The loose slope deposits consist mainly of soil detritus with a maximum block size of $10 \times 10 \times 2$ m (Figure 4a).

On the downstream side, there is a block of river terrace developed on the toe of the landslide as mentioned in Section 2 (Figure 4b), which means that the ancient landslide had formed before the first river terrace.

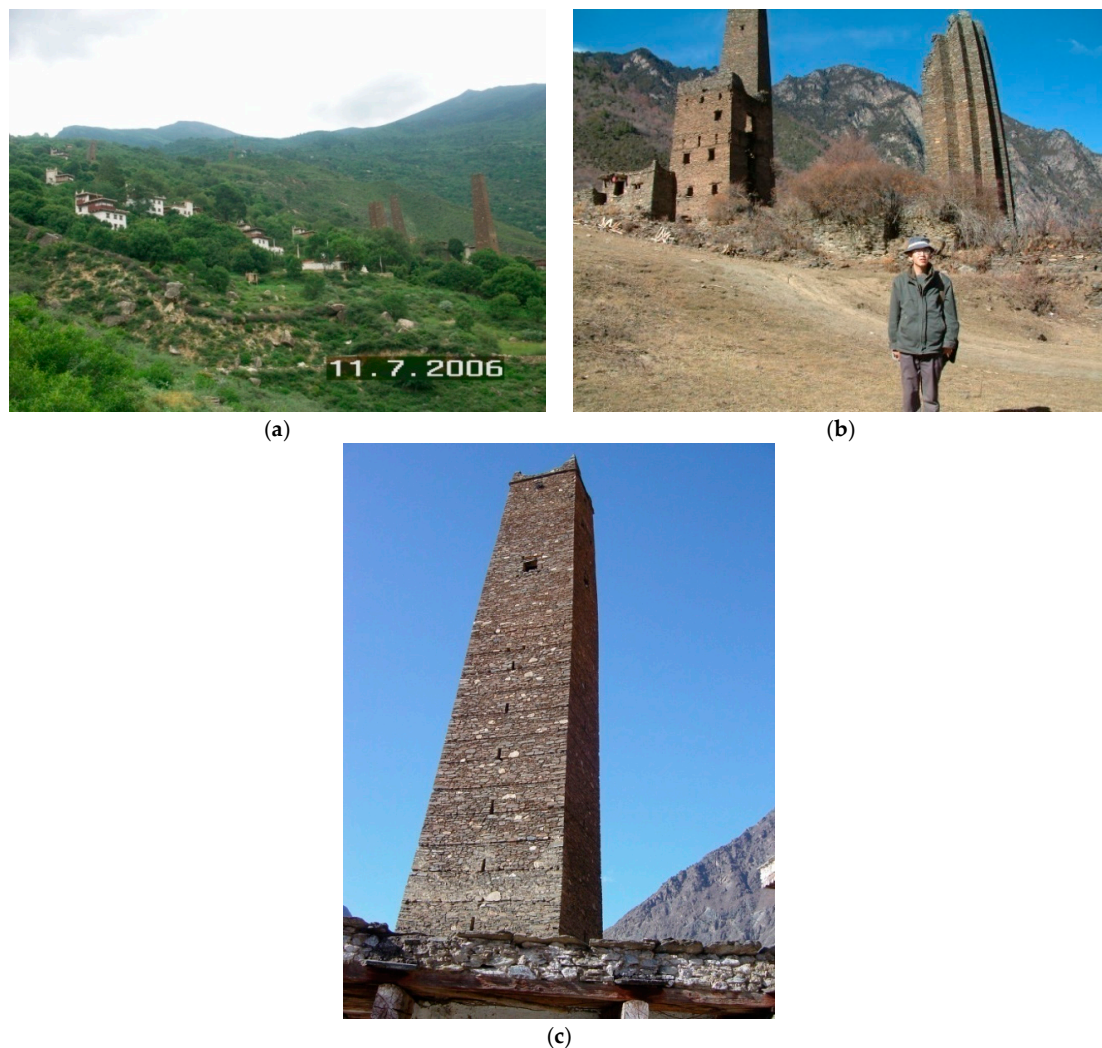
Figure 6. (a) Tibetan star-shaped towers on the slope; (b) Tibetan star-shaped towers with 13 outward-pointing corners; (c) a leaning tower caused by local uneven deformation of the landslide.

According to ground investigations conducted at different times, most of Tibetan star-shaped towers on the slope are in good condition, but some of these towers have been damaged to different degrees. Some have already collapsed while some have become leaning towers. Most of these damages were caused by local uneven deformation of the slope (Figure 6c), resulting in tensile forces within the tower body and generating tension cracks, which destroyed and caused collapse of the whole structure.

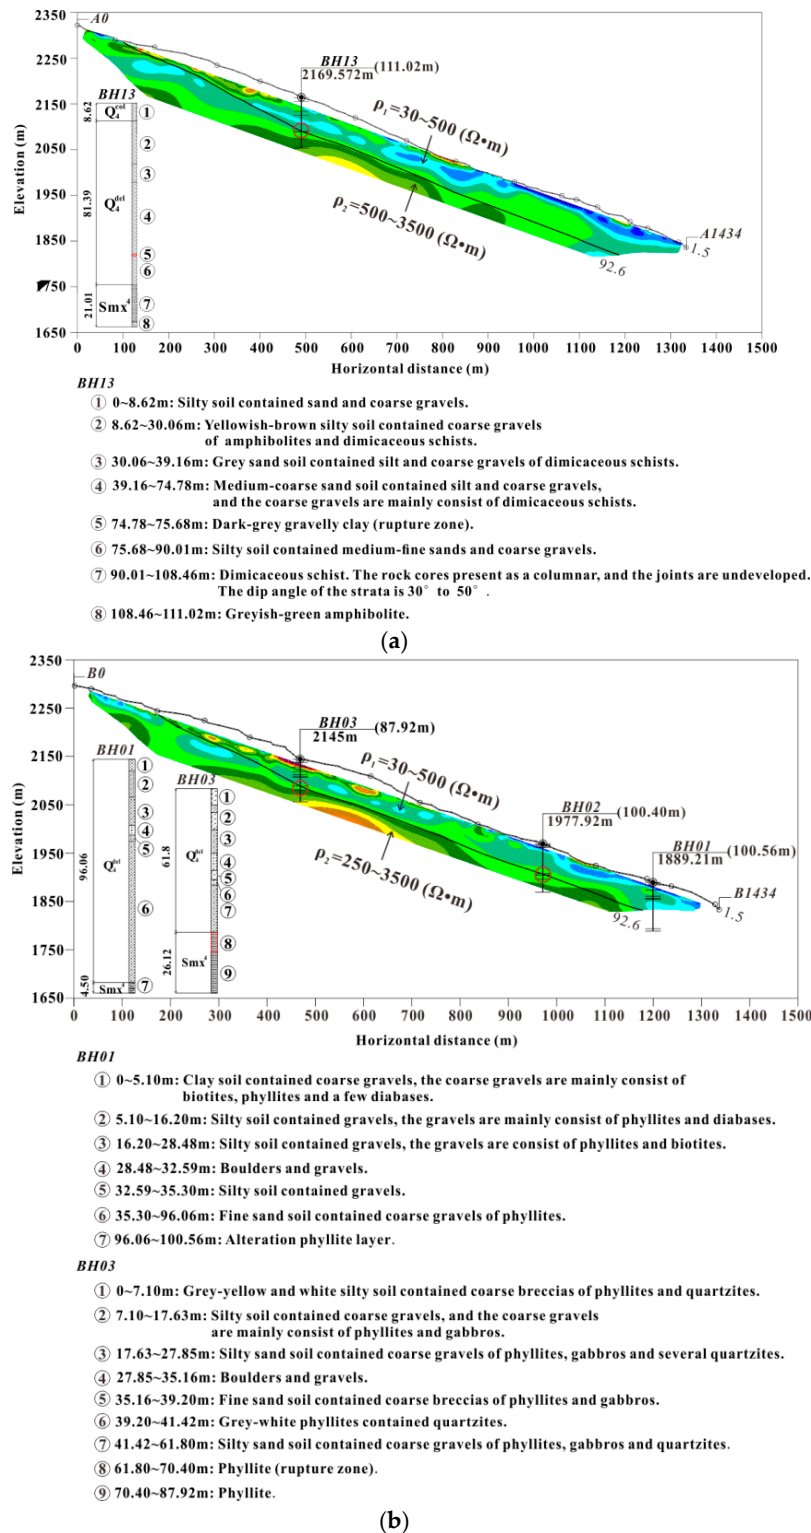
Figure 7. The contour map of electrical resistivity determined from multi-electrode resistivity method: (a–g) show the geophysical survey lines and their interpretations.

Some results from the high-density electric resistivity method are presented in Figure 7 as contour maps of electrical resistivity. At the depth of 70–90 m, there exists an obvious continual layer marked in light green with an electrical resistivity of $250 \Omega \cdot m$. The material above this layer has an electrical resistivity of 30 – $500 \Omega \cdot m$ and the material below the layer has an electrical resistivity of 250 – $3500 \Omega \cdot m$ in general. This is consistent with the constraints from the data of the boreholes. In other words, the slope consists of loose deposit and the bedrock of micaceous schist or phyllite from the fourth

formation of the upper subgroup in the Maoxian group (Smx^4). The loose deposit has an electrical resistivity of $30\text{--}500\ \Omega\cdot\text{m}$ in general, while the bedrock has an electrical resistivity of $250\text{--}3500\ \Omega\cdot\text{m}$. The light green layer with an electrical resistivity of $250\ \Omega\cdot\text{m}$ in the contour maps can be considered as a boundary between the loose deposit and bedrock.

Figure 7a shows that the loose deposit has an almost identical thickness of 90 m in the cross-section of A₀–A₁₄₃₄, as measured by both electrode A₁₄₃₄ and borehole BH13. From BH13 to A₀, the thickness reduces gradually to 0 at an elevation of about 2250 m. Therefore, we can deduce that the crown (the term is after International Association of Engineering Geology and the Environment (IAEG) Commission's Suggested Nomenclature for Landslides [30]) of the landslide is located at an elevation of about 2250 m in the cross-section of A₀–A₁₄₃₄. Similarly, we can infer that the crown of the landslide is located at an elevation of about 2200 m in the cross-section of B₀–B₁₄₃₄ (Figure 7b).

Figure 7c is obviously different from Figure 7a,b. This difference shows that the buried depth of the light green layer is decreasing gradually from the toe area to the upper part and almost crops out to the surface at an elevation of 2170 m. Thus, we can deduce that the crown area of the landslide has an elevation of 2170 m in the cross-section of C₀–C₁₄₃₄ (Figure 7c). Similarly, the boundary between the upstream and downstream side can be delineated by the transverse sections of D₀–D₈₉₄, E₀–E₈₉₄, F₀–F₇₁₄, G₀–G₇₁₄, as shown in Figure 7d–g.

From the data of all boreholes and the results from the high-density electric resistivity method, it can be concluded that the landslide deposit gradually becomes thicker from the upslope to the downslope and from the upstream to the downstream area. Overall, there is a mean thickness of about 80–90 m (Figure 7).

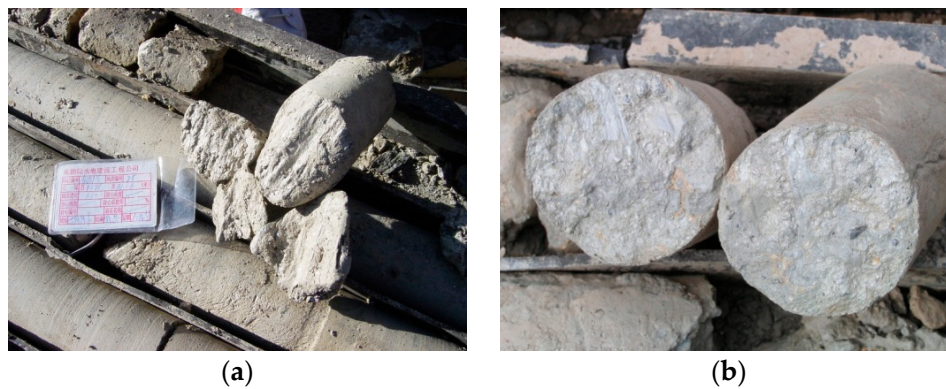
Figure 8. Landslide traces found in samples from (a) borehole BH01 at a depth of 95 m and (b) borehole BH03 at a depth of 62.8 m.

According to the borehole data, the loose deposit consists of light yellow soil containing rubble gravel, gray yellow-black silt containing gravels and solitary boulders of phyllite, which has been depicted in the borehole logs shown in Figure 7a–e. Moving down the slope surface, all boreholes have a layer rich in clay at a depth of 45–95 m, with a thickness of 1–3 m. The main exception is borehole BH04, which has no layer rich in clay. Moving further down the slope surface, bedrock has developed with a disturbed zone at the top. In some boreholes (i.e., BH01, BH03), obvious sliding traces can be observed on the bedding plane of the base rock (Figure 8). Borehole BH04 is located at the toe area of the slope (Figure 3). In this borehole, fine silty sand is located at a depth of 44.57–48.91 m, while plant roots and charred wood presented at a depth of 48.16 m (Figure 9). A soil layer containing boulders, cobbles and gravel at a depth of 64.0–90.60 m was discovered with glaciofluvial facies, while the sand and gravel layer with fluvial facies presented at a depth of 72.17–75.07 m and 76.5–81.0 m respectively. The intact bedrock contains micaceous schist presenting below 90.60 m with a corresponding elevation of 1771 m, with this elevation is being over 50 m lower than the present riverbed. Therefore, it was hypothesized that the loose deposit is a result of an ancient landslide, leading to the buried plants and charred wood.

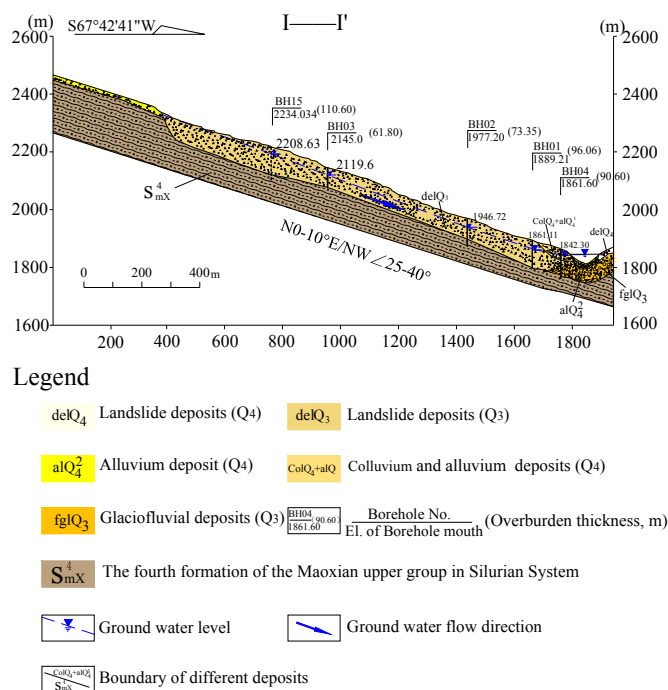
Figure 11. Cross-section of I—I'.

The slope investigated is a consequent slope as indicated before, which is prone to sliding along the weak layer of micaceous schist. If the weak layer of micaceous schist was examined by deep incision of the intensive erosion, the landslide would have been initiated as a translational failure along the weak layer, and overlaid on the glaciofluvial deposit. Thus, we infer that the slope has a structure as shown in Figure 11 at the toe area.

- (1) From Figure 11, it can be seen that the existing sliding zone was buried under the first river terrace, which resists shear forces that occur along the existing fracture zone at the toe of the landslide. Meanwhile, the stability of the river terrace indicates that the landslide has not undergone a major reaction since the terrace formed.
