Water 2017 S1 of S6

Supplementary Materials: Thermal and Physical Investigations into Lake Deepening Processes on Spillway Lake, Ngozumpa Glacier, Nepal

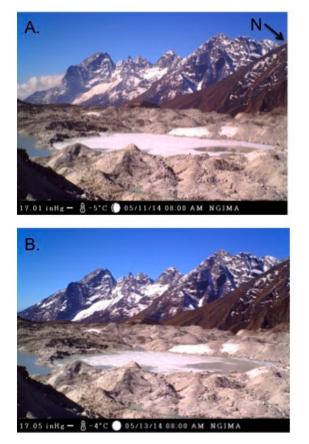
Figure S6. Time-lapse sequence of the Main sub-basin thaw from 11 May to 19 May 2014.

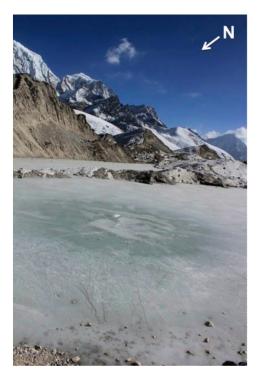
Figure S10. Frozen-over upwelling (December 2013) in the northeastern part of Main basin, Spillway Lake.
