Restoration of Old Olympias Arsenopyrites Concentrate Storage Area (Former METBA Plot) [†]

Abstract: The area of the old arsenopyrites concentrate storage area is located at the Olympias Mining Facilities. The area was formed in the 1970s as a temporary storage area for the produced concentrate of gold-bearing arsenopyrite of Olympias. The total area is 11 hectares, and in the 1980s, the concentrate was removed from the site and arsenopyrite residues, which remained on the deforested surface, were major sources of pollution of the surface and ground waters of the wider area. The remediation and restoration works of this area were initiated by Hellas Gold as a priority immediately after taking over the Cassandra Mines property. After the restoration of the area, a nursery was installed with more than 1,000,000 plants.

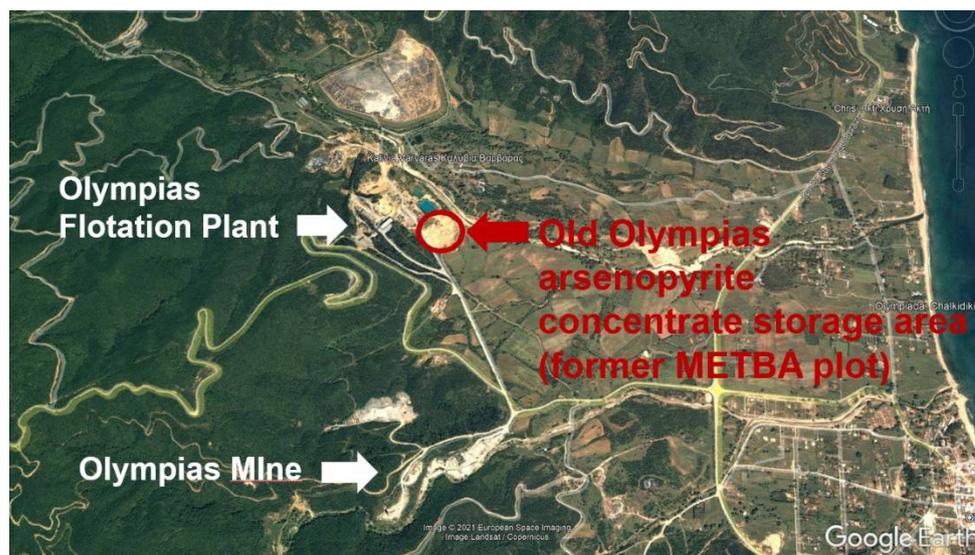
The area of the old arsenopyrites concentrate storage area (former METBA plot) is located within the Olympias Mining Facilities and, in particular, on the plot of the existing flotation plant (Figure 1). In the 1970s, the site was developed by the then mining company Hellenic Chemicals and Fertilisers Co. S.A. as a temporary storage area for the Olympias gold-bearing arsenopyrites concentrate, which was being produced, and was intended to be used in the future to recover the contained gold. In the mid-1980s, the concentrate was removed from the site in order to install the gold metallurgy plant planned at that time by Aegean Metallurgy Industries (METBA).

Figure 1. Old arsenopyrites concentrate storage area (former METBA plot) at Olympias, Halkidiki (2004).

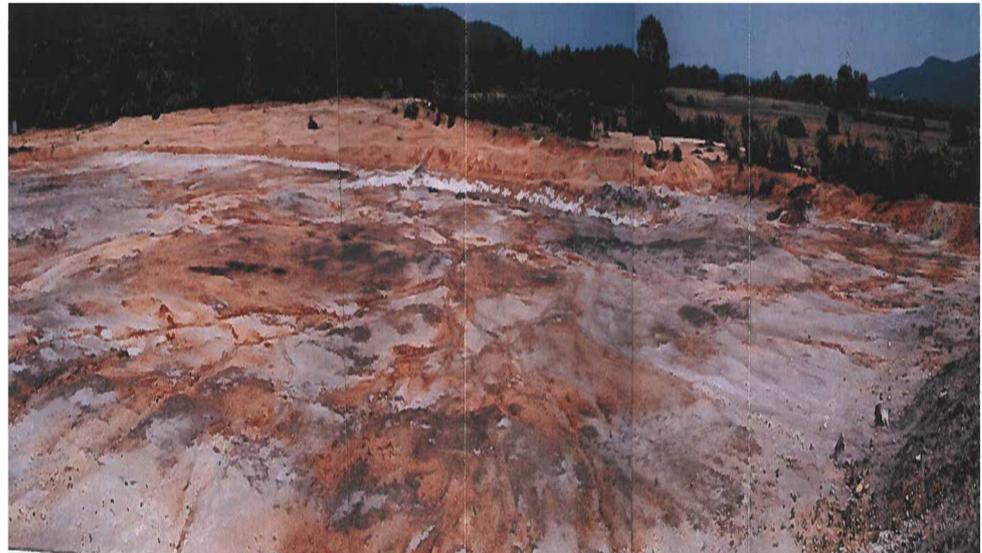
The area covers a total of 11 hectares and is located within the alluvial sediments of the Mavrolakkas creek. Pockets of arsenopyrites concentrate and its oxidised residues that remained on the deforested surface were major sources of pollution of surface and ground waters in the area for decades. The products of arsenopyrites oxidation were dissolved during periods of intense rainfall by the rainwater, which resulted in acid mine drainage generation with high concentrations of heavy metals (AMD run-off). Figure 2 shows the previous condition of the area where the pockets of the remaining arsenopyrites and its oxidised products can be distinguished.

Figure 2. Old arsenopyrites concentrate storage area (former METBA plot).

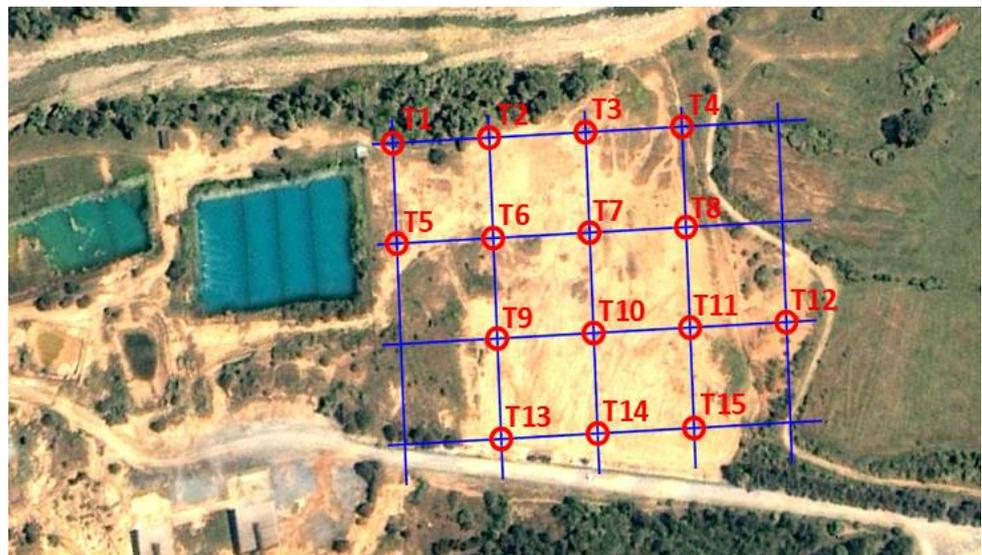
After the removal of the arsenopyrites stockpile, residues and contaminated soils were left of the surface, which were degrading the area. In order to determine the level of pollution in the area, surface soil samples from the storage area were collected using trenches up to 2 m deep on a 50 m × 50 m grid. Figure 3 shows the locations of the trenches, and Figure 4 shows indicative photographs of trenches in the area before cleaning and remediation.

Figure 3. Soil sampling grid at the old arsenopyrites concentrate storage area (former METBA plot) before remediation.

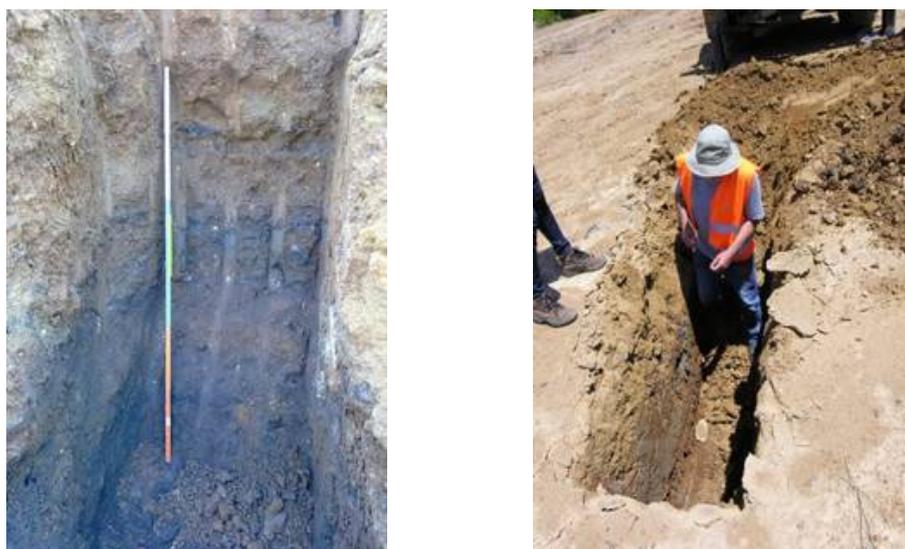
Figure 4. Indicative trenches at the old arsenopyrites concentrate storage area (former the METBA plot) before remediation.

From the above data, it is shown that the soil in the area of the old storage area contains significant quantities of arsenic due to the arsenopyrites residues, which remained on the surface after the stockpile was removed. The S content is high and has a high acid generation potential (NNP < 0). The relatively high S(SO₄) content and the very low pH indicate that oxidation and acid generation had begun, which is confirmed by the quality of run-off in the area during periods of intense rainfall. Lastly, As and Zn levels in the samples exceed the limits for disposing of in non-hazardous waste disposal facilities.

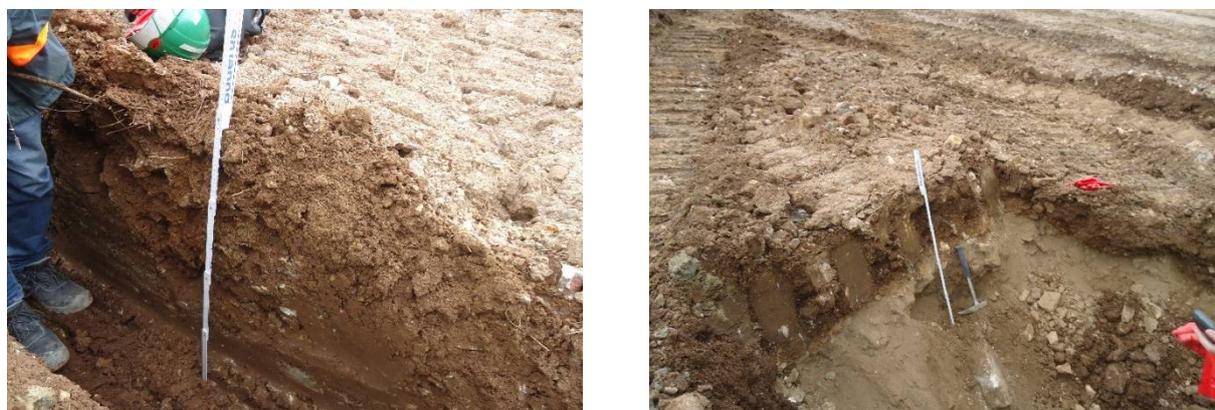
As part of the first phase, the contaminated surface layer was removed from the site that had been used as a storage area. The soil was removed to a depth of 50 cm so that the remaining soil would have metal concentrations below background values. In cases where arsenopyrites were found at greater depths, excavation continued until all material was removed. After the removal of the contaminated soil, a new soil sample was taken in order to characterise the remaining soil (Figure 5).

Figure 5. Indicative soil trenches after remediation of the old arsenopyrites concentrate storage area (former METBA plot).

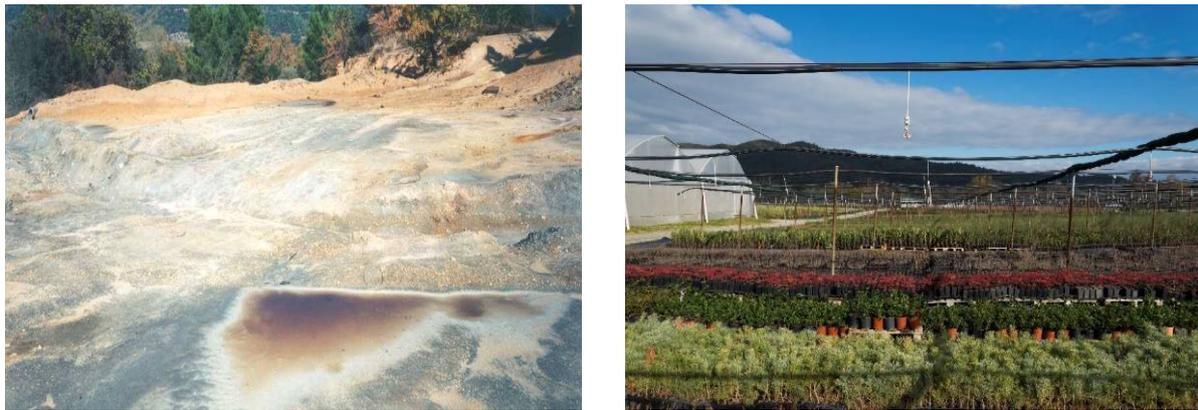
Immediately after the site was rehabilitated, a nursery facility with more than 1 million plants was set up (see Figure 6). The nursery is one of the largest in Greece and produces 320 different species of forest and ornamental plants, covering the need for local flora species for all Hellas Gold's rehabilitation projects and supporting local stakeholders. The seeds are collected from the surrounding area, and after proper handling, young saplings are grown that are then used in rehabilitation works. All categories of plants are suitable for the climatic conditions in the wider area. Moreover, the nursery also implements controlled irrigation and fertilisation programmes during the growing period, taking all necessary protective measures daily to ensure problem-free operation. In the context of maximising recycling and sustainable operation of the mining facilities, nursery plants are irrigated exclusively using water pumped from the Olympias underground mine after it is treated. At the same time, around 20 new jobs have been created, thereby bolstering economic activity in the area.

(a) Before—2005

(b) Today—September 2021

Figure 6. Restoration of the old arsenopyrites concentrate storage area (formerly METBA plot).

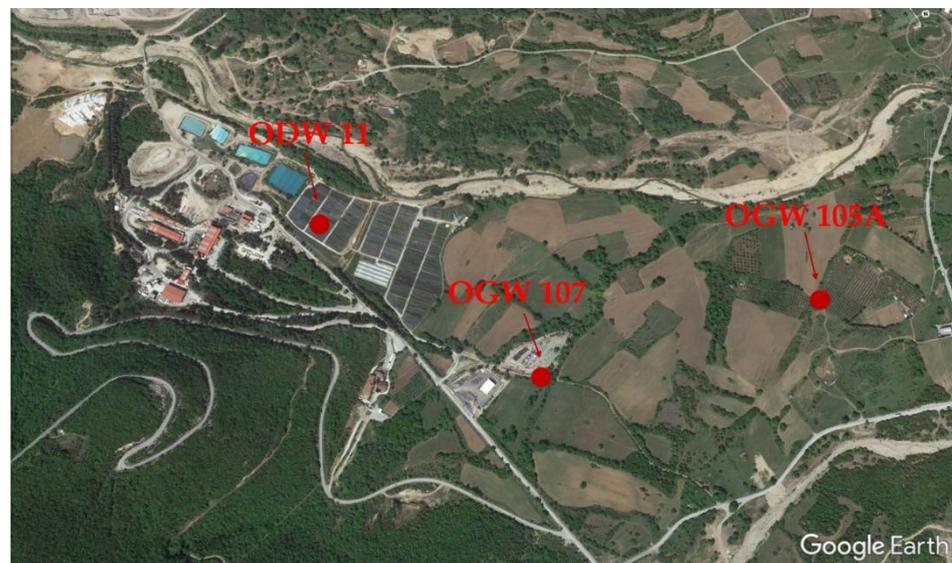
In order to check the effectiveness of remediation and restoration work at the old Olympias arsenopyrites concentrate storage area (former METBA plot), a network of ground-water monitoring stations has been established in the immediate area (Figure 7). Every month at each monitoring piezometer the aquifer level is measured, and a sample of water is taken, on which full analyses of physico-chemical properties and heavy metals are carried out.

Figure 7. Monitoring of ground waters in the immediate area of the old Olympias arsenopyrites concentrate storage area (former METBA plot).

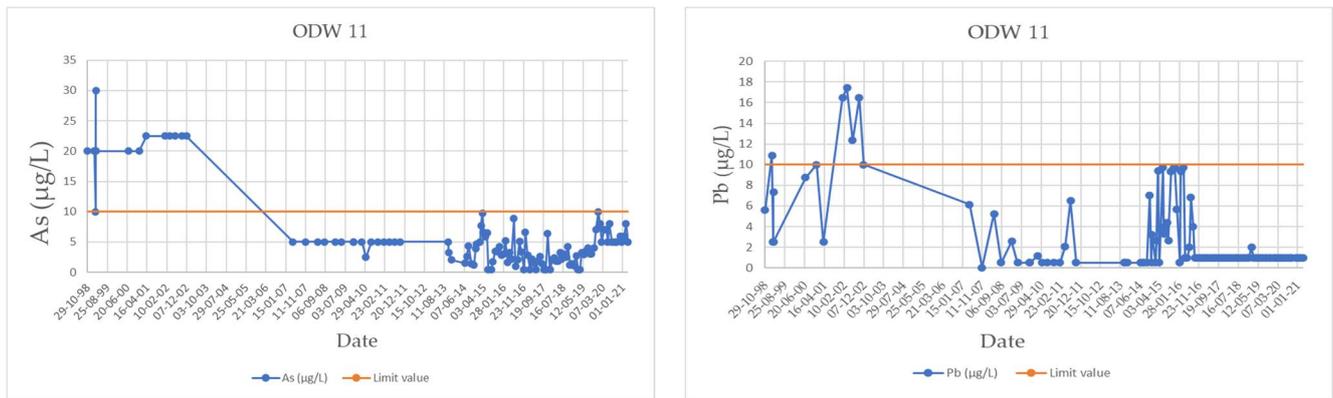
Figures 8–10 show the long-term concentration of As and Pb at the sampling location ODW11 located within the nursery area and the locations OGW107 and OGW105A situated 250 and 750 m, respectively, downstream from the old Olympias arsenopyrites concentrate storage area (former METBA plot).

The above data demonstrate that there is a clear reduction in the concentration of metals in ground waters within the old storage area and downstream from it, with concentrations systematically in compliance with the legislative environmental quality limits.

Figure 8. As and Pb in the ground waters vs. time within the old Olympias arsenopyrites concentrate storage area (ODW11 monitoring station).

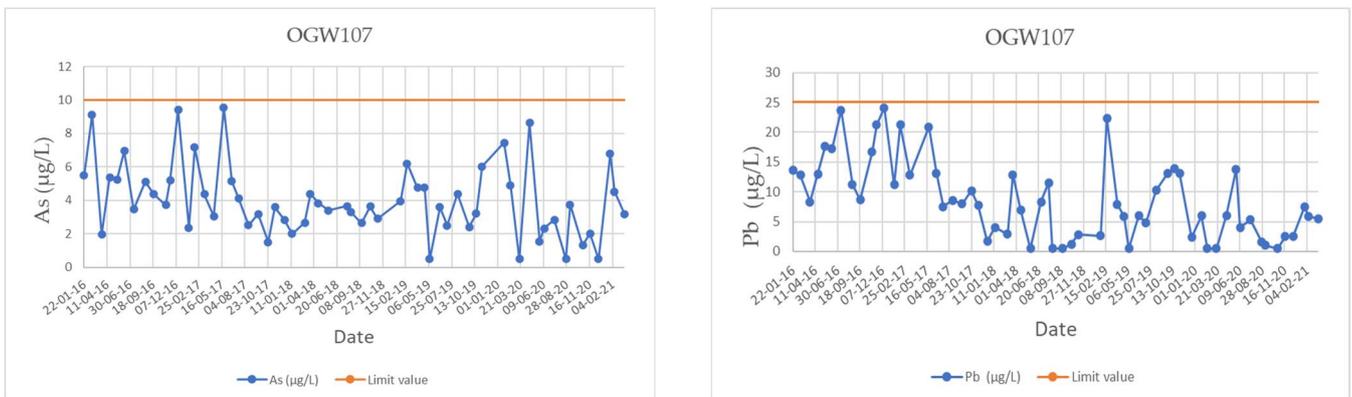
Figure 9. As and Pb in ground waters vs. time 250 m downstream from the old Olympias arsenopyrites concentrate storage area (OGW107 monitoring station).

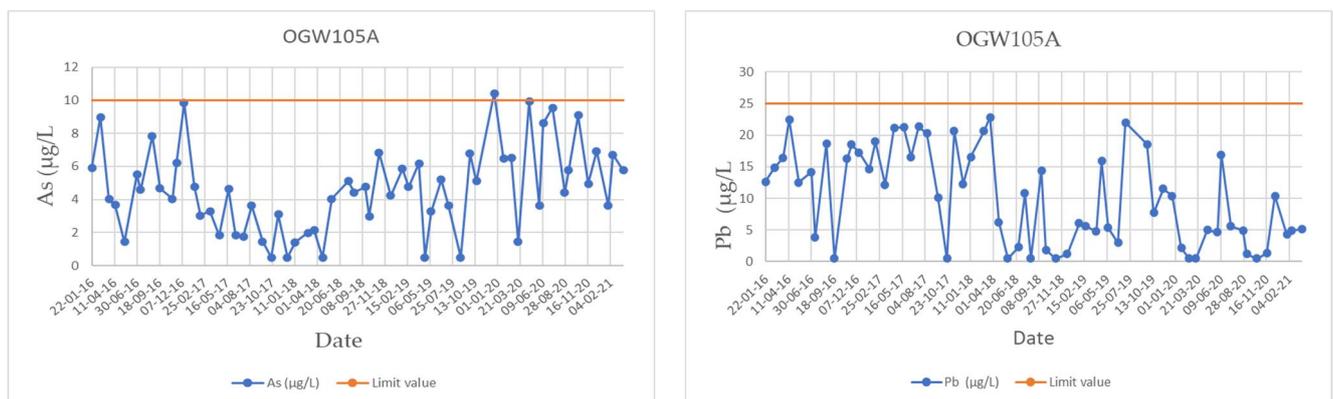
Figure 10. As and Pb in ground waters vs. time 750 m downstream of the old Olympias arsenopyrites concentrate storage area (OGW105A monitoring station).
