# The Influence of Non-Engineered Municipal Landfills on Groundwater Chemistry and Quality in Bloemfontein, South Africa

**Abstract:** This study assessed the groundwater quality around two municipal solid waste landfill sites, in the city of Bloemfontein, Free State Province, South Africa. The two landfill sites are located in two contrasting geological terrains, with both lacking some basic facilities found in a well-designed landfill. A total of eight groundwater samples were collected from pollution monitoring boreholes near the two landfill sites, with five samples representing the northern landfill site and three samples representing the southern landfill site. The samples were collected in the autumn and winter seasons to assess any possible seasonal variations. They were analysed for physicochemical (pH, electrical conductivity (EC), total dissolve solids (TDS), chemical oxygen demand (COD) and total organic carbon (TOC)) and microbiological parameters (*Escherichia coli*, total coliform). The results of the analysis showed that the waters from both landfills were generally dominated by Ca, Mg, SO<sub>4</sub>, and HCO<sub>3</sub> ions. Some of the major anions and cations

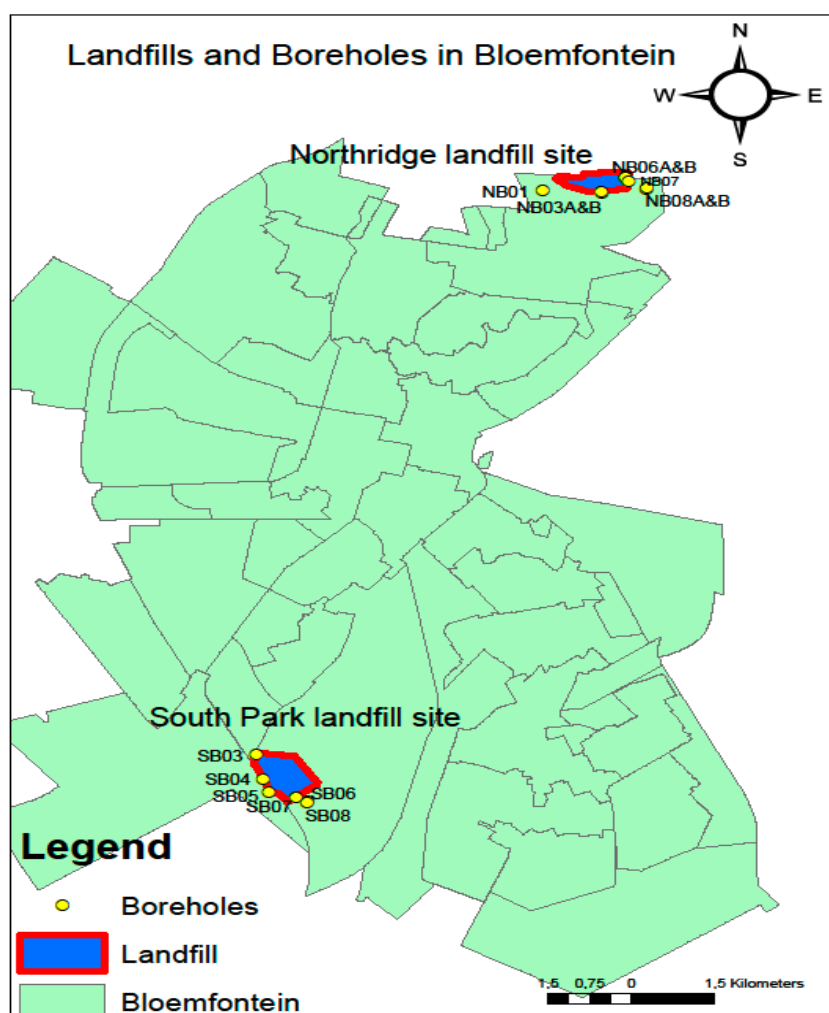
**Figure 1.** Map illustrating the two landfill sites in Bloemfontein and the location of the pollution monitoring boreholes in the vicinity of the two landfill sites.

The study area (Figure 1) comprises of two locations, namely, the northern landfill site and the southern landfill site, in Bloemfontein, Free State Province, South Africa. According to Dingaan and Du Preez [13], the climate of the area is categorised as a cold semi-arid climate (BSK) zone, which entails a steppe climate with dry winters and mean annual temperatures below 18 °C. The average annual precipitation in Bloemfontein is 514 mm, with an evaporation rate of 1676 mm [10]. The summer season ranges from October to February and winter from May to August, with an average annual mean maximum temperature ranging from 26 °C in summer and an average annual mean minimum temperature of 8 °C in winter [11]. The soil type of the study area was classified as a duplex soil, with a major portion being clay [14]. The geohydrological characteristics of the two areas under investigation are slightly different, as discussed in the next two sub sections.

To study the impact of leachate from the unlined municipal landfill sites, groundwater samples from the pollution monitoring boreholes in the vicinity of the two landfill sites (northern and southern) were collected (Figure 1). Duplicate samples were collected in autumn (2 March 2018) and winter (19 June 2018). The sampling names followed the municipal labelling of the boreholes (Figure 1). Groundwater sampling followed the description in the American Public Health Association [17]. A total of five sampling points “boreholes” were sampled in the northern landfill site consisting of boreholes NB03A, NB03B, NB07, NB06A and NB06B. Although boreholes NB01, NB08A and NB08B are included in the map (Figure 1), they were not sampled for the study as NB01 was destroyed during the development of a residential area near the landfill site, and NB08A and NB08B are located within a private property where no access was granted for sampling purposes.

For the southern landfill site, a total of three sampling points “boreholes” consisting of boreholes SB04, SB08A and SB08B. The other monitoring boreholes (SB03, SB05, SB07 and SB08) in the southern landfill site that are indicated in the map were not sampled as they were either damaged or collapsed. The water samples collected for physiochemical analysis were contained in tight-capped polyethylene bottles, while the ones for microbiological analysis were in tight-capped glass bottles to avoid any contamination. They were kept in a cooler box containing ice before being transferred to the laboratory on the same day of collection for analysis. Water quality analyses (physical, cations, trace elements, anions, and microbial) of the groundwater samples were carried out at the Institute for Groundwater Studies (University of the Free State) using ICP-MS, ion chromatography, and IDEXX (Colilert18) Quanti-Tray™.

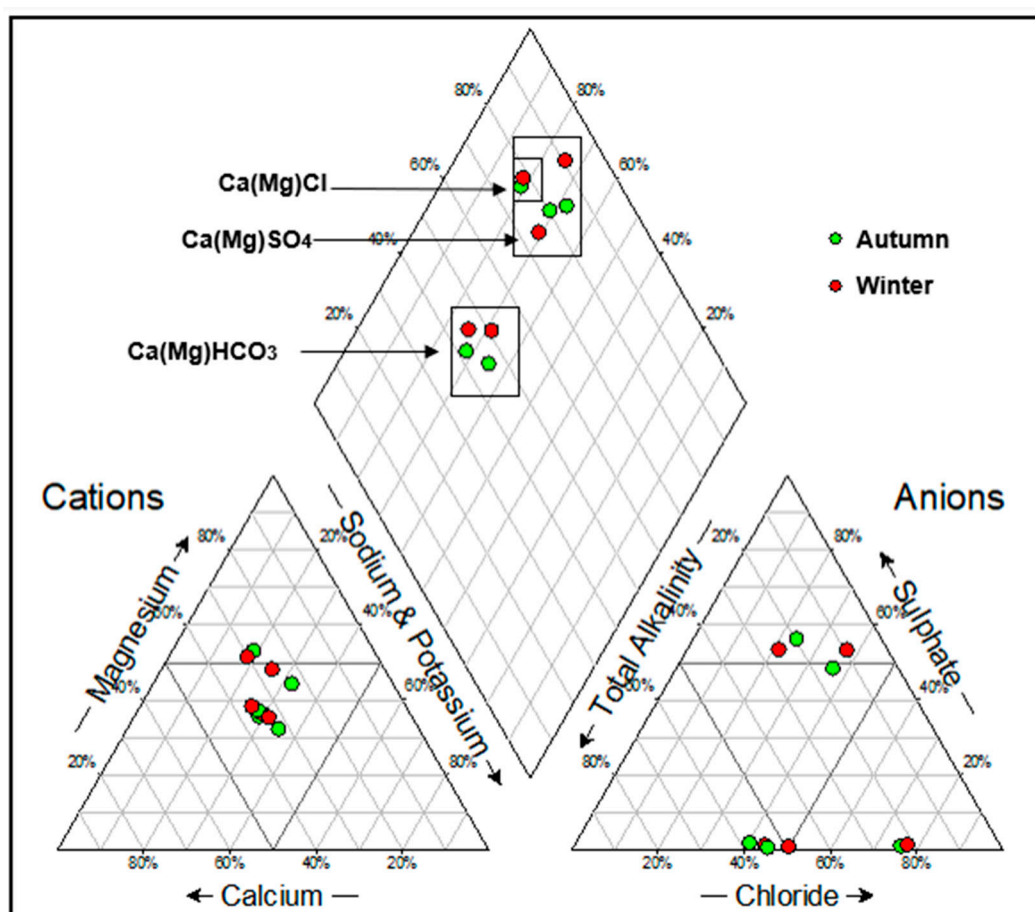
**Figure 3.** Piper diagram for the groundwater samples in the northern landfill site for the two seasons.

Piper plots were constructed to illustrate the hydrogeochemical facies for the groundwater samples, and four main water types were identified (Figures 3 and 4). Expanded Durov diagrams were plotted to further illustrate the eight chemical variables, as well as classify the water (Figures 5 and 6).

The water samples from the two landfill sites showed variation in the overall major ion chemistry, as well as similarities. Boreholes NB06A and NB06B had similar chemistry and plotted in the  $\text{Ca}(\text{Mg})\text{HCO}_3$  vicinity over both seasons. Boreholes SB08A and SB08B in the southern landfill site also plotted in the  $\text{Ca}(\text{Mg})\text{HCO}_3$  vicinity over both seasons. These water samples are indicative of dominance in alkalinity and no dominant cation. Boreholes NB03A and NB03B also had similar chemistry and plotted in the  $\text{Ca}(\text{Mg})\text{SO}_4$  vicinity in the two seasons. Borehole SB04 showed variation in the overall major ion chemistry over the two seasons. The borehole plotted in the mixed type vicinity in the autumn season and the  $\text{Ca}(\text{Mg})\text{Cl}$  vicinity in the winter season. Borehole NB07 plotted in the  $\text{Ca}(\text{Mg})\text{Cl}$  vicinity in the two seasons which indicated a dominance in the chloride anion and no dominant cation.

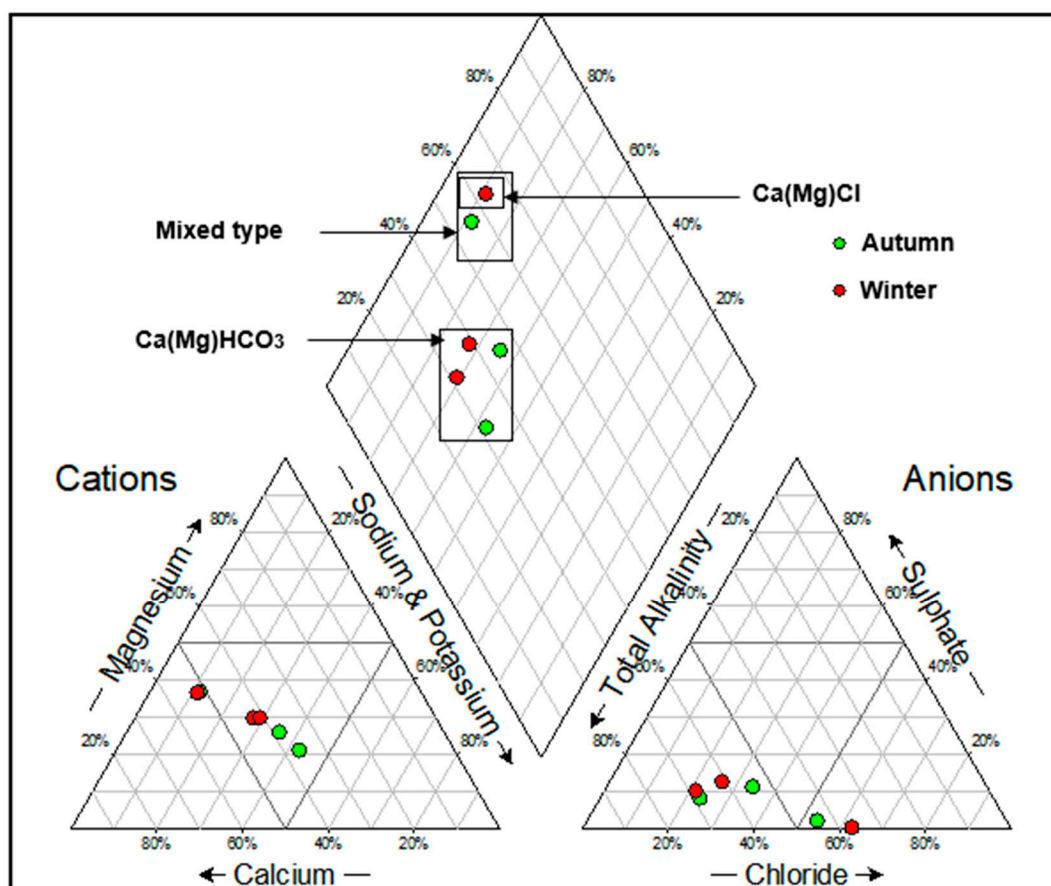
Figure 4. Piper diagram for the groundwater samples in the southern landfill site for the two seasons.

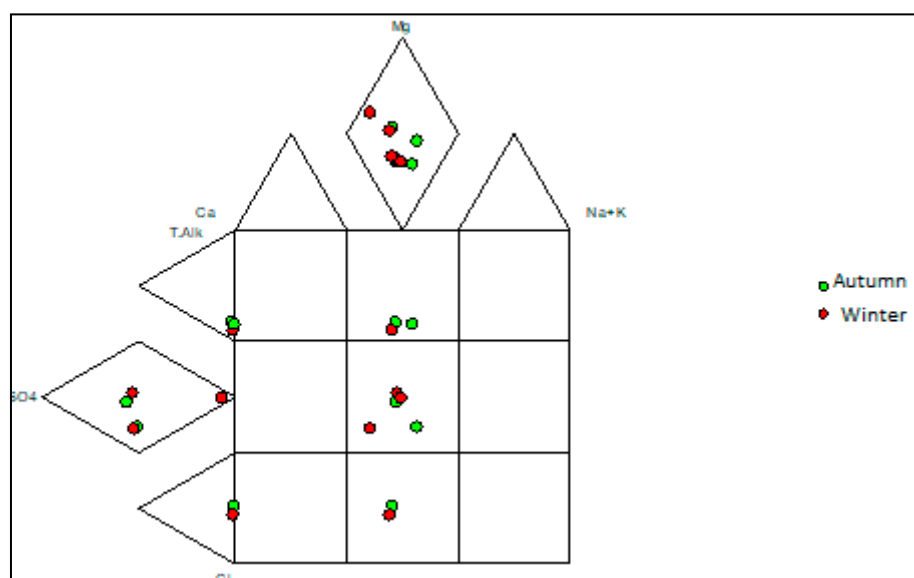
Figure 5. Expanded Durov diagram for groundwater samples in the northern landfill site for the two seasons.

Results from the expanded Durovs shows the water samples from the northern landfill site plotted on the seldom found section, as well as the unpolluted water types based on minimum requirements suggested by the Department of Water Affairs requirements for water monitoring at waste management facilities. From a hydrogeochemical perspective, these water types are represented of water undergoing continuous changes in chemistry. Sodium Adsorption Ratio diagrams were constructed to illustrate the salinity hazard of the different groundwater samples based on their electrical conductivities (Figures 7 and 8). The SAR diagram is plotted to illustrate the aquifers irrigation water quality within the vicinity of the landfill. In the northern landfill site, boreholes NB07 and NB03B had a very high salinity in both seasons. Borehole SB04 had a high salinity hazard over both seasons in the southern landfill site.

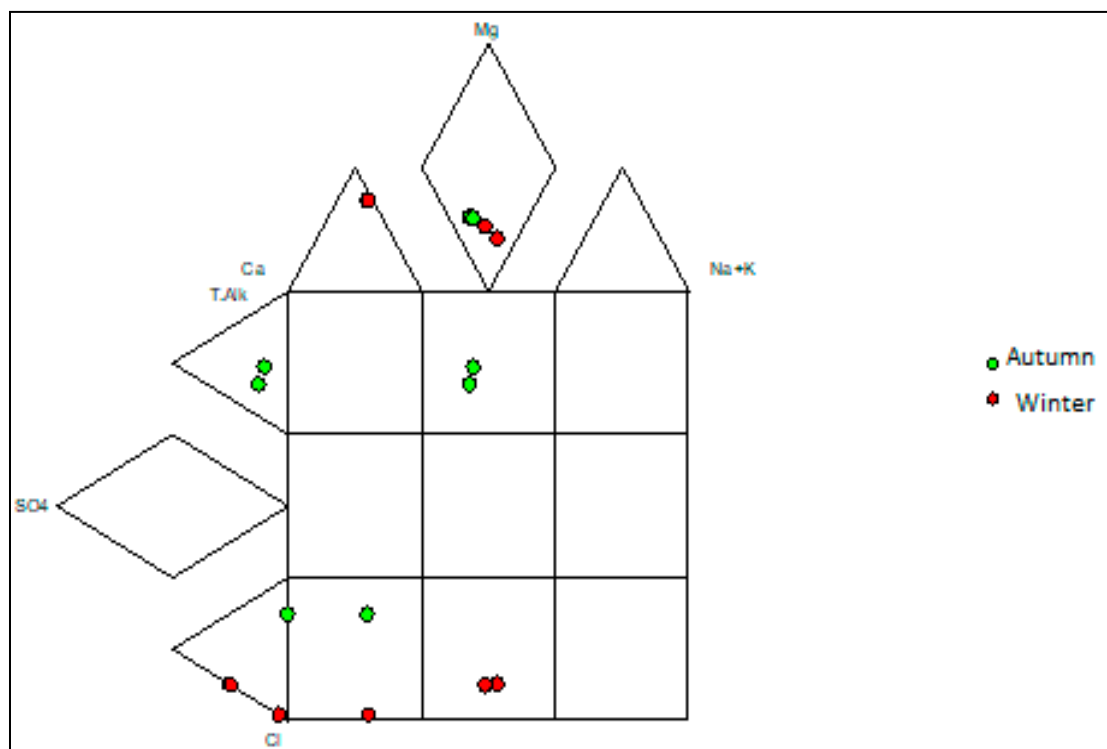
**Figure 6.** Expanded Durov diagram for groundwater samples in the southern landfill site for the two seasons.

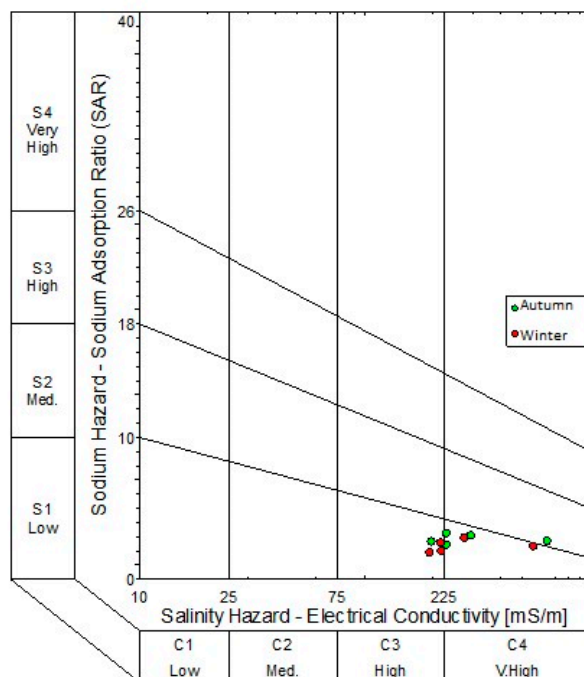
**Figure 7.** Salinity hazard (SAR) diagram for the boreholes in the northern landfill site.

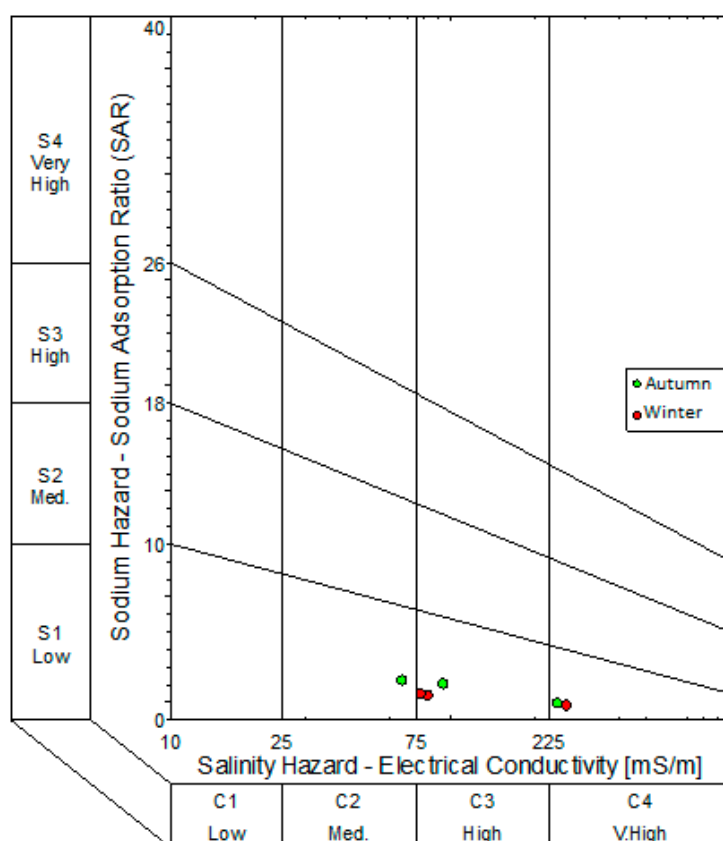
**Figure 8.** SAR diagram for the boreholes in the southern landfill site.

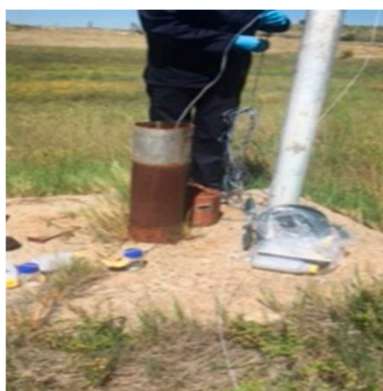
**Figure 9.** Well-constructed borehole in the northern landfill site.

Elisante and Muzuka [29], stipulate that groundwater is prone to microbial contamination, due to human activities, such as soil fertility remediation, indiscriminate refuse and waste disposal, and the use of on-site sanitation facilities. All the boreholes in the northern landfill site had zero *E. coli* concentrations over both seasons and were, therefore, within the recommended drinking water limits as stipulated by SANS 241 [22] and WHO [21]. All the boreholes in the southern landfill site had notable *E. coli* concentrations, with borehole SB04 having the highest *E. coli* concentrations over both seasons. Findings by Elisante and Muzuka [29] concluded that differences in microbial contamination in boreholes can be attributed to the quality of borehole construction, as boreholes that were well constructed had low microbial contamination in comparison to those whose mouths were set at the ground surface. Figure 9 is a representation of the status of the boreholes in the northern landfill site with Figure 10 representing the borehole in the southern landfill site, whereby significant *E. coli* counts were noted. The poor state of the borehole in the southern landfill site might have resulted in the borehole being prone to microbial contamination.

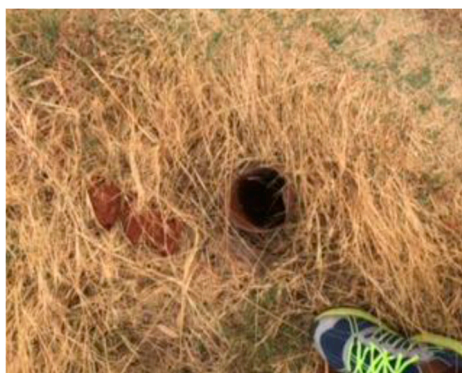
**Figure 10.** Poorly constructed borehole in the southern landfill site.

This study highlights that geology plays a significant role in the distribution of contaminants into groundwater systems. The presence of underlying dolerite in the northern landfill site resulted in the northern landfill site having a poorer water quality in comparison to the southern landfill site with respect to physicochemical parameters, while the poor state of the southern landfill boreholes made them more disposed to microbial contamination.
