# Evaluation of SHM System Produced by Additive Manufacturing via Acoustic Emission and Other NDT Methods

**Abstract:** During the last decades, structural health monitoring (SHM) systems are used in order to detect damage in structures. We have developed a novel structural health monitoring approach, the so-called “effective structural health monitoring” (eSHM) system. The current SHM system is incorporated into a metallic structure by means of additive manufacturing (AM) and has the possibility to advance life safety and reduce direct operative costs. It operates based on a network of capillaries that are integrated into an AM structure. The internal pressure of the capillaries is continuously monitored by a pressure sensor. When a crack nucleates and reaches the capillary, the internal pressure changes signifying the existence of the flaw. The main objective of this paper is to evaluate the crack detection capacity of the eSHM system and crack location accuracy by means of various non-destructive testing (NDT) techniques. During this study, detailed acoustic emission (AE) analysis was applied in AM materials for the first time in order to investigate if phenomena like the Kaise

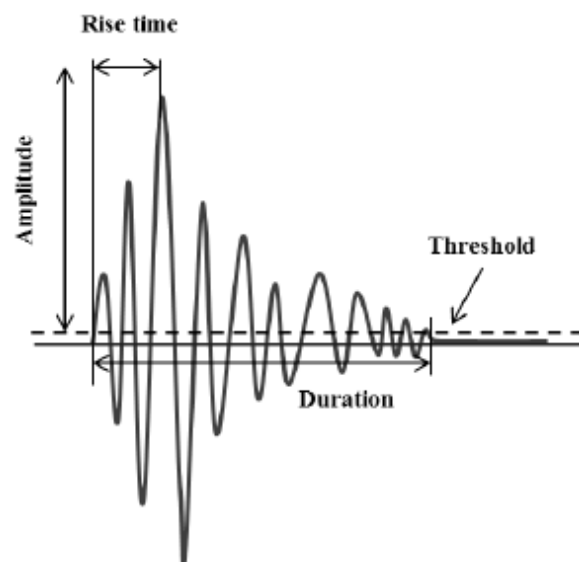
**Figure 1.** Typical acoustic emission signal with main waveform parameters.

acoustic signals, which may provide information on damage accumulation, other qualitative waveform parameters can be also significant. Parameters like maximum amplitude, energy, rise time (RT) and duration (DUR) can provide equally important information. Figure 1 shows a typical AE waveform with its basic features. AE as a technique has been extensively used in damage characterization in metals [27–30], rocks [31] and ceramics [32] among other materials while structural components like wind turbine blades [33] were also evaluated. Furthermore, in cyclic loading histories other important effects like the well-established “Kaiser effect” and “Felicity effect” should also be taken into account as essential damage accumulation indicators. In the case of the Kaiser effect, no AE is recorded until the previous maximum load has been overpassed while reloading an intact specimen [31,34,35]. On the other hand, AE will be recorded in cases of severe damage even at much lower loads than the previously applied [32]. In those cases, the ratio of the load when AE takes place and the previous maximum load is called Felicity ratio. According to the literature [36,37] Felicity ratio 1 or larger shows no damage since the last AE inspection. However, a decrease in the Felicity ratio value might be associated with cumulative damage.

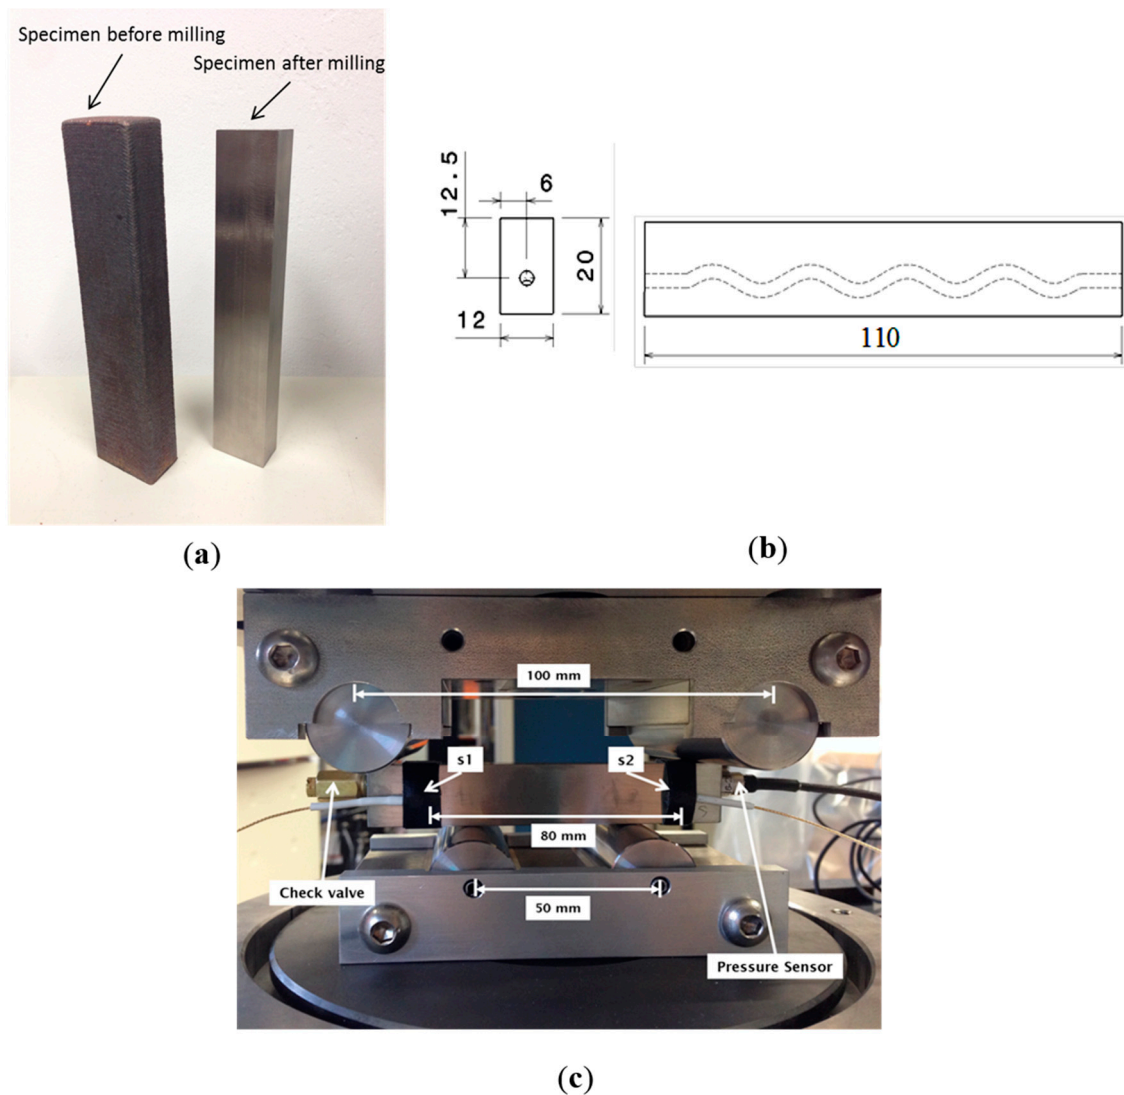
**Figure 2.** (a) Specimens produced by laser metal deposition (LMD) before and after milling; (b) four-point bending specimen, 2D side and front views; and (c) four-point bending setup with the AE and the pressure sensors placed on the specimen.

All the specimens were built with an integrated eSHM system by means of a 3D sinusoidal shape of capillary, which was built in the course of AM. The integrated capillary had a diameter of 3 mm in the LMD samples (AISI 316L) and 1 mm in the SLM samples (Ti6Al4V). The sinusoidal shape had an amplitude of 2 mm and a period of 25.7 mm. The current design lies on a previous study, where the main objective was to prove that the integrated capillary had no negative influence on the crack initiation during fatigue. The sinusoidal shape is also linked with the ability of AM to create complex structures. The locations with the highest likelihood for crack initiation from the capillary were situated on the circular cross sections that were furthest away from the specimens' neutral axis. In the current specimens, the moment of inertia alters along the capillary. This is associated with the fact that the circular cross section of the capillary from the neutral axis varied. The further the cross section from the neutral axis, the lower the moment of inertia and the higher the nominal stress and the stress at the capillary becomes. More details on the design strategy can be found in the paper of Strantzà *et al.* [9]. After production the specimens were milled to the final dimensions shown in Figure 2b. A specimen before and after milling is also depicted in Figure 2a.

Concurrently with the static loading procedure, the specimens were monitored by the pressure transducer and two AE broadband transducers (Figure 2c). The acoustic emission sensors were also placed between the supports at a distance of 80 mm. The sensors were of “pico” type of Mistras Holdings having a broadband response and peak frequency at 450 kHz. The signals were pre-amplified by 40 dB and recorded by the acquisition board with a sampling rate of 10 MHz (micro-II, 8 channels). The threshold was set at 40 dB and the acoustic coupling was improved by vaseline grease between the sensors and the metal specimen. The sensors were secured by means of tape during the loading. The analysis herein is based on the “AE events” rather than the total AE activity. An event is the source of AE and, in this case, consists of two signals received within a short window of time by both sensors. The location of the AE source can be determined between the sensors on the basis of the time delay between the two recorded signals, given that the pulse velocity in the medium is known. In the present case, localization was performed with a velocity of 5000 m/s. This velocity was measured by conducting pencil lead break tests. Analyzing only the events reduces the risk of noise contaminating the data, since it is always possible that friction in the supports or other irrelevant sources are recorded as individual hits.

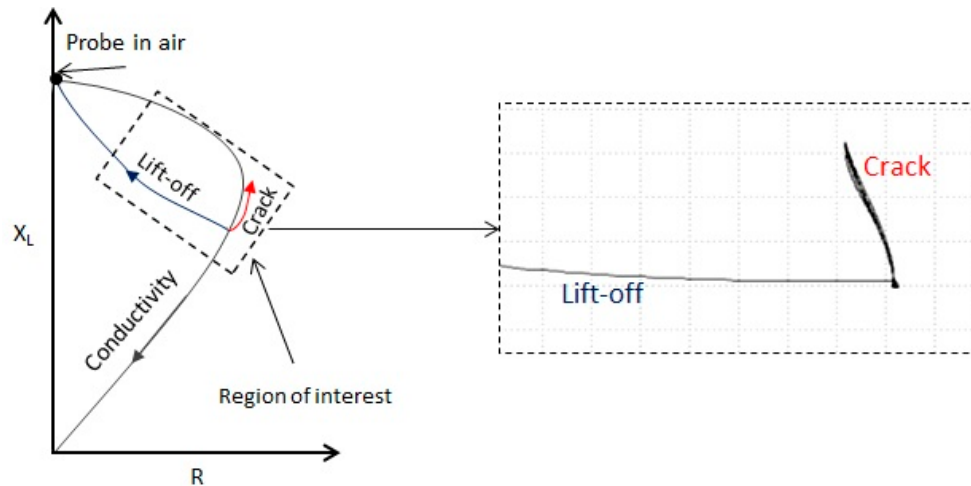
**Figure 3.** Eddy current (EC) signals from a normalized impedance plane diagram showing the defect detection in SLM2.

As far as EC is concerned, it is a technique that is used to examine rather small surface regions. The probe design and test parameters must be determined with a good understanding of the defect. The eddy current signal results are displayed in the normalized impedance plane of Figure 3. During the setup the coil resistance appears on the x-axis *versus* inductive reactance on the y-axis (see Figure 3). In order to detect cracks, it is more practical and common to adapt the phase in such a way that the lift-off (distance between probe and component) will be on the x-axis and the cracks will then appear on the y-axis by adapting the vertical amplification (depicted from SLM2 specimen in Figure 3 in the

region of interest). By doing this, the phase between the lift-off and a crack will be more visible. The angle and amplitude change of the EC signal is the main principle for signal evaluation. The locations of the cracks were clearly detected in all the specimens along the length of 110 mm. In LMD1 and LMD 2 at 50 mm and 73 mm, respectively, while in SLM1 and SLM2 at 80 mm and 45 mm.

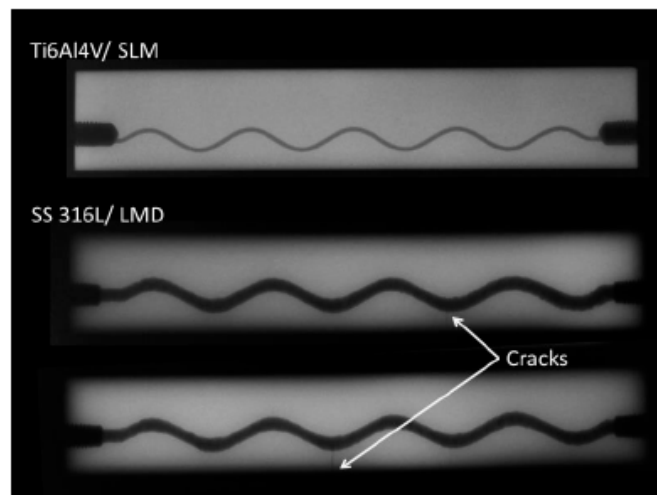
**Figure 4.** Radiographic images of the four-point bending specimens produced by selective laser melting (SLM) and laser metal deposition (LMD) after the crack detection of the effective structural health monitoring (eSHM) system.

Supplementary to EC and LPI, radiographic inspection was also performed on the specimens. In Figure 4 the radiographic images of the first sample of AISI SS316 and the two samples of Ti6Al4V are shown. The cracks are retrieved in both AISI 316L (see Figure 4) and are located on the lower part of the sinusoidal capillary on the positions that were also indicated by EC. However, the crack in Ti6Al4V could not be detected by radiographic images. The difficulties in detection may be associated with the angle between the crack and the radiation. If the radiation is not parallel with the defect, the defect may appear distorted, out of position, and less visible in the image.

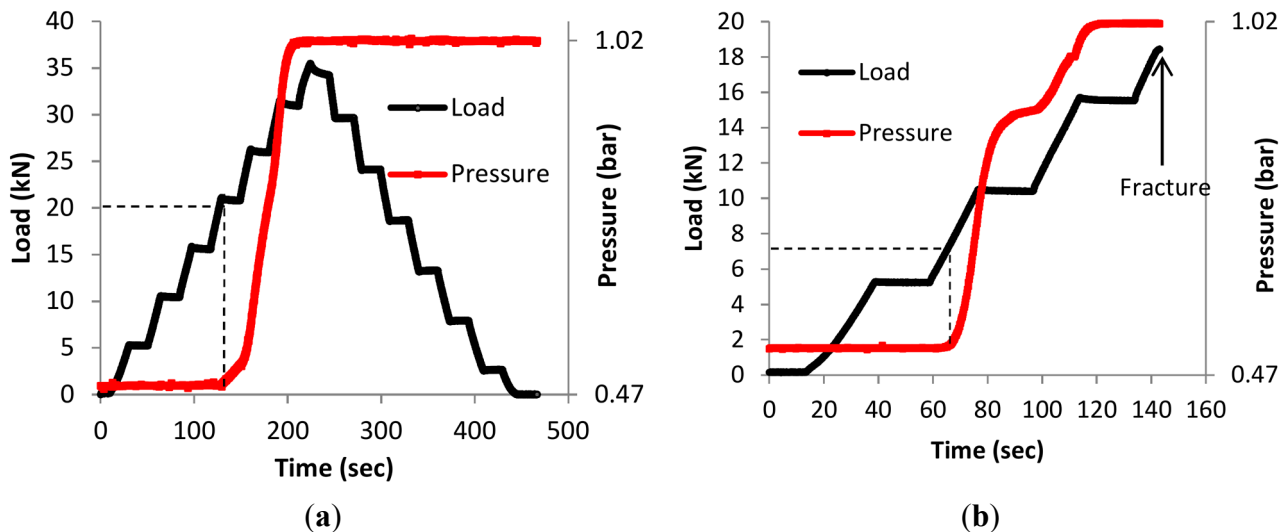
**Figure 5.** (a) Load history and time vs. time for the LMD1 sample; and (b) load history and pressure vs. time for the SLM1 specimens.

When the specimens are not under stress, the crack is closed so the internal pressure can be maintained. Therefore, prior to the static loading, pressure of approximately 0.5 bars was applied in the capillaries in order to monitor the crack opening again. During the test the specimens were monitored by AE. As previously mentioned, the loading was increased in steps of 5 kN until the maximum load of the fatigue test was reached, and then unloading was applied in steps of 5 kN. For the first two samples of LMD, the maximum load of the fatigue test was 34 kN, 20 kN for the SLM1 and 36 kN for SLM2. In Figure 5a the behavior of the pressure during the loading of LMD1 can be observed. At the load level of 20 kN a rise in the pressure is observed, where at 31 kN the pressure reaches the atmospheric pressure which is approximately 1.02 bar according to the pressure sensor. The pressure level of the SLM1 specimen, depicted in Figure 5b, indicates a pressure change at 7.5 kN where at 15.5 kN the pressure reaches the ambient pressure. It is obvious that for the SLM1 sample the pressure increase is noticeable quite early and a brittle fracture occurs below the maximum load level of crack detection, not allowing the controlled unloading to take place. This sudden failure was caused by porosity or unmelted regions of the SLM-processed material and led to an early failure. It is demonstrated in the literature that the porosity within the SLM samples has a radical effect on the failure and specifically on the fatigue behavior [40]. Pressure behavior similar to LMD1 was observed for the other two samples, which are not graphically represented. In all the cases, when the crack opens, the pressure inside the capillary starts to change to equalize with the atmospheric pressure.

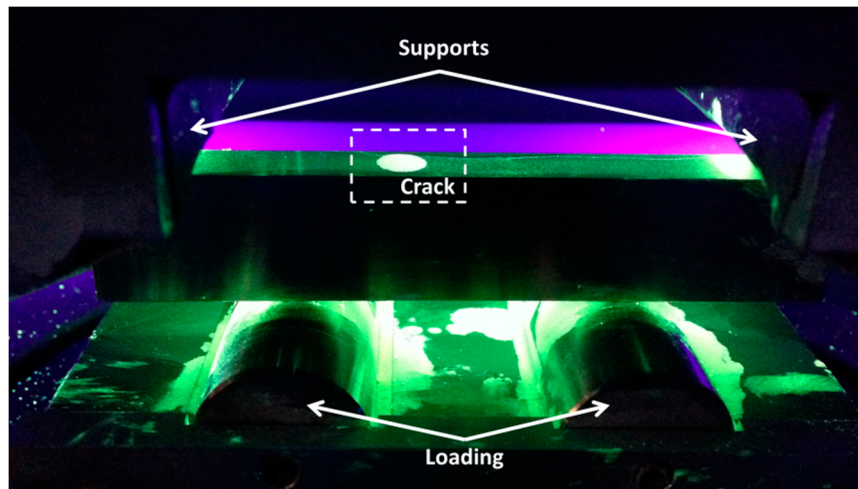
**Figure 6.** Crack location on additive manufactured samples by means of liquid penetrant inspection (LPI) level 2 under static loading.

After static loading, all specimens (except the one that failed during static loading) were subjected to another round of static loading on the load level of the crack opening. This new loading was important in order to confirm the presence of the crack by LP when it was open due to the tensile stresses. While, as mentioned, LP was not able to detect the cracks in stress-free conditions, since the crack was closed. At a certain load level of the crack opening, the specimens were coated by liquid penetrant. All the cracks were accurately located in all the specimens as is demonstrated for the LMD1

specimen in Figure 6. Those crack locations were the locations that were indicated earlier from EC in Section 3.1.

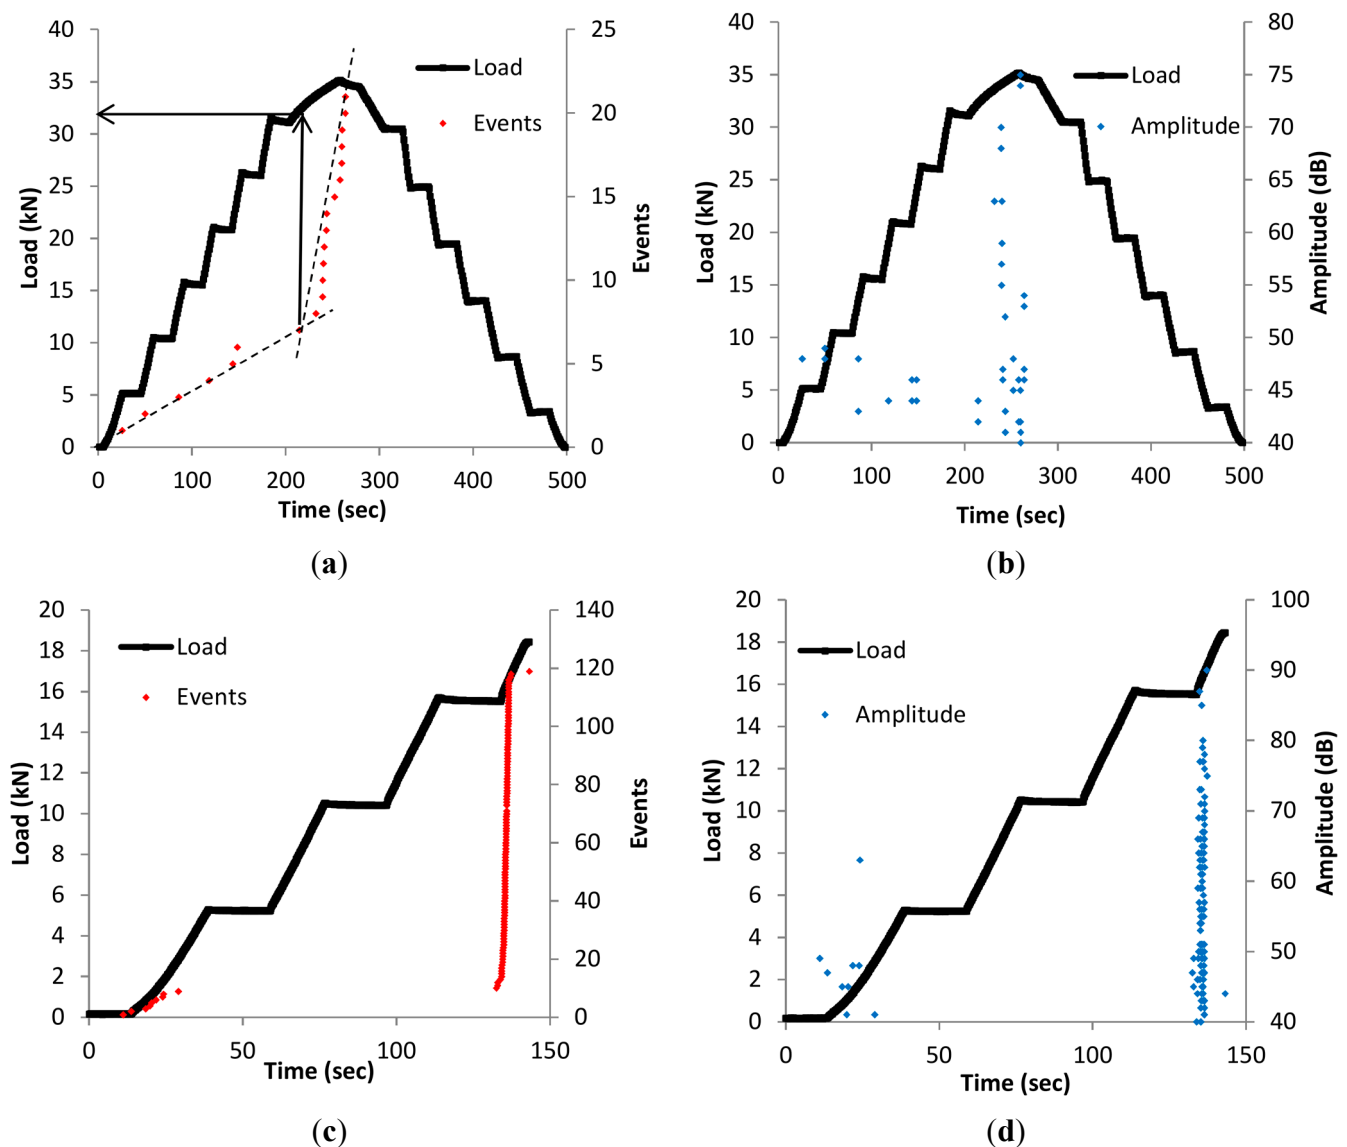
**Figure 7.** (a) Load history and number of events vs. time for the LMD2 sample; (b) load history and amplitude vs. time for LMD2 sample; (c) load history and number of events vs. time for the SLM1 sample; and (d) load history and amplitude vs. time for SLM1 sample.

In parallel with the static loading and the pressure behavior, AE technique was also used to monitor the sample behavior. In the current study the samples were already cracked so the study does not focus on crack initiation; however other mechanisms such as possible crack propagation and friction of the crack faces can be recorded. In Figure 7a the cumulative AE events and the load *vs.* time are depicted for the LMD2 sample. The event rate is moderate throughout the initial stages of loading and suddenly reaches a maximum value at the load of 34 kN which is the load level of the crack detection during fatigue loading according to the eSHM system. It is also characteristic that the cumulative number of AE events is seven until 32 kN and, up to 34 kN, the population has already increased to 21. Similar conclusions can be drawn from Figure 7b, where the amplitude and the load history *vs.* time are shown for the same specimen. Up to the load of 32 kN events do not exceed the amplitude of 50 dB. However, after that point there is also a population of signals above that level up to 75 dB. It is clearly observed that the AE hits with the highest amplitudes appear at the moment when the load reaches the maximum value of the load of the crack detection (between 30 and 34 kN), indicating possible crack propagation since the load reaches the previous maximum load applied on the specimen.

In Figure 7c, the number of events is depicted for another sample, namely SLM1. As previously mentioned, SML1 failed during static loading after reaching the load of 18 kN. It is obvious that the total number of events (120) is much higher compared to the LMD2 sample, which was not totally fractured. Additionally, AE amplitude values (Figure 7d) have also increased significantly to 90 dB at the load level of the macroscopic fracture, while for the LMD2 specimen the value is limited to 75 dB.

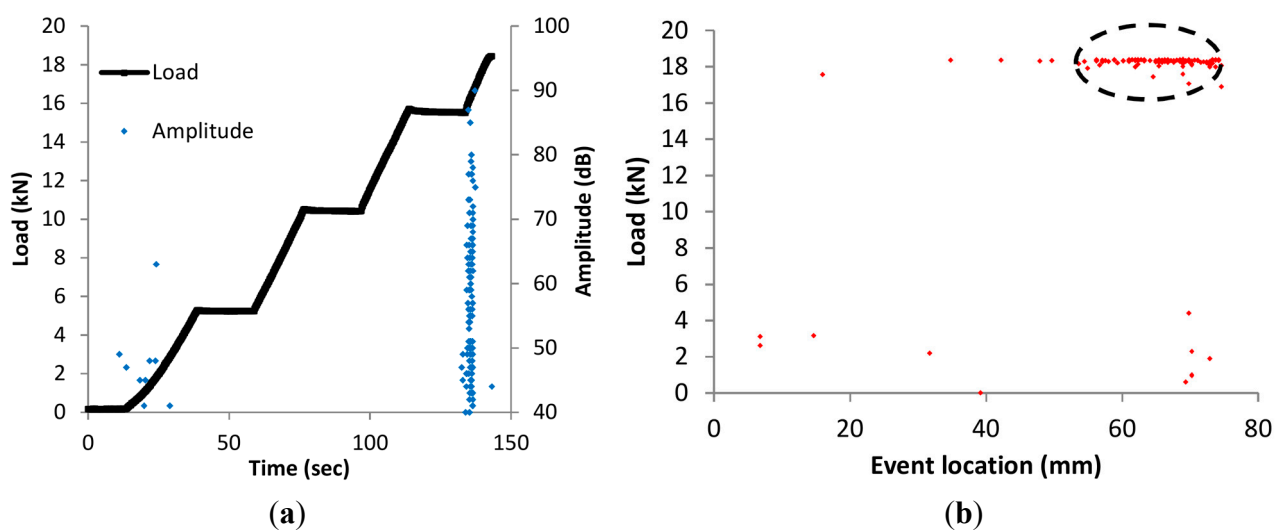
**Figure 8.** (a) Events vs. location for SLM1 specimen; and (b) load vs. event location for SLM1 sample.

In addition to the AE events history, the location of the events was also studied. Figure 8a shows the location distribution of AE events for SLM1 specimen. The event density is much higher for the position between 55 and 75 mm, where the actual fatigue crack was located (65 mm). The transient development of event location with load is seen in Figure 8b. Up to 5 kN load there are few distributed AE events (which at the location of the crack could indicate possible friction between the banks) while when the load approaches the previous maximum the crack starts to propagate and there are many events around the position of the crack, indicated by an ellipse. They are distributed within a zone of 20 mm rather than at a single location as can be concluded from Figure 8a,b. This is reasonable due to different factors of error, like the actual 3D geometry of the specimen (deviating from the applied “linear” localization method), short gauge length (80 mm) between finite diameter transducers (around 6 mm) and multiple reflections. It is important to mention that depending on the defect’s angle and size, NDT techniques such as AE, EC, radiography and LP can provide correct information on the location of a crack that is detected by the eSHM system. For example, in the case of SLM1, the AE events were localized at around 65 mm. The EC also indicated the crack at the position of 65 mm (which corresponds to 80 mm along the length of the specimen), where the actual fracture happened. On the other hand, the radiographic images and LP (level 2) in stress-free conditions could not provide a clear indication on the crack location for the SLM specimens as mentioned in Section 3.1.

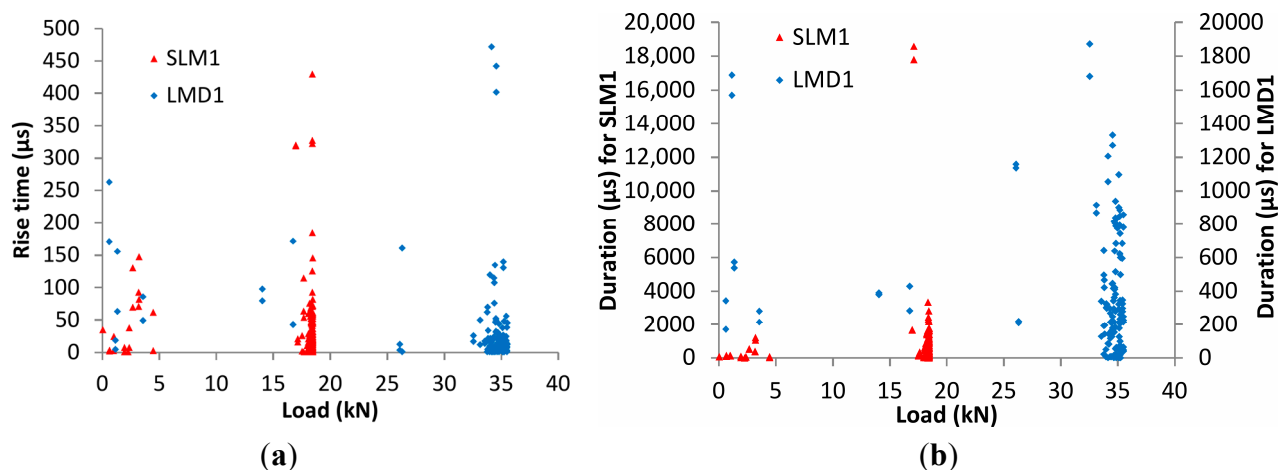
**Figure 9.** (a) Rise time vs. load history for SLM1 and LMD1 specimen; (b) duration vs. load history for SLM1 and LMD1 specimen.

In order to take into account the qualitative parameters of the waveforms rather than just their number, AE waveform parameters of duration and rise time were also analyzed. The rise time of the waveforms for the two sensors is depicted in Figure 9a for SLM1 and LMD1 samples. Each point represents the RT for each AE event during the static loading procedure. As previously mentioned, SLM1 specimen failed at 18 kN, while LMD1 followed the cycling loading up to 34 kN without fracture. It is obvious in case of both specimens that, when the load reaches its maximum value and crack propagation occurs, events with much higher rise time are emitted. The trend is very clear for SLM1, for which rise time was lower than 150  $\mu$ s up to 15 kN, while at the end, values up to 430  $\mu$ s were recorded. The same trend was repeated for the LMD1 specimen where the highest rise time

values were noticed at the maximum load of approximately 35 kN, confirming that crack propagation in AM material can be detected by a change in waveform parameters. Similar results were also produced for the duration of the waveforms as depicted in Figure 9b. The duration for SLM1 sample was limited to 2000  $\mu$ s below 15 kN, while for the maximum load, the duration increased to 18,000  $\mu$ s. The same trend was also followed for LMD1 although the duration values were much lower (up to 1800  $\mu$ s for the maximum load). Before the maximum load, the events with duration longer than 600  $\mu$ s were scarce. However, when the load approached the maximum load the density of the events with high duration strongly increased.
