# Monitoring Fatigue Damage of Modular Bridge Expansion Joints Using Piezoceramic Transducers

**Abstract:** Modular bridge expansion joints (MBEJs) are commonly used in bridges and are often subjected to fatigue damages, which necessitate fatigue monitoring of MBEJs to ensure the reliable operation of the bridges. In this paper, a stress wave based active sensing approach using piezoceramic transducers is developed to monitor the fatigue damage of MBEJ. A MBEJ involves mainly center beam, edge beam, support bar, support box, sliding bearing, sliding spring, elastomeric strip seal, full-penetration weld and reinforcing plate. In practice, for a MBEJ, the part that is most prone to fatigue damage is the full-penetration weld between the center beam and the support bar. In this paper, a specimen, which is the full-scale center-beam/support-bar (CB/SB) assembly, was designed and fabricated to facilitate the experimental study. The assembly mainly includes center beam, support bar, reinforcing plate, and full-penetration weld. The lead zirconate titanate (PZT) transducer bonded on the support bar was used as the actuator and the PZT transducer mounted on the center beam was as the sens

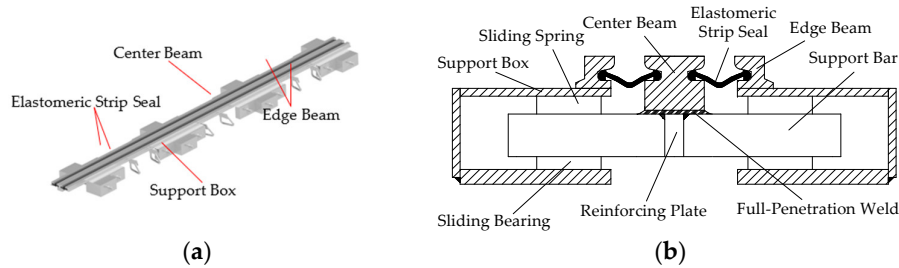
**Figure 1.** The MBEJ. (a) Three-dimensional view. (b) Main components.

In this work, we propose a stress wave based active sensing method using piezoceramic patch transducers to evaluate the fatigue damage in the modular bridge expansion joints with full-penetration weld in real-time. The MBEJ adopted in this paper is shown in Figure 1. The MBEJ involves mainly the center beam, the edge beam, the support bar, the support box, the sliding bearing, the sliding spring, the elastomeric strip seal, the full-penetration weld and the reinforcing plate. The center beam is rigidly connected to the support bar with the full-penetration weld. To strengthen their connections, the reinforcing plates are welded along the longitudinal direction of the support bar, therefore the support bar and the center beam can act as a whole sliding within the support box through the sliding bearing and sliding spring. Additionally, the edge beams are welded directly to the top of the support box, and they act as a whole while moving with the structure. In practice, in a MBEJ, the part that is most prone to fatigue damage is the full-penetration weld between center beam and support bar. Most of the fatigue damages originated in this connection zone [3,53,54].

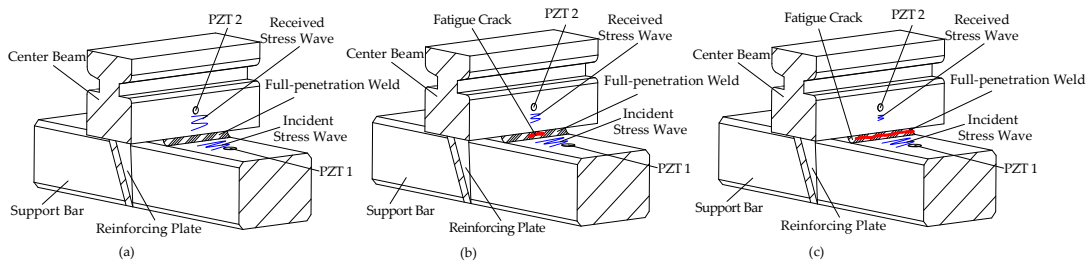
The principle of the active-sensing approach is illustrated in Figure 2. One PZT patch bonded on the support bar, as an actuator, is used to generate a stress wave, and the other PZT patch mounted on the center beam, as a sensor, is utilized to detect the wave response. Some defects are unavoidable in full-penetration weld, including undercut, overlap, pit, incompletely filled weld, and surface cracks, among other. The signals are received by a sensor at the initial state before fatigue loading, as shown in Figure 2a. When the MBEJ is under the fatigue load, these defects tend to generate stress concentration as the source of fatigue damage. With the number of fatigue cycles increasing, the fatigue damage in the throat of the weld expands, until it develops into a fatigue crack, and the signals received by a sensor decrease, as shown in Figure 2b. As the fatigue loading cycle further increases, the fatigue stress in the throat of the weld continues to accelerate the fatigue cracking in the narrow full-penetration, the received signal will continuously decrease until the fatigue loading process is complete, as shown in Figure 2c.

**Figure 2.** The principle of the active-sensing approach. (a) The initial state before fatigue loading. (b) Fatigue crack occurs in the weld throat. (c) Fatigue crack grows along the longitudinal axis of the center beam.

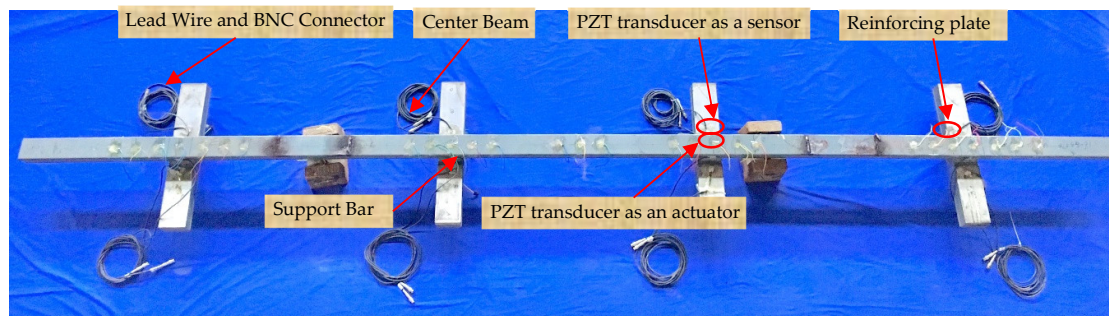
The test specimen was a full-scale CB/SB assembly that is a representative of that used in actual engineering applications, as shown in Figure 3. In the assembly, the full-penetration welds were utilized as the connections between the center beam and the support bars, and the reinforcing plates mounted along the longitudinal direction of the center beam were to strengthen these connections.

Figure 3. The photo of the full-scale CB/SB assembly of the MBEJ.

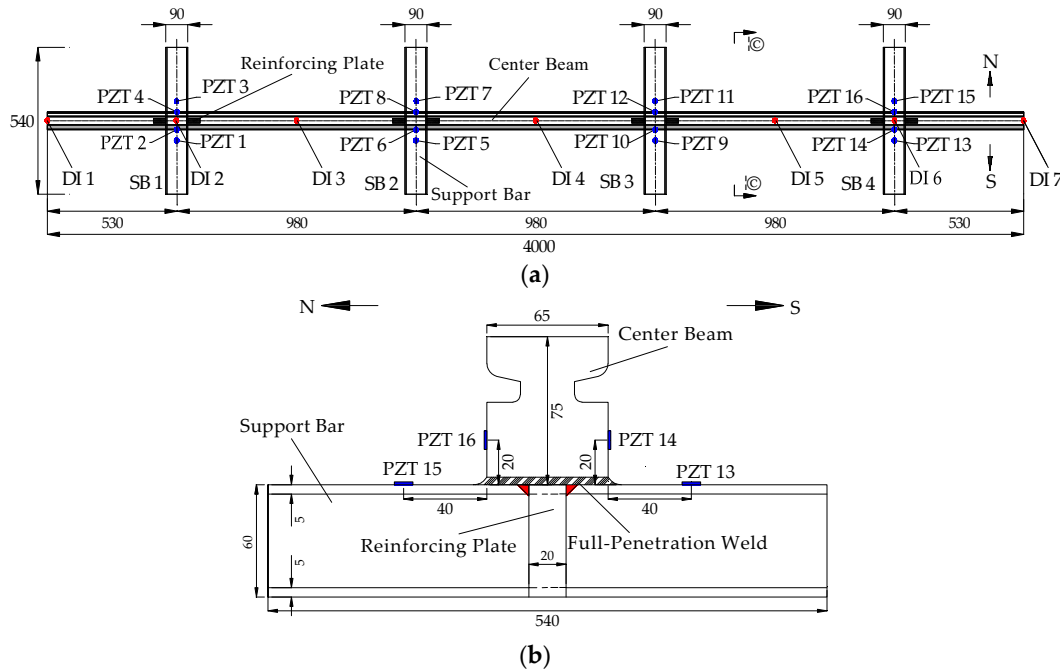
The details of the test specimen are shown in Figure 4. The center beam with a length of 4000 mm in the test specimen was connected by the support bar with a length of 540 mm. The distance between the support bars was 980 mm. The center beam was a rectangular cross-section with the groove, which was applied to install the elastomeric strip seal. Its width and height were 65 mm and 75 mm, respectively. The support bar also was a rectangular cross-section with a width of 90 mm and a height of 60 mm. These parts adopted ASTM 572 Grade 50 (Q345B) steel, and its material properties were shown in Table 1. The Young's modulus and shear modulus were 200 GPa and 76.9 GPa, respectively. Its yield stress and ultimate stress were 350 MPa and 450 MPa, respectively.

**Figure 4.** The details of the test specimen (unit: mm). (a) Top view. (b) I-I section left view.

In this research, to study the fatigue damage of the full-scale CB/SB assembly specimen, two PZT patches with compression mode was mounted on both sides of each weld joint along the longitudinal axis of CB, as shown in Figure 4. One of the PZT patches mounted on the support bar was used as an actuator to generate the stress wave, and the other one installed on the center beam was utilized as a sensor to detect the stress wave signal. The function of each PZT transducer on the test specimen is shown in Table 2. The type of the PZTs used in the test specimen is PZT-5H and each PZT transducer has a diameter of 7.4 mm and a thickness of 1.3 mm. We used epoxy to bond the PZT patches on the specimen.

During the fatigue loading experiment, to simulate the effect of the fatigue damage on the stiffness of the test specimen, the dial indicators were installed to monitor the vertical displacement of the center beam, as shown in Figure 4. After finishing a certain number cycle loading, the displacements of the center beam were measured under static load. In the test process, the load distribution beam was installed on the location between the mid-spans of two side spans in the specimen. As a result, the dial indicator at the CB/SB2 joint and CB/SB3 joint cannot be installed. Hence, the displacements of the CB/SB2 joint and CB/SB3 joint could not be obtained, and the average displacement at the joint of the test specimen was only the average displacement of DI2 and DI6.

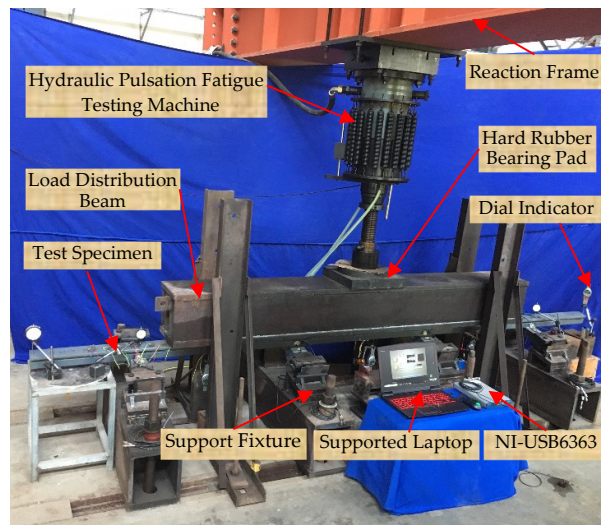
The experimental setup includes one full-scale CB/SB assembly specimen with PZT transducers, one reaction frame, one hydraulic pulsation fatigue testing machine, one hard rubber bearing pad, one load distribution beam, seven dial indicators to measure the vertical displacement, one data acquisition board NI-USB 6363, and one supported laptop, as shown in Figure 5. The hydraulic pulsation fatigue testing machine was mounted on the reaction frame, and the test specimen was attached on the support fixtures. The loads generated by hydraulic pulsation fatigue testing machine were transferred to the test specimen through the load distribution beam. The reaction frame and the support fixtures were mounted on a strong floor. Since the support fixtures were also capable of providing the supporting and securing of the specimen during the test, the support fixtures were fabricated as precisely as possible to avoid additional stress generated in the specimen as a result of the support fixtures misalignment.

**Figure 5.** Photo of the experimental setup.

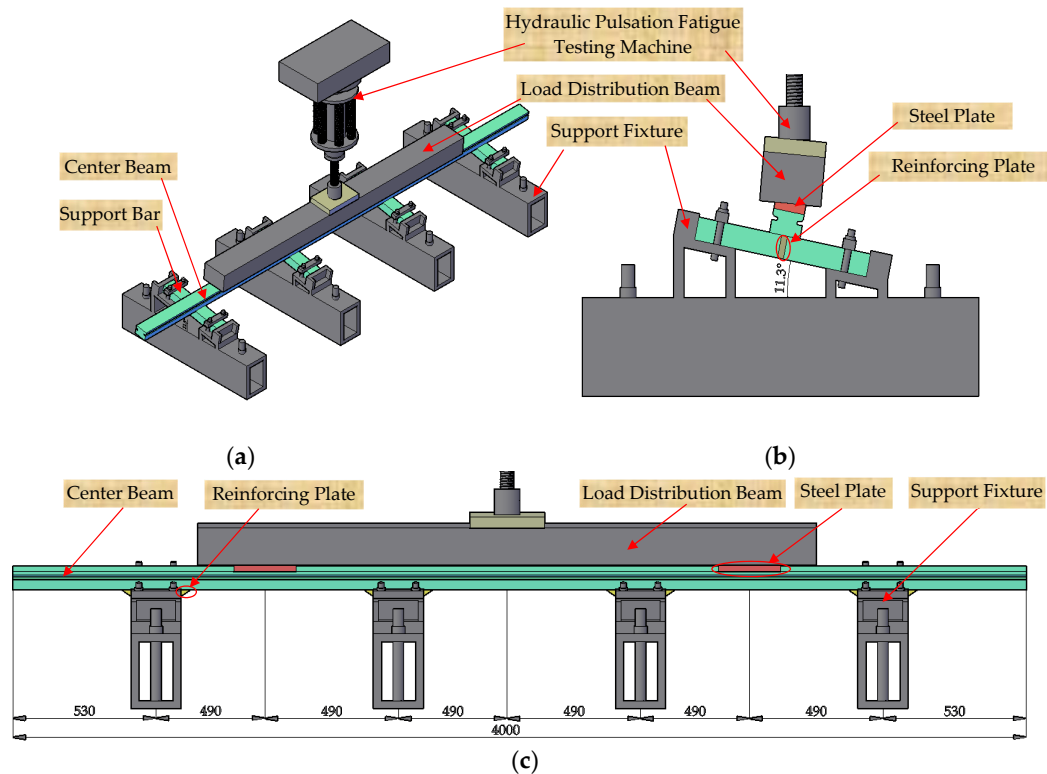
According to the guidelines of the *NCHRP 402 Report* [54], both vertical and horizontal load ranges shall be applied to the test specimen simultaneously in the ratio of 5:1. Thus, the support fixtures of the experimental setup were designed to make the specimen inclining at  $11.3^\circ$  from the horizontal plane to obtain the vertical and horizontal load ranges in the above given ratio, as shown in Figure 6. Loads were generated by the hydraulic pulsation fatigue testing machine and were transferred by the load distribution beam to the test specimen. The distance between the two load points of the center beam, which were located in the center of each outer span, was 1960 mm, as shown in Figure 6c. One steel plate and one hard rubber bearing pad were placed between the hydraulic pulsation fatigue testing machine and the load distribution beam for ensuring the good

contact performance. Moreover, two steel plates installed between the load distribution beam and the center beam can perform a good contact condition.

**Figure 6.** Loading configuration of the test specimen (unit: mm). (a) Three-dimensional view. (b) Left view. (c) Front view.

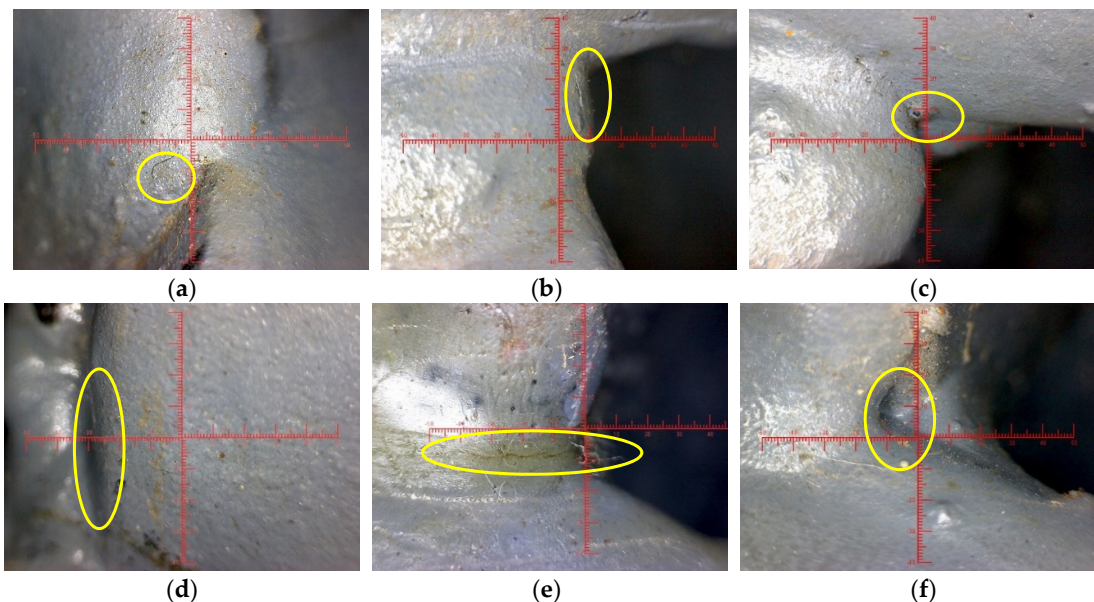
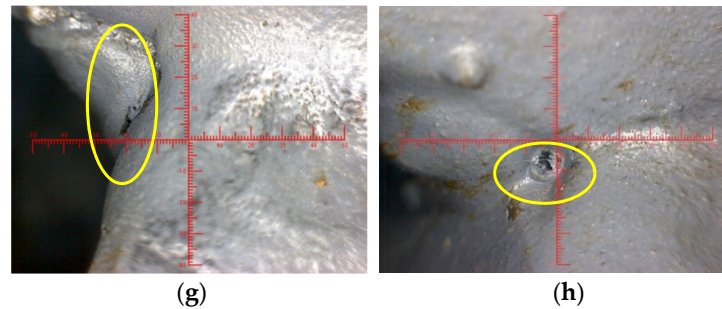
The digital magnifier was utilized to detect the fatigue appearance damage in the test specimen. Before the fatigue test, all apparent weld defects were checked, which included undercut, overlap, pit, incompletely filled weld, and surface cracks. These defects weakened the welds and tended to generate stress concentration, which was the source of fatigue damage, and should be monitored. And the detection process was as follows: (1) connect the digital magnifier to the computer as a detection system; (2) aim the lens of the digital magnifier at the weld of the test specimen, and then rotate the focal length of the lens to make the appearance of the weld clear on the computer screen; and (3) if a weld defect is found, mark and take photos with a scale to calculate the size of the defects. There were eight welds to be monitored in the CB/SB joints of the test specimen, a typical defect in each weld was selected as the focus of the fatigue test, and the partial enlargement photos of typical weld defects are shown in Figure 7. In the entire fatigue experiment, except the defect of south side of the CB/SB3 joint developed into fatigue crack, no obvious expansion was found in other weld defects, and basically there is no change in the appearance.

**Figure 7.** Partial enlargement photos of typical weld defect before the fatigue test. (a) South side of the CB/SB1 joint. (b) North side of the CB/SB1 joint. (c) South side of the CB/SB2 joint. (d) North side of the CB/SB2 joint. (e) South side of the CB/SB3 joint. (f) North side of the CB/SB3 joint. (g) South side of the CB/SB4 joint. (h) North side of the CB/SB4 joint.

For typical weld defect of south side of the CB/SB3 joint, the photo before the fatigue experiment is shown in Figure 7e, the fatigue crack diagram when fatigue load reaches 3.2 million cycles is shown in Figure 8a, the fatigue crack diagram when fatigue load reaches 4.0 million cycles is shown in Figure 8b. Comparing the three pictures, it can be seen that when fatigue load reaches 3.2 million cycles, the typical weld defect develops into obvious fatigue crack. Under the action of fatigue load, it can be seen that the fatigue crack opens, closes, opens, again and again. The fatigue crack originates in the mid-depth of the weld throat in the south side of CB/SB3 weld joint, and the crack typically grows along the longitudinal axis of the center beam.

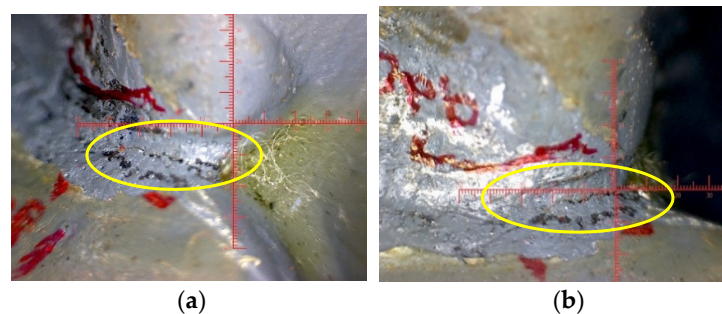
**Figure 8.** Diagram of fatigue cracks of south side of the CB/SB3 joint. (a) 3.2 million cycles. (b) 4.0 million cycles.

There is a ruler in each defect photo mentioned above. And the ruler needs to be calibrated for each defect photo due to different magnifications of the lens in the process of using. The results after calibration show that the length of the typical weld defect of south side of the CB/SB3 joint before the fatigue test is 4.55 mm. When fatigue load reaches 3.2 million cycles, the weld defect develops into the fatigue crack, and its length is 4.95 mm. When fatigue load reaches 4.0 million cycles, the fatigue crack grows along the longitudinal axis of the center beam, and its length reaches 6.72 mm.

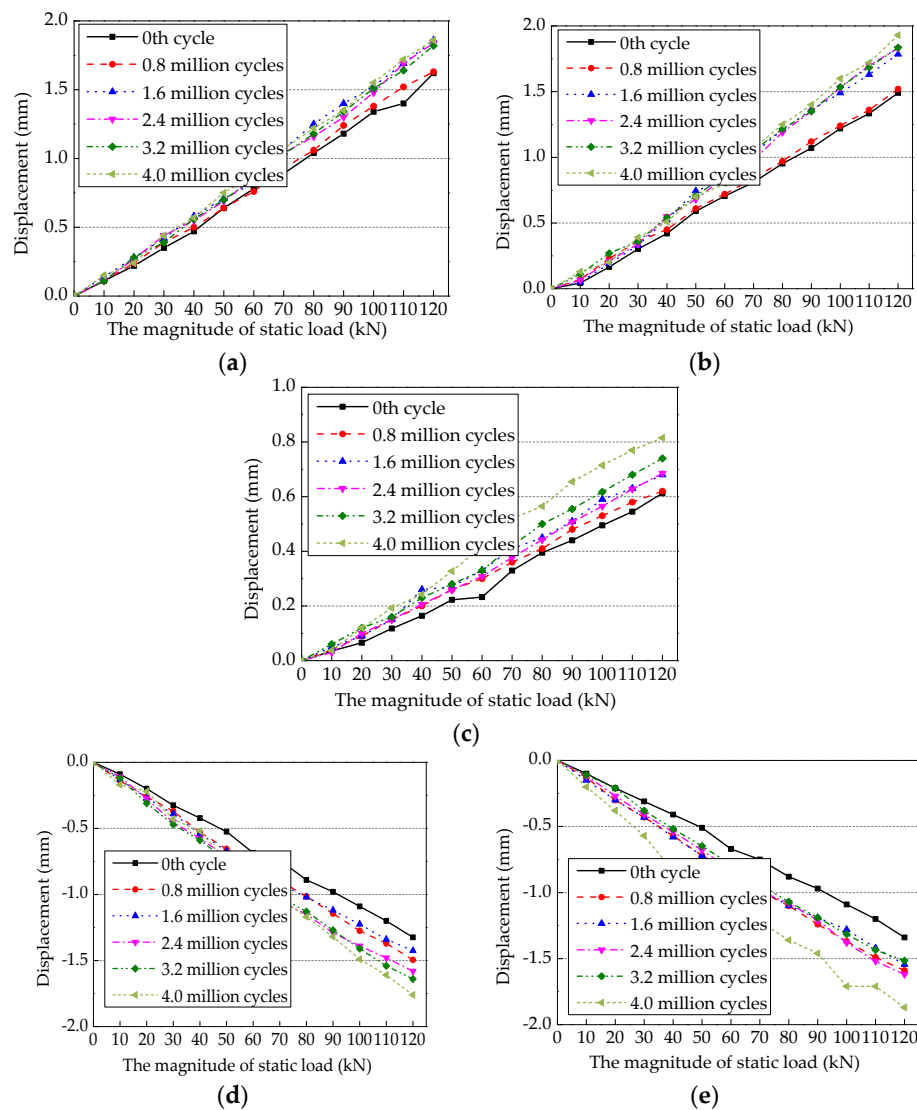
Under the static loading, there are three measurement points of displacement vertical upwards in the test, and they are the measurement points DI1 and DI7 of two ends of the center beam and the measure point DI4 of mid-span of the center beam. For the measurement points DI3 and DI5 of side-span of the center beam as the loading location, the displacement is downward. Effect of fatigue cycles on static load—displacement curve of measurement points is shown in Figure 9. It can be seen that when the fatigue cycles increase, fatigue damage of the weld gradually accumulates. This causes the support bar to be less restrictive to center beam and the overall stiffness of the test specimen decreases, resulting in the increased displacement of center beam under the same static load. For the measurement points DI1 and DI7 of the center beam, when the fatigue cycles are between 0.8 million cycles and 1.6 million cycles, the displacements of the measurement points DI1 and DI7 increase obviously under the same load, as shown in Figure 9a,b. This indicates that the fatigue damage of CB/SB1 joint and CB/SB4 joint is very small before 0.8 million cycles, while the maximum of fatigue damage is between 0.8 million cycles and 1.6 million cycles. As a result, no visible fatigue cracks occur in the CB/SB1 joint and CB/SB4 joint during the fatigue loading process.

**Figure 9.** Effect of fatigue cycles on static load—displacement curves. (a) Measurement point DI1. (b) Measurement point DI7. (c) Measurement point DI4. (d) Measurement point DI3. (e) Measurement point DI5.

For the measurement point DI3, there is a significant change between 0th cycle and 0.8 million cycles and between 1.6 million cycles and 2.4 million cycles, as shown in Figure 9d. The displacement of measurement point DI3 is affected by fatigue damage of CB/SB1 and CB/SB2 joints, and the fatigue damage of CB/SB1 joint is mainly between 0.8 million cycles and 1.6 million cycles. Thus, the displacement change of DI3 is mainly due to the influence of CB/SB2 joint.

For the measurement point DI5, there is a significant stiffness change between the 0th cycle and the 0.8 million cycles and between the 3.2 million cycles and the 4.0 million cycles, as shown in Figure 9e. The displacement of measurement point DI5 is affected by fatigue damage of CB/SB3 and CB/SB4 joints, and the fatigue damage of CB/SB4 joint is mainly between the 0.8 million cycles and the 1.6 million cycles, thus the displacement change of DI5 is mainly due to the influence of CB/SB3 joint. This indicates that CB/SB3 joint has obvious fatigue damage between the 0th cycle and the 0.8 million cycles, and the fatigue damage develops into fatigue crack at the 3.2 million cycles and extended obviously until the end of the test, resulting in more increase in the displacement of measurement point DI5 between the 3.2 million cycles and the 4.0 million cycles. For the measurement point DI4, there is a significant stiffness change between the 3.2 million cycles and the 4.0 million cycles, and in other cycles the stiffness change is uniform, as shown in Figure 9c.

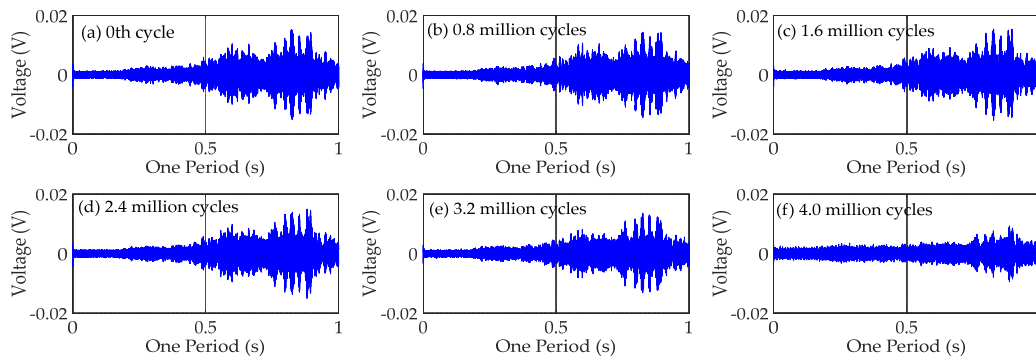
To obtain the time domain characteristics of the specimen, the following analysis takes CB/SB2 joint as an example. The time domain signals received by the PZT6 sensor for monitoring south side weld of CB/SB2 joint are shown in Figure 10. The time domain signals received by the PZT8 sensor for monitoring north side weld of CB/SB2 joint are shown in Figure 11. Each figure reflects the sensor response, at different fatigue cycles: (a) Before fatigue test, the 0th cycle; (b) 0.8 million cycles; (c) 1.6 million cycles; (d) reaches 2.4 million cycles; (e) 3.2 million cycles; and (f) 4.0 million cycles.

**Figure 10.** Time domain signals of PZT6 sensor for monitoring south side weld of CB/SB2 joint.

The results in Figures 10 and 11 show that the amplitudes of the signal decrease with the increase of the fatigue load cycles in the test specimen. This is mainly due to the existence of weld defects, and these defects tend to generate stress concentration as the origin of fatigue damage. Therefore, the weld will inevitably suffer fatigue damage under the action of fatigue load, and the fatigue damage can continually accumulate with the increase of fatigue cycles. Hence, the signal received by the sensor will become weaker and weaker with the increase of fatigue load cycles.

From Figures 10 and 11, it also can be seen that the signal received by the sensor of south side of CB/SB2 joint changes more than that received by the sensor of north side of CB/SB2 joint. It can be explained by the following analysis of the CB/SB joint under the test load, as shown in Figure 12. The details of the CB/SB joint are shown in Figure 12a. The height of the center beam is  $h$ , the thickness of the weld is  $w$ , the distance of the weld toes is  $2a$ , and the length and the height of the support bar are  $2L$  and  $d$ , and the vertical force and the horizontal force of top side of center beam are  $R_V$  and  $R_H$ . According to the equilibrium equation, mechanical model of support bar is shown in Figure 12b, and bending moment diagram of the support bar is shown in Figure 12c. From Figure 12, we can see that the bending moment on the south side weld is larger than that of the north side weld. That is to say that the weld on the south side is more prone to fatigue damage than that on the north side. Therefore, the signal received by the sensor of south side of CB/SB joint changes more than that received by the sensor of north side of CB/SB joint due to the bending moment difference between south side weld and north side weld.

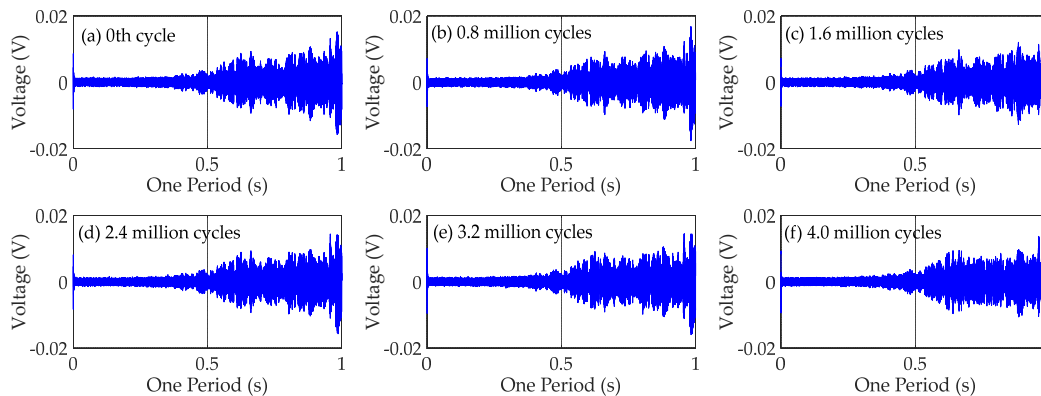
**Figure 11.** Time domain signals of PZT8 sensor for monitoring north side weld of CB/SB2 joint.

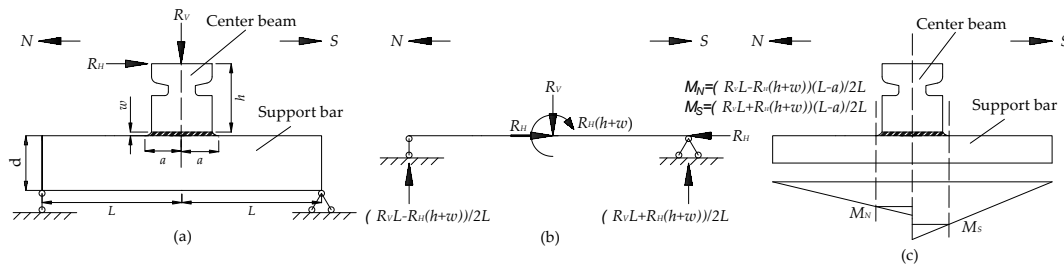
**Figure 12.** Mechanical analysis of CB/SB joint under the test load. (a) Details of the CB/SB joint. (b) Mechanical model of support bar. (c) Bending moment diagram of the support bar.

Under the horizontal force  $R_H$  and the vertical force  $R_V$ , the bending moment of the south side of the CB/SB joint is greater than the bending moment of the north side. Therefore, the weld damage of the south side of the CB/SB joint is more than that of the north side of the CB/SB joint under the fatigue load. That is to say that the energy received by the PZT sensor of the south side decreases faster and more than that of the north side for the CB/SB joint of the test specimen under fatigue load. From the figures above, it can also be seen that wavelet packet energy of the north side for the CB/SB joint changes little, which shows that there is little damage to the weld of the north side for the CB/SB joint through the fatigue test. Therefore, the subsequent analysis refers to the weld of the south side of the CB/SB joint.

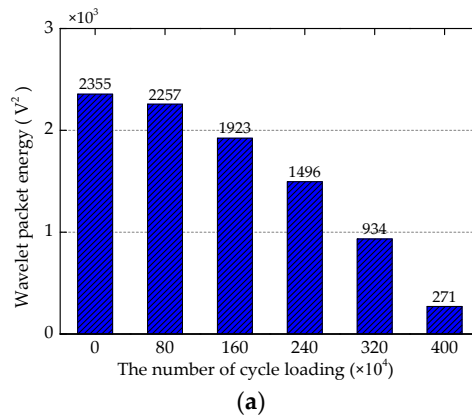
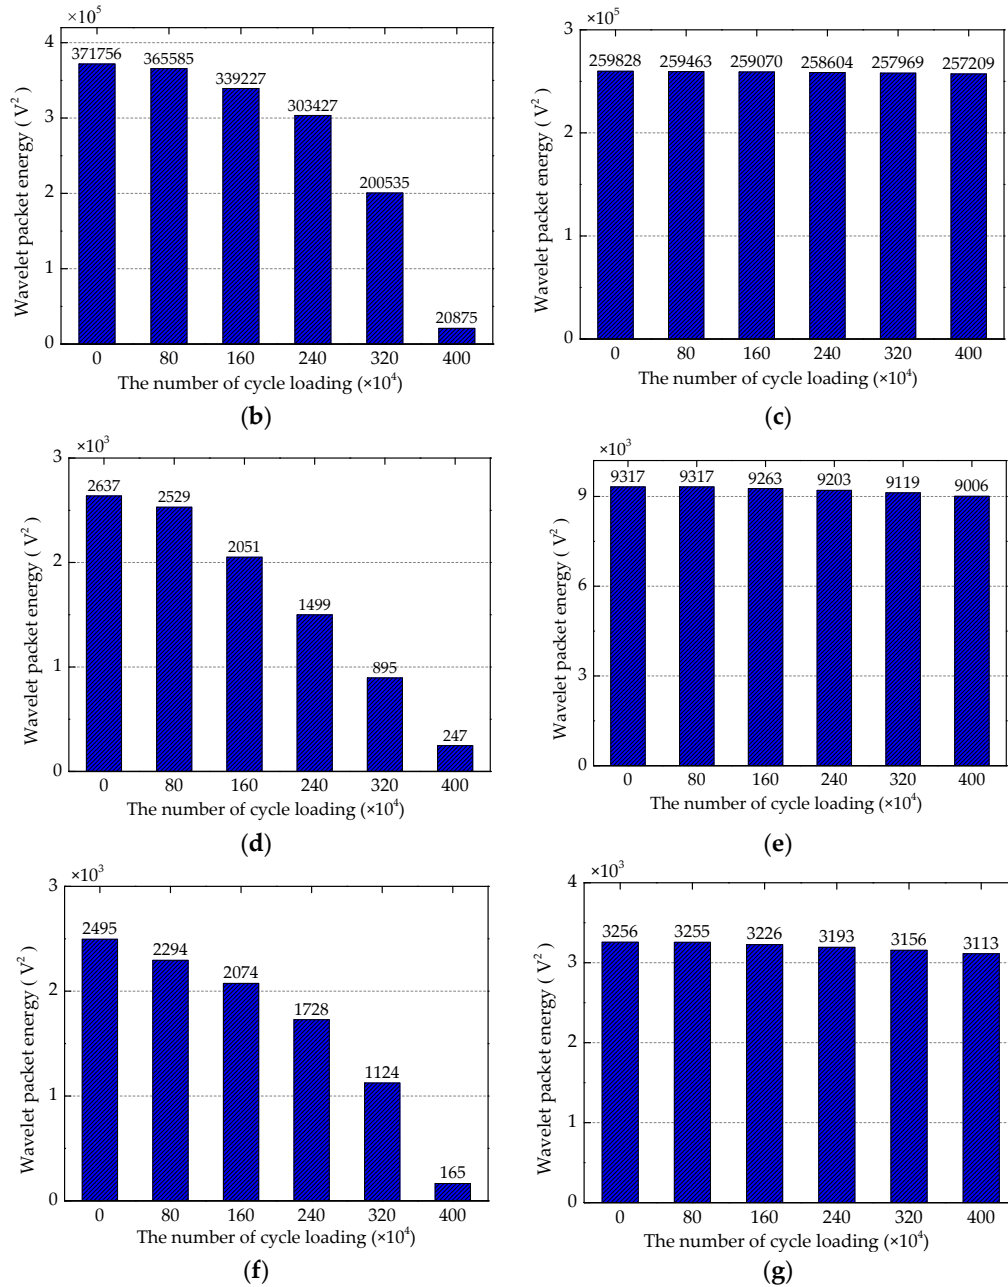
In the fatigue tests, the PZT4 sensor for monitoring the north side weld of CB/SB1 joint could not receive reliable signals, which may be caused by poor quality of lead wire soldered on the PZT4 patch. Therefore, the results from the PZT4 sensor will not be presented in the following analysis. In order to quantify the energy of the PZT signal during the fatigue test, the signal energy is computed by using the wavelet packet energy analysis. The wavelet packet energy analysis results of the specimen during the fatigue test are shown in Figure 13.

**Figure 13.** Wavelet packet energy analysis results of the specimen during the fatigue test. (a) The south side of CB/SB1 joint. (b) The south side of CB/SB2 joint. (c) The north side of CB/SB2 joint. (d) The south side of CB/SB3 joint. (e) The north side of CB/SB3 joint. (f) The south side of CB/SB4 joint. (g) The north side of CB/SB4 joint.

From these results, it can be seen the computed wavelet packet energy decreases with the increase of the number of cycle loading. This is mainly because the fatigue damage of the specimen increases gradually during the fatigue test, resulting in the decrease of the signal received by the PZT sensor. In these wavelet packet energy analysis figures, the received energy of the south side of the joint decreases much more than that of the north side for the test specimen. This is mainly because the test specimen is installed on the support fixtures of the experimental setup with an  $11.3^\circ$  inclination angle. With this inclination angle, the horizontal force  $R_H$  produced on the top surface of the center beam is parallel to the support bar and points to the south of the support bar, and the vertical force  $R_V$  produced on the top surface of the center beam is perpendicular to the support bar.

When the test specimen is in the state before the fatigue test, which represents the health state of the test specimen, the signals received by the sensors are used as the baseline signals. Therefore, compared with the results of the fatigue test, the maximum wavelet packet energy of the specimen occurs at the 0th cycle (the health state) of the test specimen. During the fatigue test, wavelet packet energy during the first 0.8 million cycles do not change significantly, which means that the damage of the specimen is extremely small. From the 0.8 million cycles to 3.2 million cycles, the slope of the wavelet packet energy decreases with the increase of number of loading cycles before reaching a saturation, which shows that the fatigue damage increases gradually with the number of cycle loading. Among them, wavelet packet energy of the south side of the CB/SB3 joint decreases the fastest, and this observation is consistent with the fact that only the weld on the south side of CB/SB3 joint eventually develops into a fatigue crack. After 3.2 million cycles, until the end of the fatigue test, the slope of the wavelet packet energy varying with the number of cycle loading grows rapidly, which indicates that the fatigue damage of the test specimen increases sharply, the fatigue crack length of the south side of the CB/SB3 joint increases from 4.95 mm at 3.2 million cycles to 6.72 mm at 4.0 million cycles. Therefore, the method using piezoceramic transducer enabled active sensing can detect the fatigue damage of the weld of the CB/SB joint in real-time.
