Article

Early Crack Detection of Reinforced Concrete Structure Using Embedded Sensors

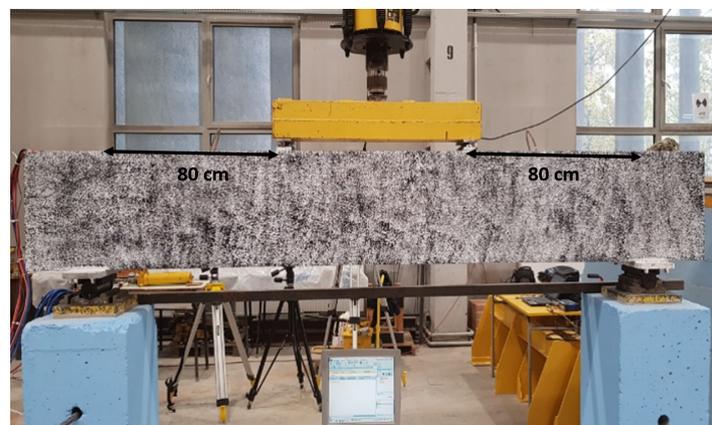
The reinforced concrete (RC) beam was casted as a specimen for the following induced cracks propagation. Figure 1 shows the test specimen of the RC beam that has the following dimensions: 2.9 m × 0.4 m × 0.2 m (length × height × width). The primary reinforcement of the 10 mm diameter consists of three lower bars in the tensile zone and two bars in the corners of the compression zone. Transverse reinforcement consists of two-legged stirrups with a diameter of 6 mm arranged in the support zone at a spacing of 150 mm. The beam was made of concrete class C25/30 with compressive strength $F_{cd} = 27.57$ MPa. The capacity of the beam was calculated according to Eurocode 2 EN 1992-1-1. The calculation results were used to determine the maximum breaking force of the beam.

Figure 1. Measuring stand and beam load position.

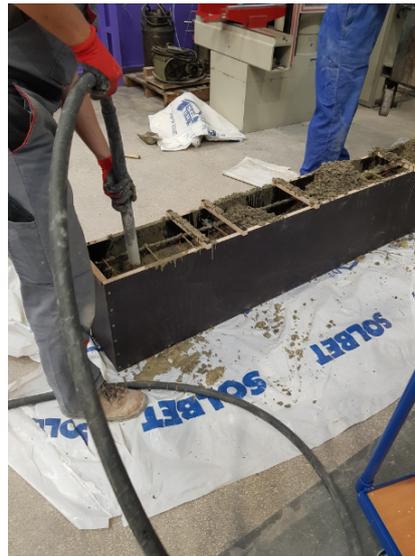
The reinforcement skeleton together with attached sensors was placed inside the formwork while maintaining the appropriate buffer cover. During laying, the concrete was properly compacted using vibrators (Figure 2).

Figure 2. Vibration during pouring the concrete and collecting of specimens.

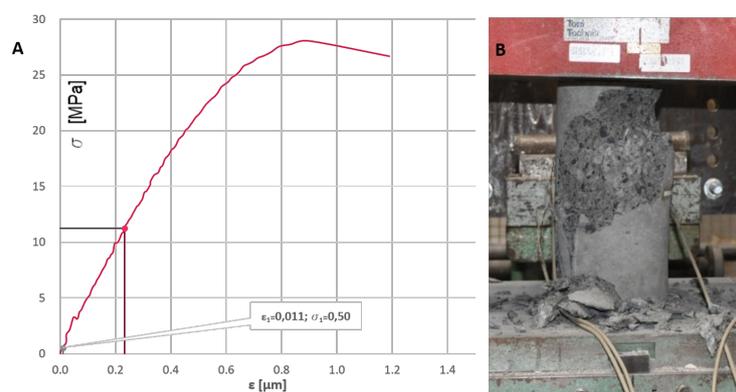
To evaluate the actual class of concrete and its mechanical properties, during the concreting, 12 additional specimens were manufactured in the form of cylinders with a diameter of 150 mm and a height of 300 mm following EN 12390-1 code. Both the beam and specimens were seasoned in similar conditions for 28 days. The beam was left in the lab after casting, but the temperature and moisture were close to constant. It was all the time indoor. The benchmark RC structure for elastic modulus were cured in water in constant temperature about 15 °C. During the period of concrete hardening and seasoning, the measurements were started. The recorded signal from the internal sensors was sampled at intervals of 5 min. In this way, the influence of concrete bonding temperature and rheological phenomena, such as shrinkage and creep of concrete, was assessed. Specimens were tested after 7, 14, and 28 days, which allowed to evaluate the increase in strength over time and determine the actual class of concrete with its compressive strength and modulus of elasticity. During compression and testing until failure the concrete specimens after the mentioned duration of the casting works, the $\sigma - \epsilon$ curve and the elastic modulus were determined. The exemplary view of the $\sigma - \epsilon$ curve and the resulting tested specimen are presented in Figure 3.

Figure 3. The $\sigma - \epsilon$ curve (A), and the view of the failed specimen after compression testing (B).

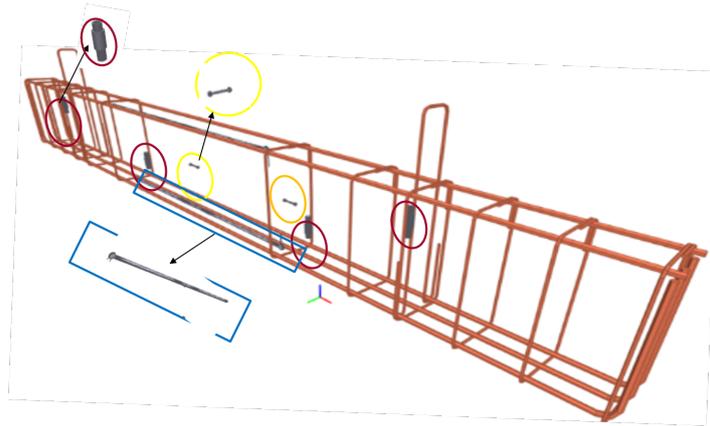
During the preparation of the benchmark RC beam, the sensors were concreted. The location of concreted sensors together with reinforcement is shown in Figure 4. Four ultrasonic sensors (red box) especially developed for RC monitoring purposes (see [25] for more details) were attached on four vertical stirrups. The positions of ultrasonic sensors are shown in Figure 5.

Figure 4. 3D view of the beam reinforcement with sensors location.

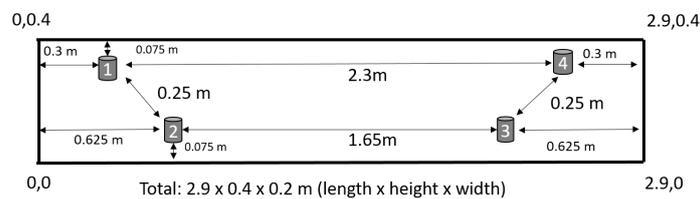
Figure 5. Ultrasonic sensor position.

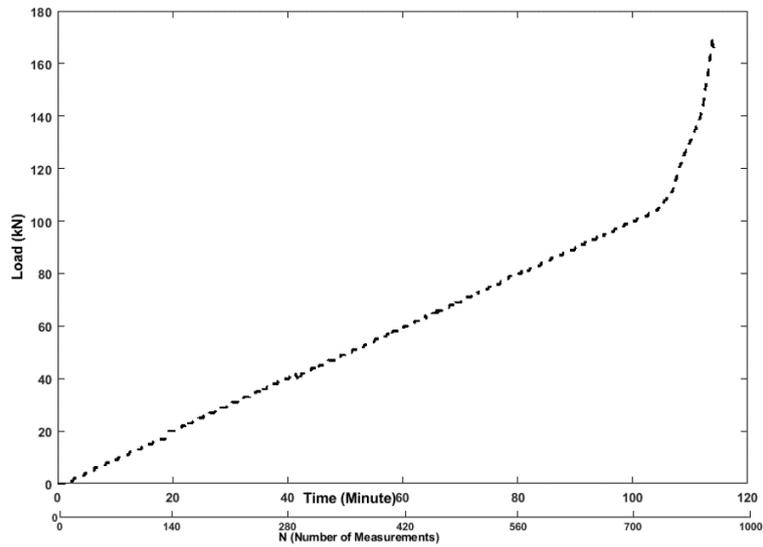
The loading machine is controlled by an analog controller. Since the main goal of the test was to evaluate the cracks evolution and the damage level with the increasing load using ultrasonic techniques (see Figure 6), it was decided to measure also the force. The loading rate was fixed at the beginning on 1 kN/min till 108 kN and then increased to 5 kN/min (Figure 6), which introduced appropriate stress/strain state in the tested specimen.

Figure 6. Loading schedule vs. number of ultrasonic measurements.

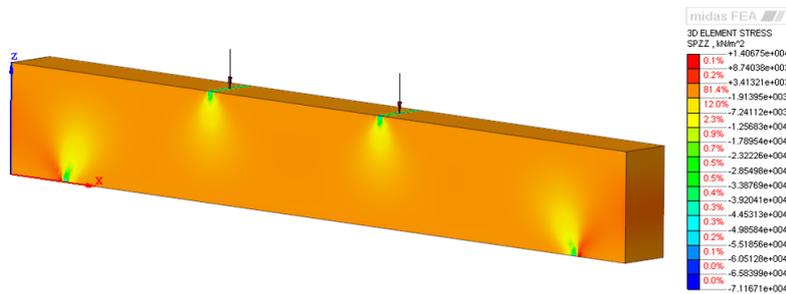
To visualize the strain distribution, the preliminary numerical FE calculations were performed basing on the material properties resulted from the quasi-static compression tests (see Section 2.1). For the purpose of examination of strain distribution, the static non-linear analysis was defined in Midas FEA, and the Newton-Raphson iteration procedure was used for FE calculations. The resulting strain distribution of the tested structure was presented in Figure 7. The force and the LVDT outputs were recorded on a computer using NI DAQ card data logger system, respectively HBM®—model QuantumX MX1615B card for the displacement and GOM Correlate for the DIC measurement.

Figure 7. The strain distribution (Midas).

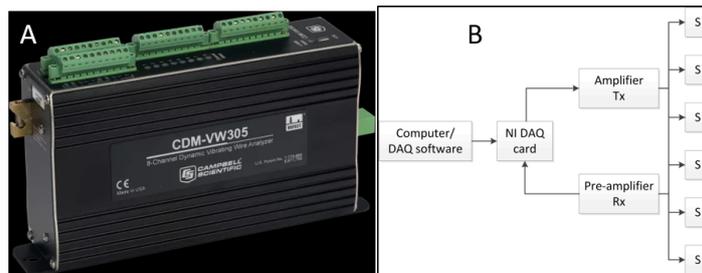
The data is collected by connecting the computer directly to the Campbell® data logger for embedded traditional sensors and customized data acquisition system for ultrasonic sensors [25]. The data logger has 16 channels (see Figure 8).

Figure 8. (A) Campbell Scientific data logger. (B) Data acquisition block diagram of the ultrasonic system.

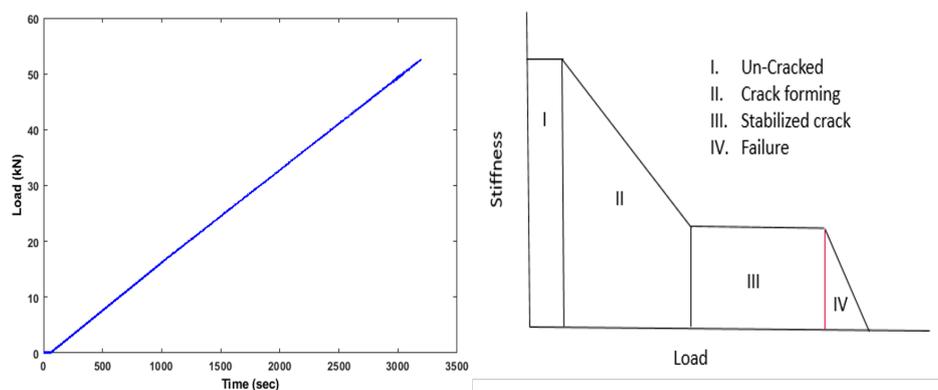
The basic idea of evaluating the bending stiffness of the RC beam under increasing in time vertical load is a deflection measurement used as a performance indicator (PI). The typical changes of beam bending stiffness during loading are illustrated in Figure 9. The degradation phase can be divided into four stages: (I) Un-cracked, (II) Cracks forming, (III) Stabilized cracks and, finally, (IV) Failure stage. Failure is typically yielding of steel reinforcement or crushing of concrete. During the test, the load was slowly and proportionally increased over time using a hydraulic jack compression machine. Simultaneously with the measurement of the load force, the responses from all sensors and measuring devices are registered.

Figure 9. Generalized bending stiffness development where four phases are shown.

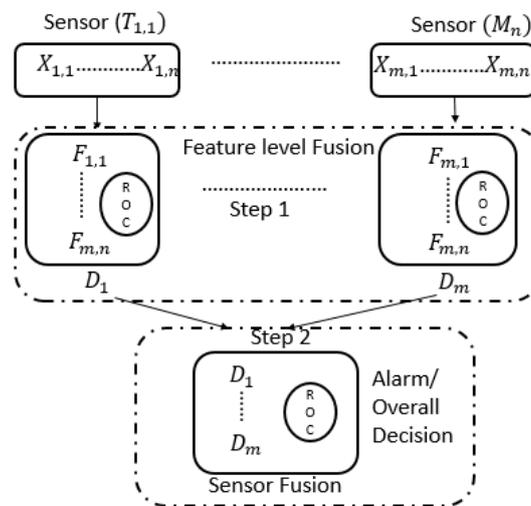
As a first step (Figure 10), the feature level of fusion will apply to a signal coming from multiple sensors. The general frame of data fusion is investigated, for example: $X_{1,1}, \dots$, where $X_{1,n}$ is the vector of data from one ultrasonic transducer pair T_{11} (one emitter and one receiver) and $F_{1,1}$ is a feature value from one transducer pair. In step 1, feature-level fusion represents the step of computing the features from all the sensors or sensors pair. In step 2, the decisions taken from ultrasonic sensor pair and outputs for other types of installed sensors, are fused using binary declaration in terms of operational changes (like presence/absence of load, presence/absence of crack/multiple cracks etc.).

Figure 10. Two-step feature-based sensor fusion model.

In this paper, a voting scheme at the decision level is used for information-based fusion. The procedure of information fusion is illustrated in Figure 10. The first step is to select a threshold for each feature from the pair of ultrasonic signals using a voting scheme. This threshold was used to discriminate between the undamaged and damaged states in the features. Generally, the weight of the value for undamaged state is lower than loading or damaged state. The next is to use the receiver operating characteristic (ROC) to compare the features for overall decision [48]. The ROC curve is a metric used for statistical evaluation of a feature, and can be used to visualize the overall decision. In the voting scheme, an overall decision is made to differentiate between damage and undamaged class following to the maximum value of the voting index [49]:

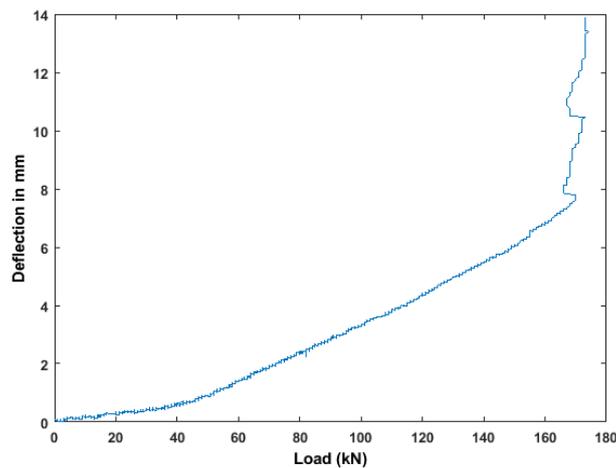
The crack opening displacement was measured by the vertical LVDT. It can be observed that there is a lack of symmetry in the loading or the shape of the beam. However, the variation of the crack width is proportional, meaning that one can suppose that the distribution of the crack opening displacement is linear all along the width of the beam. The measured load-displacement curve of the control beam is shown below in Figure 11, along with the load-displacement curve from DIC measurements can be seen in figure 19B. It can be seen that cracking occurred at approximately 42 kN.

Figure 11. Deflection (LVDT) and load.

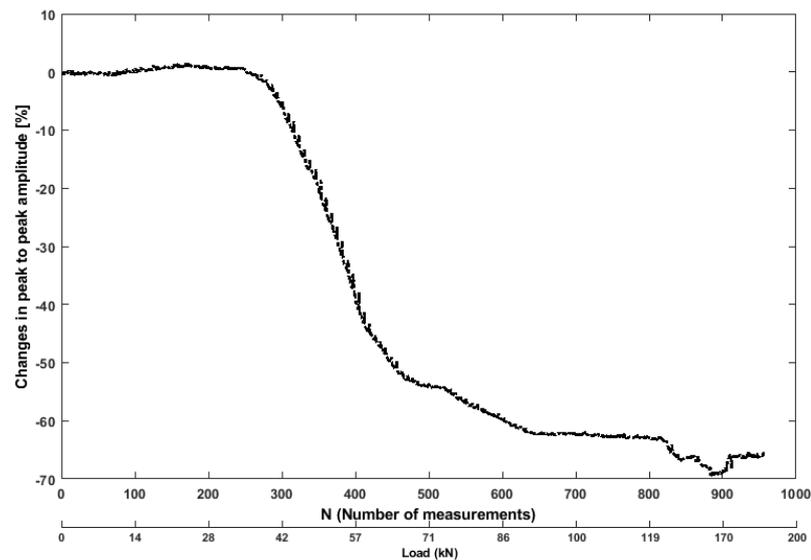
Figure 12 shows the exemplary plot for the features of the time-domain signal, i.e., peak to peak amplitude. The normalized error graphs are derived as a difference between the peak amplitude in each fixed-length time window (when the beam was subjected to external stress) and the reference of the undamaged state. Higher deviations were caused whenever the amplitude of time signals dropped with the external load increases and the progressive stage of damage (cracking). From Figure 12, it can be observed that the peak to peak amplitude changes as the stress level varies due to tension region (bottom) and compression region of the beam (top). The changes in the peak to peak amplitude stay within the range of 0–1.9%, when 0–35 kN ($N = 242$ ultrasonic measurements, which is equal to 35 kN) of the load is applied. When the applied stress increases, the peak amplitude has an obvious drop, as signal is started to attenuate with less energy and a decrease of amplitude, which indicates the crack opening. The changes had an increasing trend when 35–90 kN of the load is applied, due to forming multiple cracks opening and propagation along the beam. However, when the load between 90–160 kN was applied, the changes remain stable at the brittle-ductile transition stage. Although the beam has a large deformation indeed, there were not enough new cracks in the specimen to obstruct the ultrasonic wave propagation. The reason for this stable propagation is that the reinforcement of the tested specimen carried the highest stress under such loading conditions.

Figure 12. Values of Peak to peak amplitude feature from ultrasonic pair S01R04 time histories.

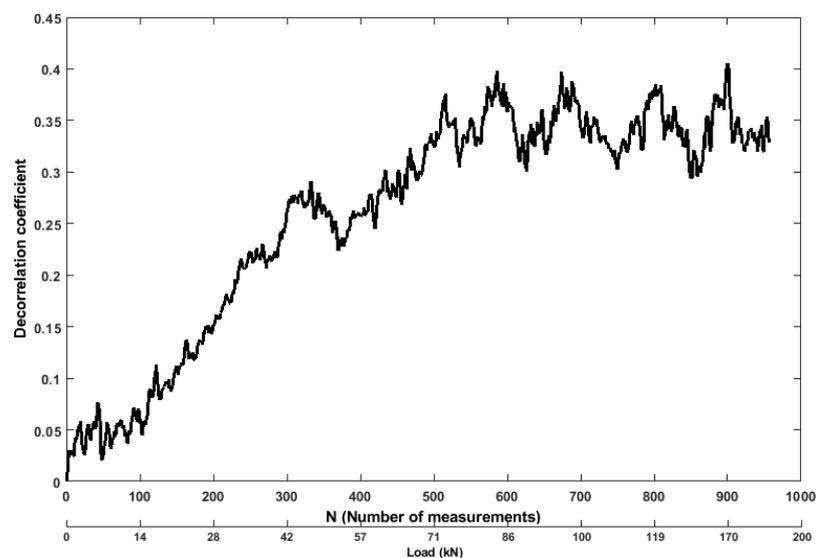
The decorrelation coefficient is obtained in the normalized form, and it can be defined as the changes in the RC benchmark structure. The initial increase of this coefficient is originated by the bending of the benchmark specimen under increasing load, because it effects on the ultrasonic wave path. With a bending tensile force of 42 kN, the coefficient (Figure 13) increased by 0.27, compared to the reference state (before the start of the experiment), and sudden drop to 0.23 took place, which is indicating the development of microcracks in the structure. When the applied stress gets more significant (the results from a bending tensile force between 42 kN to 160 kN), and the phases of the signals shifted by more than 90° , which was caused by the propagation of the crack, whereby the decorrelation coefficient increased to 0.4. Decorrelation coefficient provides an appropriate value for judging about the rate of changes in measured signal comparing to the reference signal through the correlation analysis and directing of a particular relationship between the two signals. Therefore, it is showing that the signal analysis based on the decorrelation coefficient is more sensitive. Due to its sensitivity for small changes, decorrelation coefficient can give misleading information about the signal changes due to environmental effect.

Figure 13. Values of decorrelation coefficient feature from ultrasonic pair S01R04 time histories.

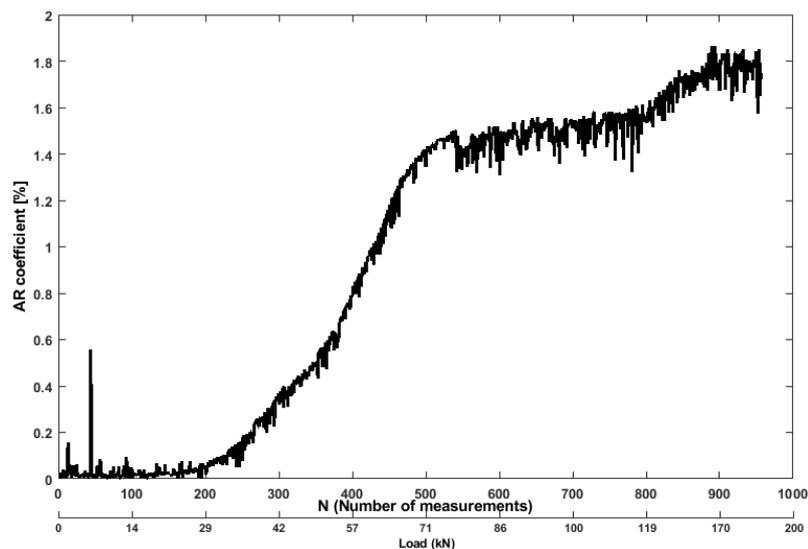
Figure 14 indicates that increment of the level of nonlinearities (cracking) in the beam subjected to external stress, and simultaneously, the amplitude of the AR parameters (increasing the residual error) tends to decrease. The AR parameters were calculated by fitting the AR model to a baseline signal from one transducer pair (top) before the start of the experiment using the RMSE technique (see [43] for more details). If cracks are present in the structure, the residual errors will increase due to higher attenuation (decreasing the AR parameters amplitude), which is caused by the increased crack width under loading. From Figure 14, it can be observed that the residual error increases as the stress level increases in the beam. The results from a bending tensile force between 36 kN to 160 kN, the rate of AR residual error increases up to 1.9 % due to energy attenuation, which indicates the opening and propagation of cracks.

Figure 14. Values of AR residual error feature from ultrasonic pair S01R04 time histories.

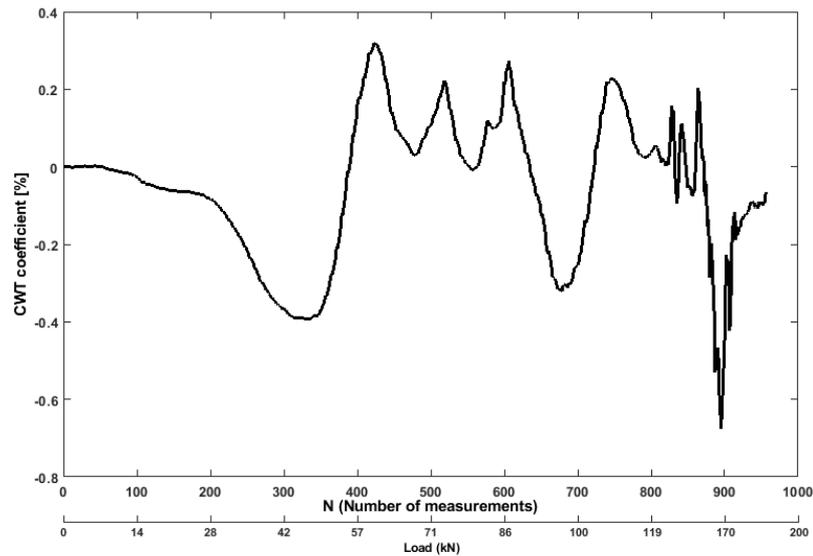
The plot for Continuous wavelet transform (CWT) is depicted in Figure 15. The energy of a signal is derived from the CWT transform from the raw signal time-series. The extracted feature from this time-frequency domain analysis is more useful than time domain only. An energy vector is established by computing the energy of each branch (scalogram) to show the energy distribution towards the frequency bands. From the comparison of CWT coefficients between the changed/damaged state and reference undamaged state (as shown in Figure 15), a noticeable deviation can be found in different frequency bands. The proposed CWT energy coefficient is obtained by calculating the root-mean-square deviation in percentage between the energy vector of the health state and that of the damaged state. From Figure 15, it can be observed that the coefficient decreases as the bending tensile as the level increases between 36 kN to 48 kN in the beam, and then it dramatically increases as the load increases between 49 kN to 60 kN. This is because most of the cracks appear on the concrete surface parallel to the load application under compression. Ultrasonic wave propagation through such direction, therefore, may miss encountering cracks. There are no large values of the wavelet coefficients since the specimen has been destroyed by the horizontal splitting cracks that prevented the propagation of ultrasonic waves from transducer 1 to transducer 2 through the concrete.

Figure 15. Values of CWT coefficient feature from ultrasonic pair S01R04 time histories.

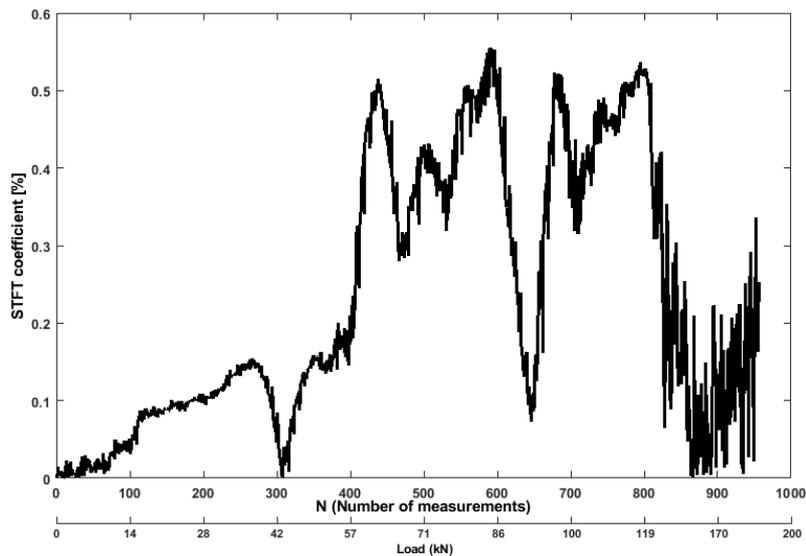
The STFT, conventional as a spectrogram, corresponds to the energy distribution of a raw signal. It can be defined the amount of energy contained in the diffuse signal as a damage-sensitive feature. The initial increase of this coefficient is originated by the bending of the benchmark specimen under increasing load, related to the amount of energy released by the specimen. With a bending tensile force of 38 kN, the coefficient (Figure 16) increased by 0.14, compared to the reference undamaged state, and sudden drop to 0.002 took place, which is indicating the signal strength decreased due to development of microcracks in the structure. It can be observed that after the load of 115 kN was applied, the strength of the signal gradually decreased as multiple cracks started to propagate through the surface, until the last phase of loading.

Figure 16. Values of STFT coefficient feature from ultrasonic pair S01R04 time histories

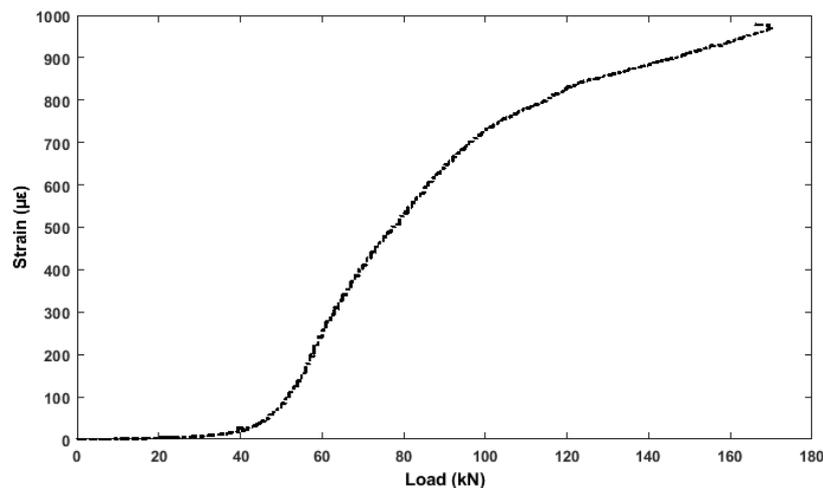
The vibrating wire strain gauges embedded inside the concrete structure (in the middle of the beam), register a steady increase in strain from 1 up to 1000 $\mu\epsilon$, during loading (Figure 17). The increase is caused by the elastic bending of the beam. The growing strain in the bending tensile state from 43 $\mu\epsilon$ onwards, indicates an inelastic change as the surface cracks.

Figure 17. Strain (bottom vibrating wire) vs. Load.

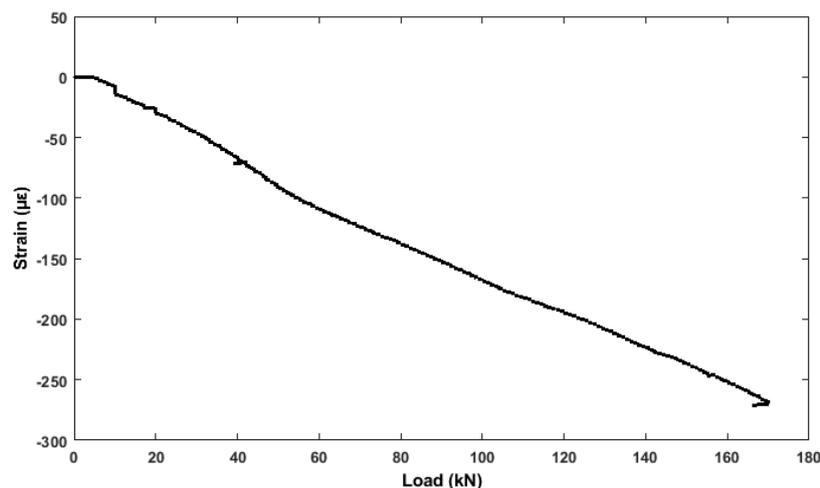
Figure 18 indicates that the rebar strain gauges embedded with top of the rebar in the RC benchmark structure, register a steady increase in strain from 1 up to 272 $\mu\epsilon$, during loading indicates an elastic change.

Figure 18. Strain (attached with top rebar) vs. Load.

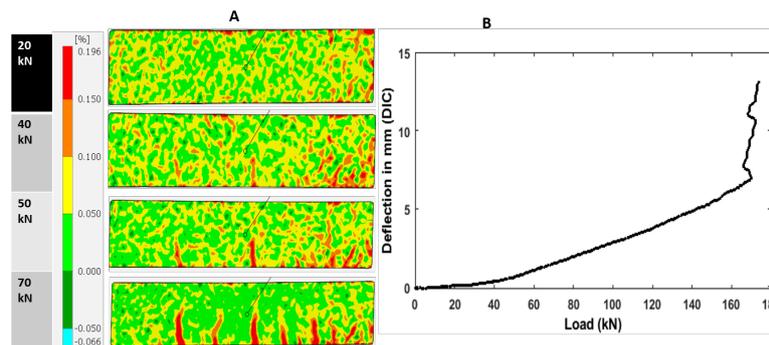
To investigate the ability of DIC to detect the degradation and characterization of the material, the data obtained from DIC frames were matched with corresponding force—deformation and beam depth—crack width profiles. The displacement of the benchmark RC beam at each load step is determined by locating each subset from the baseline image (pixel subset) in an image of the deformed test specimen through the use of the highest correlation to the reference subset. Figures 19 and 20 show the state of cracks along with strain fields at selected levels of load (A) and displacement curve (B). These figures are essential for evaluation of the state of deformation and understanding the cracking behavior of the material, especially when specimen with different properties were compared. It can be observed from Figure 19 for the benchmark RC beam that the highest level of strains is observed in the first stages (0–50 kN) of loading, and distributed through the maximum moment region immediately after peak stress and strain localization became to be recognizable as is represented by red color. In the end, one small crack is observed at 40 kN. Then one major crack together with

several other cracks (Figure 19) was visible. The first signs of deformation are at one bending tensile strength of 42 kN, which correlates with the results of embedded strain gauges and displacement sensor. When the specimen surface was examined for cracks, these cracks were not visible by the naked eye. However, through the DIC, the propagation of deformations upward in the direction of load entry is visible. At bending tensile strength of 52 kN, from this period, forming cracks became visible by naked eye. However, in the second stages (55–170 kN), DIC represents that more cracks form in the specimen, which are not visible by the naked eye. At 80 kN, the cracks are started to be visible with the naked eye. Figure 20 shows the increasing propagation of the deformation in the direction of the load, which correlates well with all the sensors.

Figure 19. Crack propagation along with strain map (A) and Deflection (B) at different load levels of specimen (1st stages).

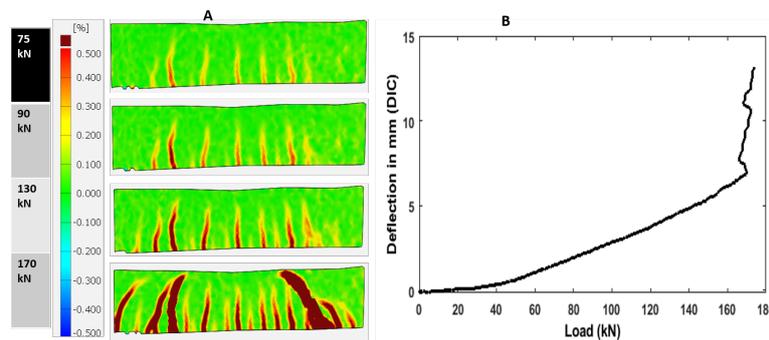
Figure 20. Crack propagation along with strain map (A) and Deflection (B) at different load levels of specimen (2nd stages).

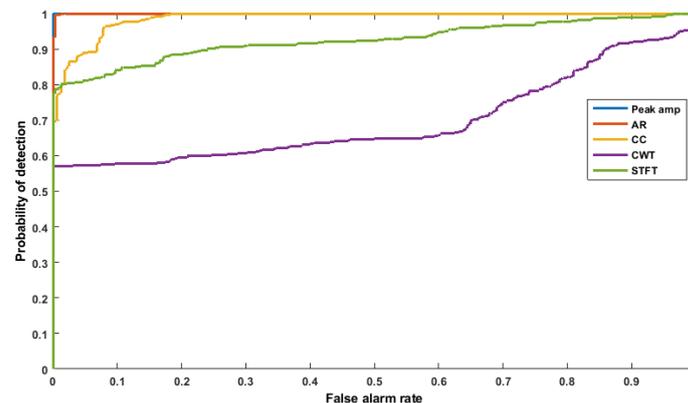
The proposed features from the ultrasonic signal are compared for sensor pair 01–04 in Figure 21 via their ROC curves. It can be seen that all the features perform fairly well in their ability to detect crack opening and propagation as well as damage states in the presence of noise. The peak amplitude coefficient and AR coefficient perform better (AUC = 1, 0.989) to classify damage from the undamaged state for the sensor pair 01–04 in this structure. This result is not unexpected because features CC and CWT coefficient values fluctuate suddenly, which miss-classified the damage state from undamaged

sate. For the proposed feature, the performance varies for different threshold values. Hence, even though there may be the best feature for a particular transducer pair and a specific threshold, so it may be suitable to use the information from all features from different sensors to reach better localization or detection of crack/changes. The output of Table 2 shows that the peak amplitude coefficient feature extracted from the ultrasonic signal performs better ($AUC = 1$) compared to all the NDT methods in this benchmark structure. It can be observed that the ultrasonic sensor detects crack (damage) located between the pair of sensors earlier than other NDT methods.

Figure 21. ROC curves for all the features in RC beam.

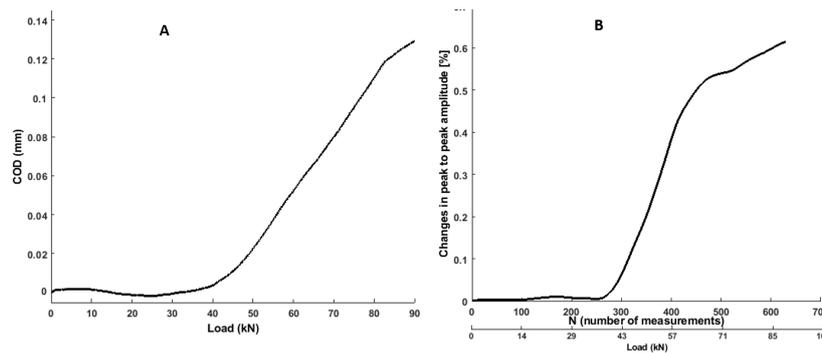
The crack opening displacement (COD) of reference benchmark structure was determined through the DIC method. To determine the crack opening displacements (COD), the displacement fields were used [50]. COD values were achieved by considering the discontinuity of two point (middle of the beam) by following the crack path (central crack), the transform of the dissipated energy and the crack opening along the crack path was measured (anticipating the crack opening width vs. depth line to zero). As peak to peak amplitude perform better ($AUC = 1$) than other ultrasonic features, therefore it was presented to link with COD. Figure 22 shows a comparison between the changes in peak to peak amplitude (absolute value) from ultrasonic feature and those measured with DIC method. One can see that COD was well matched with ultrasonic feature.

Figure 22. Load-COD (A) vs. load-changes in peak to peak amplitude (B) response of a RC benchmark structure.
