Article

Study on Retrofitted Masonry Elements under Shear Using Digital Image Correlation

Benjamín Torres, Francisco B. Varona

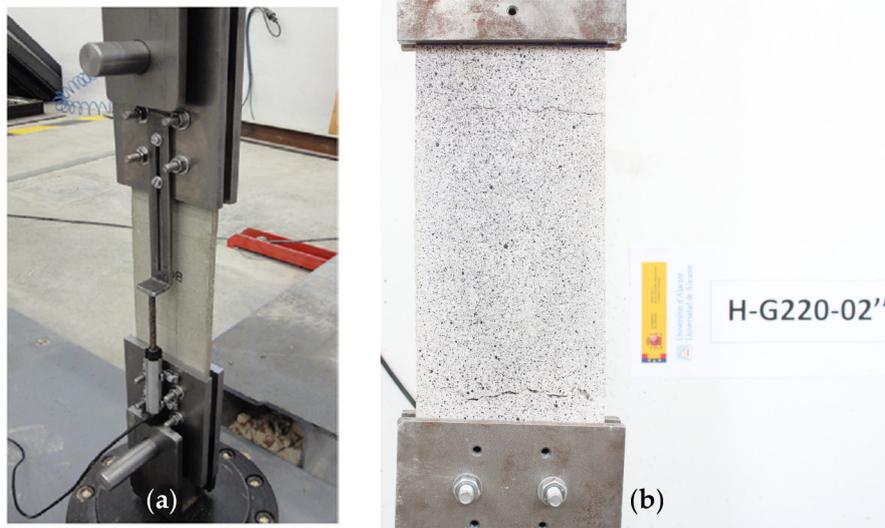
Figure 1. Direct uniaxial test of a fabric-reinforced cementitious matrix (FRCM) coupon: (a) experimental setup; (b) crack pattern.

The mechanical performance of the TRM was tested in accordance with Annex A of standard AC434 'Tensile Testing of Fiber-Reinforced Cementitious Matrix (FRM) Composite Specimens' [38]. Three coupons were fabricated with dimensions $400 \times 100 \times 9$ mm (length \times width \times thickness) and tested at an age of 60 days. Each FRM coupon was bolted to steel clamps installed in an electro-mechanical press with a loading cell of 50 kN. The test velocity was set at 0.2 mm/min, and the elongation was measured with one LVDT, as well as DIC. The experimental configuration is shown in Figure 1.

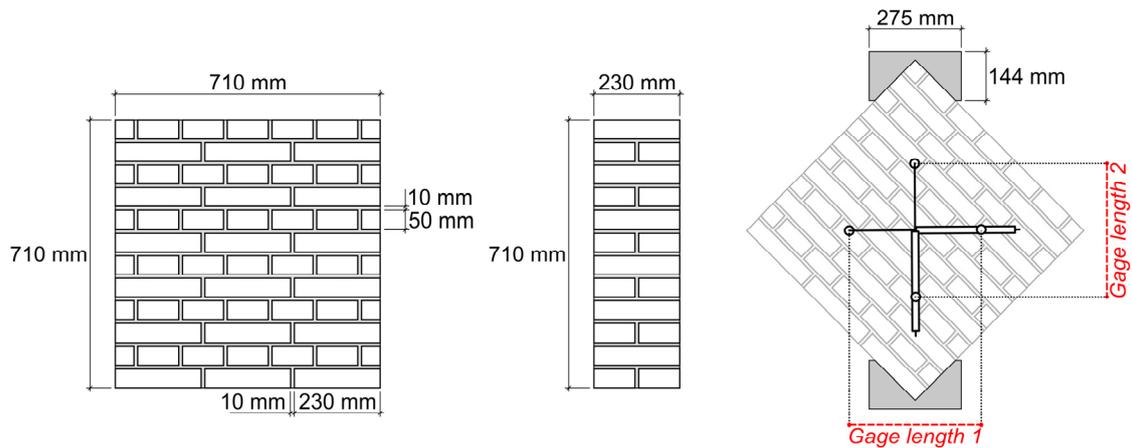
Figure 2. Masonry specimens for the diagonal tension test: dimensions and experimental setup.

On the other hand, the shear behavior of the masonry specimens was measured through diagonal tension tests in accordance with standard ASTM E519/E519M-15 'Standard Test Method for Diagonal Tension (Shear) in Masonry Assemblages' [22]. The size of each masonry sample was $710 \times 710 \times 230$ mm (see Figure 2). The test was displacement-controlled with a velocity of 0.54 mm/min. Two LVDTs were installed on one face of each specimen, one along each diagonal direction (Figure 3). Based on the specimen's deformations (obtained along the 43 cm gage lengths in

Figure 2) the shear stress vs. shear strain relationship was determined. Further details are given in the ‘Results’ section.

where Δy is the average shortening in the direction parallel to the load, Δx is the average extension in the direction perpendicular to the load, and g is the gage length (which was 430 mm in this study; see Figure 2).

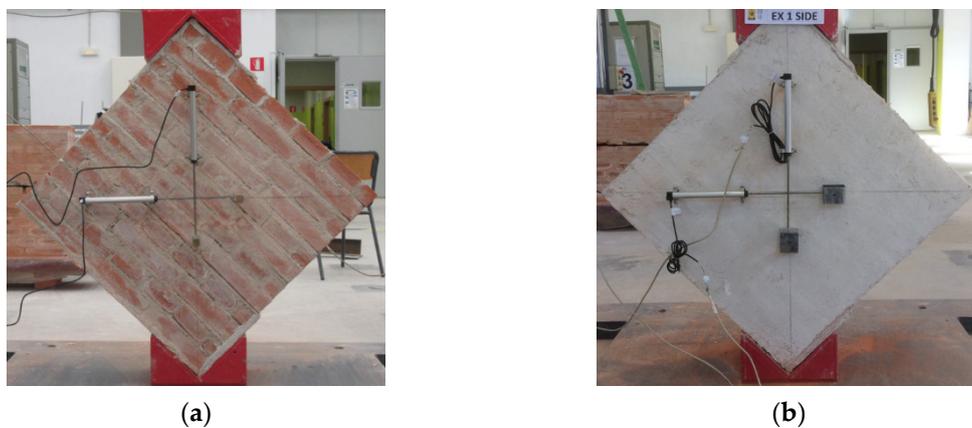
Figure 3. Installation of the LVDT devices to measure diagonal deformation: (a) installation on an unreinforced masonry specimen; (b) installation on an FRCM-reinforced masonry specimen.

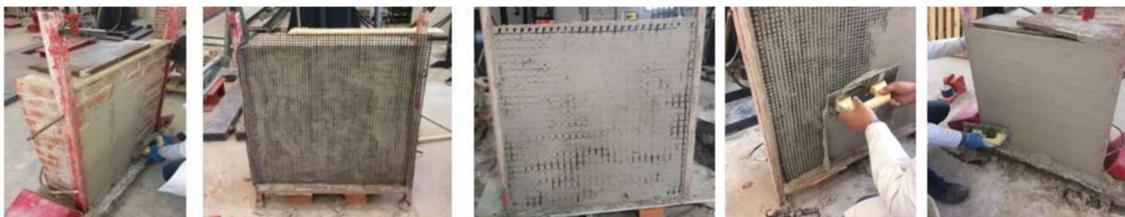
Figure 4. Illustration of the retrofitting of masonry specimens with textile-reinforced mortar (TRM) in the laboratory.

The construction procedure for the FRCM-strengthening is illustrated in Figure 4. A mortar layer was placed upon the surface of the masonry specimen to regularize the surface. The thickness of the mortar layer was approximately 5 mm. Then, when the mortar was still in its fresh condition, the reinforcing glass fiber-reinforced polymer mesh was applied. Next, a second layer of mortar was spread up to a maximum total thickness of 1 cm. Finally, the surface was evened out with a trowel.

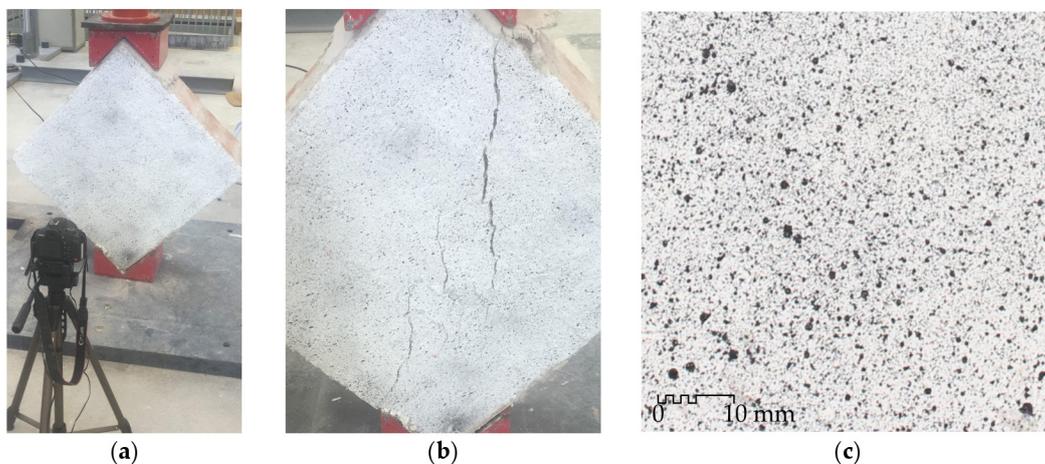
Figure 5. Installation of the digital image correlation (DIC) system to monitor shear behavior of masonry elements during diagonal tension tests: (a) experimental DIC setup; black speckle over the surface of (b) a masonry specimen reinforced with an FRCM and (c) an FRCM coupon in uniaxial tensile tests.

In this measurement technique, a crucial step is the creation of the stochastic pattern [39]. In order to optimize the DIC analysis, images with great contrast are required. This can be achieved by painting the masonry specimens white and subsequently applying a black speckled pattern (Figure 5). The size of the spots in the speckle has a notorious impact on the accuracy of the results, so a suitable balance needs to be defined based on specific setup conditions. An example of the speckle used in these tests

can be found in Figure 5c. The spray application made a random particle dispersion, with a maximum particle size of approximately 1.5 mm.

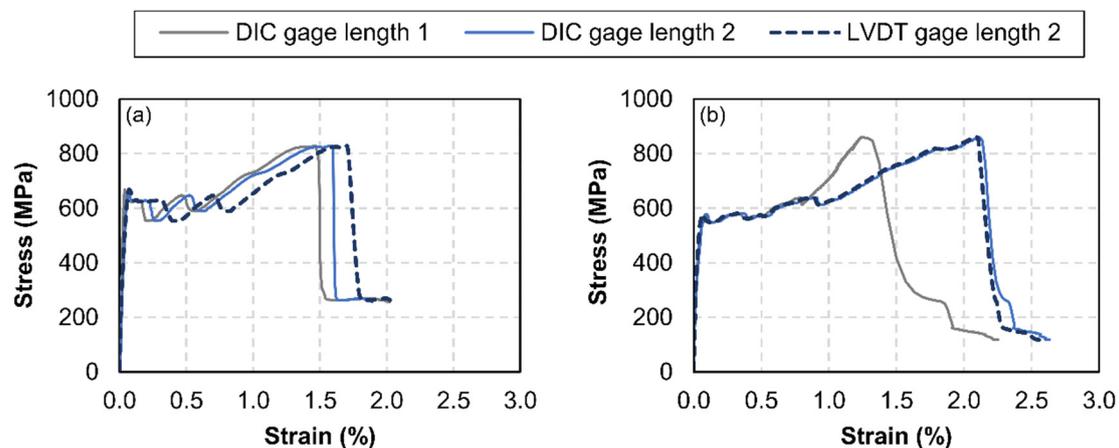
Figure 6. Tensile behavior of the FRCM: stress–strain curves of (a) specimen 1 and (b) specimen 2. Strains were measured with LVDT and a DIC system.

The experimental results obtained in the uniaxial tensile tests of the FRCM coupons are shown in Figure 6. The horizontal axis corresponds to the longitudinal elongation, and the tensile stress is shown in the vertical axis. The stress was obtained as the axial load divided by the fiber cross-sectional area. Two gage lengths were considered. Gage length 1 was the free distance between clamps, which was approximately 20 cm. This gage length could only be measured through DIC. On the other hand, gage length 2 was used to convert the displacement measured with the LVDT into longitudinal strain, and its length was approximately 30 cm (i.e., the distance between the centroids of the top and bottom bolted coupon-to-clamp connections). Therefore, the increase of gage length 2 could be measured through both DIC and LVDT. Despite three FRCM specimens having been prepared, the test only yielded adequate results in two of them, which are the ones included in Figure 6. The problem with the third specimen was caused by an excessive out-of-plane curvature induced by bending during curing. The loading conditions for this specimen were not those of uniaxial tension but rather those of the flexural-tensile state. This also made it impossible to obtain accurate results with either LVDT or with DIC (because only one camera was available).

The notorious discrepancy that is apparent in Figure 6b between the elongation measurements based on gage length 1 and gage length 2 happened because one crack appeared and grew across the edge of a pair of clamping plates, thus lying beyond gage length 1. Nevertheless, the results obtained with the DIC system showed an excellent agreement with those obtained with LVDT, especially in the case of gage length 2 in Figure 6b; the relative error between the DIC-based and LVDT-based elongation of gage length 2 in Figure 6a was approximately 10%.

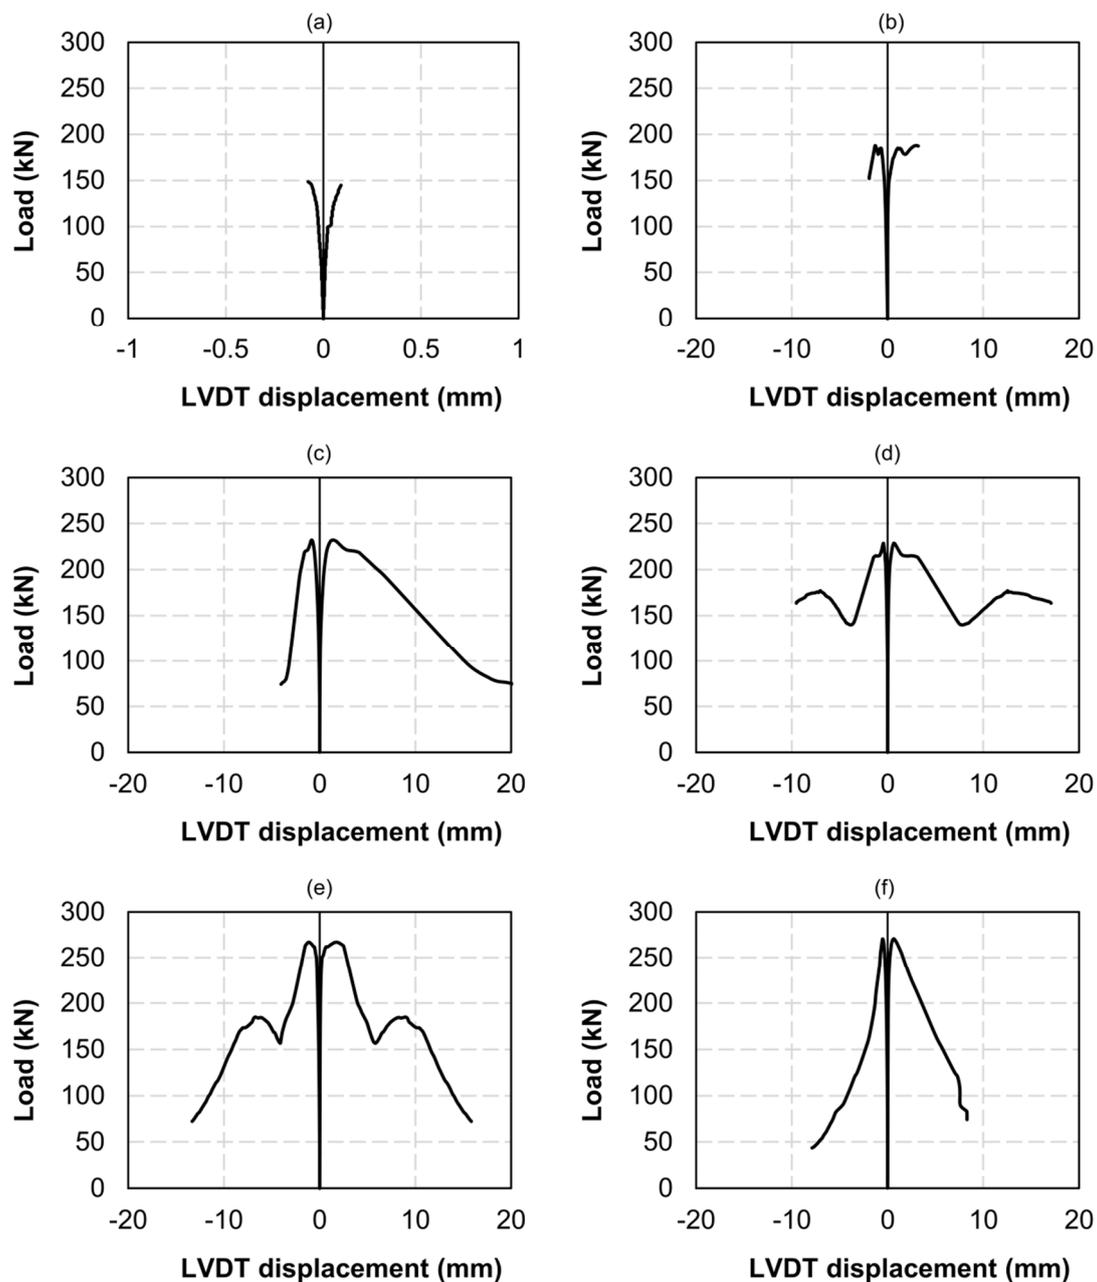
Figure 7. Load–displacement curves for all specimens based on LVDT measurements: unreinforced masonry specimens 1 (a) and 2 (b); single-reinforced masonry specimens 1 (c) and 2 (d); double-reinforced masonry specimens 1 (e) and 2 (f).

Load–displacement curves for all specimens are shown in Figure 7. The horizontal axis corresponds to the displacements measured with LVDT. The LVDTs installed horizontally produced positive displacement, which corresponded to tensile strain. Conversely, the LVDTs installed vertically yielded negative values, which corresponded to compressive strain. The load–displacement curves in Figure 7 reveal that the FRCM-reinforcements notably increased the shear capacity of the masonry specimens, not only in terms of the load applied but also in terms of the ductility. The increase in load capacity was slightly higher in the case of the double-reinforced specimens. It is important to note that the specimens had been reinforced without having been previously subjected to direct loading (although shaker-induced vibrations had damaged the specimen in Figure 7a). Single-reinforced specimens increased their maximum load by 34% with respect to the unreinforced ones, whilst double-reinforced specimens increased it by 52%.

The load and displacements lectures represented in Figure 7 can be used to calculate the shear stress (τ) vs. shear strain (γ) relationship. In accordance with ASTM E519/E519M-25 [22], the shear stress is calculated through Equation (1):

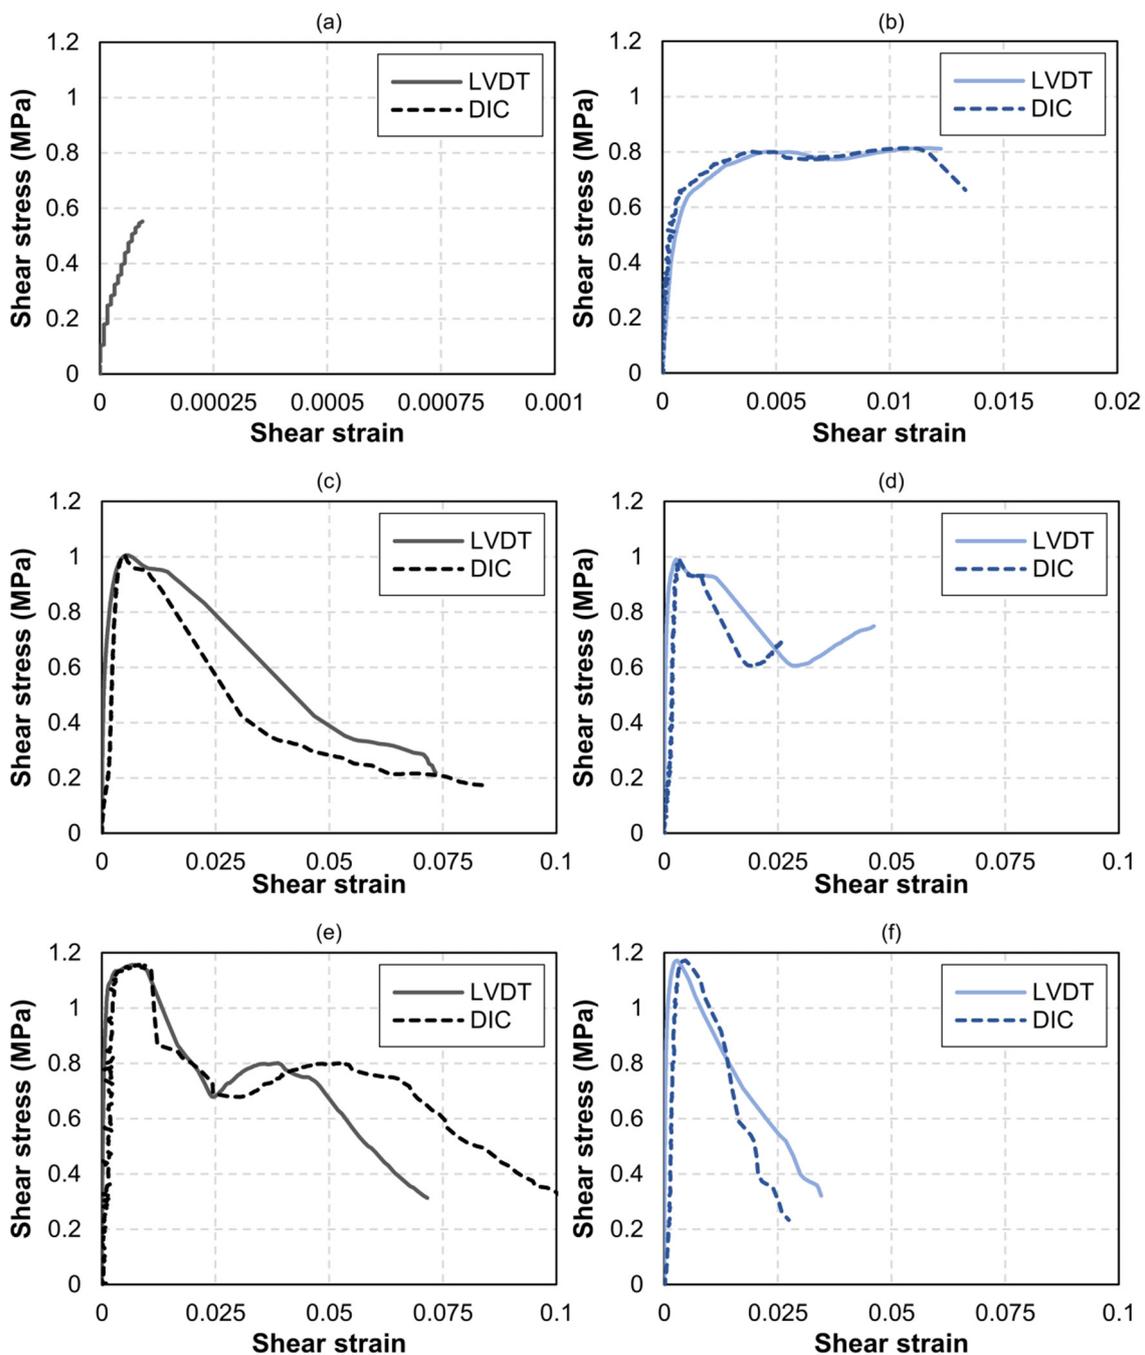
Figure 8. Shear stress–strain curves: unreinforced masonry specimens UM-1 (a) and UM-2 (b); single-reinforced masonry specimens SM-1 (c) and SM-2 (d); double-reinforced masonry specimens DM-1 (e) and DM-2 (f).

The τ – γ curves are shown in Figure 8. The shear strain γ was obtained through Equation (3), and the values of Δx and Δy are those that were registered with both the LVDT devices and the DIC methodology. In the case of the two unreinforced masonry specimens (Figure 8a,b) a large dispersion was observed in terms of both sustained ultimate load and ductility. The specimen shown in Figure 8a

(UM-1) had been previously exposed to shaker-induced vibrations for 500 h, which arguably damaged the lime mortar joints and caused the observed brittle behavior. The ultimate shear strain was very small ($94 \mu\epsilon$), and it was not possible to obtain DIC measurements. Besides, this specimen was the first one to be tested, and the high-resolution photographs were focused to capture the whole masonry specimen (including bearings); therefore, the pixel size was found to be too small for the DIC algorithm to accurately detect the strain field. In subsequent tests (Figure 8b,f) the camera focused on a smaller central area of the masonry surface, with a window size similar to the gage length of the LVDTs.

As can be seen in Figure 8a (specimen UM-1) the τ – γ relationship was almost linear until failure. Conversely, in the case of the unreinforced specimen in Figure 8b (UM-2), an inelastic behavior developed for shear stresses over 0.7 MPa, resulting in an ultimate shear strain over 1.2%. This inelastic behavior could be attributed to the friction between undamaged joint and bricks. In the case of the single-reinforced specimens (Figure 8c,d) and double-reinforced specimens (Figure 8e,f), notoriously smaller dispersions were observed. Both single-reinforced samples SM-1 and SM-2 reached a shear stress of around 1 MPa, which represented an increase of 25% with respect to UM-2 in Figure 8b. On the other hand, both double-reinforced samples DM-1 and DM-2 reached a shear stress of almost

1.2 MPa, which represented an increase of around 47% with respect to UM-2. The exact results are given in Table 2.

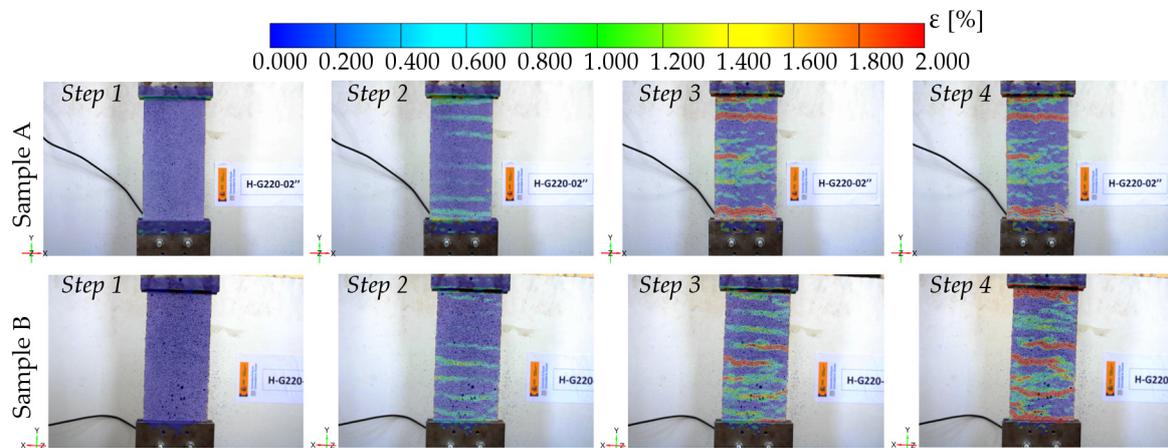
Figure 9. Longitudinal strain distribution at different load levels and crack detection by DIC analysis: step 1 test beginning, step 2 crack initiation, step 3 crack growth, and step 4 excessive crack opening.

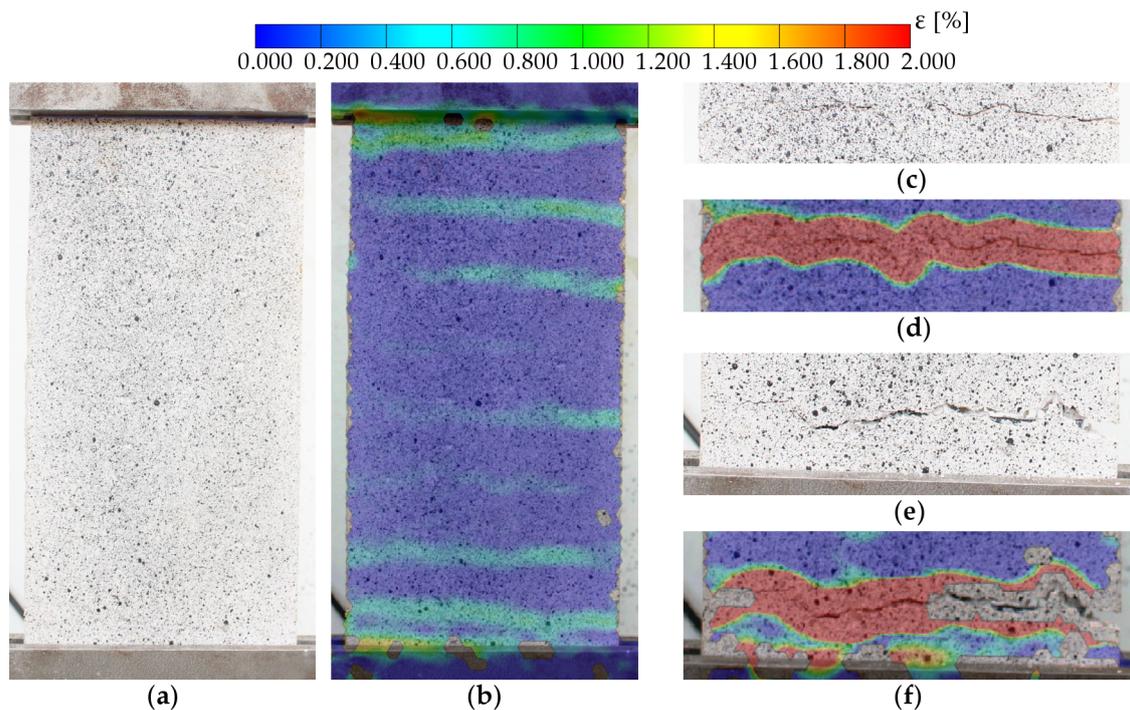
Figure 10. Spatial distribution of transverse cracks in direct tensile tests of sample A in Figure 9. Step 2 corresponding to (a) crack initiation and (b) crack identification via DIC analysis. Details of clamps in step 4: (c) visible crack near the upper clamp and (d) crack measurement via DIC; (e) non-symmetrical crack growth and (f) excessive opening detected by DIC.

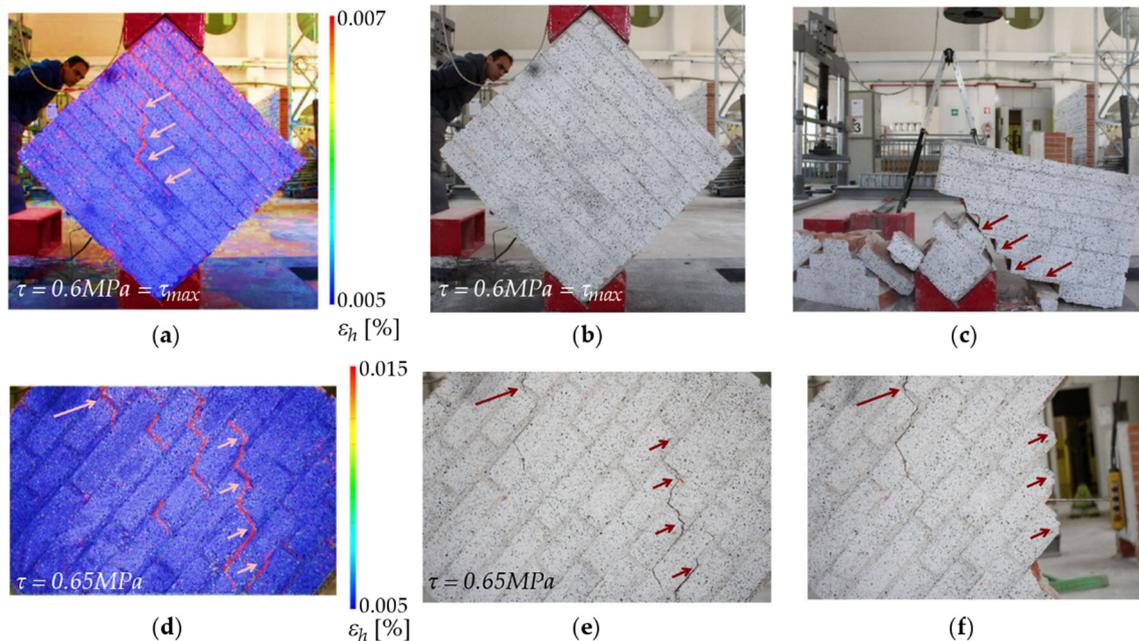
Figure 11. Failure of unreinforced masonry: Specimen (1) (a) horizontal strain (%) by DIC at maximum load, (b) last image prior to collapse, and (c) first image after collapse. Specimen (2) (d) horizontal strain (%) by DIC at 0.65 MPa shear stress, (e) image prior to collapse, and (f) first image after collapse.

In the diagonal tension test of masonry specimens, the DIC monitoring system allowed us to identify the strain distribution at the moment of failure. For example, in one unreinforced sample (Figure 11a–c), the collapse occurred in a very sudden and a brittle way. A main vertical crack (Figure 11a) developed following the mortar joints and failure resulted in a relative slide between the interfaces in the joints of both halves. However, hardly any cracks could be visually detected prior to collapse on either side, despite their registration through DIC. Another example of the velocity of this phenomenon may be observed by comparison of images in Figure 11b,c, which were taken only 5 s apart. On the other hand, the second unreinforced specimen showed a slightly different behavior. The crack propagation along the mortar joints could be observed through DIC (Figure 11a–c). The DIC

analysis in Figure 11d was made at a load level corresponding to a shear stress of 0.65 MPa, in which cracks were not yet perceptible to visual inspection. This time, the collapse took longer to take place: 150 s passed between the moment when cracks were already visible (Figure 11e) and the ultimate collapse (Figure 11f).

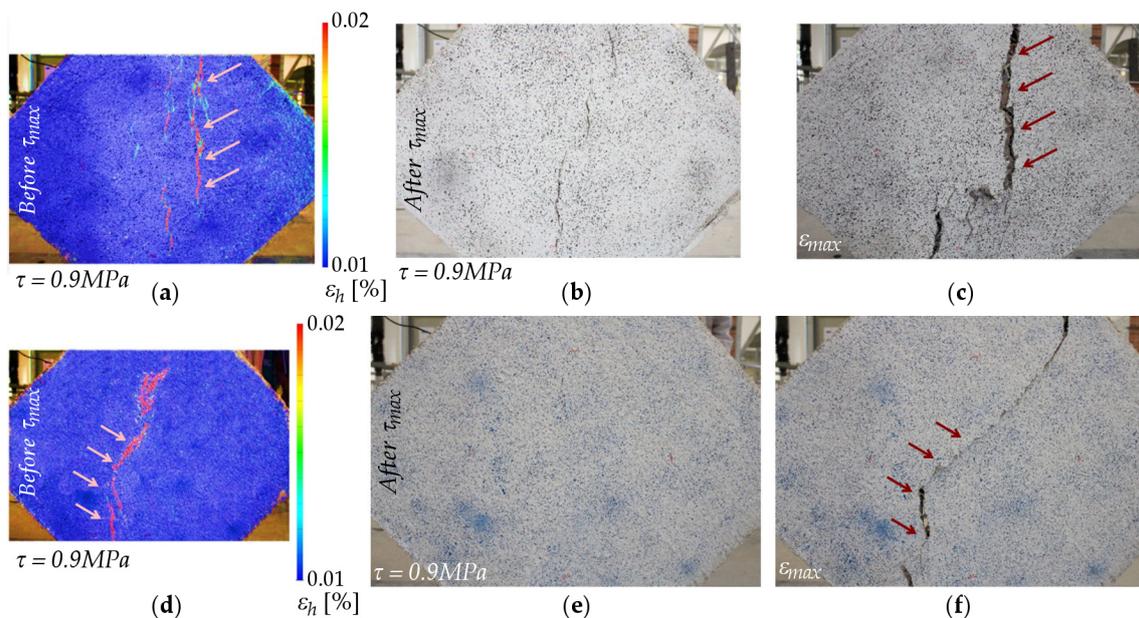
Figure 12. Failure of masonry reinforced in one side: Specimen (1) (a) horizontal strain (%) by DIC at 0.9 MPa shear stress before peak load, (b) damage at 0.9 MPa shear stress after peak load, and (c) damage at maximum test displacement. Specimen (2) (d) horizontal strain (%) by DIC at 0.9 MPa shear stress before peak load, (e) damage at 0.9 MPa shear stress after peak load, and (f) damage at maximum test displacement.

In the case of masonry specimens reinforced on one side only, the presence of the FRCM drastically changed the failure mode with respect to unreinforced specimens. DIC images for both tests are included in Figure 12. In both specimens, vertical cracks started to appear between the upper and bottom areas close to the loading shoes, clearly visible on both sides of the specimen. As the loading increased, cracks kept growing along the compressed diagonal, leaving the outer corners unaffected.

In addition, the second specimen (Figure 12d–f) started to tilt towards the reinforced side, as already noted in other experimental campaigns [42,43]. This out-of-plane effect (Figure 13), which was only observed in single-reinforced samples, did not result in a ductility reduction. Furthermore, the glass fiber of the FRCM was capable of preventing the total collapse of the masonry, which was observed in the unreinforced specimens.

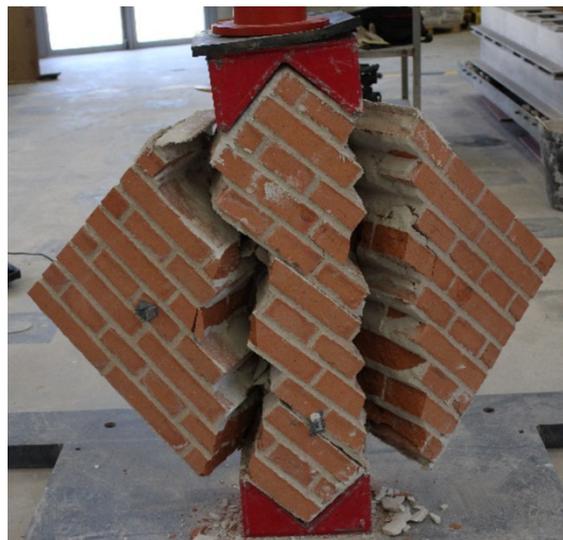
Figure 13. Tilting towards the reinforced in single-reinforced (2) specimen.

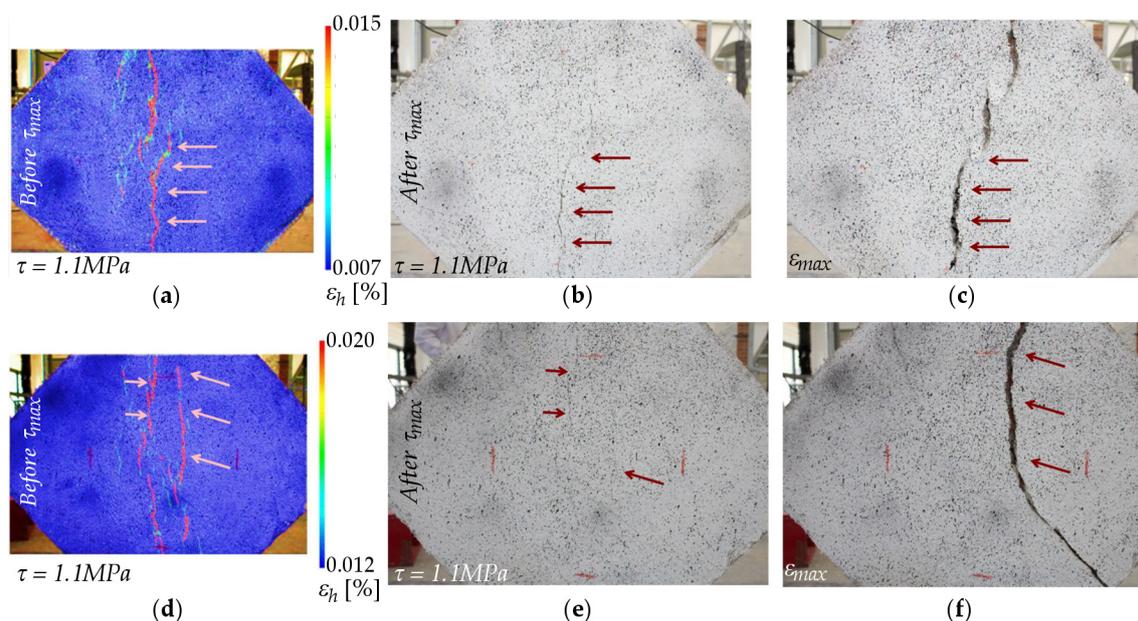
Figure 14. Failure of masonry reinforced in both sides: Specimen (1) (a) horizontal strain (%) by DIC at 1.1 MPa shear stress before peak load, (b) damage at 1.1 MPa shear stress after peak load, and (c) damage at maximum test displacement. Specimen (2) (d) horizontal strain (%) by DIC at 1.1 MPa shear stress before peak load, (e) damage at 1.1 MPa shear stress after peak load, and (f) damage at maximum test displacement.

The failure mode of specimens reinforced on both sides (Figure 14) was characterized by vertical cracks that initially appeared at the center of the specimen. The cracking pattern grew within the upper and bottom areas close to the loading shoes, and a diagonal tension failure occurred in the specimens. The tests did not end with a sudden collapse, i.e., a brittle separation of the two blocks of the specimen, thanks to the use of glass FRCM retrofitting. Both specimens exhibited very similar behavior and achieved a better performance in terms of maximum load and displacement. This enhanced strength and ductility could also be observed through the time that elapsed between the instant when cracks were visible (Figure 14b,e) and the moment when displacement reached its maximum value, which took longer than 10 min.
