A Practical Approach to Condition Assessment of Asphalt-Covered Concrete Bridge Decks on Korean Expressways by Dielectric Constant Measurements Using Air-Coupled GPR

¹ Korea Expressway Corporation, Hwaseong 18489, Korea; need@ex.co.kr (J.-Y.R.); kepark@ex.co.kr (K.-E.P.); tunnelslope@ex.co.kr (K.-H.L.)

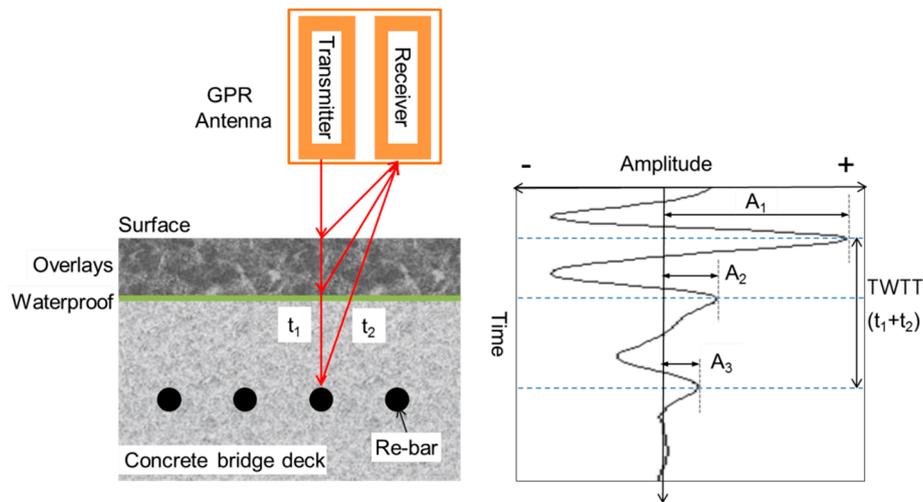
Figure 1. Illustration of Ground Penetrating Radar (GPR) scanning on an asphalt-covered concrete bridge deck and a possible path of electromagnetic (EM) waves.

Figure 1 shows an illustration of the GPR survey for the condition assessment of concrete bridge decks with asphalt overlay. A transmitter in the GPR antenna generates transient EM waves that propagate into the concrete bridge decks under asphalt pavement. Some of the incident EM waves in asphalt pavement are reflected from the AC (Asphalt/Concrete) interface and some transmit through the AC interface. The traditional method for determining the dielectric constant of a medium is the back calculation of the value by using reference drilled cores. This method is still the most common, especially when using ground-coupled GPR systems. The other very popular method is the surface reflection method [22], which can be used with air-coupled GPR systems like the one used in this study. This method uses the reflected amplitude from the bridge deck surface to compare it with the reflection on the metal plate representing a total reflector. By calculating the amplitudes, it is possible to calculate the dielectric constant of both layers (asphalts overlay and concrete deck). Equations (5) and (6) can be used to calculate the dielectric constant values of the first surface (surface of asphalts overlay) and the second surface (in this case, the top surface of concrete of bridge deck), respectively [10].

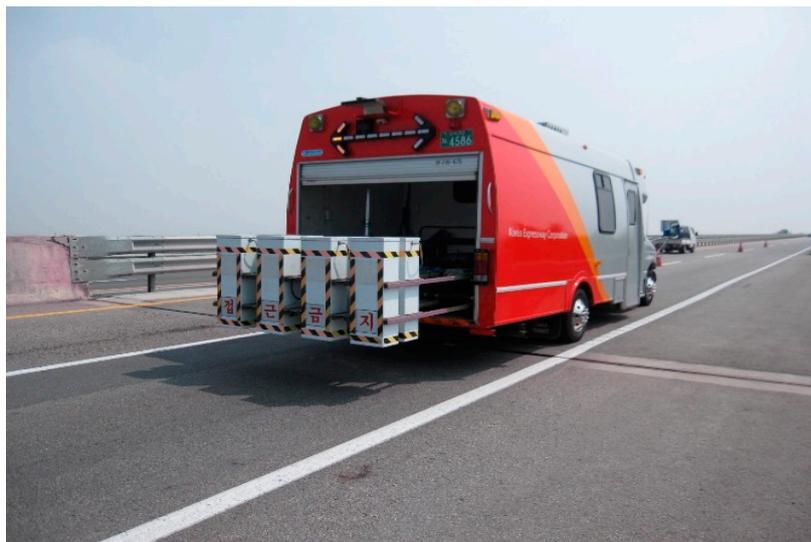
Figure 2. Photo of a GPR survey vehicle using 4-channel 1 GHz air-coupled antennas.

The GPR survey system used was Sir Series of Geophysical Survey Systems Inc. (GSSI) and it used 4-channel 1 GHz air-coupled antennas. The 4-channel antennas were installed at the back of a vehicle that had the distance measuring instrument (DMI) on one of the rear wheels. The GPR system was operated on each traffic lane, including the road shoulder, at the speed of 80–100 km/h for collecting the GPR survey data (Figure 2). The survey was carried out in accordance with the survey protocol of KEC as follows:

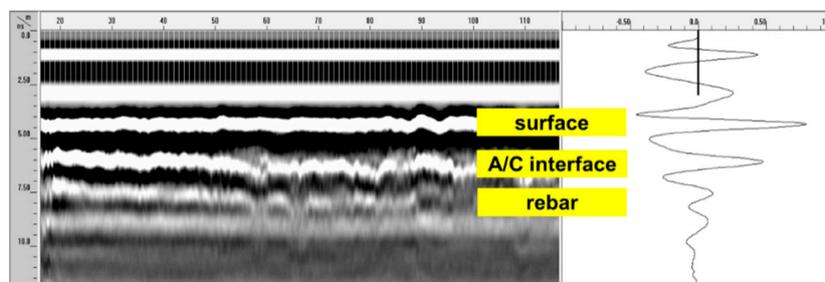
Figure 3. Typical GPR B-scan image on asphalt-covered bridge decks in one of the survey bridges in this study.

Furthermore, the survey was only conducted after confirming that the air-dried surface of an asphalt concrete layer had no standing water on the pavement surface and had no considerable debris that would affect the GPR radar signal interpretations. The GPR signals were acquired with the sampling rate to 12–14 scans/m (i.e., 1 scan for every 70 or 80 mm) in the longitudinal direction. A typical GPR B-scan image obtained on asphalt-covered concrete decks in one of the survey bridges in this study is shown in Figure 3.

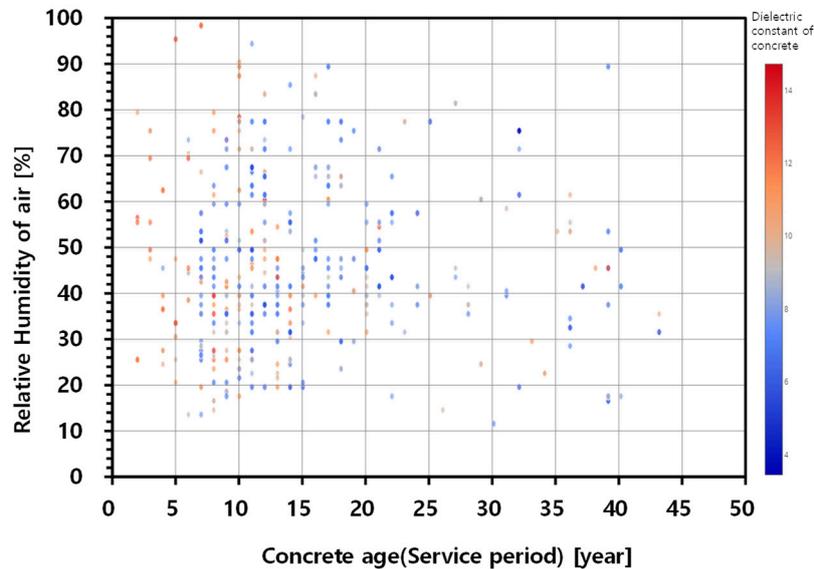
Figure 4. Two-dimensional image representing the distribution of dielectric constant of asphalt-covered bridge decks with relative humidity of air and concrete age (service period).

Figure 4 shows a 2D image representing the variation of the dielectric constant of concrete on the top of bridge decks with asphalt overlay in terms of two main influencing parameters (concrete age and relative humidity of air measured by meteorological stations) [26]. In the figure, the value of the concrete dielectric constant was presented with different colors: higher value with color red and lower value with color blue. In general, the GPR survey data appears to be greatly dispersed, which is mainly due to the variability of bridge components (e.g., concrete age, degree of deterioration, water content, etc.). However, it could be observed that the higher values of relative permittivity are shown in relatively new concrete bridges (0–10 years), which was also observed in concrete bridge decks without asphalt overlay [20]. Young concrete has plenty of water in the concrete pore system, leading to higher dielectric constant than the values in mature concrete in old bridges.

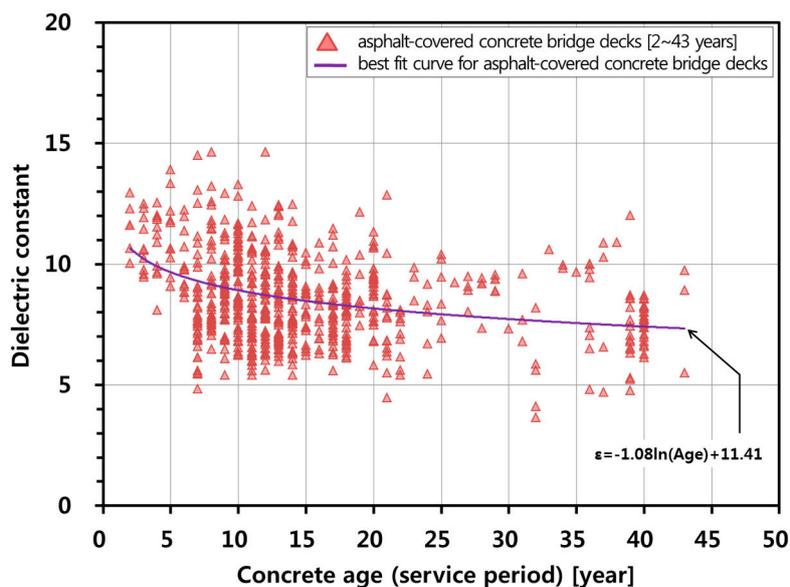
Figure 5. Variation of dielectric constant of concrete in asphalt-covered bridge deck with concrete age (service year).

Figure 5 depicts the variation of the dielectric constant of concrete with concrete age in the survey bridge decks. The dielectric constant of a concrete bridge deck under 10 years of service decreased by about 0.26 a year, while the dielectric constant of concrete over 10 years of service decreased by about 0.03 a year. In other words, as the age increased, the dielectric constant decreased at a reduced rate. This trend followed the behavior observed in the equation for bare concrete bridge deck [20]. In this study, an approximate formula representing the relationship between the dielectric constant of concrete deck with asphalt overlay and concrete age (service period of bridges) was established using nonlinear regression analysis,

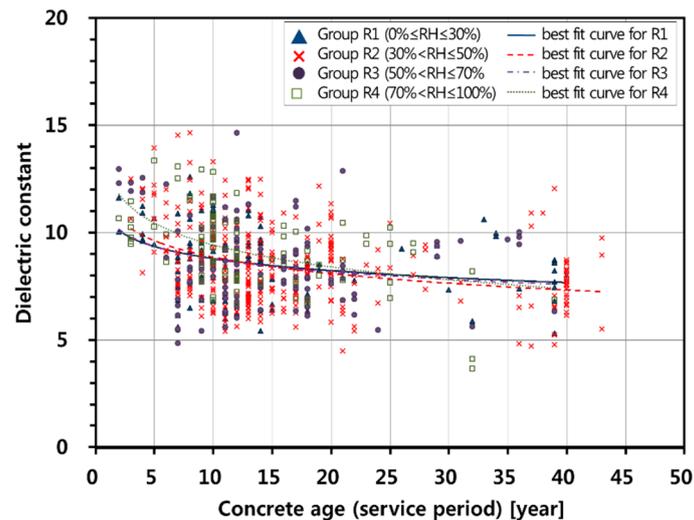
Figure 6. Variation of dielectric constant of asphalt-covered concrete bridge decks in the four bridge groups classified according to relative humidity: $RH \leq 30\%$ (Group R1), $30\% < RH \leq 50\%$ (Group R2), $50\% < RH \leq 70\%$ (Group R3), $70\% < RH$ (Group R4).

In addition, the influence of relative humidity on the relationship between concrete age (service performance period of the bridge) and dielectric constant of concrete was investigated. The research survey bridges were classified into four groups according to relative humidity: $RH \leq 30\%$ (Group R1), $30\% < RH \leq 50\%$ (Group R2), $50\% < RH \leq 70\%$ (Group R3), $70\% < RH$ (Group R4). Figure 6 shows the variation of the dielectric constant of concrete of asphalt-covered bridge decks in the four groups of bridges classified according to relative humidity. One-way analysis of variance (ANOVA) showed the statistically significant difference between the means of the three groups with RH lower than or equal to 70% (Groups R1, R2, and R3) and the mean of the group with RH greater than 70% (Group R4), with F-value = 4.747 and p -value = 0.003 at the significance level of 0.05 (see Figure 7). In addition, it was also confirmed by the analysis of covariance (ANCOVA) that there is a statistically significant difference in the effect of relative humidity on the dielectric constant of Group R4 and the other three groups (Groups R1, R2, and R3), with F-value = 16.446 and p -value = 0.00 at the significant level of 0.05. Therefore, it can be said that there is a statistically significant difference between the three groups with RH lower than or equal to 70% (Groups R1, R2, and R3) and the group with RH greater than 70% (Group R4).

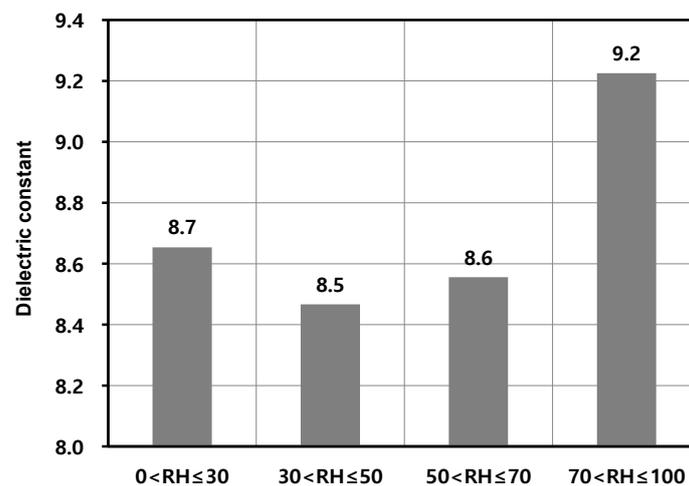
Figure 7. Means of the four groups of bridges classified according to relative humidity: $RH \leq 30\%$ (Group R1), $30\% < RH \leq 50\%$ (Group R2), $50\% < RH \leq 70\%$ (Group R3), $70\% < RH$ (Group R4).

Given concrete age, Equations (8) and (9) result in very similar dielectric constant values, with a mean absolute error of 0.05. However, Group R4 (relative humidity greater than 70%) shows a slightly greater dielectric constant for the same ages compared to the other three groups with an approximate equation,

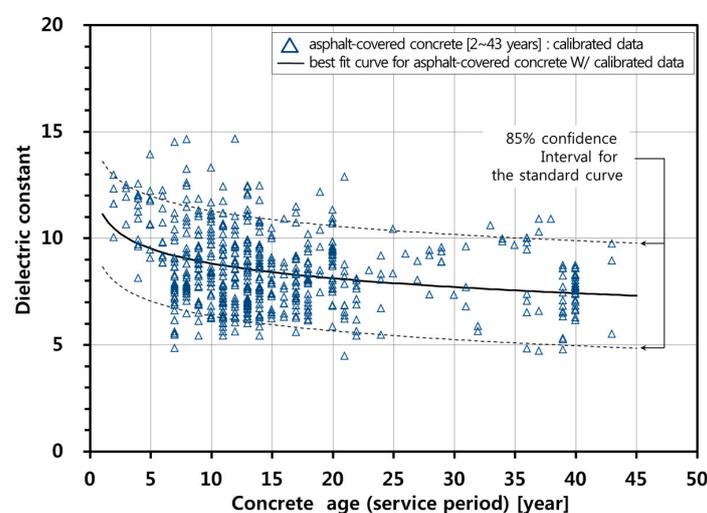
Figure 8. Proposed standard curve representing the relationship between the dielectric constant of concrete bridge deck and concrete age (service year).

where ε_i is the measured value and ε_i' is the estimated value from the fitted line. For example, the dash lines in Figure 8 show the upper and lower boundaries at a confidence level of 85%. The confidence level of 85% was determined by taking into account several engineering factors (variability of concrete quality, construction error and uncertainties in GPR measurements and analyses) and government policy on the quality control and quality assurance.

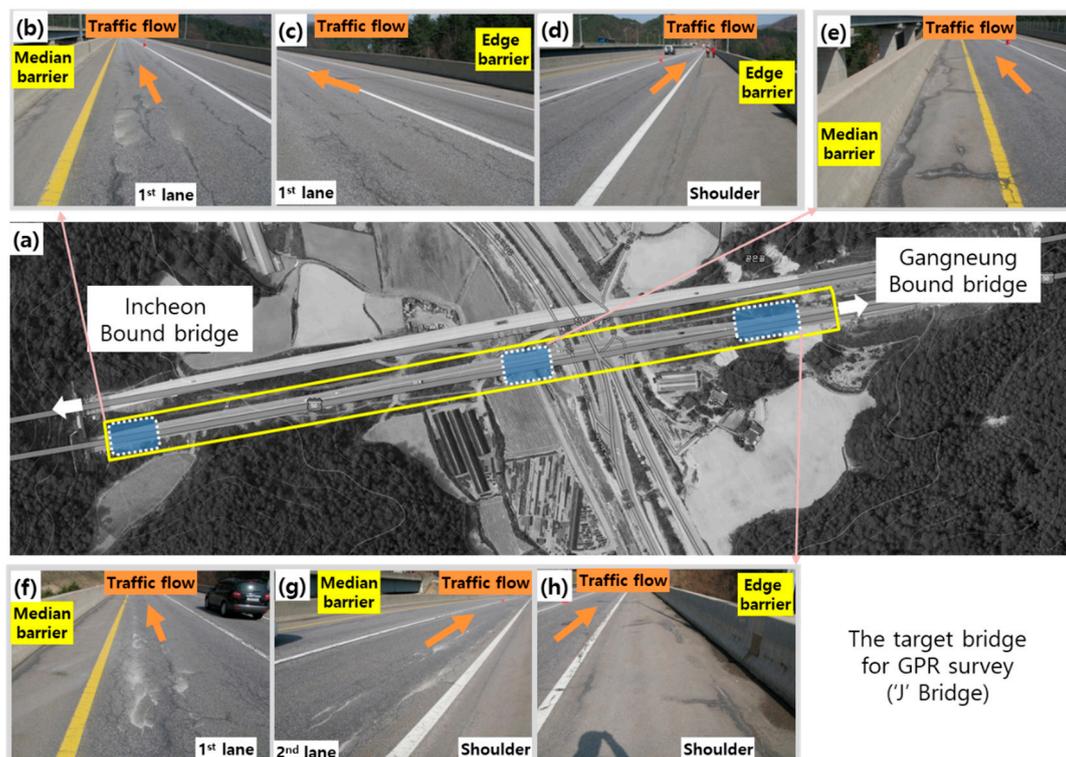
Figure 9. Overview of the target bridge (“J” bridge) for validation of the proposed GPR signal interpretation): (a) a satellite map of the target “J” bridge, (b–h) pictures presenting deterioration conditions on the surface of bridge decks in the target “J” bridge.

The target ‘J’ bridge is a steel box girder bridge constructed in 1999 with an extension of 600 m, a width of 12.15 m, and offers three traffic lanes including the road shoulder (Table 2, Figure 9). The concrete bridge deck in the ‘J’ bridge was overlaid with asphalt concrete. The target ‘J’ bridge is located at Pyeongchang on the Yeongdong expressway. Average temperature of the location is about $-10\text{ }^{\circ}\text{C}$ between December to March [25]. A great deal of deicing chlorides has been sprayed in this heavily snowed and cold region, which caused chloride-induced deterioration in concrete and created a corrosive environment of rebars in concrete.

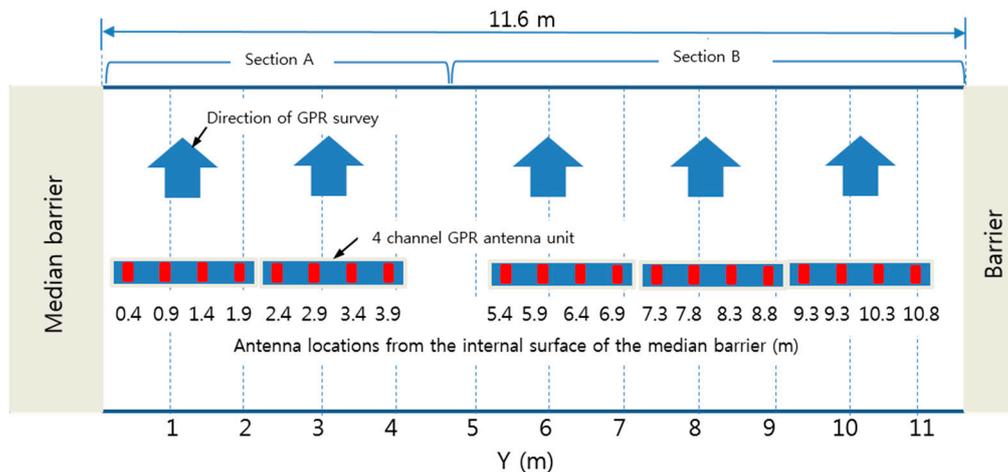
Figure 10. Illustration of GPR surveys on the target pilot ‘J’ bridge using a 1 GHz air-coupled GPR system (see Figure 2).

The test bridge has three lanes including a shoulder with a total width of 12.15 m and an effective width of 11.6 mm (distance between internal surfaces of barriers). A traffic lane was blocked during the survey time for a more accurate survey. To avoid traffic interruption, the bridge was divided into two sections (sections A and B in Figure 10). The GPR survey was performed on one section at a time, while blocking the other section. In the GPR survey of section A, GPR antennas were located at $y = 0.4, 0.9, 1.4, 1.9, 2.4, 2.9, 3.4, 3.9$ m: whereas for section B, GPR antennas were located at $y = 5.4, 5.9, 6.4, 6.9$,

7.3, 7.8, 8.3, 8.8, 9.3, 9.8, 10.3, 10.8 m (see Figure 10). Consequently, a total of 20 lines of GPR scanning were conducted with a resolution of 0.4–1.5 m (the center-to-center distance between antennas) in the transverse direction. The distance between the four antennas mounted on GPR vehicle is fixed at 0.5 m. A total of 144,848 scan data were collected in the manner of 12 scans/m in the direction of the bridge axis.

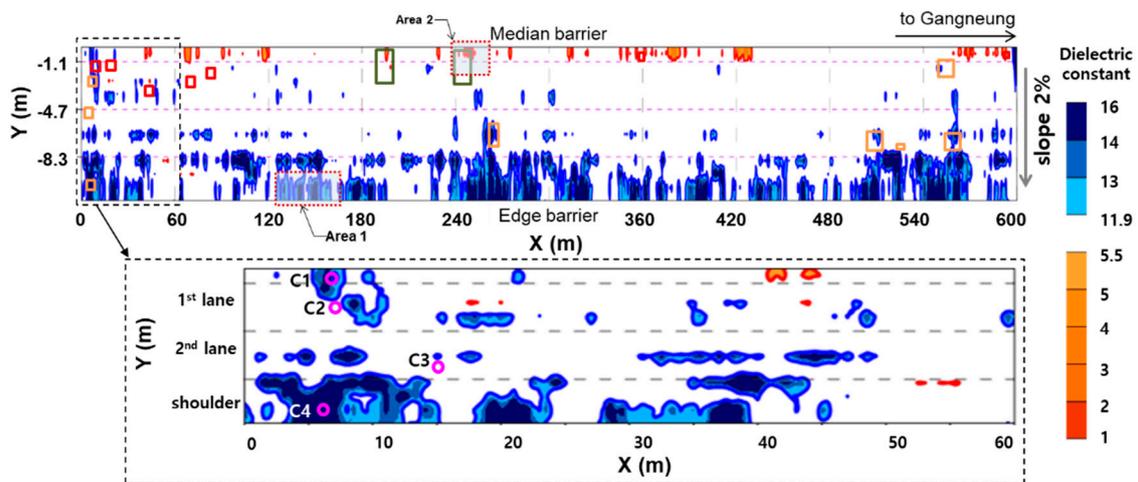
Figure 11. Plane view of dielectric constant of top concrete on the pilot target bridge deck: (red line-5.5, blue line-11.9). Surface deteriorations based on visual inspection are presented as: efflorescence, map cracking, patching).

In Figure 11, the regions with a dielectric constant value, the over upper cut-off value of 11.9 are shown as color blue, and the regions under the lower cut-off value of 5.5 are shown as color red. Overall, higher values ('blue' areas) of concrete dielectric constant were observed in the rightmost lane (i.e., close to edge barrier), while lower values ('red' areas) were observed in the leftmost lane (i.e., close to median barrier). This occurrence can be explained by the transversal slope of the pavement (i.e., 2% slope) that leads to migrating the surface water towards the right lane. Deteriorated concrete with enhanced porosity and/or dense microcracks would result in higher dielectric constant in the wet conditions (i.e., regions close to edge barrier) since the void system in the deteriorated concrete could be filled with water. On the contrary, the void caused by concrete deterioration could be filled with air, which would result in lower dielectric constant in the dry conditions (i.e., regions close to median barrier). Therefore, the test regions shown as blue and red colors can be interpreted as likely deteriorated concrete regions in the wet and dry conditions, respectively. For comparison, surface deteriorations based on visual inspection are presented as: efflorescence, map cracking, patching, in the same figure. The part of bridge decks where efflorescence was observed (marked with) exhibited high dielectric constant values. It is expected that continuous water penetration and deterioration of the inside is developing there. One interesting finding is that some damaged (or solid) regions determined from concrete dielectric constant were interpreted as solid (or damaged) regions by visual inspection on the surface. For example, the deteriorated areas according to the dielectric constant are mostly located near the median barrier and shoulder, where no obvious deterioration

is observed by visual inspection on the surface. In contrast, the dielectric constant values in most of the traffic lanes are between the cut-off values, while there are many surface-breaking cracks in the traffic lanes.

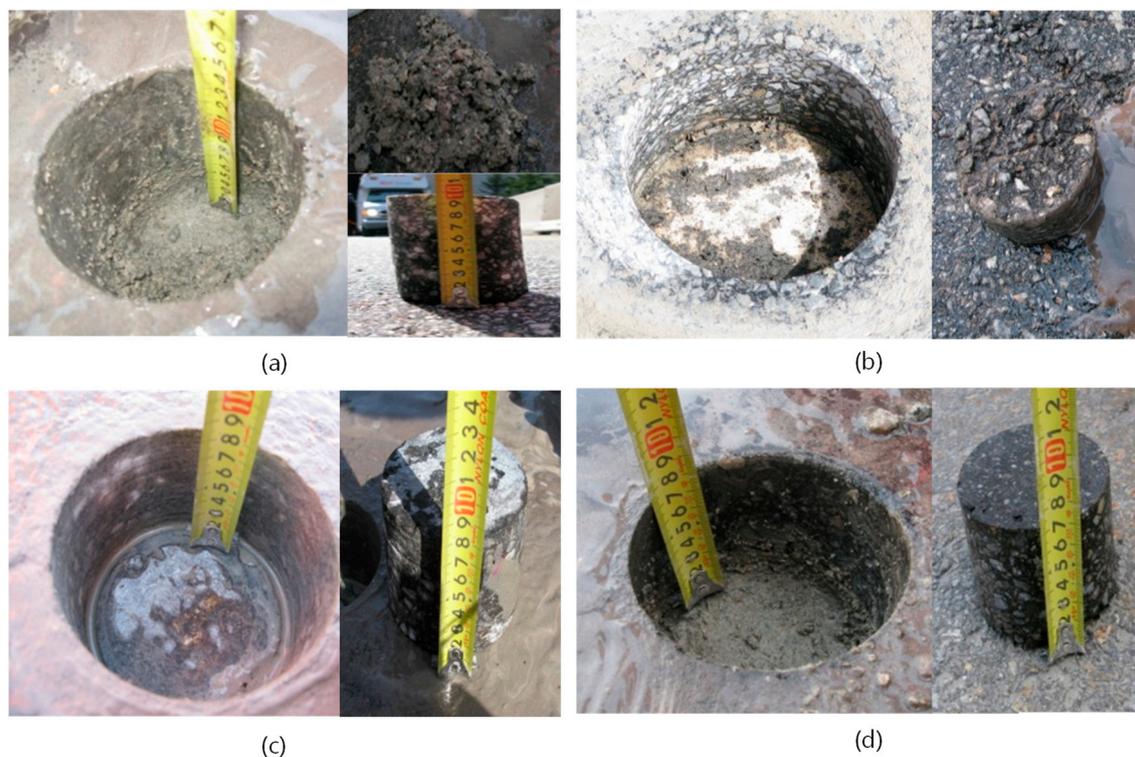
Figure 12. Evaluation of condition of asphalt-covered concrete bridge decks through core extraction from the four locations in the target bridge (“J” bridge): (a) core 1 (C1), (b) core 2 (C2), (c) core 3 (C3), and (d) core 4 (C4) (see Figure 12). Depth of deterioration in concrete decks and the condition of water-proofing-layer in the A/C interface were evaluated.

Core samples were extracted from four locations near the shoulder and the median barrier to examine the actual condition of concrete decks under asphalt overlay (see Figure 12 and Table 4). Two cores of C1 and C4 were extracted from the regions with the dielectric constant over 11.9, while two cores of C2 and C3 were from the regions with the dielectric constant within the two cut-off values. In the two cores of C2 and C3, the concrete and asphalt overlay have good bonding, and there was no evidence of concrete deterioration. However, it was observed that the waterproofing layers of the two cores C1 and C4 were deteriorated, and the interface between concrete and asphalt overlay was completely debonded. The deteriorated depths of concrete in the cores C1 and C4 were 35 and 10 mm, respectively. It was reported that weak bonding between the asphalt overlay and concrete deck can be a sign of deterioration of concrete [28]. The rainwater and deicing salt penetrated the area of the damaged overlay, and then penetrated the concrete through the weak points with poor waterproofing. Subsequently, the freeze-thaw action could result in enhanced porosity through weakening and/or softening of the microstructure.

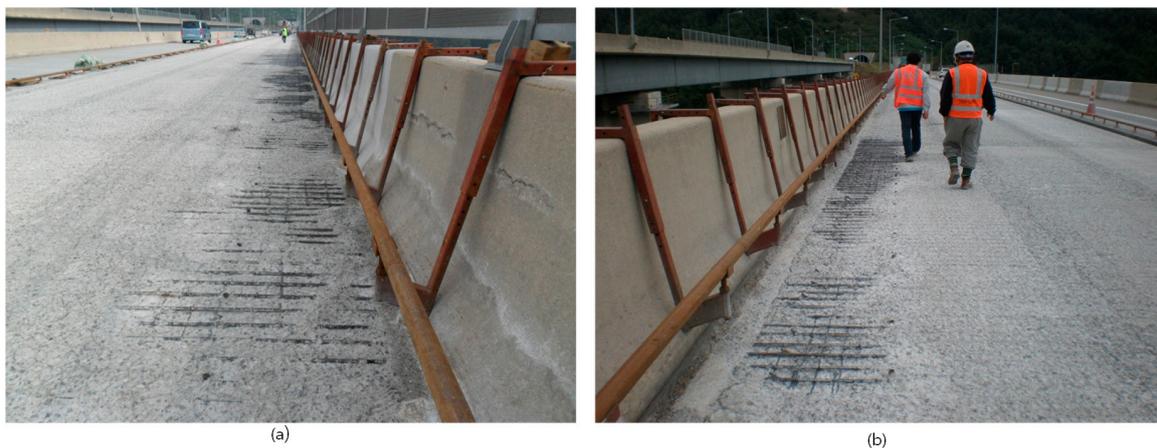
Figure 13. Actual concrete condition after removing the asphalt overlay and deteriorated concrete using a high-pressure water-jet machine in the target bridge (“J” bridge) after the GPR survey: (a) area 1 and (b) area 2 (see Figure 11).

In addition, the actual conditions of larger areas of concrete bridge decks under asphalt overlay were examined by visual inspection after removing the asphalt overlay and the deteriorated parts of concrete using high pressure water jetting. Figure 13a,b is pictures presenting concrete decks in the target pilot bridge after the water jetting process. Figure 13a clearly shows that the region with higher dielectric constant than the upper limit exhibits severely deteriorated concrete near the shoulder (area 1) although there were no visually observed damages on the surface. The deteriorated depth in the shoulders, with dielectric constant over 12, was deeper than the depth of rebars in the upper layer. Furthermore, Figure 13b shows that the region with a lower dielectric constant than the lower limit exhibits concrete deterioration deeper than rebars. It can be demonstrated that deteriorated concrete with enhanced porosity and/or dense microcracks can be identified by a higher or lower dielectric constant in the wet conditions or dry conditions, respectively. Note that the deteriorated concrete in the dry conditions could be overlooked when using visual inspection or GPR signal interpretation based on the conventional single cut-off dielectric constant criteria. The deteriorated area and ratio of reduction based on the single value criteria were 936 m² and 13%, respectively. The dual cut-off criterion resulted in 1038 m² (51 m² + 987 m²) and 15%, respectively. Consequently, these results demonstrated two important conclusions in this study: (1) the practical GPR interpretation method based on concrete dielectric constant is effective for evaluating the condition of concrete under asphalt overlay, which could not be directly estimated by visual inspection on the surface and (2) the double cut-off criteria for dielectric constant could further improve the capability of the practical GPR interpretation method in asphalt-covered concrete bridge decks in the relatively dry conditions, which could be not effectively estimated by the conventional single cut-off dielectric constant criterion.
