Sensing System Based on FBG for Corrosion Monitoring in Metallic Structures

Citation: Sousa, I.; Pereira, L.; Mesquita, E.; Souza, V.L.; Araújo, W.S.; Cabral, A.; Alberto, N.; Varum, H.; Antunes, P. Sensing System Based on FBG for Corrosion Monitoring in Metallic Structures. *Sensors* **2022**, *22*, 5947. <https://doi.org/10.3390/s22165947>

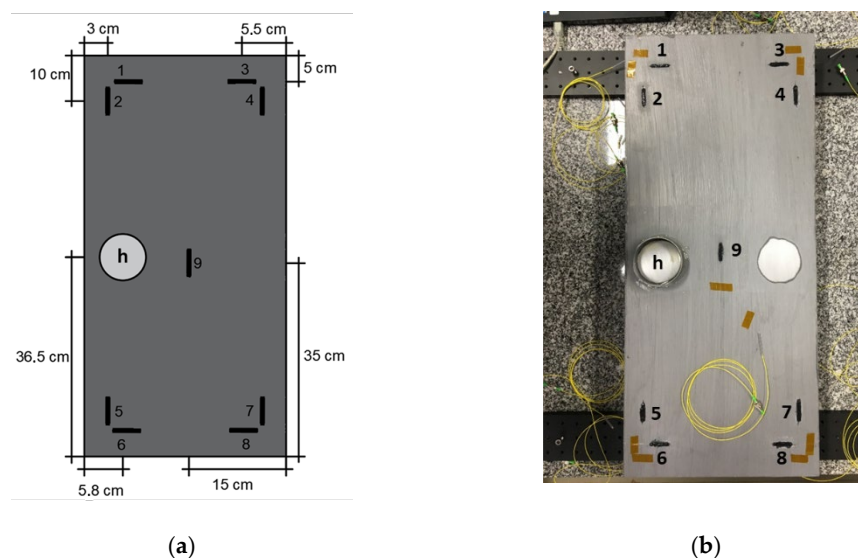
Figure 1. (a) FBG sensors' position and identification and location of the corrosion site on the metal plate; (b) photograph of the experimental apparatus.

Nine FBGs, with 8 mm physical length, were inscribed into a single-mode GF1 fiber (Thorlabs, Newton, NJ, USA) through the phase mask technique, using a pulsed Q-switched Nd:YAG laser system (LS-2137U Laser, LOTIS TII, Minsk, Belarus) emitting at 266 nm. The FBGs, each spliced to a single-mode pigtail, were distributed and fixed in a 1020 carbon steel, with dimensions of 300 mm × 700 mm and a thickness of 3 mm, according to Figure 1a.

The FBG sensors were fixed with some random strain to the plate using X120 adhesive (HBM, Darmstadt, Germany), where each FBG was embedded in an adhesive layer with 30 mm length and 5 mm width (black areas in the plate). Before gluing the FBG sensors, the protective coating of the steel plate was removed with a paint stripper in nine locations corresponding to the position of each sensor (note that the removed coating sections have the same dimensions as the applied adhesive layers with FBGs embedded to avoid the metal from being exposed to the external environmental conditions).

The corrosion was induced in a region with an area of 40.715 cm² (region “h” in the Figure 1a,b), with a 0.1 M NaCl solution. The protective coating of this region was previously removed with a paint stripper and sanded to guarantee the direct contact of the solution with the metal. A polyvinyl chloride (PVC) pipe section was glued to support the application of the fluid, without leaking along the plate and compromising the performance of the experimental procedure. However, the protective coating of two regions was removed to induce corrosion (see Figure 1b; only the one on the left side was used (h), as shown in the illustrative scheme in Figure 1a).

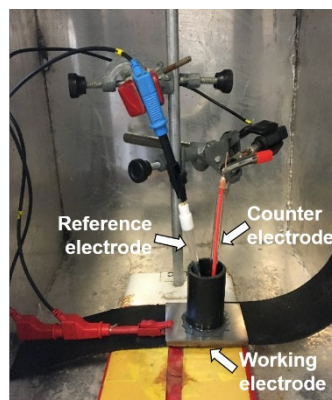
Figure 2. Experimental setup of the electrochemical cell.

tentiostat/galvanostat model PGSTAT30 (Autolab, Metrohm-Eco Chemie, with data collection made in Nova v.2.1.4 software, Utrecht, The Netherlands). Figure 2 shows the electrochemical cell assembly.

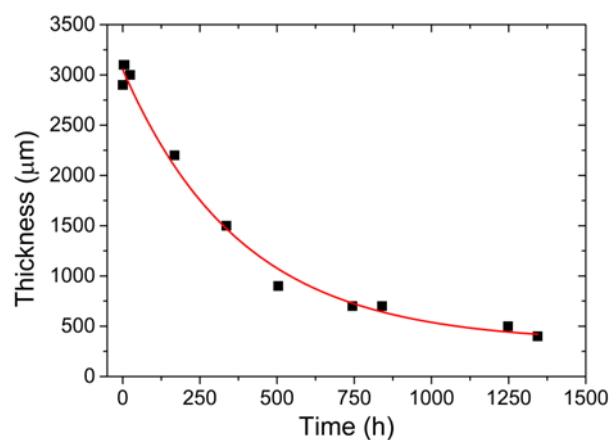
Figure 3. Thickness variation of the metal plate as a function of the corrosion time.

The thickness of the metal plate, determined by ultrasound measures, as a function of the corrosion time can be seen in Figure 3.

Through the collected results, the curve corresponding to the variation of the thickness as a function of time was determined, with a nonlinear adjustment coefficient equivalent to 98.99%. The equation that determines this correlation is expressed below, with T equivalent to thickness and t to time:

It is also noted that the ultrasound measurements can sometimes present some errors due to the procedure involved, such as the variation in the positioning of the transducers and the total contact of the transducers with the surface. This associated error can explain the high variation in thickness observed in the initial moments of the measurement, as shown in Figure 3.

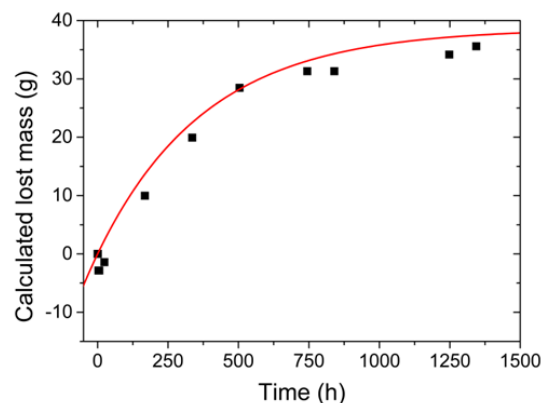
Figure 4. Variation of the calculated lost mass with time using Equation (6) (red line) and the obtained values from Table 1 (black squares).

where T_0 is the initial thickness of the plate, calculated from Equation (4), and is equal to 3053.27 μm ($t = 0$ h). Figure 4 compares the variation of the calculated lost mass using Equation (6) (red line) with the obtained values from Table 1 (black squares), showing a good fit with $R^2 = 97.21\%$.

Carbon steel, in the corrosion process, first gains mass due to the corrosion product formed in the process, and later, there is a reduction in mass after the cleaning process. It may happen, depending on the conditions of the environment, that the advance of corrosion is sufficient for the corrosion product to become adherent and not be removed with acid cleaning, causing the mass to stabilize [2].

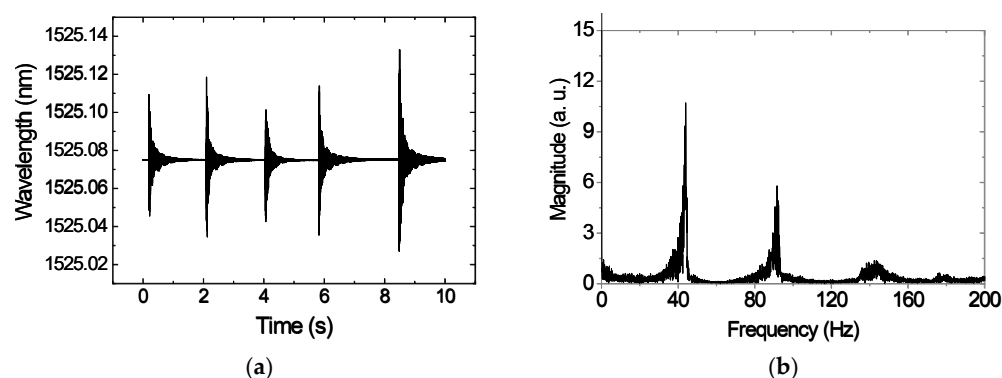
Figure 5. (a) Sensor 1 response to the application of five vertical impacts, 48 h after applying the 0.1 M NaCl solution; (b) corresponding frequency spectrum after FFT processing.

Figure 5a shows the response of FBG sensor 1 after the application of a vertical impact, five times during 10 s and 48 h after applying the 0.1 M NaCl solution. Through the fast-Fourier transform (FFT), the natural frequencies of the steel plate were determined, and the obtained results are presented in Figure 5b.

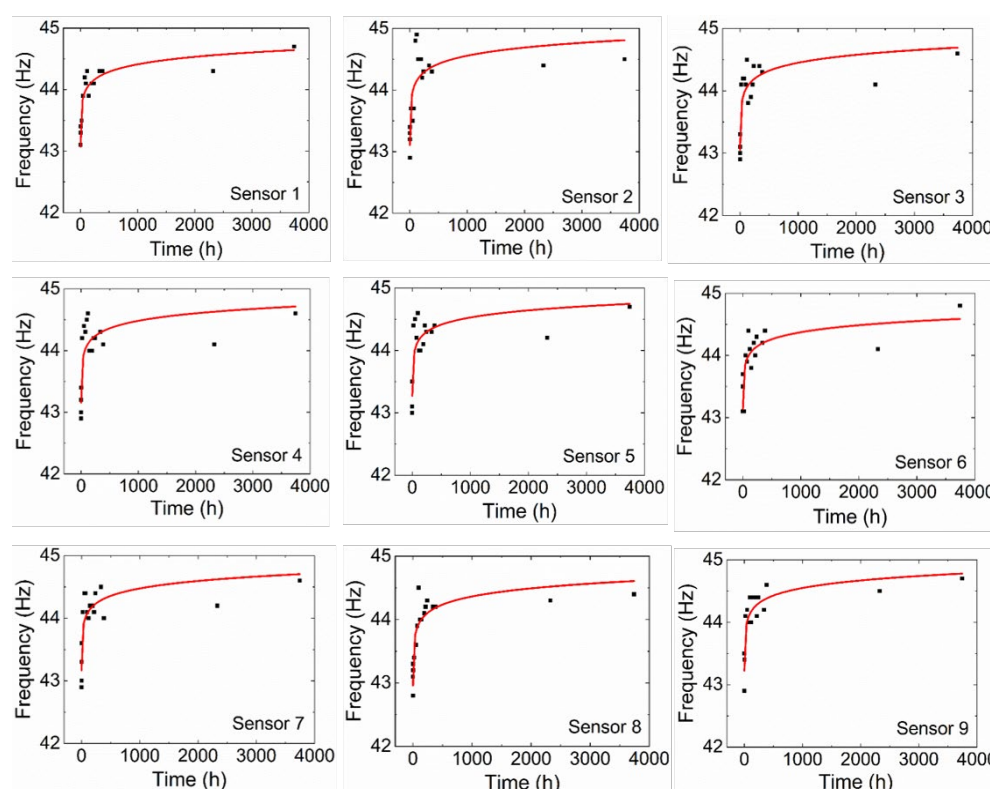
Figure 6. Natural frequency variation as a function of time of the corrosion process on the metal plate for the nine FBG-based sensors.

The frequency values found by the nine sensors, before the corrosion process and before gluing the NaCl solution container (PVC pipe section) to the plate, had an average equivalent to 44.0 Hz. After gluing the PVC pipe section to the plate, the frequency decreased by roughly 1 Hz. The experimental results of frequency variation as a function of corrosion action time for the nine sensors can be seen in Figure 6, in which the trend line that determines the behavior of the curve is defined by a logarithmic function.

The coefficient of determination and the curve equation shown in Figure 6 are presented below in Table 2.

According to Figure 6, the sensor responses present a nonlinear curve fit suitable for the predetermined needs. The instability of some sensors (particularly the ones with a lower coefficient of determination) and the offset between measurement values from different FBG sensors during the experiment can be explained by the fact that the FBGs were prestrained manually (with random strain) in the installation process, using duct tape to fix the fiber during the cure of the X120 adhesive, and consequently, relaxation of the fiber can occur. From the combination of results, it was possible to relate the plate calculated lost mass with the natural frequency variation. Thereunto, a q factor was estimated, equivalent to the ratio between the calculated lost mass and the area of the region subject to corrosion by the NaCl solution (from Section 4.1), equivalent to 18.09 cm^2 , for each of the determined times. These values can be seen in Table 3.

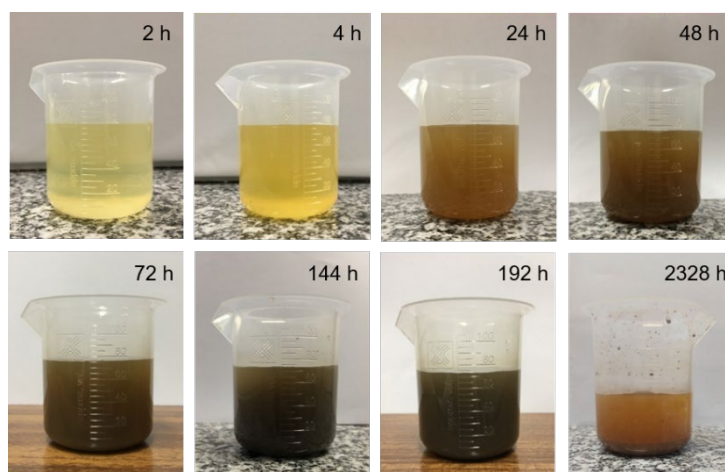
Figure 7. NaCl solution containing the steel plate corrosion products at different times.

Figure 7 presents photographs of the NaCl solution at different times of the corrosion process, with the darkening of the solution being notable. This phenomenon could be attributed to the presence of iron oxide in the collected samples, a product of the corrosion whose concentration increases in the initial moments. It was also observed that 2328 h after the application of the solution, the corrosive liquid seemed clearer, a fact that could be justified by the deposition of a greater number of particles from the corrosion process on the bottom of the container and with a larger size, after 30 min of stabilization time. At other times, these particles were dispersed, making the solution homogeneous. A greater precipitation of the solution was also observed as a result of its evaporation occurring during the corrosive process.

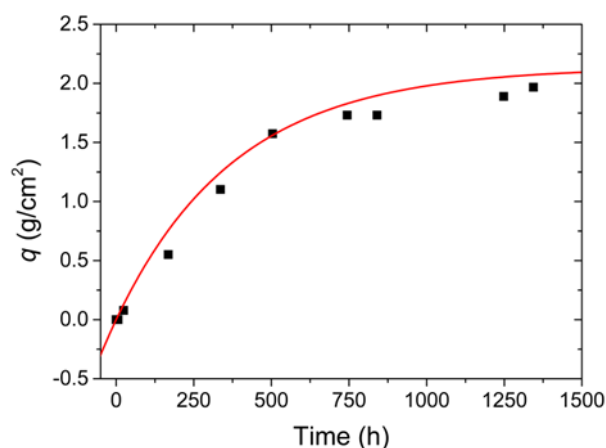
**Figure 8.** Variation of the calculated lost mass with the corrosion action time using Equation (7) (red line) and the obtained values from Table 3 (black squares).

The relationship between the q ratio values from Table 3 and corrosion time can be seen in Figure 8 (black squares). Since the q values for 3 and 6 h after the application of the solution were too small, they were adopted as null, whereas the value corresponded to 24 h after the application of the NaCl was adopted in the module, as 24 h after the application of the solution, corrosion became evident. The curve that represents the variation of the q factor in a function of time is obtained from Equation (6) and is given by the following equation:

Figure 8 also depicts the variation of the q factor given in Equation (7) (red line), and the nonlinear adjustment coefficient found between the curve and the values from Table 3 was equivalent to 98.23%.

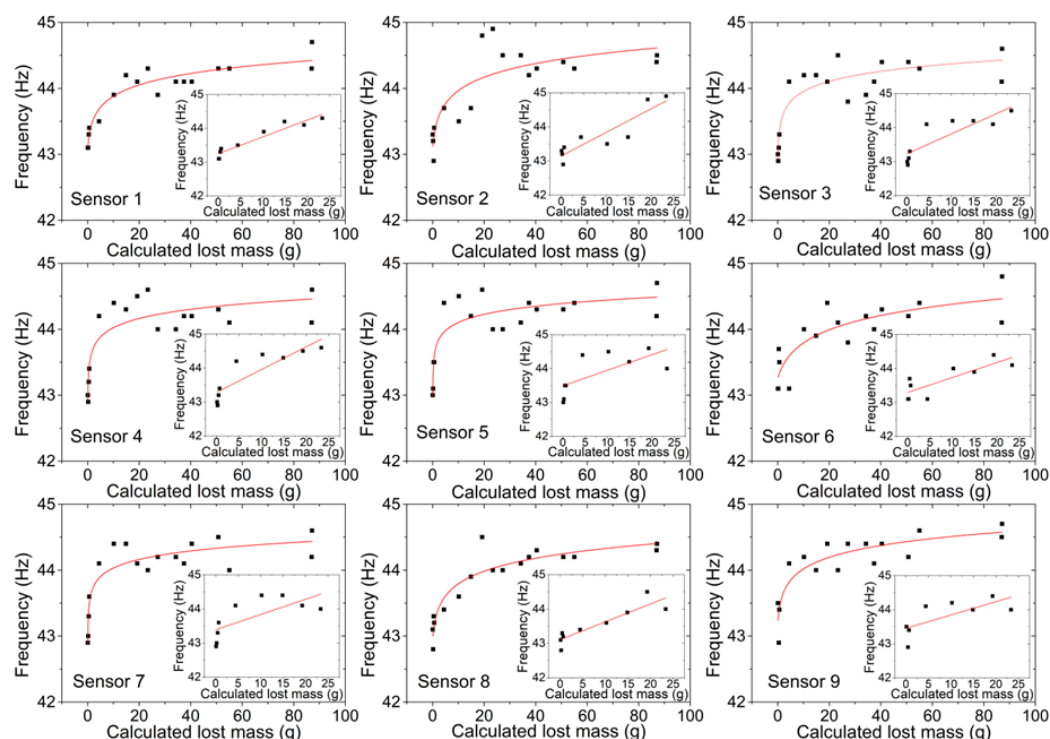
Figure 9. Relation between the calculated lost mass and the natural frequency of the plate obtained by each FBG sensor during the entire experiment. Inset images: Natural frequency variation as a function of the calculated lost mass for each FBG sensor during the initial 120 h.

The relationship between the measured natural frequency and the calculated lost mass (using Equation (8)) for each of the nine FBG sensors is presented in Figure 9.

A logarithmic function was defined for each one of the nine sensors relating the frequency and the calculated lost mass, and this correlation can be seen in Table 4. The linear adjustment for the first 120 h in which the corrosion process occurred is also presented in Table 4.

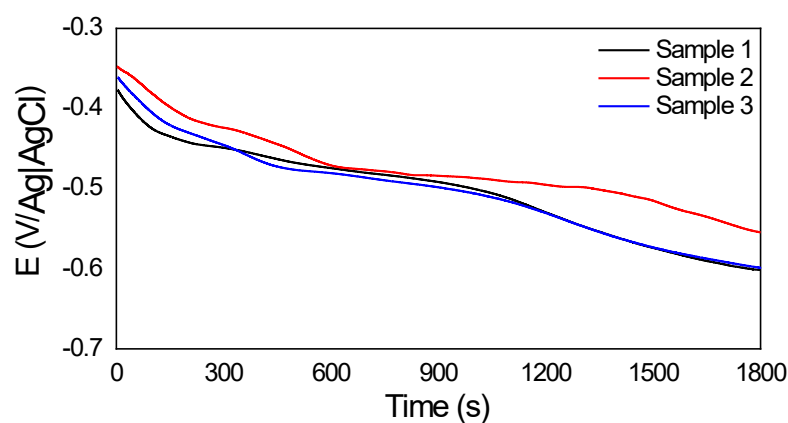
Figure 10. OCP curves for samples 1, 2, and 3 of 1020 carbon steel in NaCl solution.

Figure 10 contains the measurements obtained with the OCP for the three samples, showing that the reduction of the potential as a function of time occurs for all samples, indicating the presence of a corrosive process.

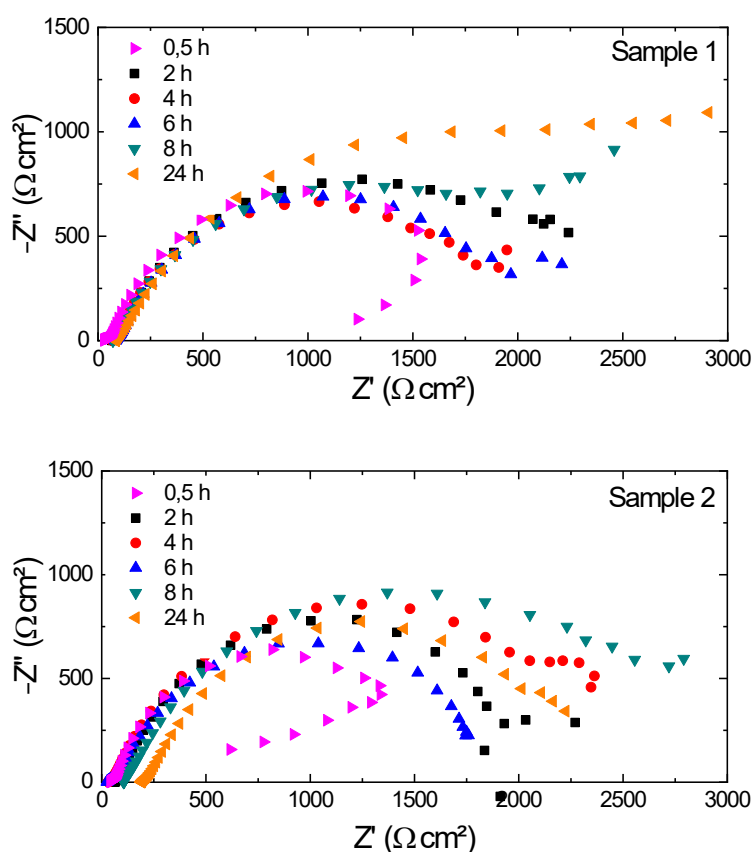
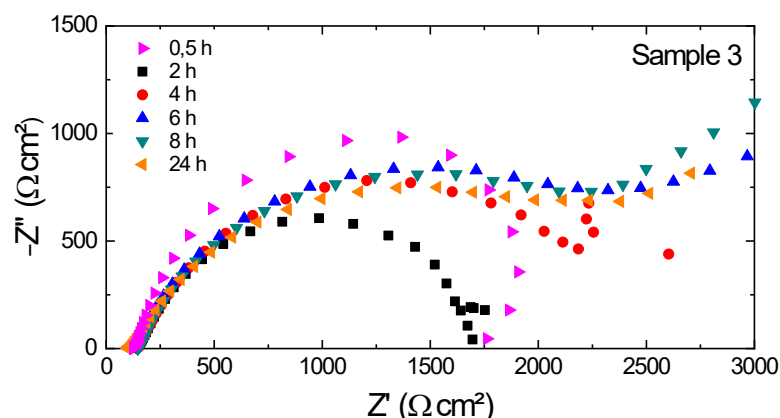
Figure 11. Nyquist diagrams for the three samples of 1020 carbon steel immersed in NaCl.

Figure 11 shows the Nyquist diagrams used to represent the electrochemical impedance results for the three samples.

The electrochemical impedance reaction may be suitable for an equivalent electrical circuit. Knowing that the horizontal axis of the Nyquist diagram represents the real impedance of the equivalent circuit and the vertical axis of the diagram corresponds to the imaginary (complex) impedance, it is possible, by the behavior of the semicircle, to infer whether the material is more or less resistant to corrosion, analyzing mainly the horizontal axis.

Thus, for sample 1, there was greater resistance with 24 h of immersion, followed by 8 h, 2 h, 6 h, 4 h, and 30 min. Concerning sample 2, the greatest resistance was obtained at 8 h, followed by 4 h, 24 h, 2 h, 6 h, and 30 min. For sample 3, the highest value found was also at 8 h, followed by 6 h, 24 h, 4 h, 30 min, and 2 h.
