# Remote Sensing Image Characteristics and Typical Area Analysis of Taiyuan Xishan Ecological Restoration Area

**Abstract:** The Taiyuan Xishan Ecological Restoration Zone is located in the west of Taiyuan City and belongs to the Xishan Coalfield. Due to the resource development activity of coal mining, which is caused by coal gangue accumulation, surface vegetation degradation, bare surfaces, and other phenomena, it is most common in this area. These have an impact on the surface ecology; however, after ecological restoration, the surface ecology has been greatly improved. There are many extraction models of vegetation coverage based on pixel dichotomy combined with multispectral vegetation index, but we believe that the combination of visible light vegetation index to construct models is relatively unexplored. The main problem of how to use the RGB image data in order to quickly and accurately extract vegetation coverage information is still under investigation and needs researchers' attention. In this paper, through selecting the vegetation coverage as the evaluation index of ecological restoration effect, a new RGB vegetation coverage CIVE calculation model is innovatively pro

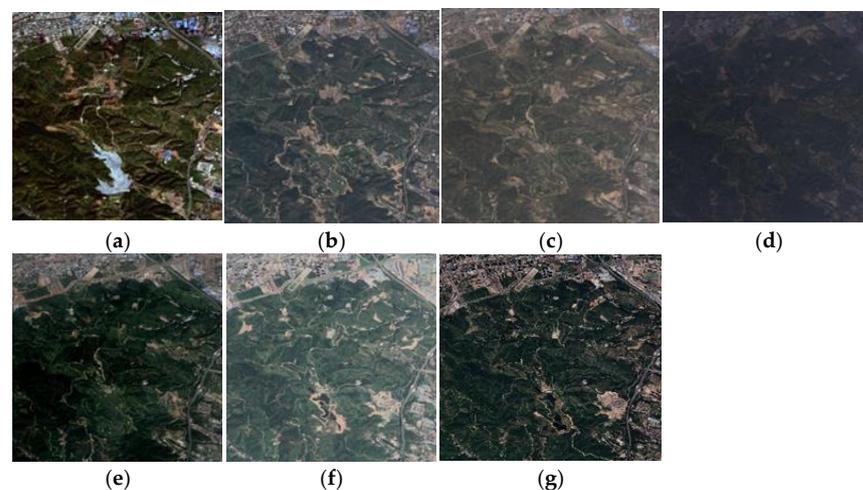
**Figure 2.** Remote sensing image of the study area. (a) 22 September 2010; (b) 17 August 2013; (c) 16 August 2015; (d) 15 September 2016; (e) 20 August 2017; (f) 20 July 2020; (g) 21 June 2021.

Combined with the existing image and governance policies of the Taiyuan Xishan Ecological Restoration Area, the treatment began in 2008. Moreover, the ecological governance goal of “laying the foundation in one year, achieving results in two years, changing the appearance in three years, and becoming a scenic spot in five years” was established, so the image analysis in 2010 and 2013 was selected. At the end of 2014, the goal of full coverage of suitable forest-barren mountains in the Taiyuan Xishan Ecological Restoration Area was completed, so the image analysis in 2015 was selected. From 2016 to the present, the Taiyuan Xishan Ecological Restoration Area has been restored by restoring the damaged surface caused by coal mining, garbage dump treatment, and other measures combined with the existing images, so the images from 2016, 2017, 2020, and 2021 were selected for analysis. We downloaded these seven issues of historical Google Earth high-resolution RGB remote sensing imagery in \*.tif format, as shown in Figure 2.

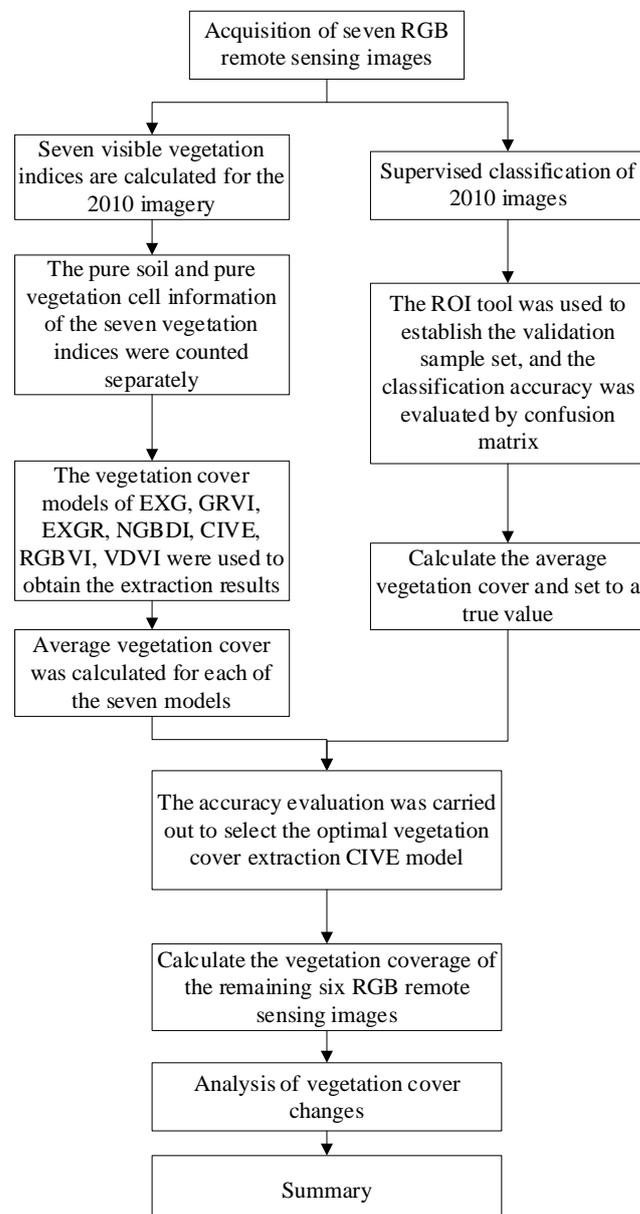
**Figure 3.** Vegetation coverage change analysis process.

In this study, seven issues of Google Earth's historical RGB remote sensing images were obtained. We calculated the seven visible light vegetation indices of the 2010 image and counted pure soil and pure vegetation cell information. In the next step, we calculated the excess green (EXG), the green–red vegetation index (GRVI), the excess green–excess red (EXGR), the normalized green–blue difference index (NGBDI), the color index of vegetation extraction (CIVE), the red–green–blue vegetation index (RGBVI), and the visible–band difference vegetation index (VDVI). In the subsequent step, we extracted the seven planting cover extraction models in order to obtain the extraction results and, then, calculated the average vegetation cover. Furthermore, the 2010 images were supervised and classified in order to obtain the average vegetation coverage. Then, accuracy verification was carried out, and the CIVE vegetation cover calculation model with the highest accuracy was selected. Finally, the CIVE vegetation coverage model was used to calculate the remaining six RGB remote sensing images, and the results were analyzed. The overall process and the flowchart of the proposed CIVE model are shown in Figure 3.

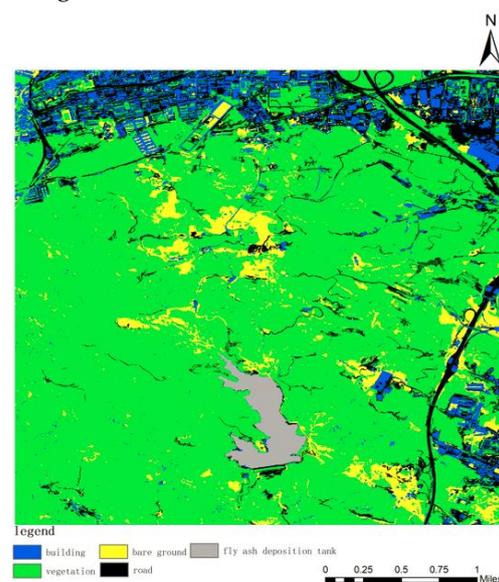
**Figure 4.** Results of image classification in 2010.

The images of the Taiyuan Xishan Ecological Restoration Area on 22 September 2010 were supervised and classified, and the classification map was obtained, as shown in Figure 4.

The verification sample set is established through the ROI tool, and the sample points marked by themselves are used as the real feature information. Furthermore, approximately 20 sample points are randomly marked for each of the five feature categories, for a total of 100 sample points, and then the classification accuracy is evaluated by using the confusion matrix tool. Subsequently, the total accuracy for the image classification results of the Taiyuan Xishan Ecological Restoration Area on 22 September 2010 is 98.68%, the Kappa coefficient (Kappa) is 98.68%, and the ROI coefficient is 98.18%. After analysis, it can be seen that the classification accuracy is greater than 98% and the classification results have high reliability.

By counting the total number of pixels in each feature category, the results are obtained as shown in Table 2.

Through calculating the proportion of vegetation pixels to total pixels, our evaluation and observation show that the average vegetation coverage is 0.737320, indicating that the overall vegetation coverage in this period is about 73.73%.

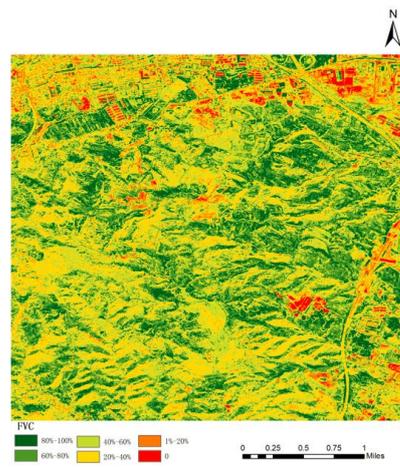
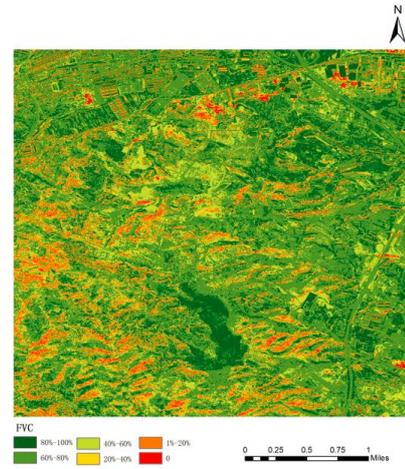
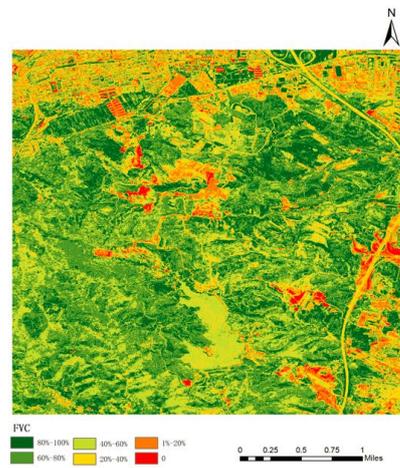
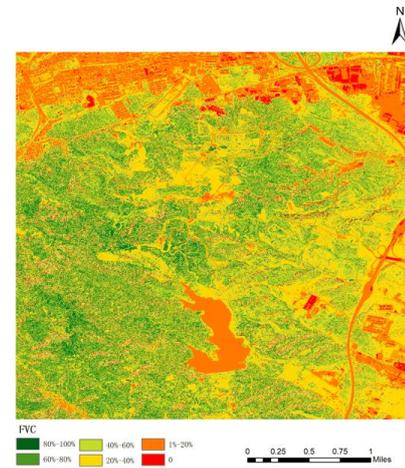
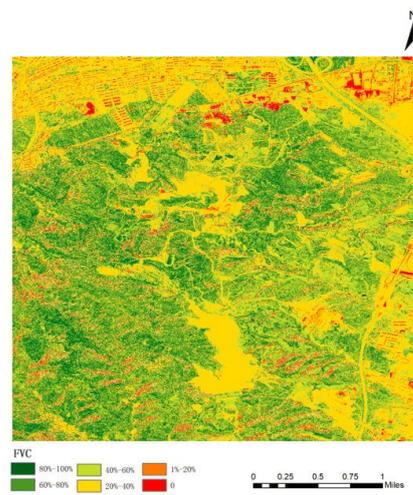
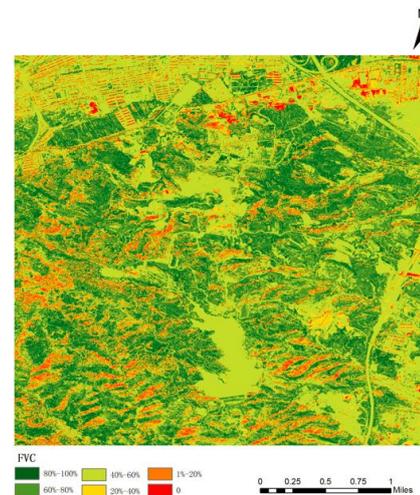
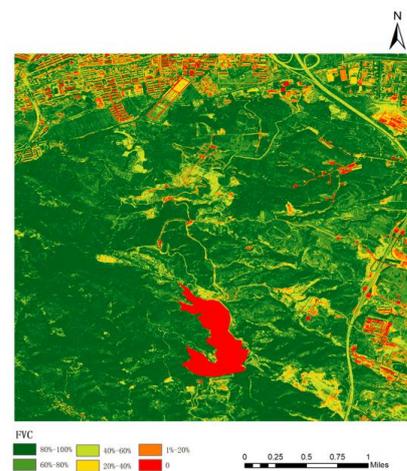
**Figure 5.** Extraction results of vegetation coverage for different models. (a) EXG; (b) GRVI; (c) EXGR; (d) NGBDI; (e) RGBVI; (f) VDV; (g) CIVE.

According to the vegetation cover extraction model and then according to the five-level classification standards of 0–20%, 20–40%, 40–60%, 60–80%, and 80–100%, the results of the vegetation cover map of the seven models on 22 September 2010 were obtained, as shown in Figure 5.

The average vegetation coverage was statistically obtained, and the accuracy evaluation of the vegetation coverage (Table 4) was carried out. From the outcomes, it can be seen, as shown in Table 4, that among the seven models, the vegetation coverage accuracy obtained by the CIVE vegetation coverage extraction model was the highest.

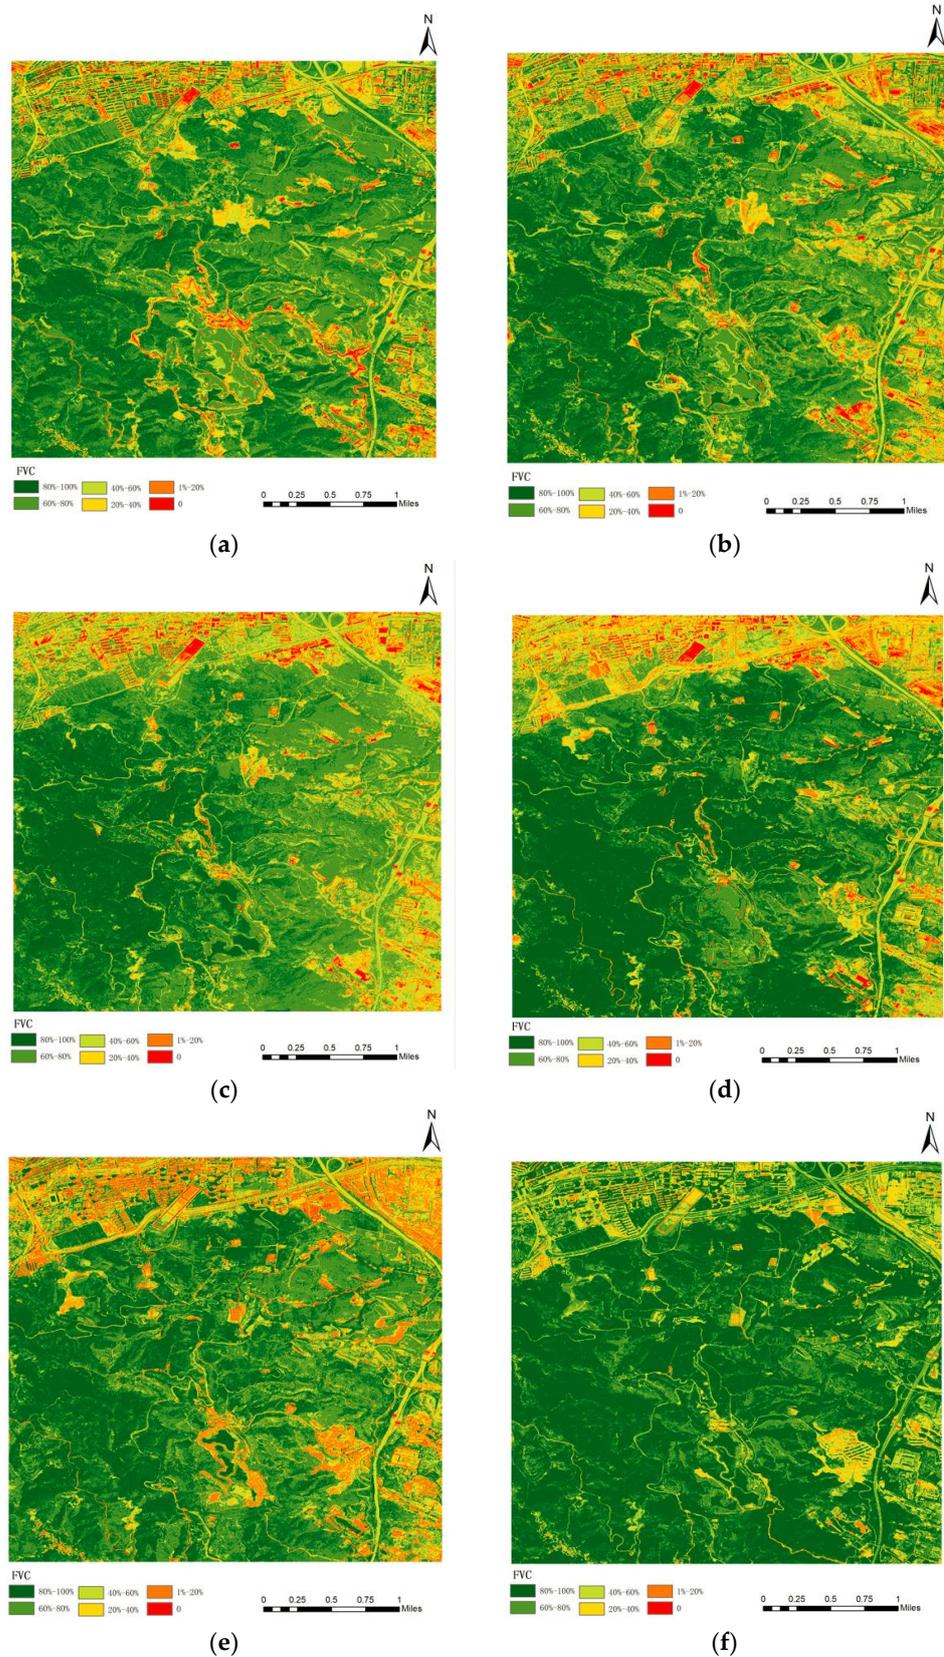
**Figure 6.** The CIVE model vegetation coverage extraction results. (a) 17 August 2013; (b) 16 August 2015; (c) 15 September 2016; (d) 20 August 2017; (e) 20 July 2020; (f) 21 June 2021.

According to the CIVE vegetation coverage extraction model, the results of the multi-stage vegetation coverage map were obtained according to the six-level classification criteria of 0, 1–20%, 20–40%, 40–60%, 60–80%, and 80–100%, as shown in Figure 6.

The spatial distribution of average vegetation coverage in 2010, 2013, 2015, 2016, 2017, 2020, and 2021 (Figure 6) was comprehensively compared, and the average vegetation coverage value (shown in Figure 7) showed a gradual increase trend. From the spatial distribution map of vegetation coverage, the area variation of vegetation coverage at different grades was different; that is, the area without vegetation cover and the area with low vegetation cover showed a downward trend, while the area with high vegetation cover showed an increasing trend. In general, the overall vegetation coverage of Taiyuan Xishan Ecological Restoration Area is high, and the continuous growth of high vegetation coverage areas indicates that the vegetation quality of Taiyuan Xishan Ecological Restoration Area is constantly improving, and the vegetation restoration trend is significant, which shows that the vegetation coverage in this area has improved significantly through government intervention and ecological restoration intervention.

Although the overall trend of improvement in Taiyuan Xishan Ecological Restoration Area is increasing, it can be found that the vegetation coverage in the southeast corner of the study area has deteriorated due to local changes. This is due to the destruction of the surrounding surface vegetation with the construction of a large number of buildings in the area, which indicates that when building residential and commercial land in the Taiyuan Xishan Ecological Restoration Area, appropriate attention should be paid to protecting the surrounding vegetation to avoid vegetation degradation, and at the same time, it is necessary to increase the greening of vegetation around the building land. This is also an important reference for the further restoration of the Taiyuan Xishan Ecological Restoration Area.

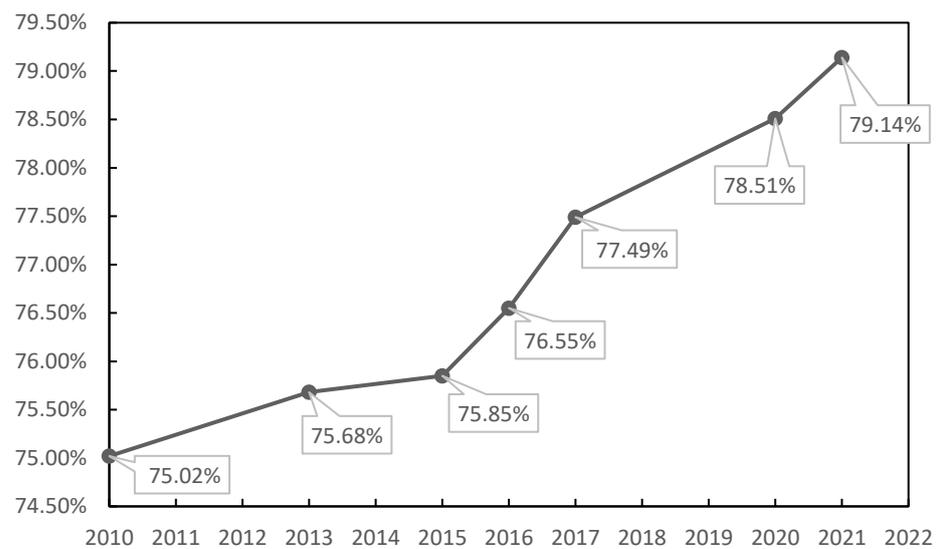
**Figure 7.** Line chart of vegetation coverage change in CIVE model.

According to the CIVE vegetation coverage model, the average vegetation coverage results obtained by the seven RGB image statistics are calculated, and a line chart of vegetation cover changes is plotted, as shown in Figure 7:

In the previous experiment, the vegetation coverage map of the seven RGB images was calculated according to the CIVE vegetation coverage model. In fact, this reflected the vegetation changes in the study area, and the vegetation coverage of most areas in the study area showed a year-by-year growth trend, from 75.02% in 2010 to 79.14% in 2021. It shows that the government's implementation of ecological restoration measures in the area has obvious results. The results of Figure 7 show that since 2010, the vegetation coverage began to slowly recover with the implementation of governance policies, increased the fastest in 2015–2017, and slowed down from 2017 to 2021 with the construction of building land in Taiyuan Xishan Ecological Restoration Zone.

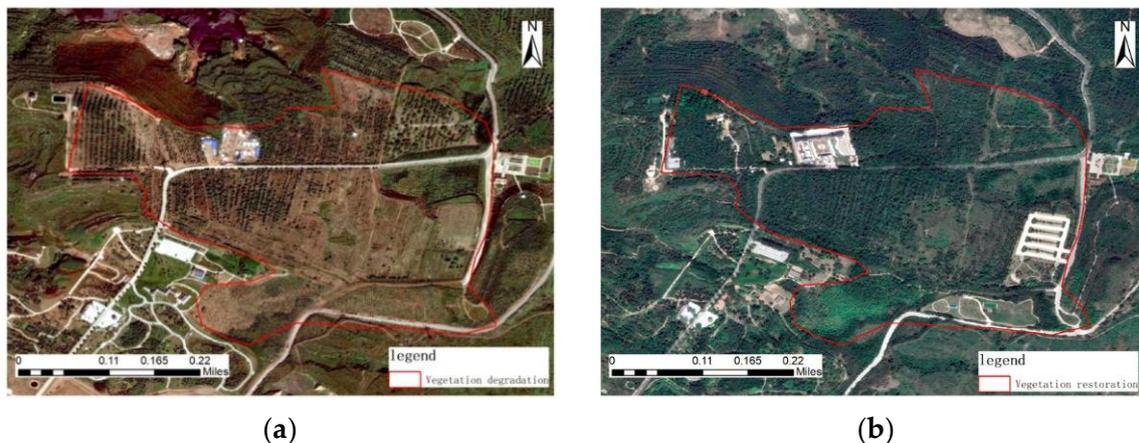
**Figure 9.** Remote sensing images before and after ecological restoration in the vegetation degradation restoration area. (a) before treatment; (b) after treatment.

Pre-governance imagery, geometric features: The sparse vegetation in the pre-governance image has multiple strips of roads and a piece of irregularly shaped bare land on which there are multiple rectangular buildings with regular geometric features. Color characteristics: The large areas of black-gray bare land with sparse dark green sparse vegetation, light blue, and white buildings above the light gray road. Texture characteristics: The sparse vegetation in this area is arranged in rows and rows, with obvious texture characteristics,

Post-governance image, geometric features: Multiple regularly arranged rectangular buildings on the original bare land are remediated as a campus, and a parking lot with regular geometry is built in the southeast of the area on top of the original sparse vegetation. Color characteristics: Large areas of black and gray bare land are treated with lush dark green vegetation and good vegetation. Texture characteristics: We observed that the distribution of features in this area is not obvious, and the texture is rough. Context characteristics: The area is predominantly densely forested vegetation, as shown in Figure 9.

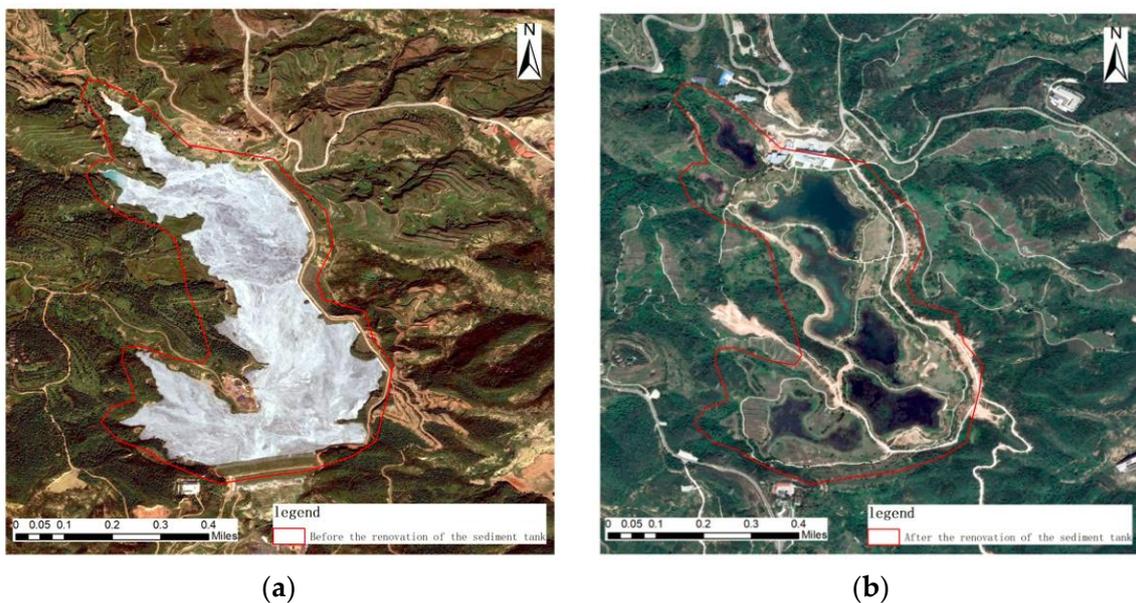
**Figure 10.** Remote sensing images before and after ecological restoration in the ash pool reconstruction area. (a) before treatment; (b) after treatment.

Pre-governance image, geometric features: The area is a sedimentary pool with irregular geometry and no obvious geometric features. There is a strip of dirt road around the sedimentary pool. Color characteristics: There is a large area of light gray sedimentary pooling in the image before treatment, surrounded by dark yellow bare land, accumulations of dark black gangue, and dark yellow roads with clear boundaries. Texture characteristics: The distribution of features in this area is not obvious, and the texture is rough. Context characteristics: The area is dominated by dark green woodland.

Post-treatment image, geometric features: After the treatment, irregular-block artificial ecological lakes were distributed in this area, and building land with regular geometric shapes was built in the upper part of the artificial lake. Color characteristics: The area is dominated by dark green artificial ecological lakes, surrounded by a low degree of light green vegetation, and some light gray roads are distributed with light yellow bare land. Texture characteristics: The distribution of features in this area is not obvious, and the texture is rough. Context characteristics: The area is predominantly densely forested vegetation, as shown in Figure 10.

For a long time, Shichagou, where the Taiyuan Xishan Ecological Restoration Zone is located, has been used as a fly ash sedimentary pond. The sedimentation pond covers an area of about 700 acres, and the total amount of fly ash dumped reached 11.2 million tons, causing serious pollution and damage to the local groundwater and surface vegetation. After geological investigation, expert demonstration, and safety assessment, the method of directly driving anti-slip piles into the rock layer for all dam bodies is first adopted to ensure the safety of the dam body. Since then, they have cleaned up 2 million cubic meters of fly ash, backfilled more than 1.5 million cubic meters of earth, treated the bottom of the lake using the most advanced geotextile leakage prevention technology, and finally turned the fly ash sedimentary pond into a green ecological lake.

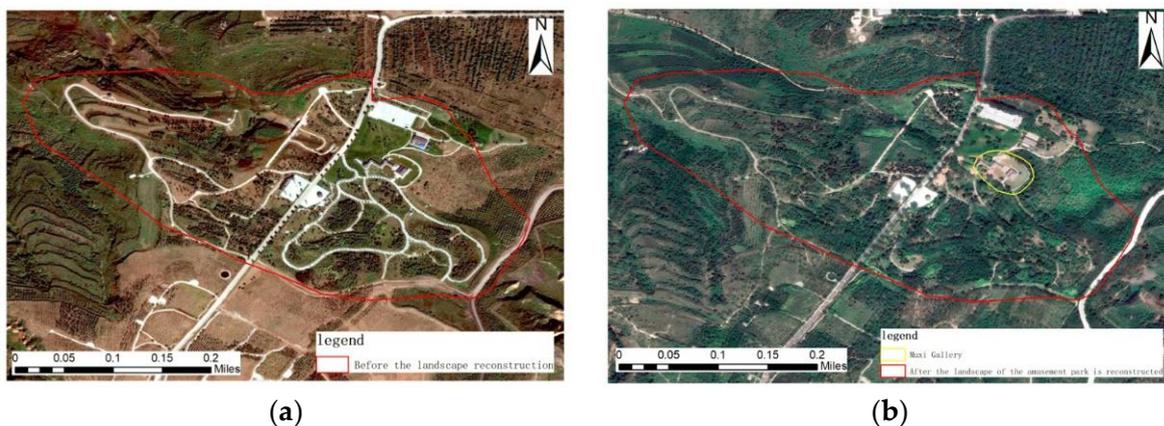
**Figure 11.** Remote sensing images before and after ecological restoration in the garden landscape reconstruction area. (a) before treatment; (b) after treatment.

the figures of the image, and the texture is rough. Context characteristics: The upper part of the area was covered by sparse the light-green vegetation before treatment, and the dark-yellow bare land was mainly below.

Post-governance imagery, geometric features: The block boundaries between vegetation areas are not obvious, striped roads are obscured by dense vegetation, and geometric features are not obvious. Color characteristics: The area is dominated by dark green woodland, where there are several rectangular gray-white buildings, and the roads are gray and distributed among the vegetation. Texture characteristics: There are no obvious regularities in the figures of the image, and the texture is rough. Context feature: The area in the image is predominantly densely wooded, as shown in Figure 11.

The landscape design of the park is mainly based on the topographic conditions of the low-lying land, which were caused by the original coal mining. Therefore, slope treatment is carried out to form a water feature, and “Muxi Gallery” pavilions and small bridges are built on the water’s surface. The water surface is divided by plants and treated with soft slopes. On the south side of the “Muxi Gallery,” a large area of lawns and small walking paths form a beautiful scenery, and in the landscape configuration, “joe, shrub, grass” combined with the stone landscape of classical gardens are combined to set up, and the surrounding pavilions, corridors, and bridges are combined to form a fresh and elegant environment. The amusement park occupies the largest area in the Wan Berlin Ecological Park, in which the spiritual “water” is used as the main center point of the landscape. Standing in the gallery, you can enjoy the fragrant beauty of the park [29].

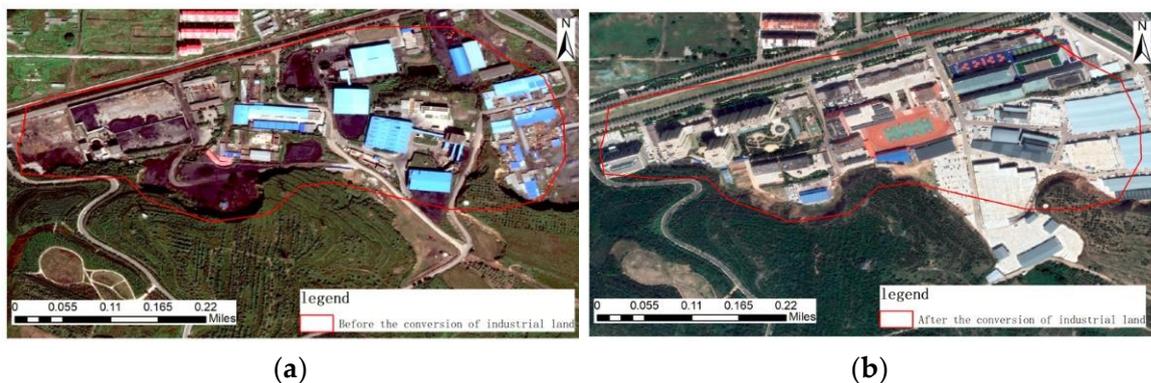
**Figure 13.** Remote sensing images before and after ecological restoration in an industrial land reconstruction area. (a) before treatment; (b) after treatment.

Pre-treatment image, geometric features: There are several rectangular shapes of plant buildings in the pre-treatment image, irregular lumpy gangue piles around the plant building, and multiple strip roads between the plant buildings and around the plant buildings. Color characteristics: The dark black gangue piles and black-gray bare land are distributed in a large area of light blue factory buildings, mixed with sparse green vegetation. Texture characteristics: There are no obvious regularities in the figures of the image, and the texture is rough. Context characteristics: The area in the image is dominated by light green vegetation with low coverage.

Post-treatment image, geometric features: The large area of factory buildings and gangue accumulation areas that existed in the post-treatment image disappeared and was replaced by building land, including residential areas, schools, transportation bureaus, etc. Color features: The color features are not obvious in the image after governance. Texture characteristics: There are no obvious regularities in the figures of the image, and the texture is rough. Context feature: The area in the image is predominantly green vegetation, as shown in Figure 13.
