# Structural Health Monitoring (SHM) Study of Polymer Matrix Composite (PMC) Materials Using Nonlinear Vibration Methods Based on Embedded Piezoelectric Transducers

**Abstract:** Nowadays, nonlinear vibration methods are increasingly used for the detection of damage mechanisms in polymer matrix composite (PMC) materials, which are anisotropic and heterogeneous. The originality of this study was the use of two nonlinear vibration methods to detect different types of damage within PMC through an in situ embedded polyvinylidene fluoride (PVDF) piezoelectric sensor. The two used methods are nonlinear resonance (NLR) and single frequency excitation (SFE). They were first tested on damage introduced during the manufacturing of the smart PMC plates, and second, on the damage that occurred after the manufacturing. The results show that both techniques are interesting, and probably a combination of them will be the best choice for SHM purposes. During the experimentation, an accelerometer was used, in order to validate the effectiveness of the integrated PVDF sensor.

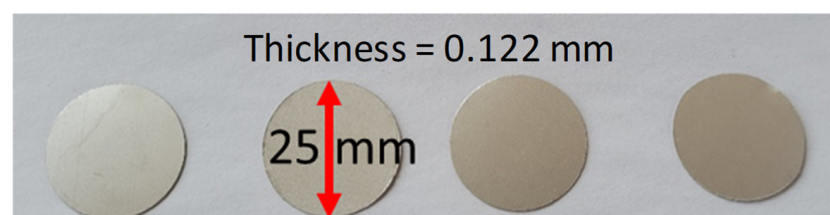
**Figure 1.** PVDF transducers cut into a disk shape.

These PVDF transducers were integrated into the middle plane of the PMC plates (between plies 3 and 4) using a liquid resin infusion (LRI) manufacturing method. The wiring was made from tinned copper wires of 210  $\mu\text{m}$  diameter, and the static capacitance was tested for each of them before and after the manufacturing, to control if they were still usable. It was tested with an LCR bridge (HM8118 from Rohde & Schwarz) and the PVDF was considered usable if the static capacitance was similar before and after the LRI (around 500 pF for this diameter).

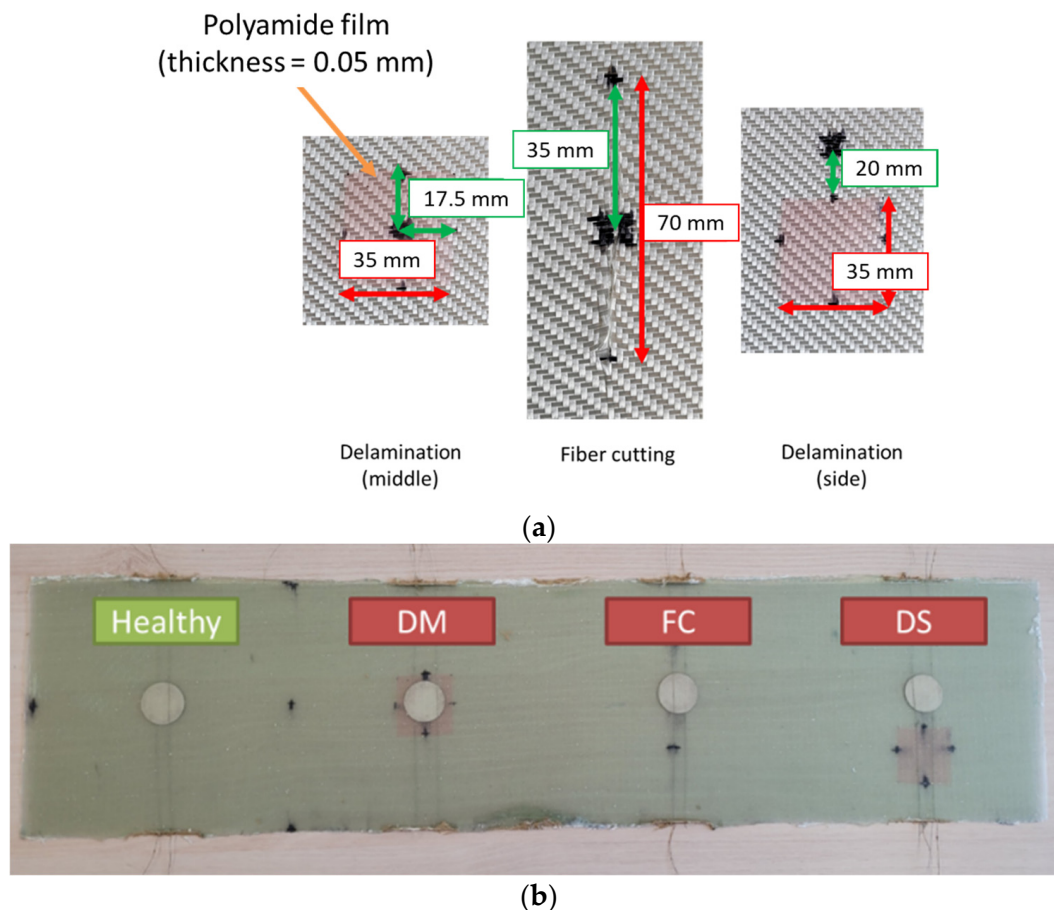
**Figure 2.** (a) Damage insertion and (b) manufactured plate before cutting.

In order to reduce the number of LRI operations, one big plate was manufactured with the dimensions of  $620 \times 150 \times 1.5 \text{ mm}^3$  and then cut into four  $150 \times 150 \times 1.5 \text{ mm}^3$  plates. One area of  $150 \times 150 \text{ mm}^2$  was used as a healthy area while three others with the same dimension were used to create damage. Two delaminations were introduced by inserting  $35 \times 35 \times 0.05 \text{ mm}^3$  polyamide film between plies 3 and 4 at two different positions: in the middle below the PVDF sensor (named DM) and on the side between the middle and the edge of the plate (named DS). One fiber cutting of 70 mm was made on the middle axe of the third ply. Each area has its integrated PVDF sensor in the middle plane (Figure 2).

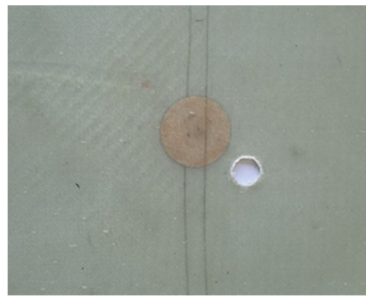
**Figure 3.** Smart PMC plate with a 10 mm diameter hole.

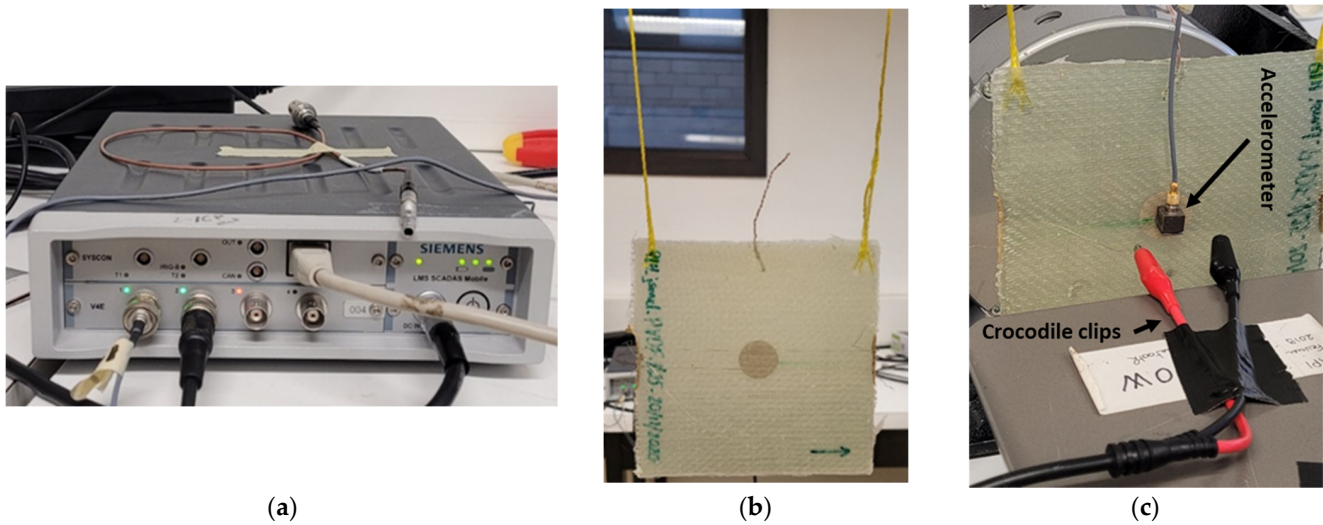
**Figure 4.** (a) Signal analyzer, (b) suspended plate, (c) crocodile clips and accelerometer.

To perform the vibration experimentation, the structure was suspended with two elastic threads in order to approximate the free-free boundary condition. The effectiveness of the PVDF as a vibration sensor has been tested and validated through several studies [33,34]. This work compared the results with those obtained by an accelerometer glued in the same position as the PVDF but on the surface. The output voltage of the PVDF was caught by two crocodile clips and connected to a signal analyzer (*Siemens*—LMS Scadas mobile 01). The equipment can be observed in Figure 4. This kind of analyzer directly manages the input and output data (fast Fourier transform (FFT) is automatically processed to visualize the result in the frequency domain) and allows observing the results in the Testlab software. It can also provide an electrical signal (signal generator). An electromechanical shaker (*Brüel & Kjaer*—Modal exciter type 4824) was used to excite the structure using a thin rod of 1mm diameter glued on the surface, in order to minimize surface excitation. In addition to this equipment, an amplifier (*Brüel & Kjaer*—Power Amplifier Type 2732) was used to provide the electrical signal delivered by the analyzer to the shaker. Figure 5 schematizes the experimental device used in the vibration tests.

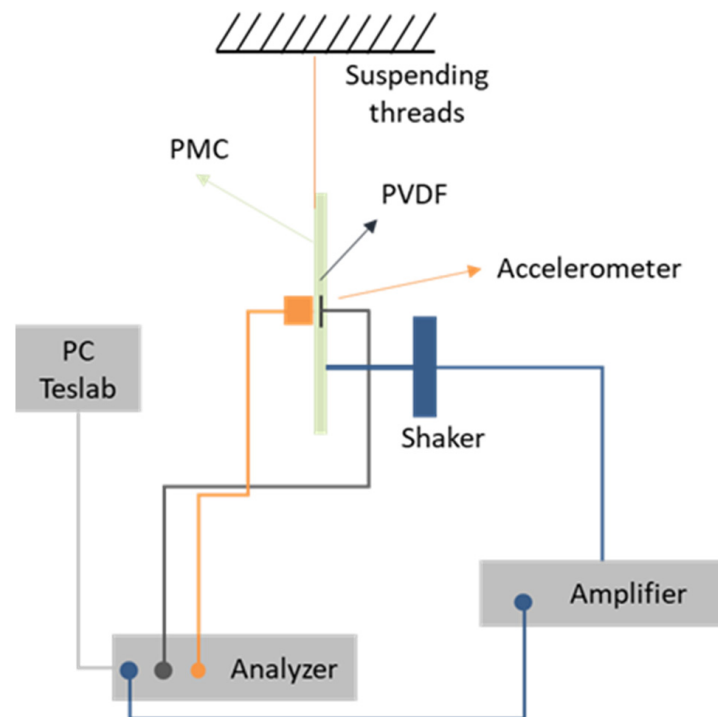
**Figure 5.** Schematic of the setup used for nonlinear vibration analysis.

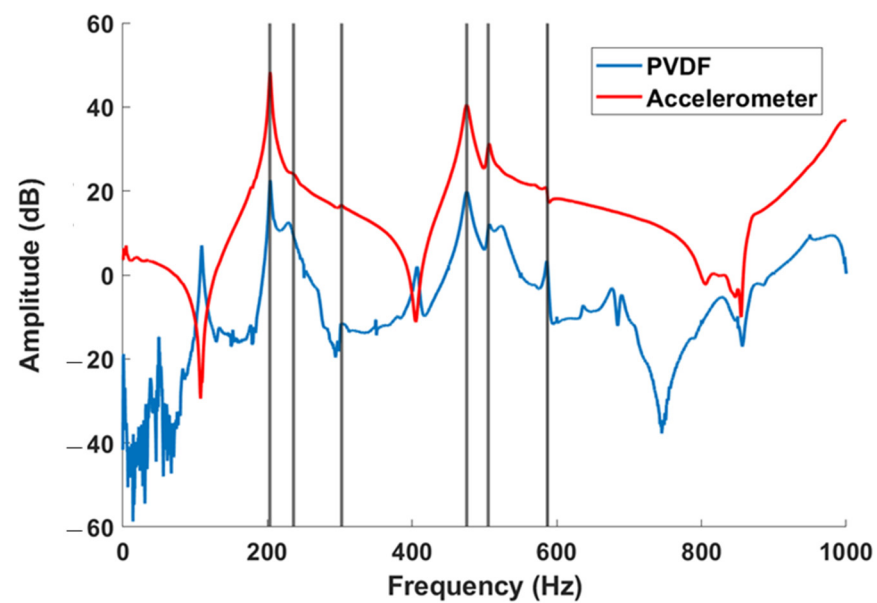
**Figure 6.** PVDF and accelerometer FRFs from impact hammer test; vertical lines represent some natural frequencies.

To validate the effectiveness of the PVDF, a hammer (*Brüel & Kjaer*—Impact hammer type 8206) was used to make the structure vibrate from a hit at a random location. The hammer has a cell force at its tip to store the input signal into the analyzer. By analyzing the frequency response function (FRF), the comparison between the two sensors showed a maximum deviation of tested natural frequencies (vertical lines) of 0.015% over the frequency range of 100–1000 Hz (Figure 6). The PVDF output was very noisy under 100 Hz. This test validated the use of the PVDF as a vibration sensor for the following experimentations.

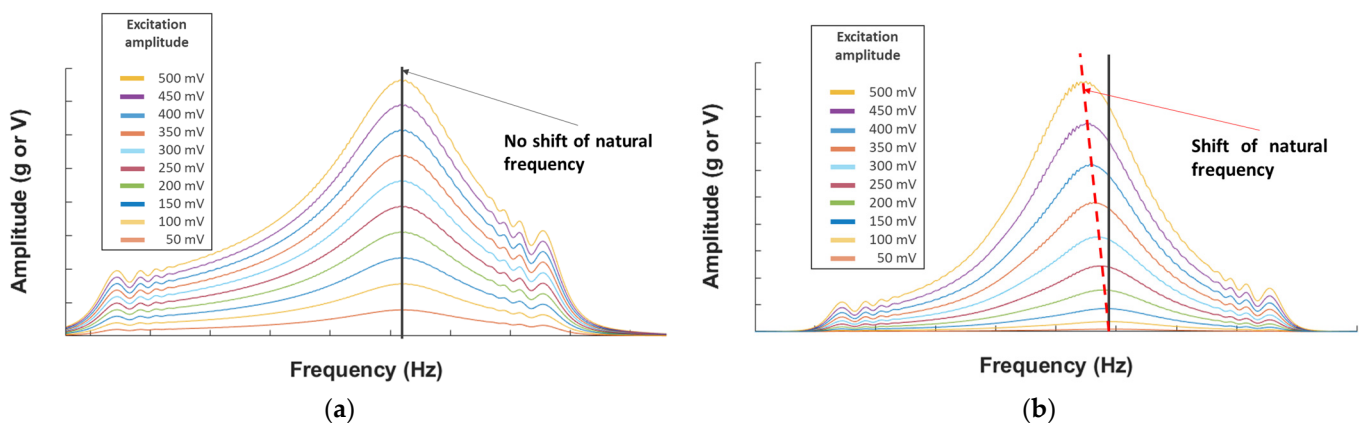
**Figure 7.** (a) Example of the NLR method for a healthy structure and (b) for a damaged structure.

In this technique, the structure is excited around its natural frequencies, with a sweep signal and increasing amplitude (for example from 100 mV to 1 V every 100 mV step). The natural frequency will be the same for each amplitude of excitation for an intact structure while a shift in frequency will be observed for a damaged structure (Figure 7). Several modes must be investigated in order to visualize which modes are influenced by the damage. This technique has been well studied and used in [20,28,29,35]. Some damage indicators and their combination can be used, such as the frequency shift ( $f_i - f_0$ ) and the sequential frequency shift ( $f_i - f_{i-1}$ ).

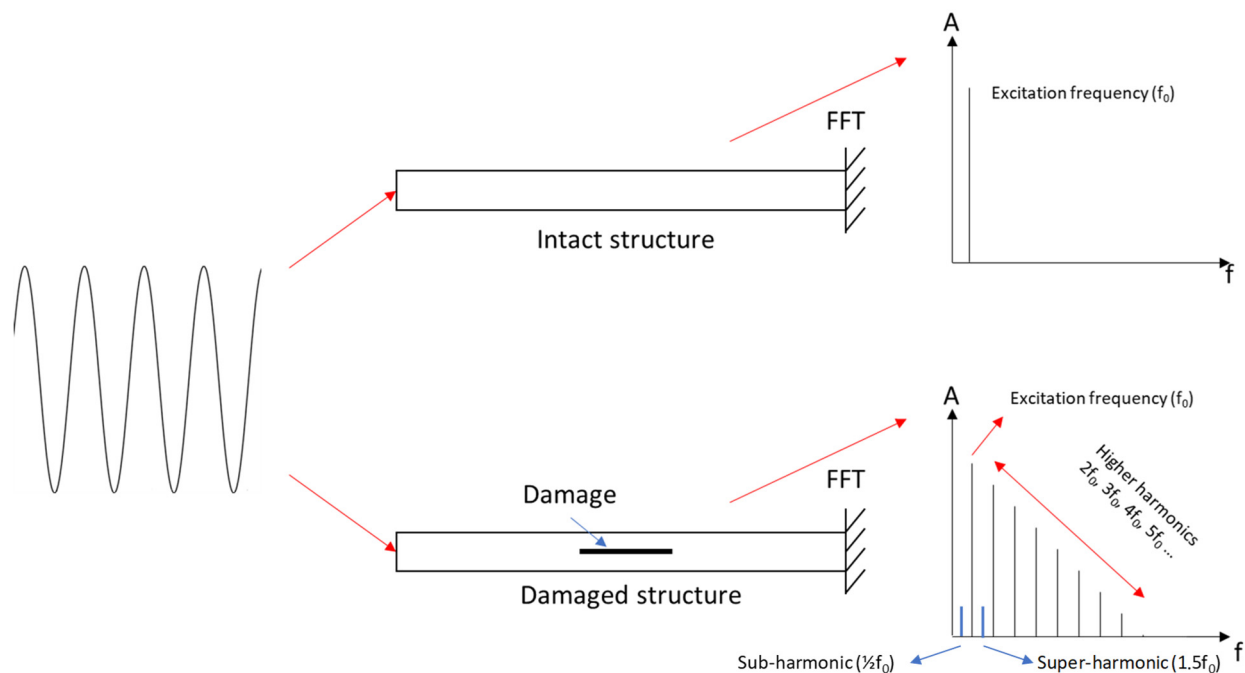
**Figure 8.** Sub- and super-harmonics generation method (adapted from [37]).

The sub- and super-harmonics generation method allows exciting the structure with a harmonic signal and observing only fundamental frequencies in the output of the healthy structure and a generation of sub- and super-harmonics in the damaged structure. Some researchers [36,37] used natural frequencies of the structure or a ratio of these natural frequencies (such as  $1/3$ ,  $1/2$ ,  $2$ , etc.) as the frequency of excitation. In addition, two kinds of super-harmonics can be observed: the integer super-harmonics ( $2$ ,  $3$ ,  $4$ , etc.) and the super-harmonics built from a combination of the sub-harmonics and the integer super-harmonics ( $1.5$ ,  $2.5$ ,  $3.5$ , etc.) (Figure 8).

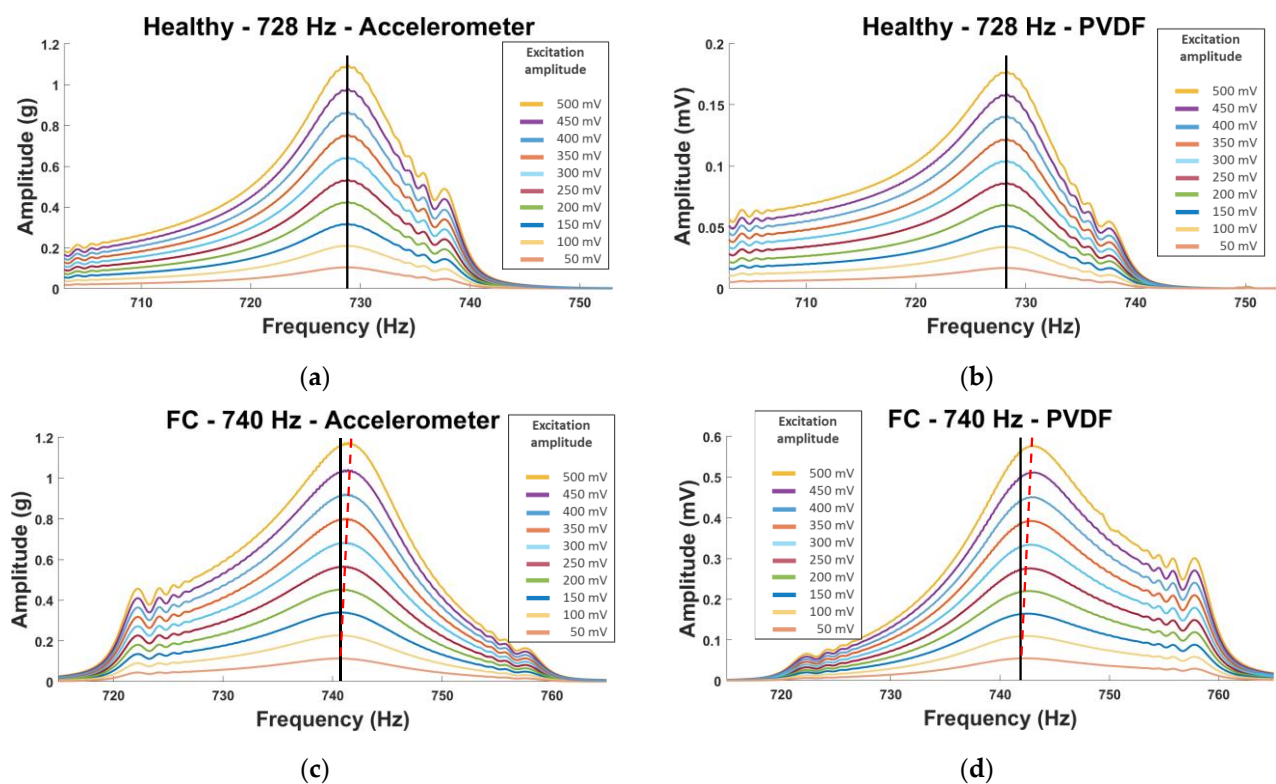
**Figure 9.** Amplitude vs. frequency curves for (a,b) healthy and (c,d) FC plates using the NLR method. (a,c) Accelerometer and (b,d) PVDF sensors.

On these curves, we can observe that the FC plate shows a small shift in frequency (red dotted line) for both sensors, while this is not the case for the healthy plate (black line). However, it is not a clear shift, and the visualization is not optimal. This is why the choice of the frequency shift parameter as a damage indicator (DI) has been made and visualized on histograms: frequency shift =  $(f_i - f_0)$ . ( $f_i$  corresponds to the natural frequency of the  $i$ -th excitation and  $f_0$  to the initial one (here 50 mV)).

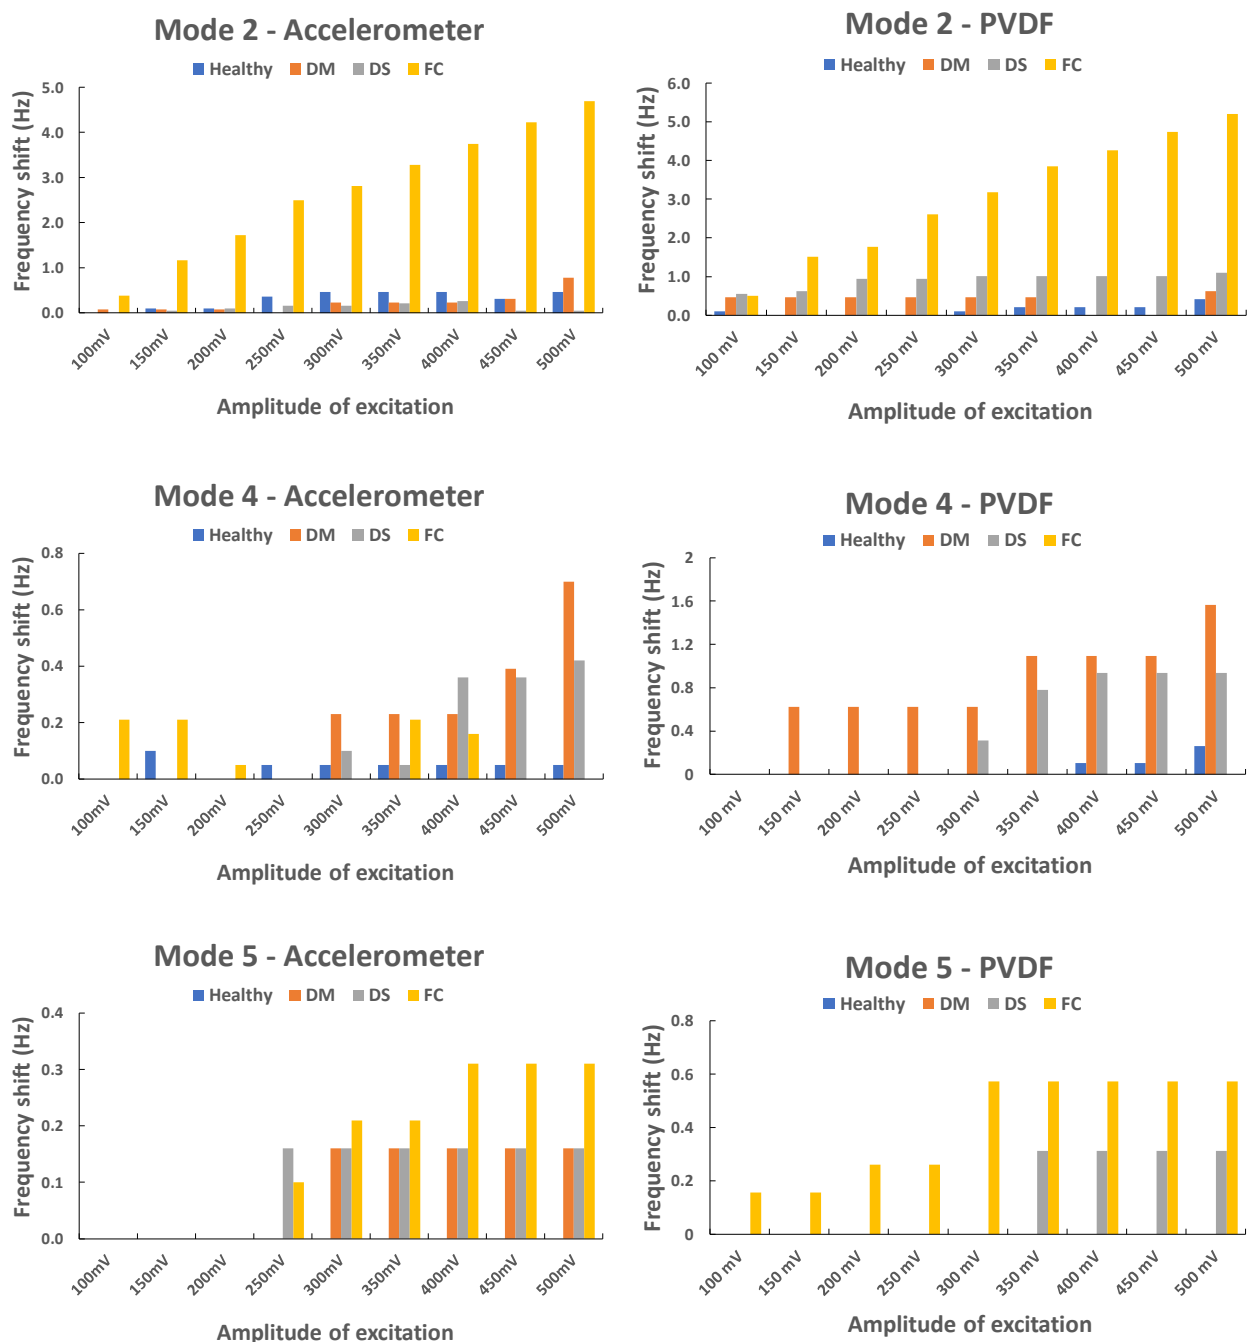
Figure 10. Frequency shift vs. amplitude of excitation: second, fourth, and fifth natural frequencies.

The DM, DS, and FC plates were compared with the healthy plate. However, the healthy plate for the first natural frequency showed a big shift, this is why this mode was not used for the comparison. Three modes (second, fourth, and fifth) showed interesting shifts (Figure 10).

The fiber cutting (FC plate) seemed to influence the vibration of the second and the fifth modes while the two delaminations (DM and DS plates) seemed to influence the fourth mode, especially DM. The second mode was investigated for the FC plate, and an interesting phenomenon was observed. Two peaks are observable for this mode with one showing a big shift in frequency, a loss around 5 Hz (Figure 11); this phenomenon is observable for both sensors and every repeated test. The second peak is observable for the sixth level of excitation (300 mV) and higher, which means the plate does not show this nonlinear behavior at a low amplitude of excitation.

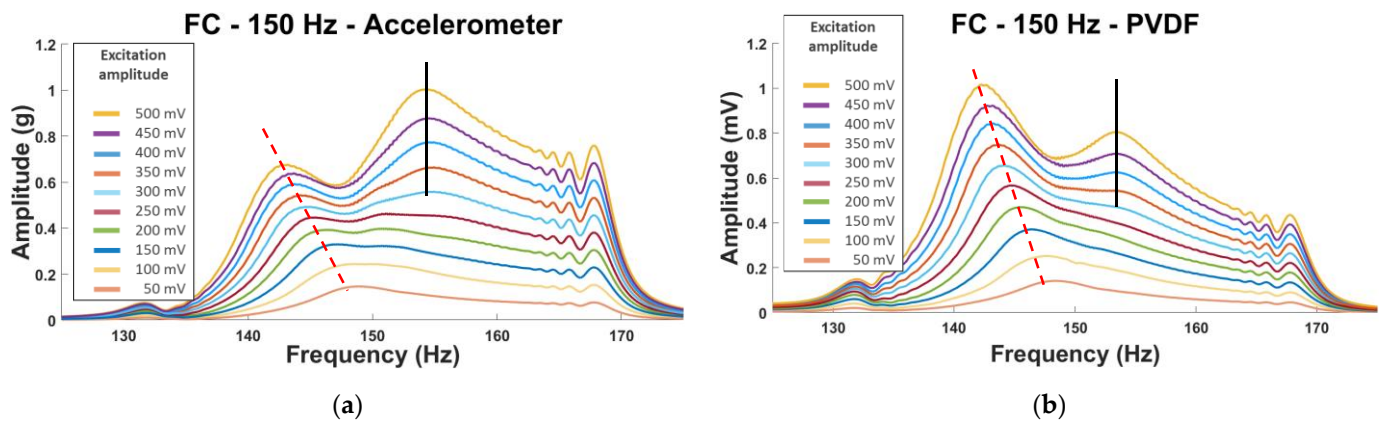
**Figure 11.** Second natural frequency of the FC plate using the NLR method. (a) Accelerometer and (b) PVDF sensor.

In the second mode, the vibration bends the plate area inside the blue “circle” in Figure 12, which corresponds to the fiber cutting location. This could create the nonlinearities in the vibration of the plate observed in Figure 11.

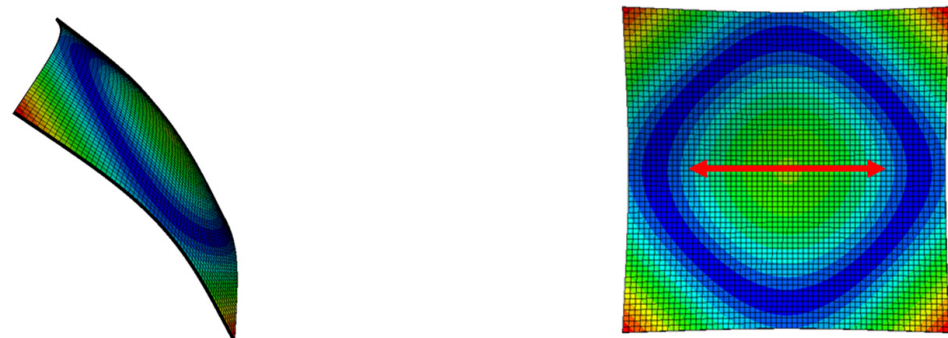
**Figure 12.** Second-mode shapes of a  $150 \times 150 \times 1.5 \text{ mm}^3$  plate from Abaqus software. (Red arrow = FC).

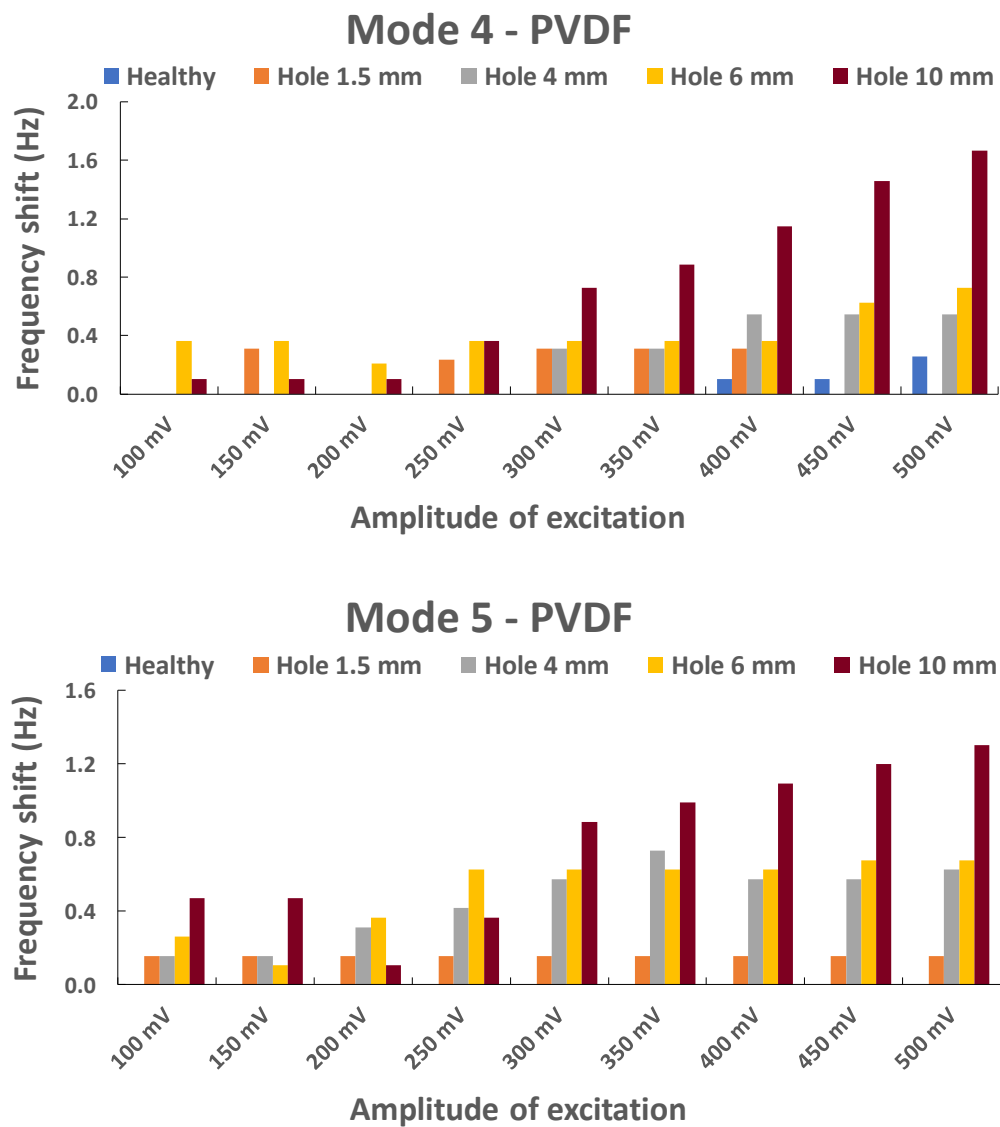
**Figure 13.** Evolution of the frequency shift in the fourth and fifth natural frequencies with an increasing hole diameter.

We recall that for this plate with incremental holes (1.5, 4, 6, and 10 mm), we will only study the response of the PVDF. Except for the first natural frequency, all the modes showed sensitivity to the presence of damage when it was greater than 4 mm in diameter. However, the fourth and fifth natural frequencies produced the best results (Figure 13). The vibration frequency offset increases with the increase of the excitation amplitude and the hole diameter, to reach significant values from 300 mV. It is clear that the 3 diameters of 4, 6, and 10 mm generate more vibration frequency shifts than that of 1.5 mm, especially in the 5th mode.

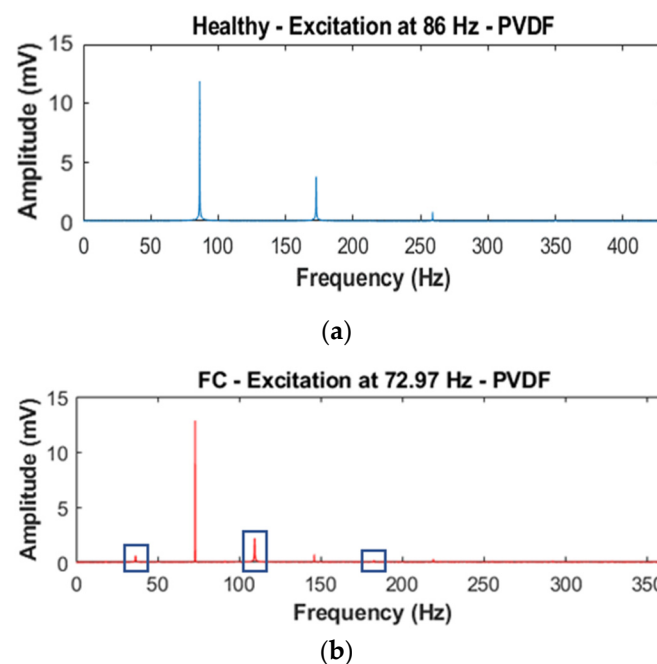
Figure 14. Amplitude vs. frequency curves for (a) healthy and (b) FC plates for the SFE method.

We observe the generation of sub- and super-harmonics on the amplitude of the output (g or V according to the sensor used) versus frequency curves for each mode and plate. Similarly, with the previous method, the visualization using this type of curve is not optimal: Figure 14 represents some peaks with very small amplitudes. This is why we propose to use the ratio  $R_{\text{peak}} (\%) = 100 \times A_{\text{peak}} / A_{\text{fundamental}}$  as a DI where  $A_{\text{peak}}$ : amplitude of the peak;  $A_{\text{fundamental}}$ : amplitude of the fundamental. The first thing we noticed is that the healthy plate also showed integer super-harmonics ( $2f_{\text{fundamental}}$ ,  $3f_{\text{fundamental}}$ , etc.), which means this cannot be used as a DI, but the sub-harmonics and their combination showed interesting results (on the FC plate curve in Figure 14, we can see these phenomena framed in blue). It is not uncommon to observe a difference between the accelerometer and PVDF when using this technique. As both do not catch the same output (voltage and acceleration), the amplitude will be different according to the frequency.

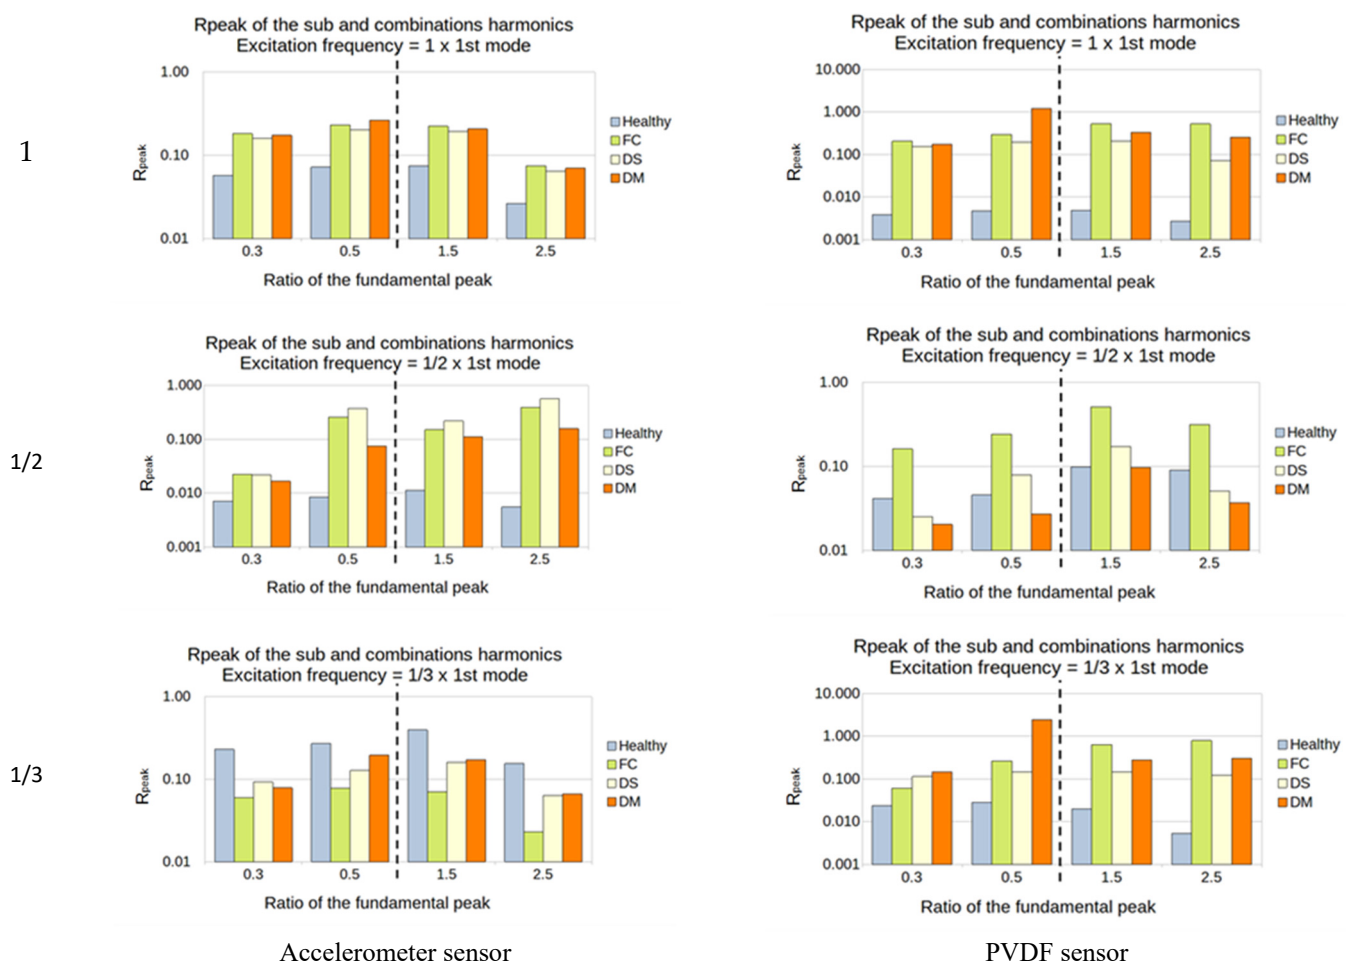
**Figure 16.** First natural frequency and its ratio of 1, 1/2, and 1/3 as the frequency of excitation.

Except for the accelerometer sensor for the excitation of 1/3, the ratio for all the other tests showed a high sensitivity to every type of damage and every sub- and super-harmonic observed, for the first natural frequency (Figure 16).

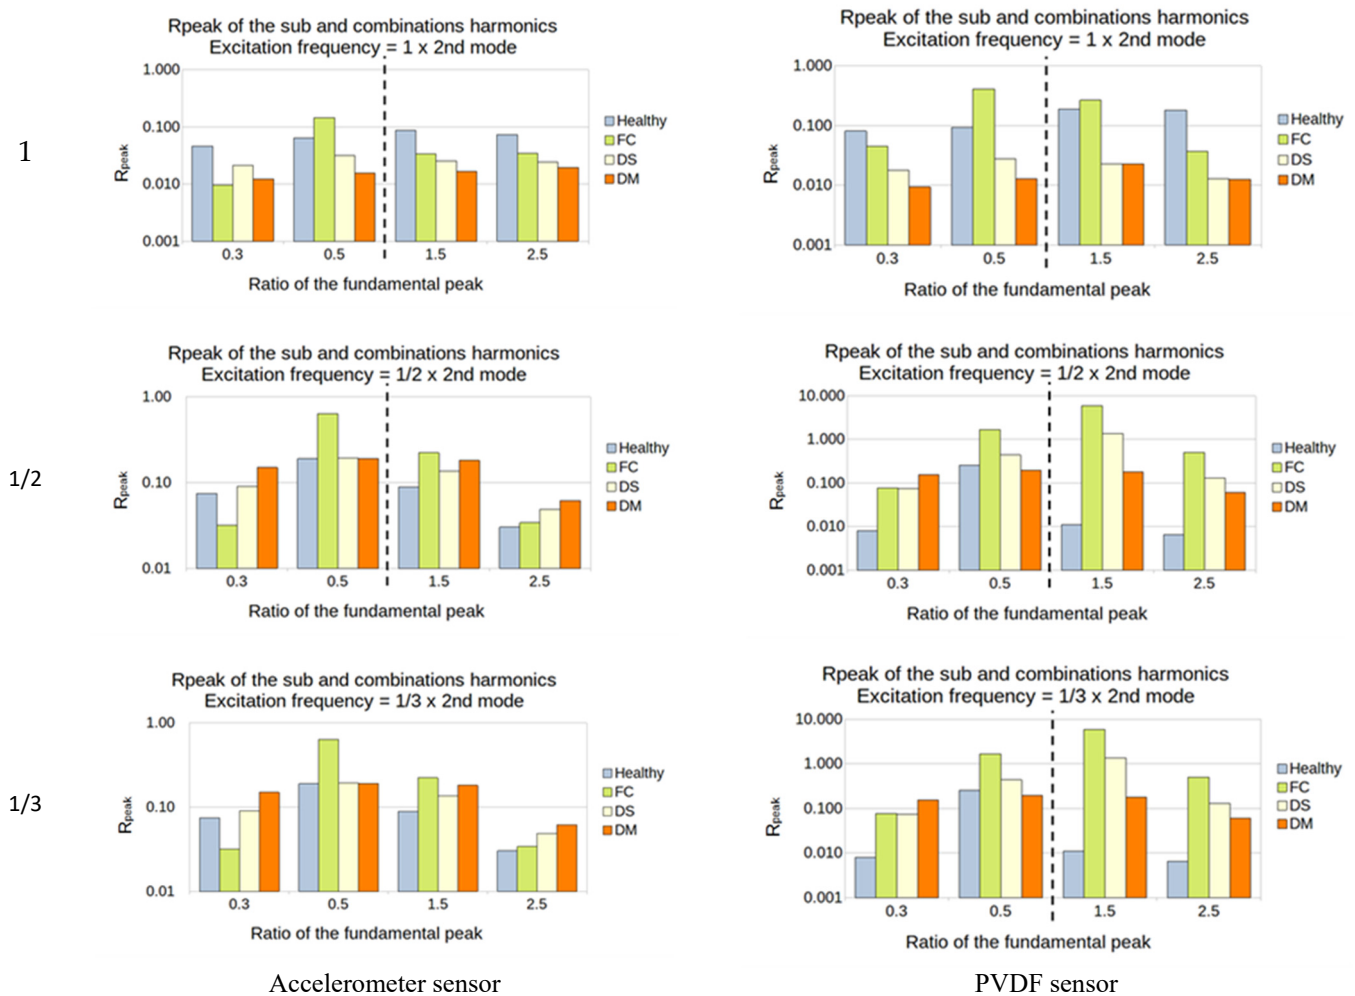
**Figure 17.** Second natural frequency and its ratio of 1, 1/2, and 1/3 as the frequency of excitation.

For the second natural frequency, the difference between healthy and damaged plates is smaller; indeed, only the FC plate showed a high sensitivity in almost all the cases. Another interesting thing is that the super-harmonics of 1.5 and 2.5 provide good results for the excitation frequencies of 1/2 and 1/3 for both sensors. No interesting results came out from the ratio of 1 (Figure 17).

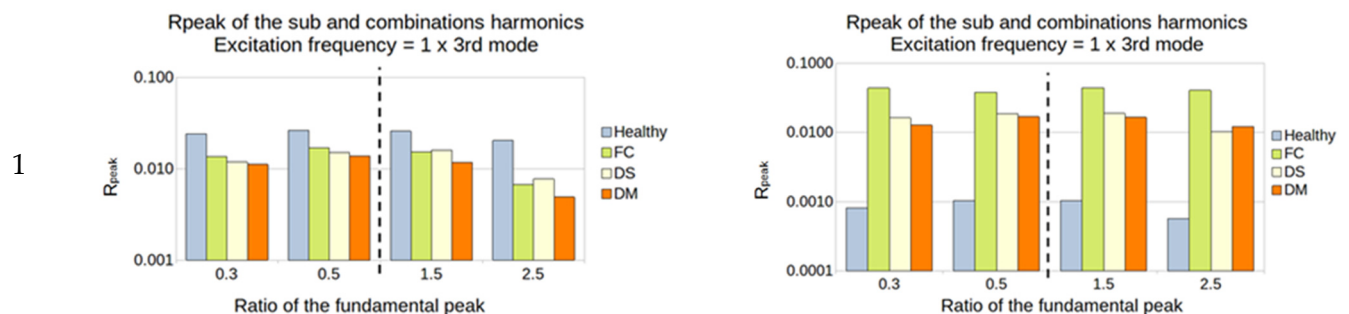
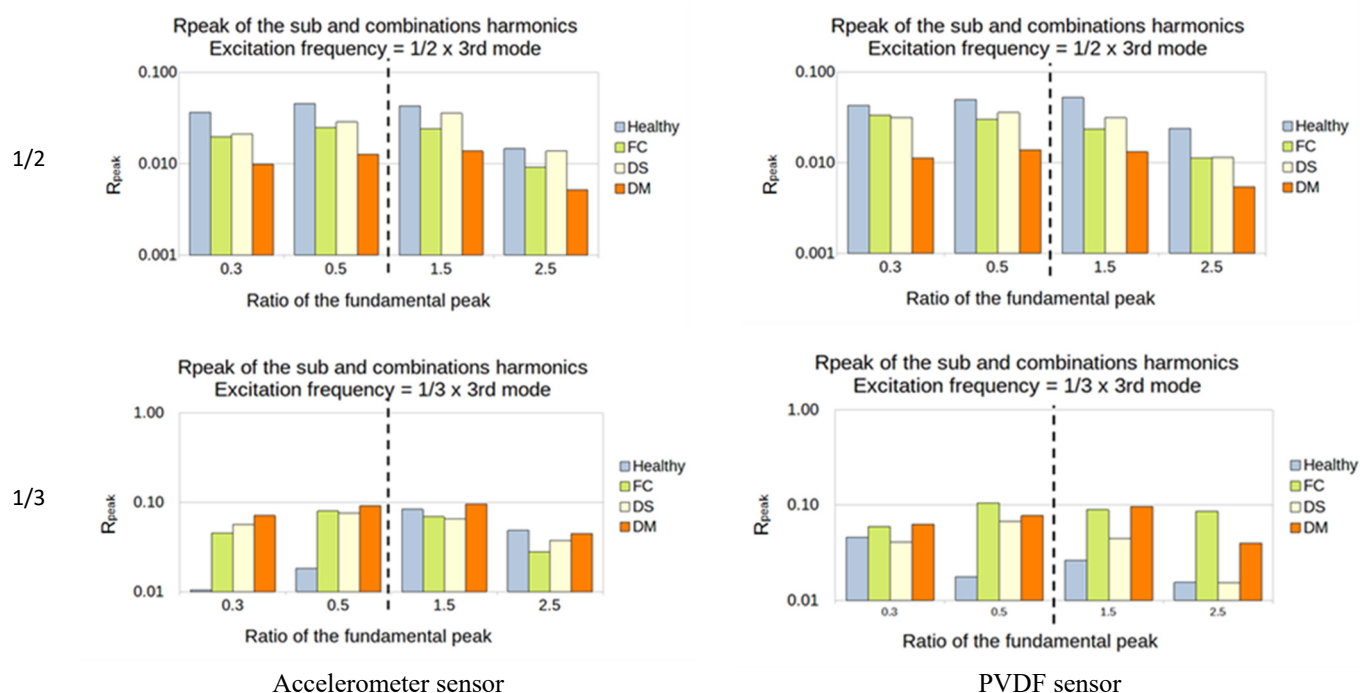
Figure 18. Third natural frequency and its ratio of 1,  $1/2$ , and  $1/3$  as the frequency of excitation.

For the third natural frequency, the PVDF showed sensitivity in every sub- and super-harmonics generation for the 1 and 1/3 excitation, while the accelerometer showed sensitivity only for the 1/3. However, the value of the ratio was weak, between 0.01 and 0.1% (Figure 18).

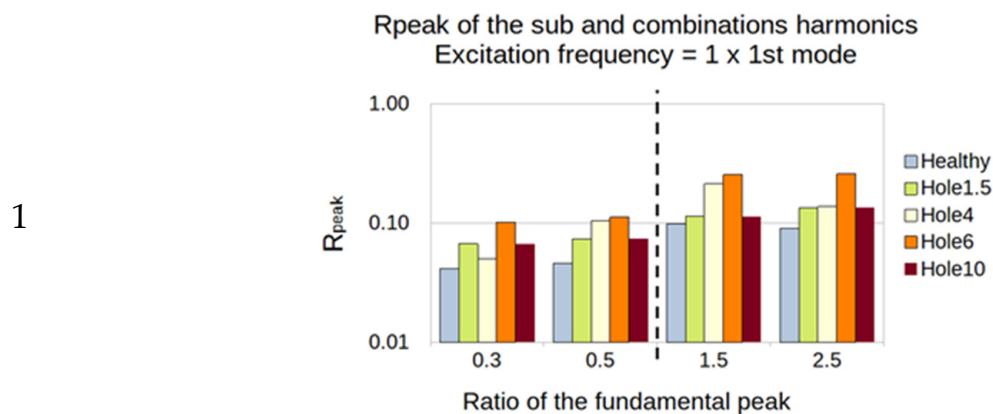
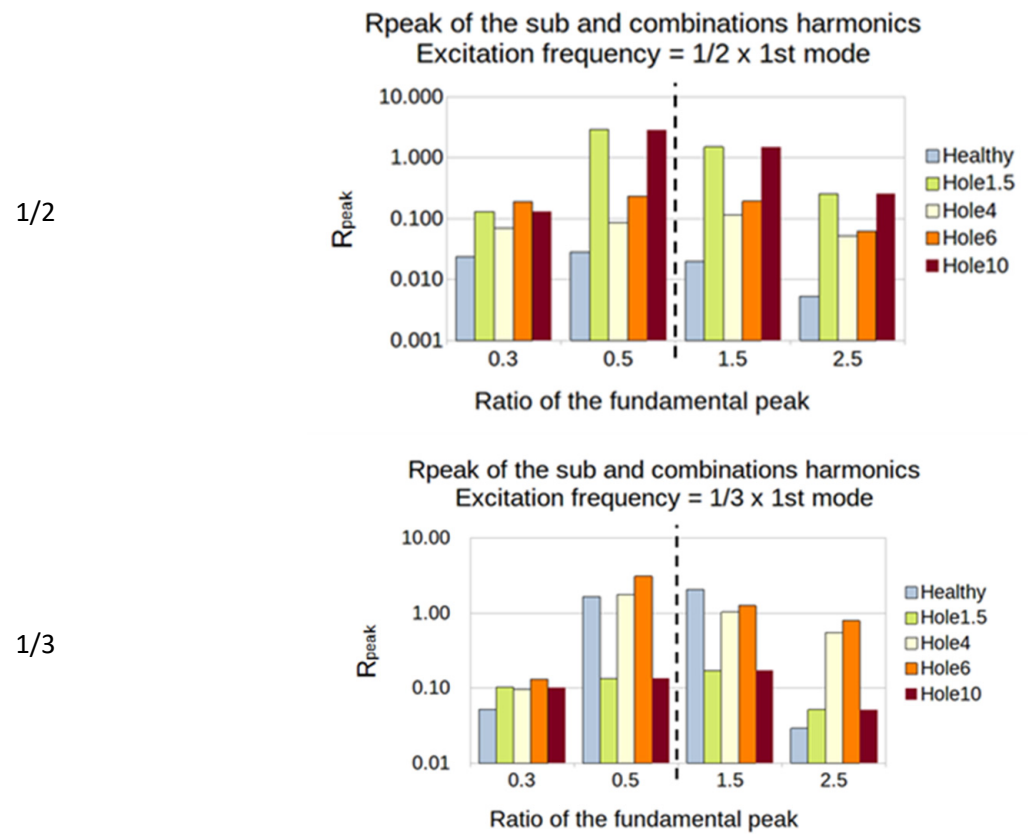
**Figure 19.** First natural frequency and its ratio of 1,  $1/2$ , and  $1/3$  as the frequency of excitation for the PVDF sensor.

This is less clear for the hole than for the manufactured damage. However, for the first natural frequency, the ratio 1 of excitation showed sensitivity for every size of the hole and every sub- and super-harmonic. The ratio of  $1/2$  showed results, and the ratio of  $1/3$  did not show anything (Figure 19).

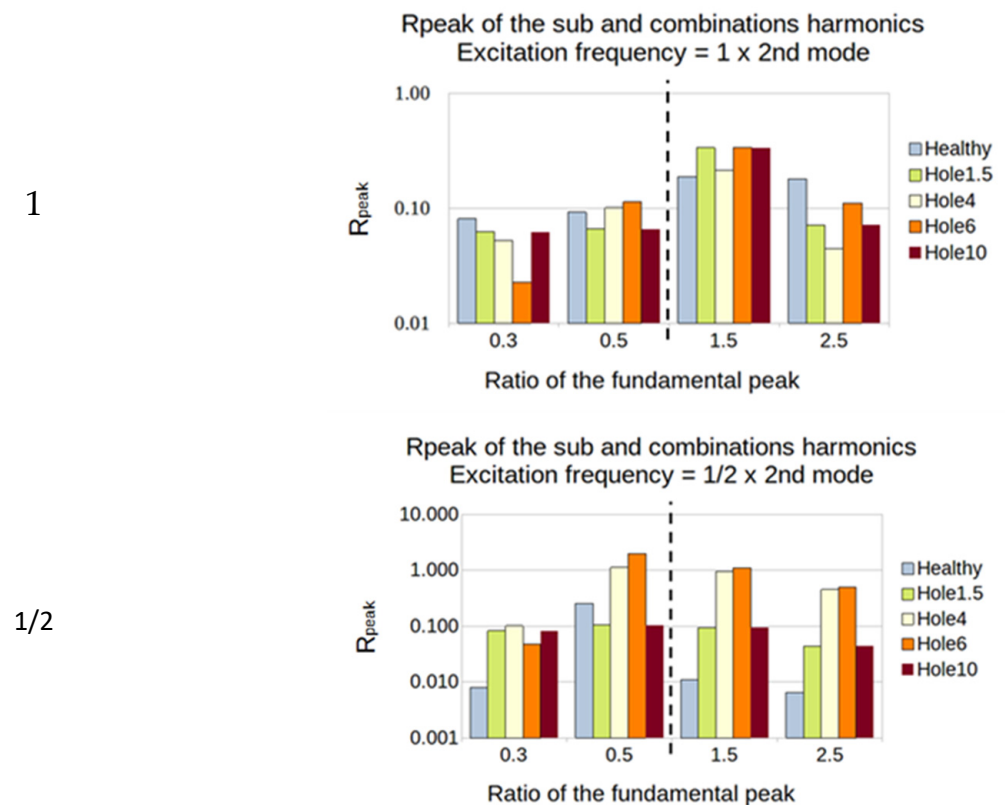
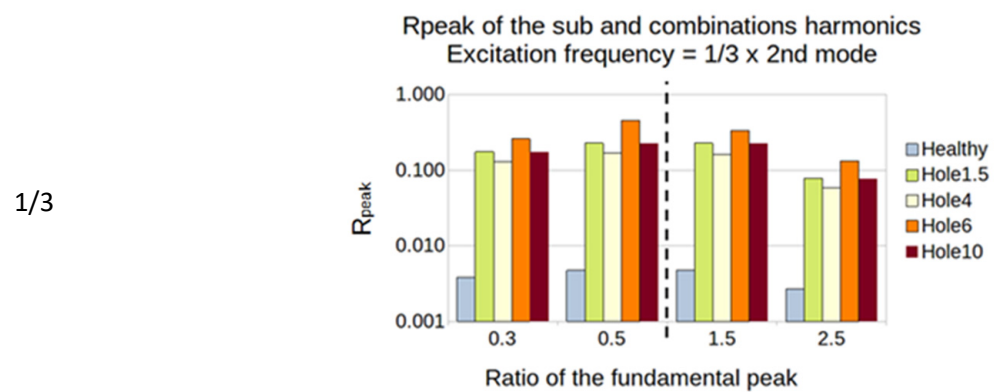
**Figure 20.** Second natural frequency and its ratio of 1, 1/2 and 1/3 as the frequency of excitation for the PVDF sensor.

For the second natural frequency, the PVDF showed a high sensitivity for ratio  $1/2$ , especially on the super-harmonics. Both sensors showed a high sensitivity for the ratio of  $1/3$  for every size of the hole (Figure 20).

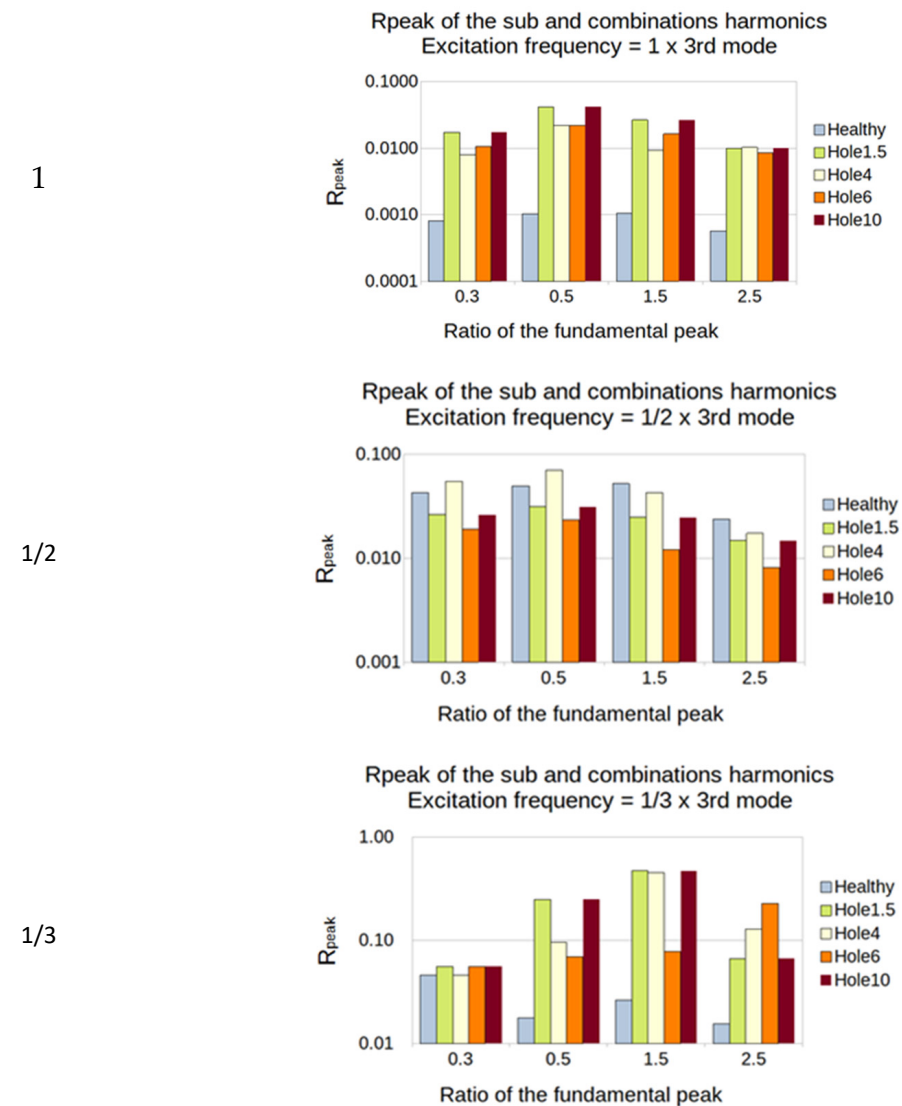
**Figure 21.** Third natural frequency and its ratio of 1, 1/2 and 1/3 as the frequency of excitation for the PVDF sensor.

For the third natural frequency, the PVDF showed a high sensitivity for the ratio of 1 and the ratio of 1/3, especially on the super-harmonics and the sub-harmonics 1/2 (Figure 21).
