# Back-Analyses of Landfill Instability Induced by High Water Level: Case Study of Shenzhen Landfill

**Abstract:** In June 2008, the Shenzhen landfill slope failed. This case is used as an example to study the deformation characteristics and failure mode of a slope induced by high water levels. An integrated monitoring system, including water level gauges, electronic total stations, and inclinometers, was used to monitor the slope failure process. The field measurements suggest that the landfill landslide was caused by a deep slip along the weak interface of the composite liner system at the base of the landfill. The high water level is considered to be the main factor that caused this failure. To calculate the relative interface shear displacements in the geosynthetic multilayer liner system, a series of numerical direct shear tests were carried out. Based on the numerical results, the composite lining system simplified and the centrifuge modeling technique was used to quantitatively evaluate the effect of water levels on landfill instability.

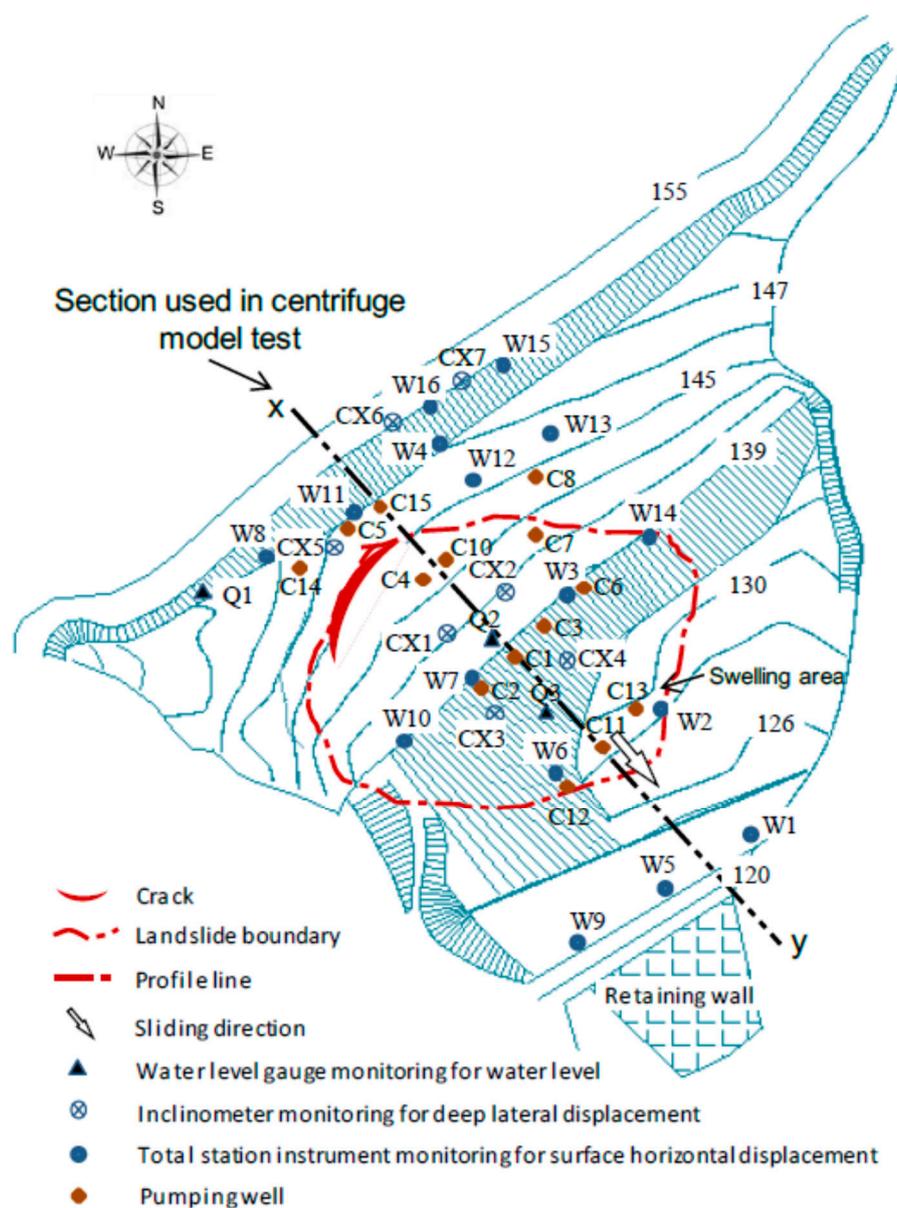
Figure 2. Site plan of monitoring points and pumping wells.

There were a total of 10 water level gauges; three were installed in the water pipes (identified as Q1–Q3 in Figure 2). The other seven were installed in the inclinometer casing (CX1–CX7 in Figure 2). The water level was measured using a standpipe piezometer interrogated with a dipmeter.

Figure 2 shows the locations of the deep lateral displacement monitor points. Using the monitoring results of gauges CX1, CX3 and CX5, Figure 7 shows a set of typical monitoring results. These three gauges are in a line parallel to the x–y line. The gauge CX3 was located in the middle of the waste body. The gauge CX1 was located at the bulging area at the lower part of the waste body. The gauge CX5 was located near the top of the waste body. Figure 7 shows that there was very little displacement at the lower part of the waste body, while there was large displacement in the middle part. The recordings of gauge CX5 show that the displacements are consistent throughout the entire depth of the gauge, where the displacement was as large as 1.5 m on 8 June. At this location, the depth of the sliding waste body was about 12 m. A comparison of the displacement results of the three gauges show that the slip surface went through the middle-lower part of the CX1 inclined tube, but not through the CX5 tube. This result suggests that the deformation occurred at the deep composite liner system. The translational slide is the most likely failure mode.

After the landslide, a variety of emergency measures have been carried out, which subsequently proved to be effective. After the 6–7 June heavy rainfall event, 15 pumping wells were drilled into the waste body, as shown in Figure 2. It can be seen from Figure 5 that after the start of the pumping, the water level in the wells fell. At the same time, a plastic film was laid on top of the waste body so as to reduce infiltration to the body. Further, the drains were unclogged so that the surface water in concave area could flow out. At the point where the leachate overflowed, the drainage pipe was connected to a gravel ditch so that the leachate could flow out. Finally, sandbags were used to exert a back pressure to

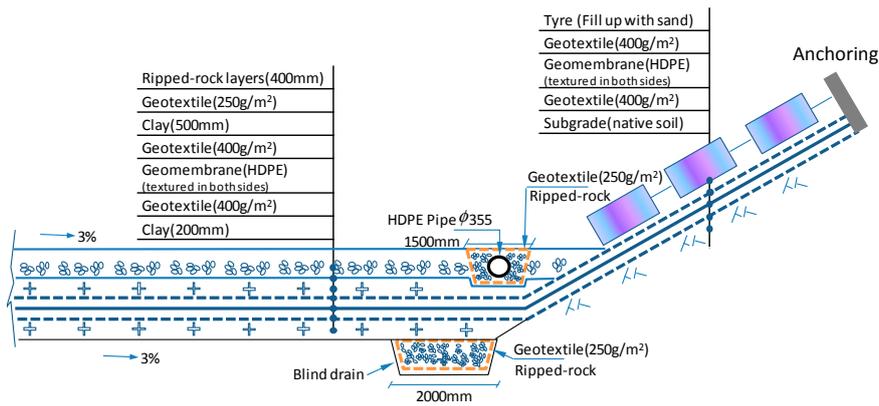
Figure 3. Structural drawing of the composite liner system.

The Shenzhen landfill was one of the earliest sanitary landfills equipped with a composite liner system, as shown in Figure 3. Based on research results and practical experience, in the composite liner, the shear strength is low at the high-density polyethylene (HDPE) geomembrane/geotextiles and the compacted clay/geotextiles interface [15]. Hence, these are the weak interfaces for the stability of the waste body.

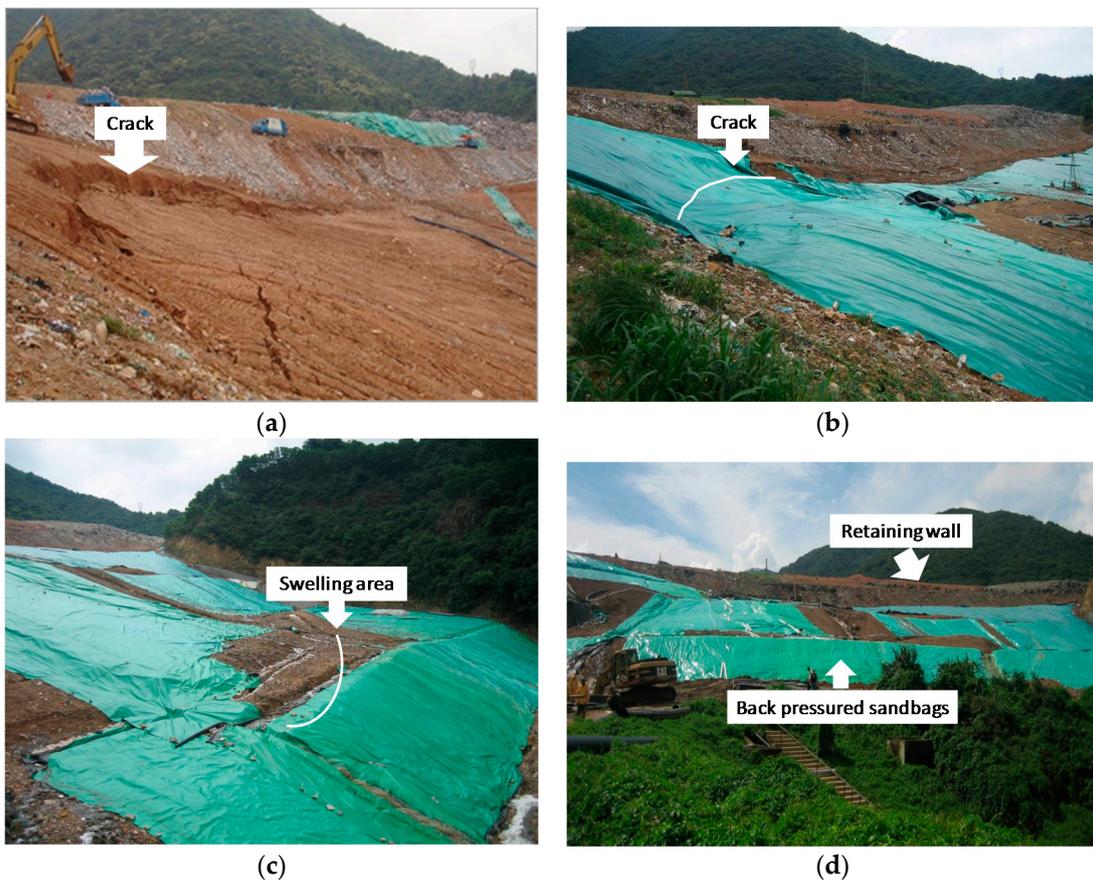
During the heavy rainfall events in 17–18 April 2008, the waste body slid by 1~2 m. The slip area was on the west side, about one-third from the top of the waste body. During another heavy rainfall event in 6–7 June 2008, the middle part and lower part of the waste body slid by 1~4 m. As shown in Figure 4, due to the slip, a ridge of more than 3 m in height was formed. There was heave in the slip area which extended from one-third to two-thirds from the top of the waste body.

Figure 4. Shenzhen landfill in June 2008 (a) Crack at the trailing edge of waste body; (b) Plastic mulch paved on the waste body surface; (c) Swelling area; (d) Retaining wall.

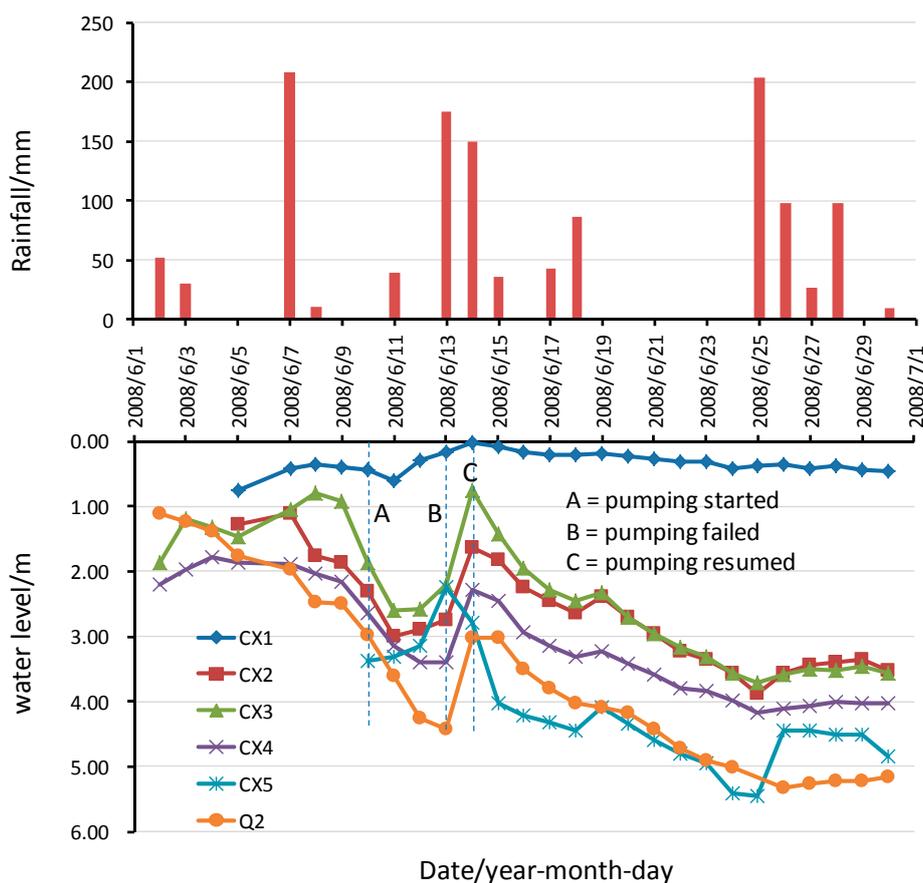
Figure 5. Change of water level with time and rainfall conditions.

Figure 5 shows some of the monitored water level data and rainfall data in June, 2008. Water depth was measured from the surface of the waste body which was taken as zero. Water level gauges CX2~CX5 and Q2 were within the slip area, which also had dewatering wells during the 2008 emergency. As shown in Figure 5, the water level within the waste body was very high at the beginning of June, and the water surface was 2 m below the surface of the waste body. It was observed onsite that leachate water mixture overflowed near the retaining wall, which eventually caused the waste body to slide during the 6~7 June heavy rainfall event. On 10 June, the construction of 15 wells within the waste body started, and plastic mulch was paved on the waste body surface so as to reduce infiltration of rainwater into the body. On 13 June, due to heavy rain and the failure of the pumping system, the water level again rose quickly. Subsequently, the pumping resumed and the water level fell quickly. The water levels in gauges CX2~CX5 all dropped to 3.5 m below the surface, and the water level in gauge Q2 dropped to 5.0 m below the surface. Regarding the gauge CX1, it was located in a position where there was a rise in topography. The thickness of the waste body was thin, and due to the supply of leachate and water from upstream, the water level change was not obvious.

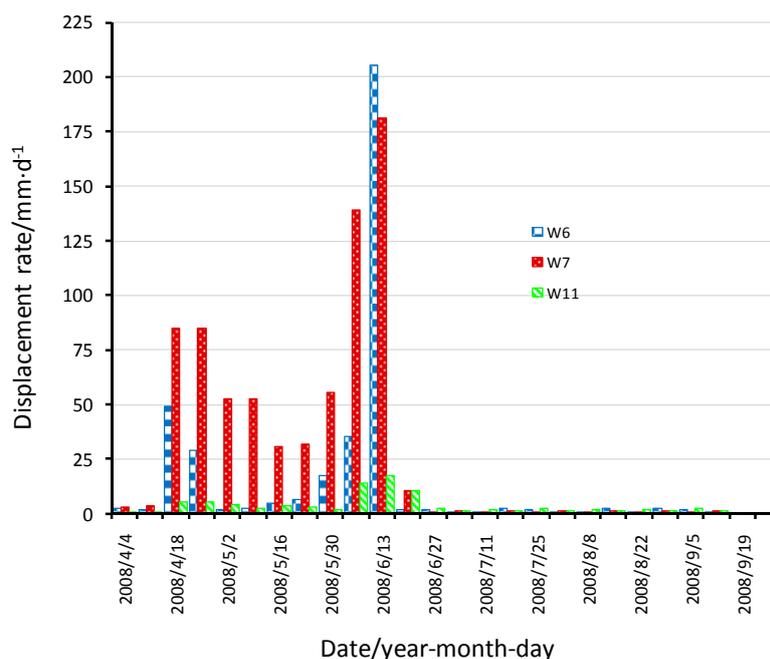
Figure 6. Surface horizontal displacement rates for gauges W6, W7 and W11.

The surface horizontal displacement rate in the waste body is a direct reflection of the landfill movement. As the monitoring frequency varied according to the season and the displacement rate (Table 1), Figure 6 shows the adjusted monitored surface horizontal displacement rates from March–October, 2008. Since the recordings of the W6, W7, W11 gauges respectively represent the horizontal surface displacements of the lower, middle and top part the waste body (Figure 2), only the results from these three gauges are shown in Figure 6.

Considering the rainfall condition in June and the rise in water level, there were increases in the average daily displacement rates for all three gauges. In particular, the large displacement rates in 6–7 June, and 13 June correspond to the two slides. As shown in Figure 6, the gauge W7 shows that the average daily surface horizontal displacement rates at the centre of the waste body were 135 mm/d and 185 mm/d during the two slides. The average displacement rate in the centre of the waste body is generally greater than that for the rest of the body. The displacement rate of the posterior region in the waste body is also generally smaller. This shows that the gauges W6 and W7 were within the same slip plane, with the centre part of the waste body moving outward.

the bulging area at the foot of the slope. After these rescue measures, it can be seen from Figure 6 that the displacement rates of the waste body slowed down significantly. In the subsequent heavy rainfall event, there was no obvious slip. These emergency measures played a key role in preventing further landslide during the 2008 rainy season.

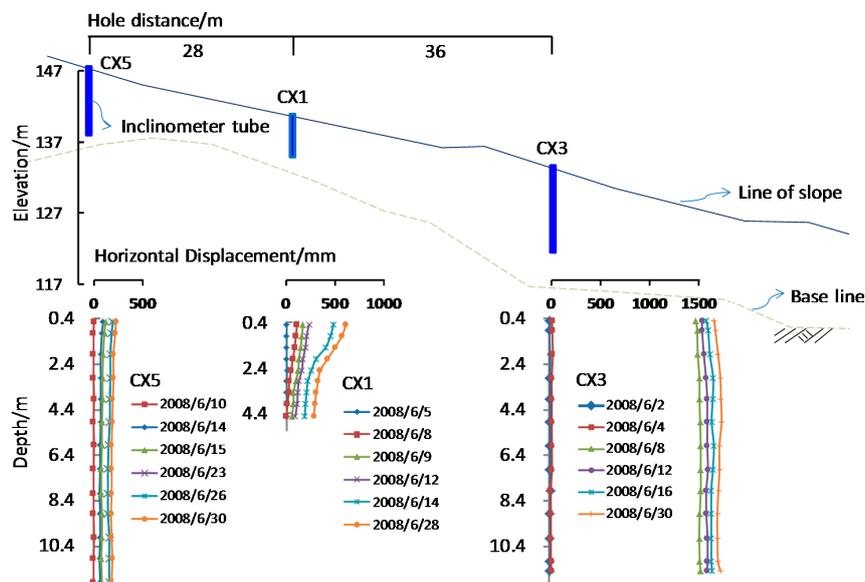
Figure 7. Monitored deep lateral displacements at various time.

It is important to note that the section in Figure 7 is much closer to the bulge area, where a ridge extended to the bottom of landfill site. Due to the steep terrain, a deep sliding deformation might appear at this location. But when considering the overall stability of the slope, x–y section that used in this model test (as shown in Figure 2) is a more representative area that is closer to the middle portion of the sliding mass. Hence, there are slightly different deformation and failure characteristics between the centrifugal model test and the monitoring results. On the other hand, the data collected under controlled laboratory conditions are useful for verifying the results of the analytical and numerical modelling methods.

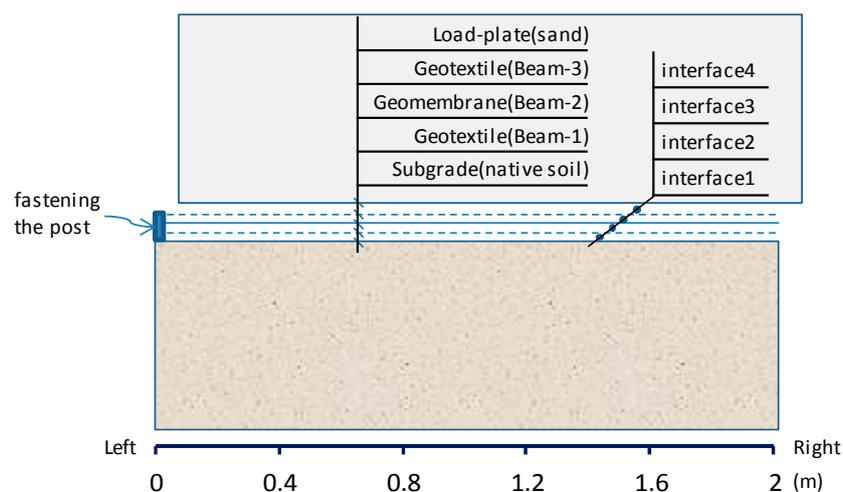
Figure 8. Composite liner system in direct shear test.

In the simulation model, the length has been set at 2 m. In the model, the left side of the liner system has been fixed so as to simulate the operation condition in the field where the fastening posts were anchored at the top of the slope, as shown in Figure 8.

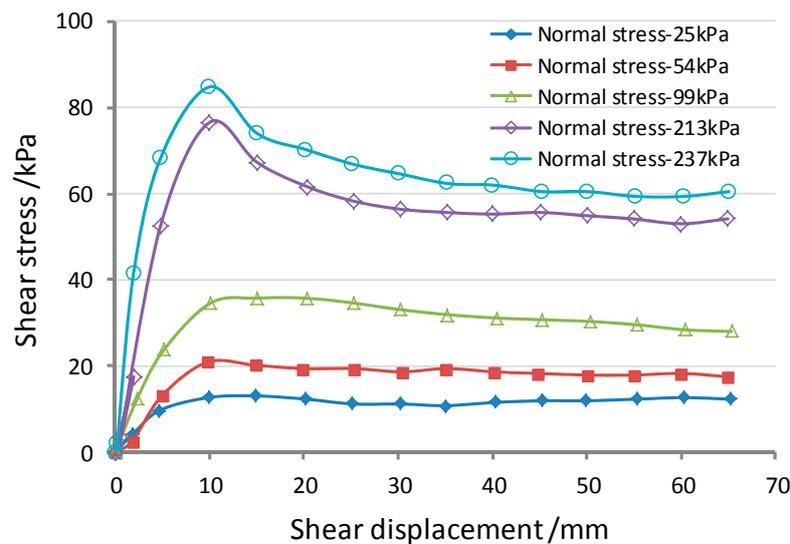
**Figure 9.** Geotextile-geomembrane friction tests (reproduced from Lin, 2009 [15]).

A series of interface tests conducted on a large direct shear apparatus (made by Geotest Company, Shaoxing, China), and the standard used in the test is ASTM (American Society for Testing Material) D5321. Interfaces are given the normal and shear stiffness values, and the interface shear strength.

strength smaller than that in the actual site, but has similar interface frictional angles (Figure 9) was anchored to the GM on the right side.

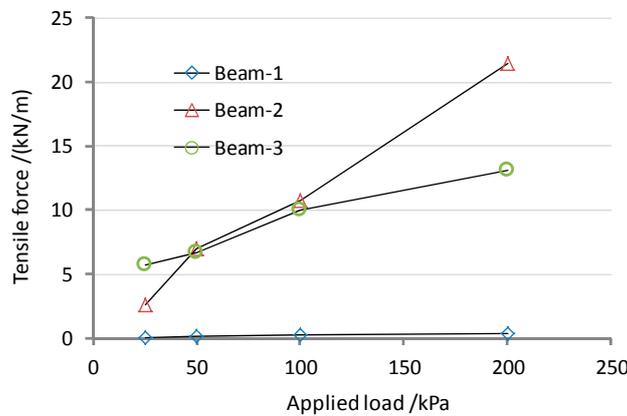
Figure 10. Tension in the geosynthetic, at anchorage from FLAC models.

In the simulated direct shear test, a constant shearing speed of 1 mm/min was used together with the normal stresses of 25, 50, 100 and 200 kPa. The tension developed at the beam anchorages in all of the numerical analysis is shown in Figure 10. It can be seen that the pulling force of the geosynthetic materials is dependent on the position. The relative shear displacements at the interfaces are shown in Figure 11. As the peak strength is minimum at the GT/GM interface, the largest relative shear displacements occurred at interface-3, and the displacements measured between the synthetic waste and the geotextile (interface-4) do not reach the post peak values. While the characteristics of interface-2 and interface-3 are similar, but since the GM tensile stiffness is relatively higher, it therefore undertakes a larger shear force coming from the upper part of the composite liner. This limits the

relative displacement transferring to interface-2 and interface-1. So, there is only a small tensile stress in the geotextile under the GM, as shown in Figure 10.

According to the results of the numerical models, the trends of the tensile stresses in the geosynthetics and the relative displacements at the interface give the quantitative data. The sliding path within composite liner at the side slope of Shenzhen landfill is most likely to occur between the upper GT/GM interfaces (interface 3).

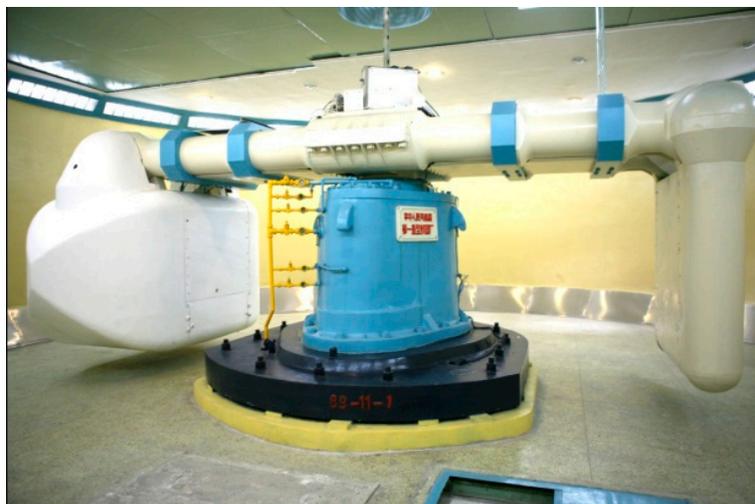
**Figure 12.** The centrifuge facility at IWHR.

To further understand the Shenzhen landfill landslide, an experiment using a physical model was carried out at an enhanced-g level. In order to generate the enhanced-g, a geotechnical centrifuge at China Institute of Water Resources and Hydropower Research (IWHR) was used. The IWHR geotechnical centrifuge apparatus has a design capacity of 450g-ton, a maximum model acceleration of 300 g and a maximum payload mass of 1500 kg, as shown in Figure 12. The centrifuge modeling technique is commonly used to examine deformations and instability of geological slopes [23]. Earlier studies on groundwater fluctuations induced slope instability in a centrifuge include Timpong *et al.* [24], Zheng and Tang [25], Knappett [26] and Yang *et al.* [27]. Previous studies by the authors were based on

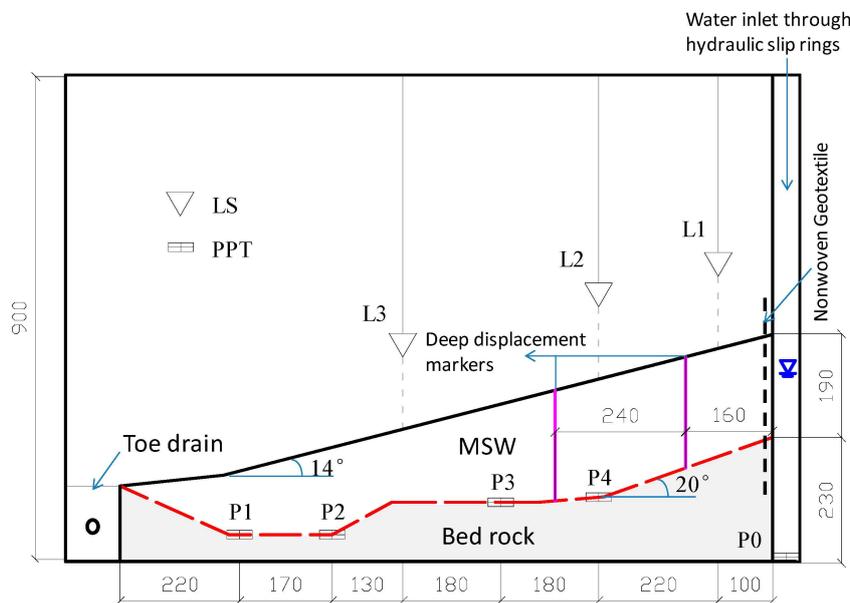
**Figure 13.** Experimental setup of model slope (Note: all dimensions are in mm).

The model was constructed in a rigid aluminum box with inner dimensions of  $135 \times 40 \times 90 \text{ cm}$  (length  $\times$  width  $\times$  height). Based on the section map along the x–y profile of the Shenzhen landfill (Figure 2), the gravity acceleration in the model was designed to be 90 g. Figure 13 shows the model slope, which corresponds to the prototype slope of approximately 108 m long.

To measure the surface settlements of the slope, three laser displacement transducers (LS) were placed on the surface of the slope. To measure the pore water pressure within the slope, four pore pressure transducers (PPT) were installed at the base of the model waste body. Figure 13 shows the positions of LS and PPT. One additional PPT (P0 in Figure 13) was placed at the bottom of seepage tank.

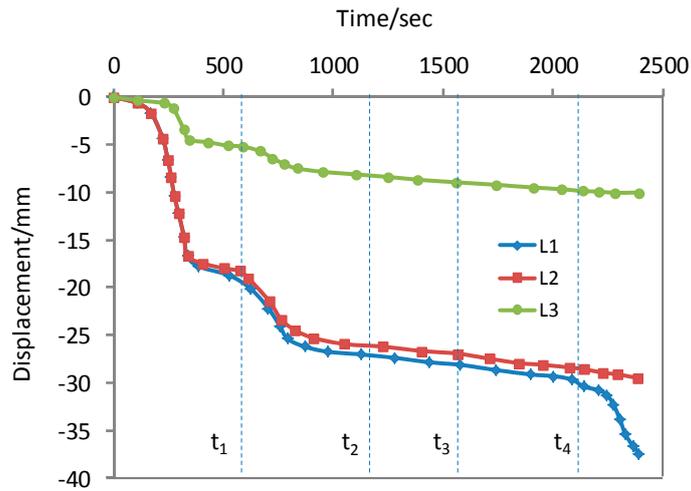
Figure 14. Variations of surface settlement with time in model slope.

The centrifuge was subjected to a stepwise increase to the design acceleration of 90 g. Figures 14 and 15 respectively show the monitored time histories of the surface settlements and pore water pressures during the centrifuge flight. Upon reaching the design test acceleration, the water level in the model waste body was raised by introducing water into the water supply chamber at the upslope end at time  $t_2$ . Figure 15 clearly shows at time  $t_2$ , the positive pore water pressure started to buildup. Between time  $t_2$  and  $t_3$ , the water supply to the chamber was kept at a constant rate of 800 mL/min and the groundwater table moved upward. This period between time  $t_2$  and  $t_3$  was approximately 7 min. When the rate of water supply to the chamber increased to 2000 mL/min at time  $t_4$ , there was a significant surface settlement as shown by the monitored displacement of L1 transducer. This phenomenon is useful to predict the occurrence of slope failure in the test model (because L1 laid above the side slope in the model, if it slips at this area, an additional settlement occurs).

In addition, as can be seen in Figure 14, the model waste has experienced a larger auto-settlement before the failure of the landfill slope. So, for this failure mode, it is a challenge to select parameters for the slope stability calculation. It is because the MSW is a strain hardening material [11], but geosynthetics interface possess mainly strain softening properties. Based on the numerical analysis in

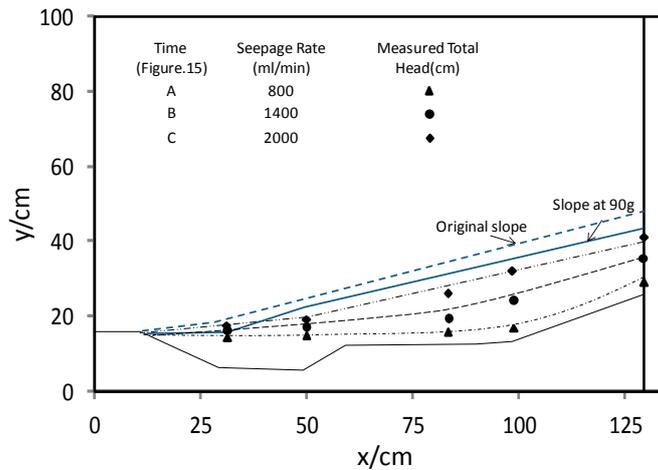
Figure 16. Variations of ground water level in model slope.

Back calculations were performed using the measured pore water pressure to establish the variations of groundwater table in the model slope, as shown in Figure 16. When the rate of water supply to the chamber was at 2000 mL/min, the back calculations show that the depth between the ground surface and the groundwater table was about 2.5 cm (corresponding to 2.25 m in the prototype). This result is very similar to the monitored data in the field on 6~7 June. During the model testing between time  $t_3$  and  $t_4$ , flooding was observed near the toe of the slope. In the back calculations, the groundwater table appeared to be higher than the ground surface. This may be attributed to the water flowing out through the tension cracks, which resulted in flooding at the toe of the slope.

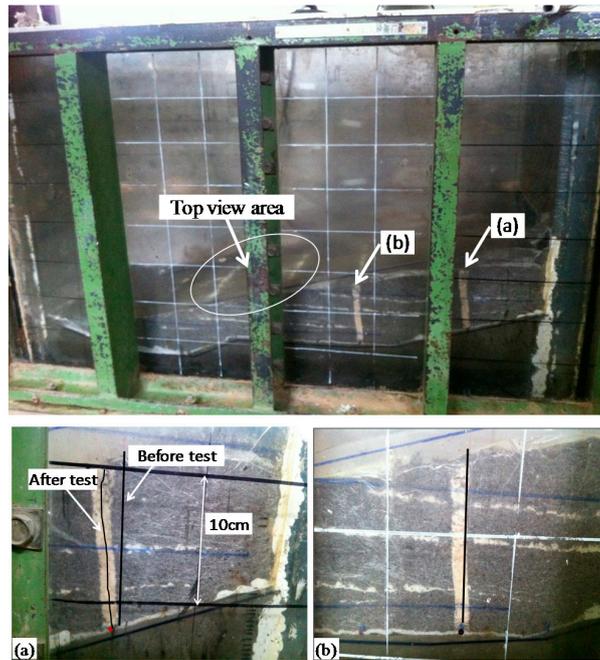
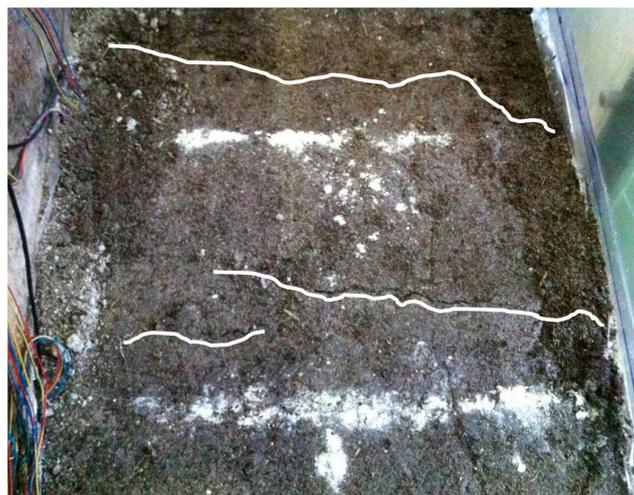
Figures 17 and 18 show the photographs of the model slope failure. The slope did not experience a large slide but tension cracks were developed in the landfill indicating the onset of sliding.

Deep slip surface along the interface of geotextile and geomembrane in the liner system at the side slope was observed. The slip distance at this location of the model was up to about 1 cm, but at the base of the slope, the displacement between the GT/GM interfaces was smaller, as shown in Figure 17. It means that the shear stress on the liner was less than the shear strength. The results show that slippage first occurred along the side slopes of the landfill, and the failure continued to develop along the base towards the toe of the landfill. This failure mode is consistent with Filz *et al.*'s [20] finite difference analyses, where the progressive failure mechanism has been used to explain this phenomenon.

Figure 17. Photographs of failure mode (side view).

Figure 18. Photograph of failure mode (top view).
