Article

Evaluation of Lead Release in a Simulated Lead-Free Premise Plumbing System Using a Sequential Sampling Approach

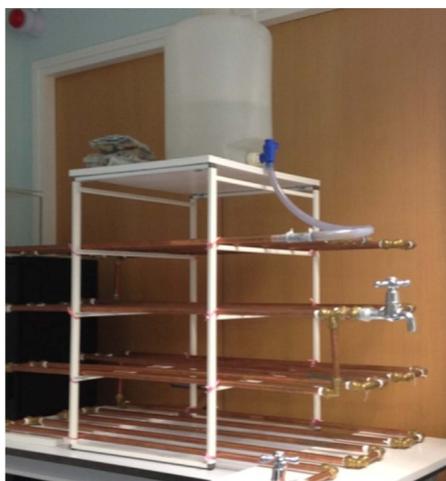
Figure 1. Photograph of the simulated lead-free premise plumbing system.

To determine whether lead contamination in drinking water will occur in a “lead-free” premise plumbing system, a typical premise system was built using locally (Singapore) purchased materials as shown in Figure 1. In Singapore, all water fittings used shall conform with the standards and requirements stipulated by the Public Utilities Board (PUB) and their use shall conform to the Public Utilities (Water Supply) Regulations and Singapore Standard Code of Practice (CP) 48. A water fitting shall be deemed to comply with the stipulated standards if it is certified by an accredited product certification body. All metallic material in contact with water shall comply with the test on extraction of metals of AS/NZS 4020:2005 in which leaching test was conducted for 24 h at 80 °C. The maximum allowable concentrations of metals leached shall not exceed the limits specified by the WHO Guidelines for Drinking Water Quality [28,29]. Copper pipes and brass fittings used in this study were microwave-digested and measured for lead content, and results showed that their lead content was

The system consists of approximately 20 m of certified (BS EN1057:2006) copper pipes (0.5 inch dia), (BS EN1254-2:1998) brass fittings (Figure 2) and stainless steel taps. The required copper pipe length is based on the average household floor area of about 95 m² in Singapore [30]. The total capacity of the system is approximately 2.8 L. The first stage of the experiment (conditioning phase) was to identify a potential lead source in the system using a modified sampling method. The second stage was to examine the effects of orthophosphate, a common corrosion inhibitor, on lead release from the identified lead source. The third stage was to assess the effects of stopping orthophosphate addition on lead release.

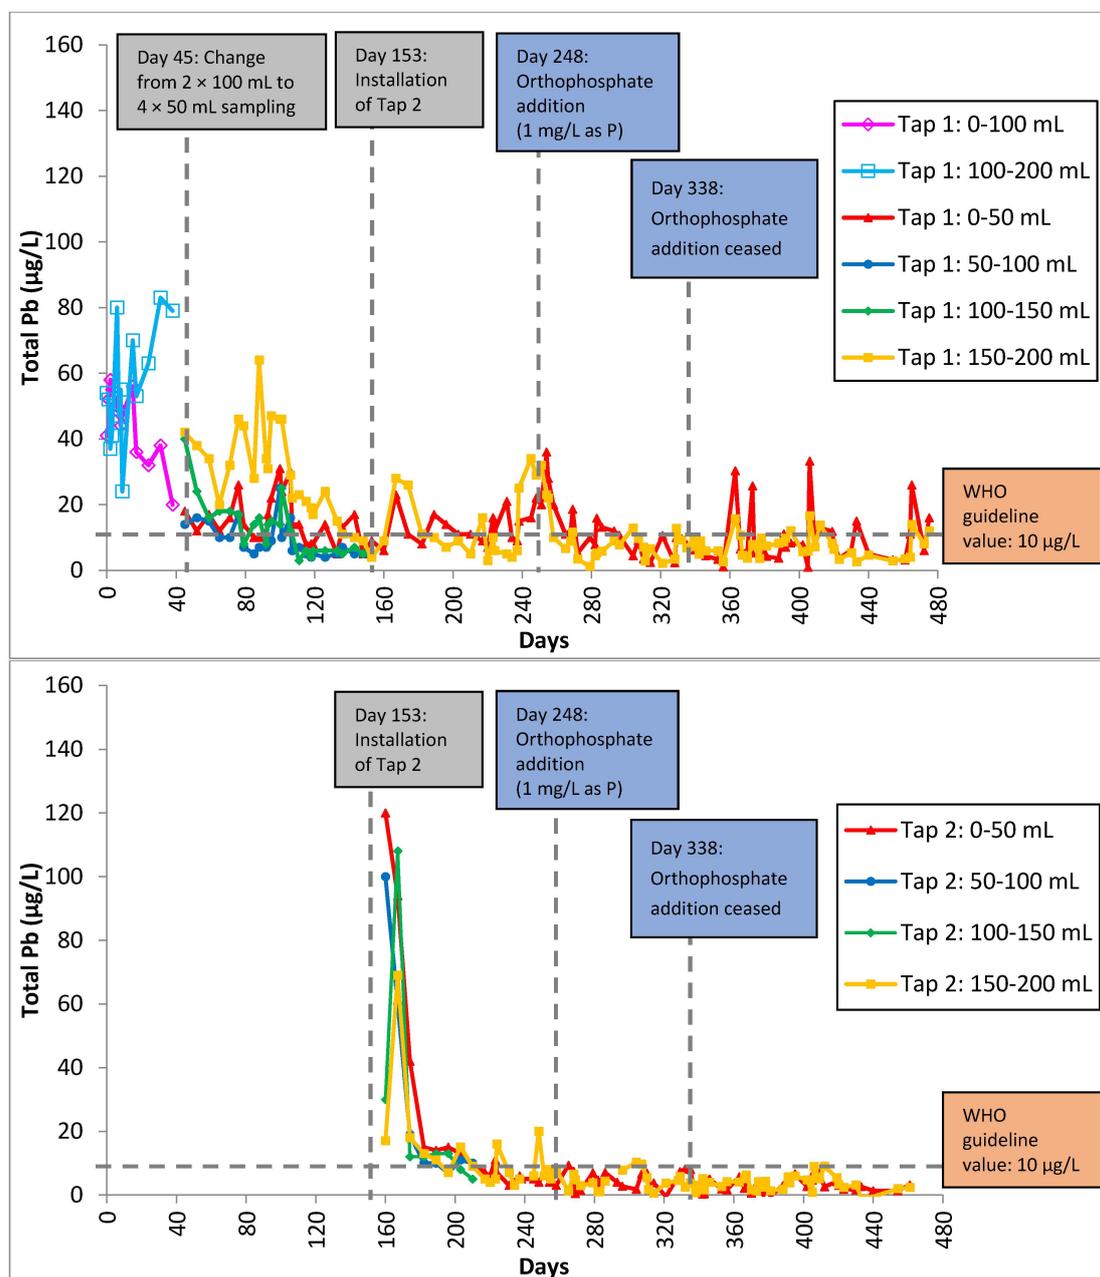
Figure 3. Total lead in Tap 1 (top) and Tap 2 (bottom) samples as a function of time for 475 days. A second tap was installed on Day 153 and orthophosphate was introduced on Day 248 and discontinued on Day 338.

Figure 3 shows the total lead release over the experimental period of 475 days. The system was first conditioned for 247 days, followed by orthophosphate addition for the next 89 days before the addition was ceased for the remaining 139 days. Total lead levels decreased gradually regardless of stagnation times (one, three and seven days), but exceeded the WHO guideline value of 10 $\mu\text{g/L}$ for the first five months. The highest lead concentration recorded was 83 $\mu\text{g/L}$ on Day 31. On Day 45, the sampling procedure for collecting the first 200 mL was changed from using 2 \times 100 mL bottles to 4 \times 50 mL bottles as the former were unable to accurately locate the lead source due to multiple brass fittings near the tap for accommodating the sharp bends and tight corners. A sampling volume of 100 mL is sufficient to detect lead contamination in drinking water in premise systems but an even smaller sampling volume may be used to provide a more accurate and precise location of the

lead source. Brass fittings were identified to be the lead source in the system. The second and third 50 mL sequential samples were discontinued after 153 days because their lead concentrations were consistently lower compared to the other samples and they were below the guideline value of 10 µg/L, indicating absence of a lead source.

A second tap was installed on Day 153 and lead levels began to spike over the next two weeks. The scale on the inner surface of the pipes and brass fittings could have been destabilized during the installation, contributing to the lead spikes. The high lead levels may also be attributed to the dissolution of the surface lead of the brass fittings that were used to connect the copper pipes to the new tap. The high lead levels were not sustained for a long period of time, returning to pre-installation

After orthophosphate addition had been ceased, total lead levels were seen to spike within a week (Figure 3). The presence of lead phosphate precipitate formed previously was not able to control lead release without a continuous supply of orthophosphate into the system. Total copper concentration increased gradually for all samples (Figure 4), suggesting that the formation of copper phosphate minerals was not effective in controlling copper levels as well. This observation is consistent with the study by Zhang and Edwards [50], who reported that the inhibitive effect of dosing orthophosphate decreased substantially after 100 days. However, total zinc continued to decrease even after orthophosphate addition had been stopped (Figure 5).

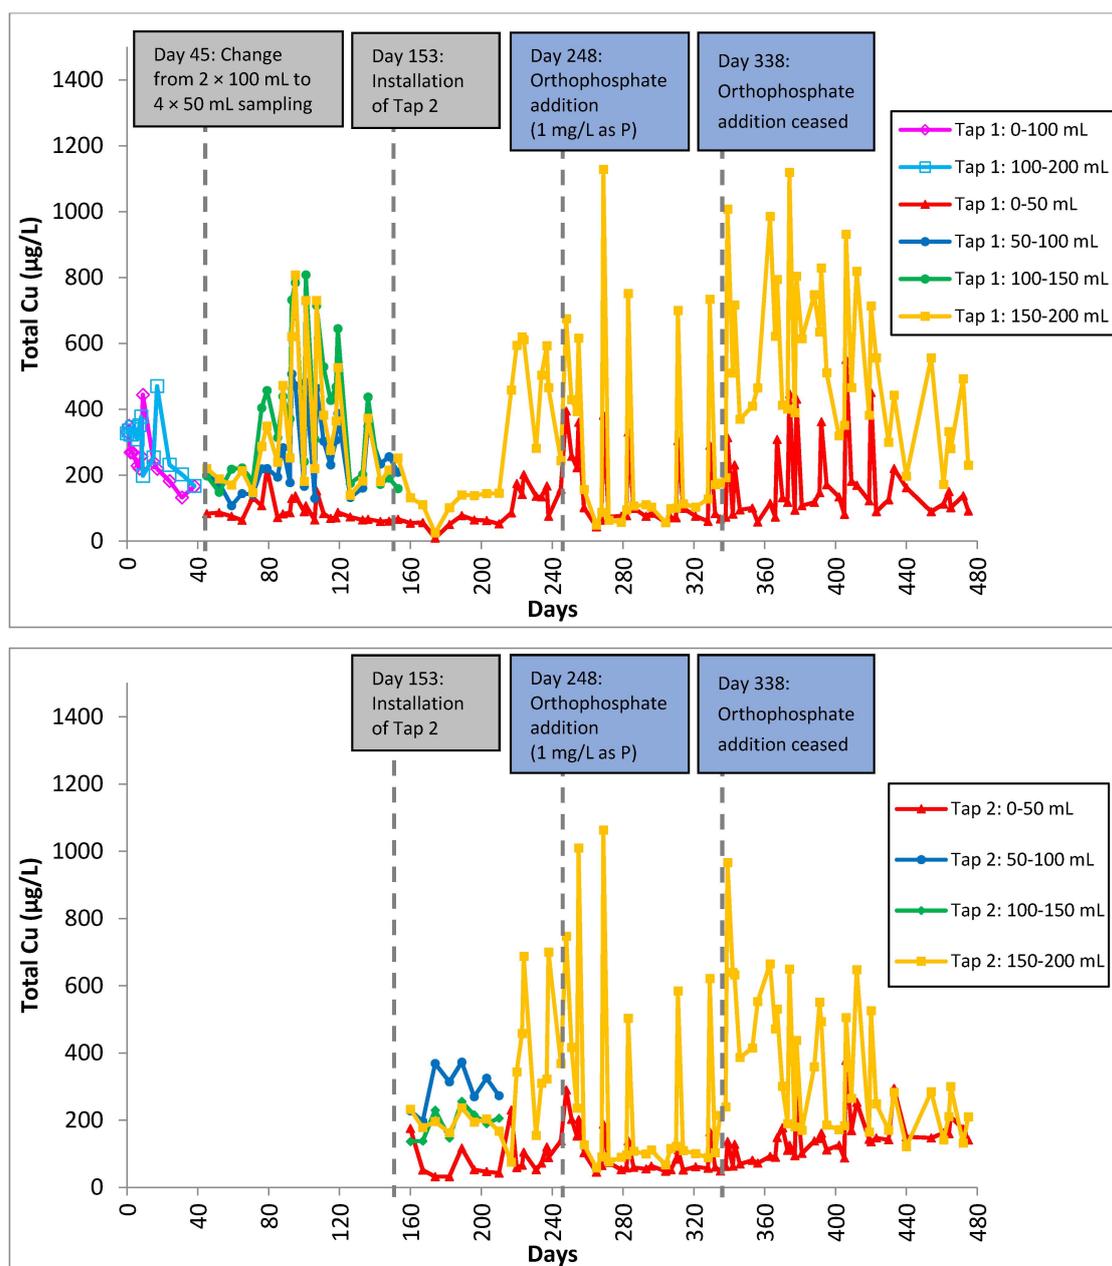
Figure 4. Total copper in Tap 1 (top) and Tap 2 (bottom) samples as a function of time for 475 days. A second tap was installed on Day 153 and orthophosphate was introduced on Day 248 and discontinued on Day 338.

Total copper was significantly higher in segments further away from the tap (150–200 mL) than those near the tap (0–50 mL). This is due to the larger copper surface area in copper pipes and brass fittings in contact with water than at the tap. Total copper levels exhibited peaks during orthophosphate addition and these peaks also corresponded to samples with one day of stagnation (Figure 4). Copper-containing scale might become loose and detach from the surface when water is flushed through the system after the last sampling. Total copper decreased gradually after orthophosphate addition was ceased as the copper phosphate minerals were eventually flushed out. Two out of four segmental samplings showed that total zinc levels were suppressed with the addition of orthophosphate (Figure 5).

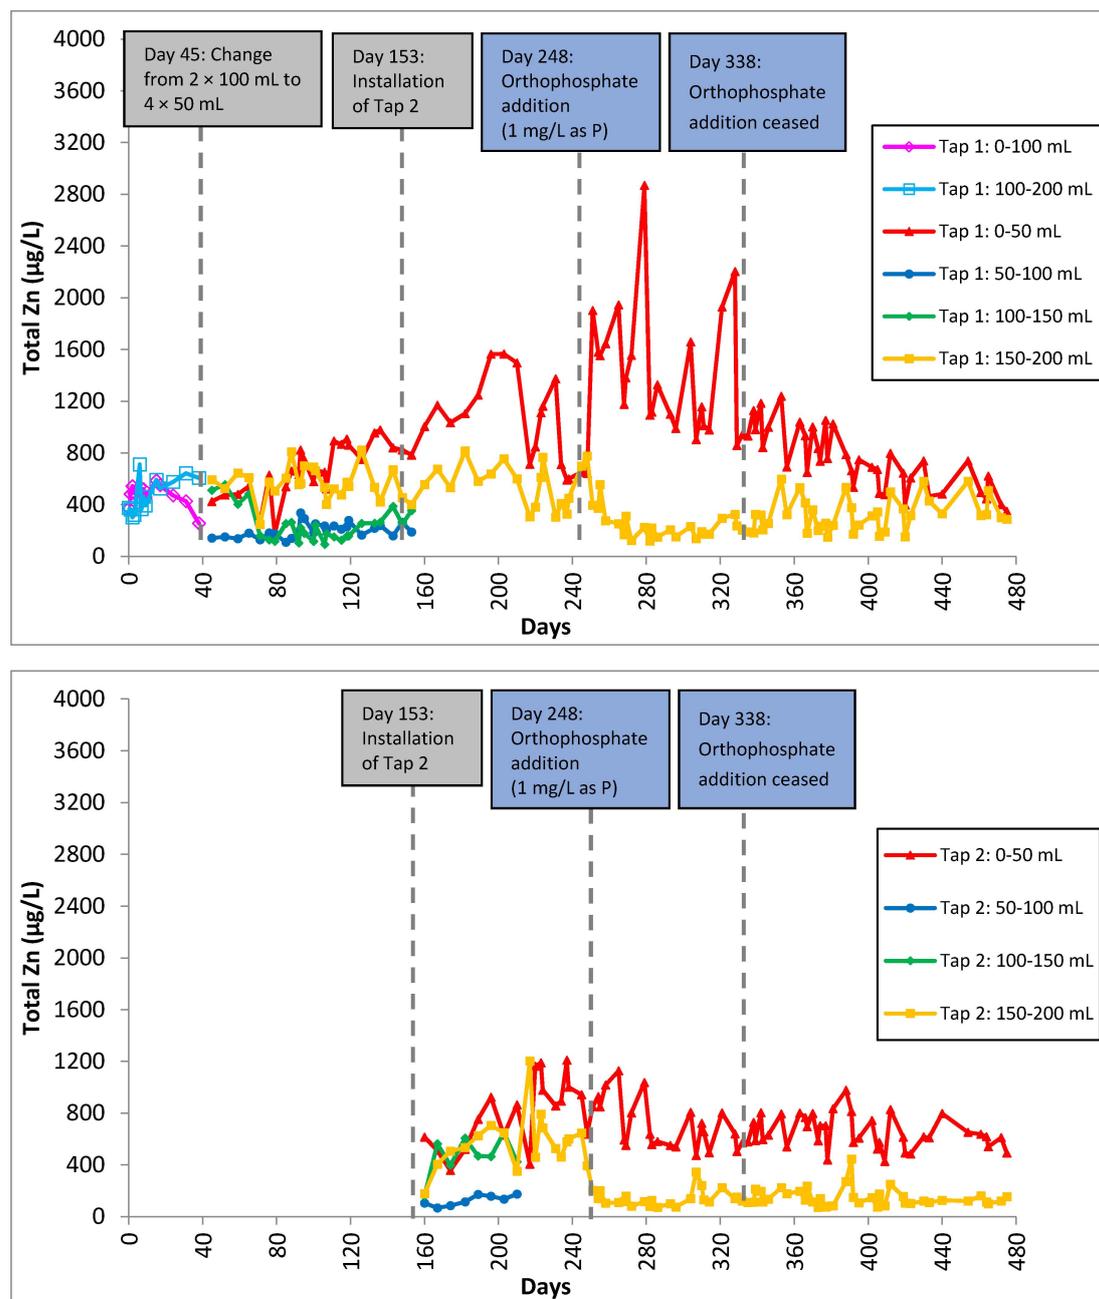
Figure 5. Total zinc in Tap 1 (**top**) and Tap 2 (**bottom**) samples as a function of time for 475 days. A second tap was installed on Day 153 and orthophosphate was introduced on Day 248 and discontinued on Day 338.

Unlike copper, total zinc was significantly higher in segments (0–50 mL) near the tap when orthophosphate was introduced. Zinc could be potentially released from the taps as zinc was added to protect other metals such as copper, iron or steel against corrosion. Total zinc in one segment (Tap 1: 0–50 mL) increased with the introduction of orthophosphate while the other segments were unaffected, indicating that they were sources of dezincification, a form of galvanic corrosion where zinc is preferentially corroded over other metals such as copper and lead. The presence of orthophosphate accelerated dezincification, resulting in more zinc release. This finding is consistent with works by Lucey [47], Oliphant and Shock [48] and Oliphant [49]. After orthophosphate addition has ceased, total Zn returned to the levels before orthophosphate was introduced.

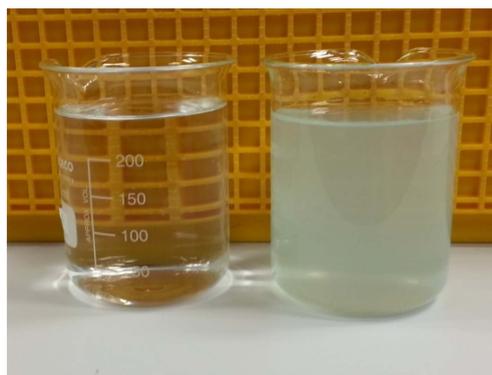
Figure 6. “Blue water” sample, before (right) and after filtration (left) with 0.45-micron pore-size nylon membrane.

“Blue water” (Figure 6) was also observed for samples with one day of stagnation. A clear, colorless filtrate was obtained when the “blue water” was filtered using a 0.45-micron pore-size nylon membrane, suggesting that the blue colorization was due to the predominant presence of copper minerals rather than soluble copper ions. The blue colorization most likely resulted from the presence of copper phosphate since “blue water” was only observed when orthophosphate was added. This finding supports the occurrence of peaks seen in total copper release during orthophosphate addition (Figure 4). Therefore, there should be caution when using orthophosphate for corrosion control if the premise plumbing system contains copper pipes. Further studies may be conducted to examine means to mitigate the formation of “blue water” with respect to the optimum dose of orthophosphate.

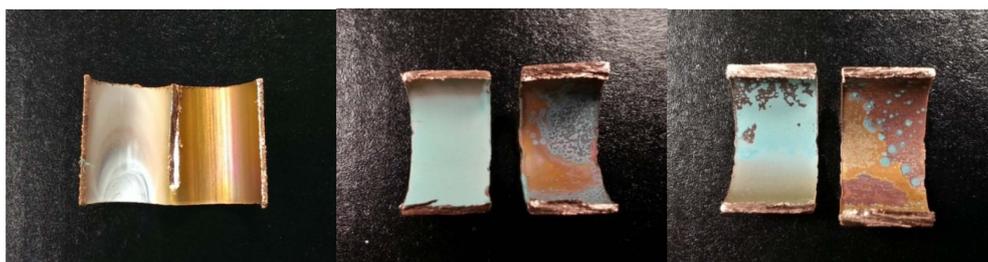
Figure 7. Cross-section of a copper pipe segment (**left**) after conditioning with tap water for 100 d, (**middle**) after 367 d orthophosphate addition and (**right**) after 433 d orthophosphate addition ceased.

Bluish-green scale (Figure 7) was observed on the copper pipe segments collected during orthophosphate addition and when orthophosphate addition was ceased. Copper corrosion products, such as copper hydroxide, carbonate and phosphate, were likely to be present, as evidenced by the same bluish-green coloration of these minerals and the scale. A cross-section of the segment showed the transformation in color of the scales from white to bluish-green when orthophosphate was introduced. Elemental mapping using SEM-EDX (Figure 8) identified the spherical crystals to be CuO and the smaller amorphous crystals to be ZnO.

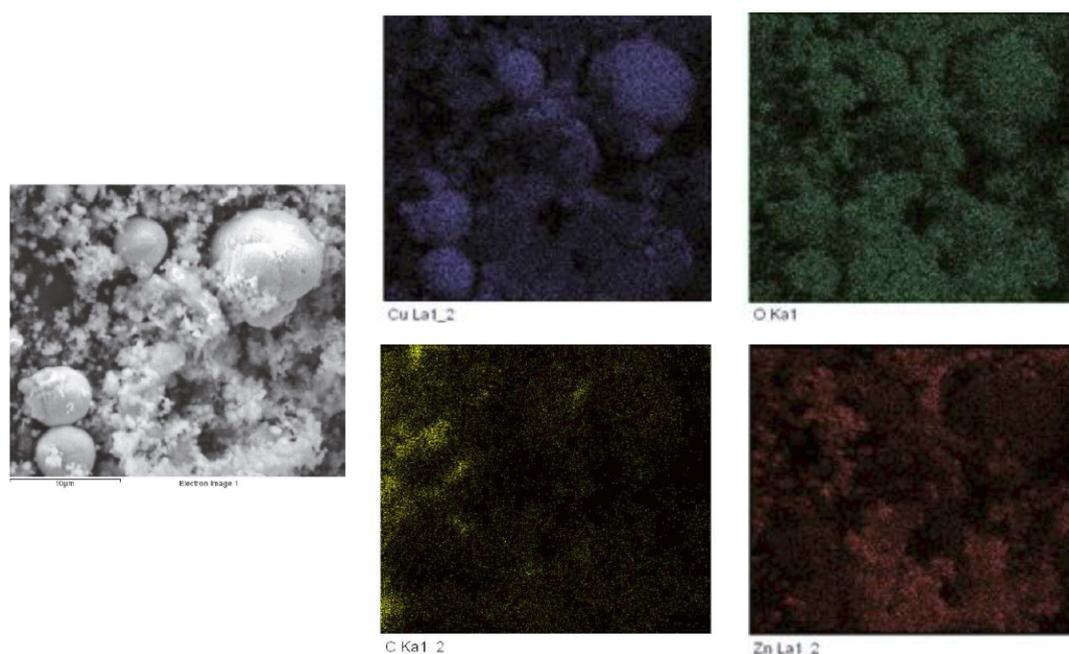
Figure 8. SEM-EDX elemental mapping of scale collected at the end of experiment.
