Article

The Radon Gas in Underground Buildings in Clay Soils. The Plaza Balmis Shelter as a Paradigm

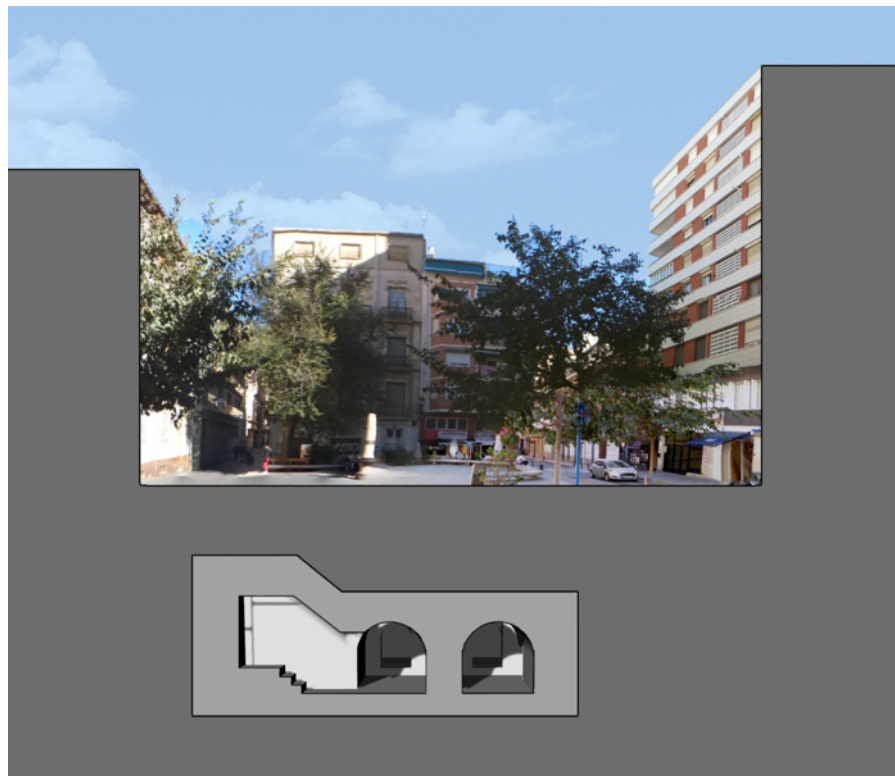
Figure 2. Photomontage of the Plaza Balmis section in its current state.

The upper enclosure is made of hollow brick, placed in the form of barrel vaults with lowered arches, ready for tambourine and plastered as shown in the sections in Figures 6 and 7. The upper top of the vaults is made of reinforced concrete, the pavement is made of mass concrete filled with compacted sand. In the original layout of the shelter, the roof contained the doorways to the enclosure and was the only direct contact to the outside, thus achieving greater protection.

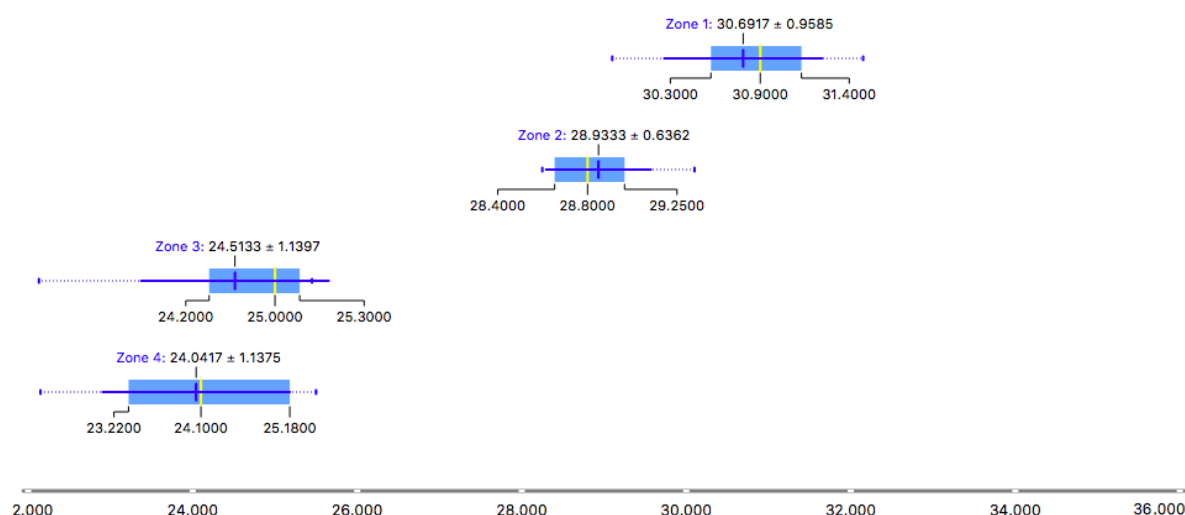
Figure 13. Box Plot zones measures on unburied building.
