International Journal of Environmental Research and Public Health

# Article Impact of Apartment Tightness on Temperature Variability during a Fire

**Keywords:** real-scale fire tests; air tightness of residential apartment; fire environment; temperature variability during a fire; fire in apartment

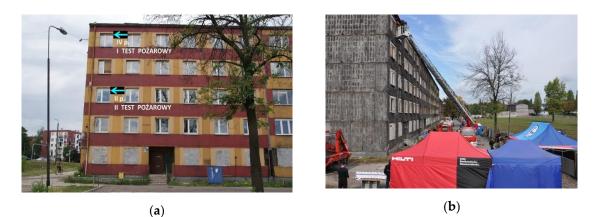
**Figure 1.** Pictures of a residential building at Pocztowa Str. 15 in Bytom from the north, scheduled for fire tests: (**a**) before the removal of facade panels containing asbestos (July 2012); (**b**) on the day of the experiment (20 September 2012).

The experiments were conducted in a residential five-story building situated in Bytom (Silesian District, Poland), which was intended for demolition. It was built in 1976, made in the technology of a prefabricated reinforced concrete slabs (after removing the facade slabs, it turned out that the building was additionally made of aerated concrete blocks, i.e., gray cellular concrete). The pictures of the building before and after removing the facade panels are presented in Figure 1a,b, respectively.

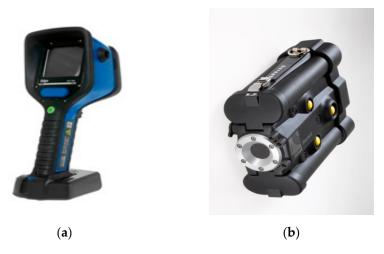
Figure 5. Pictures of two thermal imaging cameras: (a) Dräger UCF 7000; (b) Hornet 320 B.

- 3. MPI-L-16-4-16 analog signal multiplexer with recording function and accuracy in class 1 shown in Figure 4a.
- 4. Dräger UCF 7000 thermal imaging camera shown in Figure 5a. Temperature measurement in the range from -40 to 1000 °C. Resolution 160 × 120 pixels. Thermal sensitivity 0.035 °C. Tightness class IP 67 [19].

- 5. Hornet 320 B thermal imaging camera shown in Figure 5b. Temperature measurement in the range from -20 to 590 °C. Spectrum range 7–14  $\mu$ m. Resolution 320  $\times$  240 pixels. Thermal sensitivity less than 16 mK at f/1.6. Tightness class IP 67 [20].

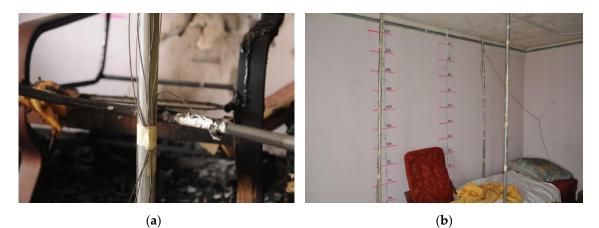
**Figure 8.** Pictures of: (**a**) a thermocouple T3 placed by the armchair after fire test; (**b**) a scale with height levels on the wall.

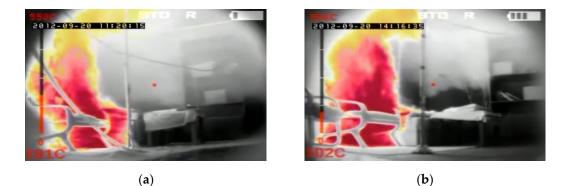
**Figure 14.** Frames from the movie recorded with thermal imaging camera at 180 s of the fire in the: (a) sealed apartment; (b) unsealed apartment.
