Article

Community-Based Portable Reefs to Promote Mangrove Vegetation Growth: Bridging between Ecological and Engineering Principles

Keywords: young mangroves; mangrove restoration; portable reef design; field observation; Amami Oshima

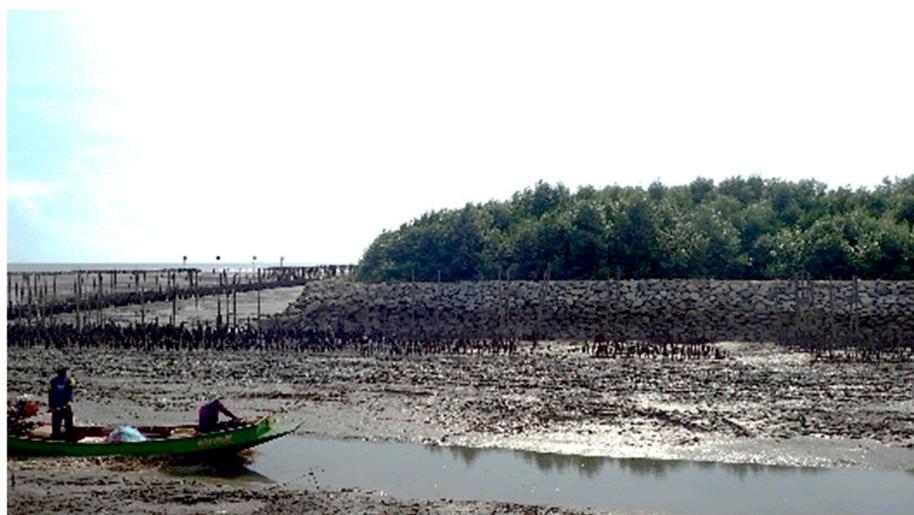
Figure 1. Successful mangrove plantation in Chonburi, Thailand—however, the rubble dike stopped the expansion of the forest [photo taken by one of the authors].

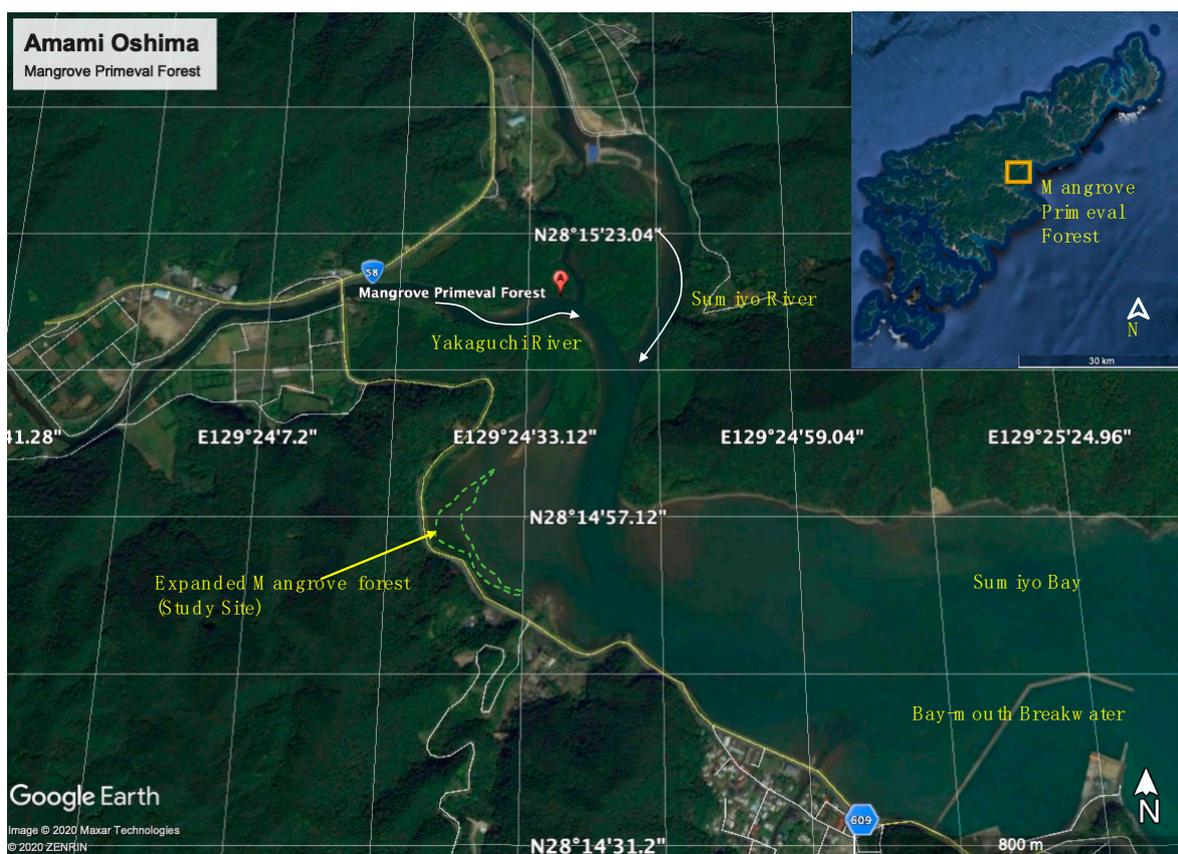
Figure 2. Mangrove study site, which is located at the inner-most part of Sumiyo Bay in Amami (study site location: 28°14'57.3" N 129°24'24.8" E).

tion period, in which the species *Kandelia obovata* in the primeval mangrove forest produces enormous seeds, whereas December is cold, and mangrove growth is not vibrant [43]. A large colony of natural mangroves (*K. obovata*) was identified in Sumiyo Bay of Amami near the inlets of the Yakugachi River and Sumiyo River (Figure 2). As observed in the field survey, mangrove seedlings were transported from the mainstream of the primeval forest and settled on the shallow mudflat with the fast-developing root system. While many mangrove forests are facing degradation in Japan, the primeval mangrove forest of Amami has been expanding for several decades [44]. This mangrove forest is located in areas where the flow of rivers is mild, and the coast is shallow and calm. When the tide recedes, the tidal flat becomes a place where organic matter from the river and the ocean is deposited, providing a habitat for a variety of animals. In addition to the favorable environmental conditions, the expansion of the area may also partially be attributed to the breakwater constructed at the bay mouth, protecting the inner bay area from offshore high waves (Figure 2).

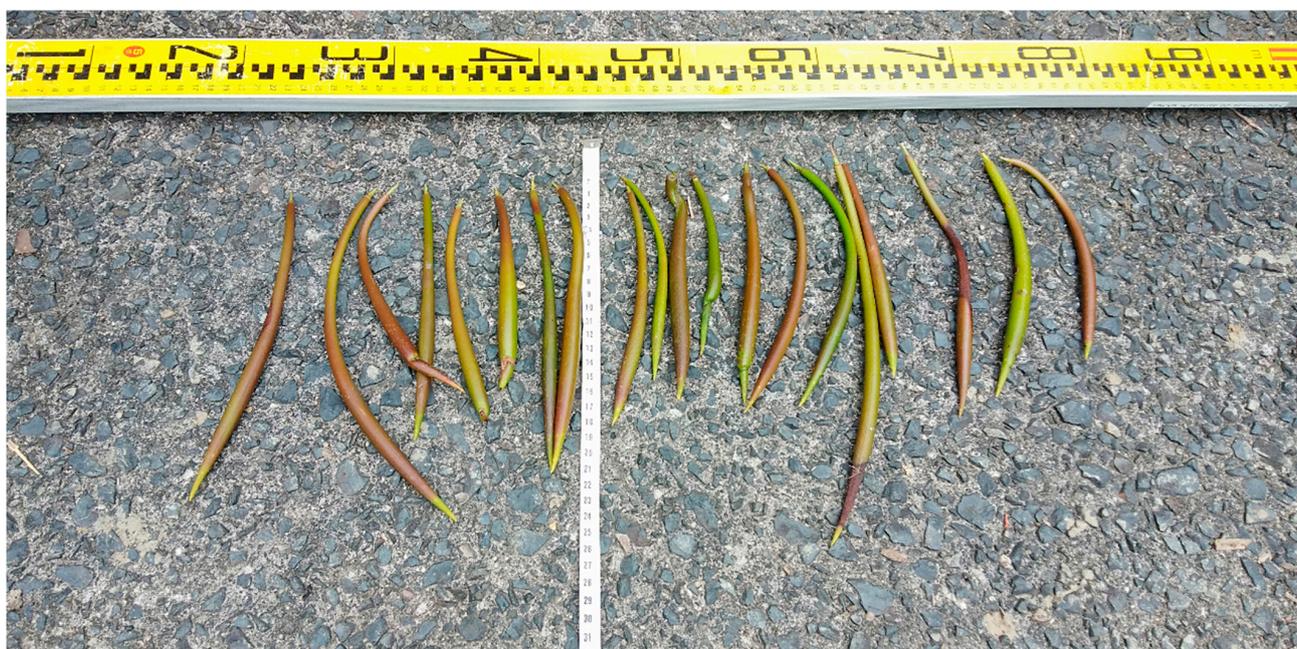
Figure 3. Mangrove seeds (propagules of *K. obovata*) collected in the Amami study site.

During the survey conducted in May, 40 mangrove propagules were collected to measure the size (Figure 3). Half were used for the plantation test in the Amami primeval mangrove forest, and the rest were transported to a laboratory in Tokyo. A topography survey was conducted to measure the ground level within the mangrove zone. The salinity level and water temperature were recorded. An aerial survey was conducted using a drone (Phantom 4 Pro; DJI Technology Co. Ltd., Shenzhen, China) to observe mangrove shrub density in near-shore, midshore, and offshore regions. Drone images were validated with field observations to confirm the densities of the mangrove plants. The elevation of the mudflat was measured using laser range finders (TruPulse 360; Laser Technology Inc., Centennial, CO, USA) (Figure 4). The predominant mangrove species observed in the study site was *K. obovata*, which is a dwarf-type tree often found in India, Singapore, Cambodia, Malaysia, the Philippines, Indonesia, Myanmar, Bangladesh, Thailand, and Vietnam [45]. The genetic and phenotypic segregation suggests that the species *K. candelin* originated from some parts of China and Japan, and it is now classified as a new species, *K. obovata* [46]. This species is often found in the intertidal region of an estuary, which is frequently inundated by tides, like other *Rhizophora* mangrove species [40]. *K. obovata* in the Amami region produces seeds, particularly between the months of May and August, which are suspended by tidal flow to colonize themselves in new locations.

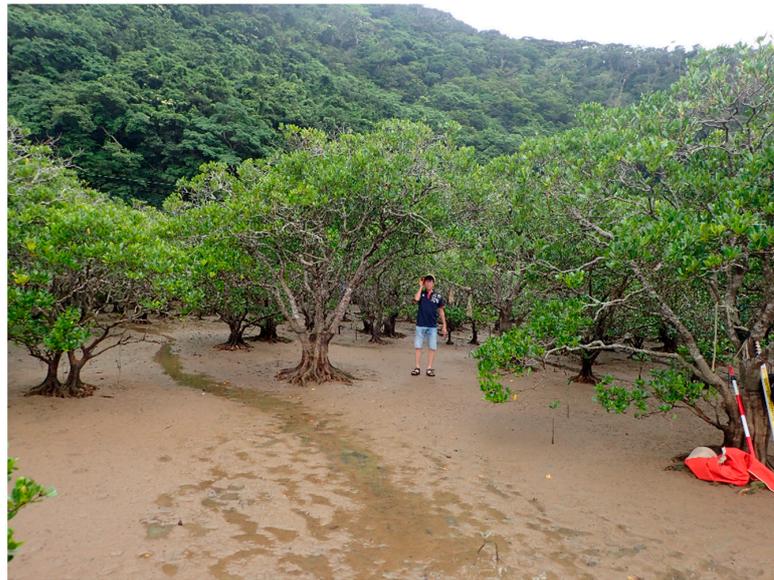
Figure 4. Measurement of the topography in the mangrove forest.

The land slope of a mangrove forest approximately 80 m wide was measured to be as mild as 1/100 on average. This can be considered as a gentle slope but not extremely flat. The density of mangrove plants varied extensively depending on location, i.e., offshore, midshore, and near-shore regions. When approaching the offshore area, it was observed that the number of plants tended to decrease. The lowest mangrove densities were found offshore, where water depths reached half a meter at high tide. Mangrove density was very sparse offshore, whereas 2–4 plants/m² in the midshore and 10–20 small mangrove plants/m² around two matured shrubs onshore were observed, as shown in Figure 5a,b.

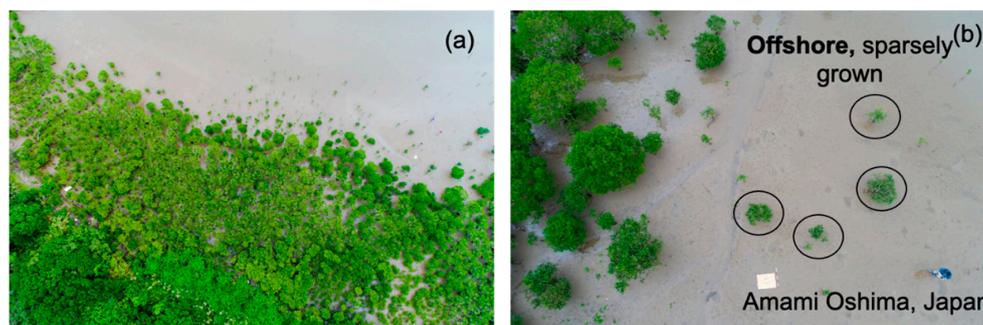
Figure 5. (a,b) Observed mangrove density at the study site in Amami (photos were taken by a drone).

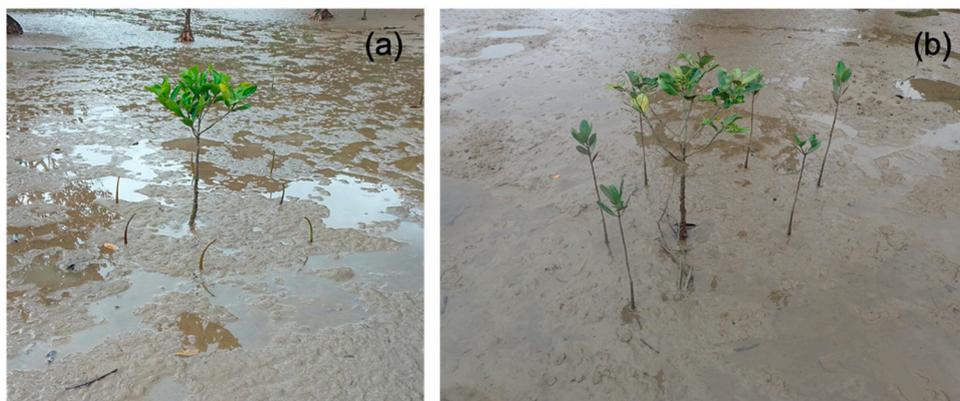
Figure 6. (a) Mangrove seeds planted around a prominent existing mangrove in May 2019 and (b) mangrove plant growth in December 2019.

Figure 6a,b illustrate the plantation of mangroves and their growth from May 2019 to December 2019. Twenty seeds with an initial seedling length of 18.5 cm on average (standard deviation of 3.5 cm) were planted in the offshore zone. The diameter of the seeds varied among the seedlings, with the widest part being 5–10 mm. As shown in Figure 3, some seedlings were completely straight, whereas the others were significantly curved, as observed during the plantation. The color of the seeds varied from green to brownish-green. Of the many plantations, one was made around an existing mangrove plant to clearly identify it during a future survey, as in Figure 6a,b, and the remaining seedlings were planted in nearby locations. In the December 2019 visit, it was found that the survival rate of planted seedlings was 75% (15 out of 20 seeds). Hydrological disturbances, such as high waves, unusual tides, and currents, especially during the typhoon season (July to October), can result in the uprooting of seedlings in soft sediments. Fortunately, however, no strong typhoon approached Amami during the half-year of this survey. Nevertheless, the five seedlings died or washed away for some reason. Various microbial organisms, such as bacteria, fungi, viruses, nematodes, and insects [47], and abiotic factors, such as high salinity levels and low and extremely high temperatures, could have adversely affected the growth of the mangrove plants [2]. The loss may also have been caused by sapling damage by animals, e.g., sea crabs, which selectively eat young seedlings. The water temperature and salinity level in May 2019 were 28.3 °C and 8‰, respectively, while the temperature reduced to 26.1 °C and the salinity increased to 19‰ in December 2019. The rise in salinity may have been because the water discharge from the two rivers is higher in spring than in winter. The precipitation chart is shown in Figure 7, which also supports the observation that salinity levels might have varied because of the difference in precipitation, which is higher in the rainy season (around June) and lower in the winter season (around December).

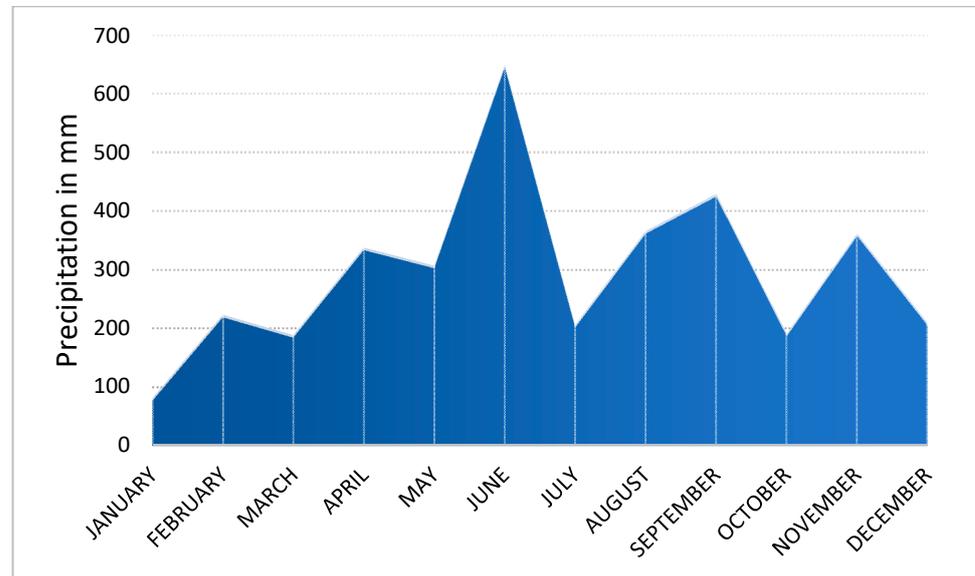
Figure 7. Monthly precipitation in 2019, recorded at Naze WMO Station in Amami (Lat 28°22.7' N Lon 129°29.7' E)—source: Japan Meteorological Agency.

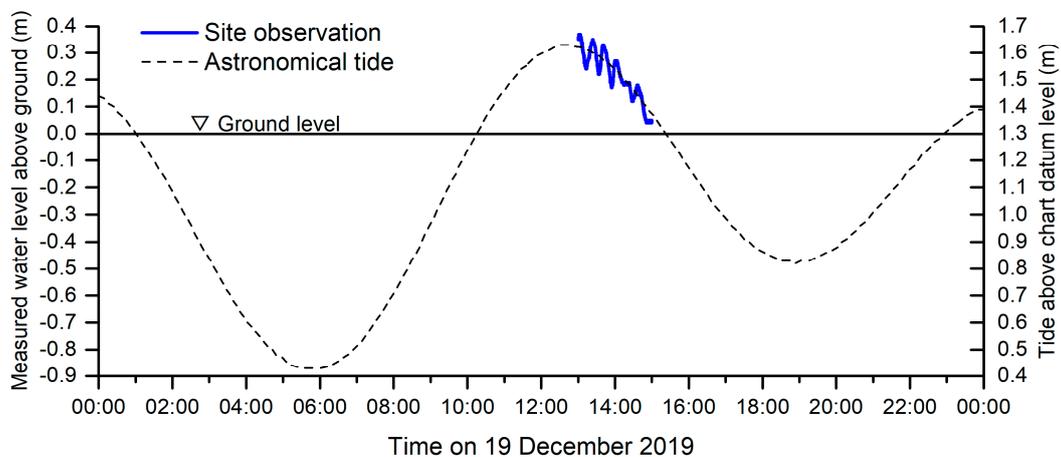
Figure 8. Water levels recorded at 1-s intervals for approximately 2 h (19 December 2019) presented in coordination with local astronomical tide data of the day.

Figure 8 depicts water levels and their fluctuations in the study site, recorded using the pressure sensor, on the one-day cycle of the predicted astronomical tide of the bay. The water level fluctuates in correspondence with astronomical tides. It dropped from nearly 0.4 to 0.05 m above the ground level in 2 h, between high to medium tidal ranges. This observation was conducted on a half-moon day during a medium tidal phase. However, the actual water level oscillated with a short period of approximately 20 min on top of the tidal curve. Although it has not been confirmed, this seems to be a sort of seiche that occurs in the bay. As a result, actual currents in mangrove forests may be faster than those induced by pure astronomical tidal forcing. However, the maximum velocity measured in the field was approximately 10 cm/s. This is significantly slower than the velocity generated in a tidal-dominant river mouth where a tidal current of more than 1 m/s often occurs [48].

Because the water depth is very shallow in the study site, frictional effects are believed to be responsible for a significant reduction in flow speed. This level of tidal currents is considered to be less impactful to young mangroves.

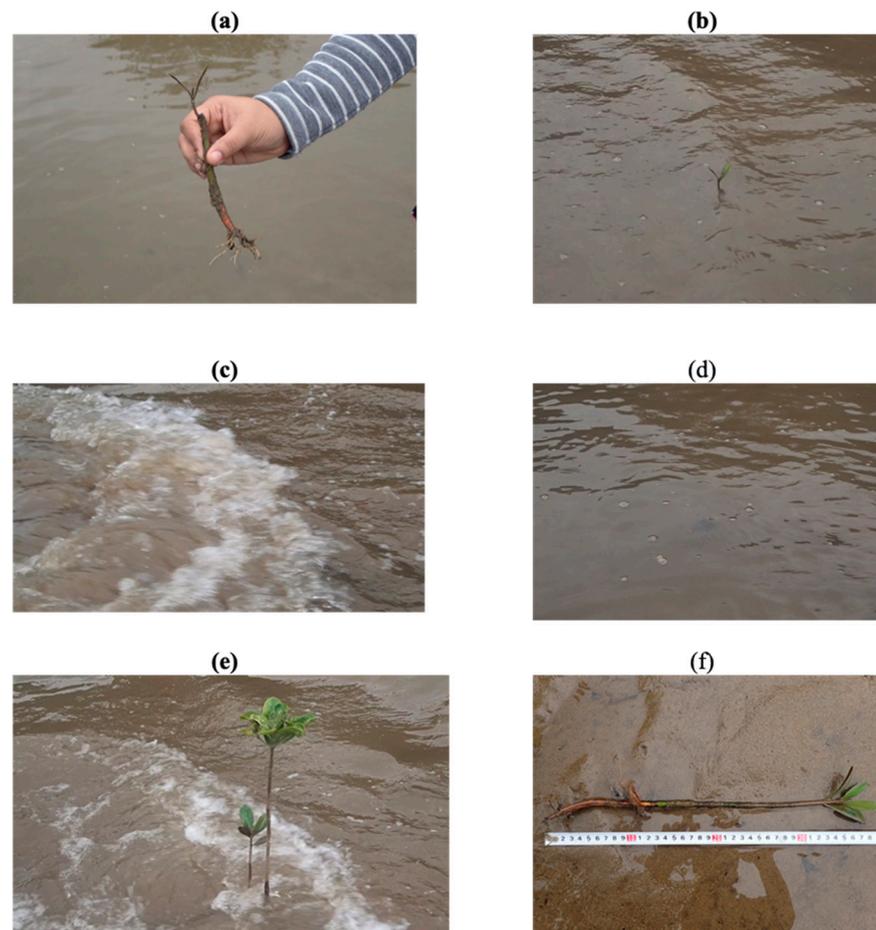
Figure 9. On-site manual wave generating test: (a) one-month mangrove, (b) before the wave test, (c) during the wave test, (d) after the wave test, (e) half-year-old and one-year-old mangroves during the wave test, and (f) half-year-old mangrove pulled out.

In the December survey, an in situ wave experiment was conducted to observe the strength of plants against waves. Waves were manually generated with a paper board for approximately 2 min, which impacted different age groups of plants, such as a month, a half year, and one year. The purpose of this test was to verify the differences in response to waves and critical wave height among the three young mangroves in different growth stages. The maximum wave height during manual wave generation was estimated to be approximately 10 cm through visual analysis with a video image. Figure 9a shows a 17-cm-long one-month-old mangrove that had two leaves, a short main root of approximately 2 cm, and thin subroots. The plant was mostly submerged during the test (Figure 9b). The one-month-old plant was broken entirely and submerged by a 2-min continuous-wave impact, as in Figure 9c,d, whereas a half-year-old and one-year-old mangrove 39 and

80 cm in height, respectively, survived without visible damage, as shown in Figure 9e. The six-month-old mangrove plant shown in Figure 9f developed a stiff root system with a length of one third the total plant length. Hence, it was firmly rooted in the sediment and could withstand the waves. The field investigation revealed that mangroves in the very early stage of growth (a few months) were particularly weak, whereas a half-year-old or older mangrove can sufficiently withstand moderate waves. Thus, special protection is required to protect mangrove seedlings from high waves in the initial two to three months. As a rough estimate, the failure limit of mangroves is considered to be a wave height of 0.1 m, which was used as a basis for the structural design of a portable reef.

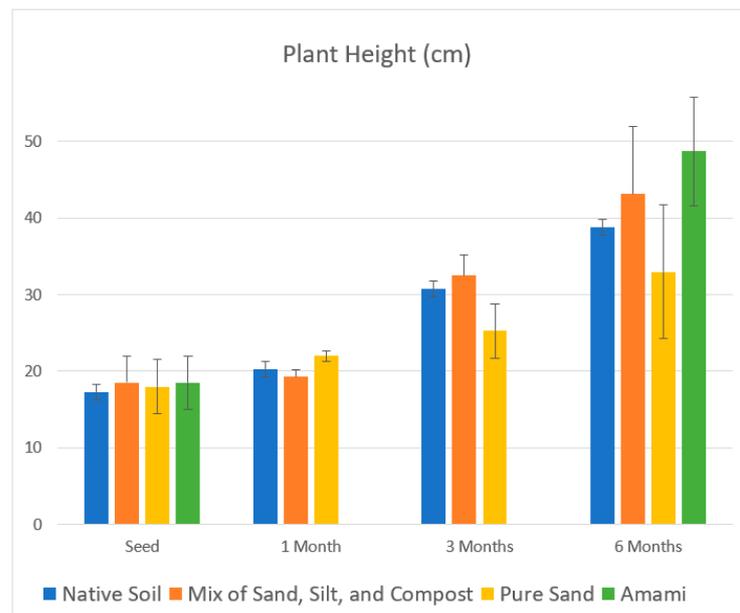
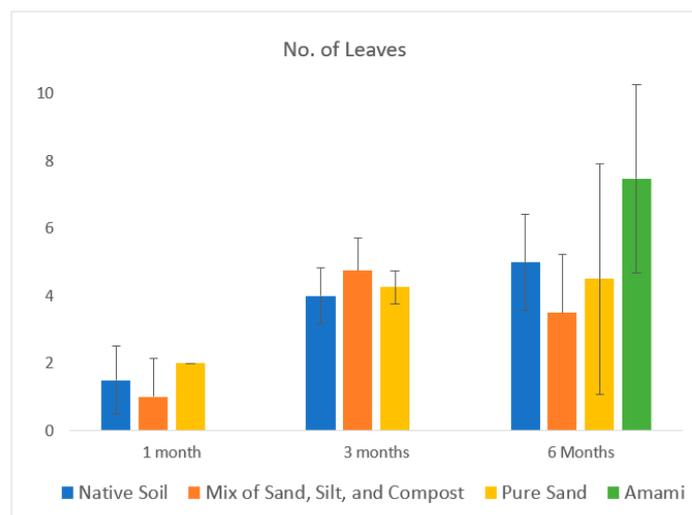
Figure 10. (a,b) Average mangrove growth in terms of height above the soil and the number of leaves recorded during six months in the laboratory: error bars indicate the range of minimum to maximum.

Figure 10a,b illustrate the mangrove evolution in terms of plant height and number of leaves in the laboratory. Mangrove growth was also measured six months after plantation at the Amami research site, as shown in Figure 6b, and compared with the sixth-month growth of plants in the laboratory. In the laboratory in Tokyo, the growth of the mangrove plant was observed for six months, and measurements were taken for the first, third, and sixth months. Pregerminated mangrove seeds (propagules) brought from the site were planted to observe their growth in different soil states: native soil, a mixture of sand, silt, and compost, and pure sand. The growth of mangroves was observed and measured in terms of the average height and the average number of leaves with standard deviations, as shown in Figure 10a,b. Pictures of propagule growth were taken at zero, one, three, and six months of laboratory plantation, as shown in Figure 11a–d. Although the initial

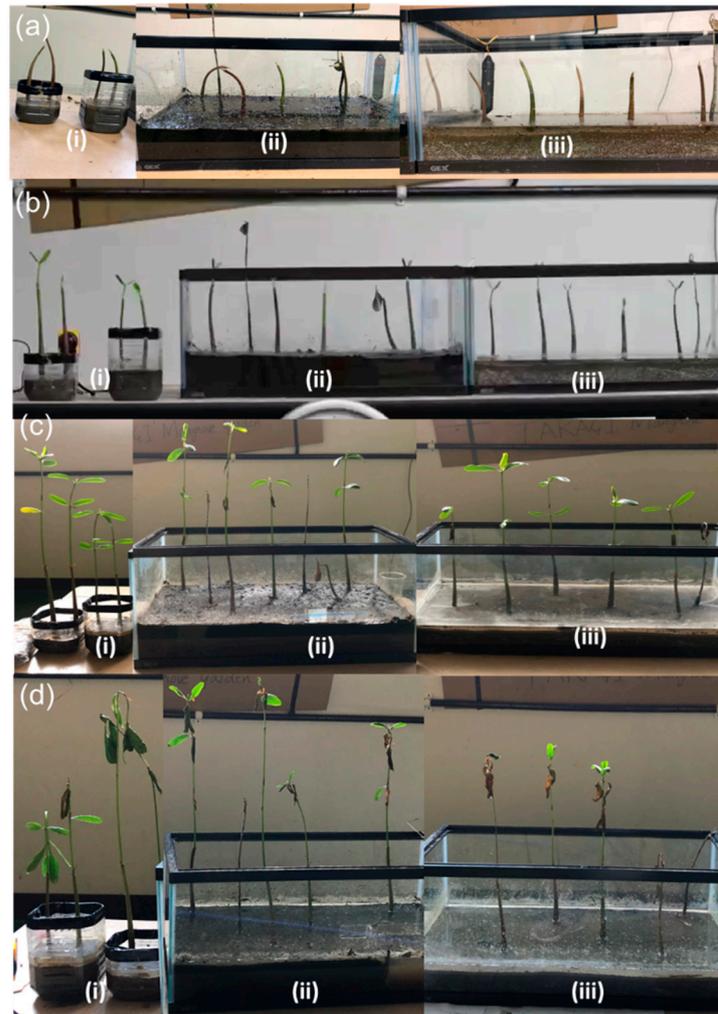
Figure 11. Growth of laboratory mangroves in (i) native soil, (ii) mix of sand, silt, and compost, and (iii) pure sand (a) on day of the plantation (5 June 2019), (b) after one month (10 July 2019), (c) after three months (9 September 2019), and (d) after six months (10 December 2019): an example of the growth record has been uploaded as a time-lapse video at <http://www.ide.titech.ac.jp/~takagi/Labmangrove.html>.

growth was similar among the three soil types, the fastest plant growth was observed in the mixture of sand, silt, and compost after six months. Two plants in the mixture soil had withered at the end of the sixth month, despite showing good growth until three months. The average height of mangrove plants in Amami was 49 cm, with an average of 7.3 leaves per plant, as in Figure 10a,b, while indoor plants demonstrated growth of a height of 38.5 cm with the number of leaves up to 4.3 on average. The laboratory-grown plants were 21% lower in height than the plants grown in Amami. Similarly, the average number of leaves after six months was 41% lower than that of the plants at the Amami research site. The laboratory-grown plants appeared weak, and the stems turned and bent downward, as shown in Figure 11d. The plants grown in native soil looked healthiest among the three soils.

The germination of seedlings began with the development of the stem with a pair of leaves in the first month in all soil media, as shown in Figure 11b. After the third month, the

average height of plants in all soil media was 28 cm above the soil surface, with an average number of leaves of 3.5. The average height and number of leaves grown in mangrove plants in all types of soil medium at the end of the sixth month were 38.3 cm and 4.3, respectively. The average increase in plant height and number of leaves in all soil media in the first, third, and sixth months were 3.7, 7.7, and 9.7 cm and 2, 1.5, and 0.8, respectively. With the arrival of new leaves, the plants lost their older leaves, which turned yellow and withered before dropping off see Figure 11c,d. Loss of leaves and decrease in leaf growth indicate lower leaf health because of environmental stresses [43]. This is probably because of the low temperature in November and December, as shown in Figure 12.

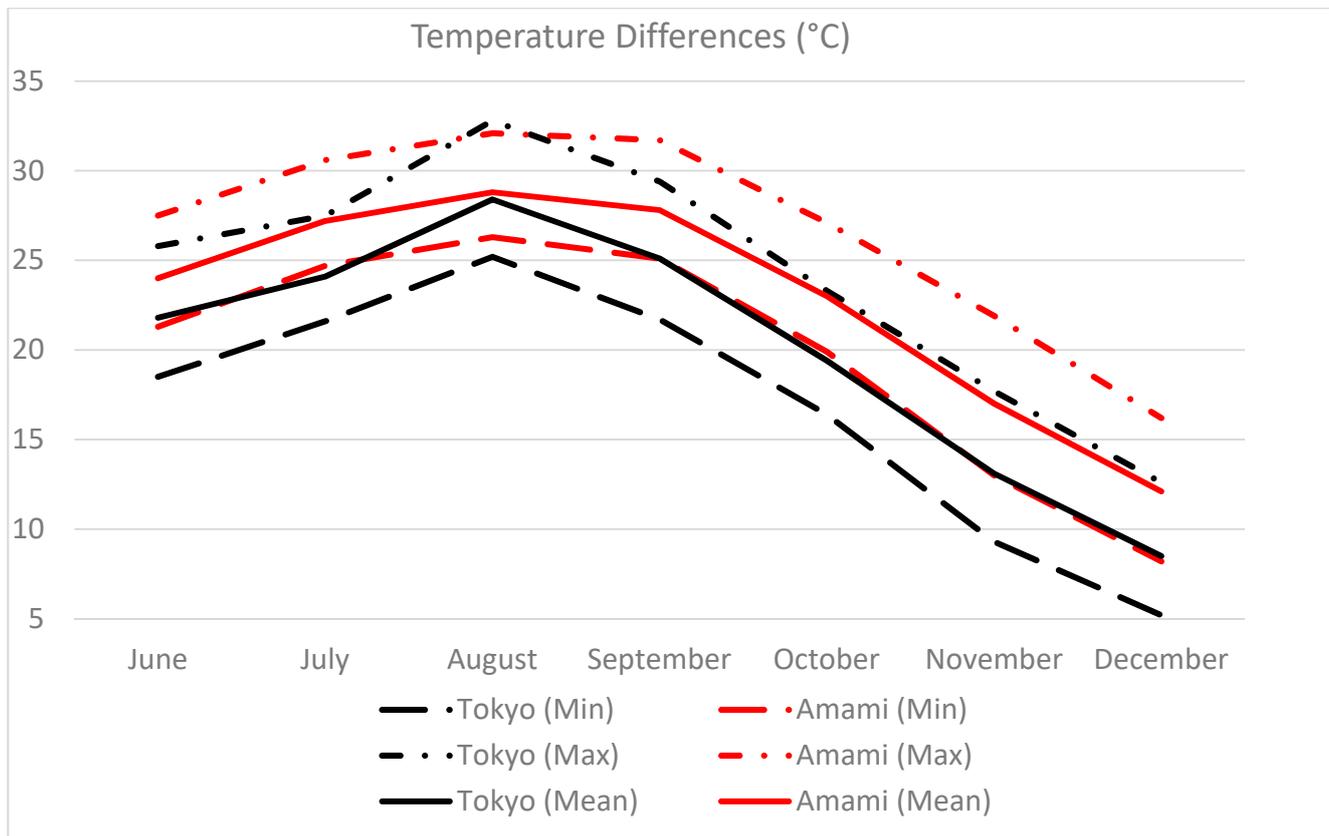
Figure 12. Comparison of average minimum, mean, and maximum temperatures between Tokyo and Amami (Kagoshima Prefecture)—source: Japan Meteorological Agency.

The air temperature differences in Tokyo and Amami for the period of six months from June to December 2019 are shown in Figure 12. On average, the temperature in Amami was 2.8 °C higher than in Tokyo. However, the maximum temperature in Tokyo (28.8 °C) was 0.4 °C higher than that in Amami (28.4 °C) in August. In December, the average temperature dropped to 8.5 °C in Tokyo, while that in Amami was 12.1 °C. The cold weather during the early winter season probably retarded the growth of mangrove plants and resulted in the withering of the leaves.

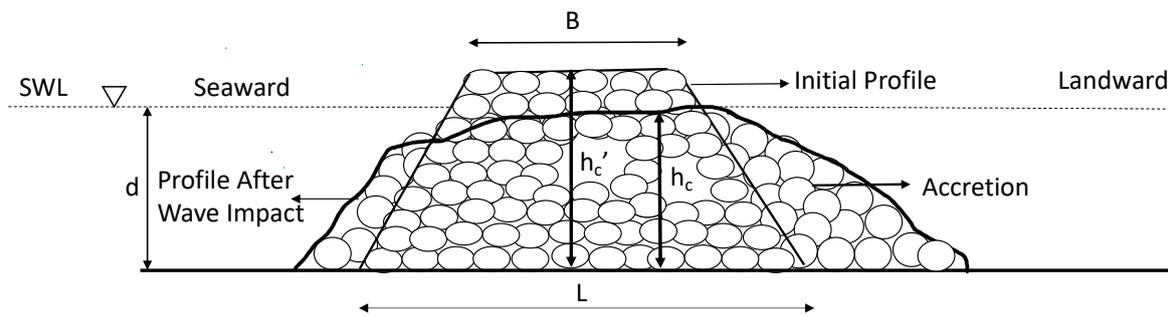
Figure 13. Typical reef profile before and after damage, adapted from Ahrens (1989) [58].

However, it is essential to allow deformation of the system to some extent, particularly in the case of smaller stones. Hence, the formula obtained by Ahrens [59], which designs a low-crested rubble-mound, reef-type breakwater without a multilayer cross section, was applied. Figure 13 illustrates the concept of the low-crested breakwater. Here, h_c' is the initial crest height, and h_c is the crest height at the end of the wave impacts, based on an empirical equation from the experiment. In addition, B is the crest width (three median stones wide: $3D_{n50}$). The stability can be examined by considering the crest height that sunk as a result of continuous wave impacts.

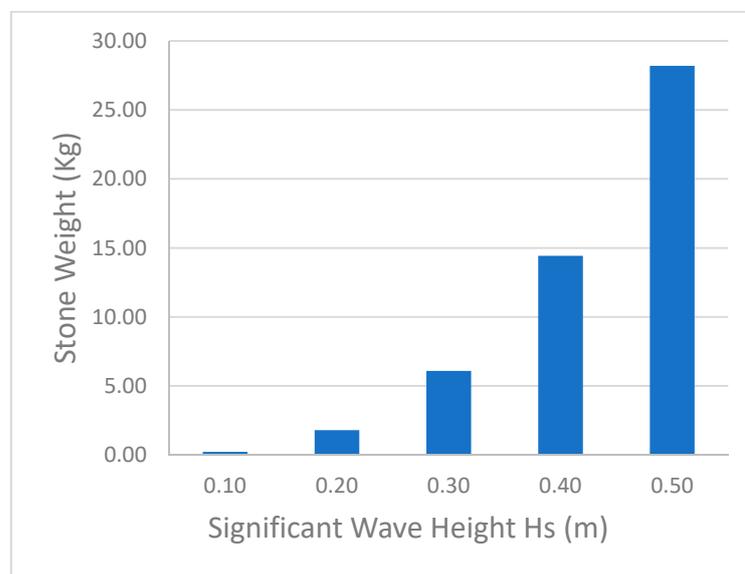
Figure 14. Required weight of single stone against a given wave height.

Equation (1) is analyzed for the range of significant wave heights (H_s), with K_D being 1.2 for quarry stone, smoothly rounded for breaking waves [57]. Here, γ_s is taken as 2800 kg/m^3 , and the slope of the structure is considered to be 1V:2.5H, leading to a slope angle α of 21.6° . The relationship between H_s and the armor unit weight is plotted in

Figure 14. When 0.3 m is used as the design wave height, the lowest stone weight is calculated to be approximately 6 kg.

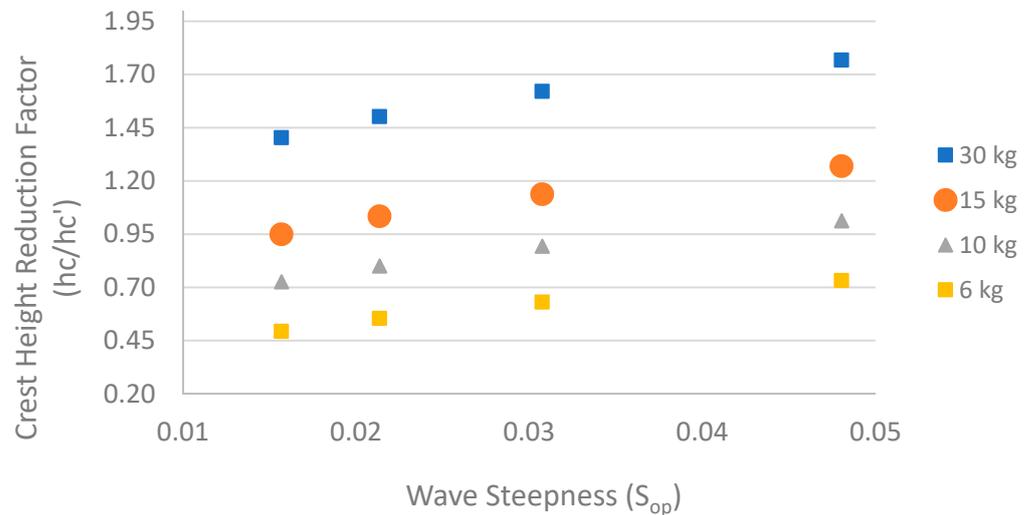
Figure 15. Crest height reduction factor (h_c/h_c') versus wave steepness (S_{op}).

Here, A_t is the structural cross-sectional area ($Bh_c' + C'h_c'^2$), C' is the average structural slope, N_s is the spectral stability number, B_n is the bulk number, and d is still water depth. Short wave periods in the range between $T = 2$ and 3.5 s are assumed to calculate the wavelength $L = \sqrt{gd}T$ and wave steepness $S_{op} = 2\pi H_s / gT^2$. The deformation in crest height (h_c) can be estimated using Equations (3) and (4). Figure 15 shows a graph of the crest

height reduction factor (h_c/h_c') versus wave steepness. If h_c/h_c' exceeds 1, the structure is fully stable, whereas, when h_c/h_c' drops below 1, the structure is less stable [57]. The structural stability increases with the increase in wave steepness. A stone weight more than 15 kg showed $h_c/h_c' > 1$, indicating a stable condition for the design wave. Hence, for the design considerations of stone, a weight of 15 kg can be used as an optimal weight, rather than 6 kg.

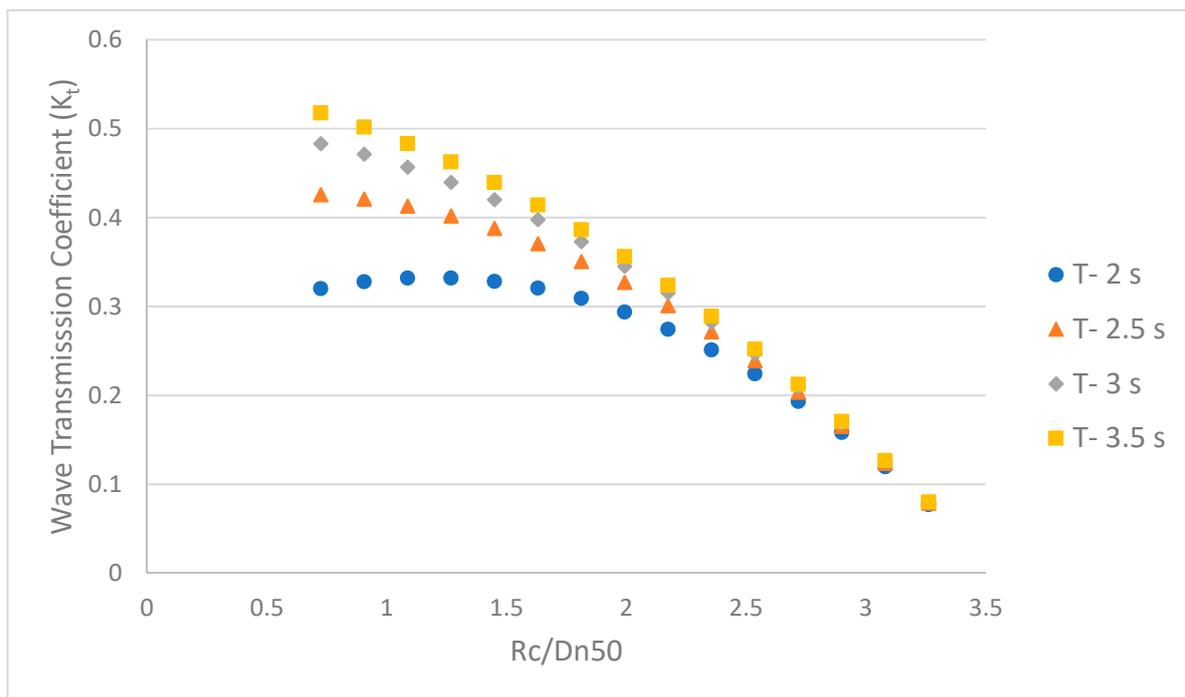
Figure 16. Wave transmission versus relative crest height.

Here, K_t is derived for the proposed portable reef design (Figure 16). The K_t value markedly varies with the change in the relative crest height (R_c/D_{n50}). The minimum K_t and maximum K_t expected of a portable reef breakwater fall between 0.07 and 0.51 for wave periods of 2 to 3.5 s. The lower the relative crest height, the higher the transmission. The lower the height of the breakwater, the smaller the stone volume required. However, a reduction in the freeboard increases the transmission of the waves and adversely affects the growth of mangroves. In the field experiments in Amami, it was found that mangroves of approximately one- or two-month-old plants were washed away by waves, even at a wave height of approximately 10 cm. Hence, K_t needs to be set below 0.3 in the case of a wave height of 30 cm at the portable reef.

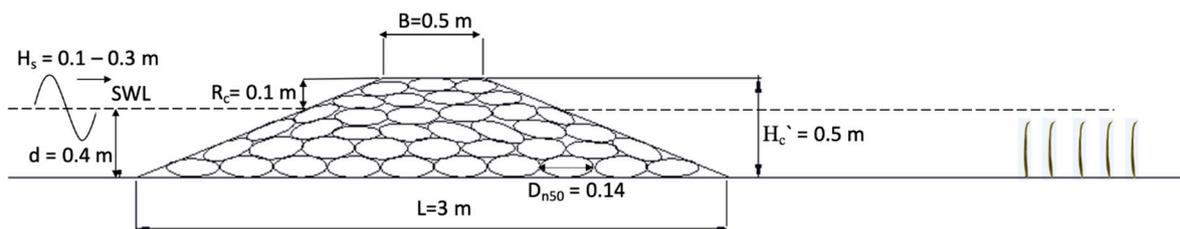
Figure 17. Example of a portable reef and mangrove planting.

As a result of these considerations, the breakwater cross section shown in Figure 17 was selected as one of the candidates to form the entire reef system as simply and feasibly as possible for the local community. The total number of stones needed to form a trapezoid per cubic meter was estimated as 145 (average of 15 kg each). Because of the low weight of the stone, construction can be accomplished without the use of heavy machinery if several workers collaborate. This is an advantage in areas where the ground is loose, such as where mangroves grow. There is a possibility that the reef top may sink a little bit owing to settlement, but it will be easy to replenish. A mangrove plantation is implemented after the reef is installed. However, plants may be washed away because of the disturbance caused by wave overtopping if planted immediately behind the reef. Therefore, it is recommended to maintain a certain distance between the reef and the plantation. It is necessary in future research to investigate how much distance is needed.
