Article

Vinyl-Asbestos Floor Risk Exposure in Three Different Simulations

Citation: Zichella, L.; Baudana, F.; Zanetti, G.; Marini, P. Vinyl-Asbestos Floor Risk Exposure in Three Different Simulations. *Int. J. Environ. Res. Public Health* **2021**, *18*, 2073. <https://doi.org/10.3390/ijerph18042073>

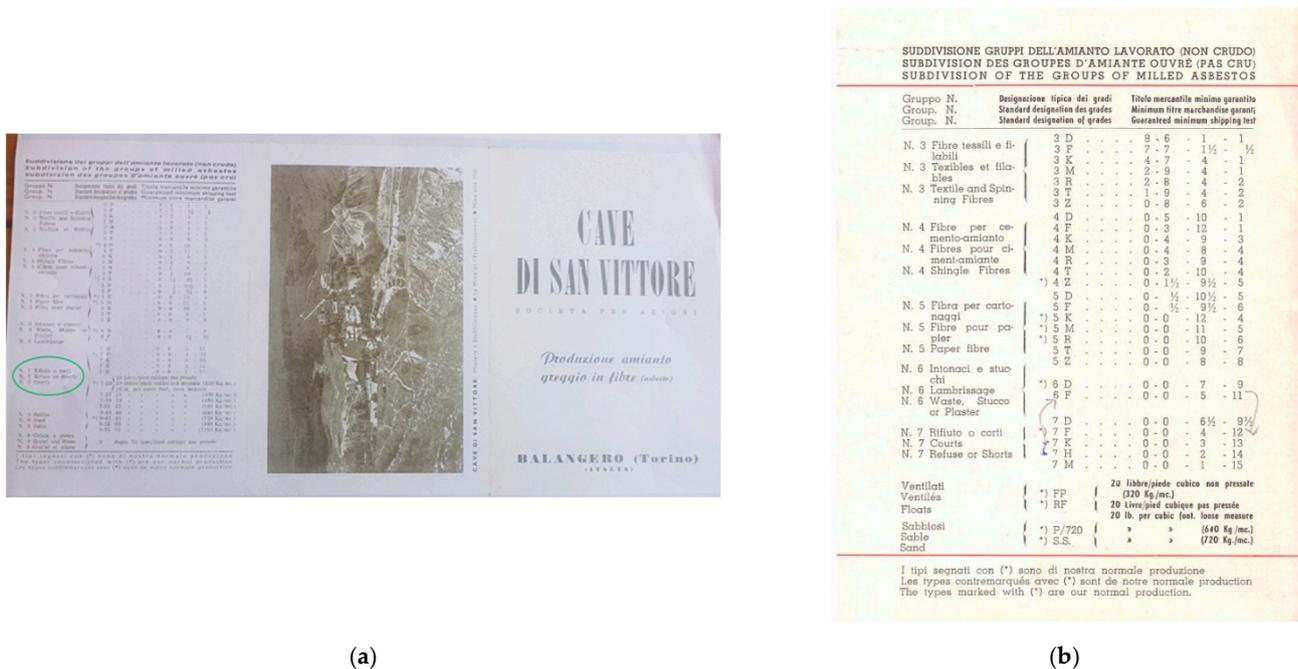
Figure 1. (a) San Vittore (Balangero, Turin, Italy) quarry, flyer extract for asbestos fiber production. Asbestos group 7 is circled in green, probably used for vinyl-asbestos floor. (b) Particularities of the subdivision of the group of milled asbestos (source: https://it.wikipedia.org/wiki/Amiantifera_di_Balangero; accessed on 10 January 2021).

From documents kept at the DIATI (Department of Environmental and Infrastructure Engineering) asbestos laboratory of the Politecnico di Torino, the asbestos fibers used for the production of vinylasbestos, produced in the San Vittore (Balangero, Piedmont, Italy) asbestos mine, as it is shown in the flyer of the mine products (Figure 1) were of Grade 7 [1]. The length of the asbestos fibers of Grade 7 were <10 mesh (corresponding to <2 mm) and this was the typology of asbestos fiber with the lowest economic value. Among all the different types of asbestos of industrial use (Actinolite, Amosite, Anthophyllite, Chrysotile, Crocidolite, Tremolite, according to the experience in the DIATI asbestos laboratory of the Politecnico di Torino, after more than 500 analyses on vinyl asbestos samples, the only one asbestos detected in vinyl tiles was Chrysotile.

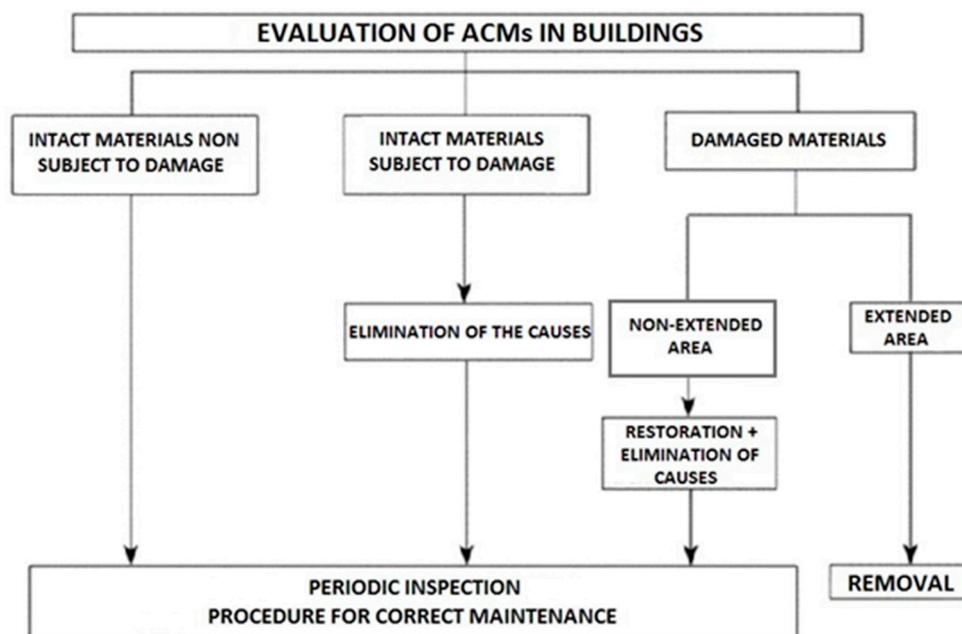
Figure 2. Evaluation scheme of asbestos-containing materials (ACMs) in building and recommendations (from Article 1, Annex: Standards and Technical Methods for Risk Assessment, Control, Maintenance and Remediation of Materials Containing Asbestos Present in Building Structure, Risk Assessment, Table 2 of M.D. 6/9/94 [4]).

Figure 2 describes the different situations that can occur during the evaluation of ACMs in buildings and the related recommendations in these different cases required by M.D. 6/9/94 [4].

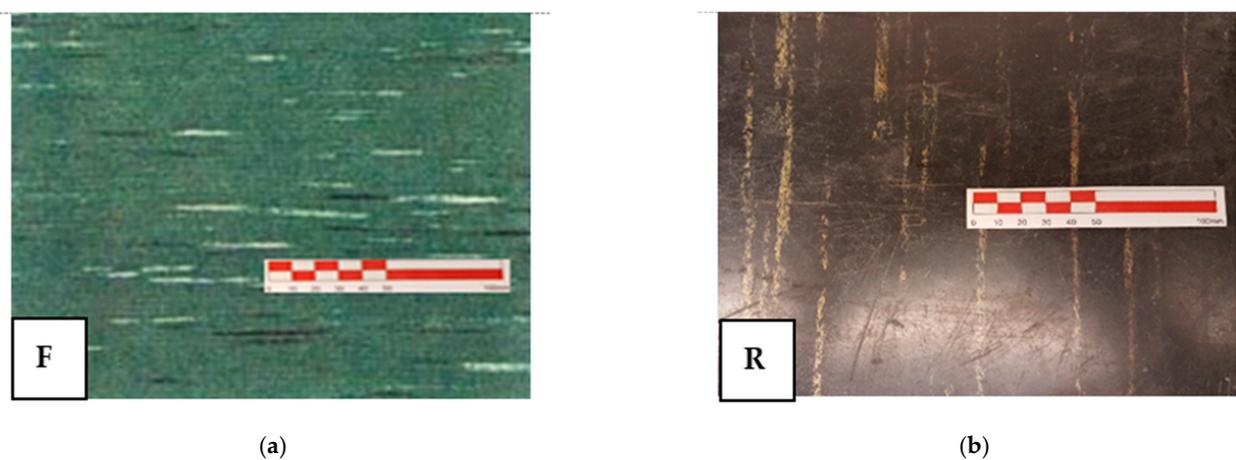
Figure 3. (a) Sample F—squared floor green tiles with white and black stripes, more flexible and in good condition (b) Sample R—squared floor black tiles with beige stripes, quite rigid and in fairly good condition.

The prevalent use of vinyl floors containing asbestos was in public buildings and popular housing. In this context, two types of vinyl from public buildings have been considered. In Figure 3, they are shown macroscopically. The green vinyl (F) on the left was laid in the 1990s and shows a flexible structure. The black vinyl (R) on the right was laid in the 1980s and shows a more rigid structure.

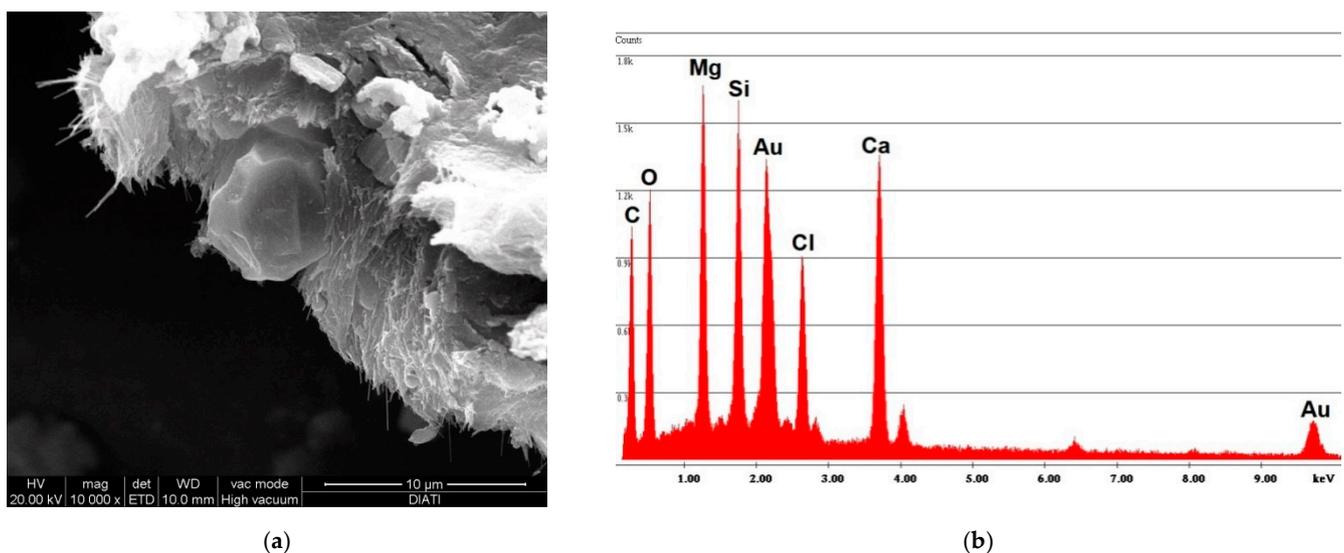
Figure 4. F sample SEM analysis. (a) Photo of incorporated fibers of chrysotile; (b) spectrum of chrysotile and vinyl chloride composition.

The simple abrasion of surface tile powder was analyzed with SEM/EDS; Figure 4 shows the spectrum obtained by analyzing the powder from vinyl F. The photo on the left shows how the fibers are completely incorporated within the vinyl matrix. The spectrum shows both of the elements that compose chrysotile, Mg and Si, where the Mg peak is greater than the Si peak; the spectrum also reports the elements that compose the vinyl matrix, Cl and Ca.

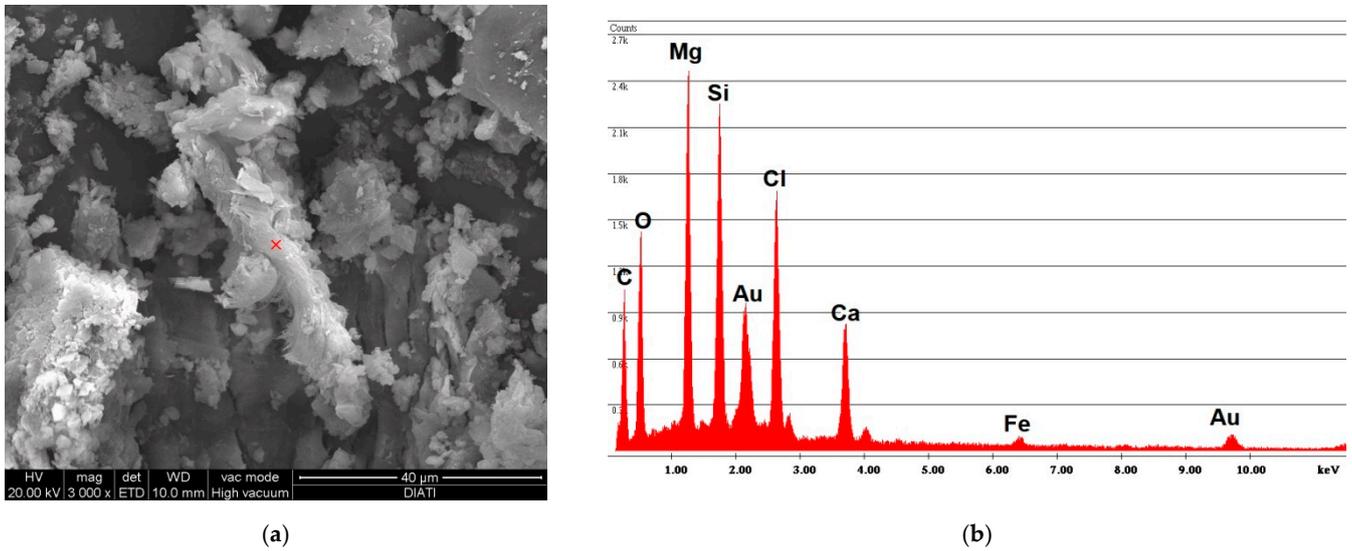
Figure 5. R sample SEM analysis. (a) Photo of incorporated fibers of chrysotile; (b) spectrum of chrysotile and vinyl chloride composition.

Figure 5 shows the same analysis, performed on the powder obtained from the vinyl sample R. In addition, in this case, the fibers are incorporated in the vinyl matrix; the spectrum confirms this aspect due to the presence of Mg and Si components of the chrysotile.

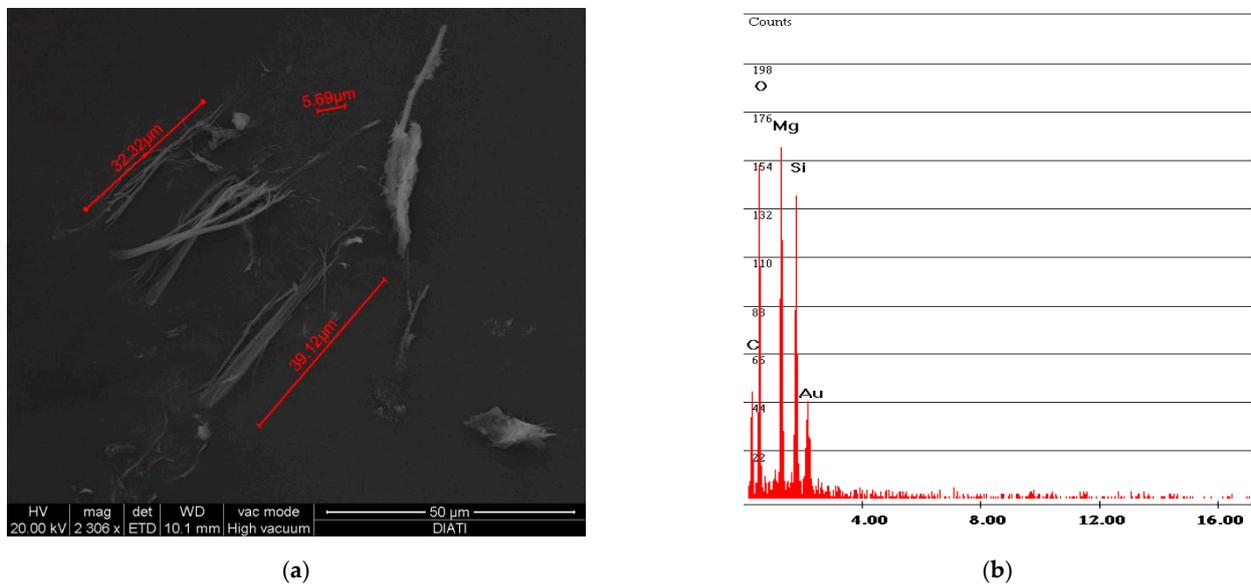
Figure 6. F sample SEM analysis. (a) Photo of free fibers of chrysotile with measurement values; (b) spectrum of chrysotile.

Figures 6 and 7 show the free fibers obtained, respectively, from samples F and R. The measurements of the fibers of both samples are in line with the particle size dimension declared by Petry US Patent [2], that is, below 2 μm . A difference can also be observed between the particle size dimension of sample R and sample F: the older and more rigid sample R has smaller fiber sizes than sample F.

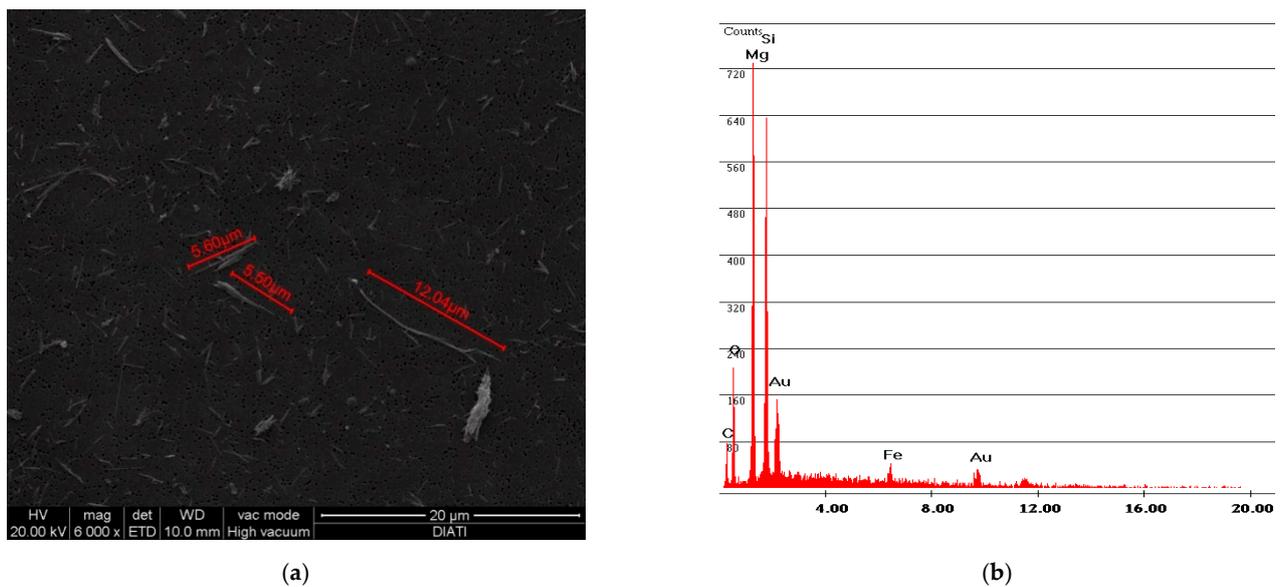
Figure 7. R sample SEM analysis. (a) Photo of free fibers of chrysotile with measurement values; (b) spectrum of chrysotile.

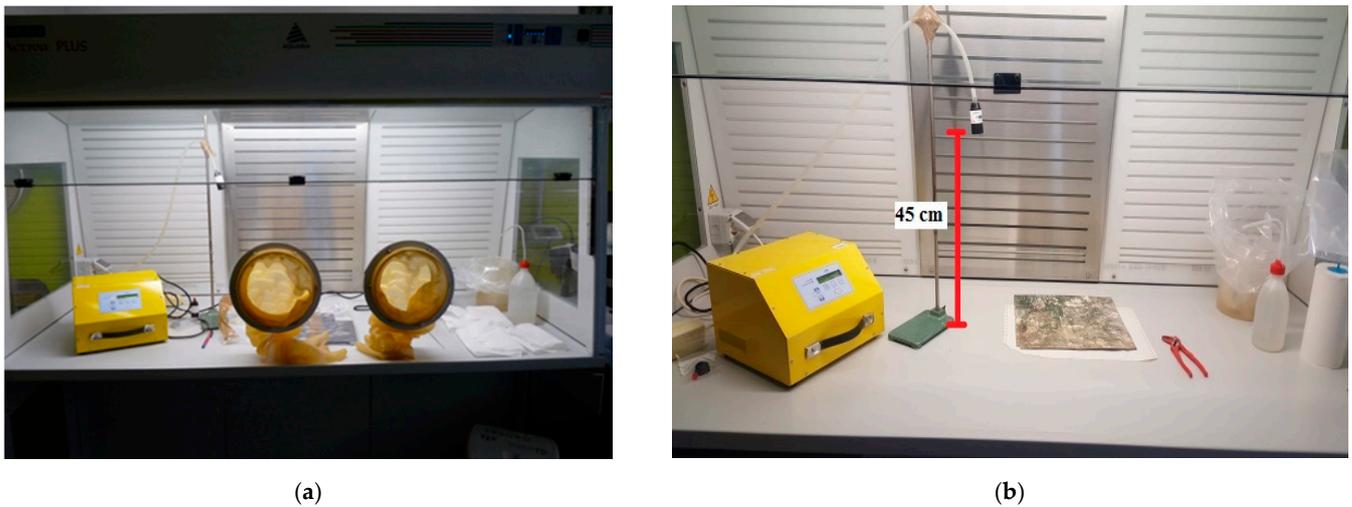
Figure 8. (a) Confined hood with gloves for simulation tests. (b) The airborne retrieval through a polycarbonate membrane.

Figure 8 shows the preparation of the hood to carry out the tests. All tests were performed safely in a confined environment using a glove box with the fan off. Airborne sampling was done with a polycarbonate membrane at 45 cm from the table. Between tests, a cleaning of the hood and an airborne analysis was always been carried out to verify the cleanness of the hood to avoid contamination.

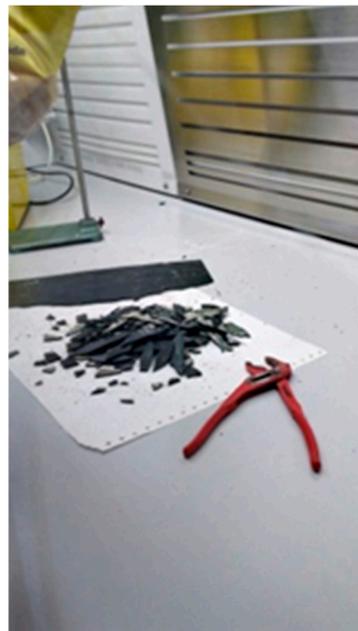
Figure 9. Multigrip plier breakage test.

During the sampling phase for the ACM mapping, a piece of tile is detached manually. This procedure must normally be carried out wet. The purpose of this test, however, was to check whether there is a release of fibers during this ACM sampling phase. In this case, the test was carried out in a confined environment, with multigrip pliers in dry condition (Figure 9). The duration time of the test was 15'. The airborne samples were then analyzed with SEM/EDS.

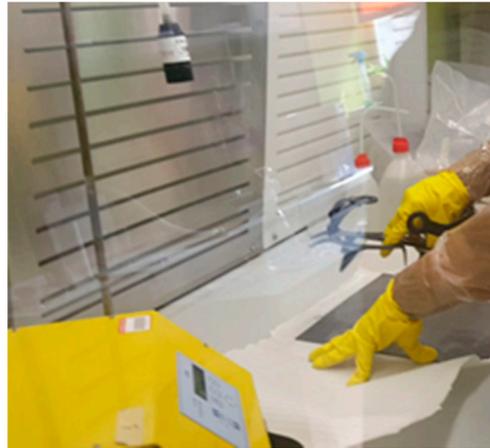
Figure 10. Vinyl tile crampon test inside the confined hood.

A vinyl floor is subject to pedestrian traffic. This test was carried out using NiCrMo steel crampons (Camp_Cassin brand (Premana, Italy)) with Hardness HRC (Rockwell scale) $53 \div 58$, to simulate the pedestrian traffic with impact and drag. The test was performed with 100 crampon shots (impact and drag) by the same operator in ten minutes. This test was performed manually from about 40 cm in height by letting the crampon fall without applying force. The number of shots could underestimate the wear carried out over time by the pedestrian traffic, but the hardness of steel is greater than any shoe worn, therefore, a possible release of fibers during the test can be representative. Figure 10 shows the performed test.

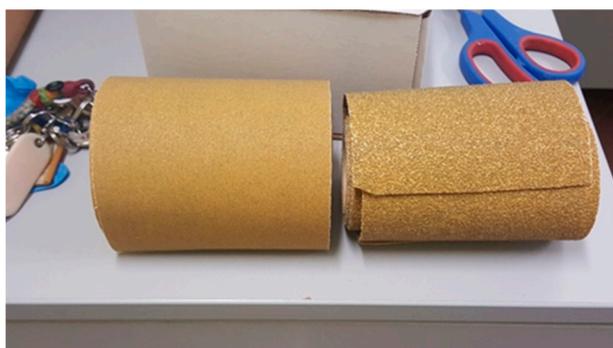
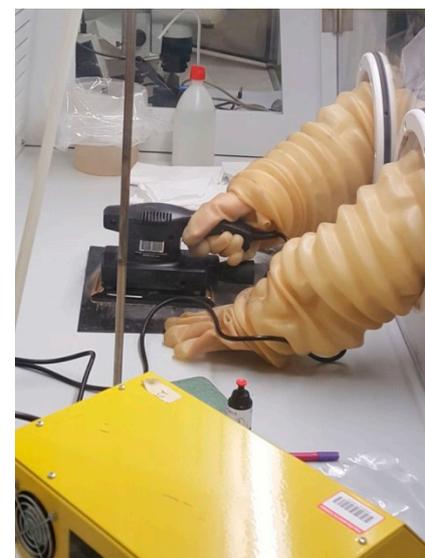
Figure 11. (a) Sandpaper used for the test. Left: fine sandpaper (dimensions: P120). Right: coarse sandpaper (dimensions: P40). (b) Performed mechanical abrasion test inside the confined hood.

In the present study, a strong mechanical abrasion of R and F vinyl tile samples was carried out using two types of sandpapers, one with a fine grain of P120 and one with a coarse grain of P40 (Figure 11). The abrasion time for each sample was 5 min.

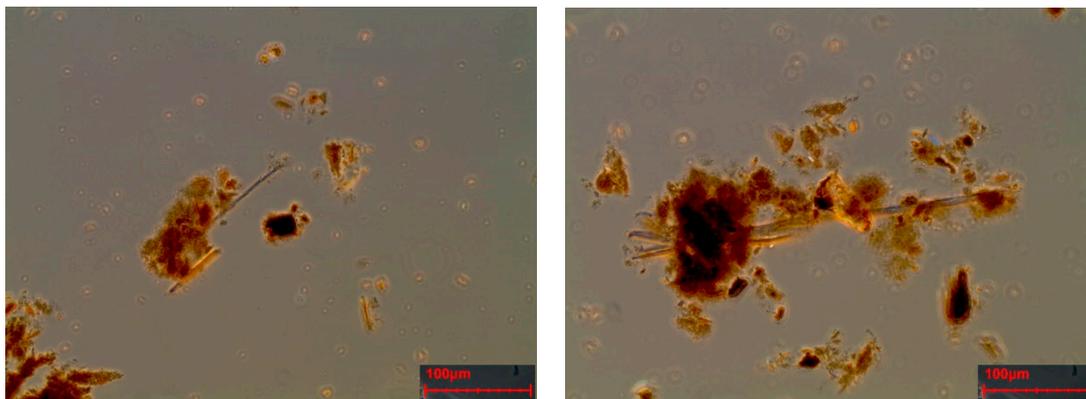
**Figure 12.** Phase-contrast microscope (PCOM) photos of the powder obtained by means of abrasion test. Chrysotile fiber with part of the vinyl glue remain attached.

The simulation tests performed on the two vinyl floor samples provided the airborne analysis for a quantitative evaluation of any release of asbestos fibers (free asbestos content). The release of free fibers into the powder, obtained from abrasion test was also quantitatively assessed (last column Table 5). The values obtained confirm, as shown in the D.M., that the percentage of chrysotile present in the vinyl flooring is in a range between 10% and 12% [3,4]. In Figure 12, two PCOM photos of the powder obtained by means of the abrasion test are reported; the presence of Chrysotile fibers is evident.

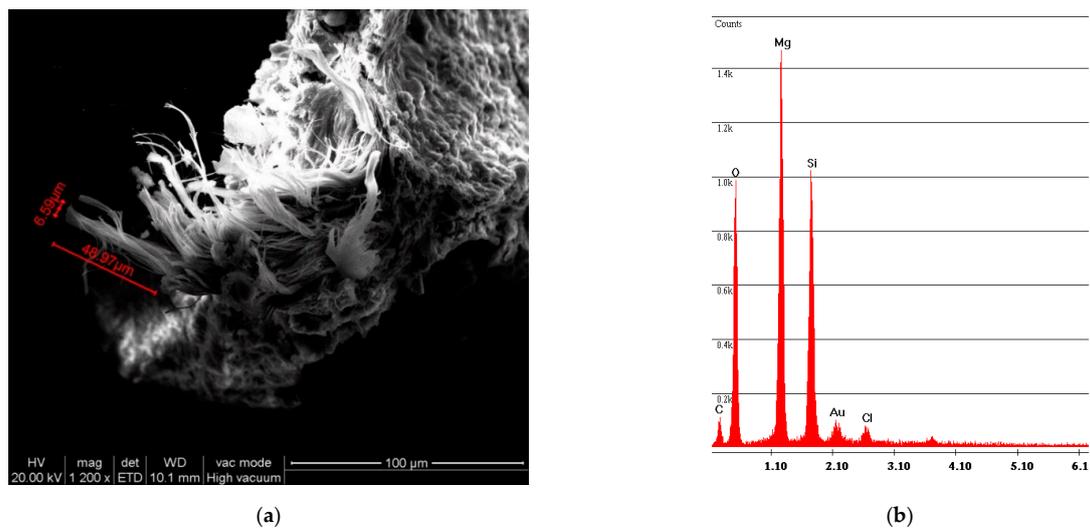
Figure 13. Sample F airborne sample of multigrip plier breakage simulation. (a) SEM photo; (b) spectrum with Mg and Si peaks indicating Chrysotile presence.

Figure 13 shows that in sample F, many fibers remain incorporated in the adhesive matrix of the vinyl, while the fibers found for the sample R (Figure 14) are free fibers.

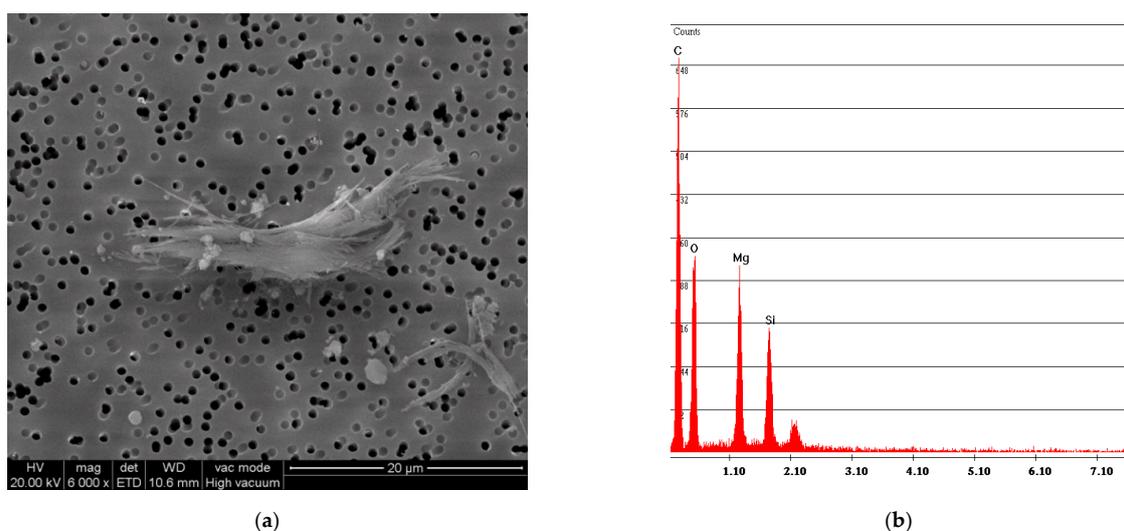
Figure 14. R airborne sample of multigrip plier breakage simulation. (a) SEM photo; (b) spectrum with Mg and Si peaks indicating Chrysotile presence.

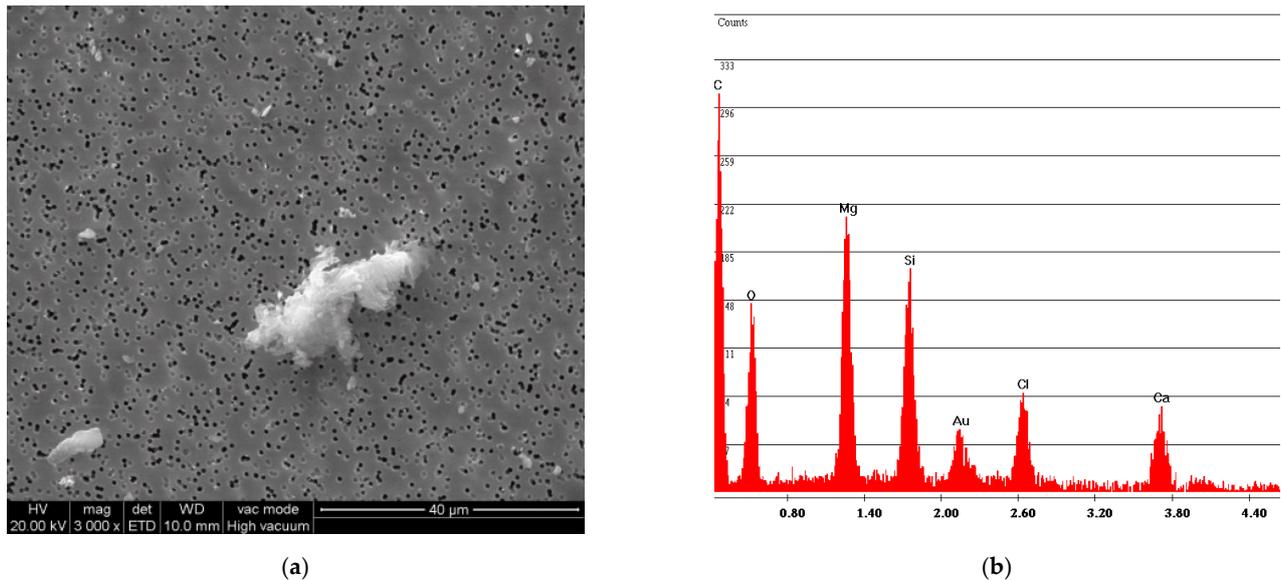
Figure 15. Sample R airborne sample of simulation for impact and drag with crampons. (a) SEM photo of incorporated asbestos fibers in the vinyl-adhesive matrix. (b) Spectrum with Mg and Si Chrysotile peaks and Cl and Ca adhesive matrix peaks.

This test was carried out with impacts and drag that simulate the trampling of the vinyl floor; this simulation did not produce fiber release. The test did not produce powder. The results obtained with Equation (1) are $C = 0$ fibers/liter for both samples. This confirms the indications given by the Italian Ministerial Decree 06/09/1994 [4], which states that there is a release of fibers only in the case of abrasion, perforation, brushing or if the vinyl floor is very deteriorated (Table 3). Figure 15 shows incorporated asbestos fibers in adhesive vinyl matrix. Figure 16 shows a piece of the adhesive matrix of the vinyl floor.

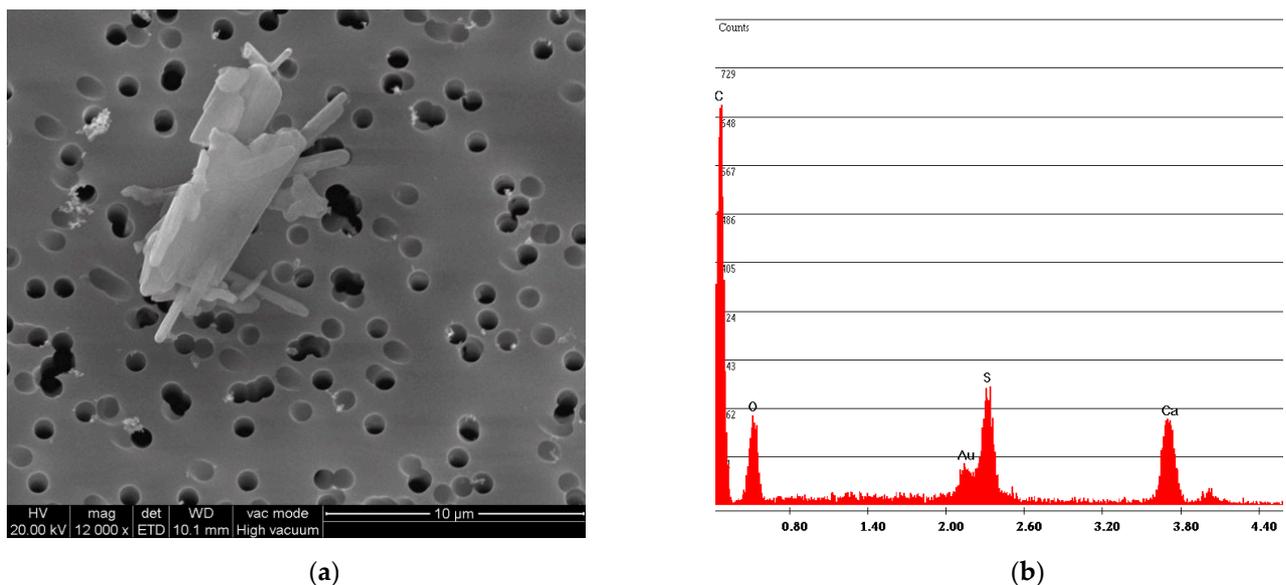
Figure 16. Sample F airborne sample of simulation for impact and drag with crampons. (a) SEM photo of part of the matrix without asbestos fibers. (b) Spectrum of the adhesive matrix.

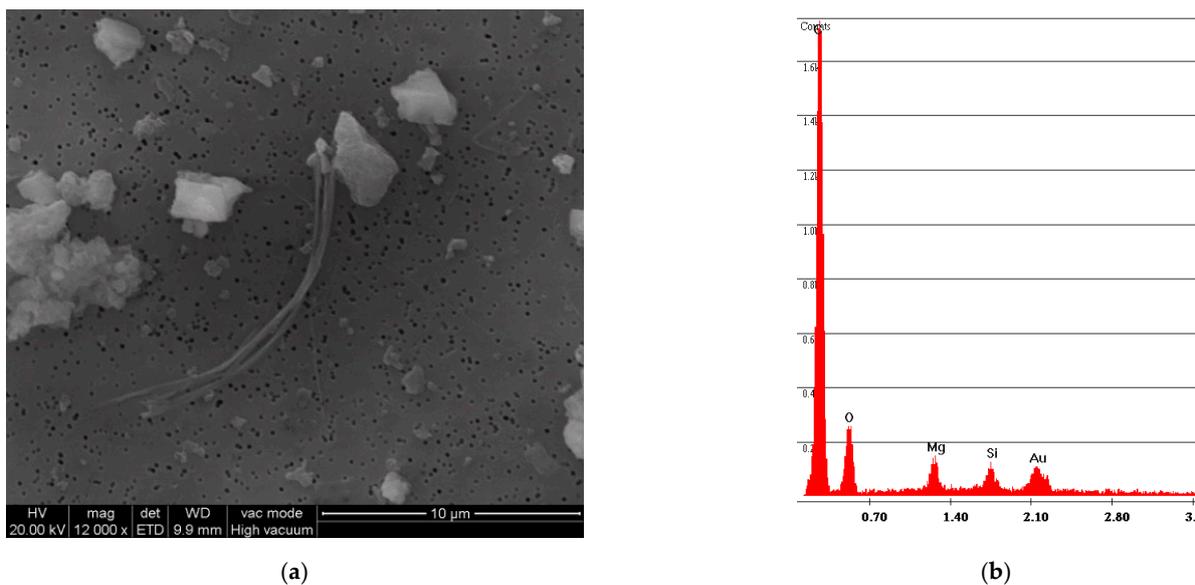
Figure 17. F airborne sample of abrasion simulation test with fine-grained sandpaper. (a) SEM photo of Chrysotile bundle. (b) Spectrum of Chrysotile with typical Mg and Si peaks.

The results obtained for abrasion with fine-grained sandpaper are $C = 12.97$ fibers/liter for sample F and $C = 24.42$ fibers/liter for sample R. The abrasion of sample R produced more longer and free fibers compared to the ones of sample F. This particular aspect is shown in Figures 17 and 18. The smaller fiber dimension of sample R had already been observed during the vinyl characterization test (Figures 6 and 7).

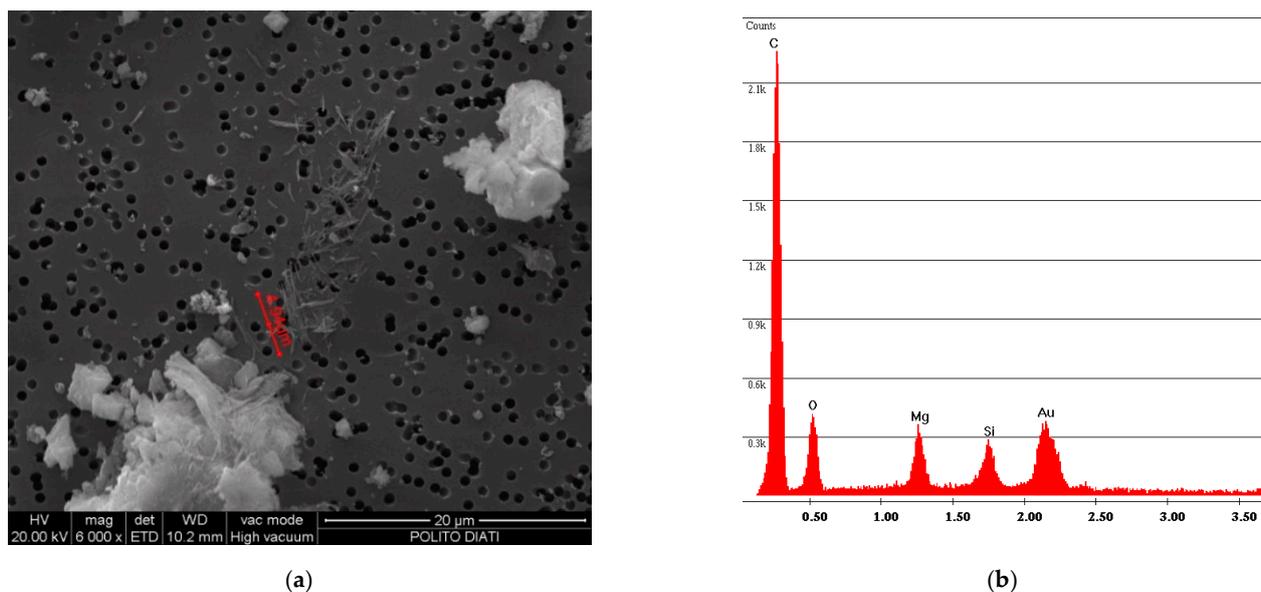
Figure 18. R airborne sample of abrasion simulation test with fine-grained sandpaper. (a) SEM photo of little Chrysotile free fibers; (b) spectrum of Chrysotile with typical Mg and Si peaks.

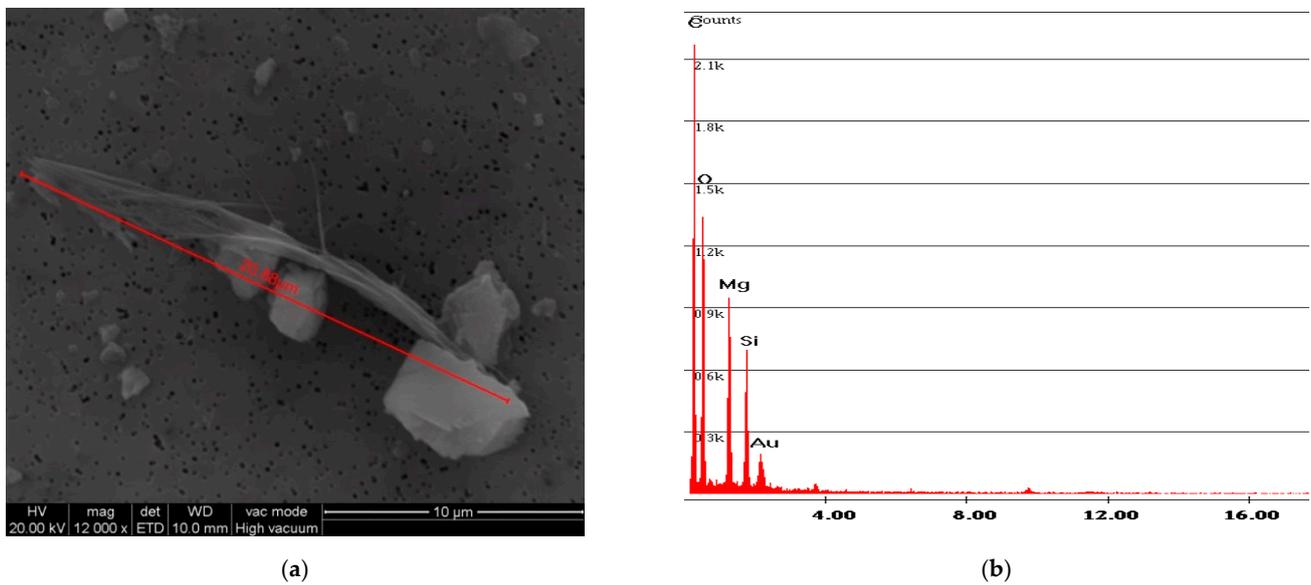
Figure 19. F airborne sample of abrasion simulation test with coarse-grained sandpaper. (a) SEM photo of Chrysotile bundle; (b) spectrum of Chrysotile with typical Mg and Si peaks.

fibers obtained with coarse-grained sandpaper were larger than the free fibers obtained with fine-grained abrasive sandpaper for both samples. Furthermore, the same trend that was observed for fine-grained abrasive sandpaper can also be observed for coarse-grained abrasive sandpaper, i.e., the fiber sizes from sample F were larger than the fiber sizes of sample R (Figures 19 and 20).

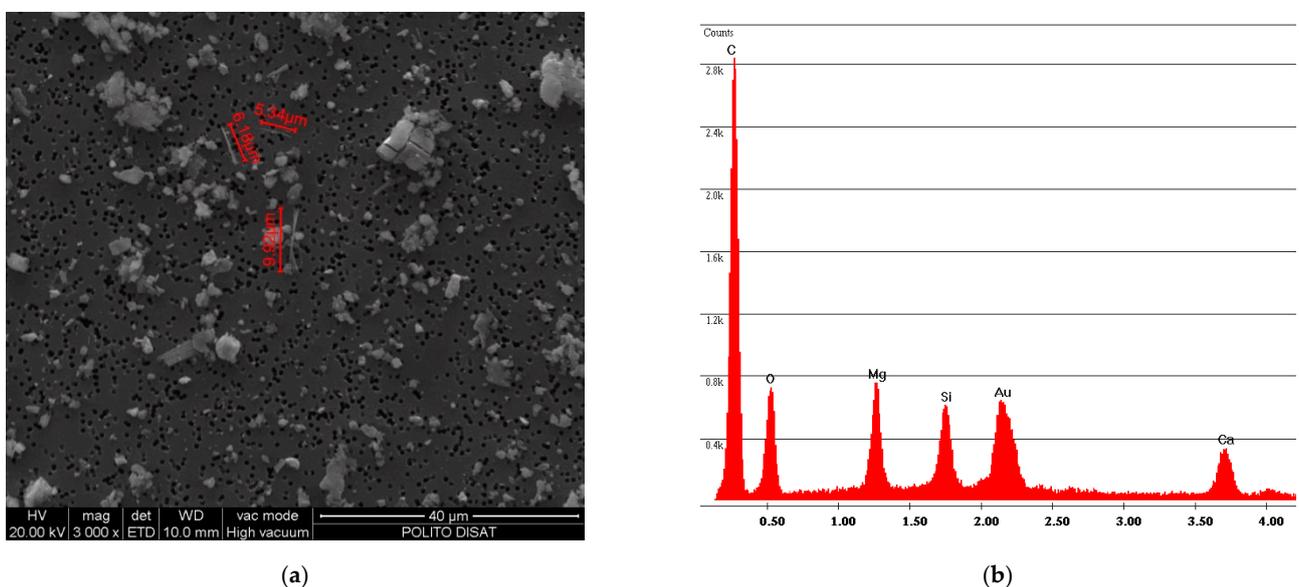
Figure 20. R airborne sample of abrasion simulation test with coarse-grained sandpaper. (a) SEM photo of Chrysotile free fiber bundle; (b) spectrum of Chrysotile with typical Mg and Si peaks.

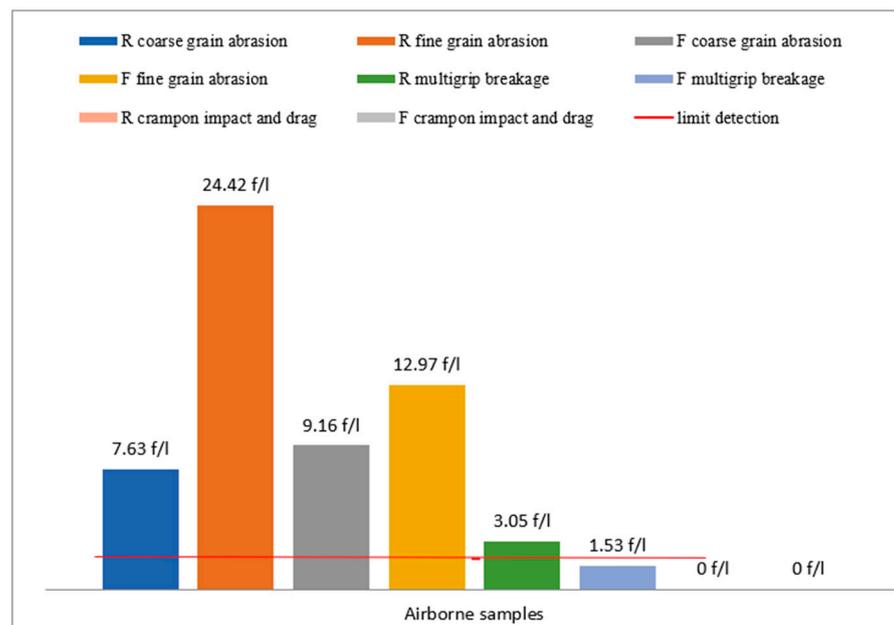
Figure 21. Histogram of the fiber/liter values calculated according to Ministerial Decree 06/09/1994 [4], for all tests carried out on samples R and F. The horizontal red line indicates the limit detection value.

Figure 21 shows a representation of all simulation tests on samples R and F. The red line represents the limit detection value according to Italian Ministerial Decree 06/09/1994 [4]. It can be observed that, in general, the R sample shows worse results than the vinyl sample F, due to its rigidity and ageing comparing to vinyl floor F.
