Article

Characterization of the Diamond Wire Sawing Process for Monocrystalline Silicon by Raman Spectroscopy and SIREX Polarimetry

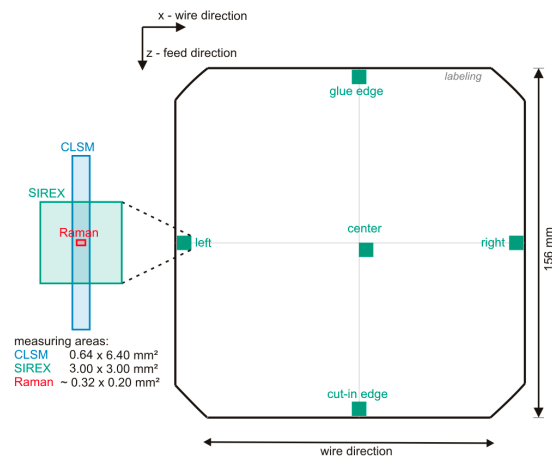
Figure 1. Schematic of a wafer ($156 \times 156 \text{ mm}^2$) indicating the positions of the characterized areas (green marked) for investigation of sub-surface stresses, amorphization and microcrack depths.

The analyzed monocrystalline silicon wafers ($156 \times 156 \times 0.22 \text{ mm}^3$) with a {001} surface orientation were taken from the wire entry side along a brick, where fresh wire is supplied (low wafer numbers of the brick), and from the used wire side (high wafer numbers). Detailed investigations were conducted at five positions on each wafer: near the wire web edge (“cut-in edge”), in middle of the

wafer (“center”), near the glued side (“glue edge”) as well as at the center-left (“left”) and center-right (“right”) of the wafer edge; see the green areas shown in Figure 1.

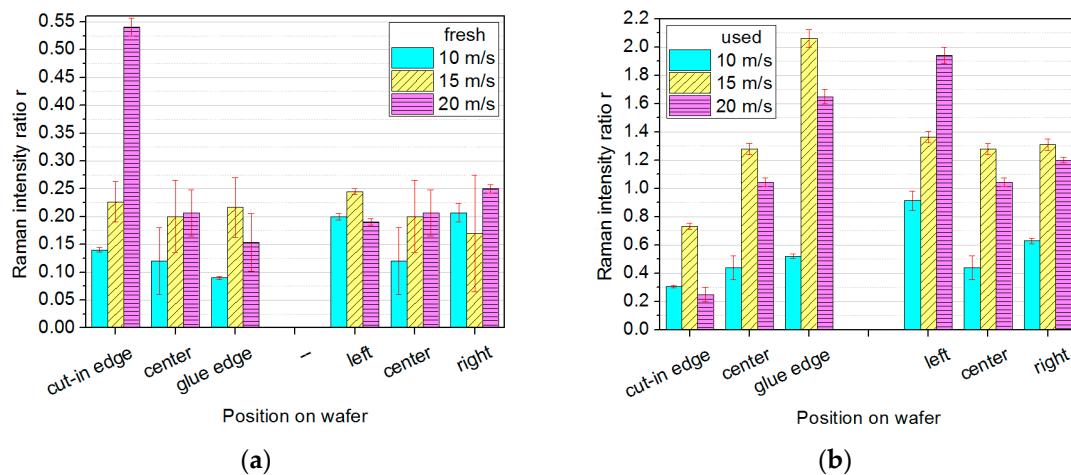
Figure 2. Raman intensity ratio r of five different wafer positions for wafers of the (a) fresh and (b) used wire side sawn with 10 m/s, 15 m/s and 20 m/s wire velocity (r mean value of 2600 Raman spectra with standard error of the mean).

Figure 2a,b depict the mean value of the Raman intensity ratio r of the amorphous to crystalline silicon phase for the measured areas on the fresh and used wire wafers. The amorphous silicon layers are inhomogeneously distributed on the wafer surface. The results for the wafers of the fresh wire side show no dependence of amorphization of the wafer position (Figure 2a). By contrast, there is likely an increasing trend from the position cut-in edge to glue edge on the wafers of the used wire side, see Figure 2b. This would imply that the degree of amorphization is correlated with the wire wear, since the sawing performance with used wire, where the diamond edges are worn, is less good. That is reflected in a higher amorphization of the silicon surface. Since the worn diamonds have a lower cutting ability, more energy may be used for the amorphization of silicon. The highest amorphous silicon fraction is found near the gluing edge, where the ductile material removal process

is the dominating effect. This results in a smoother surface with less chipping pits in the surface. Enhanced amorphization is also present on the left and right wafer edges compared to the wafer center. By using fresh wires, where the diamond edges are sharp, a brittle material removal is dominated and a surface with a lot of chipping is present. Regarding the wire velocity, the lowest fraction of amorphous silicon phase is found for the sawn wafer at 10 m/s, and the highest mean value is found for the wafer sawn at 15 m/s.

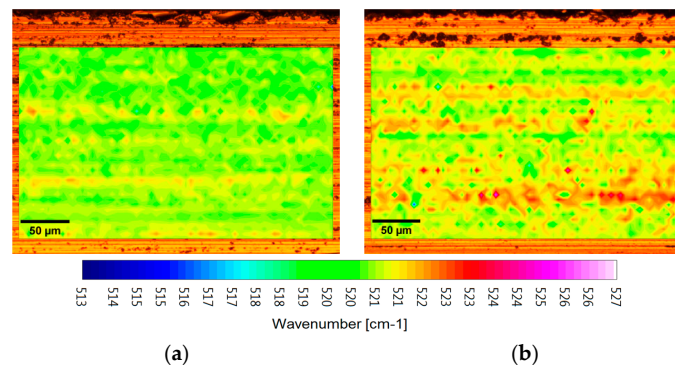
Figure 3. Mappings of the Raman shift of crystalline silicon peaks of the fastest sawn wafer (20 m/s) from (a) the fresh wire and (b) the used wire side. Both measurements were conducted near the gluing edge of the wafer.

In addition, the topographical Raman measurements were analyzed with respect to the stress-induced wave number shift of the crystalline silicon peak. Figure 3 presents an example of high-resolution Raman maps showing the crystalline peak shift acquired from the fastest sawn wafer (20 m/s) for both the fresh and used wire side. The typical sawing-induced stripe pattern is observed on all wafers. Furthermore, the c-Si wave number maps depict a more homogeneous stress distribution for the fresh wire wafers. Essentially, the measurements of the sawn wafers from the used wire side indicate locally intensified compressive stresses (positive Raman shift) parallel to the sawing grooves of up to 1.8 GPa. It follows that the stress distribution correlates with the wire wear.

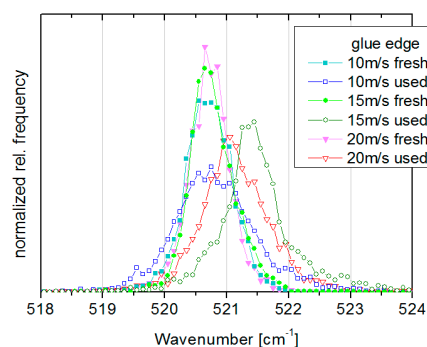
Figure 4. Normalized relative frequencies of the Raman c-Si wave number range for the measured upper wafer positions near the gluing edge.

For the measured wafer position near the glue edge, the normalized relative frequencies of the Raman c-Si wave numbers are exemplarily plotted in Figure 4. The frequency distributions show a significantly higher half width for the wafers from the used wire side (marked by blank symbols). This difference is directly associated with the c-Si wave number spread, which can be interpreted as a more inhomogeneous stress distribution. The maximum of the frequency curve of the used wafer with 15 m/s is shifted to higher wave numbers. Also wafer used-20 m/s show a peak shifting in the same direction, albeit somewhat less than used-15 m/s. Generally, the used wafer with 15 m/s shows the highest local compressive stress on the silicon surface compared to the other investigated wafers.

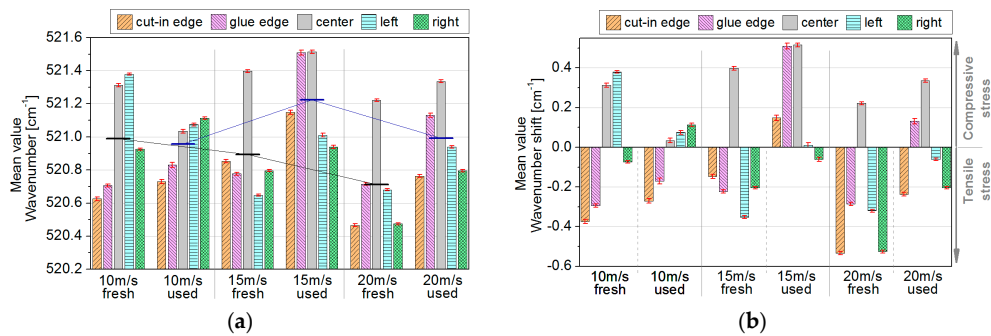
Figure 5. (a) Raman c-Si wave number mean values and (b) Raman shift with respect to the c-Si peak at 521 cm^{-1} for all measured areas on the wafers (mean value of 2600 Raman spectra with standard error of the mean). The horizontal lines show the c-Si wave number peaks averaged over the five wafer positions.

For a detailed analysis in dependence on the measured wafer position, the topographical Raman data were statistically evaluated. Figure 5a gives an overview of all mean values of the c-Si wave number peak positions and Figure 5b depicts the Raman shifts with respect to the c-Si peak at 521 cm^{-1} for the fresh and used wire wafers at the five mapping spots. Both wafers sawn with the highest wire velocity (20 m/s) show the same likely trend. Generally, except for wafer 10 m/s, the largest mean values are found in the center position of the wafer. Thus, the wafer center seems to be more compressively stressed than the areas at the wafer edges. This might be explained by the wire wear, which is in an equilibrium state at this cutting depth, since the wire web is completely exchanged at this position due to the addition of fresh wire in each forward-backward-cycle. This might affect the removal mechanism as well, leading to different stresses. Except for wafer 15 m/s fresh, the wave number values for the upper position close to the gluing edge, where the wire is worn due to the sawing process, are higher than for the position near the cut-in edge. Fresh sawing wires have sharper diamond edges and therefore better cutting performance than used ones. Therefore, the silicon material is expected to be more stressed in the wafer region at the cut-in edge.

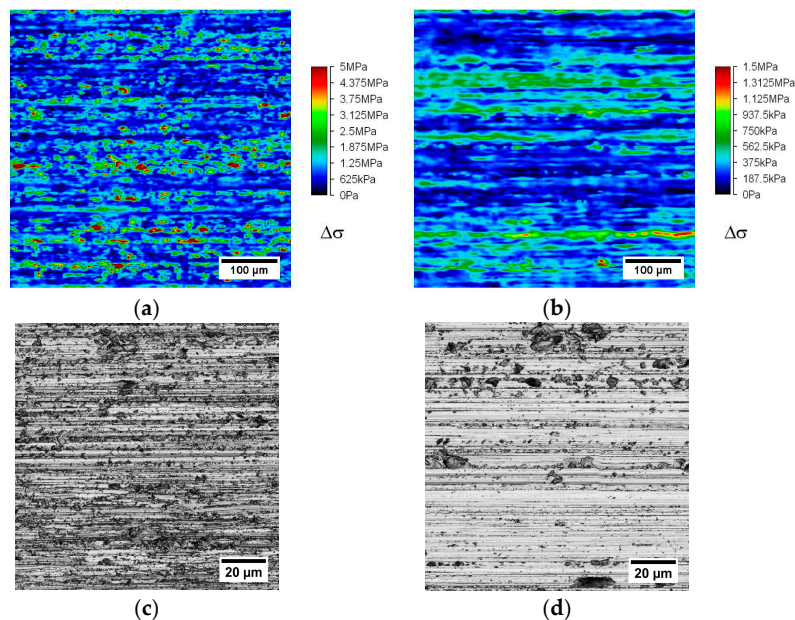
Figure 6. Calculated $\Delta\sigma$ maps from SIREX measurements on the slowest diamond-sawn wafer (10 m/s) from the used wire side. Topogram (a) is the result for the analyzed position near the cut-in edge and topogram (b) for the position close to the gluing edge. Optical (CLSM) images of a section within the SIREX topogram for (c) cut-in and (d) glue edge position.

The scanning infrared reflection topography measurements by SIREX reveal the lateral distribution of the in-plane shear stress as a measure of the damage across a wafer, as demonstrated by the comparison of maps taken at different positions on a wafer. Figure 6a,b show two maps of the calculated difference $\Delta\sigma$ of the in-plane principal stress components $\sigma_1 - \sigma_2$ at the lower cut-in edge and the upper gluing edge of a wafer. The maps clearly reproduce the structure of the sawing grooves. The maximal measured stress difference is significantly higher near the cut-in edge position than at the gluing edge.

The topogram near the cut-in edge (Figure 6a) is also characterized by a higher density of local high stress regions (“red spots”). As it has been discussed in Section 2.2.2 the surface topography itself does not contribute to the evaluation of the stresses, but certain features may correlate with higher stresses below the surface. Corresponding confocal laser scanning microscopy images (see Figure 6c,d) of the same areas show that the visible characteristic shallow pits, where material is chipped away, do not directly correlate with the red spots. In fact, one would actually assume that by chipping material away previous local stresses have been removed here. A further analysis of the sub-surface damage at the high stress positions, which is responsible here, has not been carried out so far.

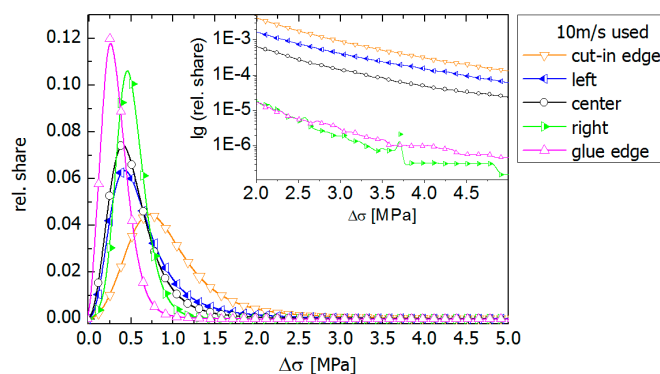
Figure 7. Histogram of $\Delta\sigma$ maps for the slowest sawn wafer (10 m/s) from the used wire side. The inset shows the $\Delta\sigma$ range from 2 to 5 MPa with logarithmic scale of the axis of ordinate.

The $\Delta\sigma$ maps were statistically analyzed using histograms (frequency distribution). The frequency of $\Delta\sigma$ was determined in the interesting range between 0 and 5 MPa in bins of 20 kPa (see Figure 7). These histograms can be characterized by a peak maximum (most frequent value), mean value and half width. The total area under the histograms was evaluated for all measured regions on the wafers. Except for wafer 20 m/s fresh, the area decreases from the position at the cut-in edge to the glue edge. The fresh wire wafers have higher area values than the used wire wafers. Furthermore, the wafers sawn with the lowest wire velocity of 10 m/s show the highest area fraction.

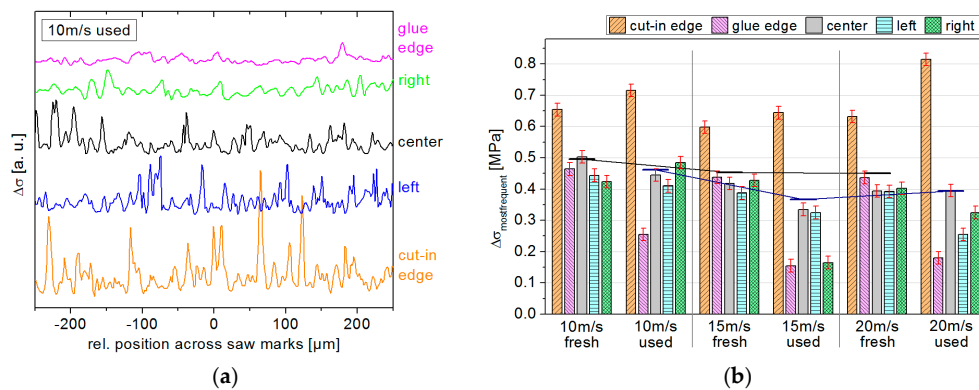
Figure 8. (a) $\Delta\sigma$ line scans across the saw grooves at the five measured positions on the slowest sawn wafer (10 m/s) from the used wire side. Data of the line scans of cut-in edge and glue edge from ref. [3] were supplemented by further positions on the wafer; (b) Column diagram of the $\Delta\sigma$ peak maximum determined from the histograms for all measured areas on the wafers (most frequent value of at least 34,000 histogram data with the given systematic error of the method). The horizontal lines show the peak maxima of $\Delta\sigma$ averaged over the five wafer positions.

The line scans of $\Delta\sigma$ in Figure 8a taken across the sawing grooves at different wafer positions of the slowest sawn wafer (10 m/s) from the used wire side show slight differences in magnitude and periodicity. A “smoothing” effect was observed, i.e., the stress differences are smaller near the glue edge of the wafer as well as on the right-hand side. This result confirms that the degree of sub-surface stress generated in the course of the sawing process is changing. The unsymmetrical smoothing behavior between the left and the right side may be explained by the fact that the wire is entering from the left wafer side in the forward mode of the bidirectional wire movement, which offers the wire with the sharpest diamonds possible. As shown in Table 1, 3 m of new wire were added in the forward mode in each forward-backward-cycle. Figure 8b shows the peak maximum (see histogram of $\Delta\sigma$ maps in Figure 7) of the measured stress difference $\Delta\sigma$ for all wafers at all positions within a column diagram. The position near the cut-in edge shows the highest values of the stress level on each wafer, whereas the fresh wire wafers show lower values than the wafers from the used wire side. Furthermore, the stress values of the glue edge position of the fresh wire wafers are clearly higher than for the same area of the used wire wafers. Also the positions center, left and right reveal higher stress values on the fresh wire wafers. A clear decrease is observed from the cut-in edge, over the center position, to the glue edge (except for fresh wafers 15 m/s and 20 m/s, where the center has the slightly lower value). Particularly large decline is existent between the cut-in and glue edge for the used wafers. Averaged over the five measured wafer positions, there is a likely trend of decreasing stress difference and inhomogeneity with respect to the wire velocity.

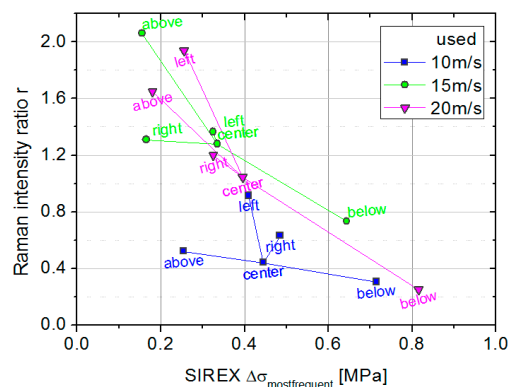
Figure 9. Maximum $\Delta\sigma$ values from SIREX measurements in relation to Raman intensity ratios r of $a\text{-Si}/c\text{-Si}$.

A comparison of the peak maxima of $\Delta\sigma$ and the Raman intensity ratio r of amorphous to crystalline silicon is depicted in Figure 9. High stress values correlate with lower amorphization, represented by a smaller Raman intensity ratio r . Both features, the degree of the amorphization and the stress difference $\Delta\sigma$, can be qualified as indication of the wire wear.

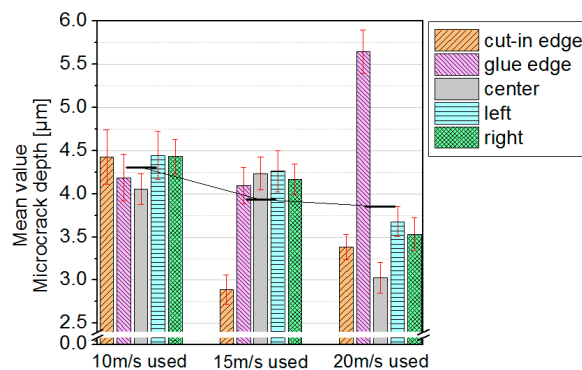
Figure 10. Microcrack depths for all measured areas on the wafers from the used wire side (mean value of 40 crack depths with standard error of the mean). The horizontal lines show the microcrack depths averaged over the five wafer positions.

Figure 10 gives an overview of the microcrack depth at the analyzed positions on each wafer as a column diagram. Based on this representation, it can be observed that the crack depth decreases with increasing wire velocity. As mentioned in [9], this behavior also correlates with lower forces in the sawing direction for higher wire velocities at a constant feed rate of the silicon ingot. Higher wire velocities could induce more material removal in the wire sawing direction, causing shallower depth damage.

The slowest sawn wafer (10 m/s) from the used wire side is characterized by a higher number and larger length of microcracks compared to the fastest sawn wafer (20 m/s). The total stress was more reduced (and the stress difference $\Delta\sigma$ was enhanced) by the slowest sawing, and deeper crack structures were induced.

Generally, the crack depths range between 1.1 μm and 13.2 μm . Obviously, the cracks in the center position are often less deep (except for 15 m/s used). Additionally, the stress level at these positions is increased. The number of cracks and their depths determine the degree of stress reduction [12].
