Article

Assessment of the Impact of Stagnation Temperatures in Receiver Prototypes of C-PVT Collectors

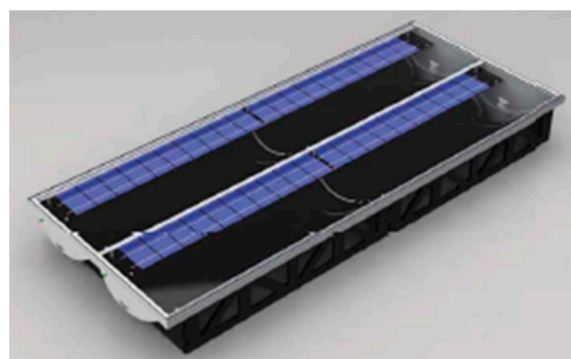
Figure 2. Prototype C-PVT collector.

Figure 1 shows a schematic of the prototype collector viewed from the top, while Figure 2 shows an image of the actual prototype. The total size of the collector is 2.31×0.955 m. The length of the thermal receiver is 2.290 m and the height is 0.158 m.

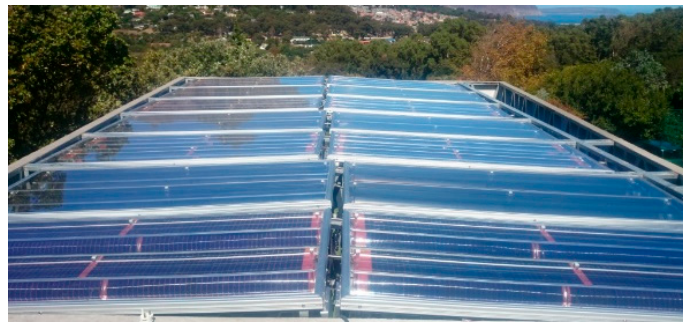
Figure 3. Prototype installation consisting of eight C-PVT collectors (closer) and six concentrating thermal collectors (farther).

Eight C-PVT collectors and six concentrating thermal (T) collectors were installed in a warm country as show in Figure 3. The eight C-PVT collectors were connected to eight micro-inverters. Four thermal loops were connected to a central tank. Three of these loops contained two PVTs and two Ts while one loop contained only two PVT collectors.

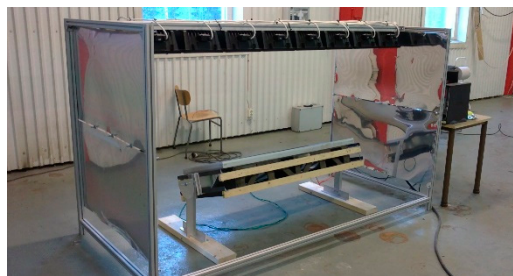
The indoor solar simulator shown in Figure 4 was utilized for the IV-curves. It consists of two rows of 8 halogen light bulbs each with 1000 W of power. As in many solar simulators, the light distribution and spectrum can be a draw-back, since it is understandably hard to simulate the energy coming from the sun, a stellar object that is a nearly perfect sphere of hot plasma with a diameter of 1.39 million kilometers and a mass that is about 330,000 times that of Earth. Regardless, for the objective of the comparative measurements between receivers, this solar simulator is well suited.

Figure 4. The solar simulator for the indoor measurements.

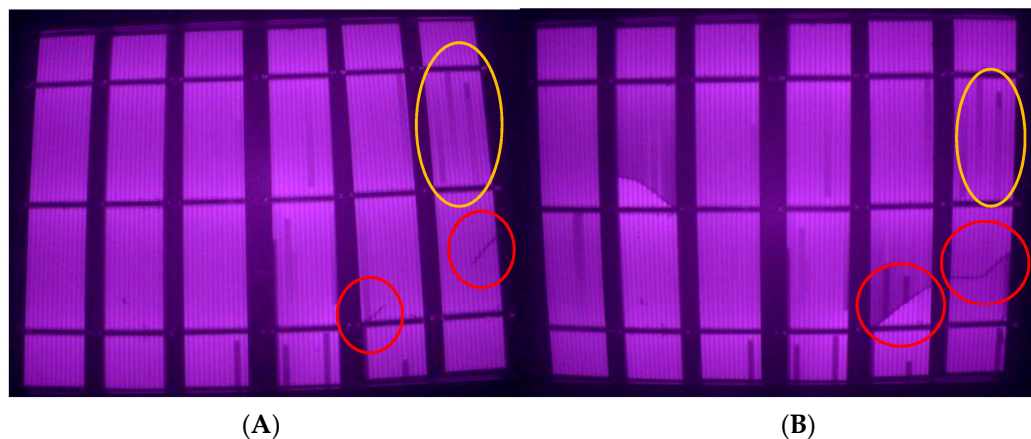
Figure 8 shows receiver 5 at the baseline and at 200 °C. The red circles show again microcracks caused by the manual production process and their expansion when heated up, although in this receiver the cracks take longer to expand. The yellow circle shows the small flaws in the cell, potentially caused during the production process of the cell or the cell wafer. These flaws seem to influence the appearance of new microcracks.

Figure 8. EL test of receiver 5. (A) Baseline (ambient temperature); (B) After the round at 200 °C.

It was the author's expectation that receiver 1 would be the receiver design least capable to withstand stagnation, while receiver 5 was expected to be one of the most successful designs, which the above images confirm.

- Microcracks caused by manual soldering; (Figure 6),
- Short circuit in one cell; (Figure 7)
- Flaws from cell production; (Figure 8)

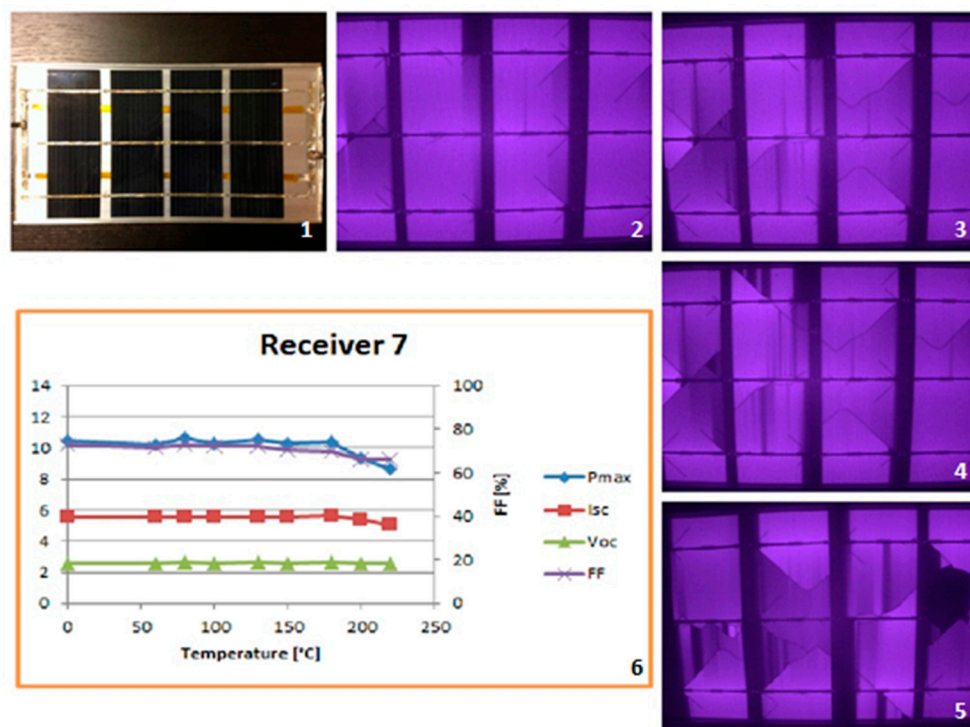
Strangely, the decrease in power is more pronounced in receiver 8 than in receiver 7, as can be seen in Figures 15 and 16. However, it must be noted that receiver 7 starts from a lower baseline scenario since it shows some microcracks from the beginning. From all the testing accomplished, it also seems safe to state that existing microcracks expand at faster rate than new microcracks are created.

Figure 15. (1) Receiver 7; (2) Baseline Round; (3) Round 5 (150 °C); (4) Round 6 (180 °C); (5) Round 8 (220 °C); (6) Parameters of the IV curve at different temperatures (Isc, Voc and Pmax shown in the left Y axis and FF in the right Y axis).

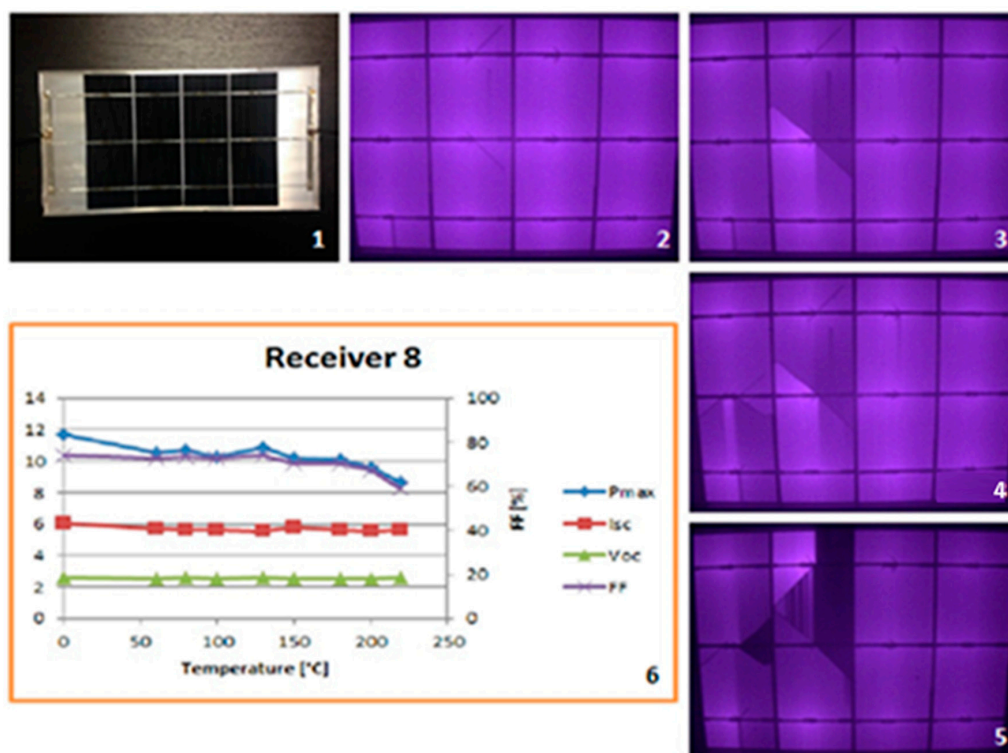
Figure 16. (1) Receiver 8; (2) Baseline Round; (3) Round 5 (150 °C); (4) Round 6 (180 °C); (5) Round 8 (220 °C); (6) Parameters of the IV curve at different temperatures (Isc, Voc and Pmax shown in the left Y axis and FF in the right Y axis).

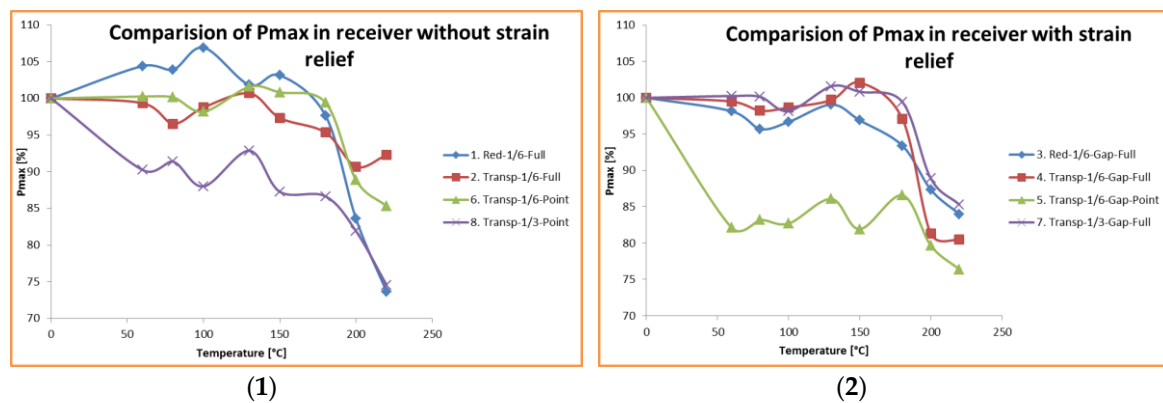
Figure 17 compares the decrease in Pmax of the different receivers at different temperatures rounds with and without the strain relief. Receiver 2 shows the most stable Pmax across all temperatures. Receiver 5 is also fairly stable if the handling problem on round 1 is excluded. Receiver 1 shows an increase of power that is difficult to explain and is assumed to have been a human measurement error, potentially combined with the small variation in the power provided by the solar simulation. Overall, receivers with red silicone have the highest power decrease, when external factors are excluded. The existence of gaps seems to reduce the number of microcracks. No prototype receiver loses more than 30% of its initial power, despite the large cell breakage shown by some of the prototype receivers in the EL imaging results.

Figure 17. (1) Comparison of Pmax decrease in receivers with strain relief; (2) Comparison of Pmax decrease in receivers without strain relief.

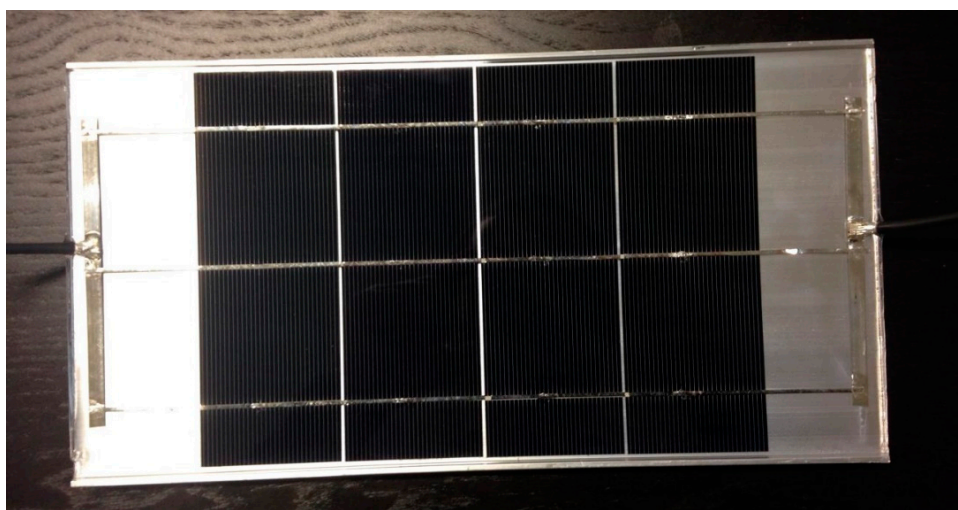
Figure A8. Receiver 8 has four $1/3$ cells with a standard cell gap, one point soldering, transparent silicon only and no strain relief.
