Article

Regular and Irregular Performance Variation of Module String and Occurred Conditions for Potential Induced Degradation-Affected Crystalline Silicon Photovoltaic Power Plants

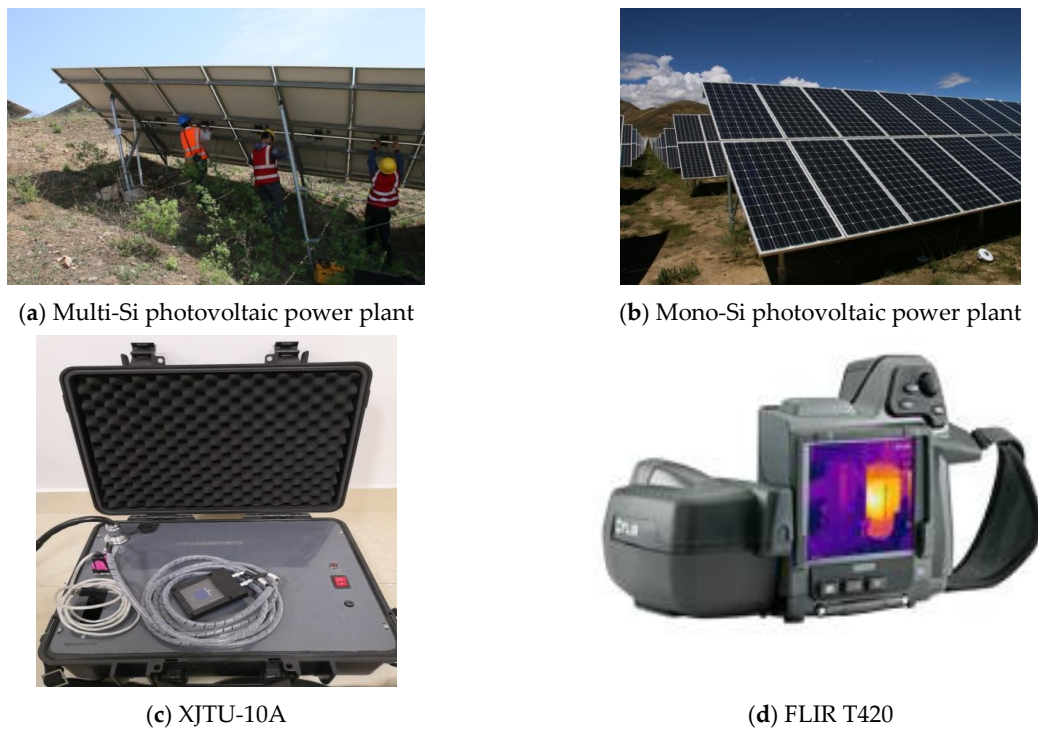
Figure 1. The studied photovoltaic power plants and experimental setup.

Figure 1 gives out the studied photovoltaic power plants and experimental setup. 20~25°C environmental temperature, 820~900 W/m² solar irradiance and 1–2 m/s wind speed were chosen as test conditions in the field. The current-voltage characteristics and output power-voltage characteristics of solar modules were tested by the portable XJTU-10A in the field. The voltages of module strings under open circuit (V_{oc}) were tested by portable digital multimeter (Fluke Corp., Fluke 15B+). Thermography images (IR images) of crystalline silicon solar modules were acquired by T420 (FLIR Systems, Inc. USA) with a resolution of 320×240 pixels. The spectral range of T420 is 7.5~13µm. And solar modules suffered from PID can be distinguished by its open circuit voltage and the thermography image [14]. The intensity of sunlight was tested by YFJ-10 solar irradiation meter. The working temperature of solar module was tested by thermocouple. The solar modules suffered from PID were labelled in sequence respectively and disassembled from module string, and carried to our laboratory. The current-voltage characteristics of PID-affected solar modules disassembled from photovoltaic array was measured by solar simulator (PASAN Sunsim 3C) under standard test conditions (STC: 1 kW/m² irradiation, 25°C module temperature and AM1.5 global spectrum). The solar

simulator was adjusted by the same type standard module. The electroluminescence images (EL images) of the crystalline silicon solar modules were tested by an EL measurement system indoor.

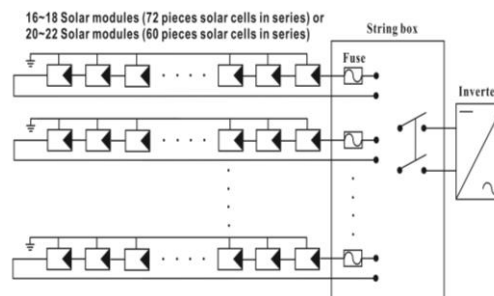
Figure 3. Typical electrical topology of sub-array for the studied photovoltaic power stations. 16~18 or 20~22 crystalline silicon solar modules were concatenated into module string. A string box with direct current switch was used to connect the module strings in parallel. The string box was directly concatenated to solar inverter. The aluminium frame of solar module was grounded for the sake of preventing electric shock.

Figure 3 shows the typical electrical topology of sub-array for the photovoltaic power stations. In Figure 3, 16~18 or 20~22 crystalline silicon solar modules were concatenated into module string. A string box with direct current switch was used to connect the module strings in parallel. The string

box was directly concatenated to solar inverter. The Al frame of solar module was grounded for the sake of preventing electric shock.

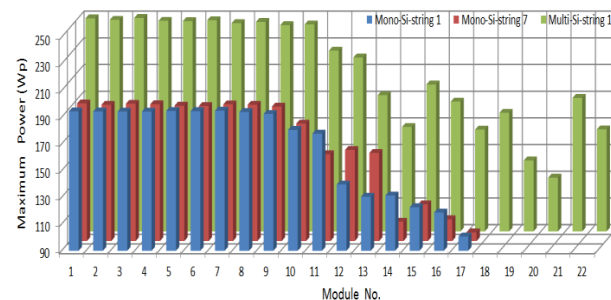
Figure 9. The change of the maximum output power for three module strings, which are monocrystalline silicon module string 1 and 7 of Figure 5a, and multicrystalline silicon module string 1 of Figure 5b, respectively.

Figure 9 shows the change of maximum power of modules from 3 different PID-affected module strings, which are monocrystalline silicon module strings 1 and 7 of Figure 5a, and multicrystalline silicon module string 1 of Figure 5b, respectively. From Figure 9, it was found that the solar modules located in the front half-string shows a normal power degradation caused by light-induced degradation, and the deterioration degrees of solar modules located in the rear half-string do not increase with the increasing negative potential except for partial monocrystalline silicon module strings. From Figure 9 and Table 1, it was also found that the negative potential relative to the aluminium frame is not sufficient, but is a necessary condition for PID. The severity of PID is not necessarily related to the magnitude of negative potential in the field. But in laboratory, the higher applied negative voltage induces more severe PID for a certain PID-susceptible solar modules. The positive potential does not induce PID. This result agrees with [37].

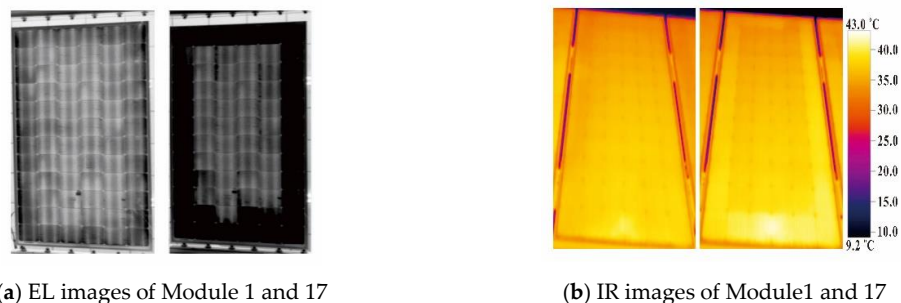
Figure 10. The electroluminescence images and thermography images of monocrystalline silicon solar modules from the same PID-affected module string. The left in (a) is electroluminescence image for module 1, the right in (a) is electroluminescence image for module 17. The left in (b) is thermography image for module 1, the right in (b) is thermography image for module 17. The solar cells near to the aluminium frame exhibit higher temperatures than the middle solar cells in module 17. Reprint from [33]. Copyright 2017, Elsevier.

In some cases, the electroluminescence images and thermography images of monocrystalline silicon solar modules from the same PID-affected module string present a regular change, as shown in Figure 10. From Figure 10, it was found that the solar cells near the aluminium frame exhibit higher temperatures than the middle solar cells in module 17; this has been proven by [36]. But in other cases, the EL image and IR image of PID-affected monocrystalline silicon solar module dismantled from the module string present an irregular change, as shown in Figure 11. From Figure 11, it was found that the solar cells near the aluminium frame do not exhibit high temperature than middle solar cells in module 14, even if the solar cells near to the aluminium frame sustain larger negative potential [32]. This finding is different from Figure 10.

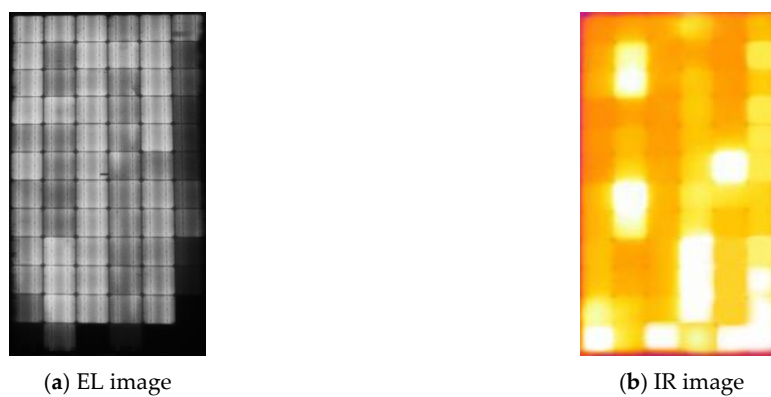
Figure 11. The electroluminescence image (a) and thermography image (b) of module 14 from the module string 7 corresponding to Figure 5a. The EL image and IR image of PID-affected monocrystalline silicon solar module exhibit an irregular change.

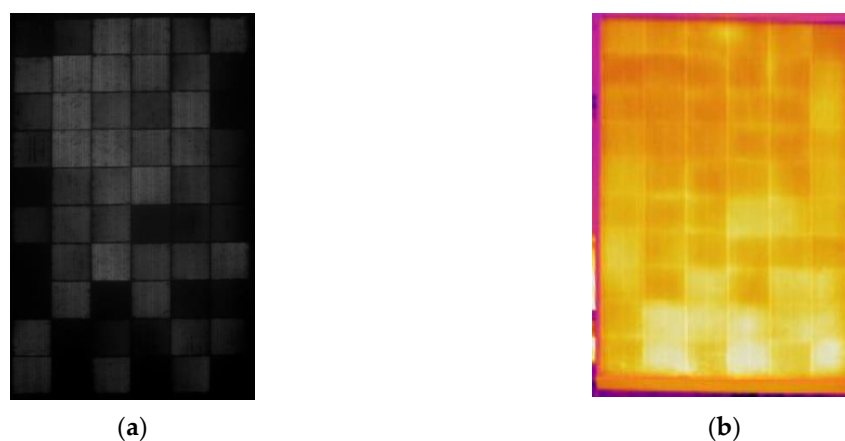
Figure 12. The typical electroluminescence image (a) and thermography image (b) of multicrystalline silicon solar module suffered from PID from the field.

Figure 12 gives out the typical EL image and IR image of PID-affected multicrystalline silicon solar module from the module string. From Figure 12, it was found that there is not a regular change in PID-affected multicrystalline silicon solar module, i.e., the solar cells adjacent to the aluminium frame do not exhibit higher temperature than the middle cells in the multicrystalline silicon solar module. According to the measured results from the field, we did not also find the regular change of IR images and EL images for PID-affected multicrystalline silicon module string in the photovoltaic power plants.
