# Impact Transient Characteristics and Selection Method of Voltage Transformer Fuse

**Abstract:** In a neutral ungrounded system, the high voltage fuses used to protect voltage transformers (VTs) often abnormally blow out, causing unbalanced VT operation. Fuses also fail to blow out in time, resulting in further damage to the VT. This paper reported the results of steady-state current testing, breaking characteristics, X-ray measurements, fuse corona testing, and electromagnetic transient impact testing for VT fuses. This paper comprehensively examines and analyzes the quality and electrical performance of VT fuses and provides new guidance for the use of high voltage fuses in voltage transformers. This paper recommends that 35 and 10 kV systems use fuses rated for a current of 1 A based on a single fuse, which is not easily oxidized and has a wound skeleton composed of an Ag or Ni melt.

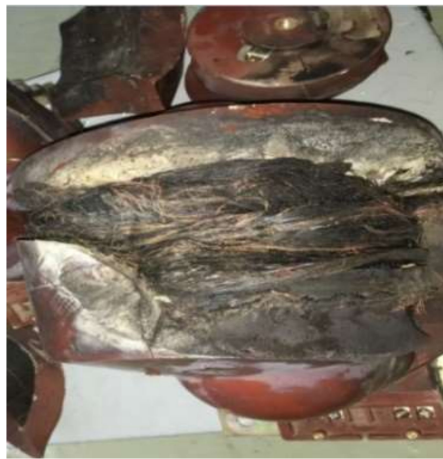
In medium and low voltage distribution network systems, a voltage transformer (VT) is installed on a busbar for monitoring, measuring, and protecting functions. Therefore, the safe and reliable operation of the voltage transformer directly affects the safety and stability of the distribution network. A high voltage fuse is generally connected in series in the voltage transformer circuit to protect the voltage transformer and prevent faults in the voltage transformer from affecting the system. The fuse is widely used in power systems because of its simple structure, safe and reliable operation, low price and current limiting capability [1]. After the fuse is fused, in order for the VT to continue to operate normally, the operator must immediately replace the high voltage fuse. If the fuse is frequently fused, the reliability of the power supply of the substation is greatly reduced. In actual operation, the high voltage fuses of VTs frequently break in an abnormal way, and in some cases the voltage transformer also burns out irregularly [2]. Figure 1 shows a VT burnout at 35 kV substation owing to a fuse failing to blow in time, the winding scale is 700:1.

**Figure 1.** Winding damage of voltage transformer (VT) for phase-A.

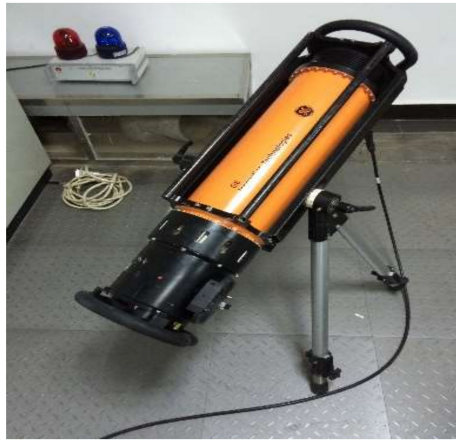
Owing to the closed structure of the fuse, this paper used X-ray inspection technology to check the internal structure of fuse. The X-ray detector is shown in Figure 14. The fuse X-ray test charts of 35 kV/2 A fuses are shown in Figure 15.

Figure 14. X-ray detector.

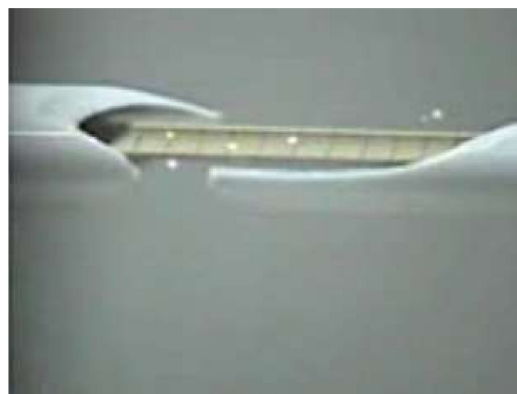
During the test, voltages of 10, 20, and 30 kV were applied to the ends of the fuses. This paper observed luminescence of the fuse coils and the number of photons from corona luminescence was measured. Figure 17 shows a corona ultraviolet image of the fuse.

Figure 17. Corona ultraviolet image of fuse.
