Article

Hygrothermal Risk in Museum Buildings Located in Moderate Climate

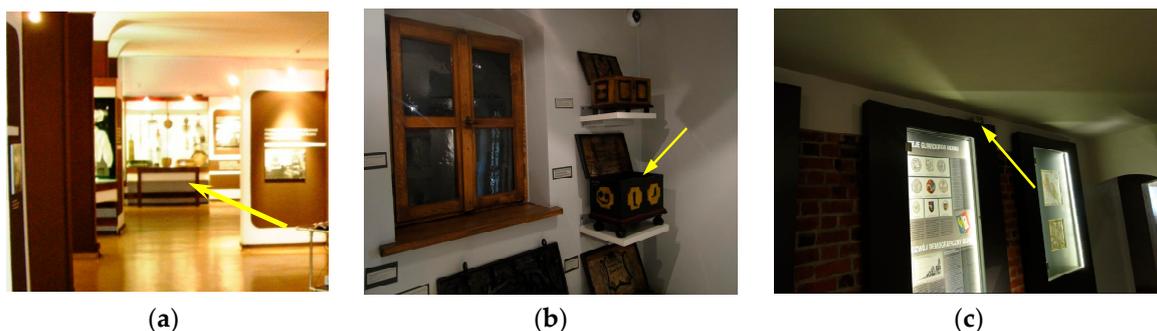
Figure 3. An example of the sensors' locations in Museum A (a) and Museum C (b,c).

Measurements of air temperature and relative humidity were carried out at representative points, which were located away from sources of heat, windows and doors. Nine sensors (type Si and Ai, see Table 2) were placed in Museum A, eight sensors (type P*Si* and Ai) in Museum B and nine sensors (type P*Si* and Ai) in Museum C. A larger number of sensors have been placed in the large exhibition halls of Museum A. The sensors were located in places where they did not disturb the exposition of monuments and were not exposed to theft or damage (e.g., on walls, on showcases, under the exhibition tables). Example locations are presented in Figure 3. One of the sensors in Museum A (sensor S2), due to the lack of other options, was located on the plasterboard wall serving as solar protection (the impact of this location is discussed in Section 3.4).

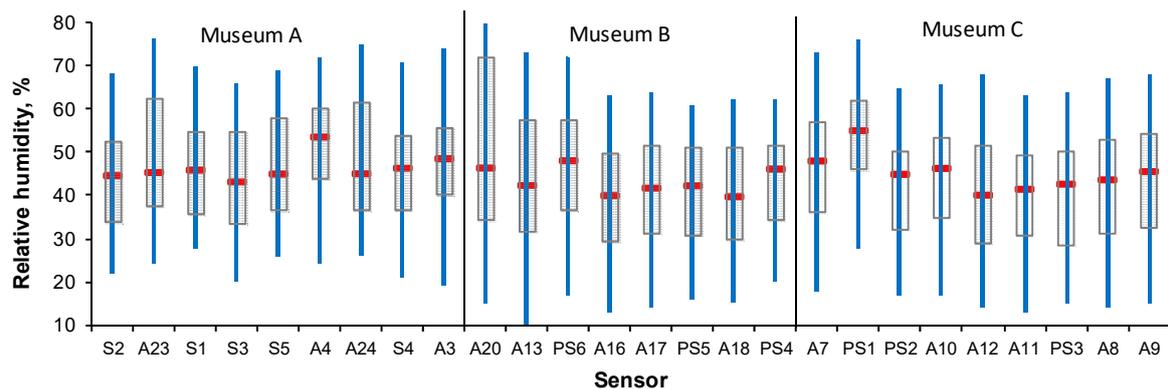
Figure 4. Annual median (in red), minimum and maximum values (in blue) and 25–75 percentiles (box in grey) of air relative humidity in all measuring points.

Recording of air temperature and humidity allowed for analysis of the variations of these parameters in studied museums. Figures 4 and 5 present the median, minimum and maximum values of temperature and relative humidity in the whole measurement year for individual sensors' location. The corresponding 25% and 75% percentiles are also presented. Annual median air temperature ranged from 19 to 22 °C and relative humidity from 40 to 55%. It can be observed that the distribution of environmental parameters varied within the museums. Since all museums were equipped with a heating system operating in winter and only one room was equipped with air conditioning the data were analyzed for these seasons separately and presented in Table 3. The results in Table 3 clearly show that, compared to the winter season, in summer not only median values are higher, but also the variation of both temperature and relative humidity are larger, which is indicated by the percentiles.

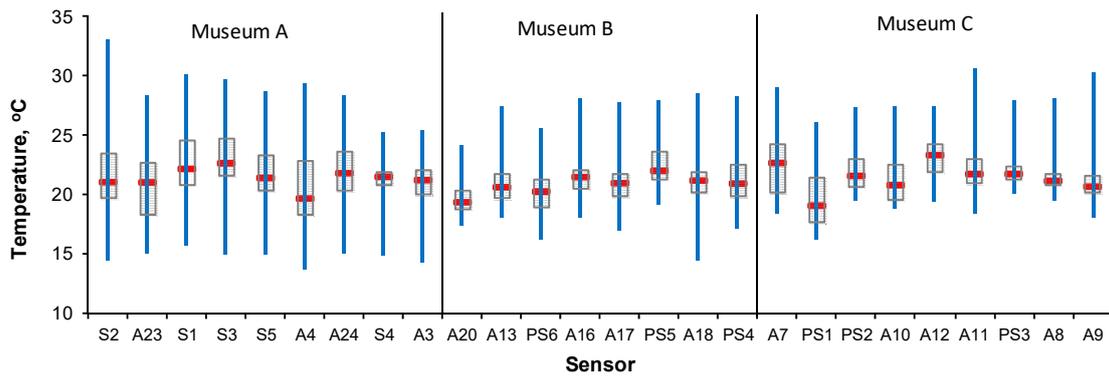
Figure 5. Annual median (in red), minimum and maximum values (in blue) and 25–75 percentiles (box in grey) of air temperature in all measuring points.

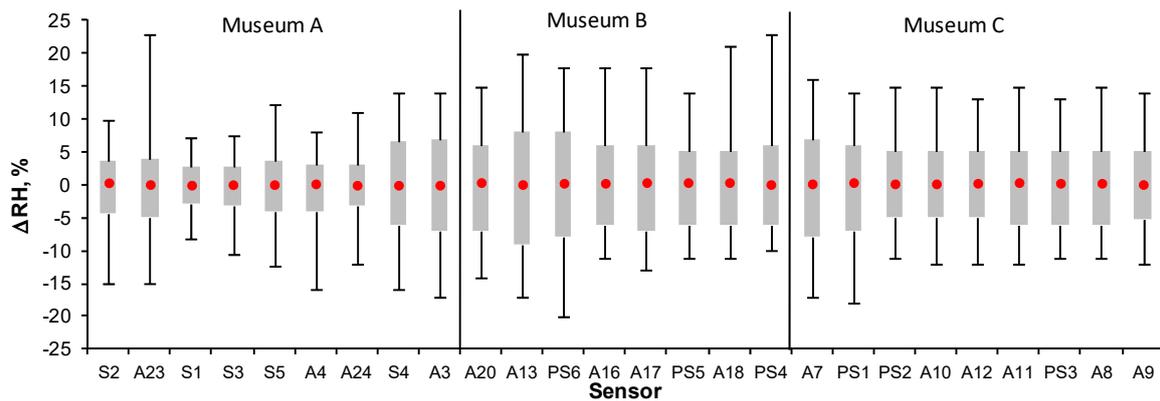
Figure 6. RH fluctuations: annual median (in red), 7th and 93rd percentiles (box) and maximum fluctuations (whiskers) based on 30-day average values, according to EN 15757 standard [6].

In addition, the monitoring results were subjected to the requirements of EN 15757 standard [6], determining the annual change cycle of RH based on of 30-day moving average (Figure 6).

The annual cycle analysis (Figure 6) confirmed the best humidity conditions in the non-air-conditioned rooms in Museum A. For 86% of the time, the fluctuations from the 30-day average did not exceed $\pm 5\%$. In the other museums, they did not exceed the maximum value of $\pm 10\%$ recommended in EN 15757 standard [6].

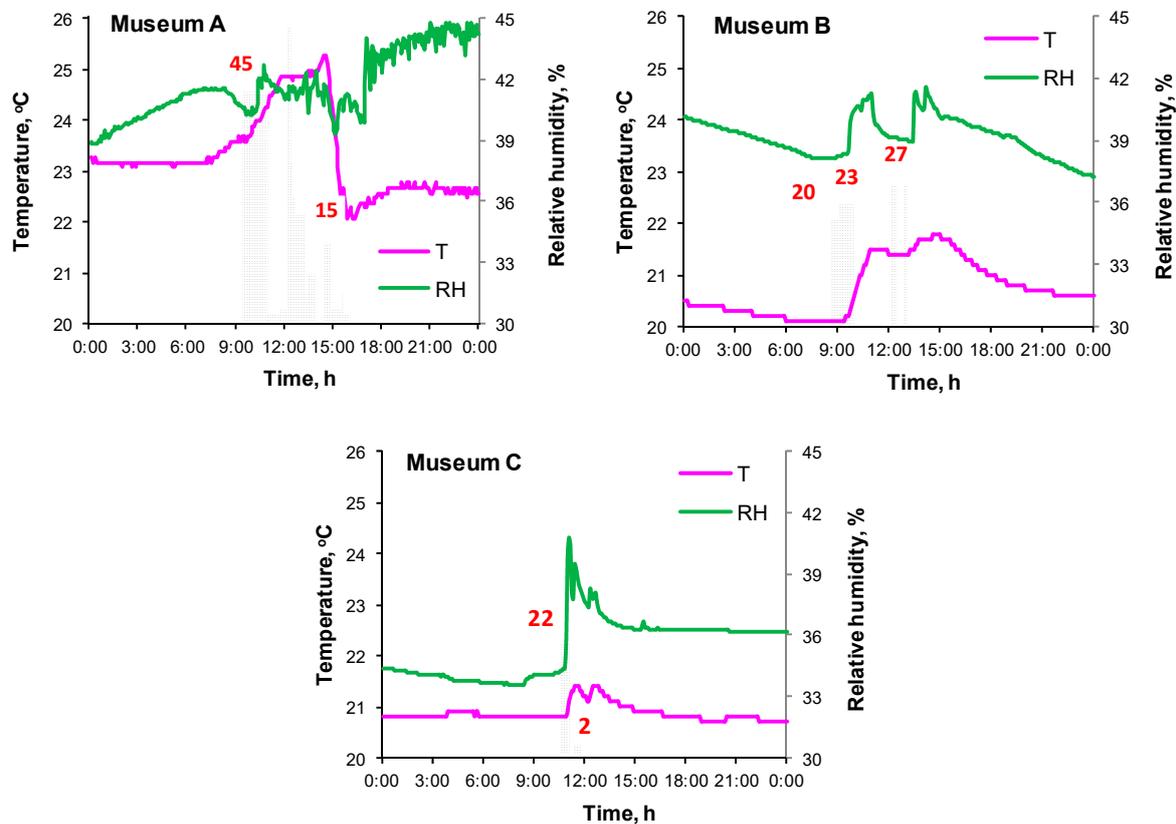
Figure 7. Comparison of indoor air parameters changes with the number of visitors in the museum for a selected day of measurements for analyzed museums: Museum A—painting exhibition, Museum B—ethnography exhibition and Museum C—historical exhibition. Numbers in red indicate visitor numbers.

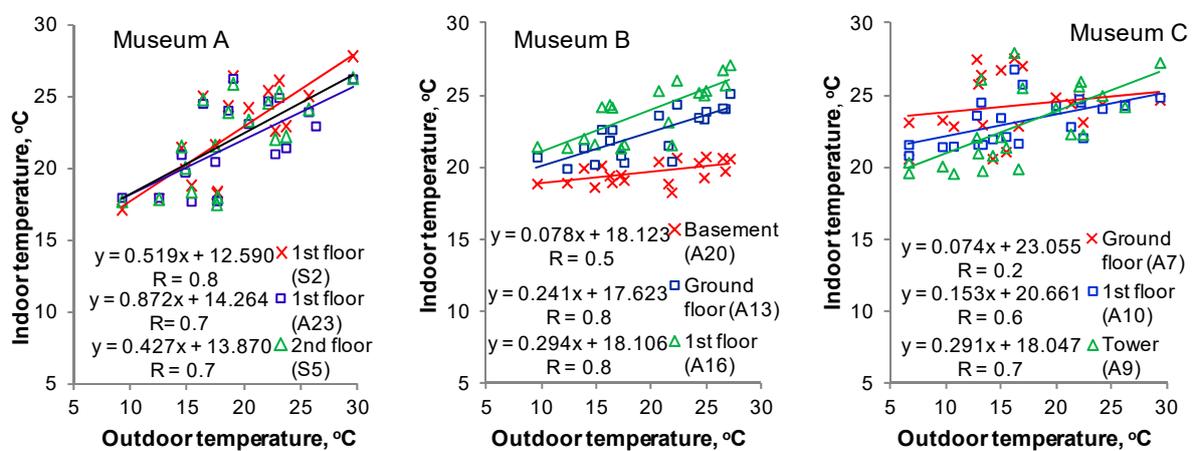
Figure 8. Correlation between internal and external temperature in the museums. Points on the graphs represent mean daily values for all unoccupied days from May to September.

The relation between indoor and outdoor temperature and humidity variations is shown in Figures 8 and 9. Points on the graphs show average daily temperature and moisture content values for unoccupied days from May to September. During the analyzed period, the external temperature varied in the range of 7–30 °C and the moisture content was in the range of 6–11 g/kg. At the same time, the internal temperature in the exhibition hall rooms has changed in a much narrower range, from approximately 18 °C to 28 °C.

In all museum rooms, the average daily internal air temperature followed the changes in external temperature. The largest increase in indoor temperature, due to increased outdoor temperature, was observed in Museum A (the highest directional coefficients in correlation equations). As one would expect in Museum C with the thickest walls and completely covered windows, temperature correlations are the weakest. Museums A and B are buildings with thin walls and large windows.

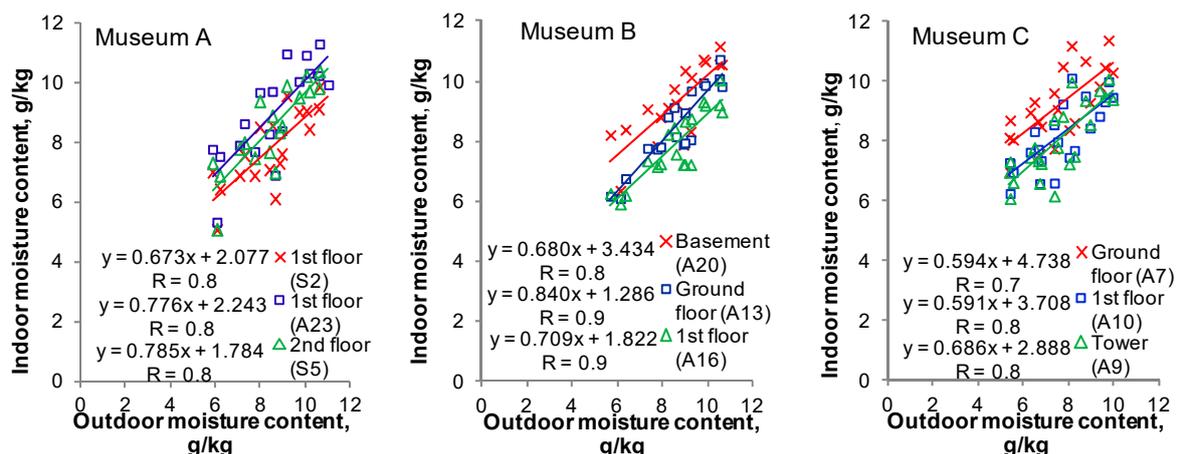
Figure 9. Correlation between internal and external moisture content in the museums. Points on the graphs represent mean daily values for all unoccupied days from May to September.

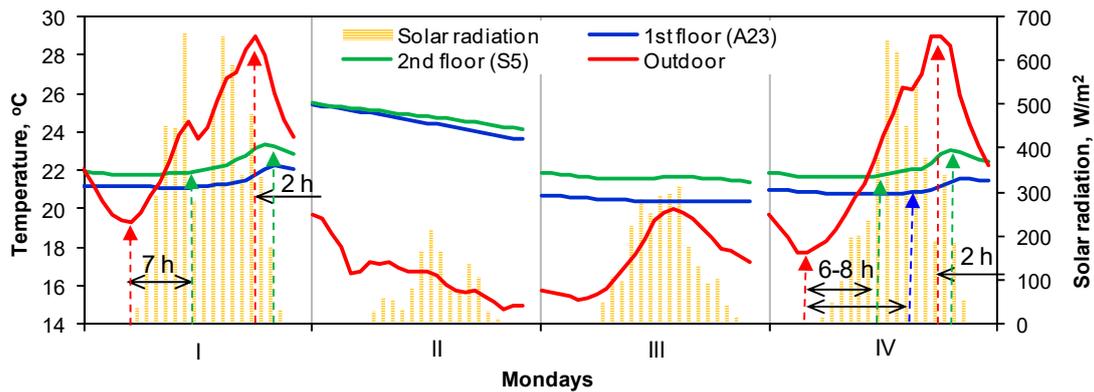
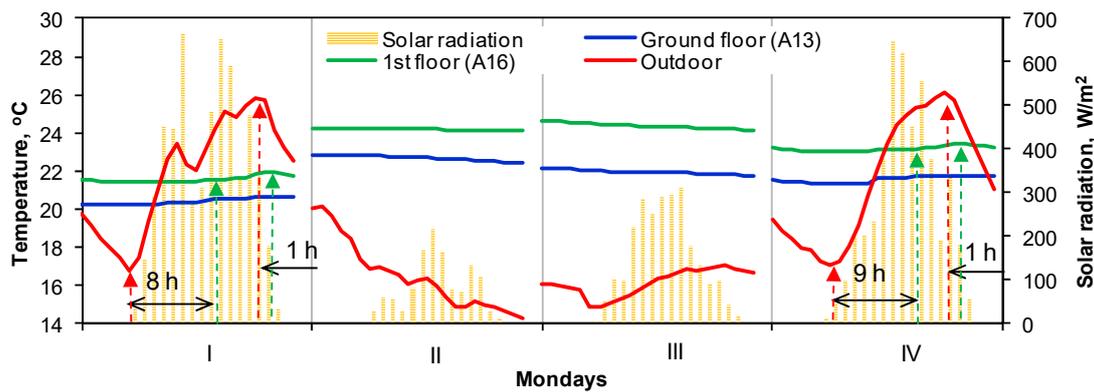
Figure 10. Variation of solar radiation and internal and external temperature for four Mondays of June in the selected locations in Museum A (a) and in Museum B (b). Data on the graph represent mean hourly values.

The detailed analyses were carried out for shorter 24 h periods (four Mondays in June) in museums A and B. Hourly average temperature and relative humidity values recorded outside and inside of museums A and B are presented in Figures 10 and 11, correspondingly. For the first (I) and the last (IV) Monday, one can observe a typical time course of the outside air temperature for the summer season. At night, the temperature was low, in the range of 18–19 °C, while during the day it gradually increased above 26 °C. A similar trend was observed for the third Monday, but the amplitude was lower. The second Monday in June was characterized by a gradual and continuous fall in the outside temperature. The temperature change was about 5 °C.

A significant increase (10 °C) in the outside temperature in the first and fourth week of June caused an increase in indoor temperature by 1 °C in the exhibition halls of museum A. In the second week, when the outside temperature was falling, the largest indoor temperature change, on average 1.9 °C, was recorded in non-air-conditioned rooms. The windows in most rooms are covered therefore direct solar gain is negligible. Thus the dominant heat gain is through opaque partitions. The effect of the increase of external temperature and the action of solar radiation is visible in the rooms only after a few hours from the moment of the increase of external T and the appearance of solar radiation (6–9 h depending on the room and museum). In museum B the internal temperature amplitude is much smaller. The maximum value of T in the rooms is delayed by one to two hours in relation to the external T peak. Both analyzed rooms in Museum A and the room with sensor A16 in Museum B have a western exposure, so the temperature drop in the room is correlated with the reduced solar radiation.

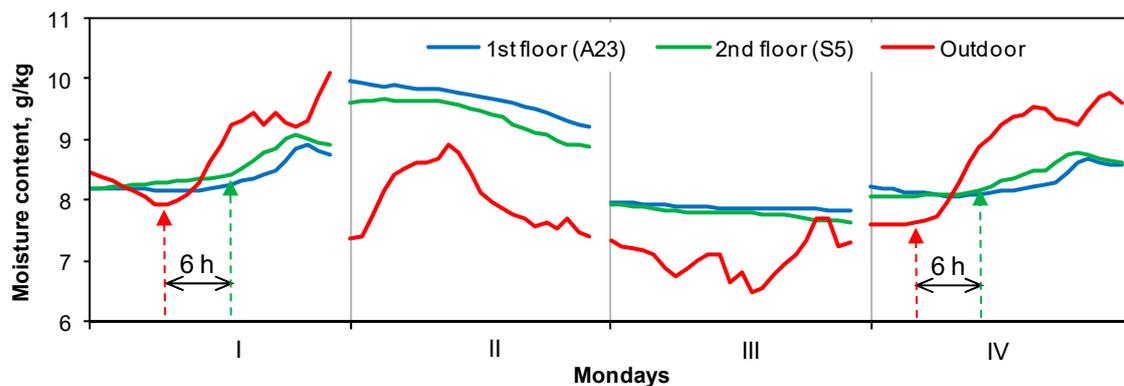
Figure 11. Variation of internal and external moisture content for four Mondays of June in the selected locations in Museum A. Data on the graph represent mean hourly values.

In the case of changes in the moisture content of the indoor air, quite a large overtaking of the moisture content of the outdoor air can be observed. The highest correlation was obtained in weeks one and four when the outdoor moisture content showed an upward trend during the day (amplitude above 2.2 g/kg). In these cases, it is possible to see the beginning of growth of RH inside and outside as well as a clear time delay. The worst correlations were obtained in the third week, which, similarly to the temperature indications, was caused by a very small variation in the moisture content of the outdoor air (maximum 1.2 g/kg). In the ethnography room of Museum A (sensor S5) even an inversely proportional correlation was then obtained (Figure 11).

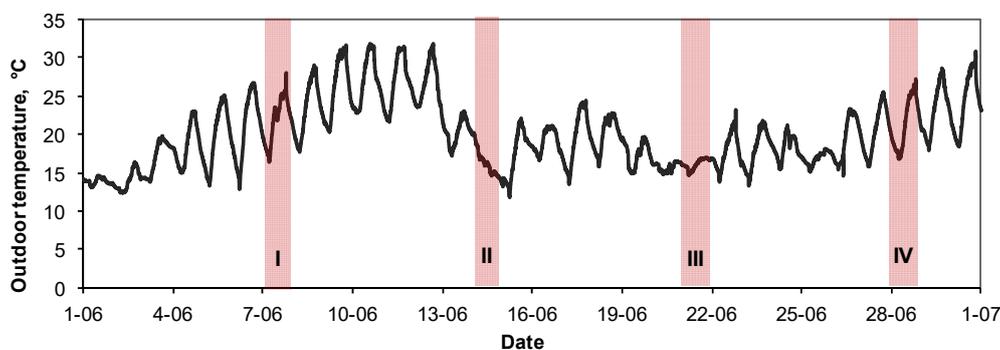
Figure 12. Variation of external temperature at Museum B in June. The analyzed Mondays are marked in red.

On the second analyzed Monday, the initial indoor temperature was high, despite the low outside temperature. It was caused by very hot days in the proceeding period from 9th to 12th of June, when temperatures during the day exceeded 30 °C, as shown in Figure 12. The heat accumulated in the walls was gradually released when the outdoor temperature decreased, causing the delay in the indoor temperature drop.

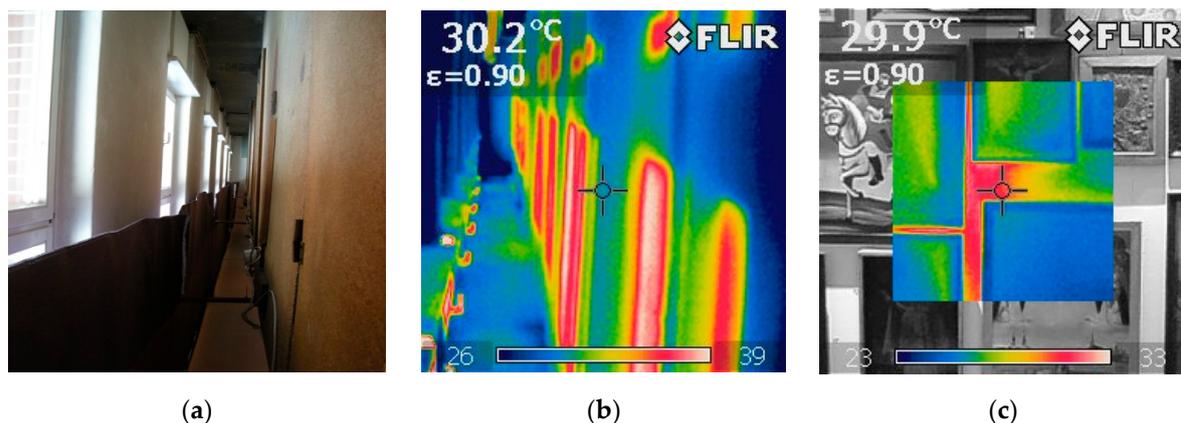
Figure 13. The curtain wall view (a) and the thermal imaging camera pictures taken for the same place—in the back (b) and the front (c) (the ethnography exhibition hall in Museum A).

In all studied museums, sun protection in windows was used to prevent direct solar radiation from penetrating inside. Only in Museum A, in the rooms of ethnographic, flora and fauna, as well as temporary exhibitions, special solar screens made of chipboard or plasterboard were used as the exhibition spaces. An example of such a solar screen in the ethnographic exhibition room is shown in Figure 13a. Figure 13b shows an uneven temperature distribution on the back of this wall. In contrast, Figure 13c shows a fragment of the front side of the wall, on which the images of various techniques were hung. An image from a thermal imaging camera was superimposed on the photo, showing the unevenness of the wall heating and the images themselves.

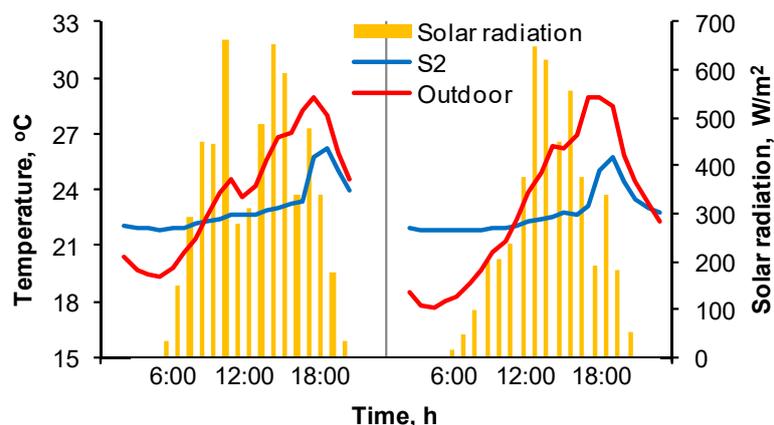
Figure 14. Variation of temperature for sensor S2 localized in Museum A on the curtain wall in the flora and fauna exhibition hall and external temperature and solar radiation for two Mondays of June.

Figure 14 shows the temperature-time course recorded in Museum A (by sensor S2) during two days when the museum was closed for visitors (i.e., only external factors affected temperature fluctuations in that period). Sensor S2 was placed directly on the curtain wall in the nature exhibitions room. The large immediate increase of temperature by 4 °C was directly correlated with the increase in outside temperature, as well as the increase in solar radiation. The windows of this room have western exposure.
