Article

Ageing Tests of Samples of Glass-Epoxy Core Rods in Composite Insulators Subjected to High Direct Current (DC) Voltage in a Thermal Chamber

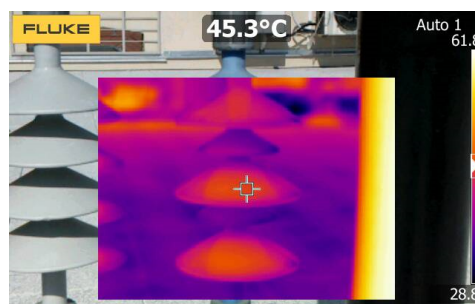
Figure 1. The surface temperature of the composite insulator housing measured with a thermal imaging camera.

The samples had a diameter of 24.0 mm and a length of 120.0 mm. The first group, marked with the letter A, were fresh reference samples and reflected the material's initial structure. The samples of the second series, marked with the letter B, were subjected to a temperature of about 50 °C \pm 2 °C for 6000 h. This temperature was selected following the measurements of the insulator housing temperature made on a sunny, cloudless day with an ambient temperature of about 27 °C. Measured temperature values under actual insulator operation conditions reached about 46 °C, as shown in Figure 1.

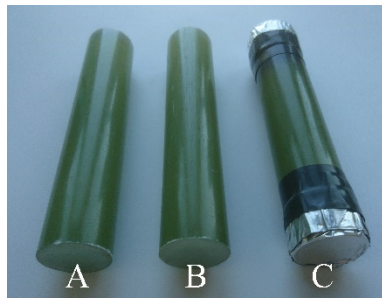
Figure 2. Glass-reinforced epoxy (GRE) material samples of the high voltage alternating current (HVAC) composite insulator carrying rod. From the left: reference sample—group A; thermally aged sample—group B; and DC and thermally aged sample—group C, with visible electrodes attached to the sample's front surfaces.

The samples of the third series, marked with the letter C, with electrodes applied to their front surfaces, were subjected for 6000 h to a temperature of about 50 °C \pm 2 °C and a DC voltage of 20 kV. The average value of the voltage distribution along the main axis of the typical insulator was about 1 kV/cm. In this research, it was applied twice as high as the electric field strength, i.e., 2 kV/cm. Increasing the voltage was supposed to accelerate the aging process. Figure 2 shows one sample from each of the three series.

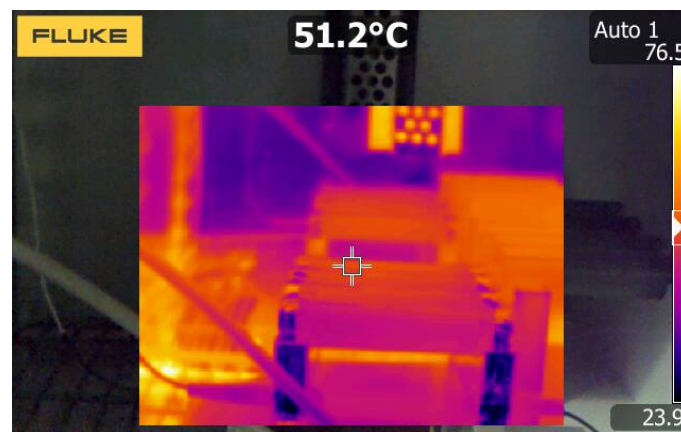
Figure 3. Samples placed in the heating chamber.

The samples were arranged in a special stand and placed in a heating chamber. Figure 3 shows the samples in the heating chamber (photograph taken with a fluke thermal imaging camera).

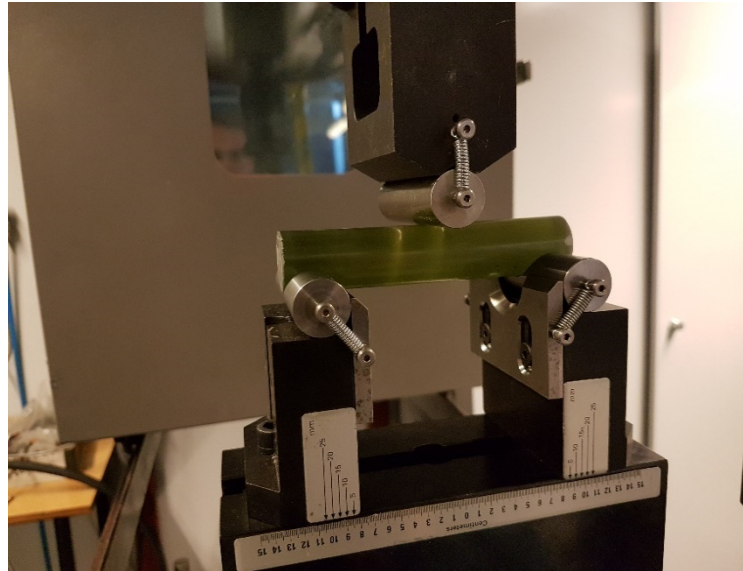
Figure 4. The sample of a group A from HVAC composite insulator carrying rod in a mechanical system for strength testing via the 3-point bending test. The notches in bottom supporting rollers are visible.

Samples from all three groups (both reference samples, thermally aged samples and those thermally and voltage aged) were tested using the 3-point bending test. For this purpose, a testing machine (INSTRON 1343) was used, which was extended with controllers and software by MTS. (MTS—Mathematisch Technische Software-Entwicklung GmbH, Berlin, Germany). Special adaptation of the support system was necessary as the tested samples had a cylindrical shape with a diameter of 24.0 mm. Therefore, in the steel rollers on which the samples were based, semi-circular notches with a radius of 12.0 mm and a depth of 10 mm were made at 100.0 mm of spacing. This is illustrated in Figure 4. A relatively low crosshead speed of 0.1 mm/min was set. This corresponded approximately to a force increase of 20 N/s.

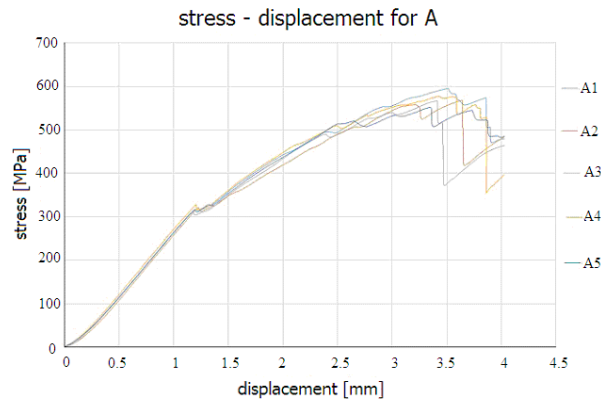
Figure 5. Mechanical characteristics of the 3-point bending test for reference samples—group A.

The mechanical characteristics of the 3-point bending test for all 13 tested samples showed a very high similarity (Figures 5–7). Small differences occurred individually for particular samples, but there were no differences in the characteristics of the samples that would be typical for groups A, B or C. For a stress that usually slightly exceeds 300 MPa (294–345 MPa for individual samples), the displacement linearly increased when stress increased. The slope of characteristics was identical for all tested samples. A slight non-linearity at the beginning of the characteristics resulted from the arrangement of the samples in the clamping system. When the stress reached about 300 MPa, the samples broke axially. Long cracks were formed that extended symmetrically from the middle of the samples and were present on the upper and lower side of the specimens, as illustrated in Figures 8 and 9. These cracks usually did not reach the ends of the samples. The formation of cracks, accompanied by a well audible crackle, was reflected by a clear fault, sometimes even two faults, on the samples' mechanical characteristics. This effect occurred for all tested samples and only the length of axial cracks differed. The formation of these cracks can be considered as a critical point. Sample stiffness was clearly reduced and, therefore, the slope of the further part of the characteristics already showed some differences for individual samples. There were also deviations from the straightforward course of the characteristics. Additional faults, visible on the characteristics of individual samples, corresponded to

the formation of consecutive cracks and the enlargement of existing ones. This was largely random, hence the significant differences in the characteristics of the different shapes. However, it should be emphasized that there was no apparent link between these discrepancies and the group to which the samples belonged.

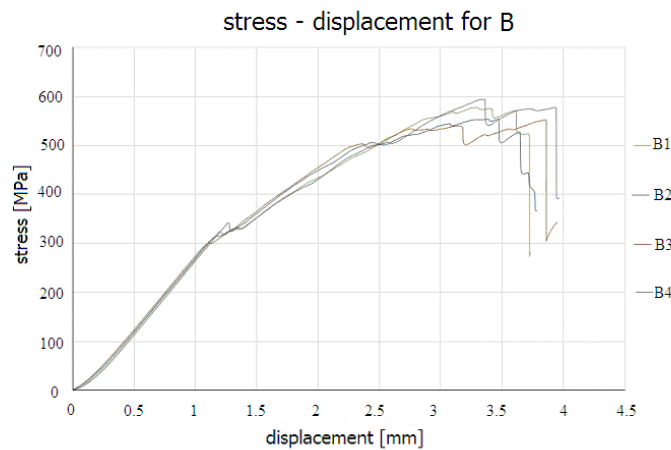
Figure 6. Mechanical characteristics of the 3-point bending test for samples subjected to temperature—group B.

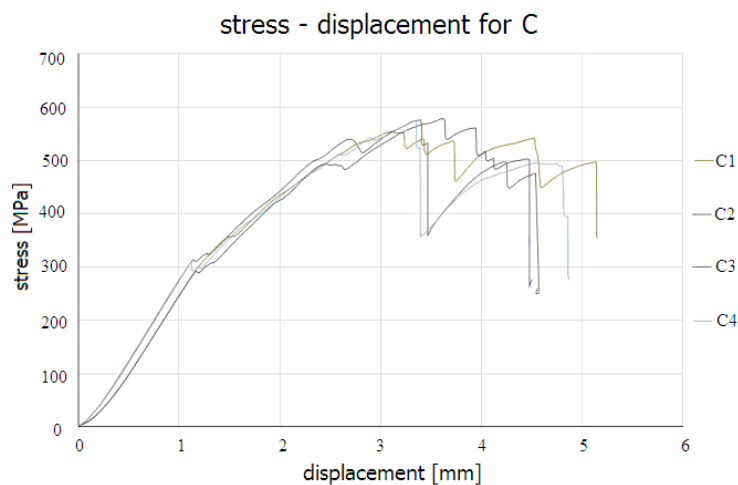
Figure 7. Mechanical characteristics of the 3-point bending test for samples subjected to high direct current (DC) voltage and temperature—group C.

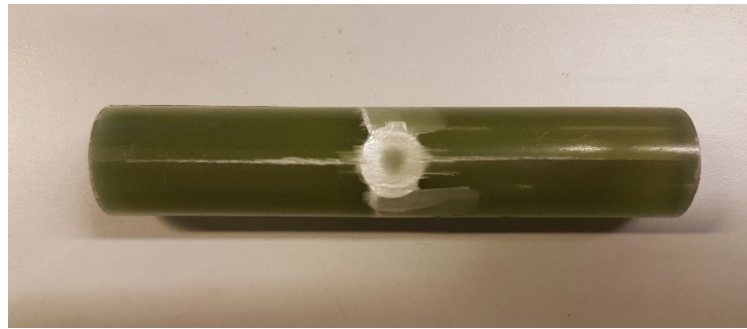
Figure 8. Long axial crack on top of sample A1, with an indentation caused by a crosshead of the strength testing machine.

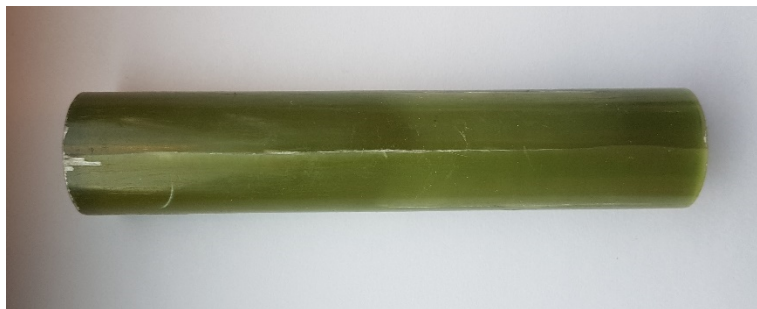
Figure 9. Long axial crack in the lower part of sample C1.

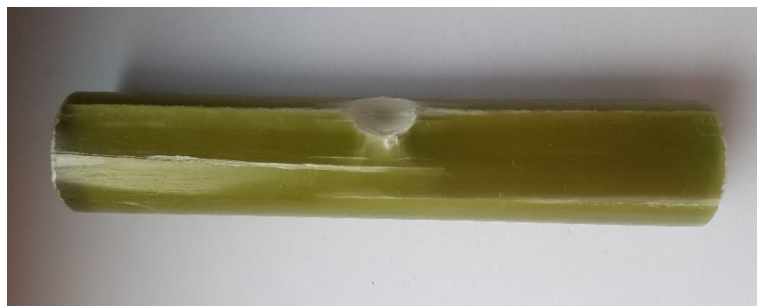
Figure 10. Indentation at the point of operation of the crosshead of the strength testing machine, long axial crack and cracks on the side surface of sample C3.

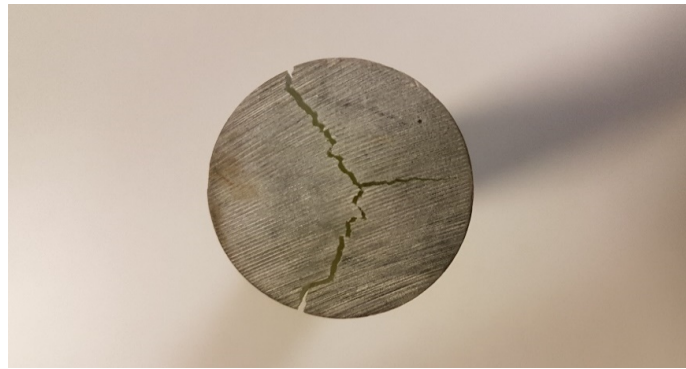
Figure 11. Cracks on flat side surface of sample C4.

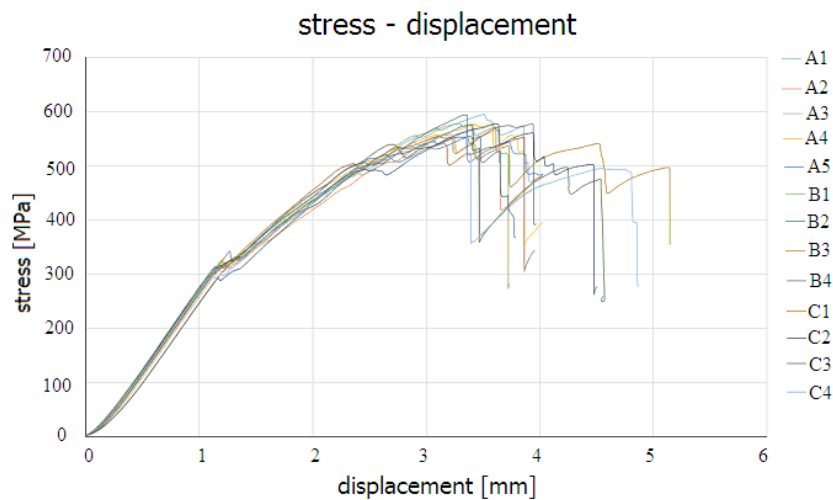
Figure 12. Mechanical characteristics of the 3-point bending test of all tested samples.

All recorded mechanical characteristics of the 3-point bending test were collected (Figure 12). The figures and tables illustrate the reproducibility of the results obtained from the 3-point bending test.

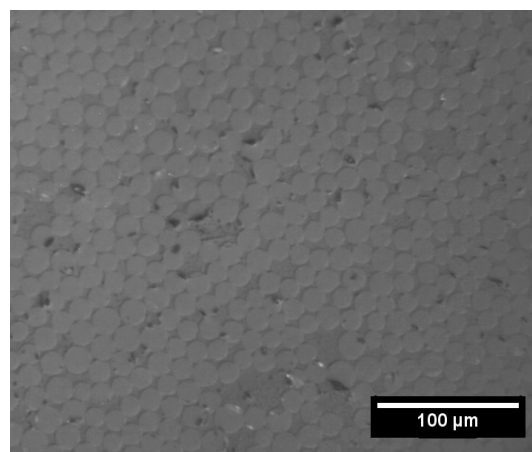
Figure 13. Microstructure image of sample A2 on its flat side surface, 200×. The ECR glass fibers in section and slightly darker epoxy resin are visible. Dark chipping of fiber fragments and less often of binder are few.

The analysis of microscopic images concluded that the microstructure of the tested material was characterized by high homogeneity. Images from different places on the tested surface, both from the same and different samples, showed no differences. The tight arrangement of fibers and binders (in the form of epoxy resin occupying about 1/3 surface) was analogous to all of the tested observation fields. The glass fiber diameter was also the same (several micrometers) with a small size dispersion. It should be emphasized that there were no differences for individual samples from groups A, B and C. Neither the long-term subjection to a temperature of about 50 °C nor the combined action of temperature and DC voltage of 20 kV caused any observable effects in the material's microstructure, which had been found in earlier studies [9]. Microstructure images of the sample material from all three groups are presented in Figures 13–15. There were few small dark chippings in the microstructure elements (i.e., fiber fragments and, less often, binder). They were created during the preparation of the surface of the samples.

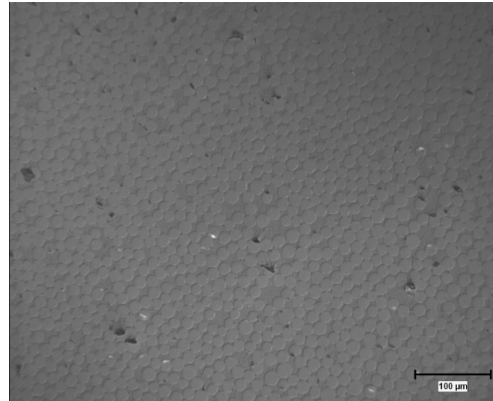
Figure 14. Microstructure image of sample B2 on its flat side surface 100×. Few dark chipping of fiber fragments and binder are visible.

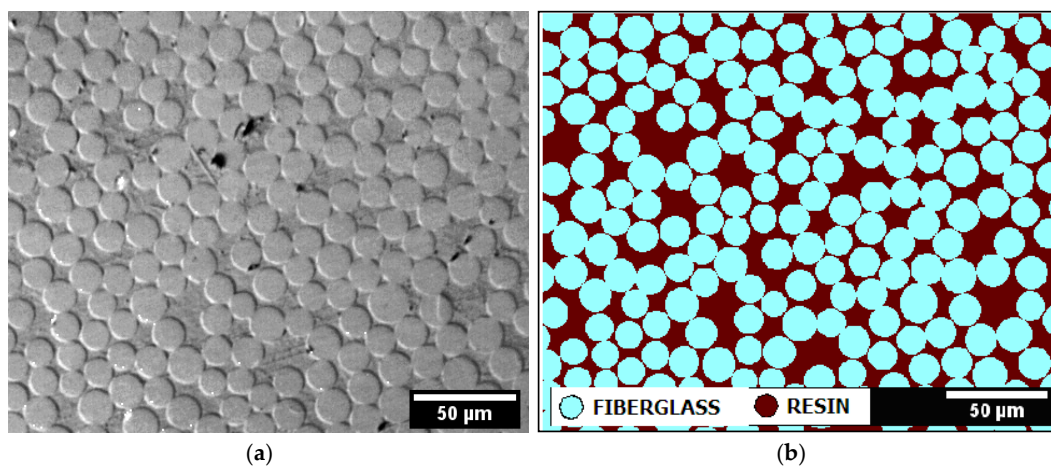
Figure 15. Microstructure image of sample C3 on its flat side surface, 200×. Few chipping of fiber fragments and binder are visible (a) on the right side and (b) the same area with a colored binary mask, which enables precise measurements to be taken.

After appropriate reformatting of the 8-bit grey scale images and processing of these images with an optical microscope, the areas with the glass fibers and epoxy resin binder were depicted and distinguished more clearly, allowing for more accurate measurements. Image analysis was carried out with a Clemex computer-based analyzer. The blue phase was made up of glass fibers against a dark organic phase. The binary mask that was applied to the image, as shown in Figure 15, allowed for

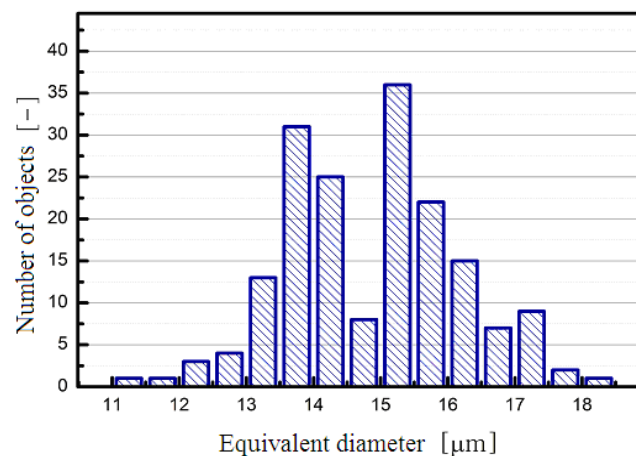
Figure 16. Size distribution of glass fiber diameters in the GRE material for the HVAC composite insulator carrying rod.

the quantitative measurement of glass fibers and resin content in the material and facilitated the determination of fiber diameters. Figure 16 shows the size distribution of glass fiber diameters obtained by averaging three microscopic images (A, B and C, one from each sample group).

On all tested micro-sections of samples A2, B2 and C3, glass fibers represented, on average, 67.0%. The differences for individual observation fields did not exceed 2.1%. The average value of the glass fiber diameter was 14.9 μm . The whole distribution was between 11.0–18.5 μm . However, over 90% of the fibers had a diameter in a narrow range, from 13.0 to 16.5 μm . The distribution was clearly multimodal, with fibers with a diameter of 13.5–16.0 μm dominating.

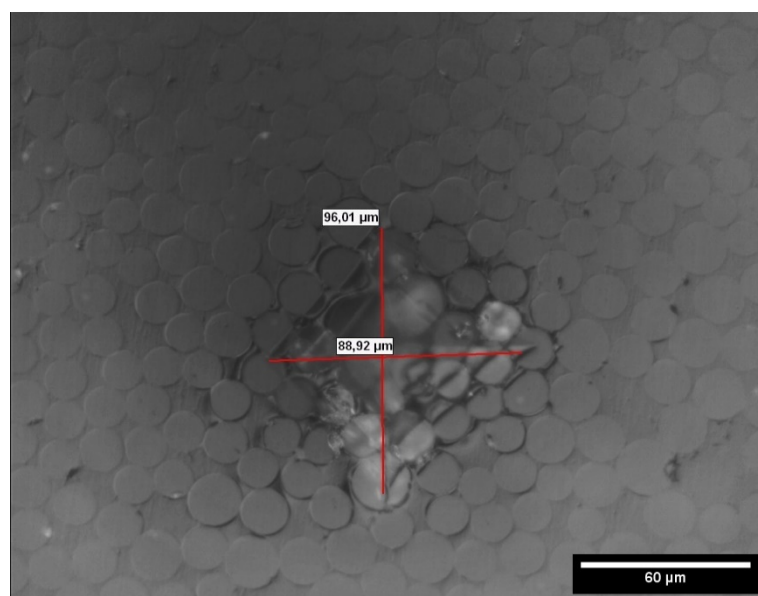
Figure 17. Image of an indenter imprint on the flat side surface of sample A2, 500 \times . In order to measure it correctly, the position of the markers was manually corrected. The measured values of the imprint diameter were averaged. There are no common microcracks running from the apex of the imprint, but there are visible fiber cracks as a result of the indenter operation.

The obtained micro-hardness values were high and clearly proved the quality of the tested GRE material of the HVAC composite insulator carrying rod. This confirmed the generally high evaluation of homogeneity and cohesiveness of the tested material. The imprints were often of a regular shape, allowing for automatic diameter measurements. In the case of less regular imprints, it was necessary to correct the marker setting manually, as illustrated in Figure 17. The typical phenomenon of relaxing the energy of load interaction through microcracks, especially running from the apex of the imprint, was not observed. However, the fibers located inside the area of the indenter operation often cracked. Images of typical imprints obtained on samples from three series are shown in Figures 17–19.

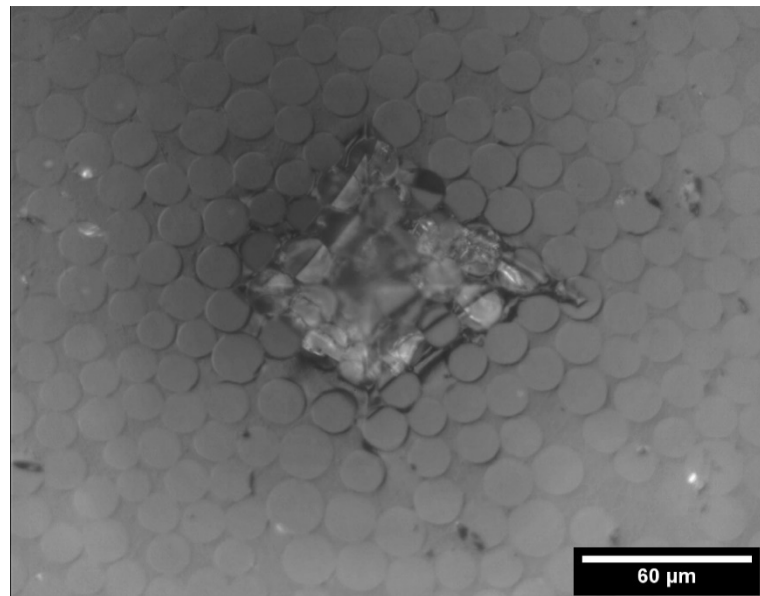
Figure 18. Image of an indenter imprint on the flat side surface of sample B2, 500×. Cracks and chipping of fiber fragments and resin damage as a result of the indenter operation are clearly visible.

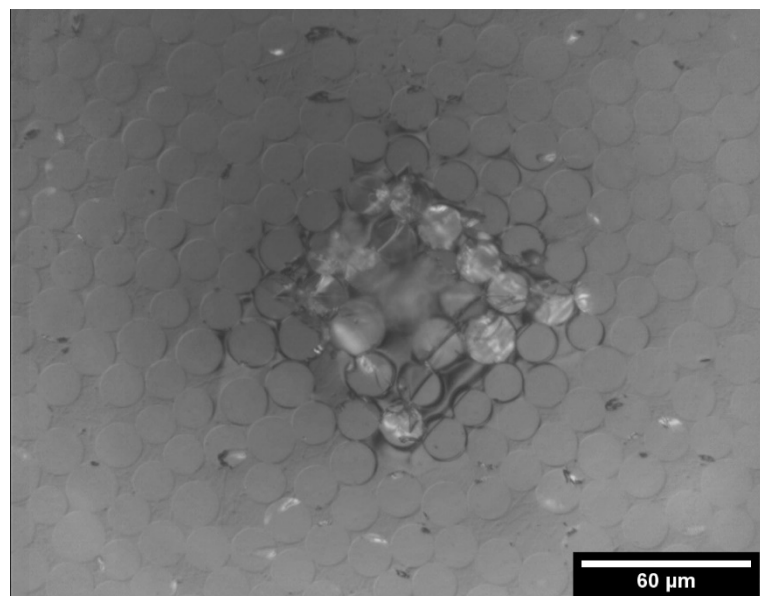
Figure 19. Image of an indenter imprint on the flat side surface of sample C3, 500×. Cracks and chipping of fiber fragments and resin damage in the area of the indenter operation are visible.
