# Thermal Performance and Comfort Condition Analysis in a Vernacular Building with a Glazed Balcony

**Abstract:** The increase in global environmental problems requires more environmentally efficient construction. Vernacular passive strategies can play an important role in helping reducing energy use and CO<sub>2</sub> emissions related to buildings. This paper studies the use of glazed balconies in the North of Portugal as a strategy to capture solar gains and reduce heat losses. The purpose is understanding thermal performance and comfort conditions provided by this passive heating strategy. The methodology includes objective (short and long-term monitoring), to evaluate the different parameters affecting thermal comfort and air quality, and subjective assessments to assess occupants' perception regarding thermal sensation. The results show that the use of glazed balconies as a passive heating strategy in a climate with cold winters is viable. During the mid-seasons, the rooms with balcony have adequate comfort conditions. In the heating season, it is possible to achieve comfort conditions in sunny days while in the cooling season there is a risk of overheating. Regarding indoor

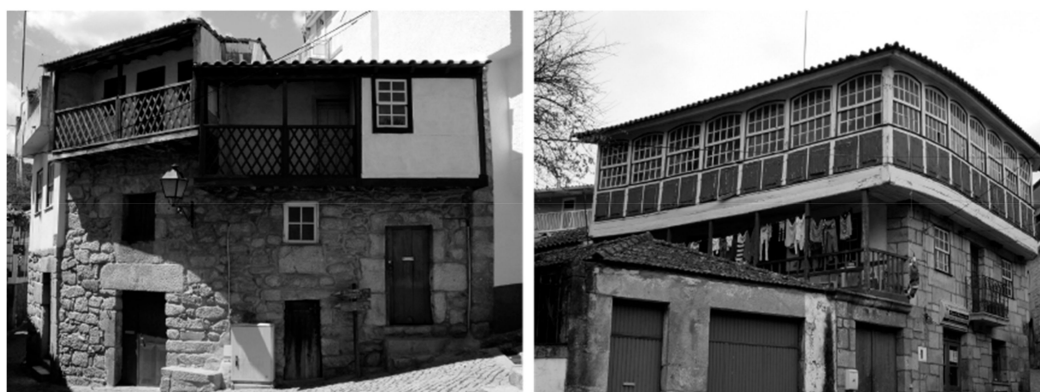
**Figure 1.** Balconies in the vernacular architecture of Beira Alta, Portugal.
