Instability Control of Roadway Surrounding Rock in Close-Distance Coal Seam Groups under Repeated Mining

Abstract: In order to solve the problems of roadway stability and easy instability under repeated mining of close-distance coal seam groups, the mechanism and control technology of surrounding rock instability under repeated mining were studied via indoor testing, field testing, physical similarity simulation experiment, and numerical simulation. The results show that the surrounding rock of roadway has low strength, low bearing capacity, and poor self-stabilization ability, and it is vulnerable to engineering disturbances and fragmentation. Affected by the disturbance under repeated mining, the roadway surrounding rock cracks are developed and the sensitivity is strong, and it is prone to large-scale loose and destroyed. The location of the roadway is unreasonable, and the maximum principal stress of the roadway is 3.1 times of the minimum principal stress, which is quite different. Thus, under a large horizontal stress, the surrounding rock undergoes long-range expansion deformation. On the basis of this research, the direction and emphasis of stability control of roadway sur

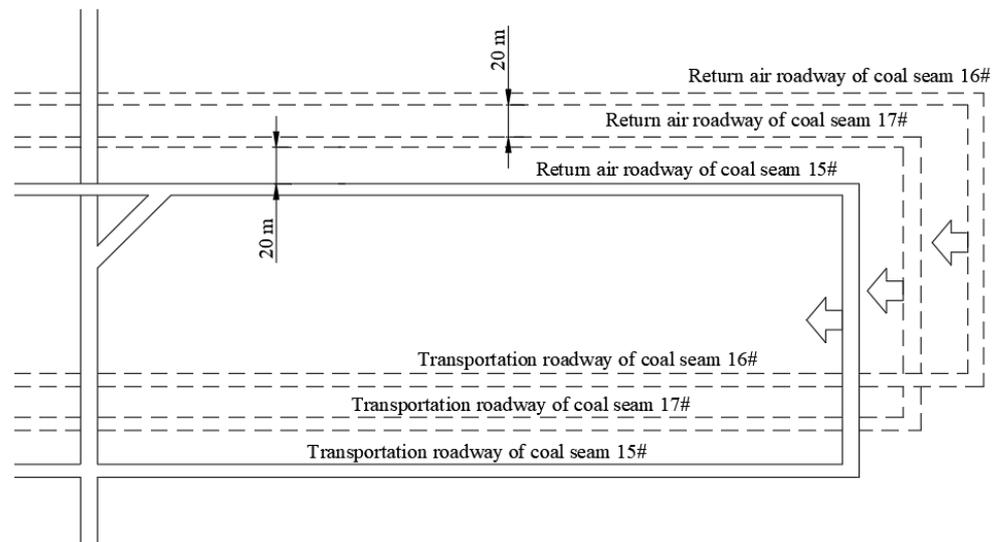
Figure 2. Layout drawing of working face and roadway.

At present, coal seams 15# and 16# have been mined, and coal seam 17# is being mined, 17,101 working face is the first mining face of the coal seam 17#, with a mining depth of 500 m. It adopts comprehensive mechanized large mining height and one-time full-height receding mining. The length of working face is 120 m, and the length of advance is 1000 m. The inclination angle of the coal seam is relatively small, and it is a nearly horizontal coal seam. The spatial layer relationship between coal seam 17# 17,101 working face layout and coal seams 15# and 16# is shown in Figure 2. The 17,101 working face roadway is separated from the coal seams 15# and 16# working face roadway by 20 m in the horizontal direction. In addition, between the roadway and the working face, there is a 10 m-length coal pillar for roadway protection. The roadway was a curved-wall-top-arch section with a width of 5600 mm and a height of 3800 mm; the arch height is 2800 mm and the rib height is 1000 mm. Bolts 21.6 mm in diameter and 2500 mm in length were used for roof and rib support. Roof and rib bolts were installed with a spacing of 1200 × 1200 mm. In some local areas, anchor cables 21.6 mm in diameter and 6000 mm in length were used for reinforcement. The roof and floor strata are mostly mudstone and siltstone in this mine. Due to repeated mining in coal seams #15 and #16, during the mining of coal seam #17 [31], the mining roadway was seriously deformed and destroyed, and significant roadway

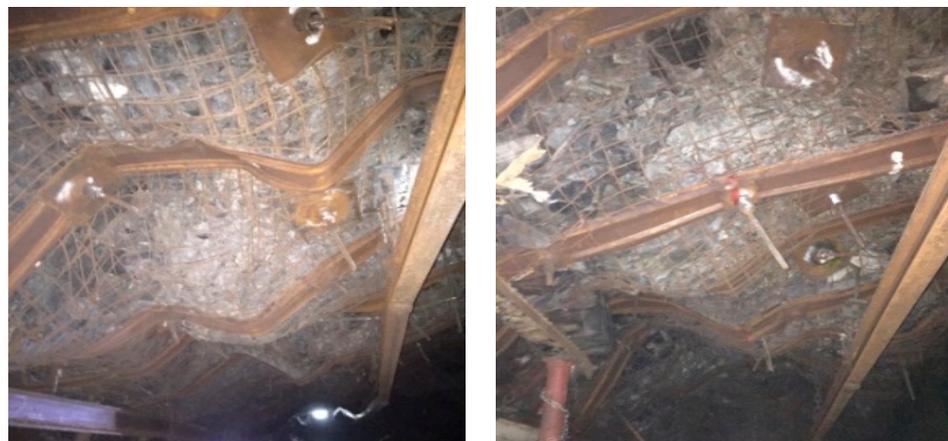
Figure 3. Deformation and failure characteristics of the roadway.

The serious deformation of the mining roadway in the working face was photographed, as shown in Figure 3. The roof of the mining roadway has a large amount of subsidence, the coal walls on both sides have moved closer, and manual repairs are repeated, and there are risks such as roof leakage and roof fall.

(1) The surrounding rock of the roadway undergoes significant deformation over a long duration. The roadway roof has an obvious shear fracture zone caused by horizontal extrusion and obvious expansion deformation. Due to the stress concentration of the coal pillars left while coal seams #15 and #16 were being mined, the surrounding rock deformation of the roadway is significant and occurs over a long period from the roadway excavation stage to the mining stage of the working face.

(2) The surrounding rock of the roadway is subjected to great pressure, and the U-shaped steel undergoes significant deformation and distortion. The coal pillar side of the roadway collapsed completely in a large area, the expansion of the solid coal side of the

(3) The surrounding rock of the roadway is relatively soft, fragmented, and its integrity is poor. Furthermore, the anchorage performance of the bolts and cables are suboptimal, the breakage and failure of anchor bolts and cables occur in many places, and the tearing of metal mesh is common.

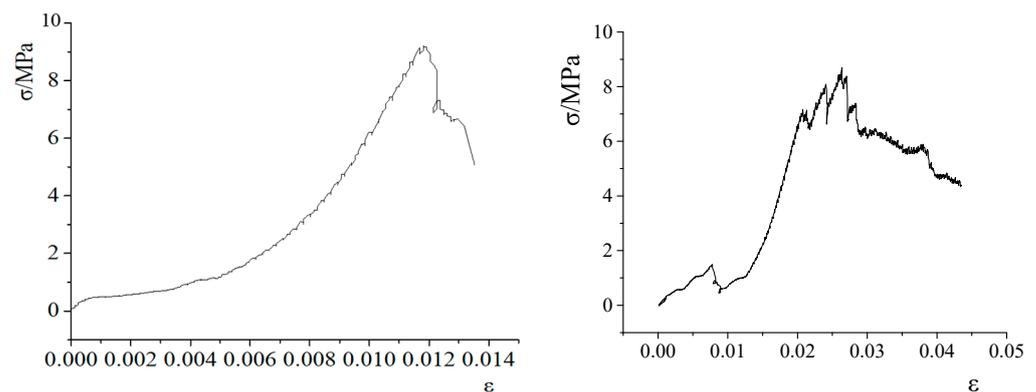
Figure 4. Stress–strain curve of mudstone under uniaxial compression.

As seen from Figure 4, the axial strain of the two mudstone specimens are less than 3% before failure, and the failure mode is brittle failure. The yield stage is relatively short, and the two mudstone specimens will be destroyed quickly when the stress exceeds its strength limit. The residual strength is very low after failure, and there is almost no bearing capacity. The failure strengths of the two rock samples are 9.5 MPa and 8.5 MPa, respectively. The average failure strength is 9 MPa, and thus, the specimens are classified as soft rock.

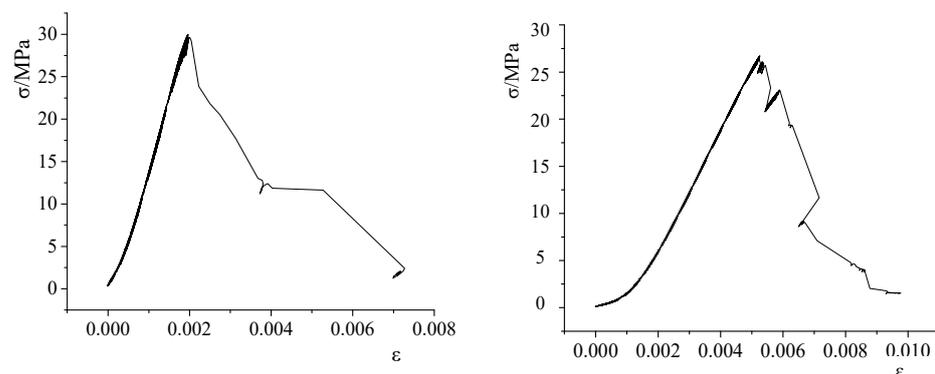
Figure 5. Stress–strain curves of sandstone specimens under uniaxial compression.

It can be seen from Figure 5 that the stress–strain curve of the siltstone specimens is not smooth, indicating that there are many cracks in the specimens, and the failure mode of the two siltstone specimens is tension failure. The axial strains of the two specimens are 0.002 and 0.005; these values signify brittle failure. The failure strengths of the two specimens are 30 MPa and 28 MPa, respectively. The average failure strength is 29 MPa, and thus, indicates that the strength of the siltstone is relatively low.

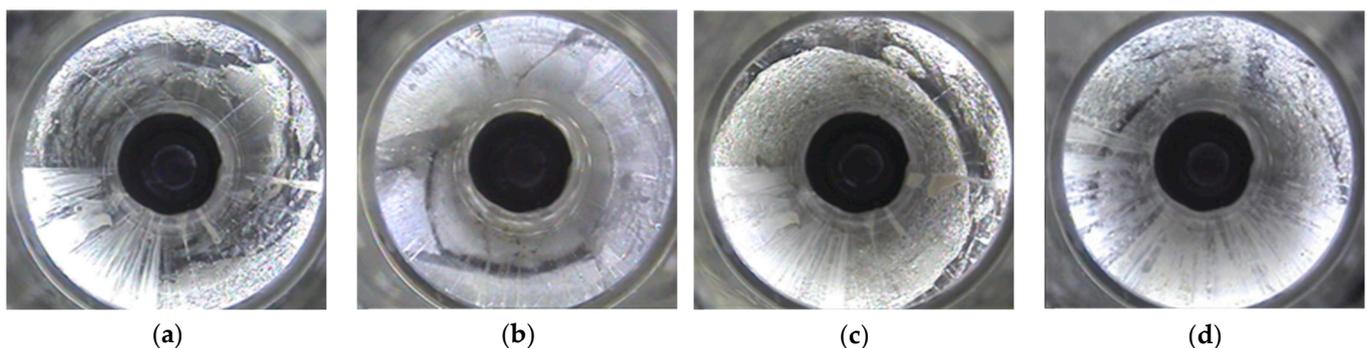
Figure 6. Crack distribution of the roof at a horizontal distance of 45.6 m from the working face: (a) Away from roadway roof: 0.6 m; (b) Away from roadway roof: 1.8 m; (c) Away from roadway roof: 2.8 m; (d) Away from roadway roof: 5 m.

From Figure 6, it can be seen that the rock mass located 0–0.6 m above the roof of the roadway is relatively fragmented, and longitudinal cracks are developed. The rock mass located at 0.6–2.8 m contains many types of cracks, such as longitudinal cracks, transverse cracks, and cross cracks, and they are relatively developed. The area at 2.8 m mostly consists of annular cracks, but local fragmentation also occurs. Annular cracks

and longitudinal cracks develop at 3.4–4 m on the roof of the roadway, and microcracks develop from 4–5.6 m.

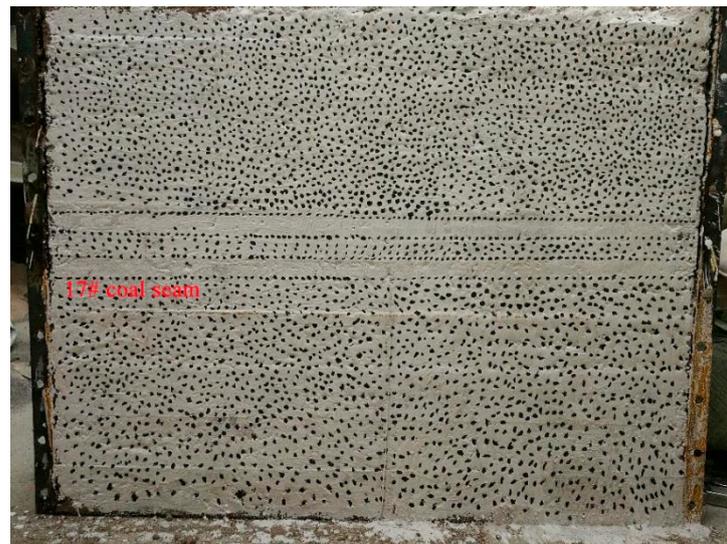
Figure 7. Similar simulation model.

The similar simulation test frame in this experiment has a length of 1.5 m, a width of 40 cm and a height of 1.5 m. The periphery of the model and the bottom plate can be strongly restrained by the steel channel of the similar simulation test frame. The matching ratio of similar materials in each rock formation in this physical simulation experiment is the best result obtained after many experiments, as shown in Table 1. Simulate different lithology materials with different matching ratios, using gypsum and lime as cementing materials, sand as aggregates [33,34]. The model is laid according to the geometric similarity ratio 1:100, the bulk density similarity ratio 1:1.6 and the time similarity ratio 1:10. The final laying model height is 1.2 m (see Figure 7). In this model, a total of four coal seams have been laid, among which coal seams 15#, 16#, and 17# belong to close-distance coal seams. In the actual engineering background, coal seams 15# and 16# have been mined and coal seam 17# is being mined. After the model is laid, the upper coal seams are mined in sequence to simulate the upper goaf. Then the coal seam 17# was mined to observe the fracture characteristics of the roof and the displacement of the surrounding rock of the roadway of the coal seam 17# after being affected by repeated mining. The model is a three-dimensional similar model. In the simulation process, the length and width of the model are the simulated coal seam working face layout direction and the working face forward direction respectively. That is, the simulated working face will advance 40 cm in length (actual advance 40 m) to observe the deformation and failure of the roadway.

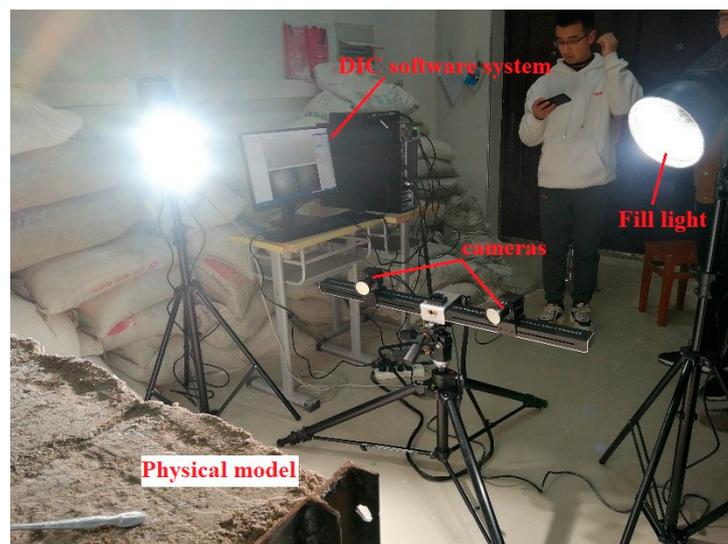
Figure 8. Digital image correlation system.

The experiment uses a three-dimensional digital image correlation strain measurement and analysis system to calculate the strain and deformation of the whole field when the model is excavated. The three-dimensional digital image correlation strain measurement and analysis system has a flexible and easy-to-use trigger function, rich external software and hardware interfaces, and the strain measurement range can be varied from 0.01% to 1000%. It adopts the digital image correlation method and uses two high-speed cameras to collect real-time speckle images of physical objects deformed in various stages. The relevant algorithm is used to match the displacement of the object with the stereo to realize the visual analysis of the displacement field data, so as to achieve the rapid, high-precision, and real-time experimental requirements, as shown in Figure 8.

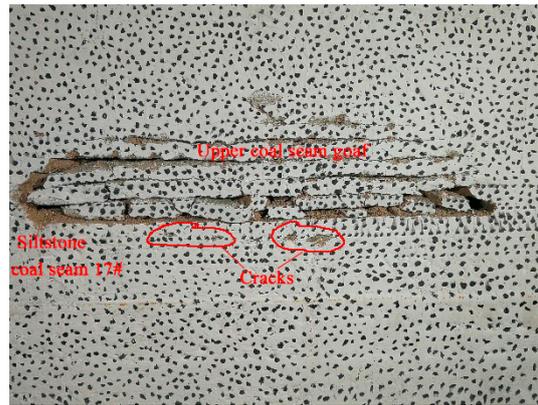
Figure 9. State of completion of upper coal seams mining.

Mining coal seams at close distance, the upper coal seams will cause a certain degree of failure to the lower coal seam. The upper coal seams are completed as shown in Figure 9.

The development of cracks in the coal and rock mass is very complicated. When the upper coal seam is not mined, there are a large number of primary cracks in the lower coal seam and the roof. After the coal seam 17# is affected by mining, as the stress around the coal and rock mass changes, the primary cracks continue to expand into new secondary cracks in different forms. It can be clearly seen in Figure 9 that the completion of upper coal seam mining has failure the coal seam 17# and the roof to a certain degree, affecting the integrity of the coal and rock mass.

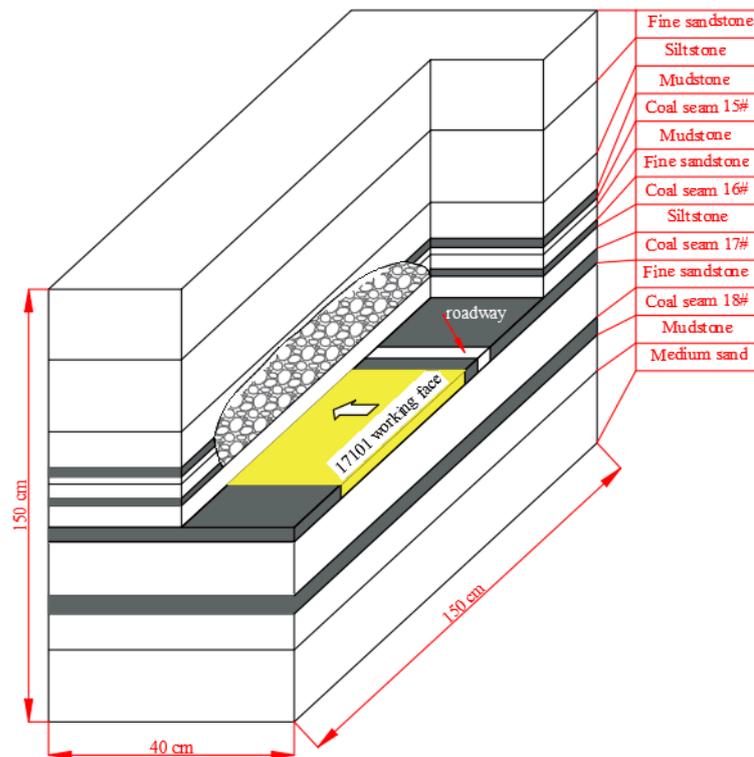
Figure 10. Excavation simulation plan diagram of coal seam 17#.

When the coal seam 17# 17,101 working face was excavated, the mining roadway had been excavated in advance. The mining plan of the simulated working face is shown in Figure 10, and the working face is advanced 40 cm (actual advance 40 m). During the mining process, Figure 11 shows the completion of coal mining in one work cycle at the working face. Here, the digital image correlation system is used to monitor the displacement of the surrounding rock of the roadway.

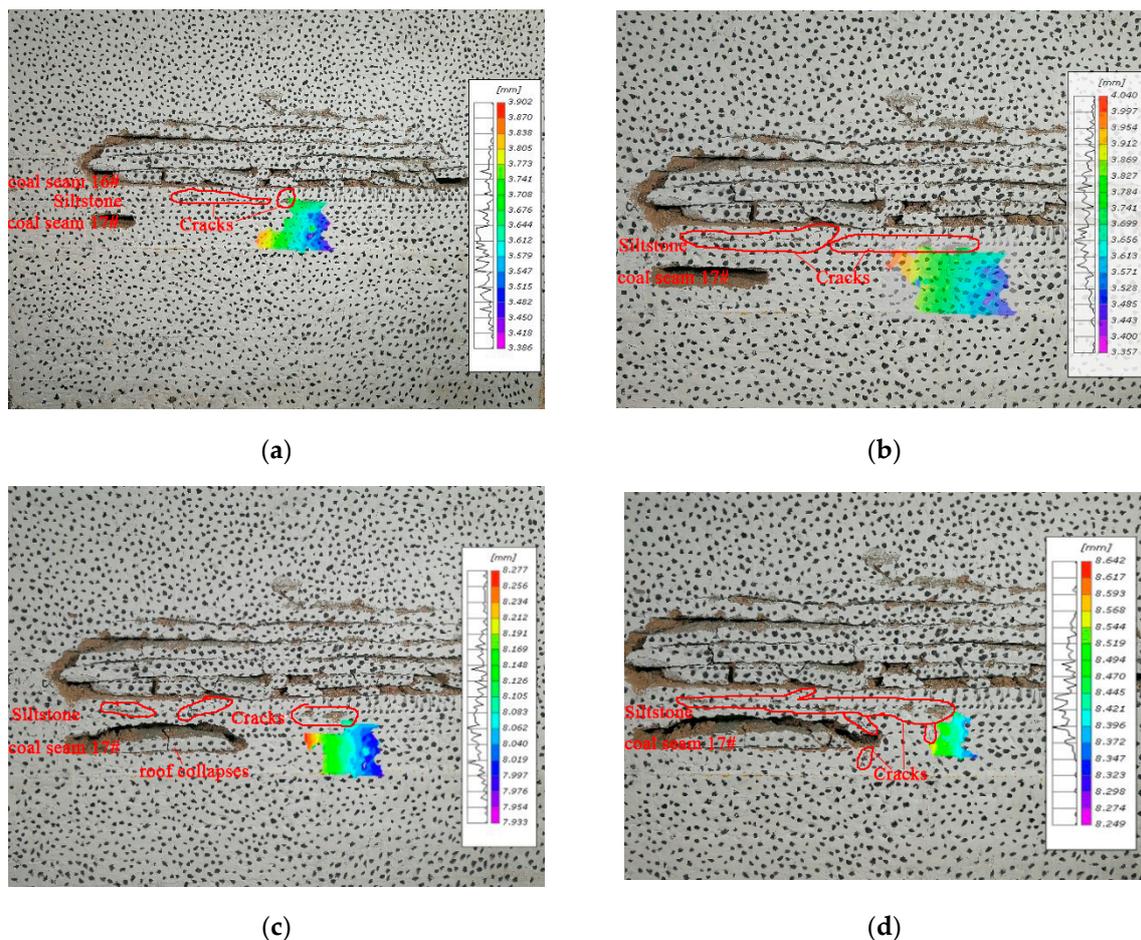
Figure 11. Displacement of roadway surrounding rock during one coal mining cycle at 17,101 working face: (a) The roof is basically stable; (b) Cracks appear in the roof rock layer; (c) Roof collapses; (d) Cracks development.

It can be seen from Figure 11a that the roof of the working face is basically stable, the overlying rock layer has not collapsed, and no obvious cracks appear. The DIC system monitors that the surrounding rock of the roadway begins to move, and the farther away from the working face, the smaller the displacement. Due to the change of the stress environment in front of the working face and the goaf above the coal seam 17#, which has a certain disturbing effect on the surrounding rock, the maximum displacement at this time is 3.902 mm. According to the geometric similarity ratio of 1:100, the surrounding rock of the roadway has a displacement of 39.02 cm.

It can be seen from Figure 11b that the cracks appear in the roof rock layer, and the cracks are connected with the cracks produced during the mining of the upper coal seam, and the roof of the deep roadway is slightly failure. With the excavation of the working face, the displacement of the surrounding rock of the roadway increases under the influence of mining.

It can be seen from Figure 11c that the roof collapses, forming the initial pressure. Under the disturbance of the mining of the coal seam 17#, the broken rock mass in a small area of the overlying goaf is more likely to lose stability. At this time, the disturbance of the roadway has a greater impact. The surrounding rock of the roadway has a displacement of 8.277 mm. According to the geometric similarity ratio of 1:100, that is, the roadway actually has a displacement of 82.77 cm, and the roadway is seriously failure.

It can be seen from Figure 11d that the roof will collapses with the mining because the roof above the working face is broken and cracks are developed. At this time, the roof has obvious separation cracks, but it has not broken and subsided, and the displacement of the surrounding rock of the roadway is increasing.

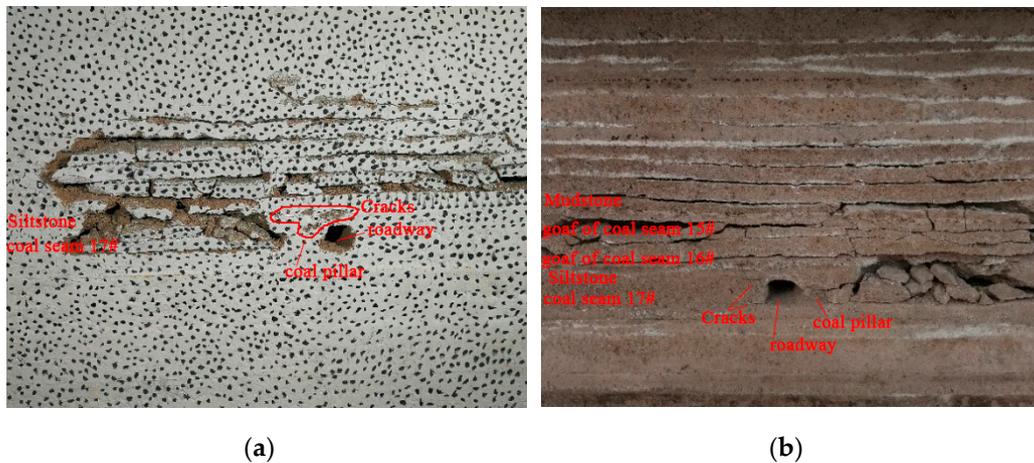
Figure 12. Failure of surrounding rock of roadway under repeated mining: (a) Surrounding rock conditions of the roadway in front of the model; (b) Surrounding rock conditions of the roadway behind the model.

Figure 12a shows the failure of the surrounding rock of the roadway under the influence of mining in front of the model. With the passage of time, the roof of the coal seam 17# is broken and its strength is reduced due to the mining of the upper coal seam, so that the roof is more likely to lose stability during the mining of the coal seam 17#. It has all collapsed and re-compacted to form a new 'masonry beam' structure. At this time, the calibration point of the digital image correlation has been destroyed, so the relevant displacement cloud image has not been recorded. The failure of the surrounding rock of the roadway intensified under repeated disturbances.

Figure 12b shows the deformation and failure of the surrounding rock of the roadway under the influence of mining behind the model. At this time, there have been obvious cracks in the roof above the roadway. In addition, there are obvious cracks in the coal pillar of the roadway protection, and there are also obvious cracks in the solid coal body, and the stability of the surrounding rock of the roadway is poor.

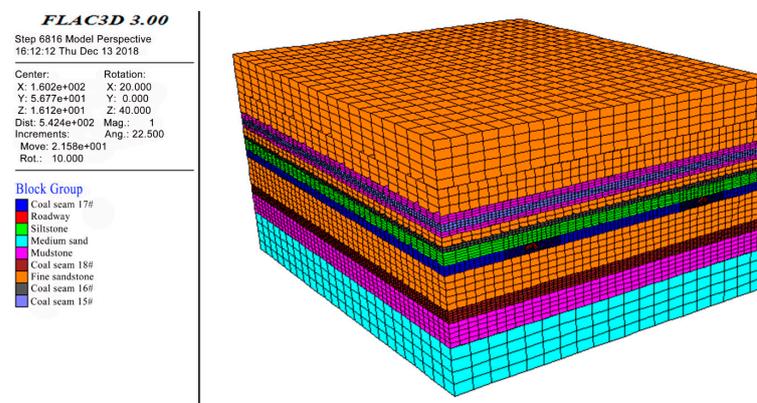
Figure 13. Numerical simulation model.

The stress of the surrounding rock is the external factor that affects roadway stability, and it is the main factor determining roadway failure. To obtain the stress distribution characteristics around the roadway under repeated mining, the maximum and minimum principal stresses around the roadway after mining coal seams #15 and #16 are simulated using FLAC3D. The mechanical parameters of the coal and rock mass are shown in Table 2. The numerical model is shown in Figure 13. The left and right boundaries, front and back boundaries, and lower boundaries of the numerical model adopt rolling boundary conditions. The length, width, and height of the established model are respectively $200 \times 200 \times 120$, representing an actual length of 200 m; a width of 200 m; and a height of 120 m. The working face length is 120 m, and in order to eliminate the boundary effect, a width of 35 m is left at each end of the model. In addition, between the roadway and the working face, there is a 10 m-length coal pillar for roadway protection. Using the Mohr Coulomb constitutive model, horizontal constraints are added to both the front, back, left, and right boundaries of the model, so that the horizontal displacement of the front, back, left, and right boundaries is 0. The bottom boundary of the model also writes the corresponding command to make it immobile, so that the horizontal displacement and vertical displacement of the bottom boundary are both 0. The vertical stress on the upper boundary is calculated according to the gravity of the overlying rock. Since the distance

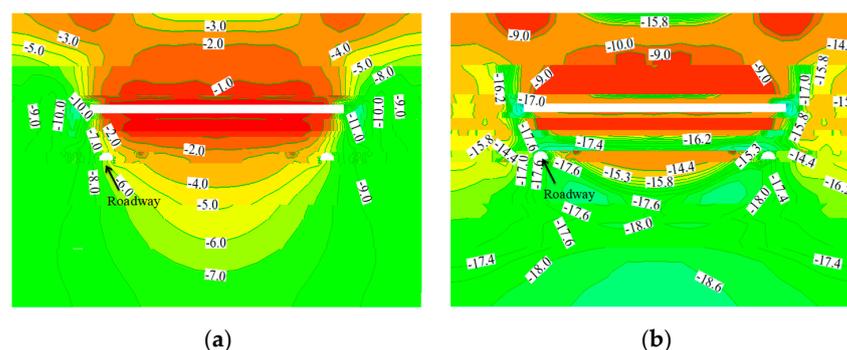
Figure 14. Stress distribution characteristics of floor stress after coal seam 15# mining: (a) Minimum principal stress (MPa); (b) Maximum principal stress (MPa).

- (1) The stress concentration occurs under the coal pillar, and an area with a certain range of stress reduction appears under the goaf after mining coal seam 15#. At this time, the minimum principal stress is -6.0 MPa, and the maximum principal stress is -17.6 MPa. The maximum principal stress is approximately 2.93 times the minimum principal stress.
- (2) After coal seams 15# and 16# are mined, the pressure of coal seam 17# is further decompressed, and the stress concentration degree is reduced accordingly. However, the horizontal distance between the roadway and the edge of the coal pillar is 10 m, which is

close to the coal pillar. Affected by the stress concentration degree of the coal pillar, the minimum principal stress at the mining roadway axis is -6.0 MPa, the maximum principal stress is -18.6 MPa, and the maximum principal stress is approximately 3.1 times the minimum principal stress.

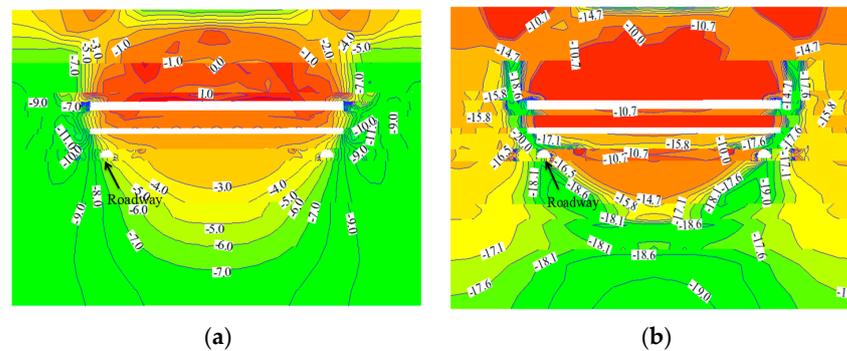
Figure 15. Stress distribution characteristics of the floor after coal seam 16# mining: (a) Minimum principal stress (MPa); (b) Minimum principal stress (MPa).

From the surrounding rock stress distribution, it can be known that the maximum principal stress in the direction of the roadway axis of coal seam 17# is approximately three times that of the minimum principal stress, although it belongs to the stress reduction when the roadway is located at a horizontal distance of 10 m from the edge of the pillar. According to the Moore–Coulomb strength criterion, the greater the difference between the maximum principal stress and the minimum principal stress, the more easily roadway failure occurs. As the maximum principal stress is a horizontal stress and the minimum principal stress is a vertical stress, the failure degree of the two sides of the roadway rib is more serious than that of the roof and floor under high horizontal stress. Therefore, the location of the roadway is unreasonable, as a reasonable location is a horizontal distance of at least 15–20 m from the edge of the coal pillar.

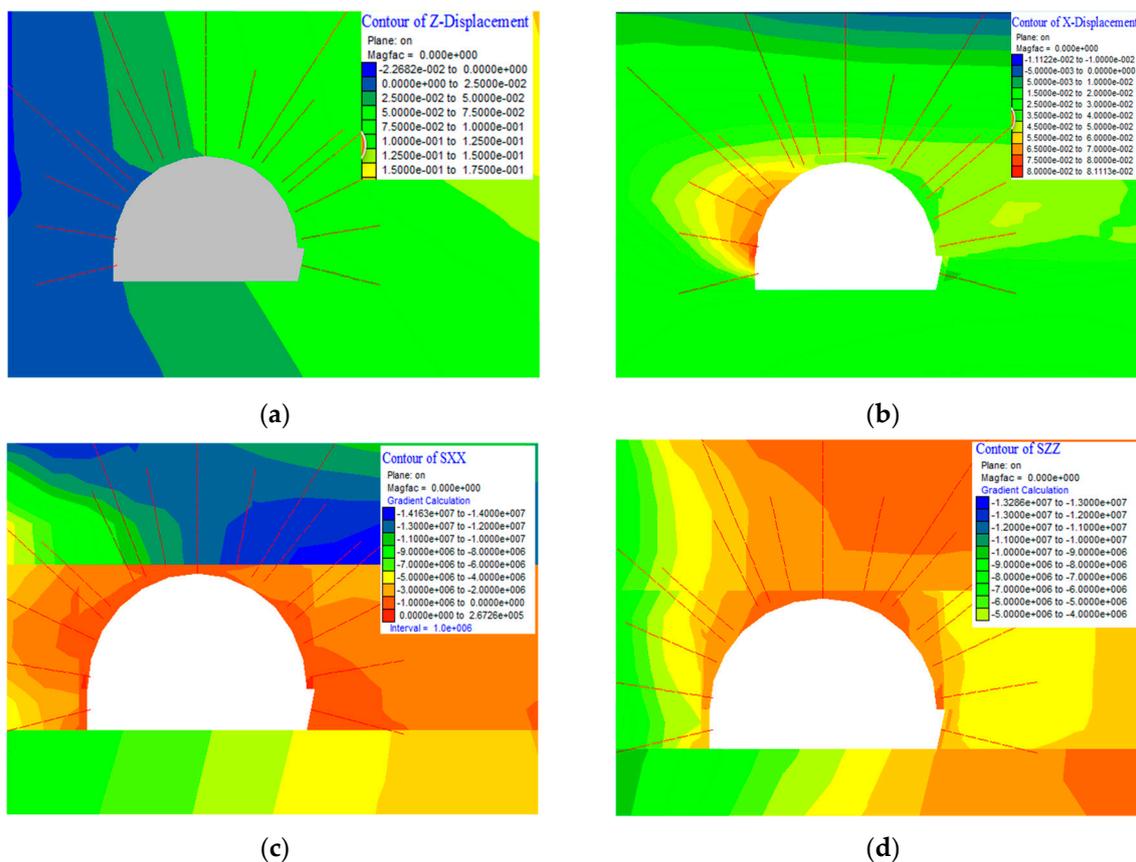
To obtain the control mechanism of the roadway surrounding rock of the repair scheme and the actual effect of this control technology (i.e., long bolt + high-strength anchor cable + U-shaped steel shed + grouting) under repeated mining, considering the geology and mining conditions of the mine's close-distance coal seam groups, the distribution characteristics of the stress and displacement of the roadway surrounding rock are simulated using FLAC3D. The simulation process is consistent with the previous Section 3.4, but the parameter assignment of the different support scheme to be proposed is fully considered in the modeling process. The control effect diagram of the roadway surrounding rock is shown in Figure 17.

Figure 17. Stress distribution characteristics of floor after coal mining: (a) Vertical displacement; (b) Horizontal displacement; (c) Minimum principal stress; (d) Maximum principal stress.

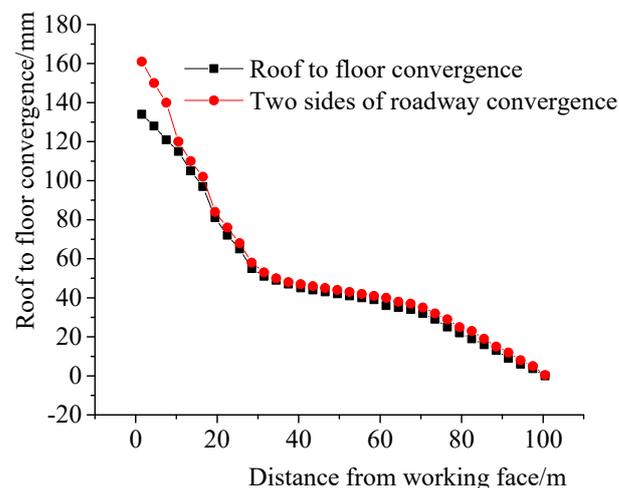
Figure 18. Displacement change curves of the roadway.

To further evaluate the effect of the roadway surrounding rock restoration, the deformation characteristics of the roof, floor and two sides of the roadway are observed. Measuring points are set up 60 m from the working face for the roof, floor and two sides of the roadway. The deformation characteristics of the roadway are observed while the working face advances. The observation results are shown in Figure 18.

It can be seen that, when the distance of the measuring points from the coal face is 100 m, the convergence of the roof to the floor and the two side ribs of the roadway is very small. As the excavation of the coal seam, due to repeated mining, the displacement of the roof to the floor and the two side ribs of the roadway gradually increases. The maximum convergence of the roof to the floor is 134 mm, the maximum convergence of the two sides of the roadway rib is 161 mm, and the deformation amount of the roadway surrounding rock is within the safe and controllable range.

The observation results show that the repair scheme (i.e., long bolt + high-strength anchor cable + U-shaped steel shed + grouting) applied to the roadway surrounding rock improves the stress state of the surrounding rock, effectively reducing the deformation of the roadway surrounding rock. The technology greatly improves the supporting effect and achieves the effective control of the surrounding rock deformation under repeated mining in close-distance coal seam groups.
