Article

Utilization of Two Sensors in Offline Diagnosis of Squirrel-Cage Rotors of Asynchronous Motors

Petr Kacor

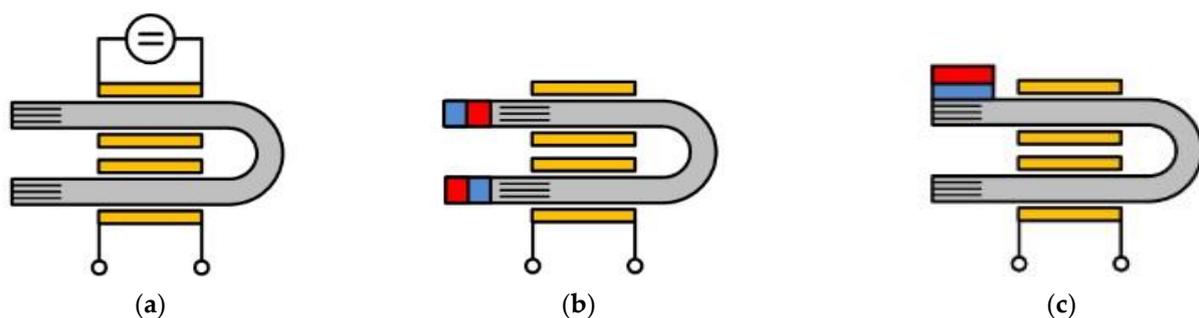
Figure 1. The selected design of active sensors: (a) DC supply excitation; (b) with permanent magnets positioned on the yoke poles; (c) with a permanent magnet positioned in one part of the yoke only.

Figure 1a shows a sensor excited by a DC current source, Figure 1b shows a sensor where excitation is provided by permanent magnets glued to the poles of the sensor's magnetic circuit, and finally Figure 1c shows a variant with a permanent magnet on one pole of the sensor. In all cases, the magnetic sensor circuit was made in a U-shape to simplify the handling of the sensing coil. Although such sensors are quite simple to manufacture,

we found a number of problems when aligning them to the rotor. These active sensors showed a high tendency to vibrate due to the pulsating magnetic pull as the rotor rotates.

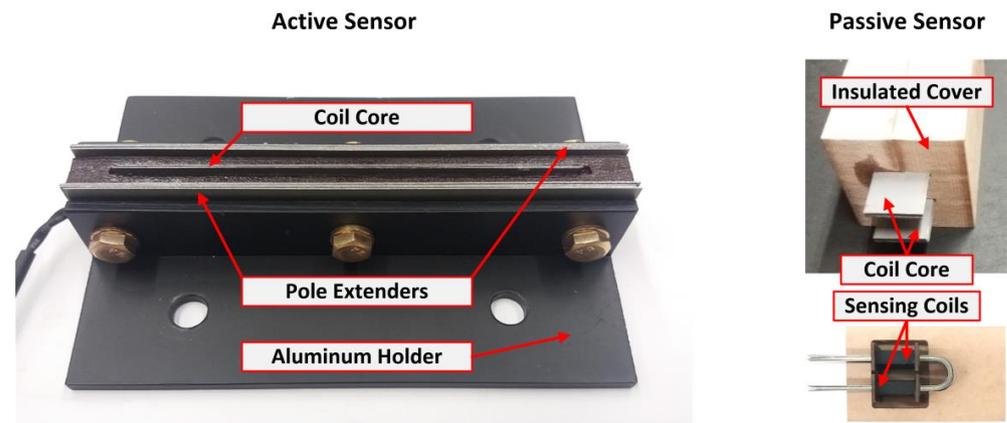
Figure 2. Design configuration of the sensors—Active sensor with the sensing coil between pole extenders and Passive sensor with two coils configuration.

The passive sensor in Figure 2 consists of a magnetic circuit also made of oriented sheets and bent into a U-shape. Two sensing coils are attached to its poles. Each of the coils contain approximately $N = 500$ turns of insulated wire and the two coils are electrically connected in series to increase the value of the induced voltage. The passive sensor assembly is fixed in a non-magnetic insulating enclosure.

To eliminate the vibrations transferred to the sensing part of the sensor, we partially separate the excitation and sensing functions by dividing the sensor into 2 pieces, active and passive. The active sensor contains excitation permanent magnets NdFeB type N42. Its sensing coil is placed longitudinal between the pole extensions and wound on an insulating core frame. The coil contains approximately $N = 150$ turns of insulated wire and is oriented in the axis of rotation. The pole extensions and the core of the sensing coil are assembled from high grade oriented electrotechnical sheet M165-35. The active sensor assembly is clamped with brass screws between aluminum holders, see Figure 2.

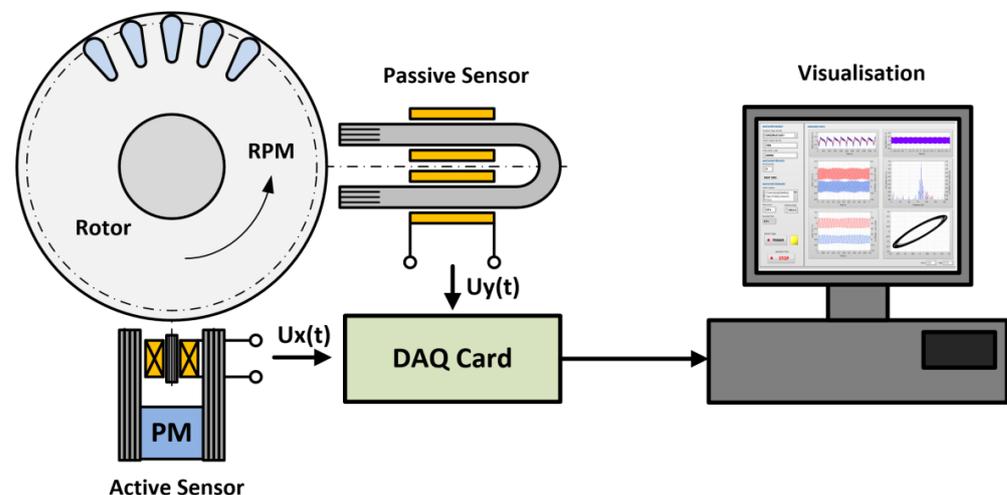
The configuration of the measurement system shown in Figure 3 was found to be the most convenient from a practical point of view. Identification of rotor faults uses a combination of active and passive sensors rotated 90 deg relative to each other. The active sensor generates the necessary static magnetizing field and senses its change as the rotor rotates. The passive sensor captures the stray field near the rotor surface.

Figure 3. Basic configuration of the measuring system with two independent sensors.

The voltage outputs of both sensors are fed to a DAQ card connected to a computer. The measured voltages are then adjusted, amplified, filtered, and processed by software. The modified signals are then analyzed and displayed graphically for the operator to evaluate.

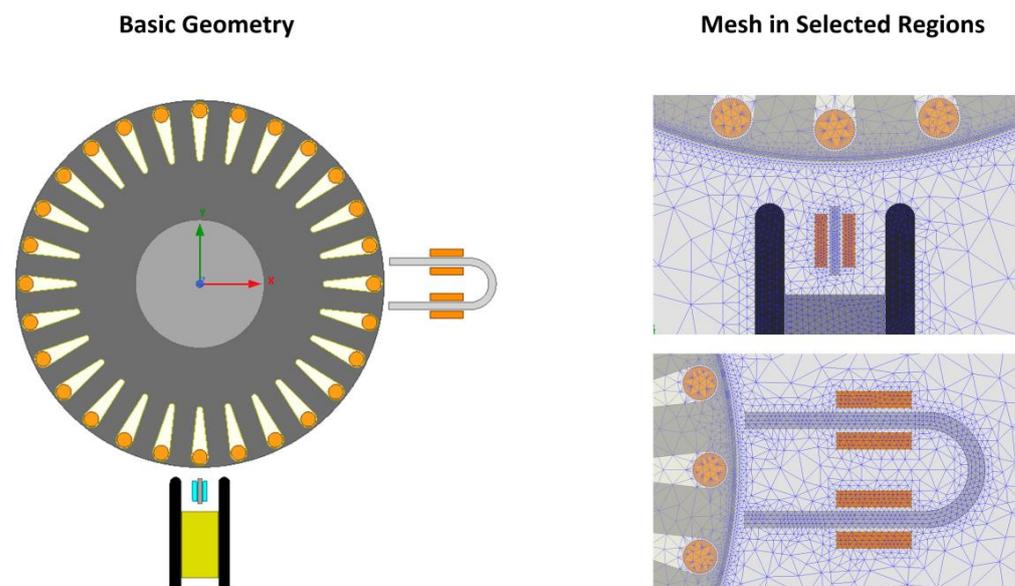
Figure 4. 2D FEM model of the test rotor assembly with mesh in the sensor regions.

The active sensor is located at the bottom, while the passive sensor is located on the right along the direction of rotor rotation. In the air gap and rotor bar regions, the model is built with a precision mesh to eliminate false induced voltage waveforms due to poor discretization. The FEM model contains approximately 60,000 elements and transient time analysis was used to solve the model.

A 2D FEM electromagnetic model was used as a basic tool to verify the functionality of the designed rotor measurement system. In the initial phase, the FEM model was used to find the most suitable arrangement of sensors and to determine their optimal positions and dimensions. The FEM model contains a rotor sheet with slots in which the rotor bars are placed in isolation, see Figure 4.

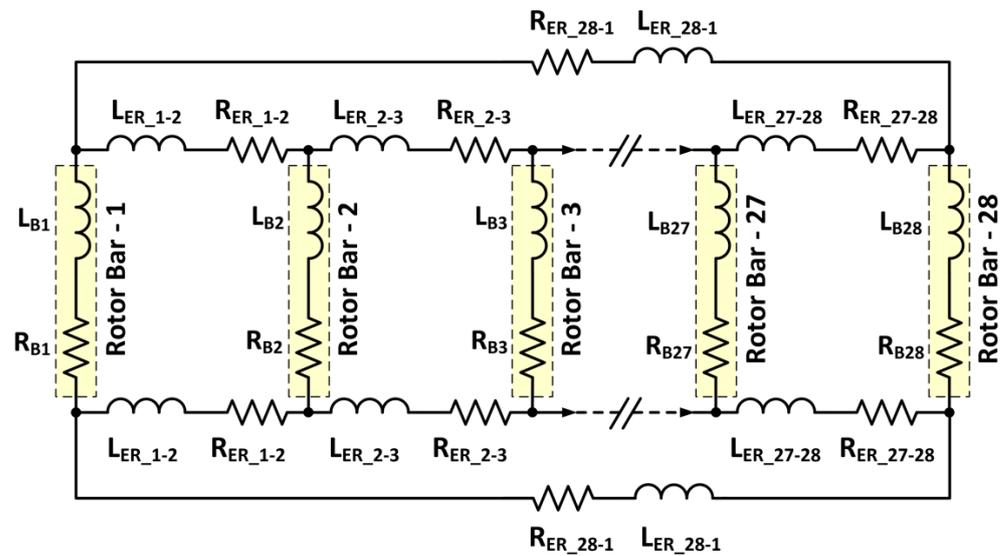
The circuit diagram is fully enclosed and consists of inductances and resistances. The circuit elements are arranged to represent the electrical coupling of the rotor bars (R_{bx} , L_{bx}) with the end-ring segments (R_{er_xy} , L_{er_xy}) [32,33]. By changing the values of the circuit elements, the characteristics of the bars and end-rings can be described in the case of a simulated fault, e.g., a broken bar, a ring segment with reduced conductivity, or overall a combination of faults.

Figure 5. Equivalent electrical circuit of the rotor cage.

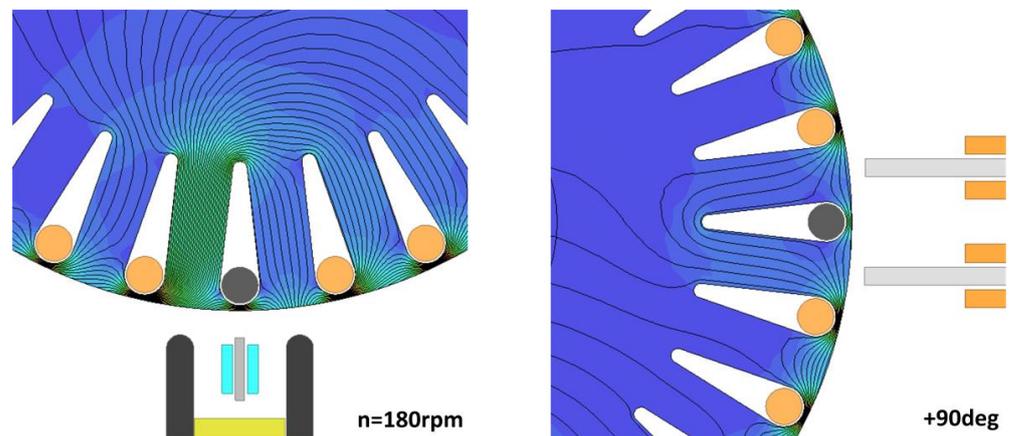
The faulty bar is shown here in black color. No voltage is induced in this broken bar and the current value $I_{bar} = 0$ A. No reaction flux is then generated in the surroundings of the bar and a part of the magnetic flux passes through the adjacent tooth. At this point, a deformation occurs in the total magnetic field, which is captured by the sensing coil of the active sensor and also by the coil of the passive sensor.

Figure 6. Magnetic flux density distribution on the 2D FEM model of the test rotor assembly.

When the rotor is rotated by 90 deg, the broken bar reaches the passive sensor. Here, the magnetic flux lines are locally closed through a region across the rotor teeth that surround the faulty bar and the contact bridge of the closed slot. This local distortion of the magnetic flux reappears in the stray field and is again detected by the passive sensor.

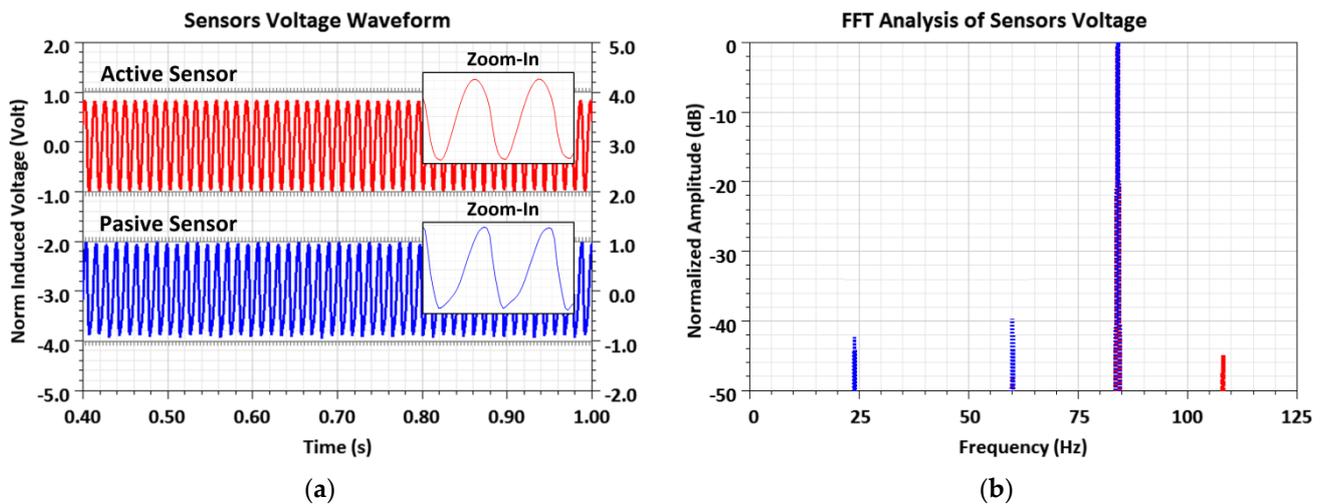
The induced voltage waveforms on the sensing coils of the active and passive sensors of the FEM model are shown in Figure 7a. A time window $t = (0.4-1.0)$ s is selected for plotting, where the voltage waveforms are in steady state already. The waveforms are offset in the graph to avoid overlapping and to make them clearer. The red color corresponds to the induced voltage of the active sensor, the blue color to the induced voltage on the passive sensor. The voltage range of both signals is also normalized in the interval $(-1,1)$. The time waveform of both voltages is not pure sinusoidal but shows a shape deformation. The deformation is more visible in the voltage waveform of the passive sensor. A healthy rotor without defects shows a regular waveform of both induced voltages without deviations. Figure 7b shows the FFT analysis of both sensor signals. The normalized amplitude spectrum is shown, where the frequency $f_x = 84$ Hz visibly dominates. The value of this frequency corresponds to the set rotor rotation speed $n = 180$ rpm and the number of its slots (bars) $N_{dr} = 28$. The sidebands also appear and do not exceed the value of -40 dB in amplitude. The sidebands are much more significant in a passive sensor.

Figure 7. FEM model of a healthy rotor without any defects: (a) normalized waveforms of the induced voltages in the sensors; (b) FFT analysis of induced voltage waveforms.

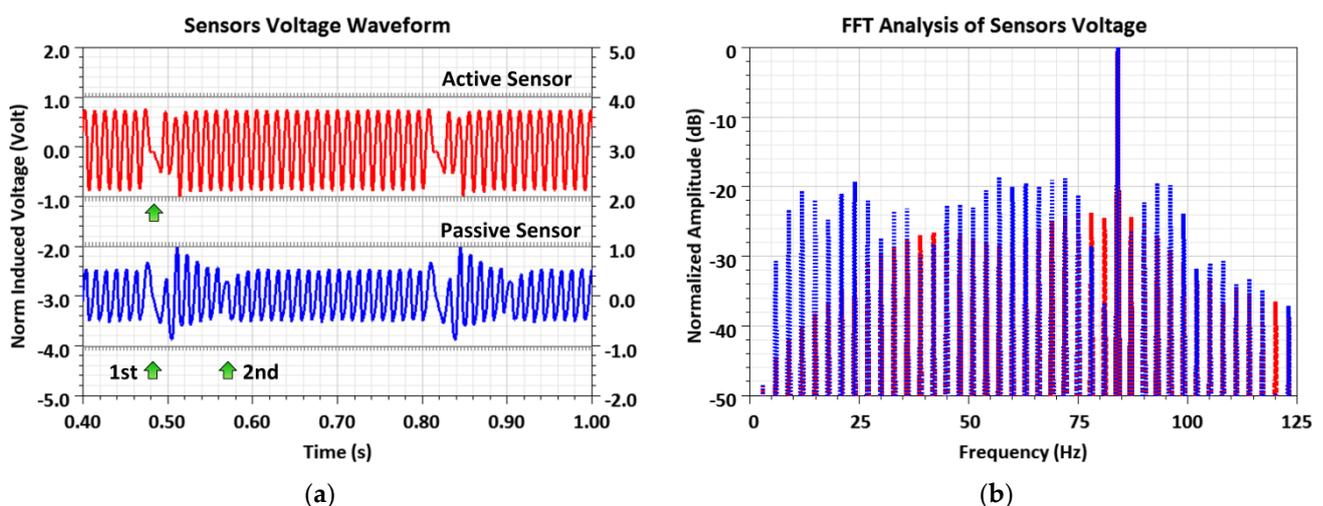
Figure 8a shows the induced voltage waveforms for the FEM simulation of 1 broken bar. There is a region on the induced voltage waveform of the active sensor where part of it is completely missing (green arrow). This empty region is periodically repeated at the same time intervals as the rotor rotates. This indicates a fault in the bar, where the voltage is induced, but no electric current flows through the bar due to the missing electrical connection to the end-ring. The lack of a reactive magnetic flux will create a significant distortion in the otherwise regular voltage waveform on the active sensor. On the voltage waveform of the passive sensor, the information about the broken rotor bar appears at the same time point as for the active sensor ($t_1 = 480$ ms). However, the voltage waveform is different on the passive sensor due to its different design nature. With a time delay of about $\Delta t = 85$ ms (in time $t_2 = 565$ ms), the information about the broken bar reappears by the oscillation of the induced voltage on the passive sensor. This is the point at which the broken bar is close to the passive sensor and the rotor has rotated 90 deg (+7 bar displacement).

Figure 8. FEM model of a rotor with a broken bar: (a) normalized waveforms of the induced voltages in the sensors; (b) FFT analysis of induced voltage waveforms.

Figure 8b shows the FFT analysis of the voltages of both sensors. In addition to the main harmonic $f_x = 84$ Hz, there are significant sidebands with a frequency separation of $\Delta f = 3$ Hz indicating a bar fault. For the active sensor, the signal offset is approximately

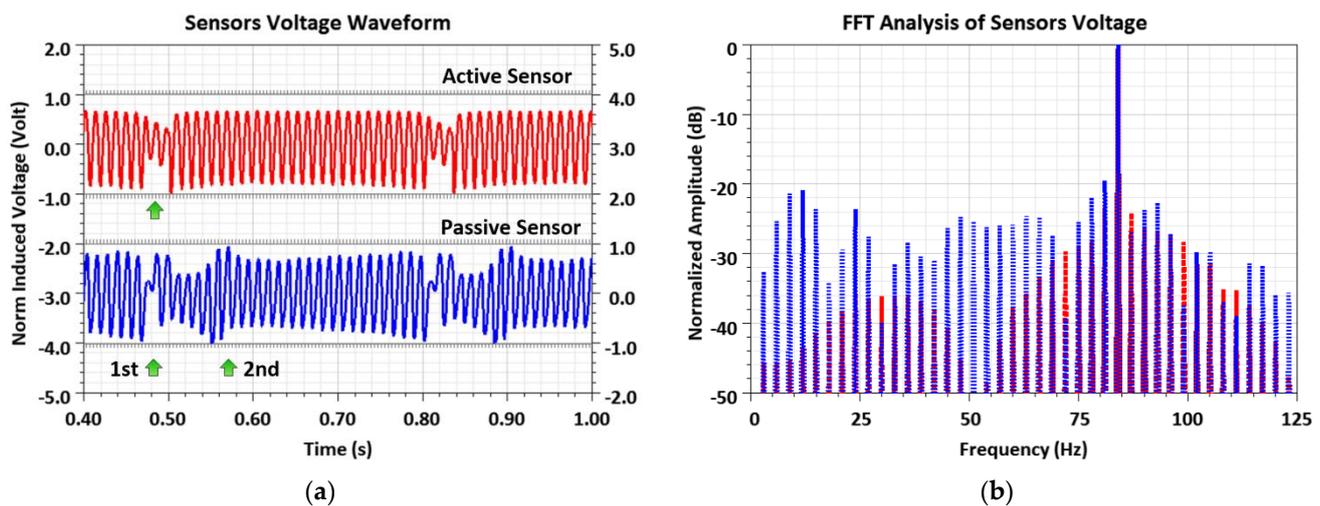
In the FEM simulation of a broken end-ring segment between the bars, this defect again presents similarly on both sensor induced voltage waveforms. It can be seen in Figure 9a that the broken segment between the bars causes multiple oscillations just as it passes over the excitation poles of the active sensor. The waveform is then further deformed in time by the DC component.

Figure 9. FEM model of a rotor with a broken end-ring segment: (a) normalized waveforms of the induced voltages in the sensors; (b) FFT analysis of induced voltage waveforms.

A segment failure is repeatedly visible on the induced voltage waveform of the passive sensor, similar to the case of a broken bar. The information about the faulty segment is at the same time instant as for the active sensor ($t_1 = 480$ ms). It appears as an oscillation and a significant waveform distortion. Then, the amplitude of the oscillation decreases and then slowly increases until the faulty segment (2 adjacent bars with a faulty segment) is close to the passive sensor. Here again, the amplitude of the induced voltage increases suddenly ($t_2 = 565$ ms). Figure 9b shows the FFT analysis of the voltages of both sensors. With the main harmonic $f_x = 84$ Hz, significant sidebands with frequency spacing $\Delta f = 3$ Hz appear. For the active sensor, the sideband is concentrated around the main harmonic and also around the frequency $f_2 = 28$ Hz, which corresponds to the number of rotor slots. In a passive sensor, the sidebands are distributed over the entire displayed frequency range (0–125 Hz). The lowest value of the offset signal is in the order of −21 dB.

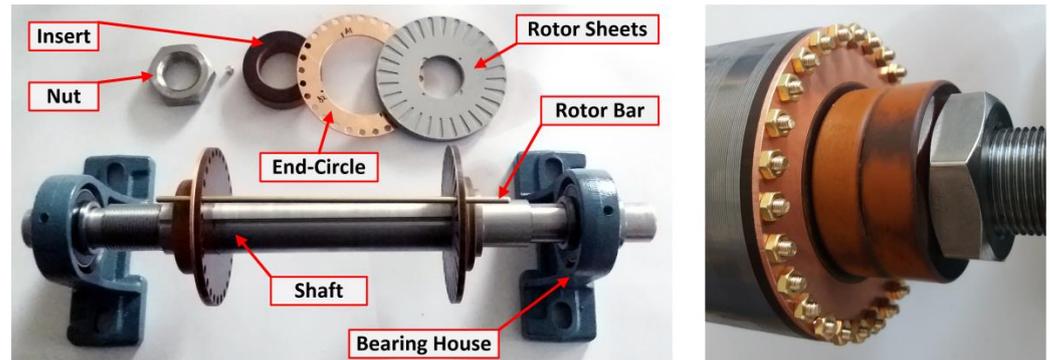
The rotor bars are made of brass with a diameter of $d = 4$ mm and are threaded at both ends. The end-rings are milled from copper sheet with a thickness of 2 mm. All rotor bars are insulated in the rotor slots by using insulating tubes. Similarly, the end-rings are separated from the rotor by an insulating plate and are not electrically connected to the rotor sheets. Figure 10 shows the individual parts of the rotor before it is assembled and partial view of the manufactured test rotor.

Figure 10. The test rotor set with individual components.

The rotor bars are fixed to the end-rings with nuts. The overall rotor arrangement was chosen to make fault simulation easier. The rotor allows testing, for example, a change in the conductivity of the end-ring, a break in the end-ring or part of the end-ring, a reduced conductivity of the bar, a broken rotor bar or a combination of these faults. A basic rotor measuring setup with sensor arrangement is shown in Figure 11.

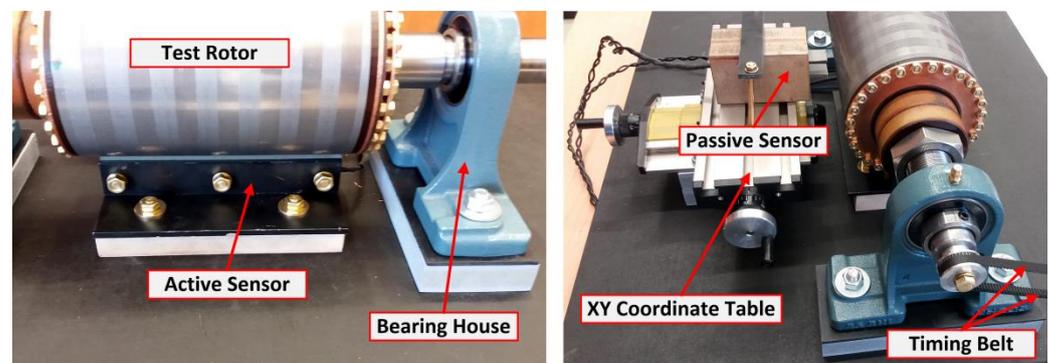
Figure 11. Overall view of the measuring system with test rotor.

The rotor rotation is ensured by the NEMA17 stepped motor operated by a driver via the Arduino module. The motor rotation speed is fixed to $n = 180$ rpm (3 rps), and it needs about 10 s to reach the set speed in linear acceleration mode. The stepped motor is attached to the rotor by timing pulleys and a rubber timing belt to eliminate the motor vibrations as well as to ensure exact revolution without slip. The shaft with the test rotor is placed in bearing housing.

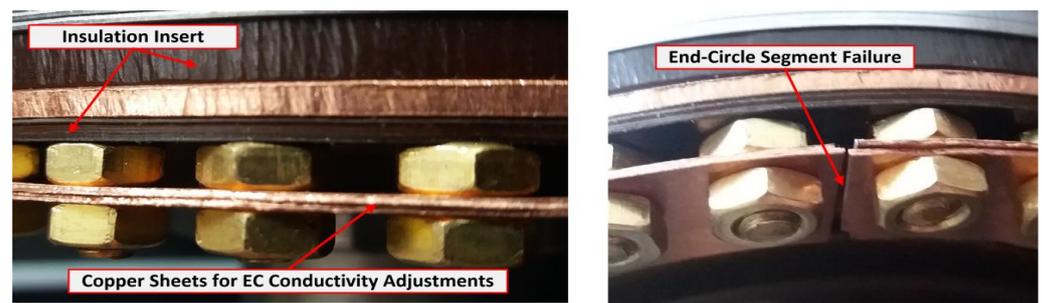
Figure 12 shows selected modifications to the test rotor end-ring to simulate its failure. Figure 12 shows the set-up for simulating the conductivity of the ring. Here, the original solid cross-section of the end-ring is replaced by a set of copper plates. The number of sheets determines the final value of the conductivity. Figure 12 also shows a simulation of a broken segment of the end-ring between the bars. The air gap causes a disconnection of the initially solid ring. The rotor bars remain conductively connected to the rest of the ring.

Figure 12. Construction adjustments of the test rotor with overall ring conductivity decrease and disconnecting in the end-ring segment between the bars.

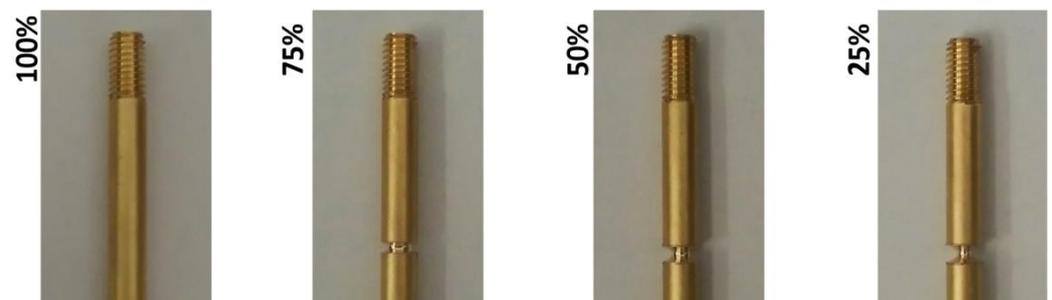
To simulate the defects of the rotor bars, geometric modifications were made to their cross-section as shown in Figure 13. Many of the authors [18,21,27] use direct drilling of rotor bars to create a defect. In our case, the reduction of the active cross-section of the bar is achieved by turning the cross-section at about 1/5 of its total length. The bars so prepared are sequentially inserted into the slot and the effect of the conductivity drop can be measured.

Figure 13. Decreasing the rotor bar diameter to reach 75%, 50% and 25% of its original cross-section.

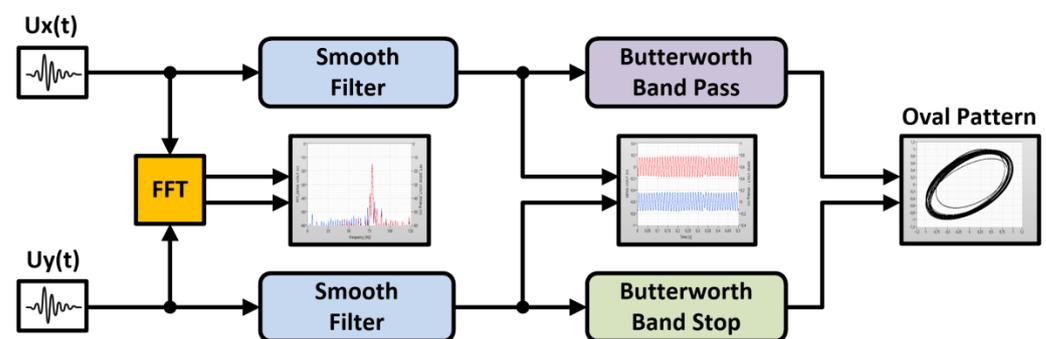
The measurement system is based on the LabView platform. The voltage outputs of both sensor signals are captured by the NI-DAQ card. FFT analysis is performed directly from the sensor signals. The signals are software smoothed and further amplified, filtered and processed, see Figure 14.

Figure 14. Signal processing diagram from active and passive sensors.

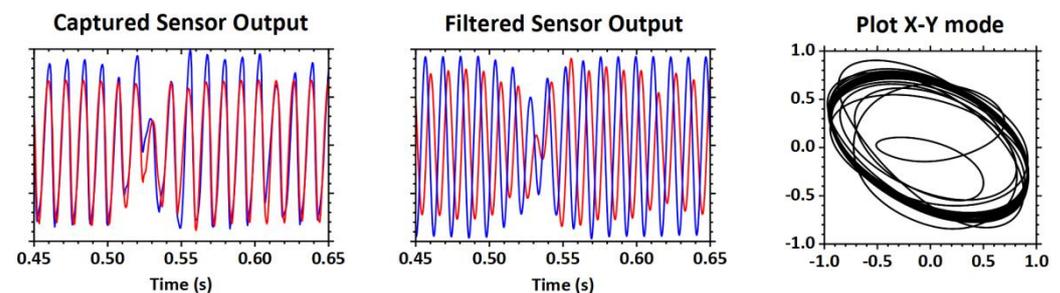
Butterworth Band Pass and Butterworth Band Stop filtering adds a phase shift naturally to both signals [38,39]. We use this mutual phase shift of the two signals in the X-Y mode display, which is then represented by an oval shape, see Figure 15.

Figure 15. Example of processing of FEM simulated signals from active and passive sensors.

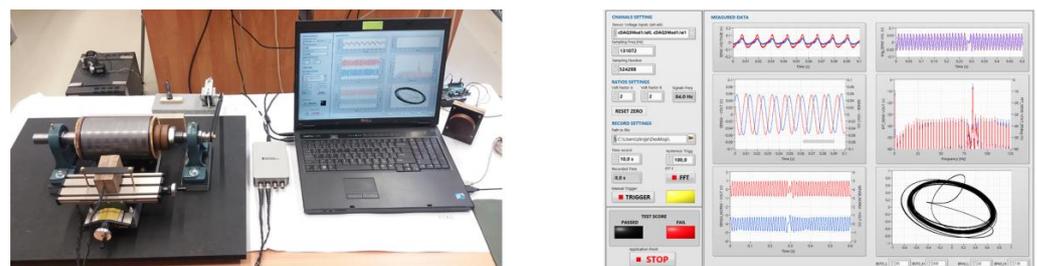
The basic arrangement of measurements on the test rotor is shown in Figure 16. On the left is the base with test rotor and sensors, on the right is the PC with LabView and visualization panel.

Figure 16. Completed experimental setup with visualization panel in LabView.

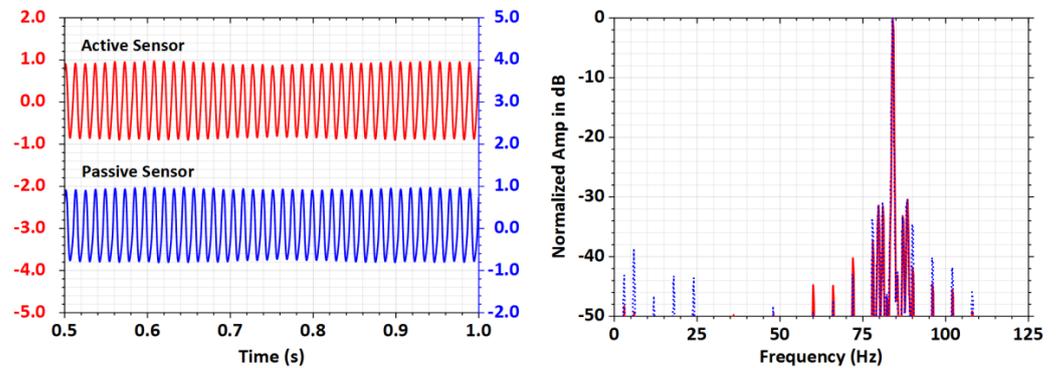
Figure 17 shows the measured voltage time waveforms from both sensors and the FFT spectrum of the signals when the rotor is simulated without defects. The assembled test rotor shows eccentricity, which is clearly visible in the waveforms. The eccentricity is caused by assembling the rotor sheets on the shaft without additional machining. The voltage waveform is uniform with no distortion or deformation.

Figure 17. Outputs of a healthy rotor without any defects.

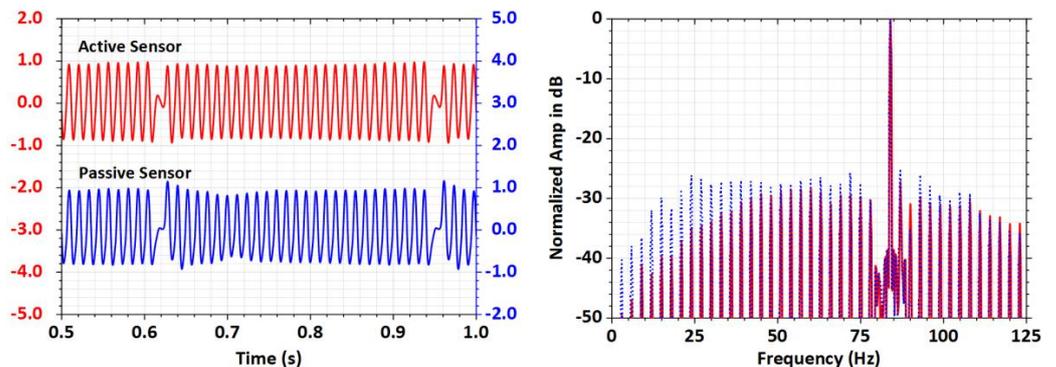
Figure 18 shows the waveforms for the broken bar simulation. The voltage waveforms of the two sensors captured in the interval $t = (0.5 \div 1.0)$ s show periodically repeating distortions, which indicate the missing part of the induced voltage. In FFT analysis, significant sidebands are formed on both sides of the dominant harmonic $f_x = 84$ Hz. The signal to maximum amplitude offset is about -26 dB.

Figure 18. Outputs of a rotor with broken bar.

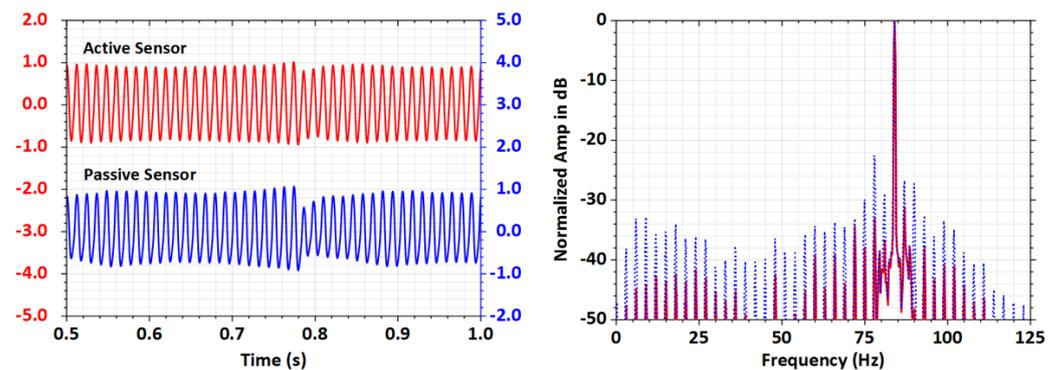
In the simulation of a broken end-ring segment, see Figure 19, the waveform of the induced voltages deforms differently. The voltage waveform at the defect location shows only a slight drop at the active sensor, while the passive sensor responds to the missing end-ring segment with a significant voltage jump in the voltage waveform. The sidebands in this fault form more in the lower frequencies, the higher frequencies gradually decay with harmonic order. The passive sensor shows a better sensitivity to this type of fault and the level of signal offset here is about -32 dB, the active sensor shows a lower level, about -42 dB.

Figure 19. Outputs of a rotor with broken end-ring segment.

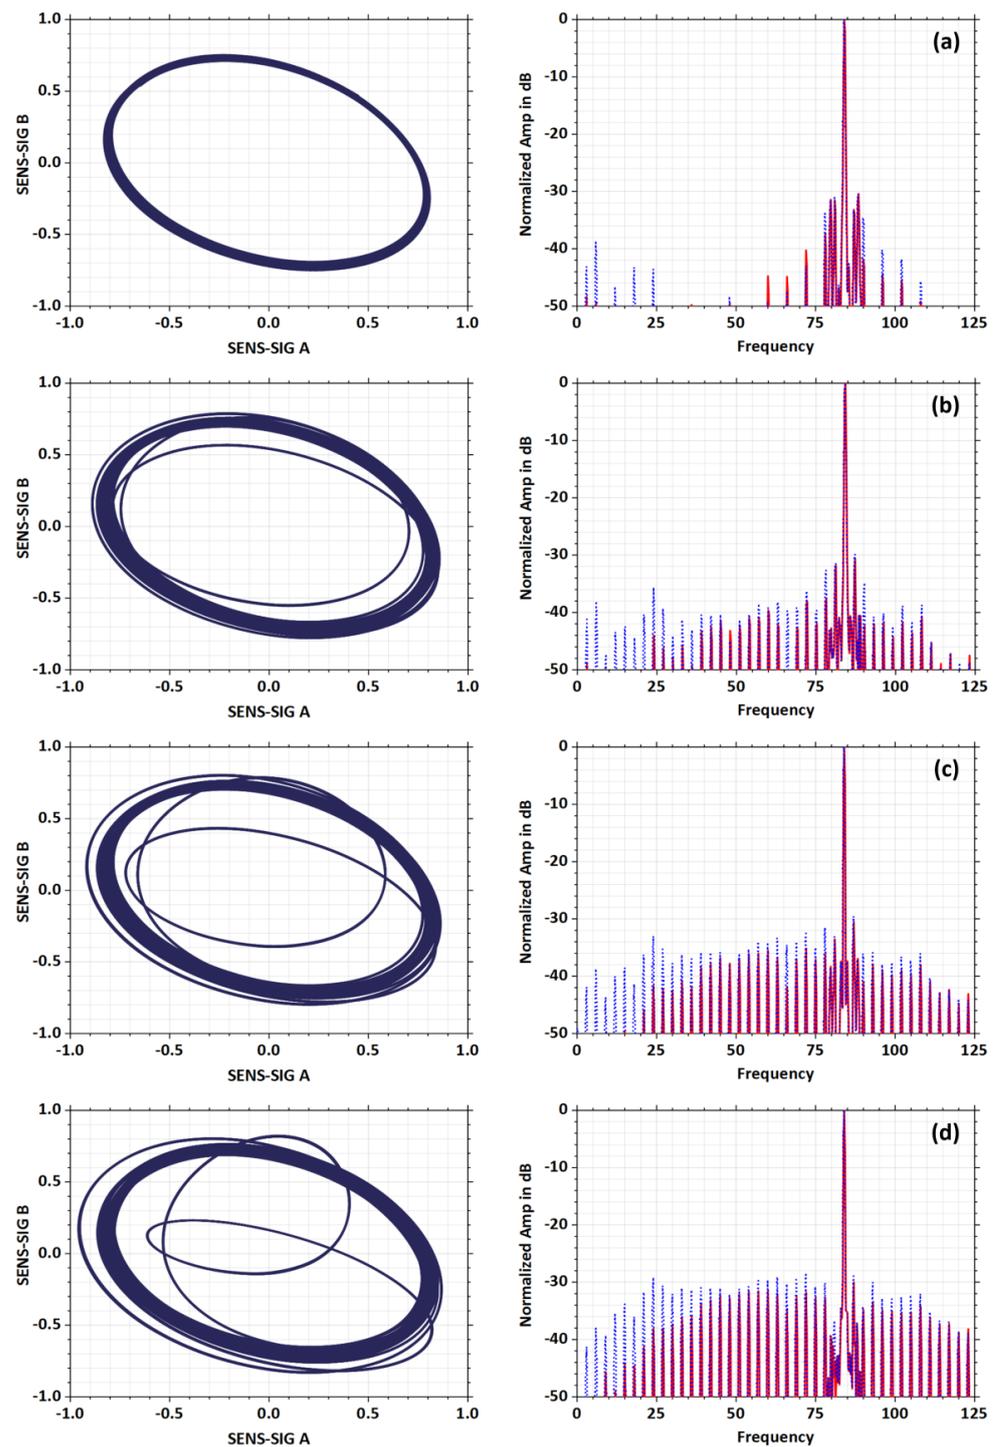
Figure 20 shows the dependencies as the electrical conductivity of the 1 pc rotor bar is incrementally reduced. At the same time, the effect of the decreasing cross-section of the rotor bar on the spectrum of FFT analysis and the plotting of oval patterns is also compared. The orbiting point at the boundary of the oval traces the voltage dependence between the two sensors. In one revolution of the test rotor, the pattern contains 28 orbits of the plotting point. Ideally, in a rotor without defects, the pattern takes the form of a smooth oval whose thickness is affected by the eccentricity, see Figure 20a.

Figure 20. Comparison of FFT and oval patterns for the rate of rotor bar failure: (a) Reference oval pattern for rotor without defect; (b) 25% Cross-Section Loss; (c) 50% Cross-Section Loss; (d) 75% Cross-Section Loss.

As the bar resistance increases, the plotting point gradually separates, see Figure 20b–d, as the voltage waveforms respond by decreasing the induced voltage at the defect bar location. At a 25% loss in bar conductivity, a deflection from the original defect-free oval becomes apparent. At 75% bar conductivity loss, the plotting point circulates near the center of the oval. The rotor failure is easily identified even with a relatively small drop in bar conductivity.

As can be seen from Figure 20b, a defect in the rod (air bubble, reduced conductivity) is only detectable at approximately 25% loss in rod cross-section. It was observed that at lower fault ranges <25% of rod cross-section loss, the pattern only slightly expands and the fault resolution is worse. The fault is much more identifiable on FFT analysis of both signals. In the case of a completely cracked bar or set of bars, the patterns on Figure 21b–d show a significant deviation of the plotting point from the original oval shape and these types of faults are very well identifiable. In the second phase of verification, the defects in the end-ring were measured. Again, it is evident that the range of damage (porosity) had to achieve at least 30% cross section loss for this defect to be reasonably visible, see Figure 22b.

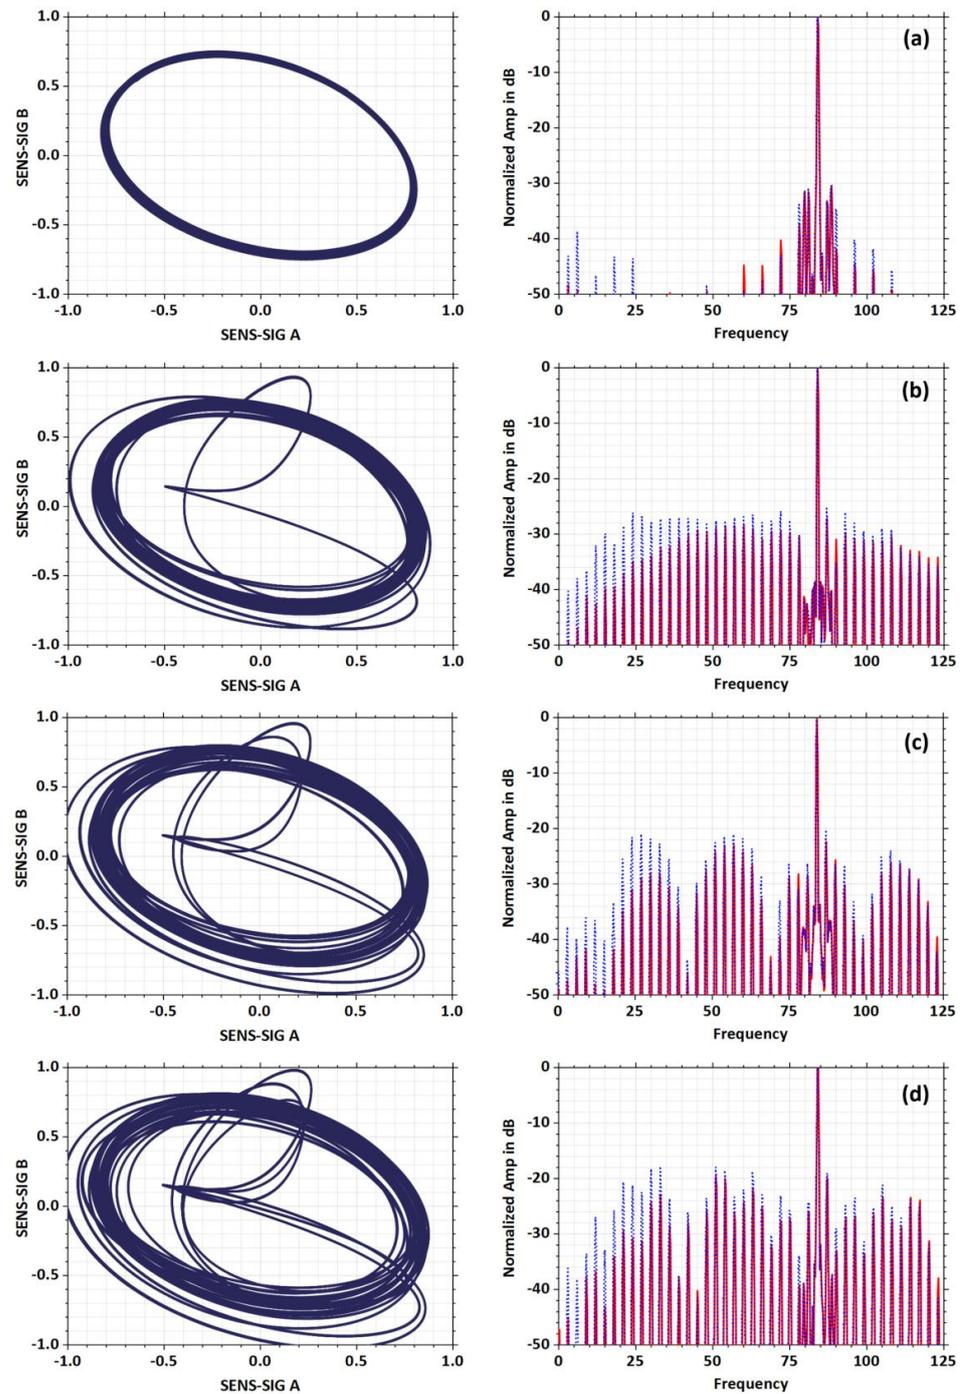
Figure 21 shows the deformation of the oval pattern when the rotor bars are completely broken. The number of broken bars is gradually varied during the test. The 1 pc of a completely broken bar plots a multiple curve on the oval with a characteristic sharp point in the center of the oval, see Figure 21b. If the number of broken bars is higher, the number of these crossed curves increases. Furthermore, there is also separation of the oval on its lateral sides, see Figure 21c,d. The shape of the crossed curves depends on the relative position of the broken bars in the rotor, but they always pass through the center of the oval.

Figure 21. Comparison of FFT and oval patterns for the selected number of broken bars: (a) Reference oval pattern for rotor without defect; (b) 1 Broken bar; (c) 2 Broken bars; (d) 3 Broken bars.

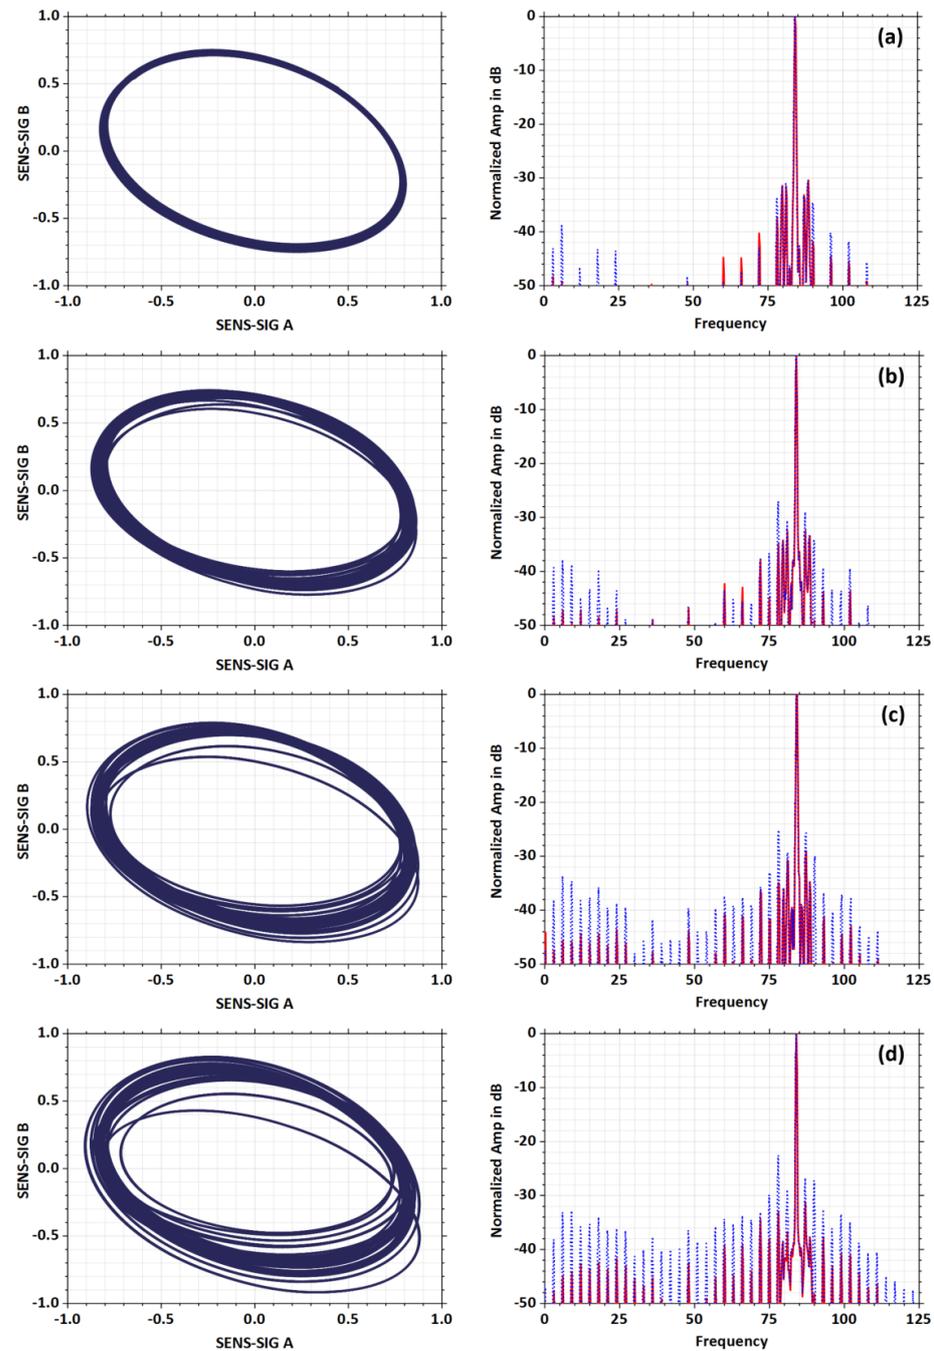
Figure 22 shows the change in the overall deformation of the oval pattern when a failure occurs in a segment of the end-ring. The change in the conductivity of the connection between the two bars of the initially separated segment was simulated. As the conductivity of the segment decreases, the proportions of the oval remain almost identical, but its inclination in the symmetry longitudinal axis changes significantly. With a fully broken segment between the bars, see Figure 22d, the plotting point moves along a set of elliptic curves that are rotated relative to each other. The measurement sensitivity is lower in this case, which is also evident from the FFT analysis of the spectra. This fault is better visible in the passive sensor, which shows a faster increase in sideband amplitudes.

Figure 22. Comparison of FFT and oval patterns for failures in segment of end-ring: (a) Reference oval pattern for rotor without defect; (b) 33% Cross-Section Loss; (c) 67% Cross-Section Loss; (d) 100% Cross-Section Loss.

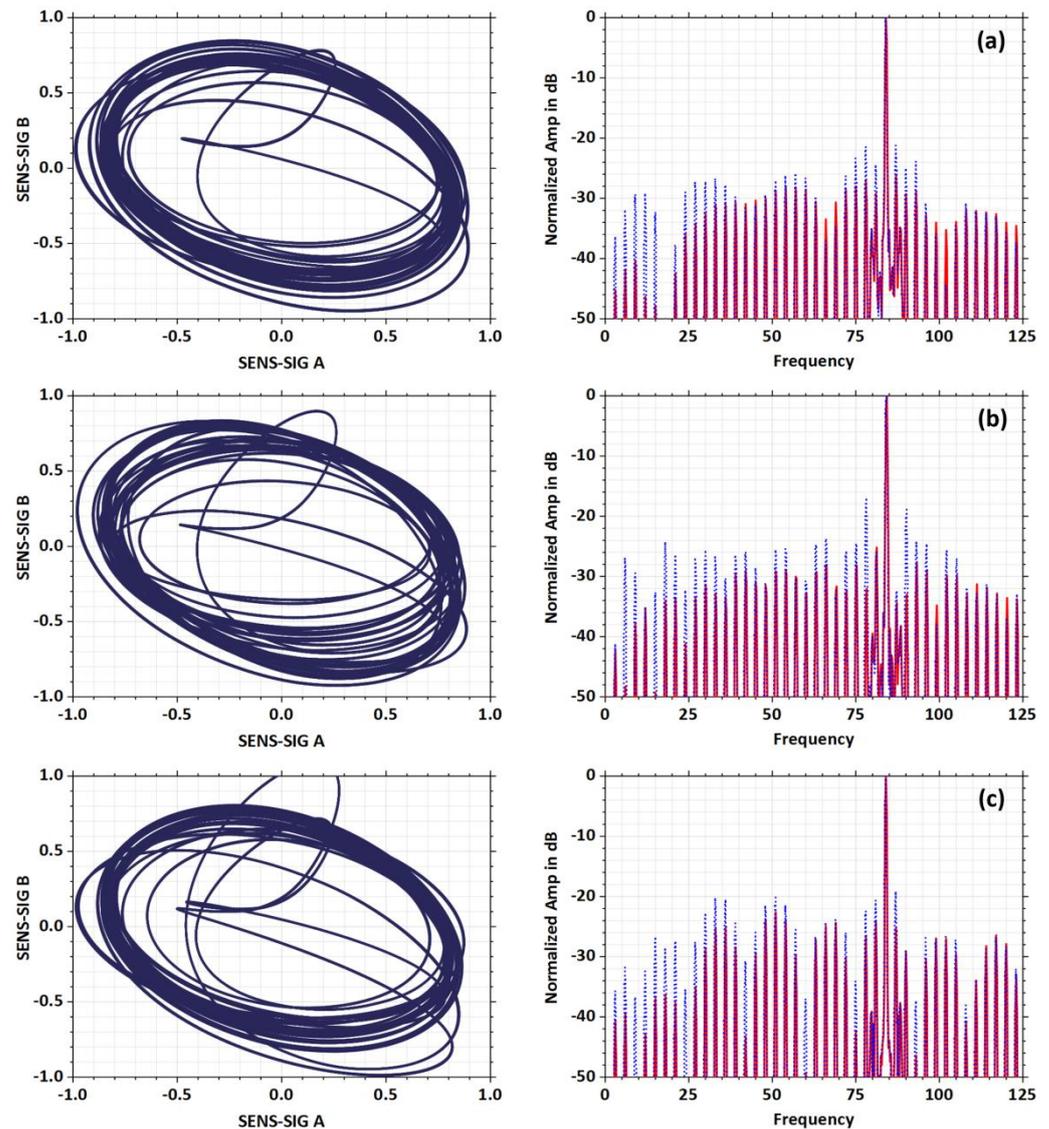
Combined rotor failures are shown in Figure 23. A broken bar in combination with a broken segment of the end-ring or multiple failures such as 2 broken bars with a broken segment, etc., cause significant deformation of the originally smooth oval pattern. The plotting point gradually separates from the original oval pattern in multiple sequential steps. The patterns also tilt and form internal loops. Their final form is in fact a composite of the patterns typical of the elementary faults in Figures 21 and 22. The sidebands in the FFT analysis completely fill the space to the left and right of the dominant harmonic $f_x = 84$ Hz and illustrate the significance of the fault simulated on the test rotor.

Figure 23. Comparison of FFT and oval patterns for combined rotor failures: (a) 1 broken bar + 1 broken end-ring segment; (b) 1 broken bar + 2 broken end-ring segments; (c) 2 broken bars + 1 broken end-ring segment.

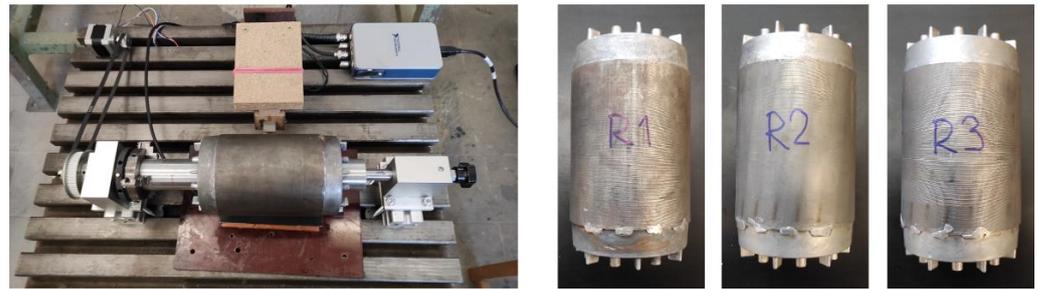
The designed measurement procedure and sensor configuration was verified on several real rotor prototypes. Figure 24 shows the basic arrangement of the measurement system with the rotor fixed between the aluminum conical centering tips. Figure 24 also shows representative rotor samples prepared for defect detection. The rotor samples are unmachined, without shafts, and were collected after casting and cooling.

Figure 24. Measurement system for real rotor testing.

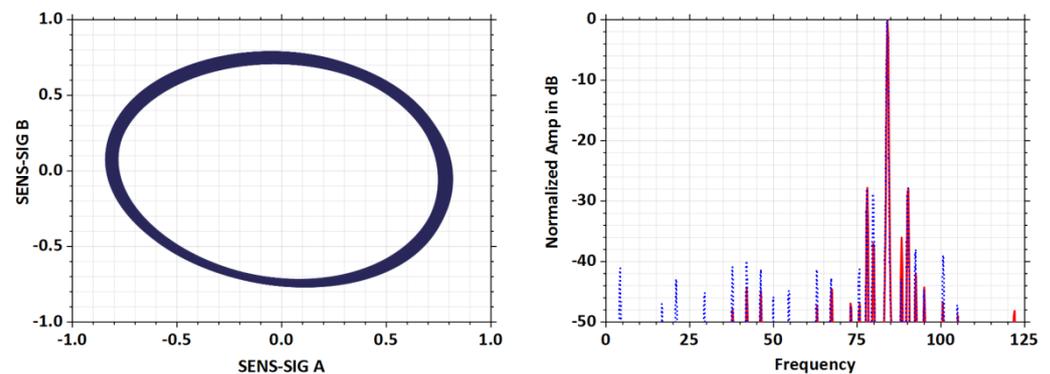
Measurements were in general the same as in the previous test rotor. However, the main task was different and was to use the visualized oval pattern to determine the fault in the end-ring or rotor bars. Most of the tested rotors represented by sample R1 displayed a pattern similar to that shown in Figure 25. The oval shape is relatively smooth, its thickness being affected by eccentricity. FFT analysis indicates only a thin sideband concentrated around the dominant harmonic $f_x = 84$ Hz. The measured prototype rotors contain $N_{dr} = 20$ fully closed slots, and the rpm had to be set higher than the test rotor. The frequency band offset thus reaches $\Delta f = 4.2$ Hz.

Figure 25. Outputs of a rotor R1 (no defect).

For a real rotor without defects, the trajectory of the rendering point in X-Y mode forms a regular and smooth oval, see Figure 25. The defect in the real rotor can no longer be explicitly set, as in the case of the test rotor, but the fault identification is performed directly. As can be seen from Figures 26 and 28, the defects in the real rotor are more likely to occur in a combined form. The oval in Figure 26 tends to increase in thickness and there is only a slight crossing of the plotting point trajectory. The frequency band is centered to the left of the dominant harmonic $f_x = 84$ Hz. The shape of the oval shows a character consistent with an end-ring defect. A series of crossings and inner loops appear in Figure 28. The loops in the center of the oval are smooth and do not contain sharp shapes. The bars in the rotor will not be completely interrupted, but considerable porosity can be expected. One of the rods has a very significantly reduced conductivity. The frequency band appears on either side of the dominant harmonic $f_x = 84$ Hz.

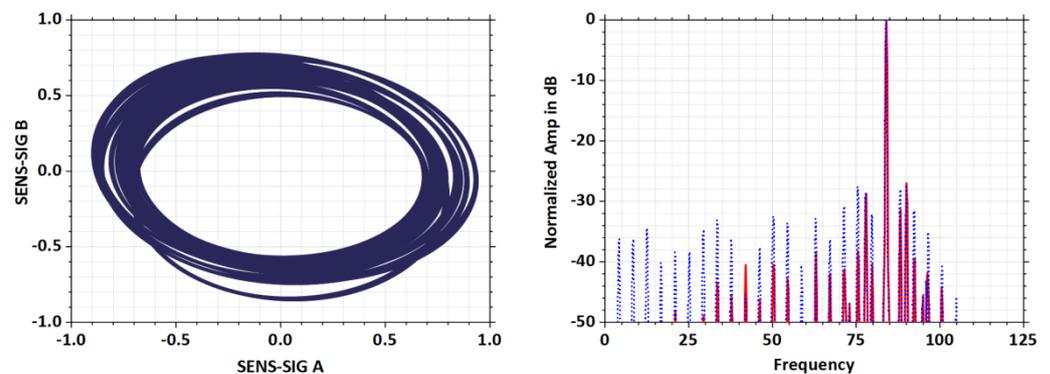
In the group of rotors, a sample labeled R2 was found that showed a different oval shape, see Figure 26. FFT analysis indicated the appearance of a sideband in the lower frequency range. The oval pattern is separated and the plotting point circulates along mutually tilted elliptical shapes. From this output, we assumed that this is a fault in the end-ring.

Figure 26. Outputs of a rotor R2 (defect in end-ring).

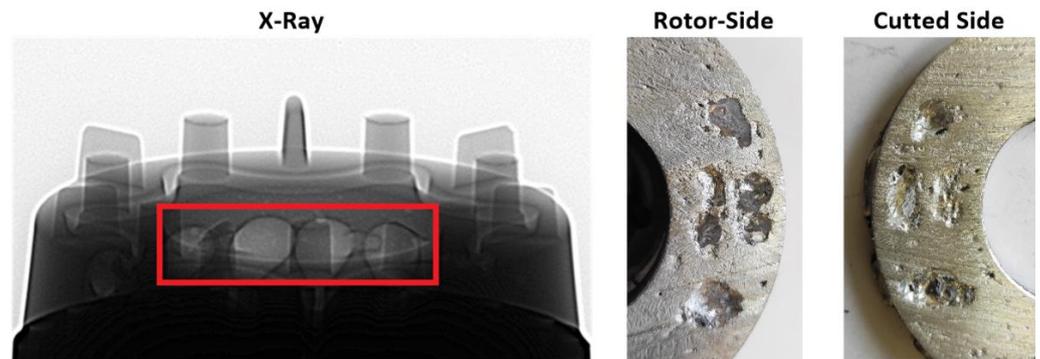
end-ring. The destructive method of cutting through the end-ring illustrated the scale of this defect, which significantly reduces the conductivity of the end-ring segments.

Figure 27. X-ray photography of tested rotor R2 and mechanical cut of end-ring.

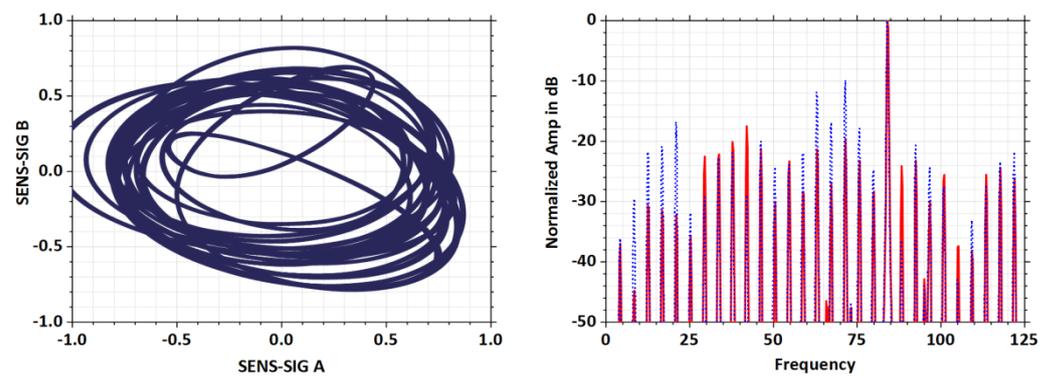
The rotor labeled R3 presents a sample with a combined fault in the rotor bars, see Figure 28. The internal crossing of the trajectory of the plotting point is characteristic of a fault in the rotor bars.

Figure 28. Outputs of a rotor R3 (multiple defected rotor bars).

The FFT analysis indicates a significant presence of sidebands on both sides of the dominant harmonic and also a better sensitivity of the passive sensor to this type of fault. A cut made at 1/3 of the rotor length exposed air bubbles and deeper holes in several rotor bars, see Figure 29.

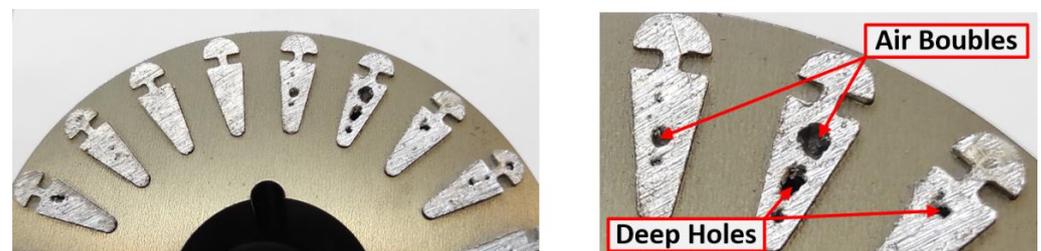
Figure 29. Cut in 1/3 of the length of the sample R3.

However, this does not automatically imply that the presence of failures in this cross-section is complete. According to the oval pattern, there are probably more damaged bars, or bars with a high content of air bubbles or holes, in the tested rotor R3.
