Influence of the Cable Accessories Installing Method on the Partial Discharge Activity in Medium Voltage Cables

Abstract: This article proposes a method to modify the construction of a medium voltage (MV) heat shrinkable cable termination in cases of atypical damage to the shields of cross-linked polyethylene (XLPE) insulated cables. The proposed solutions include a modified method of assembling electric field control coating. An attempt was made to check the effect of such damage to the shields of MV cables with XLPE insulation on the level of occurrence of partial discharges within the cable termination. The investigations included testing the XRUHAKXS 1 × 240/25 cable type using the electric method (ME) and high frequency (HF) method with sinusoidal AC test voltage. As a result of the measurements, the values of total charges in the period and phase-resolved partial discharge (PRPD) patterns were obtained. The presented experimental results show the influence of the damage of the semiconducting coating surface on the occurrence of a defect in the cable termination without a modified method of control mantissa pinning. We suggest new methods of assembling MV cable accessories in

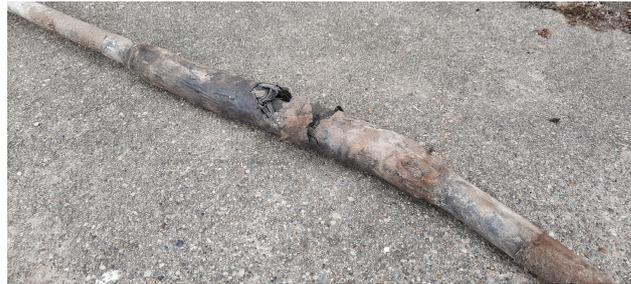
Figure 1. Example of damage to a cable joint mounted on a cable type XRUHAKXS 1 × 240/50.

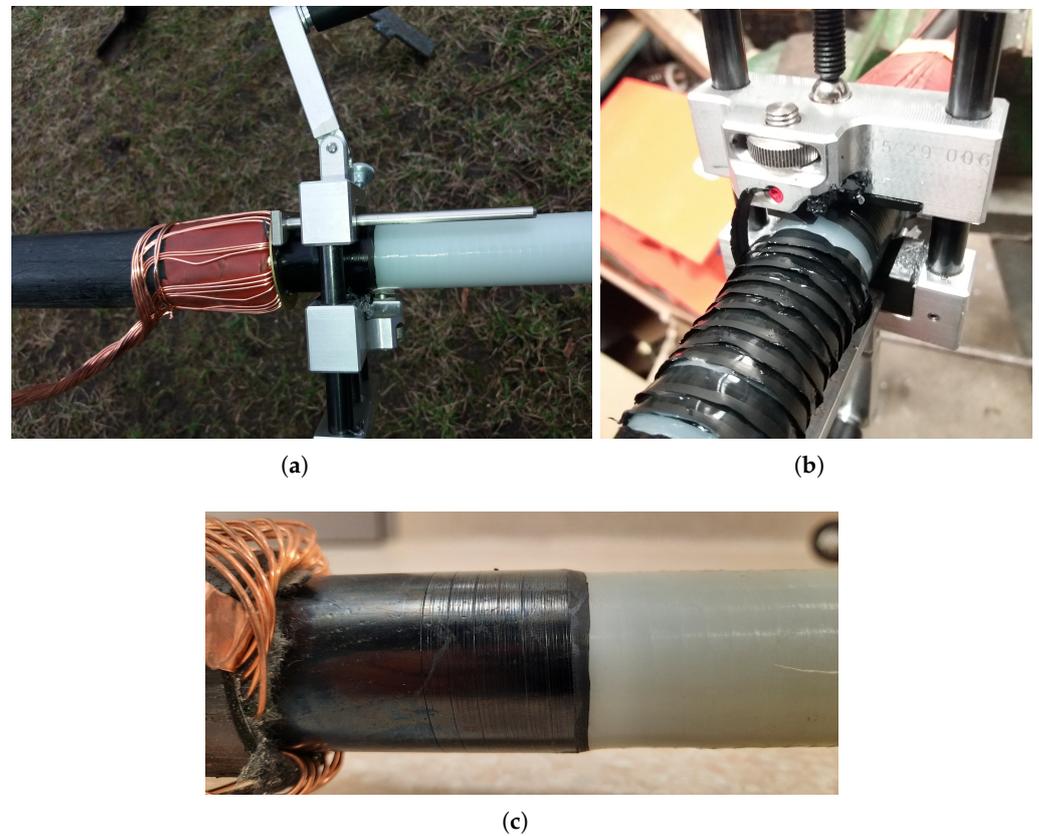
Figure 2. Process of preparing cable type XRUHAKXS $1 \times 240/25$ for installation of MV cable accessories: (a) device for removing shield from the insulation, (b) action removing shield from the cable insulation, (c) view of the cable shield after improper use of the device

Analysis of the state of the art showed that not too many publications consider the unusual cases of semiconductor coating failure in the cable insulation system (Figure 2c), which may lead to failure of the entire cable insulation [15,27]. Therefore, the subject of this paper is to pay attention to the aspects of the correct method for installation of the cable terminations, which has a direct impact on the generation and development of PD in the MV cable lines. The results and analysis presented in the next part of this paper clearly show that the incorrect execution of a cable joint or cable termination directly affects the operation and reliability of the entire cable system. According to the authors' experience, some of the tools used in on-site work to remove the screen from the main insulation of the cable may significantly damage the insulation surface (Figure 2). A visual inspection of some newly assembled and finally unaccepted MV cable terminations (Figure 3) showed damage to the shield surface and deformation of the semiconductor coating. These are defects that in some perspective may lead to the PD. They are also very difficult to detect during the first on-site screening tests and even during typical commissioning tests after the assembly of the MV cable line [32–34].

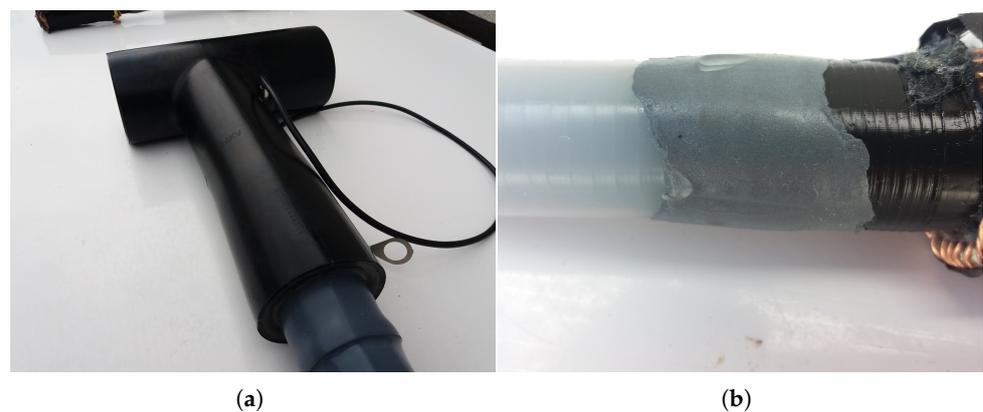
Figure 3. MV separable tee shape connector: (a) external view, (b) view of shield damage and control mantis deformation

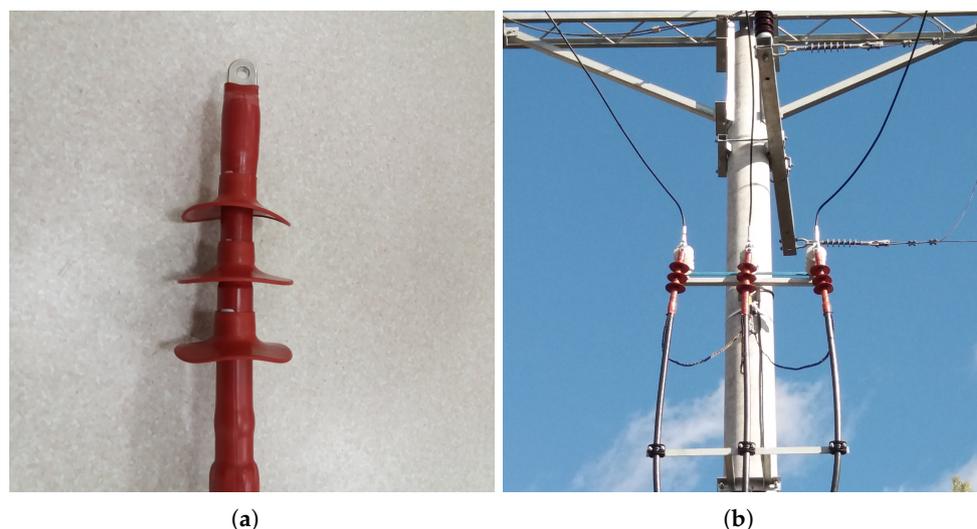
Figure 4. Heat shrinkable of MV cable termination type 24-EPOT-1/70-240/(U): (a) assembled cable head, (b) example of cable head application.

terminations. The prime assumption for this research was to use only typical materials commonly available in the joints and terminations mounting kits and used in on-site work for cables in exploitation. The cable terminations used in this research were 24-EPOT-1/70-240/(U) type, manufactured by Energy Partners, which are designed for connecting single-conductor cables with XLPE insulation and extruded screen at a rated voltage of 12/20 kV with MV distribution devices (switches, fuse bases) in overhead conditions. This type of termination can also be used in dusty and dirty environments (switching stations, transformer chambers) (Figure 4).

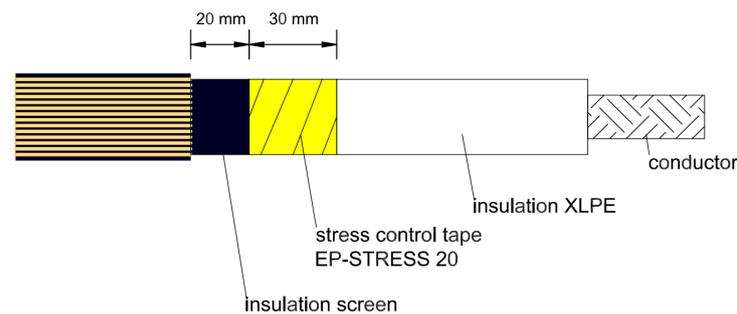
Figure 5. Correct assembly of the EP-STRESS 20 control strip according to the assembly instructions for the Energy Partners heat shrink termination type 24-EPOT-1/70-240/(U).

Figure 5 shows a fragment of the assembly instructions for installing the EP-STRESS 20 control tape. According to Figure 5, one should tie the tape below 20 mm of the end of the screen, carefully fill the edge of the end of the screen on the insulation, and finish it with 10 mm on the insulation.

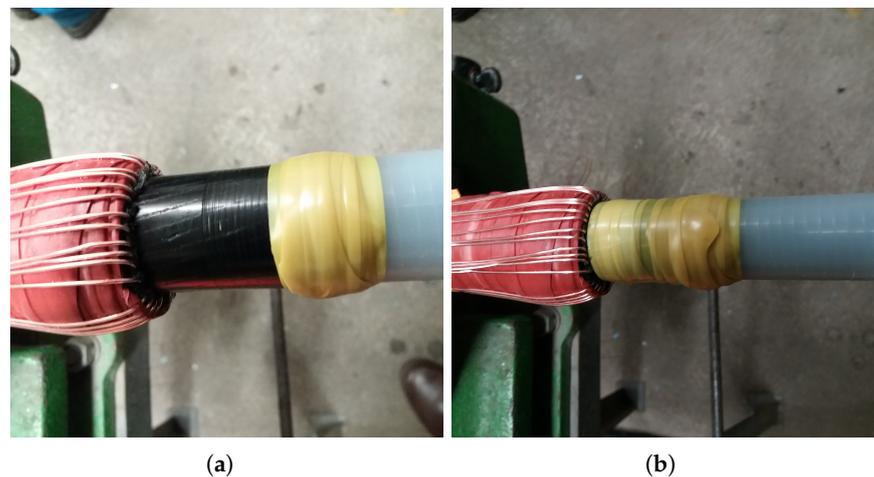
Figure 6. Stage of installation of the SN cable head type Energy Partners 24-EPOT-1/70-240/(U): (a) installation of the EP-STRESS tape on the cable surface according to the assembly instructions, (b) additional fastening of the tape on a larger area of the cable screen.

The modification introduced in this research consisted of adding an extra wrap of EP-STRESS 20 control tape over a larger area of the shield on one side of the cable (Figure 6b), which covered the damage to the shield caused by the stripping device. Further work on both terminations was carried out by the installation instructions. The modified termination was marked for later identification.

Another analysis involved the MV cable without corona rings on the cable terminations. The Q_{wtd} for the U_p in the range of 12 kV to 26 kV increased to the values of 48 pC and 41 pC for the ME and HF measurement methods. With the $U_p = 32$ kV, the Q_{wtd} value increased more than tenfold. In the case of the maximum and average charge values, such increases also occurred for both measurement methods. After removing the corona bells, an increased value of Q was noticed. This was due to the heterogeneity of the electric field strength on the uneven shapes of the cable terminal. An increase in U_p causes an increase in E in these places. An increase in Q in this situation was expected according to fundamental principles of the PD generation. After reaching the value of $U_p = 36$ kV, there was a defect and breakdown of the insulation in the cable terminations. The value of the registered Q_{max} reached the value of 136.7 nC for the ME method and 112.4 nC for the HF method, and the Q_{wtd} reached 2707 pC and 3831 pC, respectively. Figure 12 shows the successive stages of dismantling the insulation and control layers of the cable termination to confirm the location of the defect. The visible place (Figure 12d) with a diameter of approximately 4 mm and a depth of approximately 5 mm is damage to the surface of the cable insulation. The terminal of the semi-conductive coating and the insulation is at the contact point. It is a zone of discontinuity of the electric field. The surfaces of the EP-STRESS 20 control belt and the RSCT control tube were also damaged. This situation occurred in the termination, which was mounted according to the assembly instructions. At the other end of the cable, where additional control tapes were attached to cover the entire surface of the semiconducting coating (Figure 6b), the cable was not damaged.

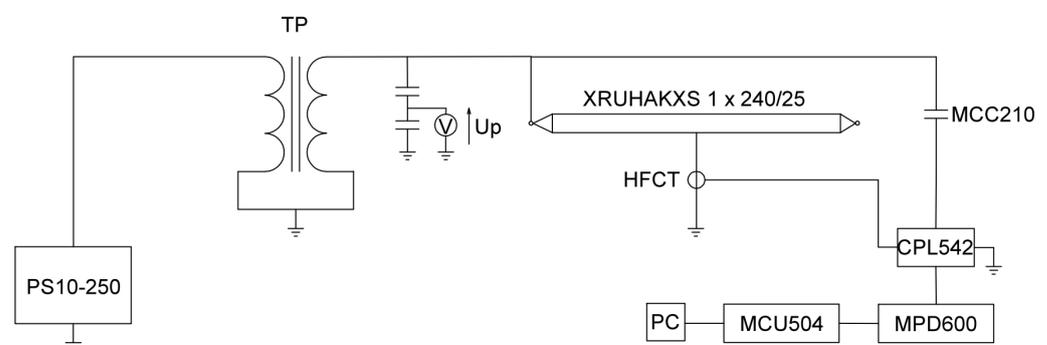
Figure 7. Scheme of the measurement system.

The test was carried out on a test bench equipped with the following devices (Figure 7):

1. PS10-250 control panel,
2. Capacitive voltage divider to measure the output voltage of the test transformer,
3. TP test transformer with mains frequency $f = 50$ Hz and voltage ratio $\vartheta = 0.22/110$ [$\frac{kV}{kV}$],
4. Omicron MPD 600 PD analysis system, which includes:
 - (a) PC,
 - (b) MPD600 data acquisition unit,
 - (c) MCU504 control unit,
 - (d) CPL542 measuring impedance,
 - (e) CAL542 charge calibrator,
 - (f) MCC210 coupling capacitor,
 - (g) HFCT coil type 991/21.

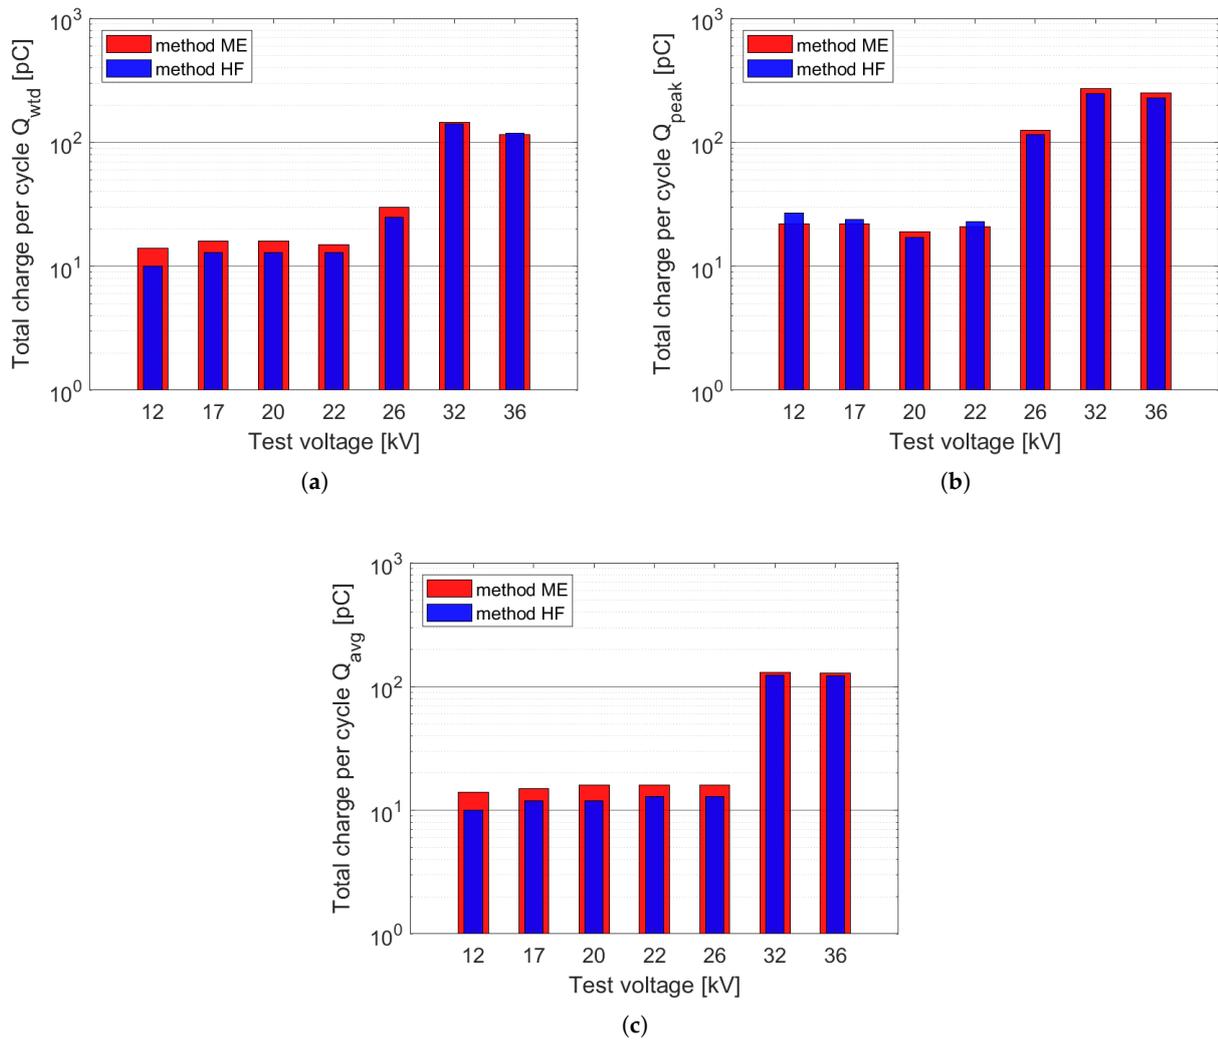
Figure 8. Values of apparent charge Q depending on the test voltage U_p for a cable with the installed corona rings registered with the ME and HF methods: (a) Q_{wtd} , (b) Q_{peak} , (c) Q_{avg} .

In the scenario with the corona rings, the value of the Q_{wtd} , under the influence of increasing the test voltage to the value of $U_p = 22$ kV, was practically constant at approximately 15 pC for the ME and HF methods. A slow increase to the value of approximately 30 pC occurred at the $U_p = 26$ kV. The subsequent increase of the voltage to $U_p = 32$ kV resulted in an increase of Q_{wtd} to the value of 145 pC and its decrease to 115 pC at the voltage of $U_p = 36$ kV.

For the Q_{peak} and Q_{avg} values, a similar situation occurred regarding their increase with the increase of the test voltage U_p . Furthermore, there was a decrease in the charge value for the U_p above 32 kV for both measurement methods. The analysis of PRPD images for the cable with installed corona rings for U_p range from 12 to 22 kV showed no PD increase in both half cycles, and their level was kept constant. The only noticeable value in this voltage range were single PD pulses that appeared at angles $\phi = 20^\circ, 130^\circ, 200^\circ$, and 320° . The intensity of these PD increased with increasing voltage values from 20 to 90 events per second.

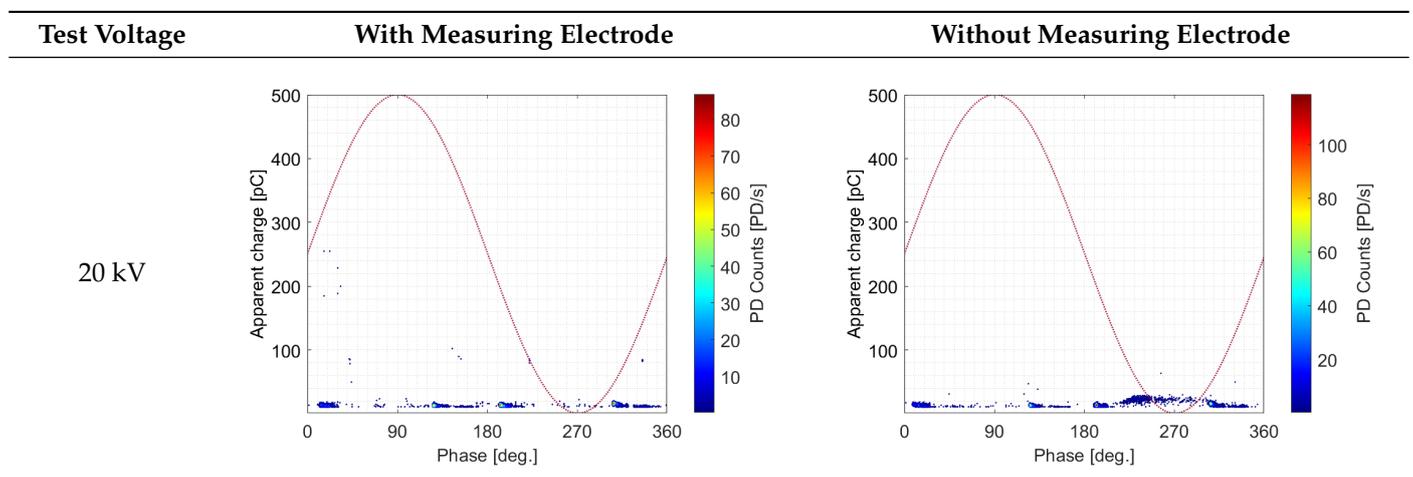
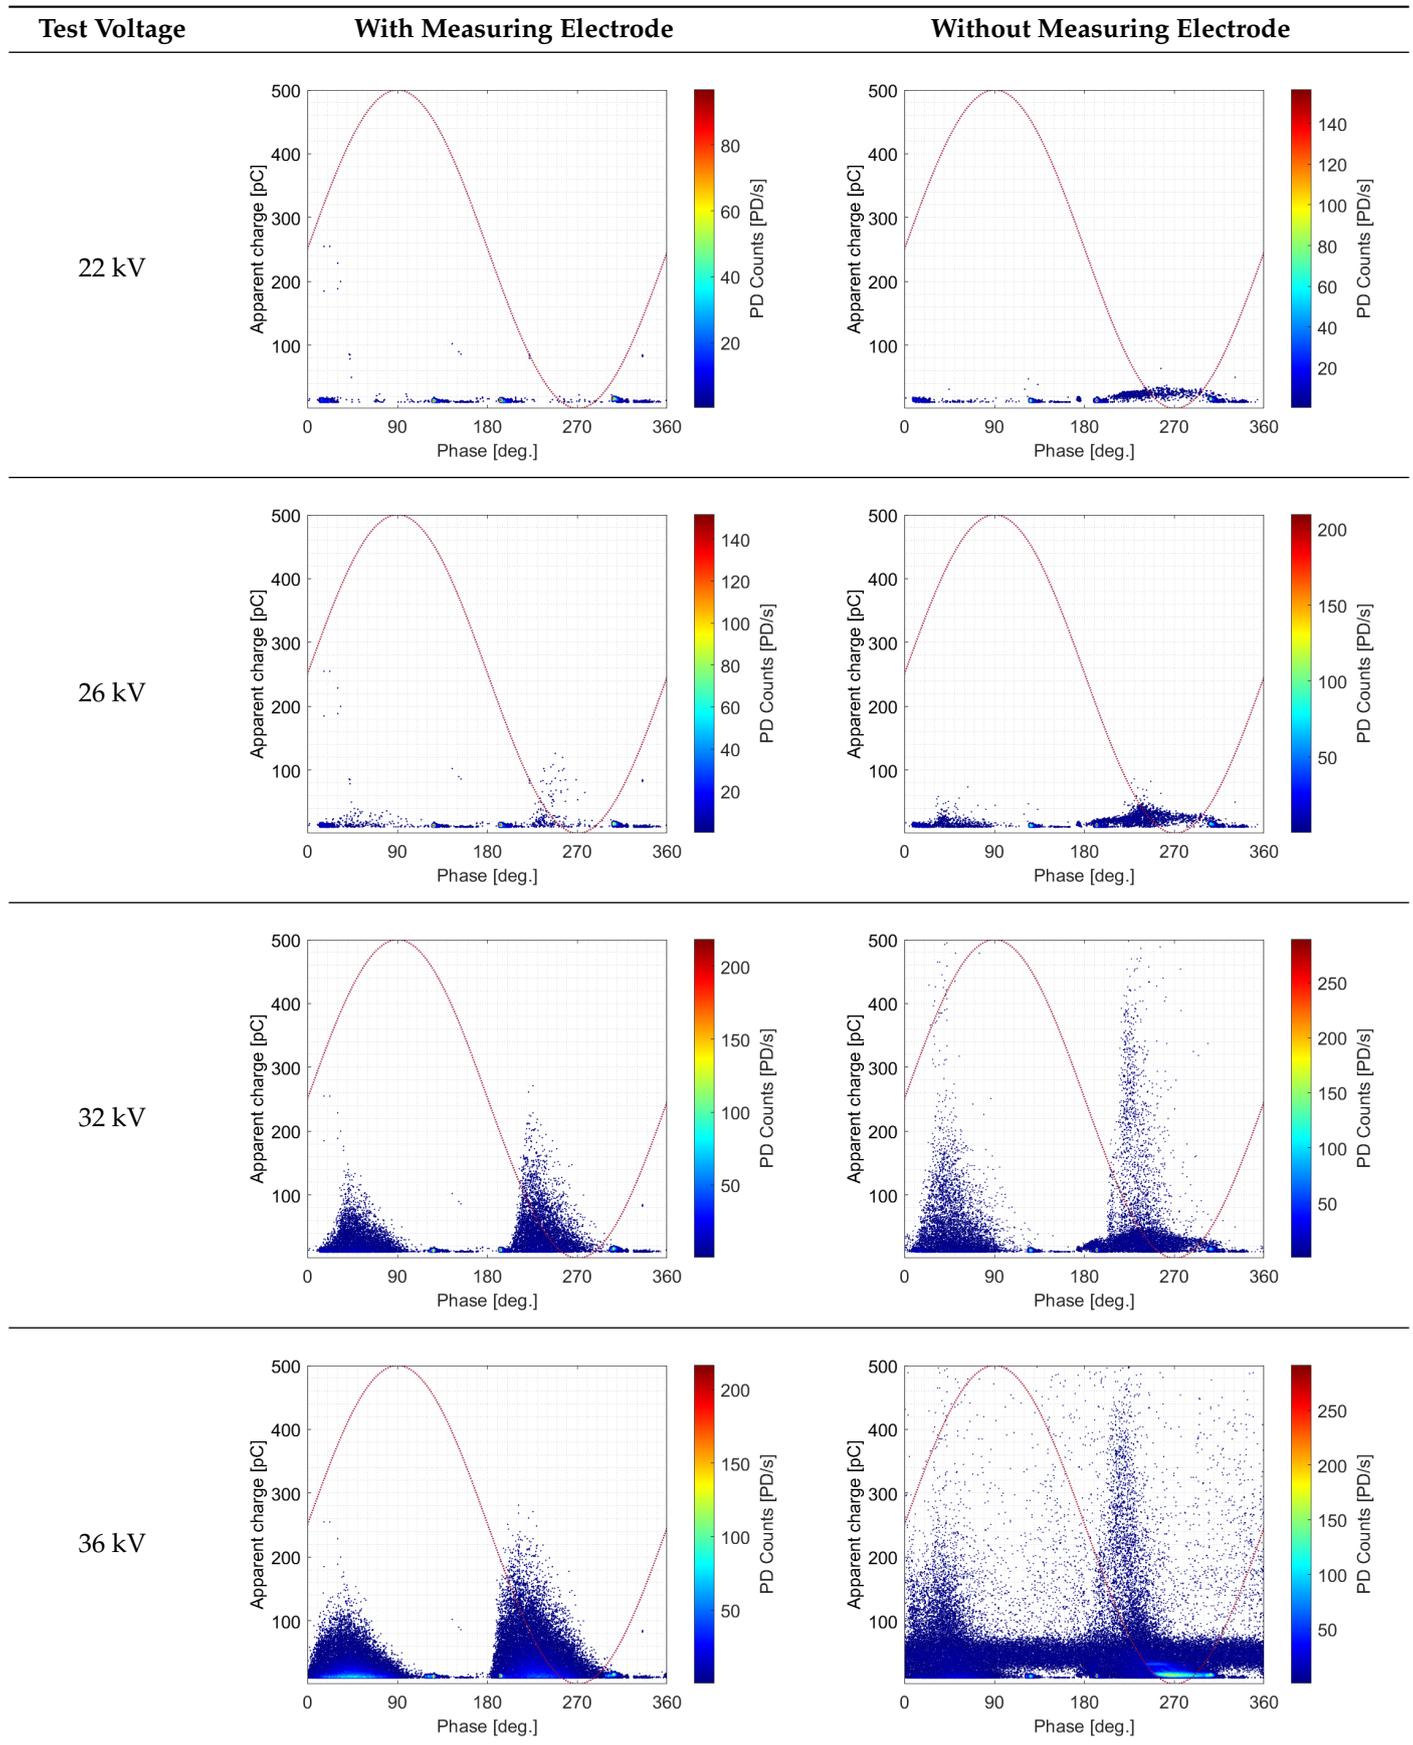
Table 3. PRPD images recorded by the ME method.

In the case of U_p above 26 kV, in the negative part of the sinusoid between the angles $\phi = 180^\circ \div 270^\circ$, single PD pulses of low intensity (20 events per second) and values of approximately 100 pC were observed. Increasing the U_p to the value of 32 kV resulted in the appearance of a more significant number of PD of a similar intensity; their value increased to approximately 200 pC.

Additionally, PD appeared in the positive part of the sinusoid between the angles $\phi = 0^\circ \div 90^\circ$. The value of these PD was approximately 120 pC. With the test voltage $U_p = 36$ kV, the number and value of PD increased to 250 pC, and its level was higher in the negative half cycle of the supply voltage.

The analysis of PRPD images for the MV cable termination system without corona rings at $U_p = 12$ and 17 kV did not show an increase in PD for the ME and HF methods (only noise was recorded and single PD pulses). Forcing voltage from the value of $U_p = 20$ kV caused an increase in the number of PD with values not exceeding 50 pC with an intensity below 50 events/sec in the negative part of the sinusoid, in the phase range $\phi = 200^\circ \div 330^\circ$. With the $U_p = 32$ kV, the PD in both half-periods of the sine wave increased to maximum values of 500 pC. A characteristic form appeared in the range of phase angles $\phi 30^\circ \div 60^\circ$ and $210^\circ \div 240^\circ$ for both measurement methods (Tables 3 and 5).

This can probably be related to corona discharges on the copper ends of MV cable terminations. A very similar PD form was presented in [26], which represents the XLPE insulation with metal file inserts in a cable joint made on an MV cable with a voltage of 11 kV. Regarding the described scenario, it seems very likely that with this type of defect, the PD increase would be noticeable at the test voltage value below $U_p = 20$ kV. This form suggests an increase in PD in the insulation-metal connection in the tested MV cable termination.

The analysis of PRPD images at the test voltage $U_p = 36$ kV confirms the PD presence in the entire phase interval, which may be characteristic of the damage to the cable surface that occurred at this voltage.

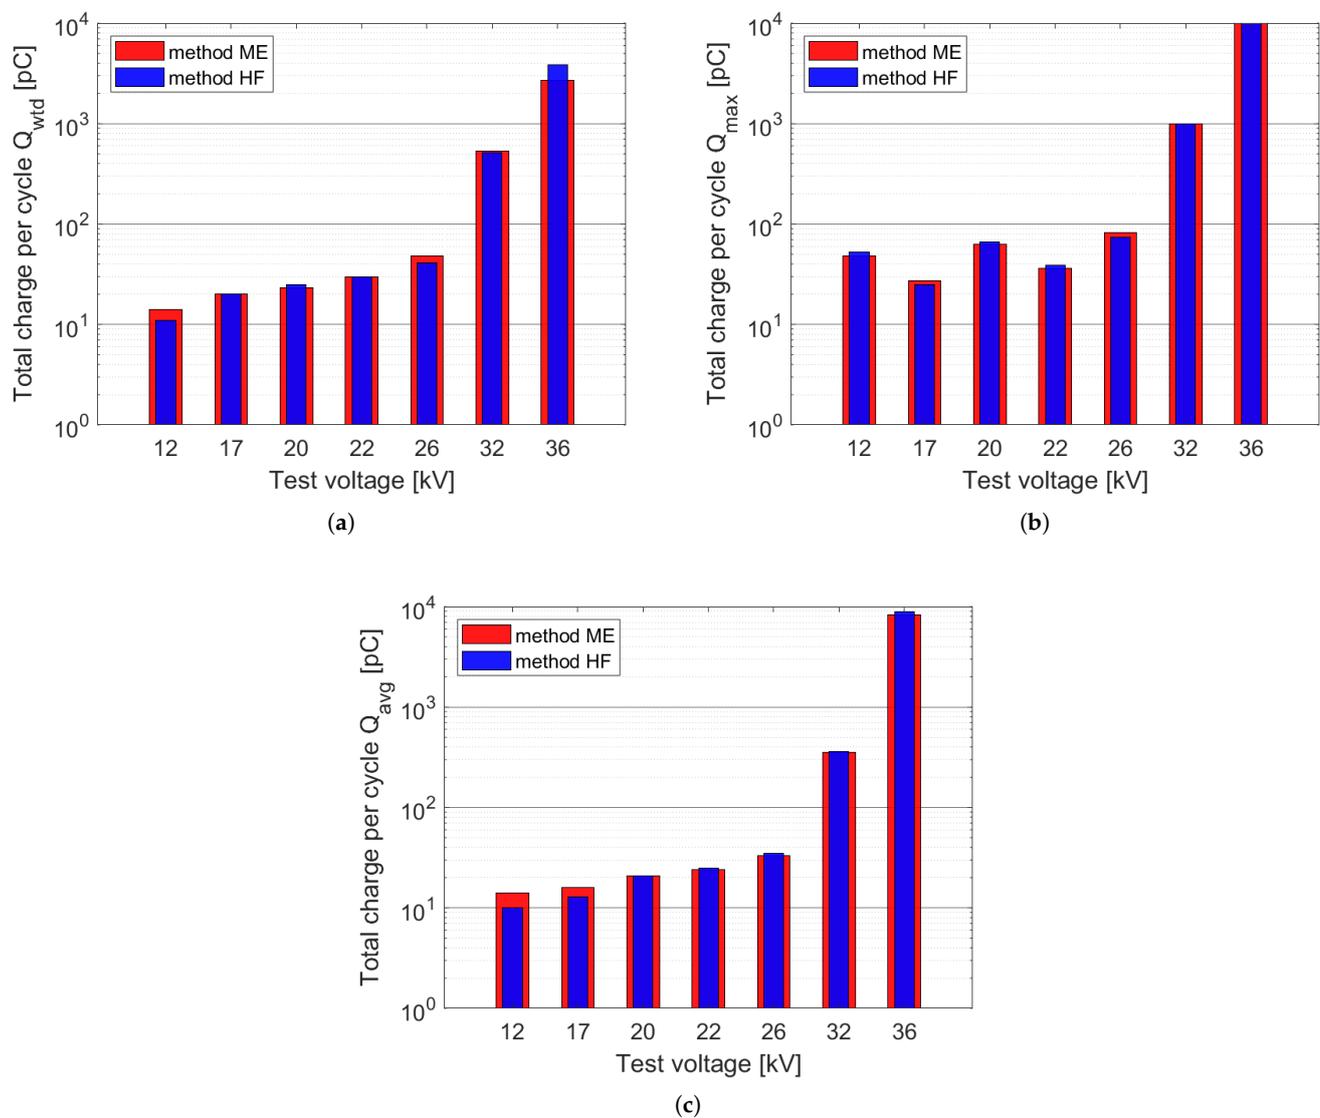
**Figure 9.** Graphical presentation of the value of Q depending on the U_p for a cable without installed corona rings, registered with the ME and HF method: (a) Q_{wtl} , (b) Q_{peak} , (c) Q_{avg} .

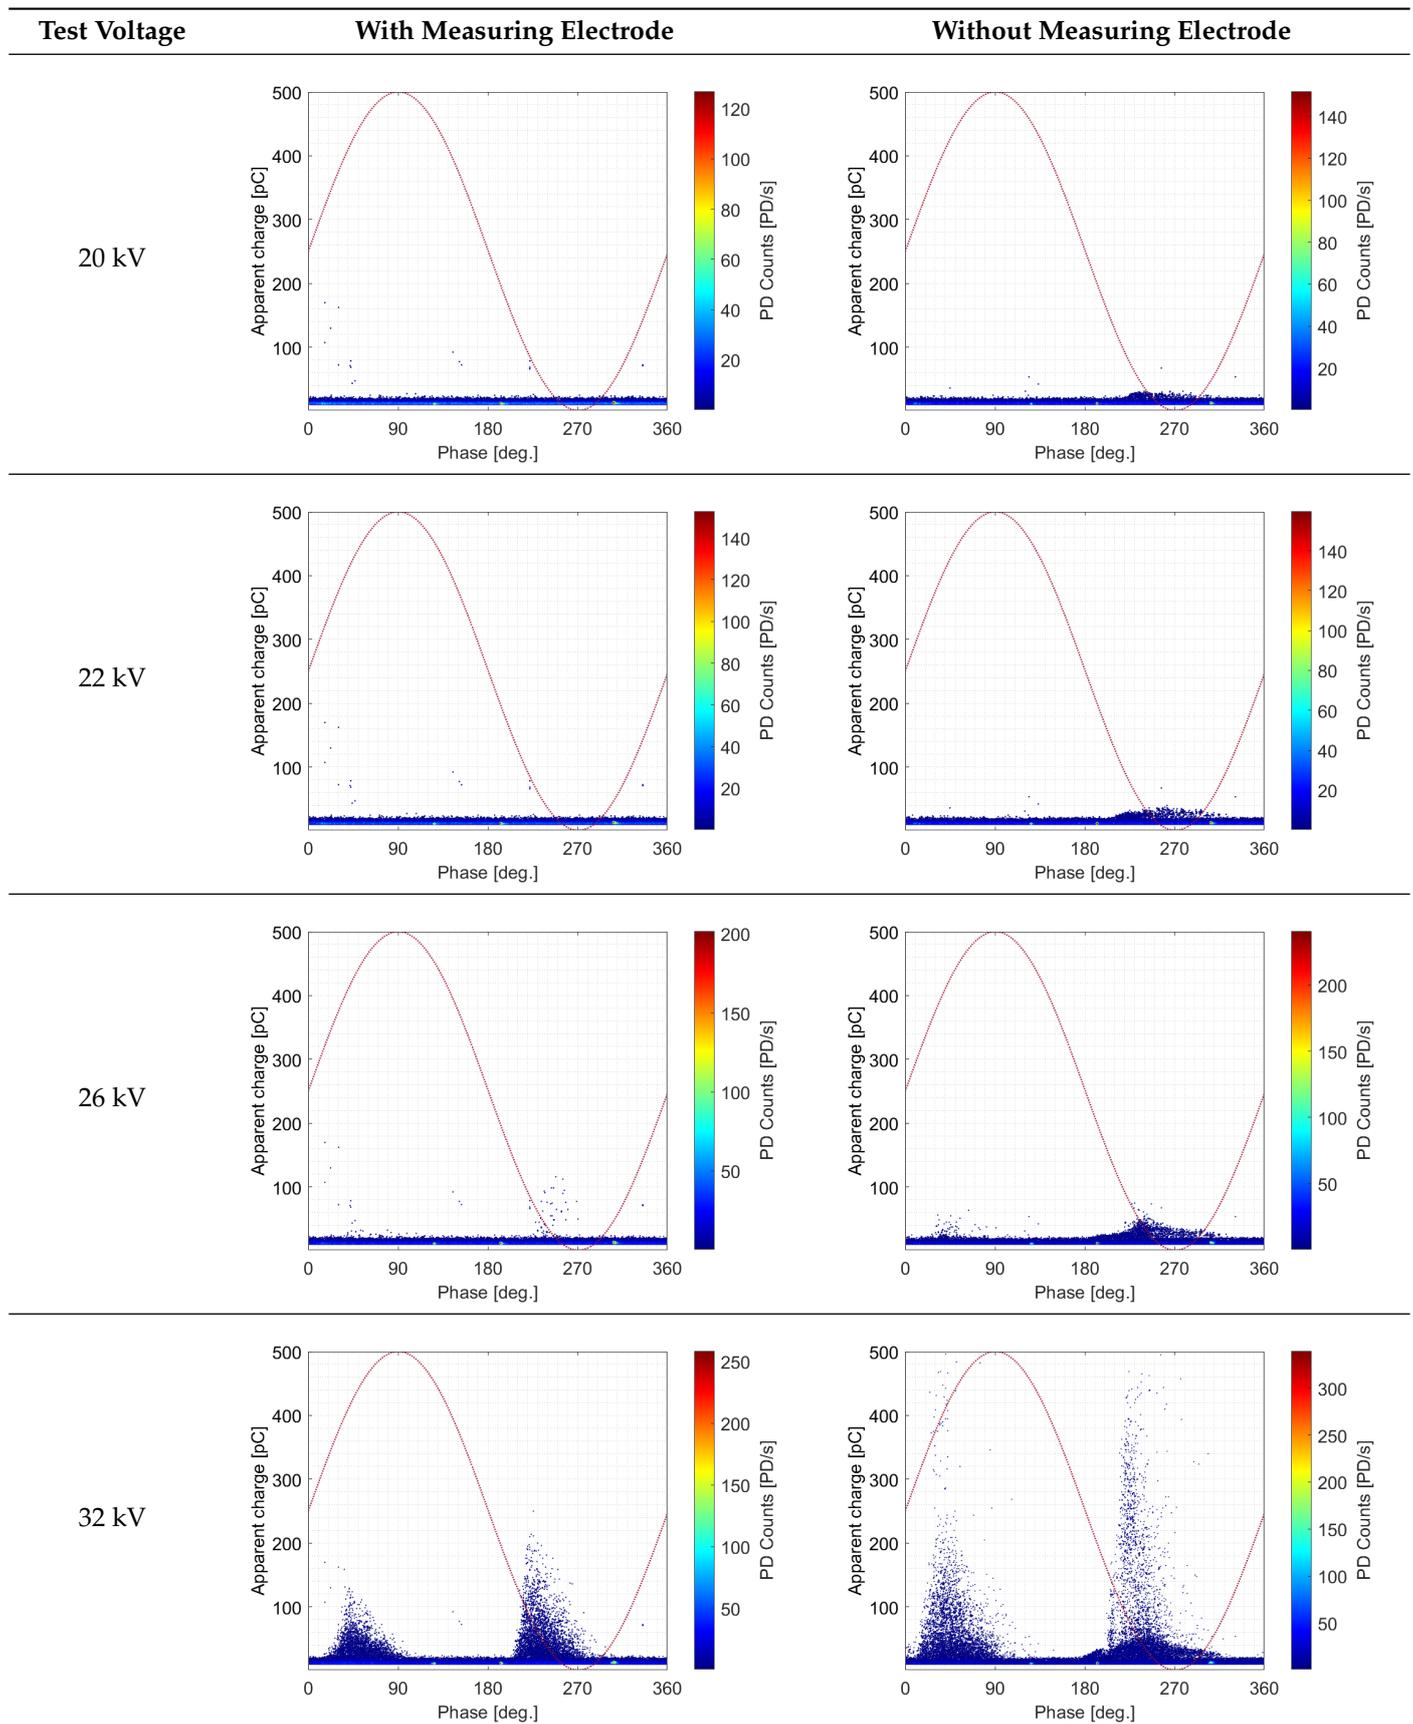
Table 5. PRPD images recorded with the HF method.

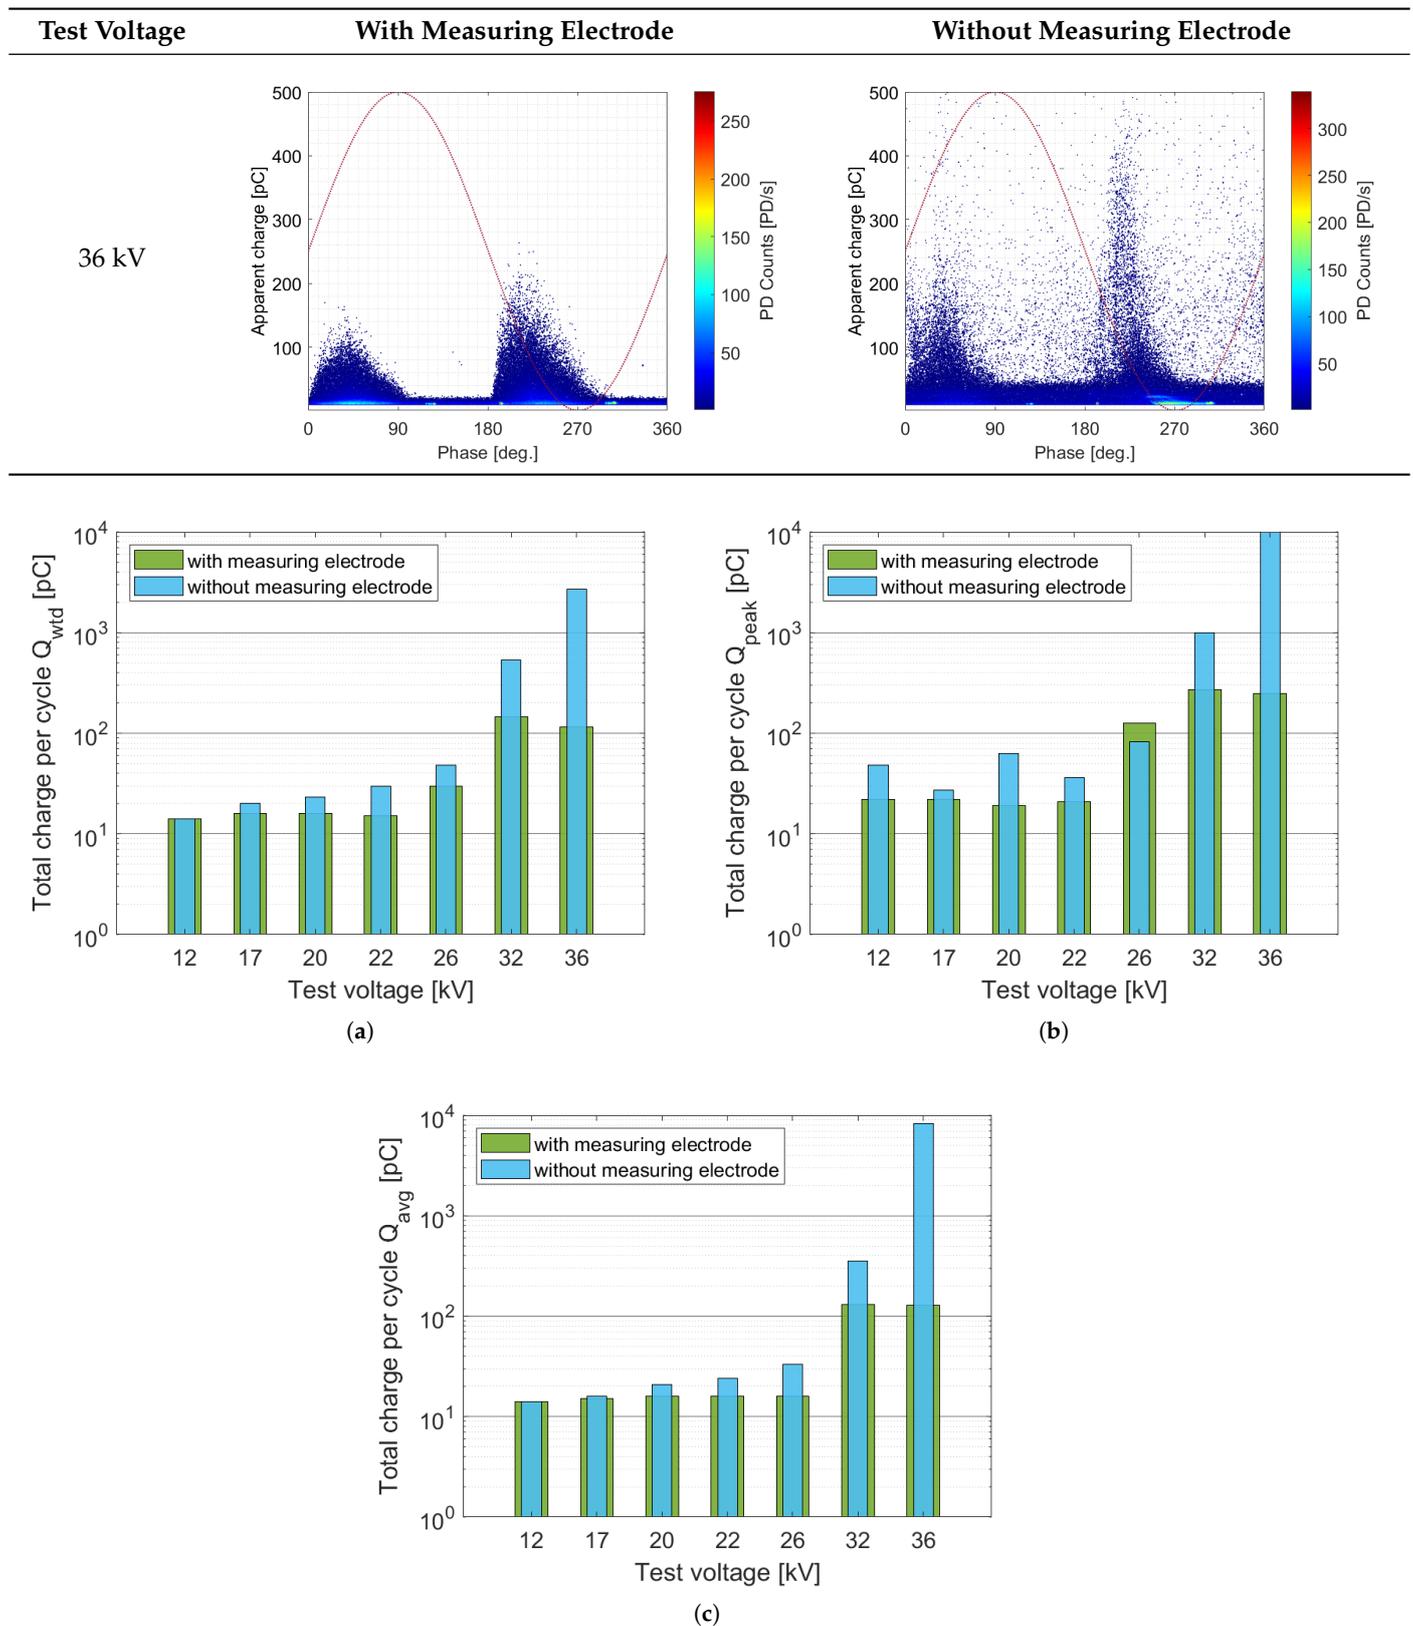
Figure 10. Graphical presentation of the value of Q depending on the U_p for a cable in a configuration with installed and removed corona rings using the ME method: (a) Q_{wtd} , (b) Q_{peak} , (c) Q_{avg} .

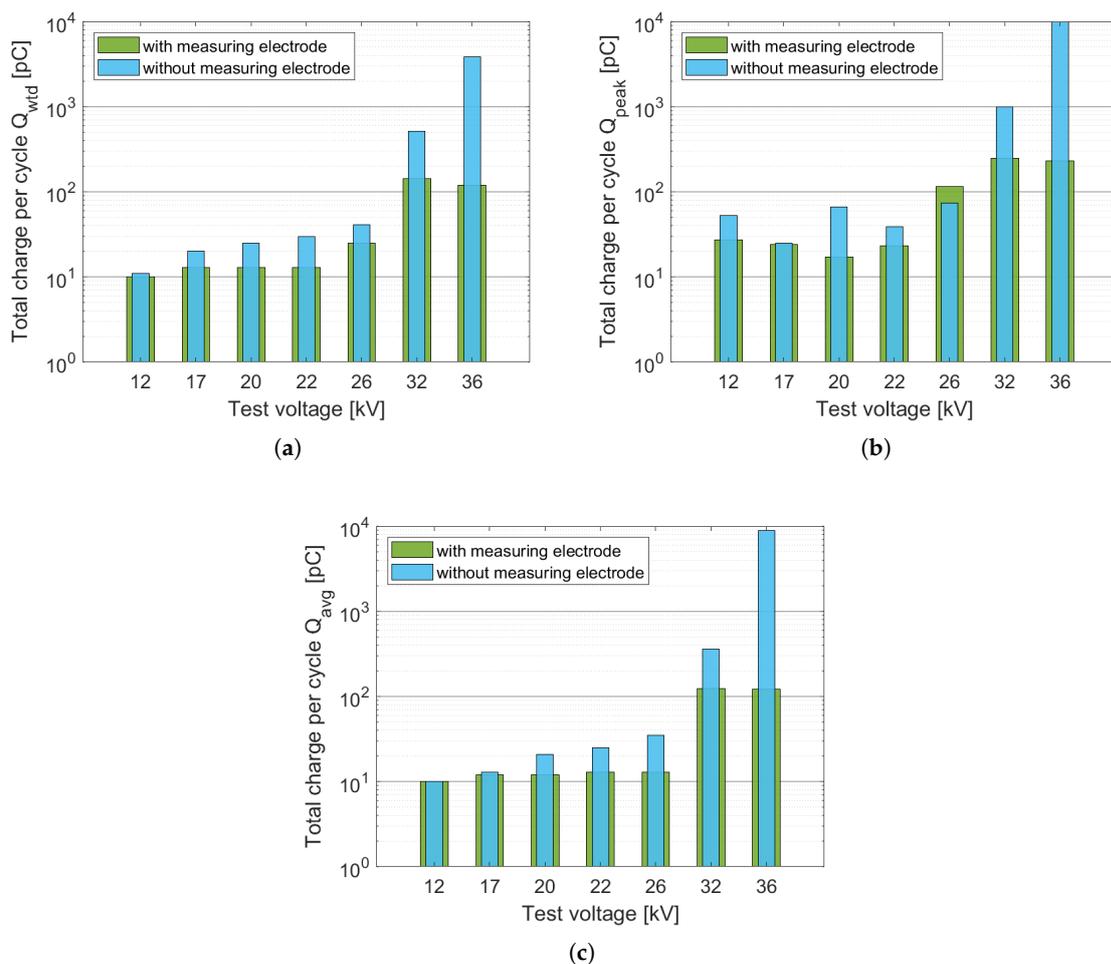
Figure 11. Graphical presentation of the value of Q depending on the U_p for a cable in a configuration with installed and removed corona rings using the HF method: (a) Q_{wtd} , (b) Q_{peak} , (c) Q_{avg} .

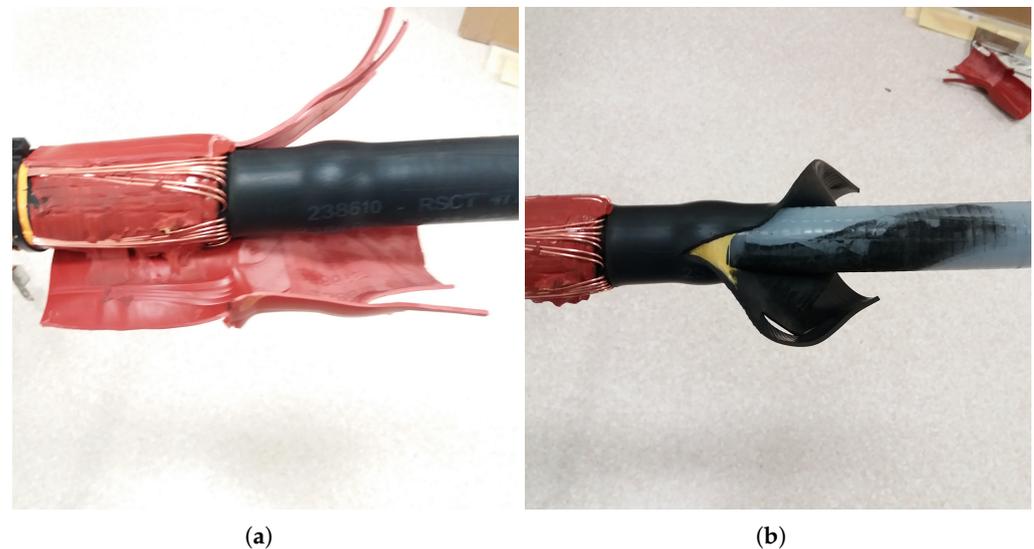
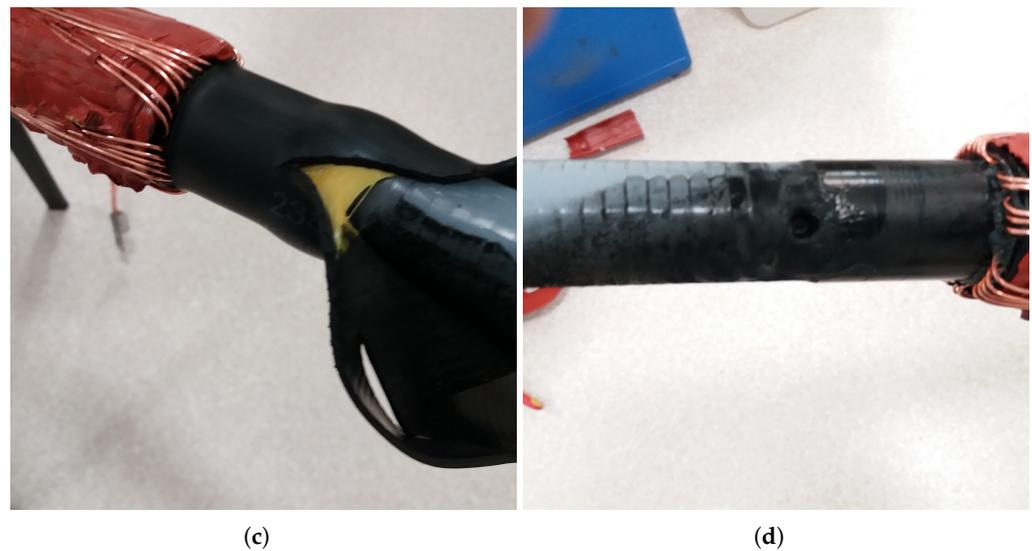
Figure 12. Damage to the surface of the insulation and the shield of the XRUHAKXS 1 × 240/25 cable at the MV cable termination: (a) disassembly of the insulating pipe RART 49/16-450, (b) disassembly of the control tube RSCT 47/14-160, (c) disassembly of the control strap EP STRESS 20, (d) view of damage to XLPE insulation

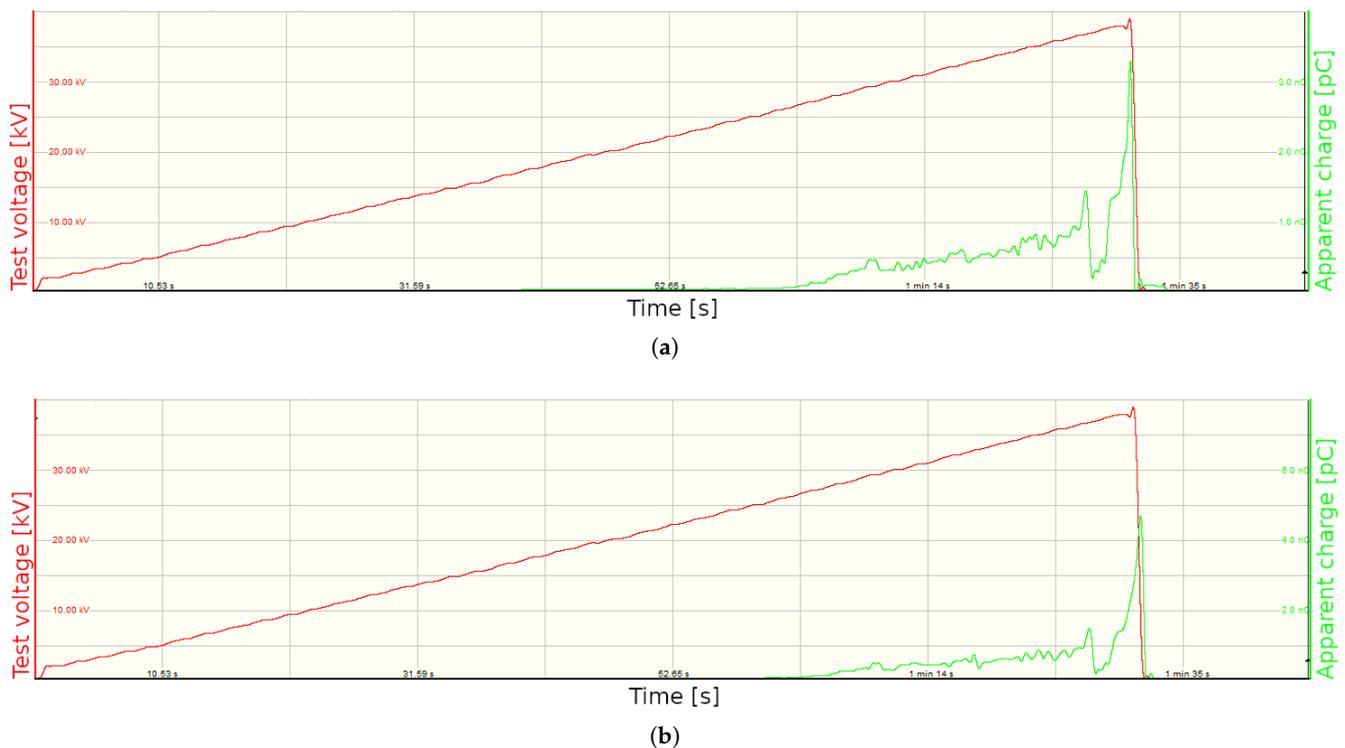
Figure 13. Waveforms of the $Q(U_p)$ dependence for the voltage ramp without corona rings: (a) ME method, (b) HF method.

By analyzing the above event, the $Q(U_p)$ dependencies were determined for the ME and HF measurement methods, which are shown in Figure 13. The following dependencies show that the rapid increase in charge values occurred at the $U_p = 32$ kV (for both methods). Along with the further increase in the voltage value, the complete extinction of PD activity occurred (description of the phenomenon above). A very sharp increase in the value of Q , which exceeded 3 nC (ME method) and 4 nC (HF method), caused a cable insulation defect at the test voltage $U_p = 36$ kV. In practice, this situation indicates what Q value can cause immediate damage to the MV cable termination.
