# Effect of Ground Electrodes on the Susceptibility to Damage of Customer Premises Equipment (CPE) under Impulse Conditions

**Citation:** Muhammad, U.; Mohamad Nor, N.; Ramli, A.M.; Ahmad, N.N. Effect of Ground Electrodes on the Susceptibility to Damage of Customer Premises Equipment (CPE) under Impulse Conditions. *Energies* **2022**, *15*, 1247. <https://doi.org/10.3390/en15031247>

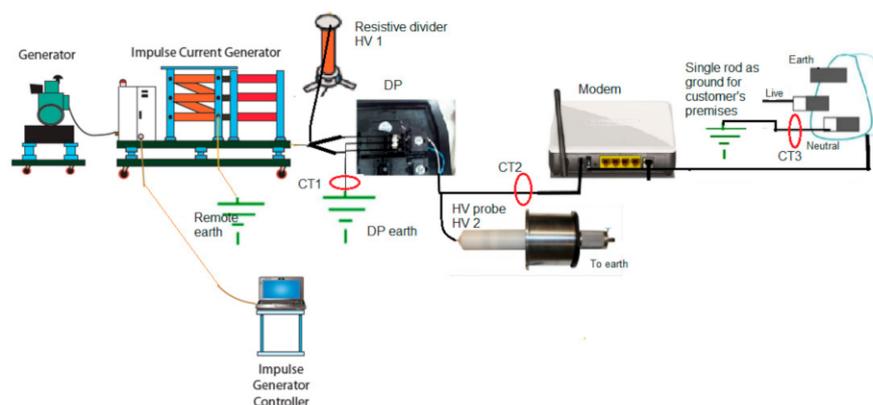
Figure 1 shows the test setup used, where a combination impulse generator that can generate 1.2/50  $\mu$ s from the magnitudes of 30 kV to 300 kV. A current rating of 10 kA was used, which was injected into the distribution pole (DP) box. The cable that entered the DP box was the paired cable, and the one that went out from the box was the drop wire; these cables were based on ANSI/TIA/EIA 568-B [10]. Inside the DP box, a gas surge arrester was used to divert the high current to the ground during overvoltages; the gas surge arrester was connected to several ground electrodes, defined as ground electrodes for the DP. The details of its configurations and ground resistance  $R_{DC}$  values are listed in Section 2.2. A voltage divider with a ratio of 3890:1 and a current transformer 1 of 0.01 V/A were used for the measurement of the applied voltage and current of the ground electrode. The signals of voltage and current were obtained with a digital storage oscilloscope (DSO).

**Figure 1.** Test arrangement used in the study.

From the DP, via drop wires, the DP was connected to the modem where the voltage and current of the modem were measured with divider, HV2 with a ratio of 1000:1 and a current transformer with 0.1 V/A sensitivity, where both measurements were captured by the DSO. In order to replicate the condition and connection of the modem at the premises, a diesel generator was used to set the modem to 'ON' mode, and the neutral part of the power adapter was connected to the ground electrode, which in this case was a single rod electrode. The power adapter used for the modem in this work was the earth pin made of plastic to ensure any high voltage or current would be discharged to the ground electrode of the power adapter via a neutral cable, which was a typical TT ground systems used in Malaysia, as outlined in [11].

Current transformer 3 measured the current that flowed to the ground through the utility's ground installation. Figure 1 shows the test setup used in the study. Because we expected various modems to have different susceptibility levels toward lightning, one type/brand of modem was used throughout the tests, and the modem was replaced with a new one after every test was carried out. The lowest charging voltage that was capable of generating this impulse generator was 30 kV injected into the paired cables before the DP. It should be noted that there was no direct connection from the ground of one equipment piece to another (i.e., the ground for the DP was not connected to the ground of the power adapter and remote earth).

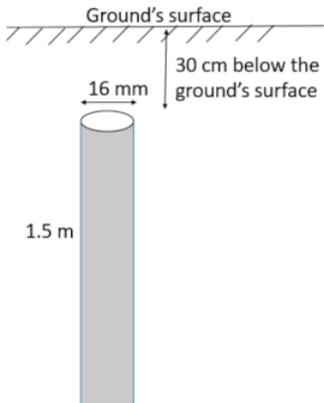
<p>(a) Single rod electrode</p>	46.0	150.8	103.1

Sixteen ground electrodes under tests were used and installed at sites 1, 2a, and 2b, where these ground electrodes were labelled DP earth. Table 2 summarizes the ground electrodes used, in which 6 of these configurations were similar to that presented in [5], with the rod electrode configuration being as follows: (a) at 1.5 m length, with 16 mm diameter rod; (b) the rod electrode (a) connected by copper plate, of 2 cm width,

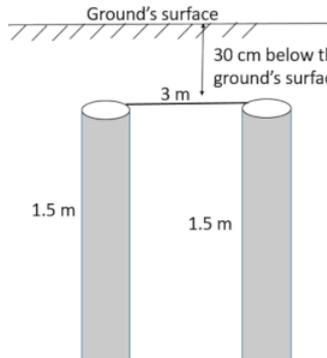
<p>(b) 2-rod electrode</p>	30.9	78.7

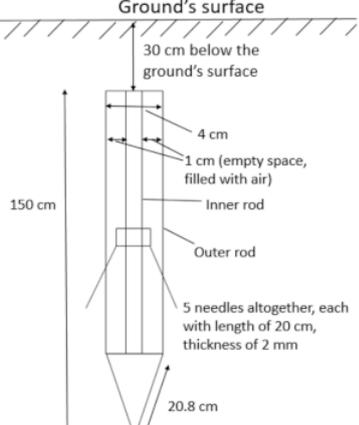
<p>(d) Grounding devices with spike rods (GDSR)</p>	31.4	88.5	69.1

0.2 mm thickness, and 3 m length; and (c) was the rod electrode (b), connected to another rod electrode with 3 m copper plate. Configurations (d), (e), and (f), consisted of a grounding device with spike rods (GDSR), with dimensions shown in Table 2 in configuration (d). Configuration (e) consisted of configuration (d) connected to a single rod electrode (a), and configuration (f) with a GDSR, connected to two rod electrodes, with 3 m copper plate from one rod to another. All of these electrodes were installed 30 cm below the ground’s surface. At site 2, four other electrodes were used, placed 50 m away from the six configurations installed earlier, with two electrodes in similar configuration to (a) and (d), while the other two configurations (g) consisted of configuration (a) connected to 2 m × 2 m ground electrode, and configuration (h) consisted of configuration (d) connected to the 2 m × 2 m ground electrode. The same copper plate, with the width of 2 cm, thickness of 0.2 mm, and length of 3 m was used in the test to provide connection to the mesh.

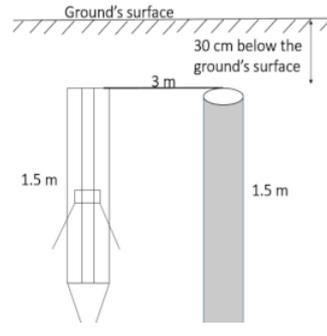
<p>(e) GDSR with single rod electrode</p>	19.2	49.8

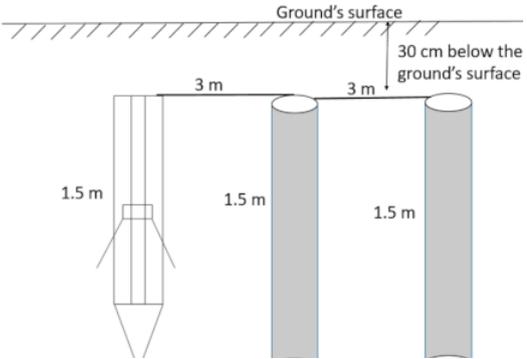
<p>(f) GDSR with 2-rod electrodes</p>	14.2	34.6

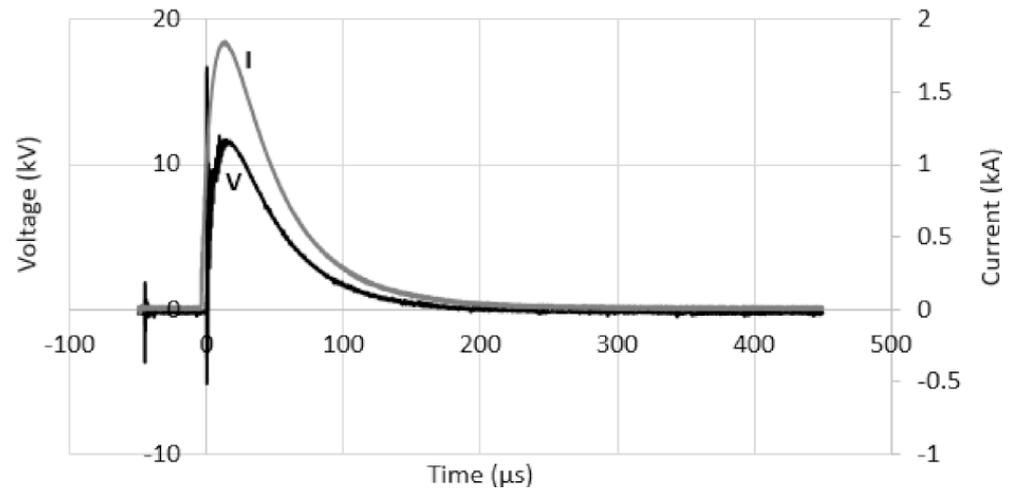
**Figure 2.** Voltage and current traces, measured with voltage divider 1 and current transformer 1, respectively, for configuration (f) installed at site 1.

The measurement from the voltage divider 1 was taken to represent the applied voltage, while the current transformer 1 was the current that flowed to the DP's ground. Figure 2 shows the voltage applied to the DP. As stated in Section 2.1, the voltage applied to the gas surge arrester, while the current trace of Figure 2 was measured as the current that flowed to the ground at the DP, indicated the DP earth of various configurations in Figure 1. Similar traces were seen for other ground electrode configurations and impulse polarity, except for some changes in the magnitudes of voltage and current, depending on the ground electrode's performance. The Figure shows fast rise times of voltage and current traces, and the current signal follows the voltage signal on both front and decay times, indicating a predominantly resistive behavior of the ground electrode. Throughout the course of the test, it was difficult to achieve the desired charging voltage of 30 kV when the tests were performed on configurations (b) and (c) installed at site 1, and configuration (b) installed at site 2, under negative impulse polarity, despite the fact that several attempts were made. When charging voltage levels were increased under negative impulse polarity on these configurations, higher than 30 kV, triggering in the impulse generator was achieved. It is

From the voltage and current plots, impulse impedance values were measured by dividing the peak voltage by the peak current,  $V_{peak}/I_{peak}$ . Table 3 shows the impulse impedance  $Z_{imp}$  values in comparison to their corresponding  $R_{DC}$  for each ground electrode and for both impulse polarities. The Table illustrates that the  $Z_{imp}$  values are always lower than that of the corresponding  $R_{DC}$  values for both impulse polarities. The percentage difference between the  $R_{DC}$  and  $Z_{imp}$  values was measured by taking the difference between  $R_{DC}$  and  $Z_{imp}$  and dividing it by  $R_{DC}$ , and the resultant was multiplied by a hundred percent. We observed that generally the higher the  $R_{DC}$ , the higher the percentage difference was between  $R_{DC}$  and  $Z_{imp}$ . This finding is similar to that found in several publications [6,7], Refs.[12,13] whereby the degree of reduction is dependent on the  $R_{DC}$  values. This is thought to be due to the dependency of the electric field  $E$  on the soil resistivity  $\rho$ , and the current density  $J$ , where  $J$  is in general a division of current  $I$  to the cross-sectional area  $A$ , as defined in Equation (1). As generally known, the non-linearity in impulse impedance, where a reduction in  $R_{DC}$  to impulse impedance  $Z_{impulse}$  would occur if the electric field  $E$  were higher than the critical electric field  $E_c$ . For a high  $R_{DC}$ , the ground electrodes may have been installed in high  $\rho$ , have a low  $A$ , or have both conditions, which would cause a rise in the electric field value  $E$ , exceeding the  $E_c$ . Due to this, a higher rate of non-linearity, which causes a higher percentage of reduction in impulse impedance from  $R_{DC}$ , would be exhibited for ground electrodes with a high  $R_{DC}$ . Another reason could be due to larger air voids for soil in high soil resistivity in comparison to low soil resistivity where the air voids may have filled up with water, and the soil is more compacted. Hence, more discharges might have occurred in high soil resistivity (high  $R_{DC}$ ) in comparison to low soil resistivity (low  $R_{DC}$ ), causing a significant reduction in impulse impedance from its  $R_{DC}$  in high soil resistivity (high  $R_{DC}$ ).

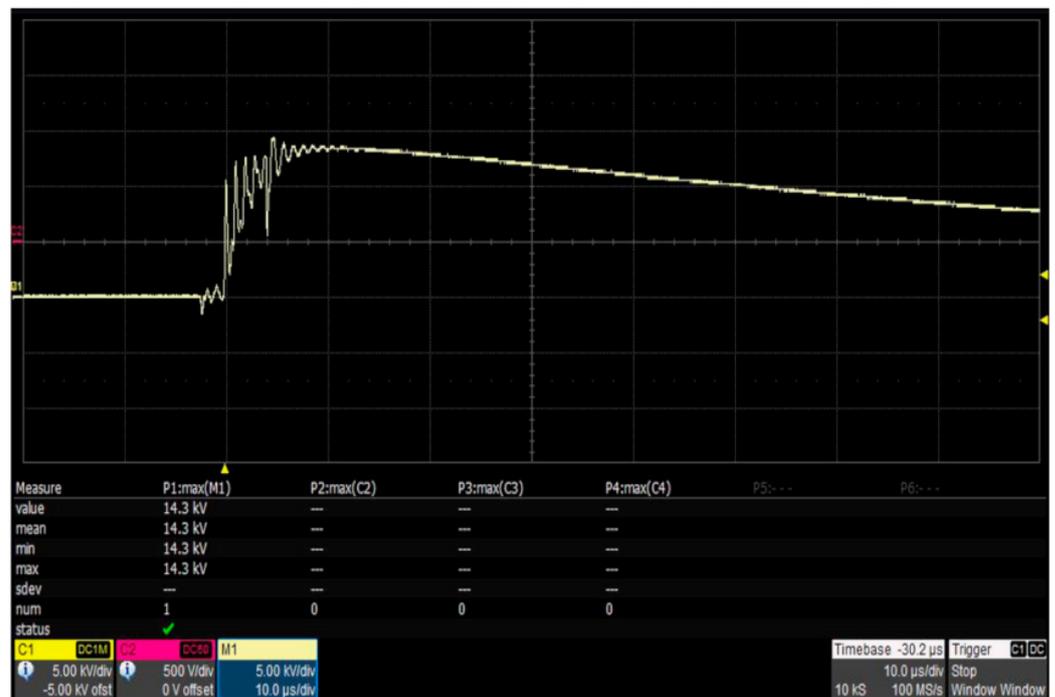
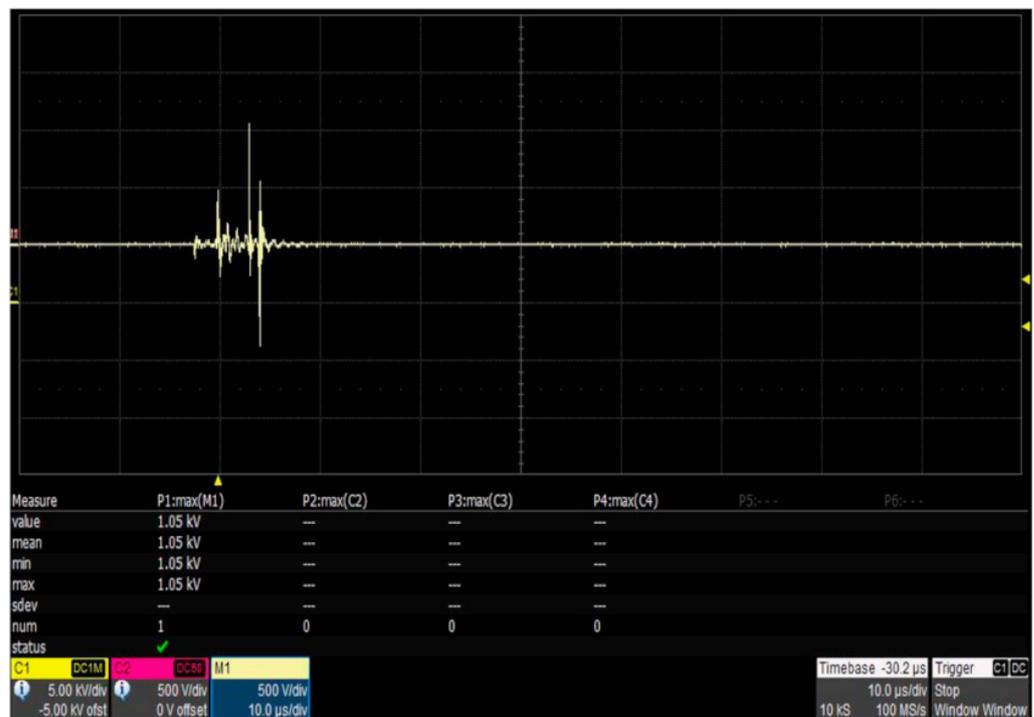
**Figure 3.** Measured traces on the modem for the case of no damage to the modem for configuration (h) installed at site 2b (a) Voltage trace measured with voltage probe 2 (x scale is  $10 \mu\text{s}/\text{div}$ , and y scale is  $5 \text{ kV}/\text{div}$ ); (b) Current flows through the modem, measured with current transformer (CT) 2 (x scale is  $10 \mu\text{s}/\text{div}$ , and y scale is  $5 \text{ kV}/\text{div}$ , and the voltage magnitude is multiplied by 10, since the CT used had a sensitivity of  $0.1 \text{ V}/\text{A}$ ).

In this study, the voltage divider 2 was used to measure the voltage applied on the modem, while the current transformer 2 was applied to measure the current that flowed through the modem, as shown in Figure 3a,b, respectively, for voltage and current traces for configuration (h), installed at site 2b under positive impulse polarity. It can be seen from both Figures that the traces had fast rise times and were found to be rather distorted. These traces were for the condition of no damage to the modem, i.e., the modems were found to be in good working condition after the tests were carried out. On the other hand, higher voltage and current traces were observed for the case of damage to the modems, shown in Figure 4a,b for voltage and current traces, respectively. As can be seen in the Figure, a collapse of voltage was seen in Figure 4a with oscillations, which were followed by a slight increase in the current magnitudes, indicated in the corresponding Figure 5a. A sudden voltage drop followed by an increase in current is a typical indication of equipment breakdown when high voltage tests are carried out on it, as discussed in [9]. Oscillations in the voltage trace could be due to harmonics that may be present due to pre-discharges within the test circuit in the modem.

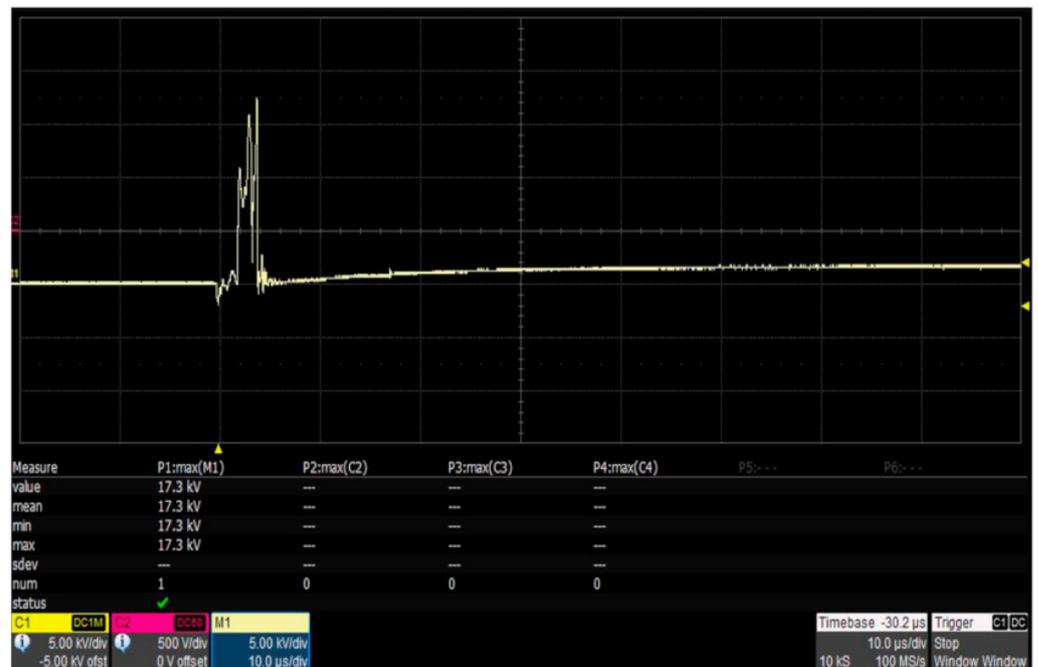
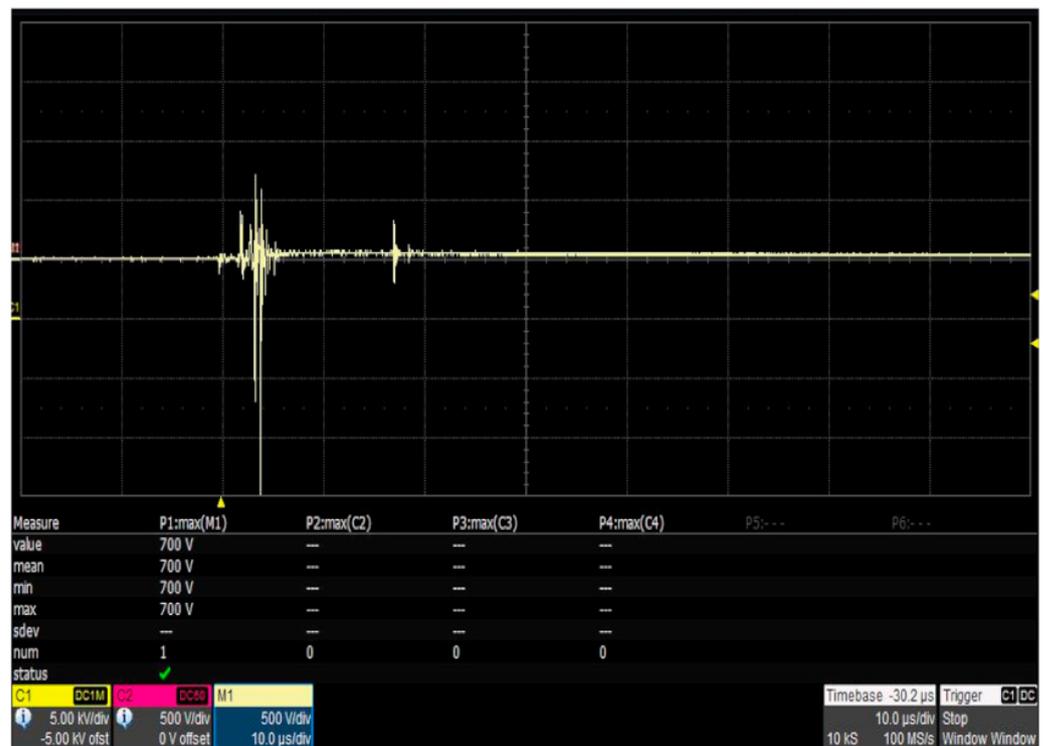
**Figure 4.** Measured traces on the modem for the case of damage to the modem for configuration (d), installed at site 2b (a) Voltage trace measured with voltage divider 2 (x scale is 10  $\mu$ s/div, and y scale is 5 kV/div); (b) Current flows through the modem, measured with current transformer (CT) 2 (x scale is 10  $\mu$ s/div, and y scale is 5 kV/div, and the voltage magnitude is multiplied by 10, since the CT used had a sensitivity of 0.1 V/A).

Despite the fact that new modems were used for every test, it was noted that voltage and current traces produced from the voltage divider and current transformer were of many shapes; they were found to be different not only in various ground electrodes, but also in both impulse polarities for the same ground electrodes. This could be due to many components in the modems that affected the way that the currents and voltage went through them, and the damage may have been caused by the failure that occurred in different components from one test to another.

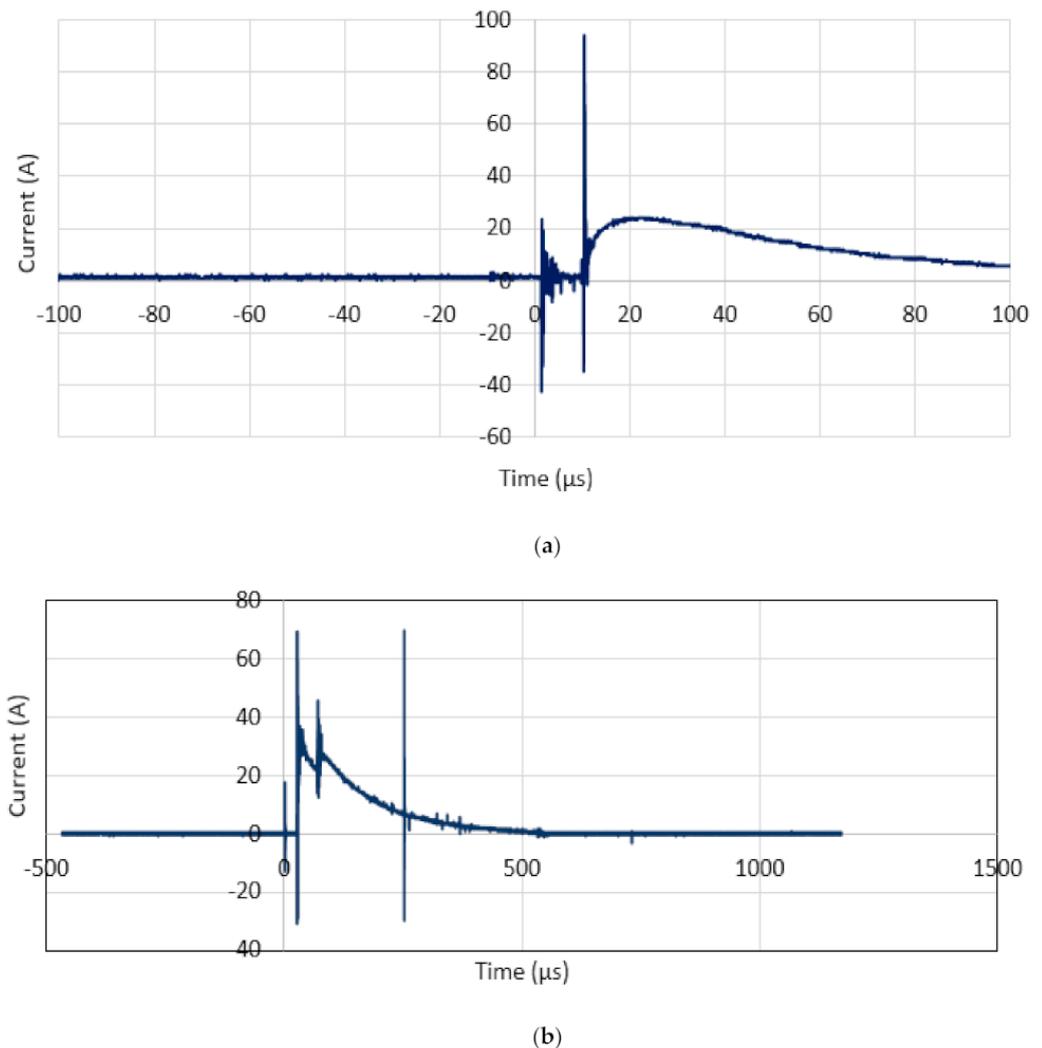
**Figure 5.** Current flows through the power adapter, measured with current transformer (CT) 3 (a) Configuration (b) installed at site 1, for the case of no damage to the modem; (b) Configuration (a) installed at site 2, for the case of damage to the modem.

Current transformer 3 measured the current flows through the power adapter, where the typical current trace was shown in Figure 5a,b, respectively, for the case of no damage and damage to the modems. The current traces were, however, found to be different in shape and magnitude for different configurations and impulse polarity; some had current traces that flowed to the ground of the modem that was found to be zero. Table 4 summarises the voltage and current magnitudes of the modem and the condition of the modem post-tests. In correlating the  $R_{DC}$  values of the ground electrode with the damage to the modem, it can be seen that the damage to the modem occurred in the ground electrode with an  $R_{DC}$  value below 30  $\Omega$  in high resistivity soil (site 2), while a higher  $R_{DC}$  value was seen in low resistivity soil (site 2a), and no damage was seen for the ground electrode with an  $R_{DC}$  value below 46  $\Omega$ .
