Article

Innovative Strain Sensing for Detection of Exterior Wall Tile Lesion: Smart Skin Sensory System

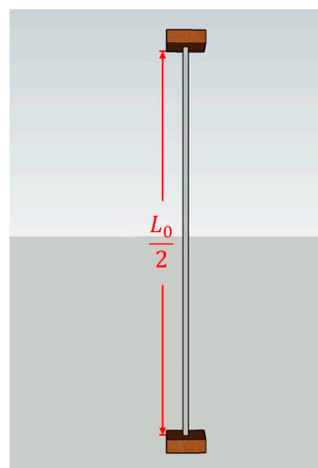
Figure 1. Unstrained wire length.

A string-type strain gauge works on the basis of the principles of a resistive strain sensor (or resistive strain gauge). In this study, force was applied to nichrome wires to produce an electrical resistance value, which was then evaluated; resistive strain sensors have great potential for use in human-machine interfaces and so-called electronic skins [12]. A study that employed nichrome wires to measure changes in voltage values generated by the impact of an object was conducted in which zero-voltage correction of the Wheatstone bridge was performed [13]. In the study, nichrome wires were diagonally wired on the surface of test objects. A string-type strain gauge acted as one of the arms of the Wheatstone bridge, wherein the wire length was proportionate to the resistance value. As the nichrome wire was stretched, the corresponding resistance value increased. Equation (1) presents the formula for the resistance value, where R is the resistance value, ρ is the resistance coefficient, L is the wire length, and A is the conductor cross-section area. According to Equation (1), as the wire length increases, the resistance value also changes. The setup of the string-type strain gauge is shown in Figure 1, where L_0 is the original length of the gauge. The folded-back laying method was applied to the wall, and the end point of the wire was set to be on the same side in order to increase the length variation of the string-type strain gauge. Thus, the wire length is $\frac{L_0}{2}$, as shown in Figure 2. When lesions on the wall surface produce a deformation of X mm, the wire length changes to $\frac{L_x}{2}$. The changes to the resistance values applied to the string-type strain gauge before and after compression are governed by Equation (2), where R_0 is the original resistance value of the string-type strain gauge and R_x is the resistance value after compression. Changes in the resistance value caused the Wheatstone bridge to lose balance and produce a change in the output voltage value, V_{out} , as shown in Equation (3), where V_{CC} is the power supply voltage and R_F is the fixed resistance of the bridge. The Wheatstone bridge is illustrated in Figure 3. In the present study, because the output voltage of the Wheatstone bridge was extremely small and required processing through an amplifier and a filter, the voltage signal was amplified 2250 times by using a second-order active filter and then 10 times more by using a back-end program. Thus, the voltage signal was amplified 22,500 times (Equation (4)), where V_O is the final output voltage.

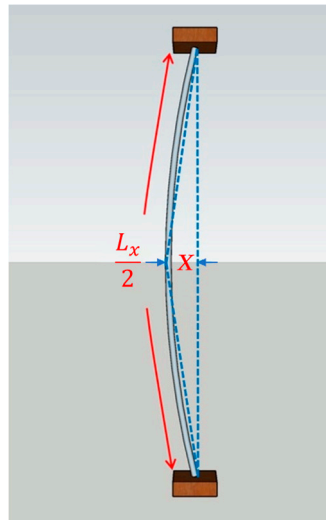
Figure 2. Strained wire length and deformation amount.

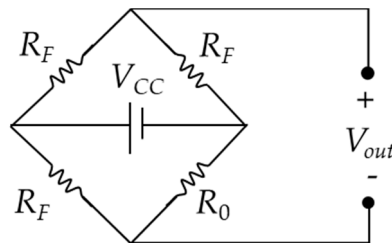
Figure 3. Wheatstone Bridge.

During the experiments in this study, changes in the resistance values of the string-type strain gauges were extremely small and difficult to determine directly. Therefore, a conversion circuit was used to convert the changes in resistance values into voltage signals; the Wheatstone bridge is the most

commonly used resistance conversion circuit and one that is the most suitable circuit for measuring small resistance changes [16]. However, commercially available resistors often contain errors. Even if four 1-K Ω resistors with the same specifications are installed on the four arms of a Wheatstone bridge, the output voltage may not be zero volts. In a high-magnification amplifier circuit, such an error may cause the amplifier to export saturation voltage, meaning that an accurate value cannot be measured. Therefore, in this study, error compensation was performed for the Wheatstone bridge. In addition, when electric current flows through a string-type strain gauge, heat energy causes the temperature to rise. This rise in temperature positively affects the resistance values of a string-type strain gauge, which results in an unbalanced Wheatstone bridge. Such a situation can lead to erroneous belief that the gauge is strained. Therefore, temperature compensation was performed; both the aforementioned compensations minimized the chance of misjudgment in this experiment.

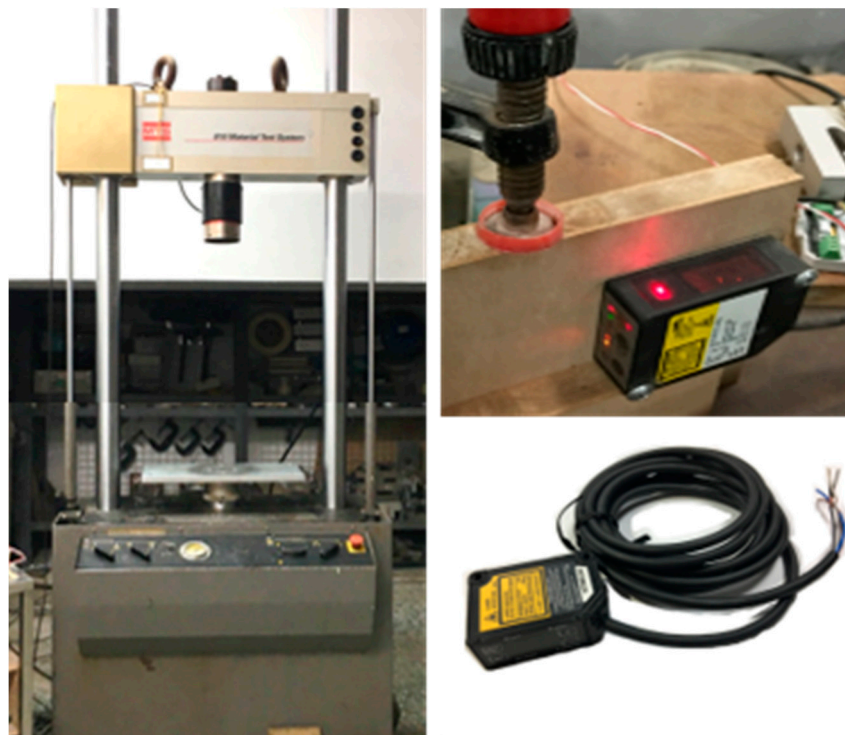
Figure 4. MTS and laser displacement sensor.

(a dynamic material testing machine, No. 318.25, MTS Systems Corporation, Eden Prairie, MN, USA) was used to compress the center point of the RC specimen to cause displacement (from one to 10 mm in 1 mm intervals). Displacement was measured using a laser displacement sensor (CD22, Optex FA, Ogoto Otsu, Japan) (Figure 4). In Experiment C, a plywood specimen measuring $150 \times 150 \text{ cm}^2$ was installed into an aluminum frame, and tiles were placed on top. The tiles covered an area of $100 \times 100 \text{ cm}^2$, and this area was used to imitate tiles on an exterior wall. Different areas behind the plywood were compressed to cause micro-deformation leading to tile lesion. Micro-deformation was created, as in Experiments A and B, with one rotation producing a displacement of 1 mm, and measurements were again taken from one to 10 mm in 1 mm intervals. Subsequently, S4 was used to detect the deformation position and level of damage caused.

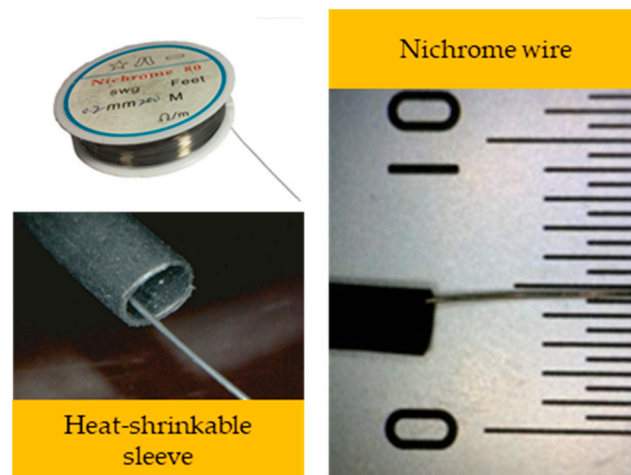
Figure 5. Nichrome wire of the string-type strain gauge.

The string-type strain gauge used in this study employed nichrome wires with a diameter of 0.2 mm that were ductile and displayed a high resistance value of $34.7 \Omega/\text{m}$; this high resistance value made them ideal for signal processing. In Experiment A, a nichrome wire was set on an acrylic sheet. When the acrylic sheet was bent, the string-type strain gauge was compressed, generating a change in the resistance values. In Experiments B and C, heat-shrinkable sleeves were used as outer-layer protection to avoid errors caused by the contamination of the string-type strain gauge (Figure 5). After installing the string-type strain gauges, resistance values were measured using a low-resistance potentiometer. Next, a Wheatstone bridge was used to convert the resistance values into the voltage change amount, and the voltage was inputted into a computer through a data acquisition system (DAQ, USB-6008, National Instruments, Austin, TX, USA) after appropriate amplification and filtering.

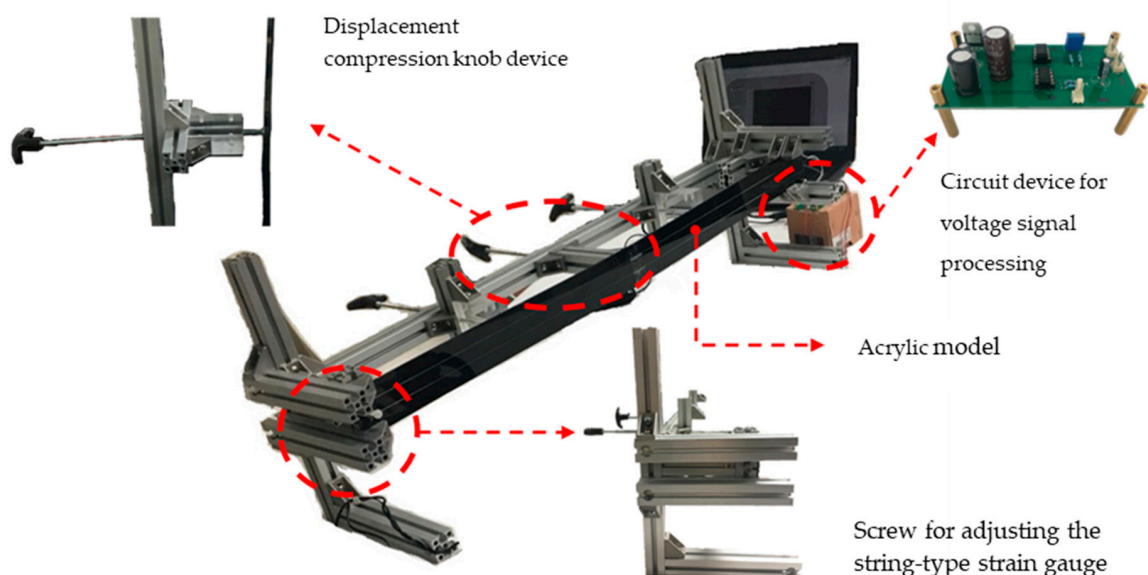
Figure 6. Aluminum frame for the acrylic model experiment.

Experiment A used acrylic as a specimen and had a tile area of $30 \times 30 \text{ cm}^2$ with a string-type strain gauge installed diagonally (combined length = $42.5 \text{ cm} \times 2 = 85 \text{ cm}$). The experiment involved applying a focused force to the center point to cause displacement in order to determine the correlation between deformation of the string-type strain gauge and the voltage value. In this experiment, an aluminum extrusion was employed as the support frame, and the acrylic specimen was clamped at the upper and lower ends. Nichrome wires were placed on top of the acrylic specimen and a securing screw on the frame was used to adjust the tension on the string-type strain gauge. A displacement compression device was installed on the support frame, and the rotating hub of this device created 1 mm of displacement for every rotation, thereby controlling the degree of deformation, as shown in Figure 6. Upon deformation, the string-type strain gauge measured the corresponding voltage value, which was collected by the signal processing circuit.

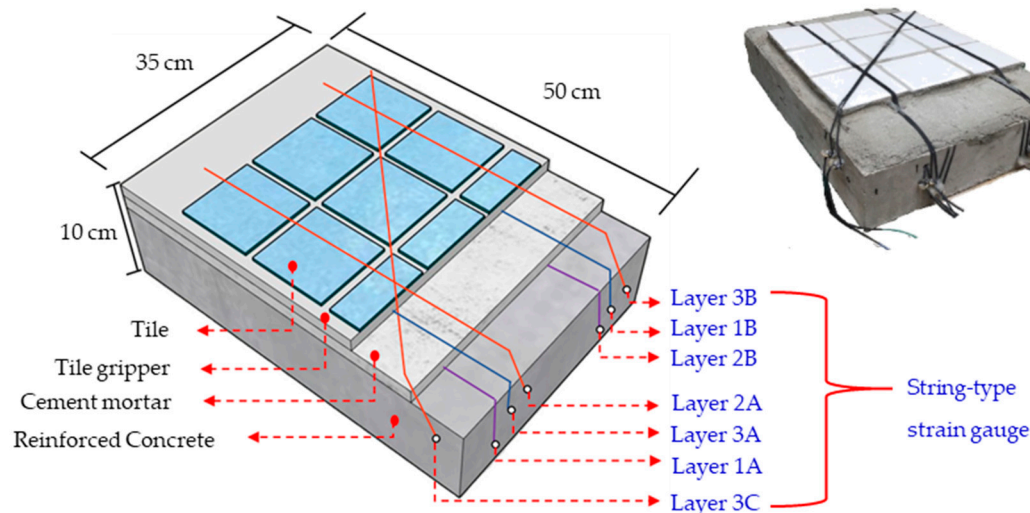
Figure 7. String-type strain gauge layout on the reinforced concrete specimen.

The string-type strain gauges were installed on the RC, cement mortar, and tile surface layers, divided into Layers 1–3. From Figure 7, the string-type strain gauge laid between the RC and cement mortar layers was designated Layer 1; the string-type strain gauge laid between the cement mortar and tile layers was designated Layer 2; and the string-type strain gauge placed on the surface of the tile layer was designated Layer 3. Layers 1A, 1B, 2A, 2B, 3A, and 3B were arranged in parallel, whereas 3C was arranged diagonally, meaning Layer 3 was arranged both diagonally and in parallel.

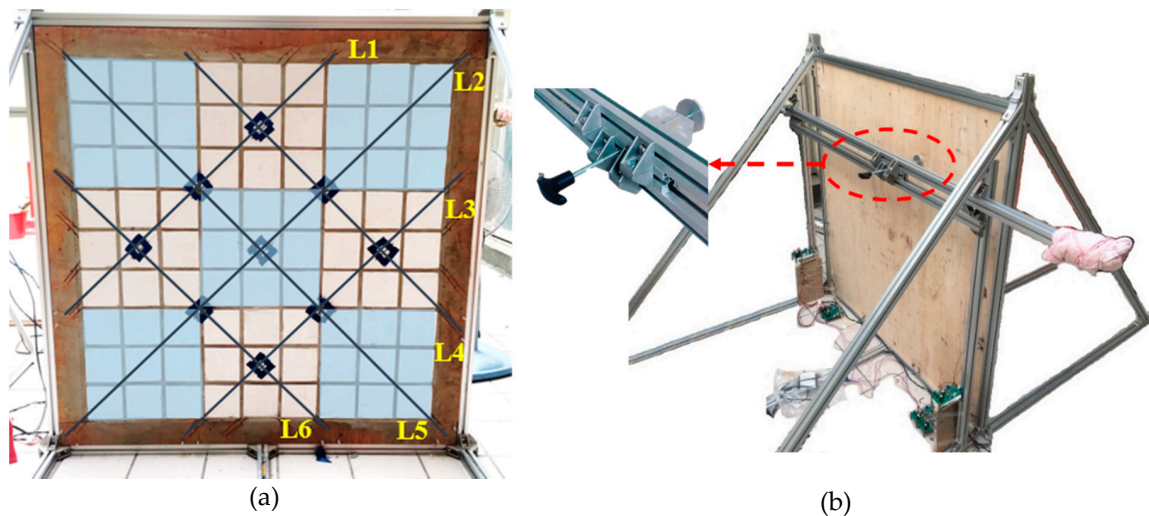
Figure 8. (a) Model imitating exterior wall tiles using a plywood specimen and (b) a displacement compression device.

Experiment C used a plywood specimen as a model for testing S4 that involved simulating an exterior wall with a tile area of $100 \times 100 \text{ cm}^2$. The tiles were laid on the plywood specimen, which measured $150 \times 150 \text{ cm}^2$, by using a resin tile gripper. Experiment A confirmed the feasibility of applying a string-type strain gauge, and Experiment B demonstrated that fixing string-type strain gauge to the surface of the tile was more economical and convenient for use with buildings. A crisscrossing design was employed to cover the largest area with the minimum amount of string-type strain gauges, with segments folded back and forth by fixing the string-type strain gauges to the same end on the back of the plywood. A total of six strain gauges (L1 to L6) were set on the 100 cm^2 tile surface, and this surface was divided into nine areas (Areas 1–9), which are visible in Figure 8a. Subsequent system designs were determined according to the nine areas. An aluminum extrusion was used as a support frame for the plywood, and a 5 cm diameter disk was used as a displacement compression device on the rear of the specimen. This device was used to alter the degree of deformation, and the compression position was adjusted by moving an aluminum pole on which the device was fixed. The displacement caused by the device was 1 mm per rotation, as in Experiments A and B (Figure 8b). After deformation of the exterior wall, the voltage values generated by the string-type strain gauges were processed by a signal processing circuit and then converted by the DAQ and input into a computer.

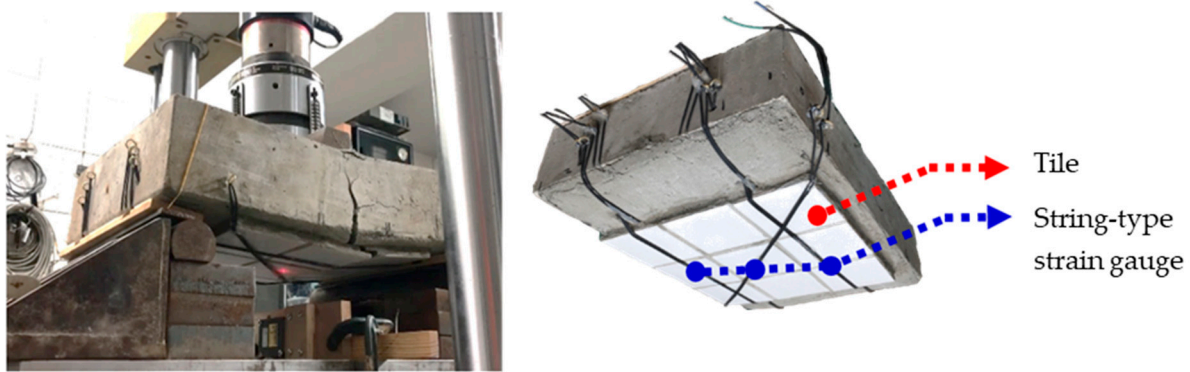
Figure 11. Compression test that used the MTS to apply force on the back of the specimen.

In Experiment B, using an RC specimen, a 250-kN MTS (No. 318.25, MTS Systems Corporation, Eden Prairie, MN, USA) was employed to compress the specimen and generate displacement. The use of an MTS is common in displacement tests for RC [14,15] because deformation is generally a long-term process, and the use of an MTS, which forces protrusion, can shorten the required time. Displacement was measured using a laser displacement sensor to verify the feasibility of using string-type strain gauges on the exterior walls of buildings, and the optimal laying level was identified by comparing the experimental values with the theoretical values. The string-type strain gauges were laid in three layers—the concrete, cement mortar, and tile layers (Layers 1–3, respectively)—with seven gauges across the three layers. As in Experiment A, force was applied to a single point on the back of the specimen using the MTS (Figure 11), at displacement values of one–10 mm, and the voltage values of the seven gauges were measured simultaneously during the compression process, providing seven sets of values for polynomial regression. Each gauge had 11,992 measurements. The seven regression curves are presented in Figure 12a, and reliability was indicated by an $R^2 > 0.98$. Subsequently, the performance of the string-type strain gauges across the three layers was compared and analyzed. A string-type strain gauge comprises a fine wire, which makes it convenient for laying on the surface of a tile during construction and maintenance. Consequently, the wiring method in Layer 3C was the optimal design, because its polynomial regression equation was $y = 0.0419x^2 - 0.0965x + 0.0444$,

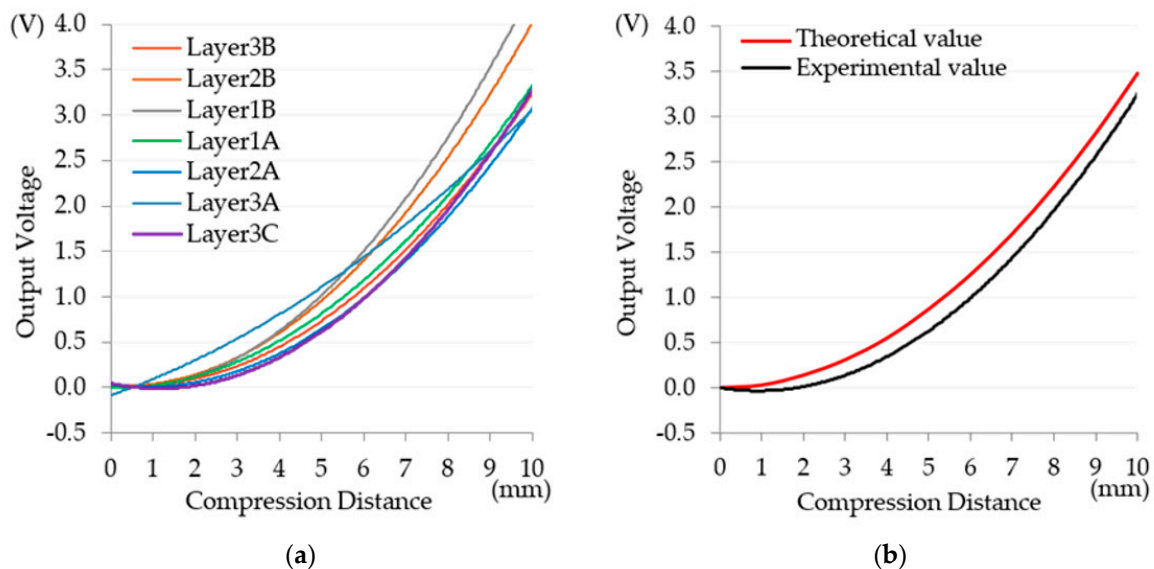
Figure 12. (a) Result analysis for Experiment B and (b) comparison between theoretical values and experimental values of Layer 3C.

and its R^2 was 0.9972. Comparisons between the theoretical and experimental values showed that the trend for the compression distance was consistent with the voltage values, with the difference between the two curves being almost equidistant, indicating that the results have a certain degree of validity (Figure 12b).

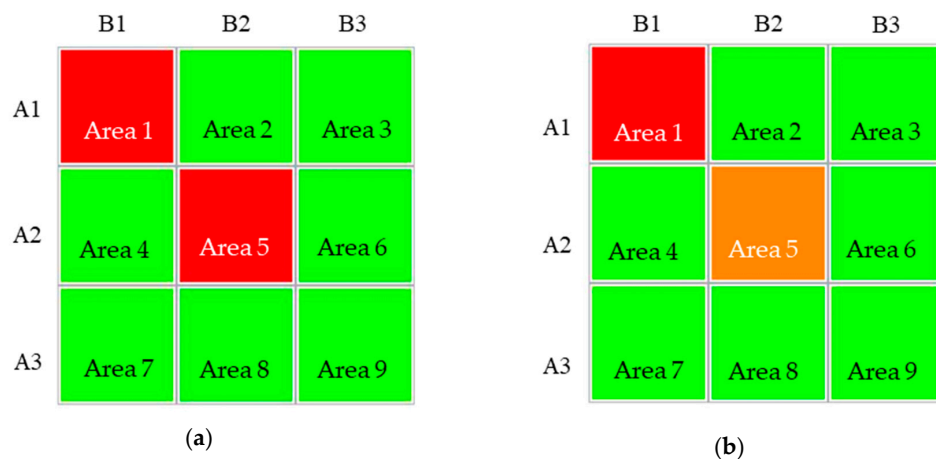
Figure 13. Warning areas judgment logic. (a) First Step; (b) Second Step.

Fuzzy theory was used as the foundation for the design of S4, wherein the measured voltage value was transmitted to the computer, and the fuzzy theory was applied to determine the location from which deformation or deterioration occurred. One study used LabVIEW for software control of complex devices and DAQ to perform laser imaging [17]. In the present study, LabVIEW (LabVIEW 2015, National Instruments, Austin, TX, USA) was employed as the human-machine interface for S4 that can be used by relevant personnel for monitoring. S4 conducts location judgment and hazard warning by determining the relative magnitude of the voltage value, and colors are displayed on the system to distinguish the relative risk. For example, S4 first uses green to indicate a safe area and red a dangerous area, after which it delineates green as low-risk areas, orange as moderate-risk areas, and red as high-risk areas. The system then investigates the relationship between these locations. The experiment was conducted according to the 10 preset deformation points. As illustrated in Figure 13a, more than one hazard area was identified because the values calculated were relatively high during the first round of judgment by S4. If the system revealed two red hazard areas but only a single compression test was performed in the upper-left corner of Area 1, which may be due to inaccuracy caused by change in the string-type strain gauge or large damage intervals for the numerical values. According to the logic of the system, a second-step judgment is conducted based on the correlation values between the locations to more accurately determine the hazardous areas. The method involves adding up the connected areas (intersected horizontally and vertically) in each area and arranging the rows (A1, A2, and A3) and columns (B1, B2, and B3) into nine squares. Take A1 and B1 as examples; A1 represents the sum of the values of Areas 1, 2, and 3, and B1 represents the sum of the values of Areas 1, 4, and 7. Take Area 1 as another example; Area 1 is the sum of the values of row A1 plus column B1 (Areas 1, 2, and 3 + Areas 1, 4, and 7). Larger values are normally caused by the fuzzy theory or abnormal voltage values. The most hazardous areas are more accurately presented after the first and second steps have been taken (Figure 13b).
