The Mechanical Properties of Reinforced Concrete Plate-Girders when Placed Under Repeated Simulated Vehicle Loads

Jinquan Zhang, Pengfei Li *, Yan Mao and Zhenhua Dong

Research Institute of Highway, Ministry of Transport of the People's Republic of China, Beijing 100088, China; rih_jqzhang@163.com (J.Z.); Y.mao@rioh.cn (Y.M.); dongzhenhua2009@126.com (Z.D.)

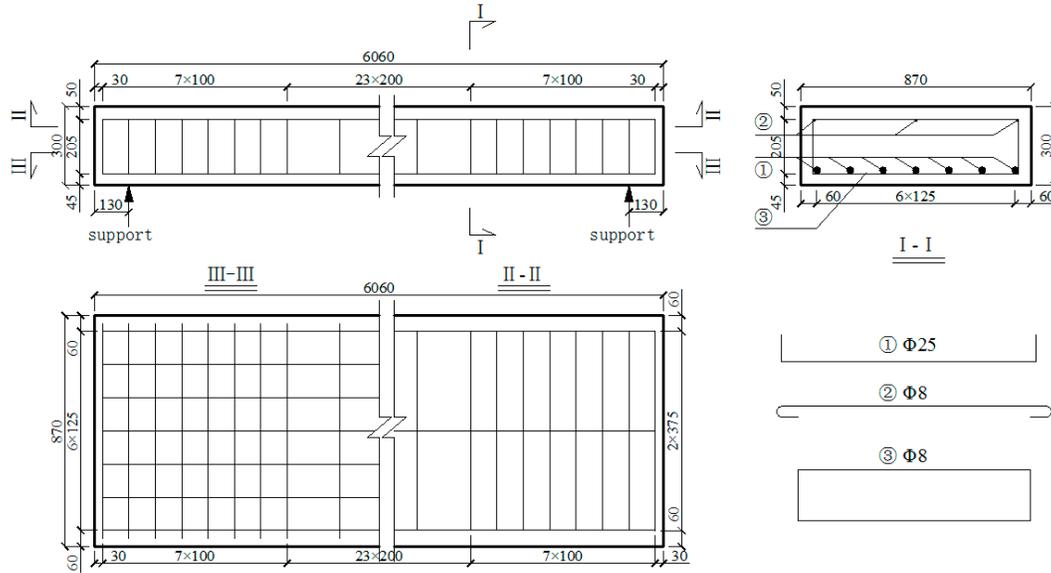
Figure 1. Specimen size and reinforcement drawing (mm).

Three full-scale prototype concrete plate-girders with a length of 6 m were designed according to the general principles presented in Highway Bridge and Culvert Standard Drawings (1973–1993), named as Beams-1–3. The dimensions of the test specimens are shown in Figure 1. C50 concrete material was used in the design of the beam members and the average experimental compressive strength of standard concrete cubes was 56.8 MPa. Seven lengths of HRB400 rebar with an ideal yield strength of 400 MPa and a diameter of 25 mm were set evenly along the bottom of the concrete plate-girders. The measured tensile yield strength and the ultimate tensile strength of the steel rebar were 436 MPa and 634 MPa, respectively. HRB335 round rebar with an ideal yield strength of 335 MPa and a diameter of 8 mm was used for the stirrups, and a spacing of 100/200 mm was employed. The measured tensile yield strength and the ultimate tensile strength of the stirrups were 359 MPa and 527 MPa, respectively. Three HRB335 longitudinal bars with a diameter of 8 mm were placed at the top of the beams, and the thickness of the protection layer was 45 mm. In order to simulate the effect of actual vehicle load on the beams and determine the loading scheme of the tests, a two lane bridge with a width of 8 m and a span of 6 m was designed using the concrete plate-girders, and the calculated span l_0 was equal to 5.7 m, as shown in Figure 2.

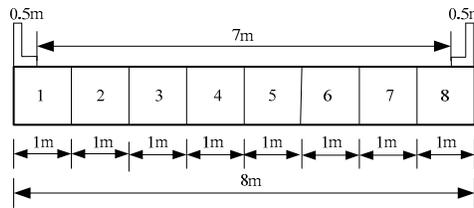
Figure 2. Bridge cross section layout.

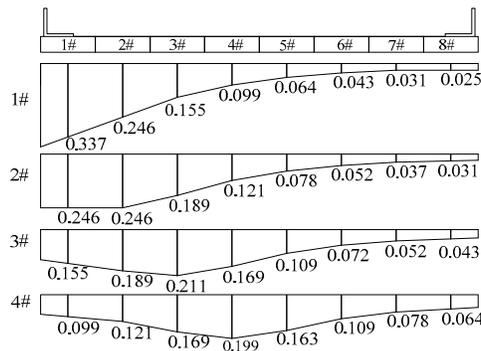
Figure 3. Horizontal distribution coefficient influence line.

The influence curve of the transverse distribution coefficient of the 1#–4# beam specimens is shown in Figure 3.

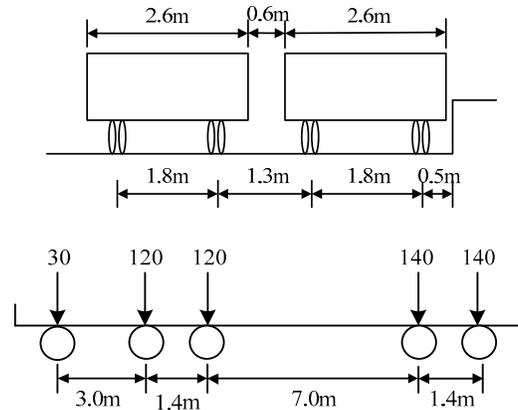
Figure 4. The vehicle load arrangement (kN).

According to provisions stated in the General Specifications for the Design of Highway Bridges and Culverts (JTG D60-2015), the transverse and longitudinal arrangements of highway grade I vehicle load is shown in Figure 4. The maximum load affecting the middle span of each beam under the action of rear axles was calculated on the basis of both of the influence curve of the transverse distribution of beams and the transverse arrangement of vehicle loads. Assuming that the transverse connections between the beams are intact, and the vehicle loads are arranged along the outermost sides. In this case, the maximum equivalent load acting on Beam-2 is 77 kN. In order to simulate the effects of actual vehicle loads on bridges, the amplitudes of cyclic loadings were set as 77 kN, 97 kN, and 121 kN in order to assess the performances of the beams at 1.0, 1.25, and 1.6 times of the highway grade I vehicle load, as listed in Table 1.

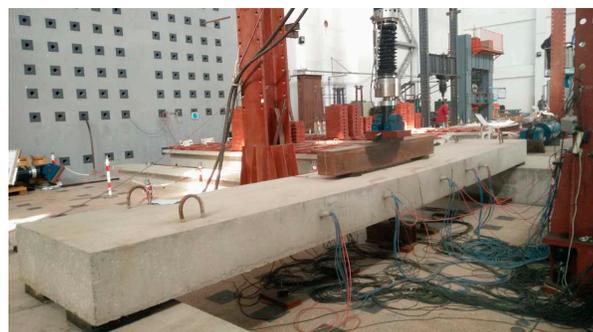
Figure 5. Diagram of loading device.

In order to achieve a pure curved section in the middle portion of the beam specimens, and to simulate the actual axle action of a vehicle equivalent to a highway grade I vehicle load, the forces were loaded using distributive beams with a spacing of 1.4 m. Ordinary plate rubber bearings were set at both ends of the test specimens, as shown in Figure 5. A series of vertical cyclic loading tests was conducted using a hydraulic jack.

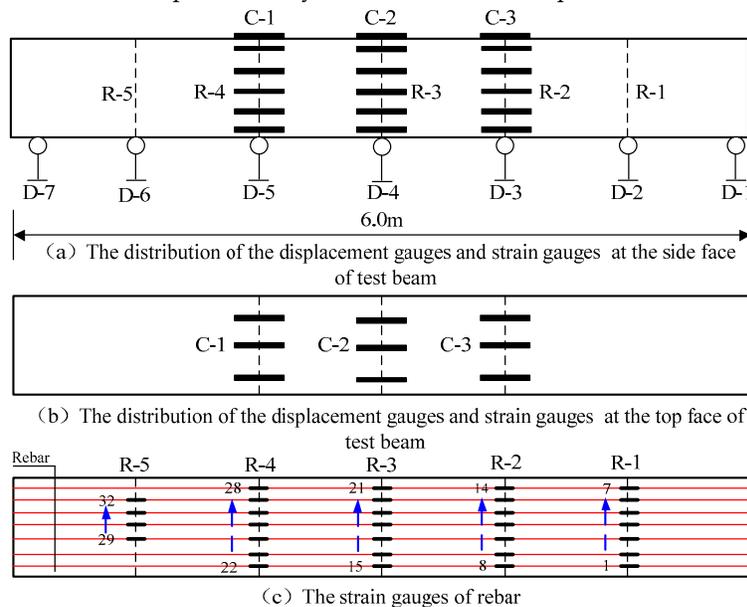
**Figure 6.** Diagram of the measuring scheme and measuring point layout.

In order to measure deflection at different positions along the beam span, displacement meters were installed at the middle span, the loading point, at the one-sixth span position, and at both ends of the beams. Additionally, concrete strain gauges were arranged along the perimeter of the beam sections, at both the middle span and the loading point of the test beam, in order to measure the concrete strain. Strain gauges were also arranged on seven of the lengths of longitudinal rebar in order to measure the strain experienced by the rebar in different positions, as shown in Figure 6.

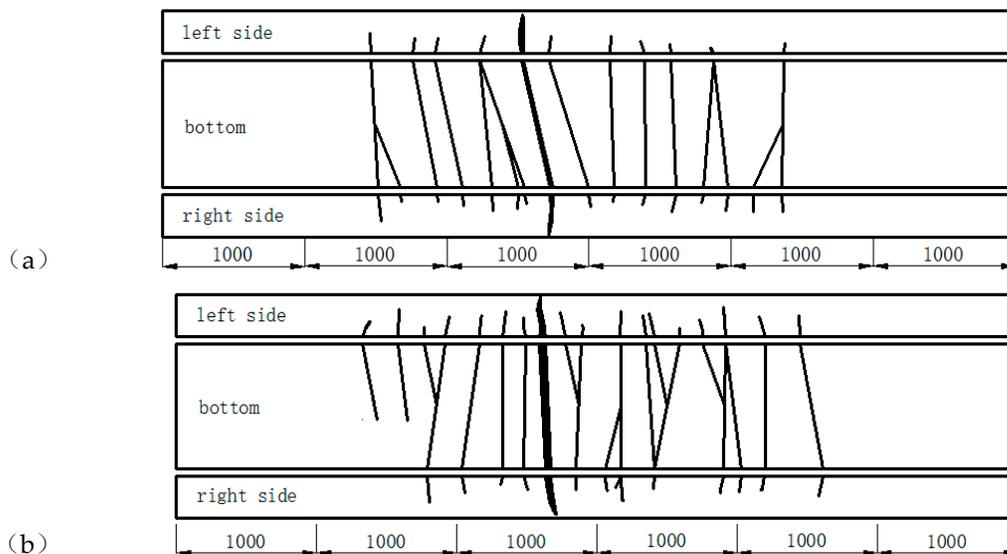
Figure 7. The collapse state of (a) Beam-2 and (b) Beam-3 (mm).

600,000 times, with the beam continuing to remain in the crack stability stage. Finally, a dominant crack in the beam span suddenly extended and widened when the 650,147th cycle was achieved, resulting in a fracture in the beam specimen. At this point, the beam underwent a sudden, major deformation and lost its bearing capability due to the ruptures of the five rebar steels in the bottom of the beam. The concrete in the compression zone was raised, accompanied by shedding.

Similar behaviors occurred when Beam-3 reached the 10,000th load cycle but in this case the height of the cracks that developed along the side faces were larger. Beam-3 reached the crack stability stage between loadings of 100,000 times to 300,000 times. However, when the load cycles reached 377,240 an abrupt fracture occurred due to the rupture of the rebar in the bottom of the specimen. This rupture occurred without obvious precursors. Easily identifiable fatigue failure characteristics can usually be found on the fracture surface of the rebar, but in this case no necking phenomenon was observed. The limit failure modes of Beam-2 and Beam-3 are shown in Figure 7. Excluding the main cracks, there was little variation in the width of the additional cracks in Beam-2 and Beam-3. Before the overall fracture of the beam specimens occurred, the maximum residual crack width was about 0.08 mm.

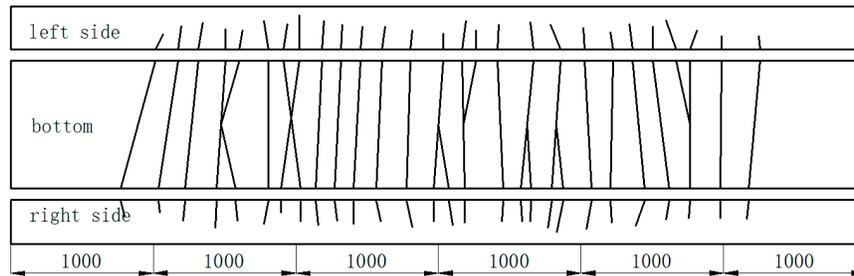
Figure 8. Beam-1's crack distribution (mm).

No fractures occurred in Beam-1 after 2,000,000 loading cycles with a maximum loading force of 77 kN. At the base of the beam, the penetrating cracks were distributed uniformly along the length of the beam. The cracks also extended up to half of the height of the web, with a spacing of 20 cm. The cracks tended to close up following the unloading stage, with a maximum crack width of 0.1 mm. When adjacent to the middle part of the beam, residual crack widths were generally less than 0.08 mm. Throughout the cyclic loading process, the crack development of Beam-1 could be divided into the rapid development stage, the slow development stage, and the stable stage. The final condition of Beam-1 and its crack distribution is shown in Figure 8. In this instance, all of the cracks occurred when the load cycle had been performed 100,000 times. Beam-1 displayed more cracks than Beam-2 and Beam-3, with most of the cracks located 10 cm below the beam height. A new crack occurred at the end of the beam, on both sides, when the load cycling had been performed 1,000,000 times. The crack developed gradually, spreading up the beam and reaching about half the overall height of the beam. The number, height, and width of the cracks did not increase when the number of loadings increased from 1,000,000 times to 2,000,000 times.

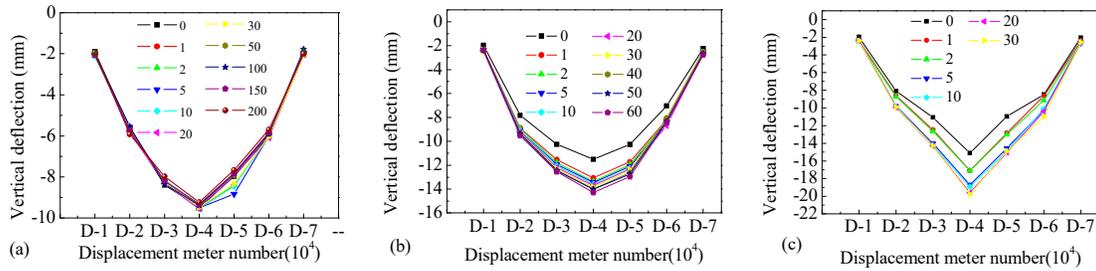
Figure 9. The deflection changes of (a) Beam-1, (b) Beam-2, and (c) Beam-3.

The deflection curves of the different measuring points along the span of Beam-1, Beam-2, and Beam-3 under different cyclic loads of varying amplitudes are shown in Figure 9. For the test of Beam-1, the maximum mid-span deflection was 9.56 mm after 2,000,000 loading cycles, and no obvious change in vertical deflection was detected along the span as the loading cycles increased. The maximum mid-span deflection was only 1.5% higher than the deflection caused by the initial static load, indicating that the beam was basically in an elastic stage. For Beam-2, the vertical deflection that occurred at different positions along the beam span under peak static load was significantly higher than the deflection that occurred under the initial static load. For Beam-2, the mid-span deflection increased by 13.7% after 10,000 loading cycles. From this point the deflection increased slowly, and vertical deflection increased by 20.4% compared with the initial static load after 300,000 cyclic loading cycles. A brittle fracture failure occurred in the mid-span of Beam-2 when the loading cycle reached 650,000. When Beam-2 had experienced 600,000 loading cycles, the mid-span deflection under the peak load was 14.3 mm, 24.5% higher than the deflection that occurred under the initial static load. The deflection–span ratio was about 1/420.

Beam-3 displayed similar variation in vertical deflection to that of Beam-2. The mid-span deflection under peak loading was 13.6% higher than the deflection under the initial static load when the loading cycle had been repeated 10,000 times. The vertical deflection of the mid-span increased suddenly and obviously after 50,000 cyclic loadings, and the maximum deflection of the mid-span increased by about 23.8% compared with the initial value. The mid-span deflection was 19.75 mm, which is 30.8% higher than the initial static load after 300,000 loading cycles, and the deflection–span ratio of the beam was about 1/300. Finally, a brittle fracture failure occurred in the

span of Beam-3 after to 370,000 loading cycles. During the entire cyclic loading process, the deflection of Beam-2 and Beam-3 increased nonlinearly with the increase in loading cycles, indicating that the damage to the beam accumulated gradually under repeated vehicle loads, while the stiffness of the members lessened.

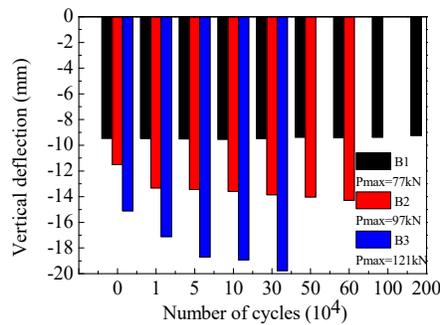
Figure 10. A comparison of maximum mid-span deflection across different cycle times.

The vertical deflection of the different beams’ mid-span under a range of loading cycles is shown in Figure 10. When the overload effect is not considered, Beam-1 was able to survive 2,000,000 cyclic loads. The deflection of Beam-1 was essentially stable as the cycles increased, and there was no serious or irrecoverable deformation. For the destructive tests of Beam-2 and Beam-3, the vertical deflection of each section underwent the process of increasing–stabilizing–brittle failure with the increase in cycles. The deflection stability stage was the same as the fatigue damage process of the tensile rebar at the bottom of the beams. In addition, the deflection development of Beam-3 was significantly faster than that of Beam-2, indicating that a more serious cumulative damage can be achieved by increasing the amplitude of the cyclic loadings. Therefore, the repeated actions of overloaded vehicles can increase the deformation of concrete beams, and accelerate the development of internal damage. The higher the proportion of overload is, the more obvious this trend.

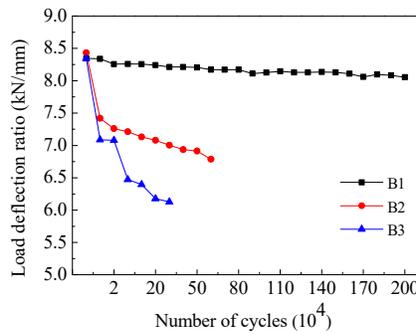
Figure 11. The load deflection ratio of test beams.

Bending stiffness is one of the most important indicators used to characterize the performance of reinforced concrete beams. The deflection analysis shows that the stiffness of the test beams decreased gradually with the increase of load cycles. In the test, the bending stiffness of the beam can be reflected by the load–deflection ratio of the mid-span section under different loading cycles, as shown in Figure 11. For the test of Beam-1, the load–deflection ratio curve decreases slowly, indicating that the bending stiffness of the beam decreased slightly with the increasing cyclic loading, and the bending stiffness of the beam decreased by 4.4% compared with the maximum value after 2,000,000 cycles. For Beam-2, the load–deflection ratio decreased rapidly after 10,000 cycles, and then decreased gradually until the final failure stage, indicating that the bending stiffness of the beam decreased gradually with the increase in loading cycles; after 60,000 cycles the stiffness was 48.7% lower than the initial stiffness. For the test of Beam-3, the load–deflection ratio maintained a relatively fast descent rate during 50,000 cycles, and the descent rate slightly decreased during 50,000 to 300,000 cycles but was still higher than that of Beam-2. The ultimate bending stiffness of the Beam-3 following 300,000 cycles was 55.4% lower than its bending stiffness under the static load.

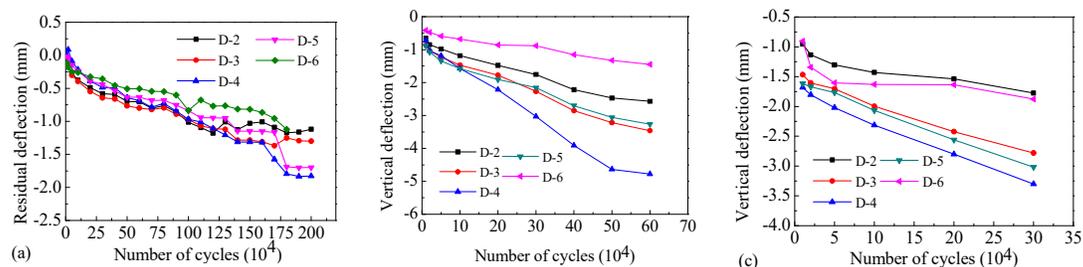
Figure 12. Residual deflection trend of (a) Beam-1, (b) Beam-2, and (c) Beam-3.

The development of the internal damage done to the beams directly corresponds with residual deflection. The residual deflection curves along the key sections of Beam-1, Beam-2, and Beam-3 after different loading cycles are shown in Figure 12. For the test of Beam-1, under a vertical load amplitude of 77 kN, the residual deflection increased linearly and slowly along the different positions of the span with the increase in the number of loading cycles, and the residual deflection decreased gradually from the mid-span to both ends. At 2,000,000 loading cycles, the maximum residual deflection of section D-4 was 1.8 mm, and the maximum residual deflection was 19.5% of the absolute deflection. For the test of Beam-2, under a vertical load amplitude of 97 kN, the vertical residual deflection along the different positions of the span increased significantly with the increase in loading cycles. After 300,000 loading cycles, the maximum residual deflection of the mid span section was 3.0 mm, which accounted for 21.6% of the absolute vertical deflection. After 600,000 loading cycles the maximum residual deflection of the mid span section was 4.8 mm, which accounted for 30.75% of the absolute vertical deflection. For the test of Beam-3 with a vertical load amplitude of 121 kN, the variation trend of the vertical residual deflection was similar to that of Beam-2. The residual deflection increased rapidly with the increase in the number of loading cycles. After 300,000 loading cycles, the maximum residual deflection in the middle span was 3.3 mm, which accounts for 18.5% of the absolute vertical deflection.

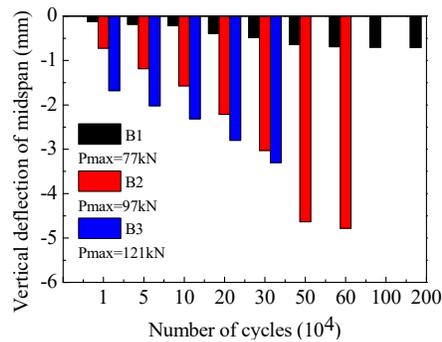
Figure 13. A comparison of the maximum mid-span residual deflection across different cycle times.

The comparison of mid-span maximum residual deflection for the different test beams under a range of loading cycles is shown in Figure 13. Our results indicate that residual deflection increased with the increase of the vertical load amplitude over the same amount of cycles, and that the overload ratio influences the beam's degree of cumulative damage.

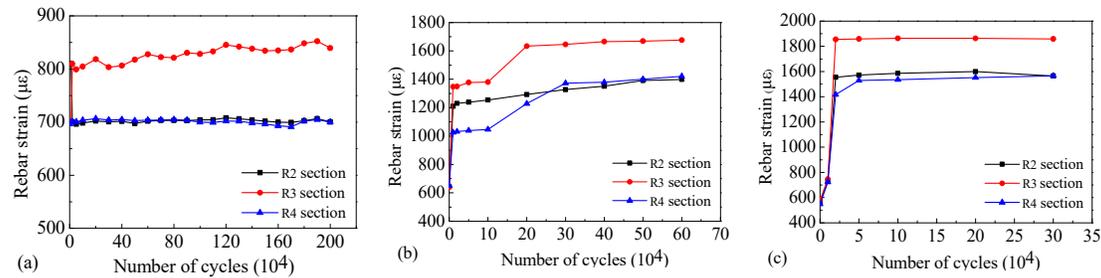
Figure 14. The strain variation trend of the rebar in (a) Beam-1, (b) Beam-2, and (c) Beam-3.

During the cyclic loading process, the average strain on the rebar and concrete in a section of the beam was taken to be representative of the corresponding strain in that section. The variation trend displayed by the average longitudinal reinforcement tensile strain and the average concrete compressive strain along the different sections of the beam span are shown in Figures 14 and 15. The maximum tensile strain of the longitudinal reinforcement in Beam-1 was $855.1 \mu\epsilon$, and the strain on the rebar did not alter significantly with an increase of loading cycles. The rebar in Beam-1 did not reach yield strain throughout the entire testing process. The maximum tensile strain of the longitudinal reinforcement in Beam-2 was $1765.3 \mu\epsilon$, which underwent several stages of development, including sudden increase–stable–accelerated growth–stable strain development with the increase of loading cycles. The maximum tensile strain of the longitudinal reinforcement at mid-span in Beam-3 was $1858.7 \mu\epsilon$, which underwent sudden strain increase and stable strain development with the increase of loading cycles.

According to our observations, the sudden increase in the strain on the bottom tensile rebar corresponds with the generation and rapid development of the cracks in the concrete beam. The stress is gradually transferred to the rebar as the concrete slowly develops cracks. The rebar was forced to bear the cyclic loads when the cracks developed completely. At this stage, the strain on the rebar entered the stable development stage under static load with a stable peak load. The strain on the rebar underwent a smaller increase under the same load because in this case the damage to the rebar had not yet developed. Until the fatigue fracture of the rebar occurred, the maximum strain in the rebar did not reach yield strain.

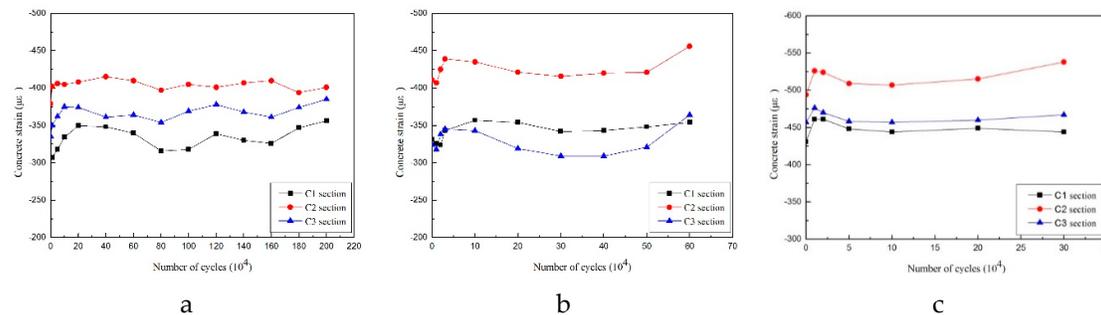
Figure 15. Variation trend of compressive strain on concrete of (a) Beam-1, (b) Beam-2, and (c) Beam-3.

Figure 15 shows the variation in the maximum compressive strain on the concrete at the compressive edge of the top of the test beam. The maximum strain was the average strain at the compressive edge of the concrete when the static load reached its maximum value after a specific number of cycles.

During the initial loading stage, when the number of cycles was below 50,000, the concrete's strain grows rapidly. As the cracks develop it gradually enters the stable stage. In the second stage, when the number of cycles was between 50,000 and 90% of the total number of loading cycles, the compressive strain growth of the concrete was small and the cracks also entered the stable development stage. In the third stage, when the number of cycles was more than 90% of the total number of loading cycles, the compressive strain of the concrete entered an ascending stage, ultimately leading to the failure of the specimens. The strain of the concrete at the compressive edge of the top of the beam did not reach yield strain during the entire loading process. The mechanical behavior of the concrete beams under cyclic loading is largely determined by the presence of tensile steel bars.

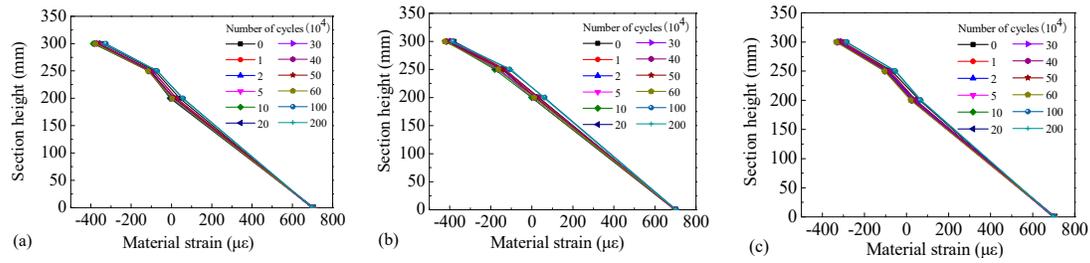
Figure 16. Strain distribution of Beam-1 of (a) section C-1, (b) section C-2, and (c) section C-3.

longitudinal reinforcement tensile strain in the same section were measured, and their distribution along the section height of the beams is shown in Figures 16–18.

It can be observed that the strain distribution of the concrete across different sections of the test beams possessed linear characteristics, which conforms to the plane section assumption. After 10,000 loading cycles the position of the neutral axis increased compared with the initial static load, and the position of the neutral axis was seen to increase slowly as the number of cycles rose. Because Beam-1 was in an elastic state during the loading process, the rebar's strain under different cyclic cycles remained stable. However, due to a gradual accumulation of residual strain in the rebar during the testing process, the performance of Beam-2 and Beam-3 were gradually degraded, and the strain on the rebar increased gradually during different loading cycles. Our results indicate that the fatigue damage experienced by the steel bars was small and the functional performance of the beams remained stable under the repeated action of standard vehicle loads. However, when subjected to the repeated action of overloaded vehicles the damage to the rebar accumulated quickly and their performances degenerated significantly, leading to the early fatigue failure of the beams.

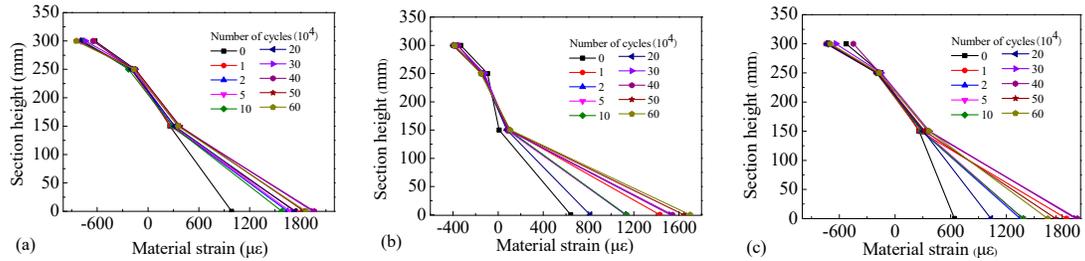
Figure 17. Strain distribution of Beam-2 of (a) section C-1, (b) section C-2, and (c) section C-3.

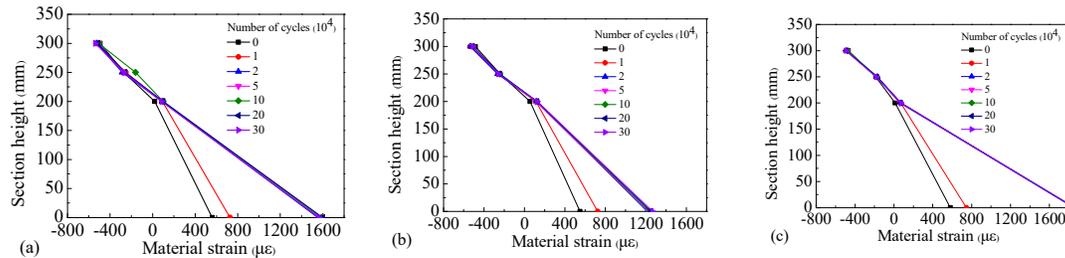
Figure 18. Strain distribution of Beam-3 of (a) section C-1, (b) section C-2, and (c) section C-3.

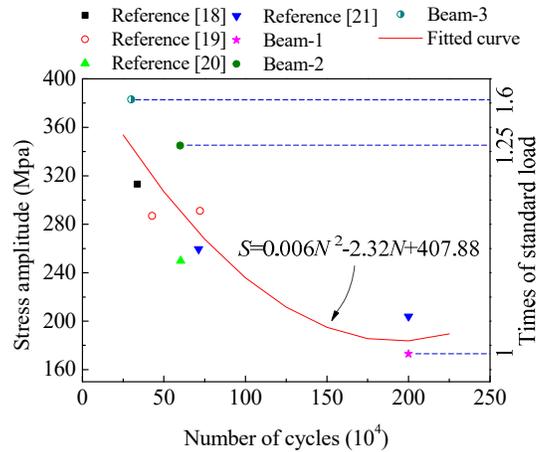
Figure 19. Fitting life-overload proportion curve of reinforced concrete beams.

Based on our analysis of the fatigue test results for reinforced concrete beams, data with similar conditions were selected. The fatigue life data of different specimens under different stress levels as stated in reference [18–21] are shown in Figure 19. The stress amplitude–number of cycles (S–N) curve of ordinary reinforced concrete beams can be obtained by fitting these data, and the stress amplitude (S) can be calculated as,

$$S=0.006N^2-2.32N+407.88 \quad (2)$$

where N is the number of cycles. Therefore, the relationship between the vehicle loads and the number of cycles can also be deduced from the results of this study. For example, when the vehicle load was 1.25–1.6 times the standard load, the number of cyclic loads experienced by the concrete beams was between 200,000–750,000.
