Article

Assessment of the Condition of Wharf Timber Sheet Wall Material by Means of Selected Non-Destructive Methods

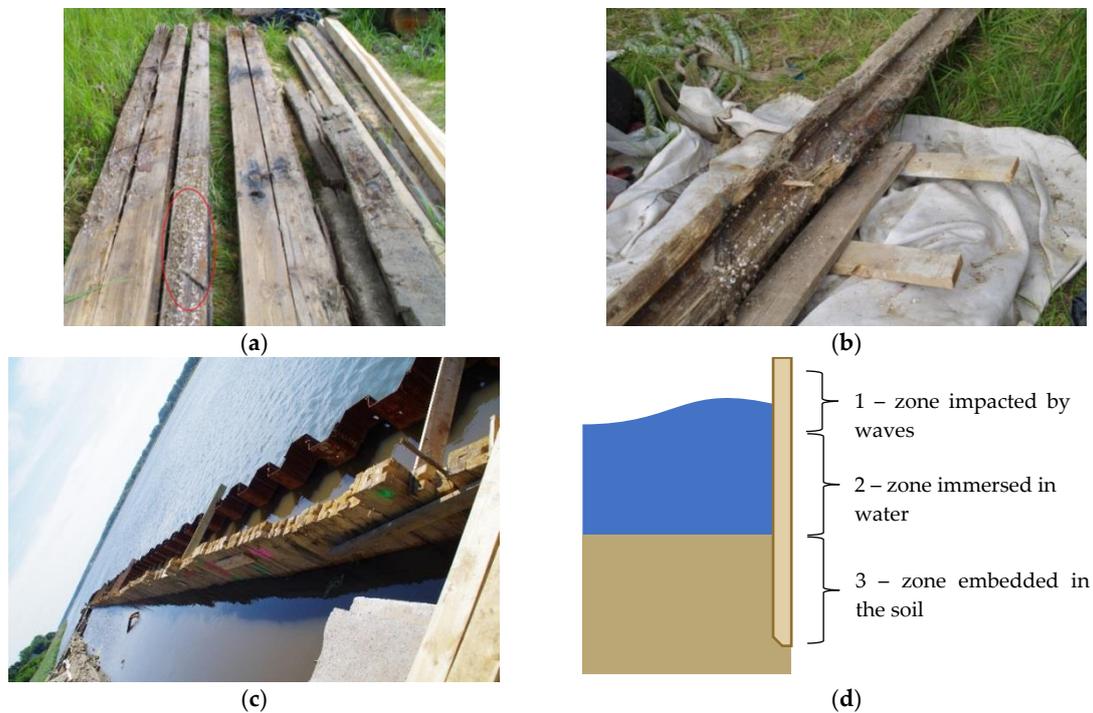
Figure 1. (a,b) View of wharf timber sheet pile wall from which samples were taken for testing (the zone impacted by waves is marked with red ellipse); (c) view of rebuilt wharf timber sheet pile wall; (d) scheme of the global structure with the location of the specimens.

in the ground, under the groundwater table, has preserved its constant volume. Bacteria destroy the cellulose very slowly, while the lignin remains constant, and water replaces the large cellulose molecules. The original waterfront layout has been reconstructed, see Figure 1c.

The main objective of the work is to develop a methodology for testing of wooden structural members using non-destructive techniques. This is aimed at obtaining information which is necessary to assess the technical condition of the material in wooden members and to conduct a global structure analysis. In particular, to carry out such analysis, it is required to estimate the values of mechanical parameters and to assess possible zones of destruction. The detailed aim is to compare the quality of wood subjected to various environmental conditions (Figure 1d).

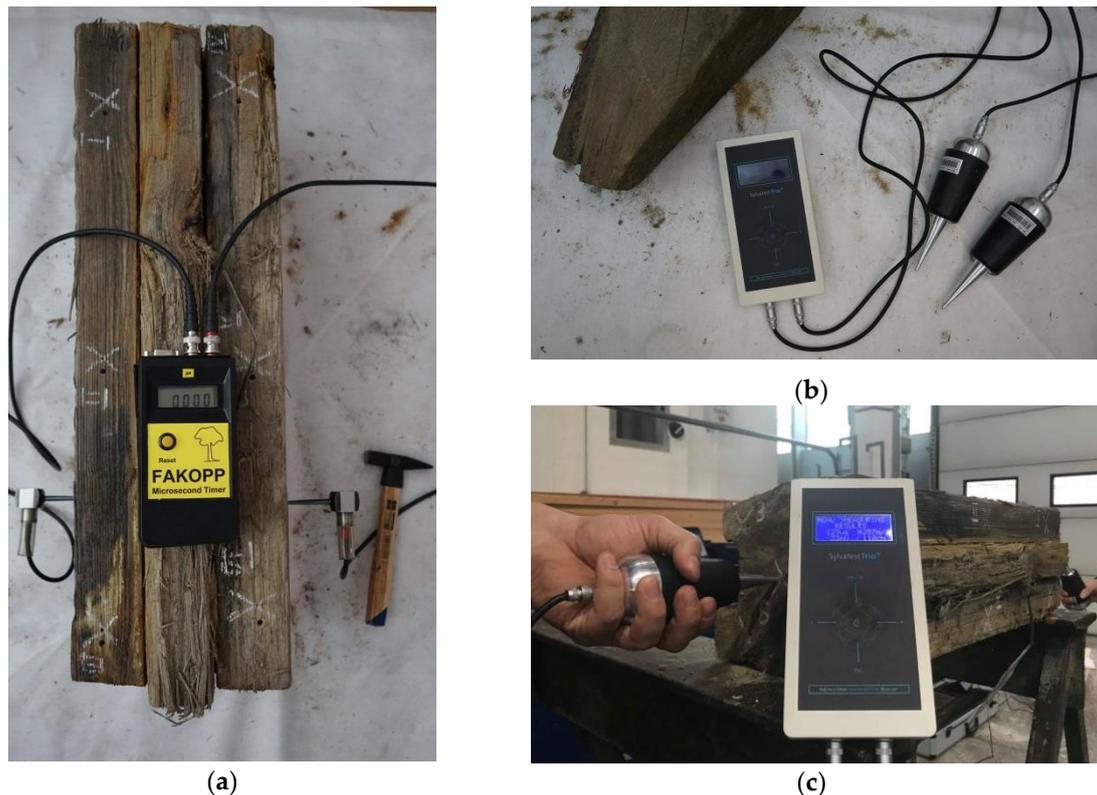
The Fakopp Microsecond Timer (Figure 2a) uses the stress wave technique. The test consists of exciting a stress wave with a single strike of a special hammer. The device probes are driven directly into the tested sample. There is no need to drill holes as in the case of other devices (e.g., Sylvatest Trio). The device measures the time of wave propagation between the two probes (the receiving probe and the transmitting probe).

Figure 2. Devices for testing by acoustic method: (a) Fakopp Microsecond Timer using stress wave; (b) Sylvatest Trio device using ultrasonic wave; (c) Sylvatest Trio device during test.

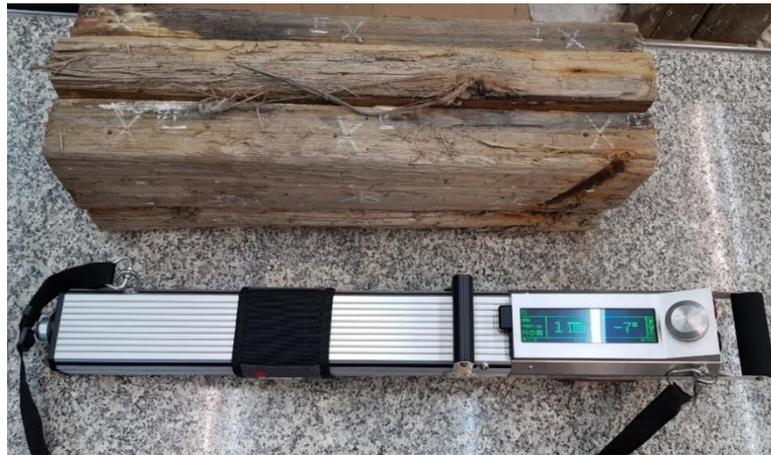
The test consists of measuring the energy needed to drill the resistance drilling device's metal needle into the material. The test makes it possible to detect structural discontinuities, damage, knots and other flaws and also to estimate the density and strength of the material [22]. The device measures the drilling resistance of a drill with a diameter of 1.5–3.0 mm and a length of 300–500 mm, rotating at a constant speed of about 1500 rpm (Figure 3).

Figure 3. IML RESI PD-400S device used in tests.

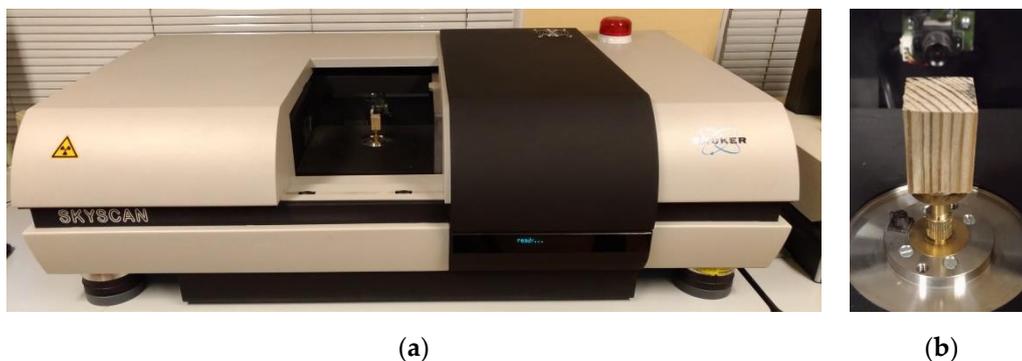
X-ray micro-computed tomography (Skyscan 1172, Bruker, Kontich, Belgium) is a state-of-the-art non-destructive technique for visualizing the inner structure of the tested object [36,37]. In essence, the tests consists of mathematically reconstructing the three-dimensional microstructure of the tested material on the basis of a series of high-resolution X-ray pictures. The scanning consists of recording a series of projections taken during the slow rotation of the sample placed on the scanner's rotary fixture [38]. The Bruker SkyScan 1172 microtomograph used in the tests and a view of a sample placed in the scanning chamber are shown in Figure 4 below.

Figure 4. (a) Bruker SkyScan 1172 device; (b) sample of timber mounted on stage inside scanning chamber.

The samples were scanned in the Bruker SkyScan 1172 device (Figure 4a). The same set of scanning parameters was used for each of the samples in order to ensure identical scanning conditions. The selected major scanning parameters are summarised in Table 4 below.

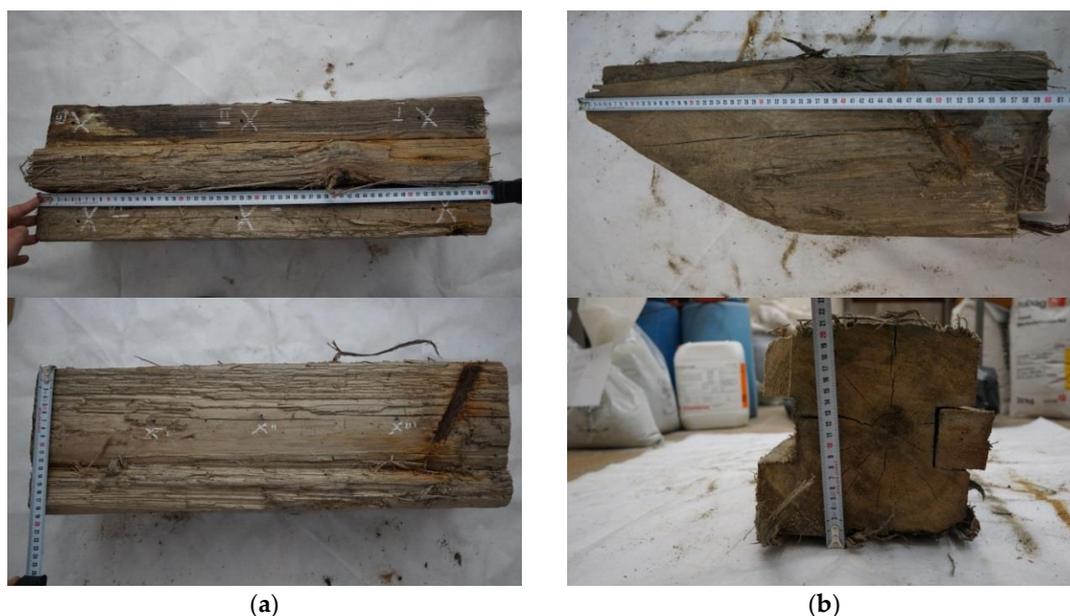
Using the testing methods and devices described in Section 2, a series of tests were carried out on samples taken from the wharf timber sheet wall. The samples dimensions were about 18 cm × 20 cm cross-section and 60 cm length (Figure 5). The samples come from different locations in the wharf structure, which means that in the course of their service they were submerged to different levels and exposed to the variable impact of water. The material of the samples is pinewood (*Pinus sylvestris* L). The tests were carried out in a laboratory at Wrocław University of Science and Technology.

Figure 5. Samples and their dimensions: (a) sample 1 cross section 18 cm × 20 cm and length 60 cm, (b) sample 3 cross-section 18 cm × 20 cm and length 60 cm with cut.

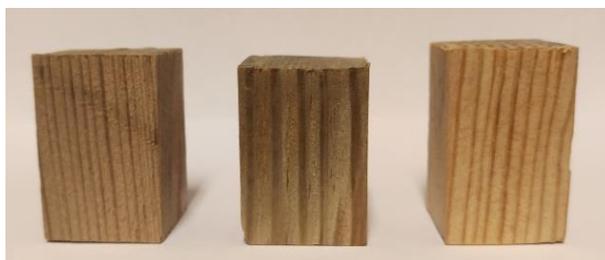
- “1” a portion of timber from the zone impacted by waves—a sample with c.a. 20 mm × 20 mm × 30 mm dimensions,
- “2” a portion of timber from the zone submerged in water—a sample with c.a., 20 mm × 20 mm × 30 mm dimensions,
- “3” a portion of timber from the zone sunk in the ground—a sample with c.a., 20 mm × 20 mm × 30 mm dimensions.

Figure 6. Samples prepared for scanning: “1”, “2” and “3” (from left to right).

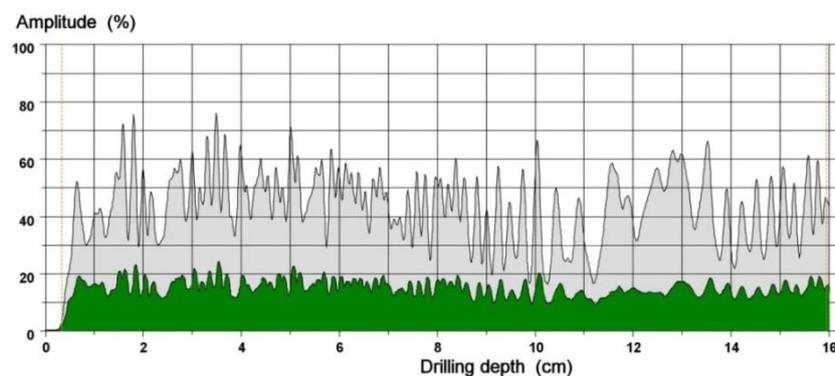
Drilling resistance tests were carried out on 3 samples with a moisture content of $18 \pm 1\%$. Twenty measurements were performed on each of the samples. An exemplary drilling resistance curve and a feed force curve are shown in Figure 7. The depth to which the biological corrosion of the wood extends (3 mm in this case) can be easily read off the diagram. The drilling resistance test results for the particular samples are presented in Tables 6 and 7.

Figure 7. Exemplary drilling resistance curve (green) and feed force curve (grey).

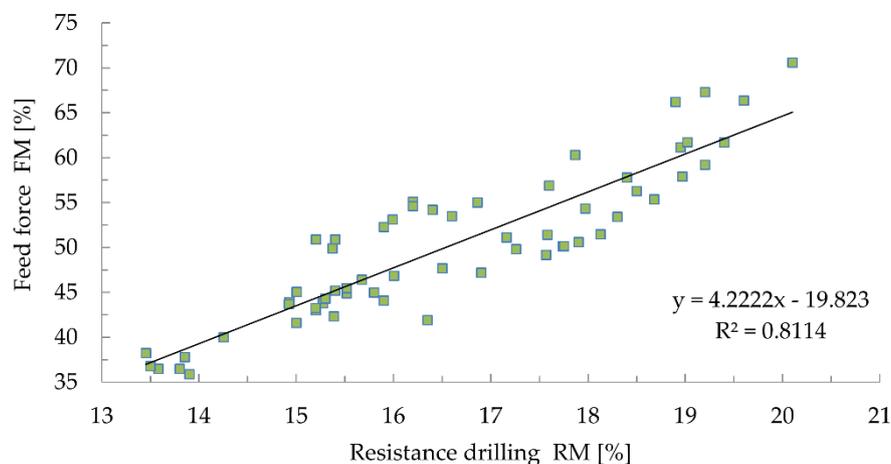
Despite the quite good correlation (Figure 8) between drilling resistance and feed force ($R^2 = 0.8114$), no correlation between these quantities and density was found (Figures 9 and 10), which casts doubt on the correlativity between them [32,46]. The results obtained using the drilling resistance method can be used to estimate the depth of wood damage in static load analyses to reduce the cross sections of the members.

Figure 8. Correlation between drilling resistance and feed force.

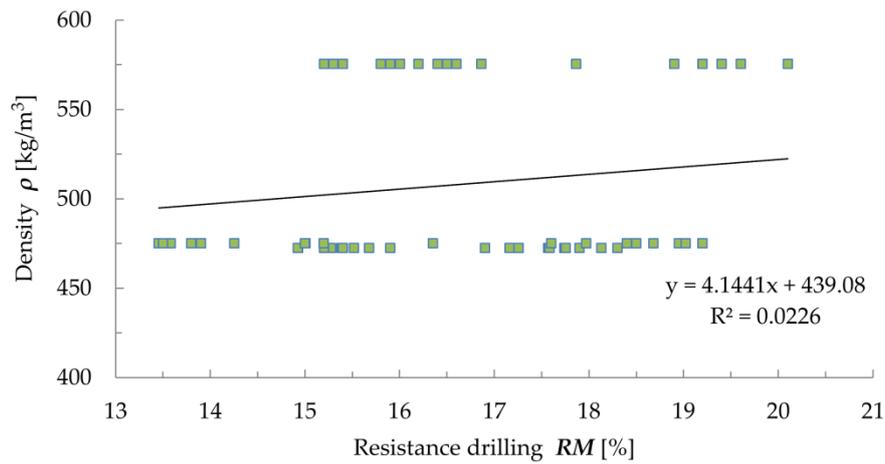
Figure 9. Correlation between drilling resistance and density.

In the case of the resistance drilling tests, the obtained coefficients of determination between drilling resistance and density ($R^2 = 0.0226$) and between the feed force and density ($R^2 = 0.2012$) do not indicate any correlation between the results. Drilling resistance testing should be treated not as a quantitative, but qualitative assessment. The results obtained by means of this method can be used to estimate the depth of material damage in static load analyses to reduce the cross sections of the analysed members [14,49].

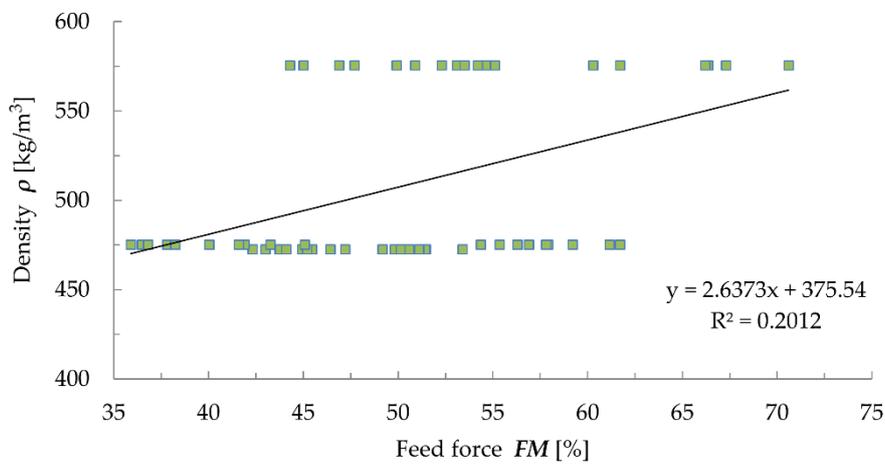
Figure 10. Correlation between feed force and density.

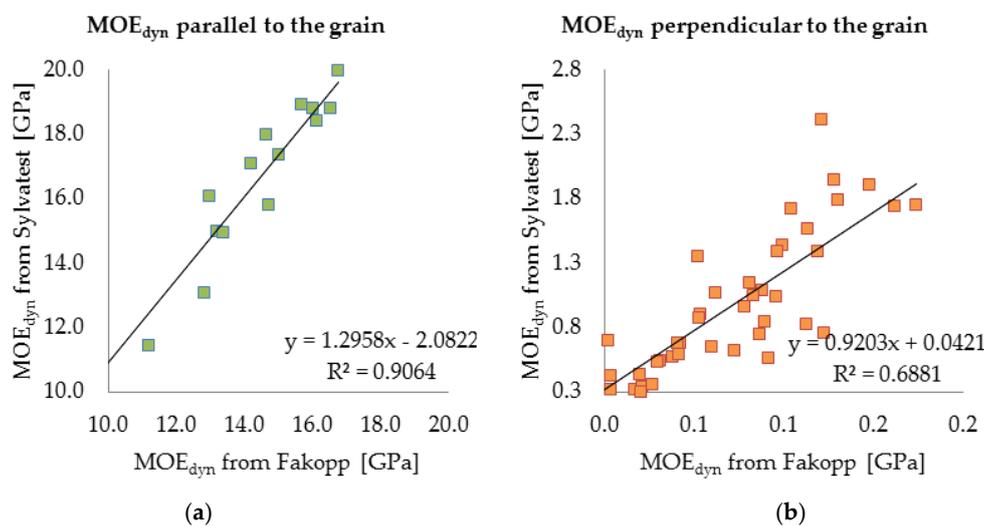
Figure 11. Correlation between dynamic modulus of elasticity determined using ultrasonic wave method (Sylvatest) and stress wave method (Fakopp) for all the samples for all moisture content levels for both directions relative to grain: (a) parallel; (b) perpendicular.

As one can see above, the results yielded by the two measuring methods using the Sylvatest Trio device and the Fakopp Microsecond Timer are similar. For the selected samples the correlation coefficient along and across the grain amounts to respectively $R^2 = 0.9064$ and $R^2 = 0.6881$. This result can be regarded as satisfactory and it indicates the two methods can be used complementarily to estimate the material parameters of wood.

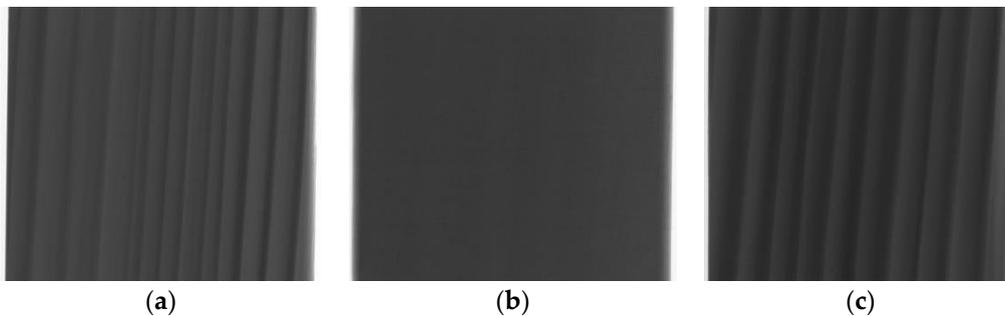
Exemplary projections for all of the tested samples are shown in Figure 12.

Figure 12. Exemplary projections for samples: (a) "1"; (b) "2"; (c) "3" (scale 200%).

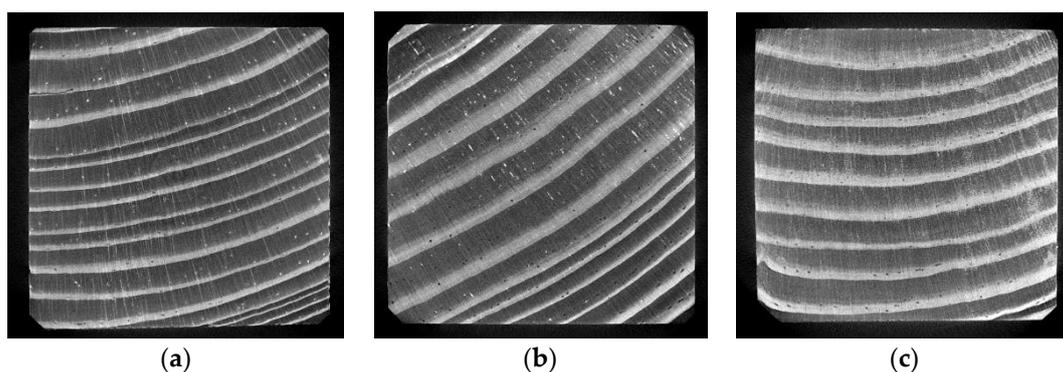
Exemplary cross sections of the samples, obtained by reconstructing the 3D sample model are shown in Figures 13 and 14, at a scale of respectively 200% and 800% (an enlarged fragment of the image).

Figure 13. Exemplary cross sections of samples: (a) "1"; (b) "2"; (c) "3" (scale 200%).

The cell structure is practically invisible due to the adopted scanning resolution. Only the early and late wood with local flaws (small microcrack in sample “1”) and higher-density inclusions (samples “1” and “2”) can be distinguished. In the images obtained from scanning, sample “3” is generally brighter than the other two, which unambiguously indicates its higher density. This is particularly visible in the cross sections (Figures 13 and 14). It also appears from the reconstruction that the late growth rings, which are denser (brighter in the imaging results), are thicker and occupy more material volume in samples “2” and “3”, whereas in sample “1” the volume fraction of late growth rings is clearly smaller. Moreover, small highly dense (probably mineral) inclusions are noticeable in samples “1” and “2”.

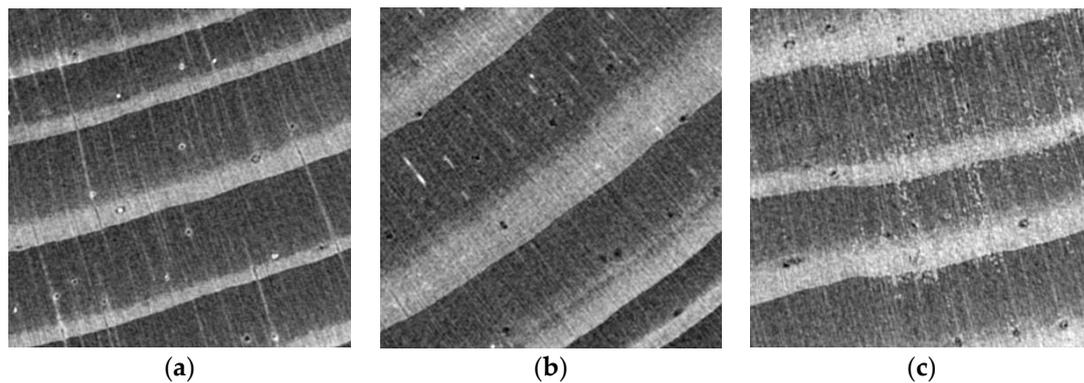
Figure 14. Exemplary cross section (scale 800%): (a) sample “1”; (b) sample “3”; (c) sample “2”.

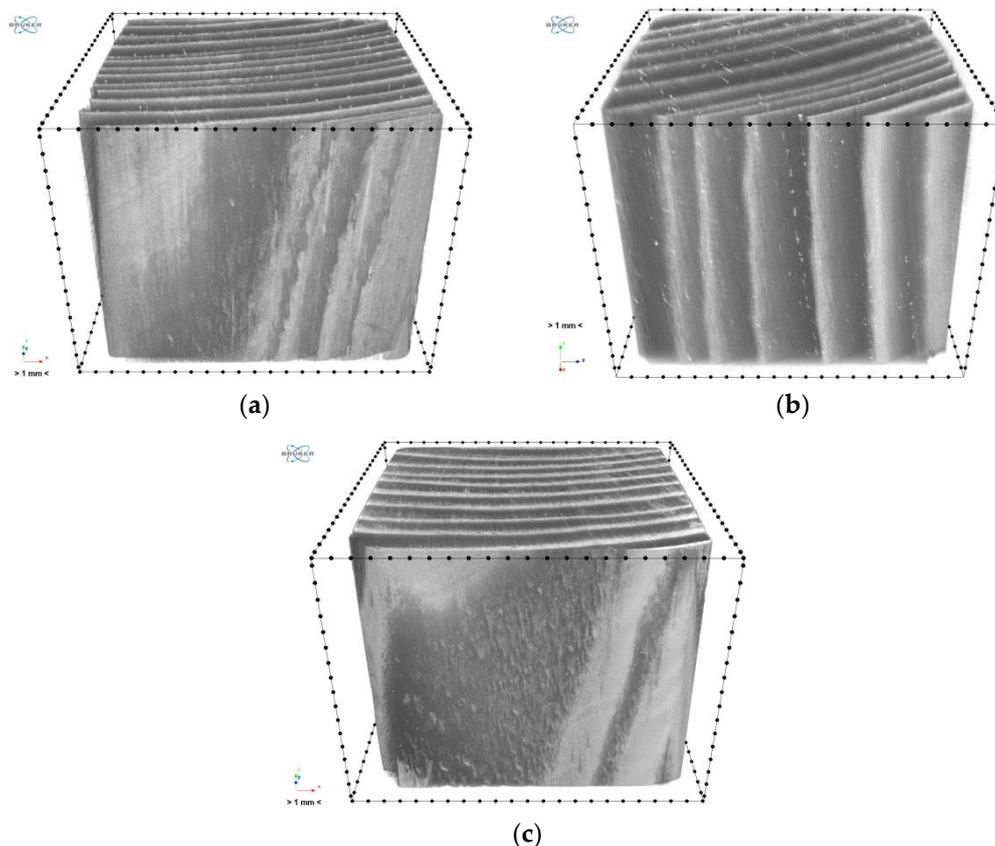
Figure 15 shows the rendering of the 3D model of the samples.

Figure 15. Reconstruction—3D view: (a) sample “1”, (b) sample “2”, (c) sample “3”.

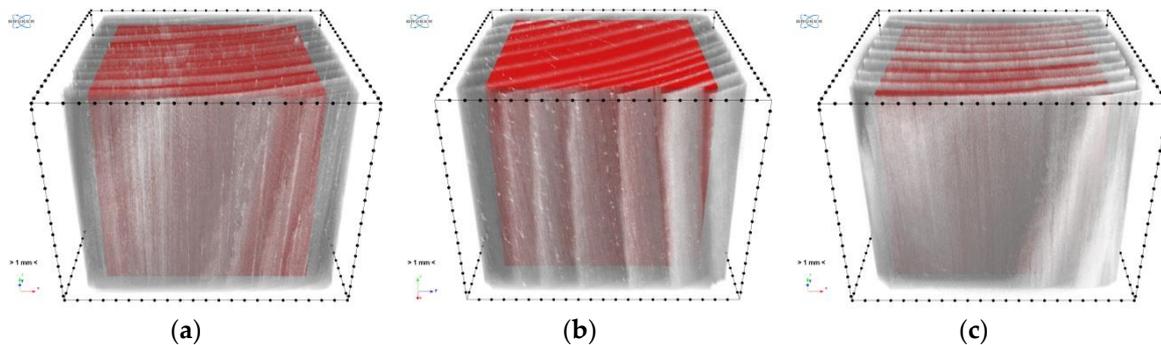
A cubic area of $(1200 \text{ vox})^3$ completely contained within the volume of the tested material, i.e., the so-called volume of interest (VOI), was selected in order to quantitatively characterise the above observations. The selection of VOI is shown in Figure 16 below.

Figure 16. Selection of VOI: (a) sample "1"; (b) sample "2"; (c) sample "3".

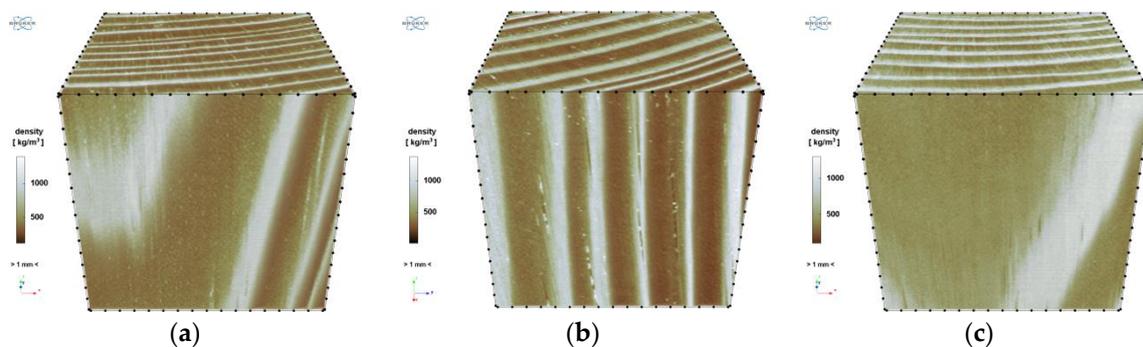
As mentioned, there is a correlation between greyscale and density. Thanks to the use of such a correlation in the linear form as in [41,42], the spatial distributions of local density in the analysed samples (Figure 17) and the statistical distributions (histograms) of density in the VOI of the particular samples (Figure 18) were determined. The correlation coefficients were determined by comparing the mean density of a given sample with the average grey level in VOI, and the density of the air with the average grey level of area outside the sample (visible in the images obtained from X-ray micro-computed tomography). The coefficient of proportionality of this correlation, determined independently for each of the three samples, amounted to respectively 5.884, 5.808 and 5.906. The distributions presented below were obtained using the mean value of this coefficient, i.e., 5.866.

Figure 17. Spatial distribution of density: (a) "1"; (b) "2" and (c) "3".

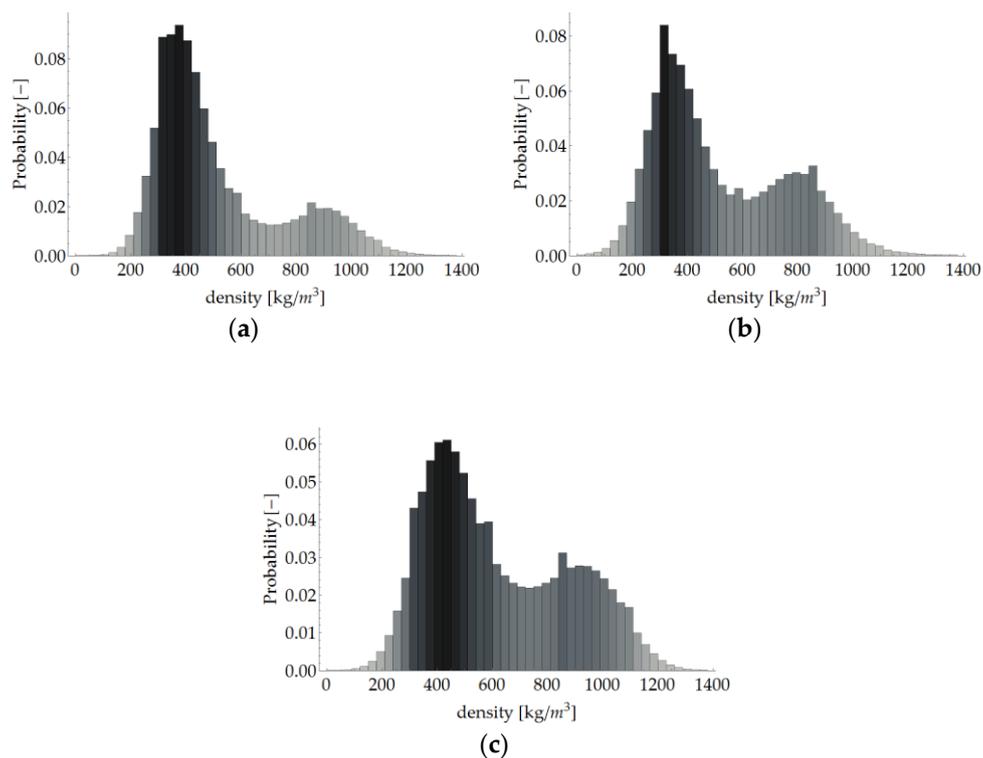
Figure 18. Histogram of local density in VOI: (a) sample “1”; (b) “2” and (c) “3”.

As one can see, the above histograms represent bimodal probability distributions. This means that there occur two principal components. In the case of this analysis, these are the early and late growth rings. Segmentation, i.e. partitioning the image into segments occupied by the particular components, was performed using the thresholding preceded by a smoothing filter. The threshold value of brightness corresponds to the grey level value at which the image histogram reaches a minimum (sample “1”: 135, “2”: 122, “3”: 149). A morphometric analysis was carried out for the two image components. In particular, the volume fraction of the component and the spatial distribution of its local thickness [47] were determined and then its mean thickness was calculated. The calculated values are shown in Table 11 and the thickness distributions are presented in Figures 19 and 20. In order to avoid the error connected with determining thickness at the boundary of VOI, the area of the latter was limited to the volume of $(1000 \text{ vox})^3$ by applying dilation with a radius of 100 voxels.

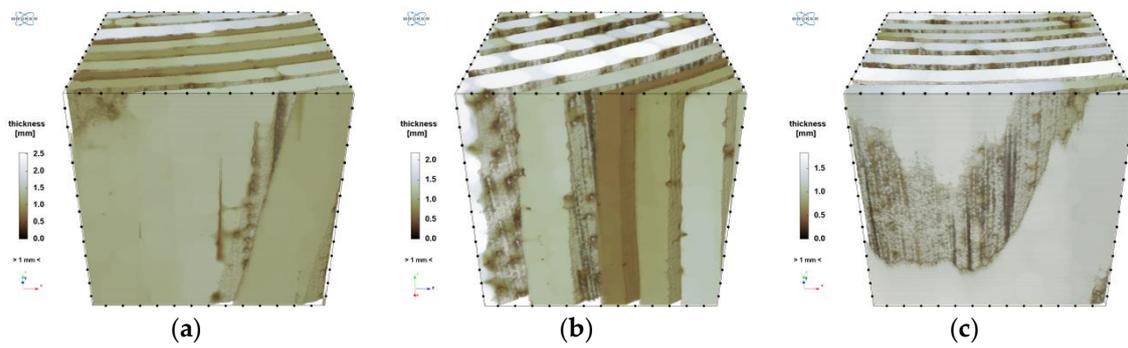
Figure 19. Distribution of local thickness of early growth rings: (a) sample “1”; (b) sample “2”; (c) sample “3”.

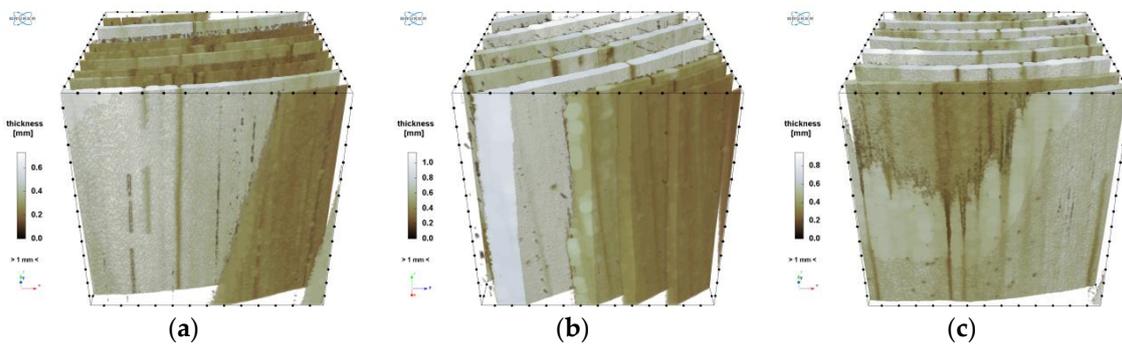
Figure 20. Distribution of local thickness of later growth rings: (a) sample “1”; (b) sample “2”; (c) sample “3”.
