Article

# Effect of Polymer Addition on Performance of Portland Cement Mortar Exposed to Sulphate Attack

**Abstract:** Resistance to degradation contributes greatly to the durability of materials. The chemical resistance of polymer–cement composites is not yet fully recognized. The goal of the research presented in this paper was to assess the performance of polymer–cement mortars under sulphate aggression, as compared to unmodified cement mortar. Mortars with polymer-to-cement ratios from 0 to 0.20 were stored in either a 5% MgSO<sub>4</sub> solution or distilled water for 42 months. During this time, changes in elongation, mass, and compressive strength were determined. The results of these investigations, together with the visual and microscopic observations, allowed us to conclude that polymer–cement composites demonstrated better resistance to the attack of sulphate ions than unmodified cement mortar, even when using Portland cement with enhanced sulphate resistance.

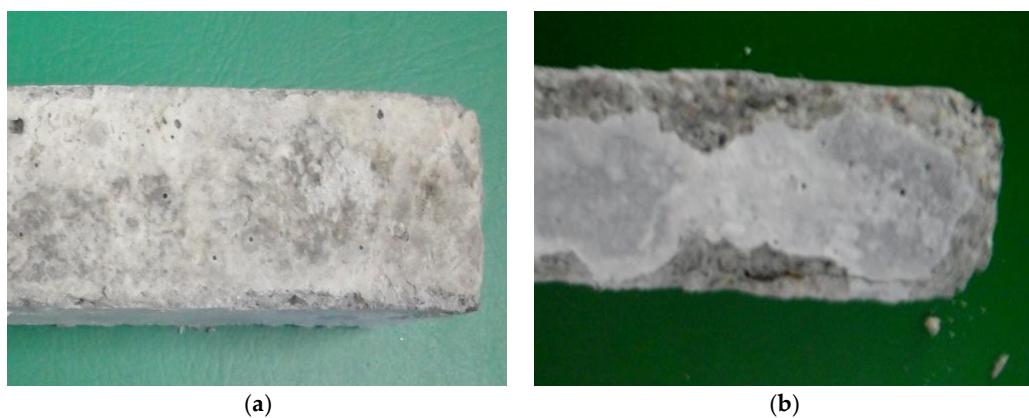
The unmodified Portland cement mortar began to demonstrate clear signs of corrosion after 12 months of exposure to the 5%  $\text{MgSO}_4$  solution (Figure 6a). After 42 months of exposure, the specimens were seriously damaged, which is in good correlation with the results of previously reported test results (Figure 6b). In addition, the structure of the mortar was damaged in a manner corresponding to the above observations. Needle-like ettringite crystals were present after 12 months (Figure 7a), while—as described in the Introduction—massive ettringite forming the shells around the aggregate grains, dominated after 42 months of exposure (Figure 7b).

**Figure 6.** Cement mortar without polymer stored in 5%  $\text{MgSO}_4$  solution: (a) after 12 months; (b) after 42 months.

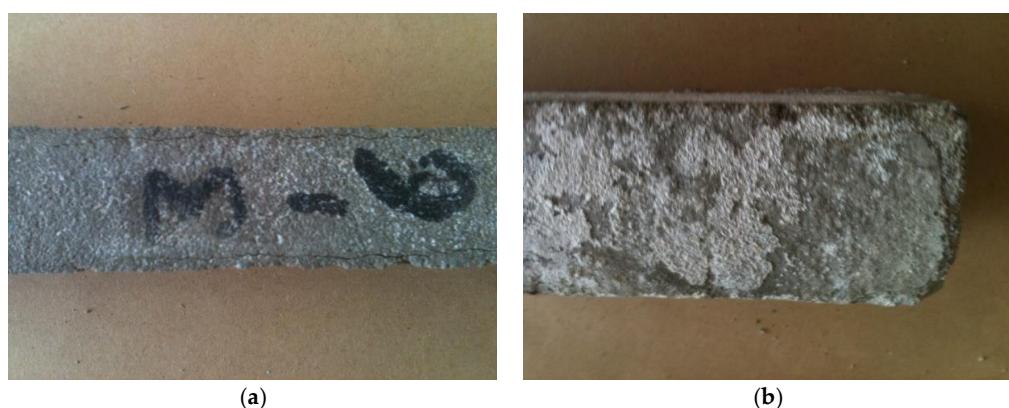
Adding polymer to the Portland cement mortar led to an improvement in the composite performance subjected to the sulphate aggression. Even a small content of the polymer modifier (polymer-cement ratio 0.05) delayed the beginning of corrosion (Figure 8a). However, after a longer exposure, this composite showed a similar degradation as that without modification (Figure 8b). Due to the action of the polymer, the structure of the composite was more homogeneous and compacted, thus less water-permeable (Figure 9a). However, after 42 months, clear signs of weakening of the structure could be seen, namely microcracks and delaminations in the aggregate-paste contact zone (Figure 9b).

**Figure 8.** Polymer-cement mortar,  $p/c = 0.05$ , stored in 5%  $\text{MgSO}_4$  solution: (a) after 12 months; (b) after 42 months.

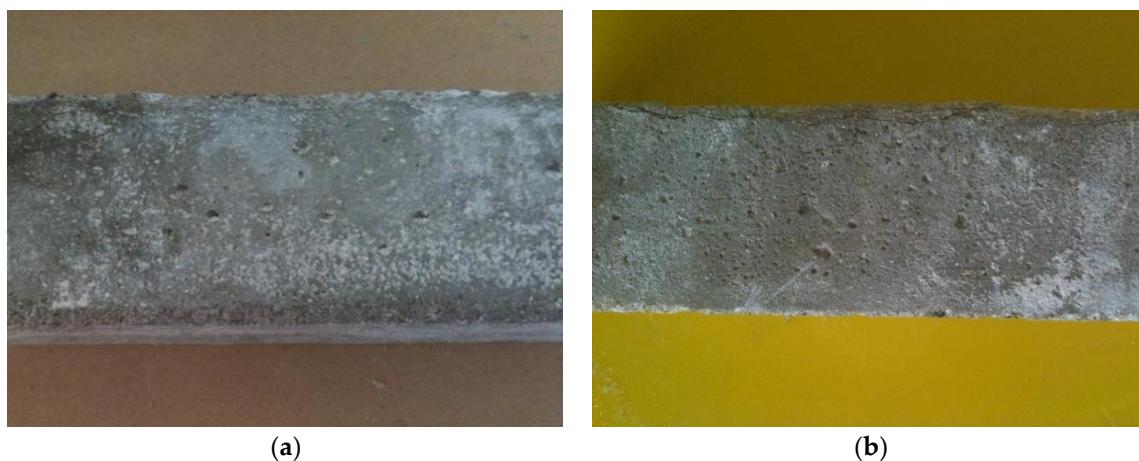
Higher polymer content brought more substantial enhancement in the mortars' behaviour. After 12 months of exposure to the 5%  $\text{MgSO}_4$  solution, only efflorescence without advanced corrosion symptoms could be found on the specimens' surfaces (Figure 10a), while after 42 months of exposure, the specimens were still in satisfactory shape, with only moderate visible signs of corrosion (Figure 10b). The microscopic observations of the structure of the polymer-cement mortars were in good correlation to these findings. The structure of the composite with a polymer-cement ratio of 0.20 looked sound after 12 months of exposure to the sulphate solution (Figure 11a), while after 42 months of exposure, it showed only slight microcracks and deformations (Figure 11b). The action of the polymer content was sufficient to ensure not only a tighter structure but also better adhesion between aggregate grains and hardened cement paste.

**Figure 10.** Polymer-cement mortar,  $p/c = 0.20$ , stored in 5%  $\text{MgSO}_4$  solution: (a) after 12 months; (b) after 42 months.
