# Mechanical Behavior and Failure Mode of Steel–Concrete Connection Joints in a Hybrid Truss Bridge: Experimental Investigation

**Keywords:** hybrid truss bridge; steel–concrete connection joint; mechanical behavior; failure mode; strain; static test

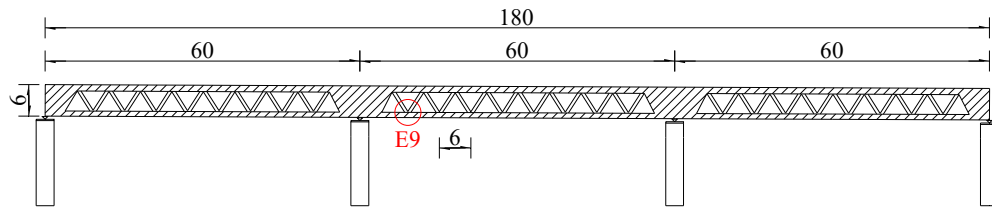
**Figure 1.** The most unfavorable joint (unit: m). E9: the ninth joint of the lower chord from left to right.

As shown in Figure 1, two specimens with the scale of 1:3 were designed on the basis of the typical steel–concrete connection joint E9, which was selected from the preliminary design of the first hybrid continuous truss bridge in Chinese railway bridges.

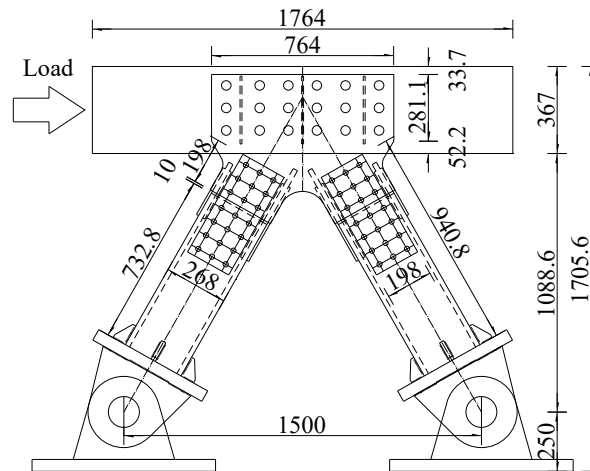
**Figure 2.** Schematic diagram of the specimen (unit: mm).

Figure 2 shows the schematic diagram of the joint specimens. Furthermore, Specimen 1 (Southwest Jiaotong University, Chengdu, China) and Specimen 2 (Southwest Jiaotong University, Chengdu, China) shared the same model parameters. The steel–concrete joint consists of the concrete chord (1764 mm × 334 mm × 367 mm), gusset plates ((CRTB) Tycoon Industrial Development Co., Ltd., Baoji, China) (764 mm × 629 mm × 16 mm) perforated 18 holes (40 mm in diameter), PBL shear connectors (Southwest Jiaotong University, Chengdu, China) (12 mm in diameter), steel truss-web members (268 mm × 184 mm × 20 mm), steel reinforcements (12 mm in diameter), and rectangular stirrups (8 mm in diameter). The material properties of C50 concrete (Sichuan Southwest Cement Co., Ltd., Chengdu, China), Q370qE steel (Baoshan Iron & Steel Co., Ltd., Shanghai, China), and HRB400 steel (Baoshan Iron & Steel Co., Ltd., Shanghai, China) are listed in Table 1.

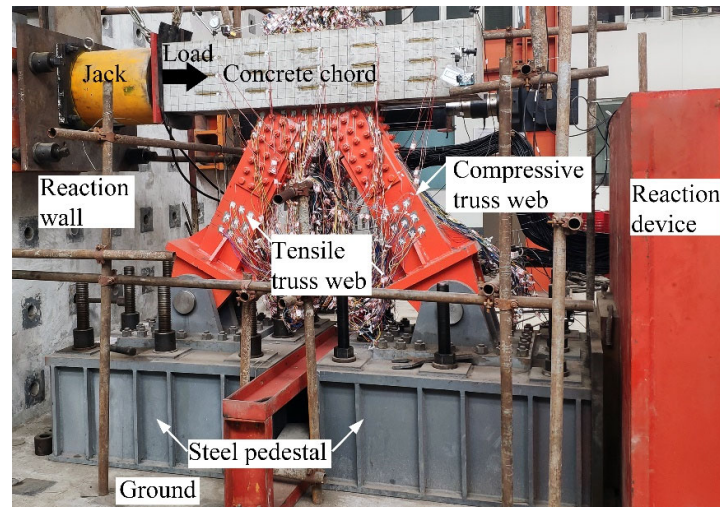
Figure 3. Experimental setup.

The static tests of the steel–concrete connection joints were carried out in the National Engineering Laboratory for Technology of Geological Disaster Prevention in Land Transportation, and the experimental setup is shown in Figure 3. To provide enough reaction force, two steel pedestals and a reaction device were installed on the ground. The steel pedestals with the hinge supported the connection joints. The horizontal load was offered by the loading jack with a capacity of 6300 kN, acting on one end of the concrete chord, whose direction was shown by the solid arrow in the Figure 3.

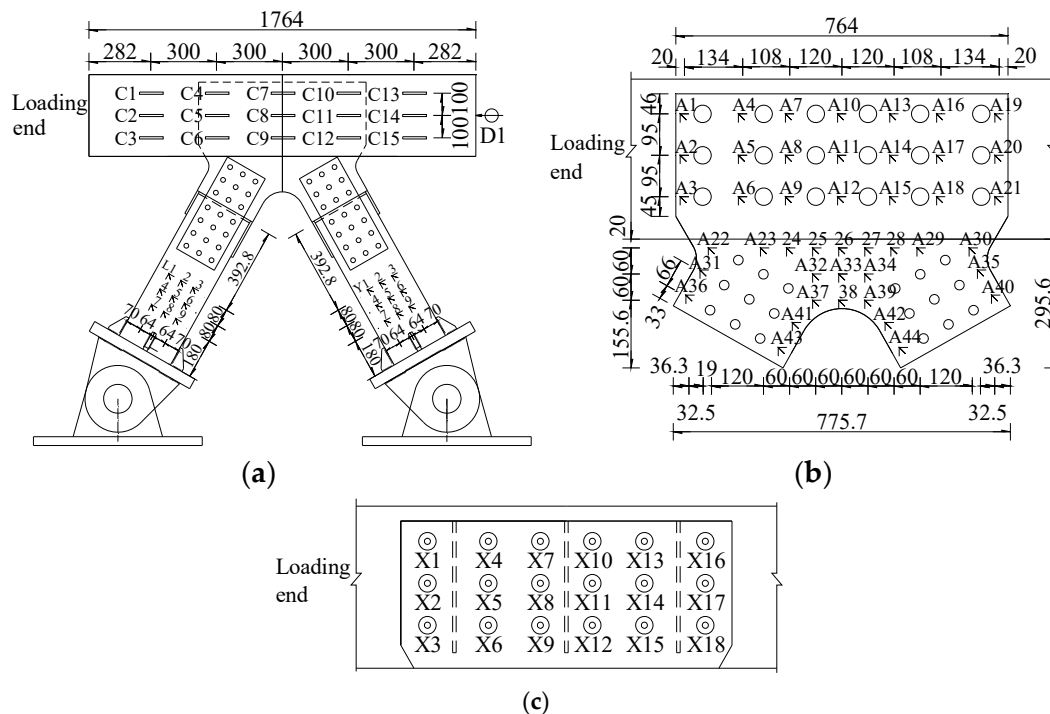
**Figure 4.** Arrangement of the displacement meters and strain gauges (unit: mm). (a) The concrete chord and steel truss-web members; (b) the gusset plates; and (c) the PBL shear connectors. C1: No. 1 strain gauge of concrete chord; A1: No. 1 strain gauge of gusset plates; X1: No. 1 strain gauge of PBL shear connectors.

Before the formal multi-step loading, pre-loading was performed to avoid assembly clearance. The loading step of 400 kN was adopted within 0–2000 kN. Then, when the horizontal load was in the range of 2000–3000 kN, the loading step was reduced to 200 kN. Finally, the loading step of 100 kN was applied until the end of the loading procedure. The laser displacement sensor (D1) was used for measuring the horizontal displacement in the loading direction. Furthermore, the strain gauges were installed to monitor the strain of the main components, including the concrete chord, gusset plates, PBL shear connectors, and the steel truss-web members, as shown in Figure 4.

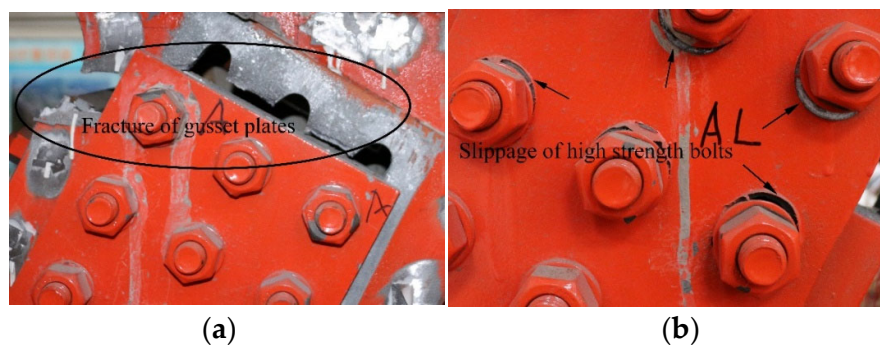
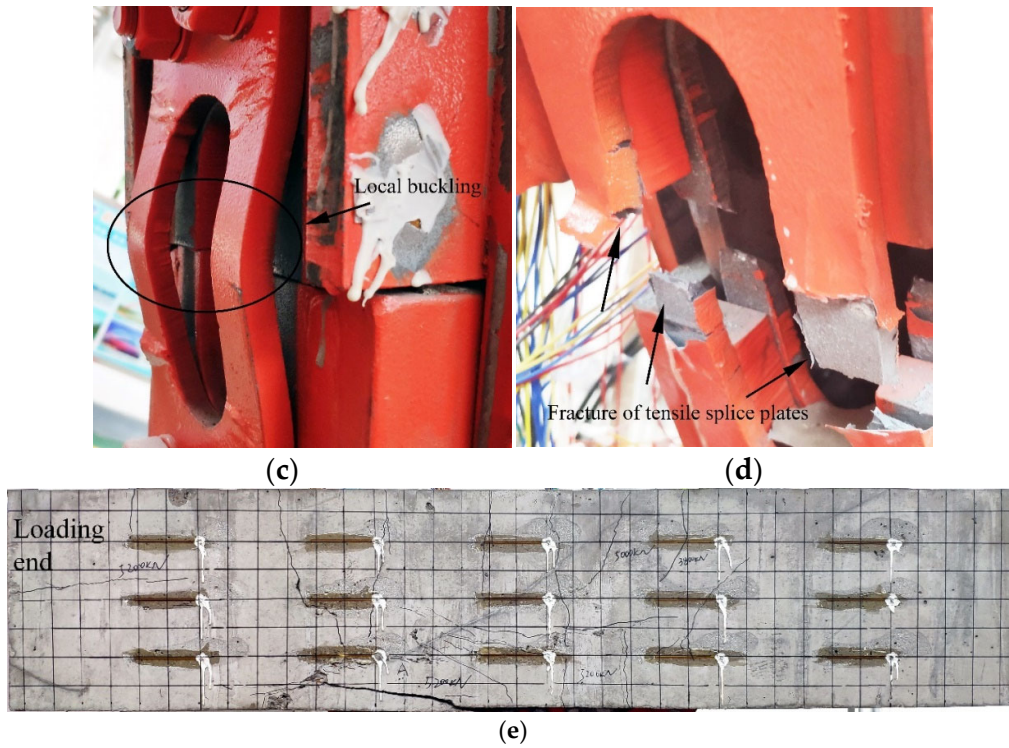
**Figure 5.** Failure modes of Specimen 1: (a) the fracture of gusset plates; (b) the slippage of high-strength bolts; (c) the local buckling of the compressive splice plates; (d) the fracture of the tensile splice plates; and (e) the concrete cracking.

To precisely investigate the failure modes of the proposed connection joints, the experimental phenomena and data were recorded in detail. Figure 5 and Figure 6 present the failure modes of Specimen 1 and Specimen 2, respectively. For Specimen 1, there was no macroscopic damage until the applied load reached 3800 kN. Then, the relative location between the gusset plates and the splice plates was changed on the tension side. Additionally, the initial crack with the length of 170 mm appeared on the concrete chord and which did not develop any more in the subsequent loading

procedure. At the load of 4400 kN, local buckling of the splice plate on the compressive side was observed, as shown in Figure 5c. Then, in Figure 5b, the visible slips of high-strength bolts were noticed at the load of 4800 kN, which indicated that the high-strength bolts were out of action. When the applied load reached 5200 kN, a lot of cracks appeared on the concrete chord, as shown in Figure 5e. Finally, two noises were heard within seven seconds due to the fracture of the gusset plates and splice plates with hand holes (in Figure 5a, d), meanwhile, Specimen 1 lost its bearing capacity to resist the external load.

Based on the experimental observation of two specimens, the order of the destruction course of the proposed connection joints was the local buckling of the compressive splice plates, the slippage of high-strength bolts, the cracking of the concrete chord, the fracture of the gusset plates and the tensile splice plates. Clearly, two specimens showed similar test phenomena and failure modes. Nonetheless, the damage degree of Specimen 2 was greater than that of Specimen 1, for example, the gusset plates of Specimen 2 were pulled to the point of total fracture. The difference in the experimental results between the two specimens is attributable to the fact that the first fracture of Specimen 1 dissipated part of the energy, making Specimen 1 unable to continue to bear a greater load, and also causing the damage degree to be less than that of Specimen 2.

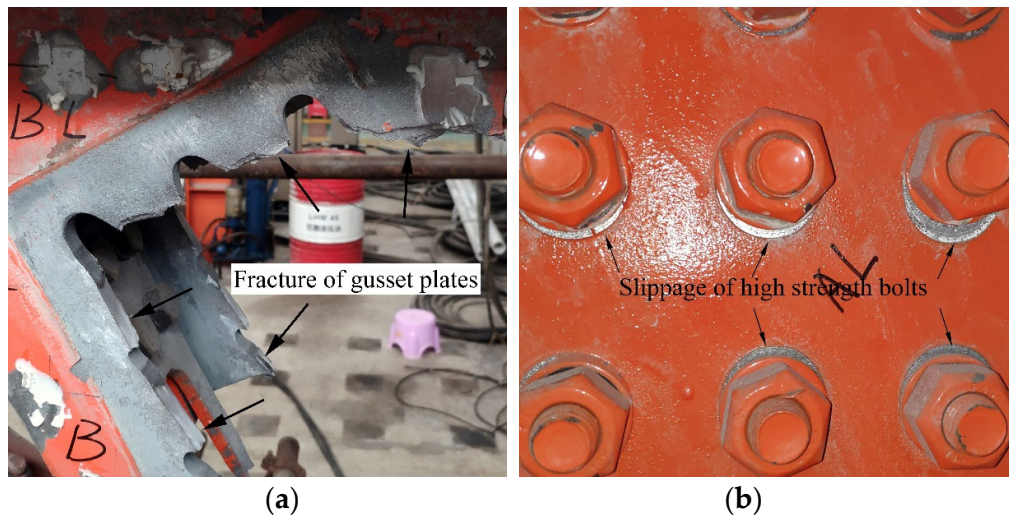
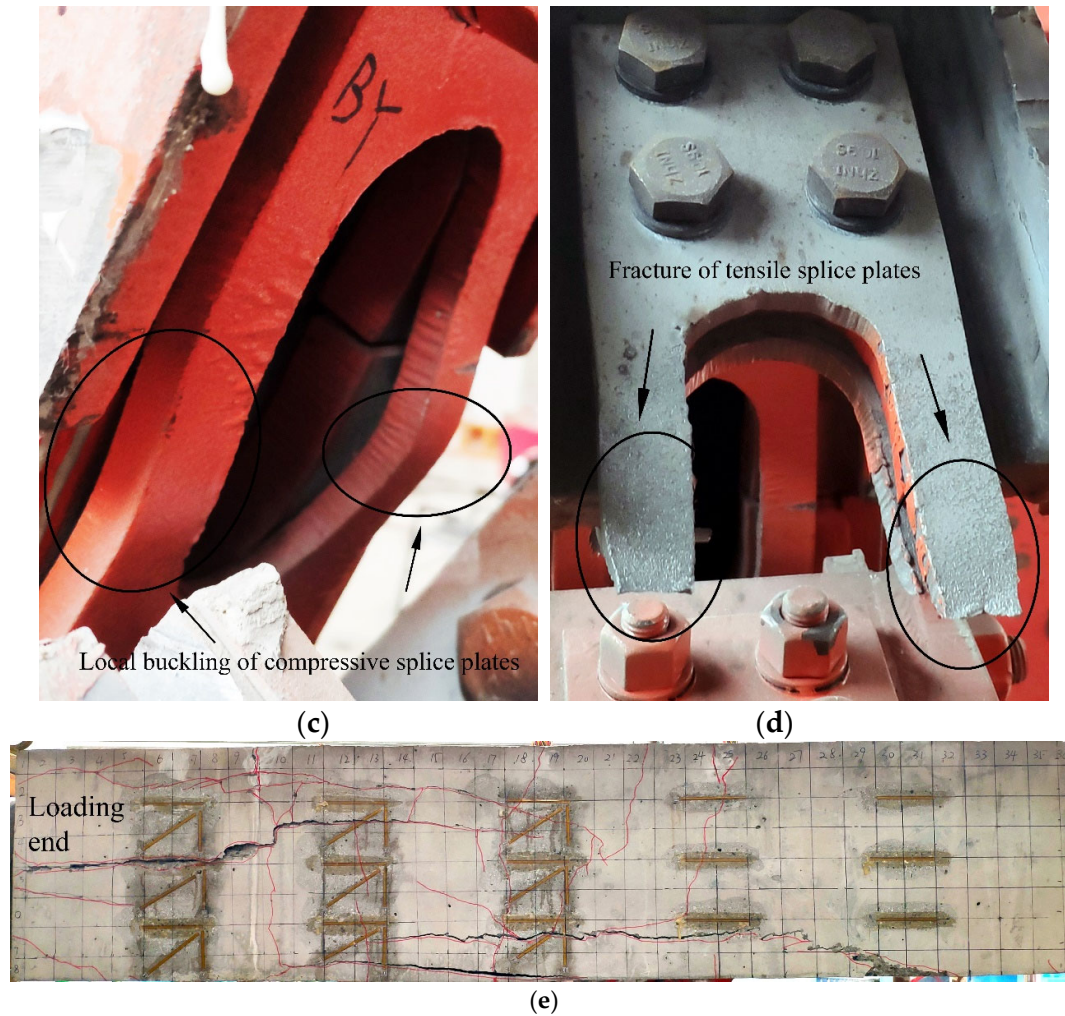
**Figure 6.** Failure modes of Specimen 2: (a) the fracture of the gusset plates; (b) the slippage of the high-strength bolts; (c) the local buckling of the compressive splice plates; (d) the fracture of the tensile splice plates; (e) the concrete cracking.

For Specimen 2, the first crack of the concrete chord emerged near the loading end at the load of 3400 kN, but this crack did not spread in the latter loading stages. Furthermore, the relative location malposition between the gusset plates and the splice plates with hand holes was also observed. Then, the local buckling of the compressive splice plates and the slippage of high-strength bolts were observed, as shown in Figure 6c, b. At the peak load of 5400 kN, it can be seen from Figure 6e that some cracks severely developed. Finally, the gusset plates suddenly broke completely causing a sound to be heard and Specimen 2 lost its bearing capacity, as shown in Figure 6a. Meanwhile, looking at Figure 6d, the splice plates with hand holes were also pulled off.

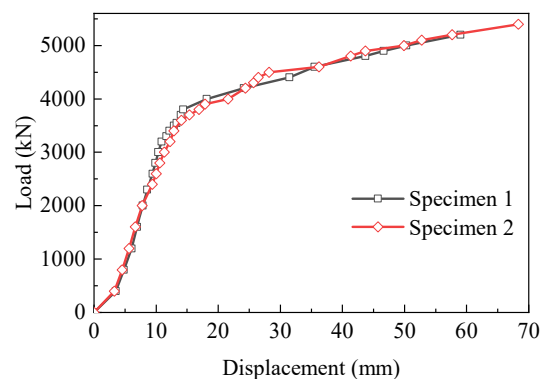
Figure 7. Load–displacement curves of the two specimens.

Figure 7 presents the relation between the applied load and the horizontal displacement. As shown in Figure 7, two load–displacement curves were almost coincident. The corresponding displacement linearly increased with the increase in the applied load in the initial stage. Specimen 1 began to yield, and the curve started to flatten at the load of 3200 kN. With the increase in the load, the exposed gusset plates were pulled to fracture and the composite joint failed to carry the applied load. Hence, the peak load of 5200 kN was regarded as the bearing capacity of Specimen 1. In contrast to Specimen 1, the ultimate capacity of Specimen 2 reached 5400 kN.

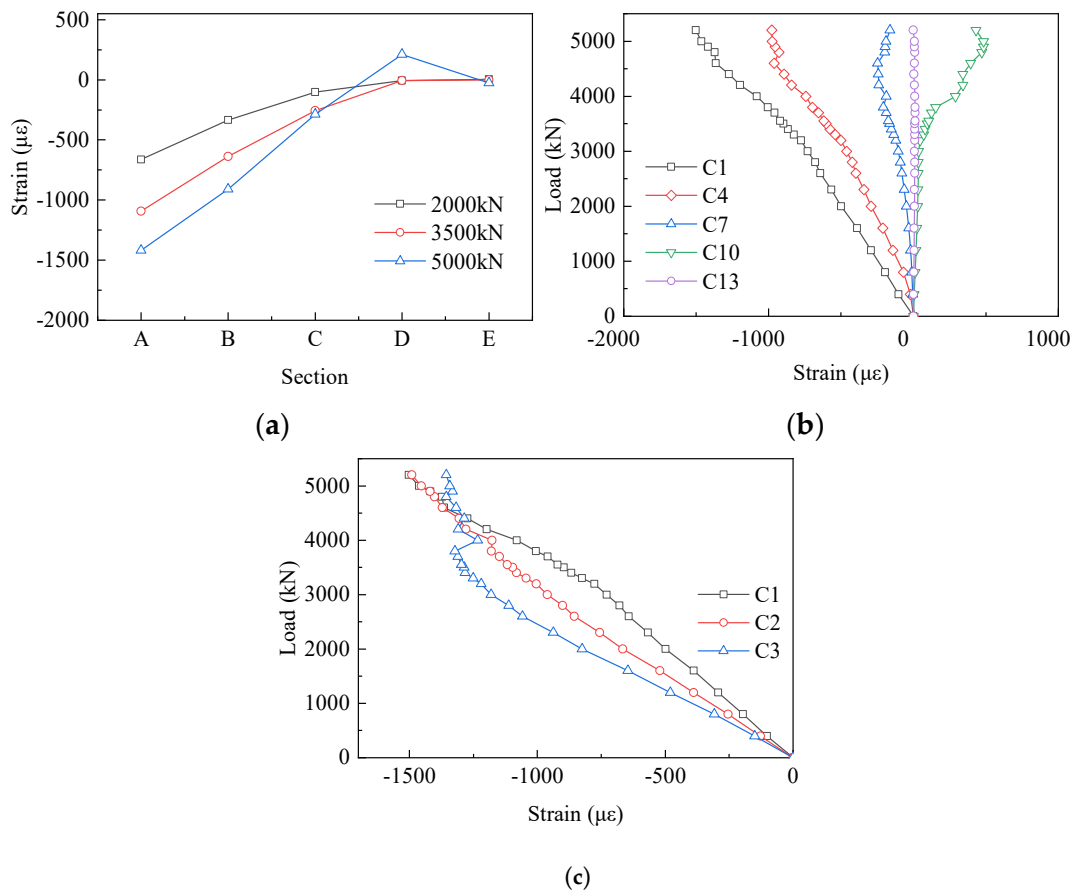
**Figure 8.** Strain results of the concrete chord: (a) the average strain values of each section; (b) the first row of the strain gauges; (c) the first column of the strain gauges.

Specimen 1 was selected as the narrative object to avoid redundancy in the following sections. The strain results of the concrete chord are set out in Figure 8. To minimize the influence of the strain gauge failure, the average strain values of each section in the elastic state (2000 kN), elastic-plastic state (3500 kN), and closely ultimate state (5000 kN) are shown in Figure 8a. There is a clear trend of reducing in the compressive strain values. Evidently, concrete near Section A suffered from the biggish axial force. At the load of 2000 kN, the compressive strains of Section B, C and D were 50%, 15% and 1% of the strain of Section A ( $-663.14 \mu\epsilon$ ). The average strain values decreased quickly along the loading direction, because PBL shear connectors transferred force efficaciously from the concrete chord to the gusset plate. Moreover, the area of the concrete chord close to Section E was almost not subjected to the load. Figure 8b and c presents the strain values of the first row and the first column of gauges, respectively. There was a rapid decrease in the compressive strain values along the loading direction on the concrete chord. For example, the strain values of C1, C4, C7, C10 and C13 were  $-498.32 \mu\epsilon$ ,  $-291.49 \mu\epsilon$ ,  $-49.06 \mu\epsilon$ ,  $29.82 \mu\epsilon$ , and  $6.73 \mu\epsilon$ , respectively, at a load level of 2000 kN. Conversely, in the vertical direction, the strain values of C2 and C3 were 1.34 times and 1.66 times the strain of C1 ( $-498.32 \mu\epsilon$ ). There was a significant increase in the strains from the top to the bottom of the concrete chord.

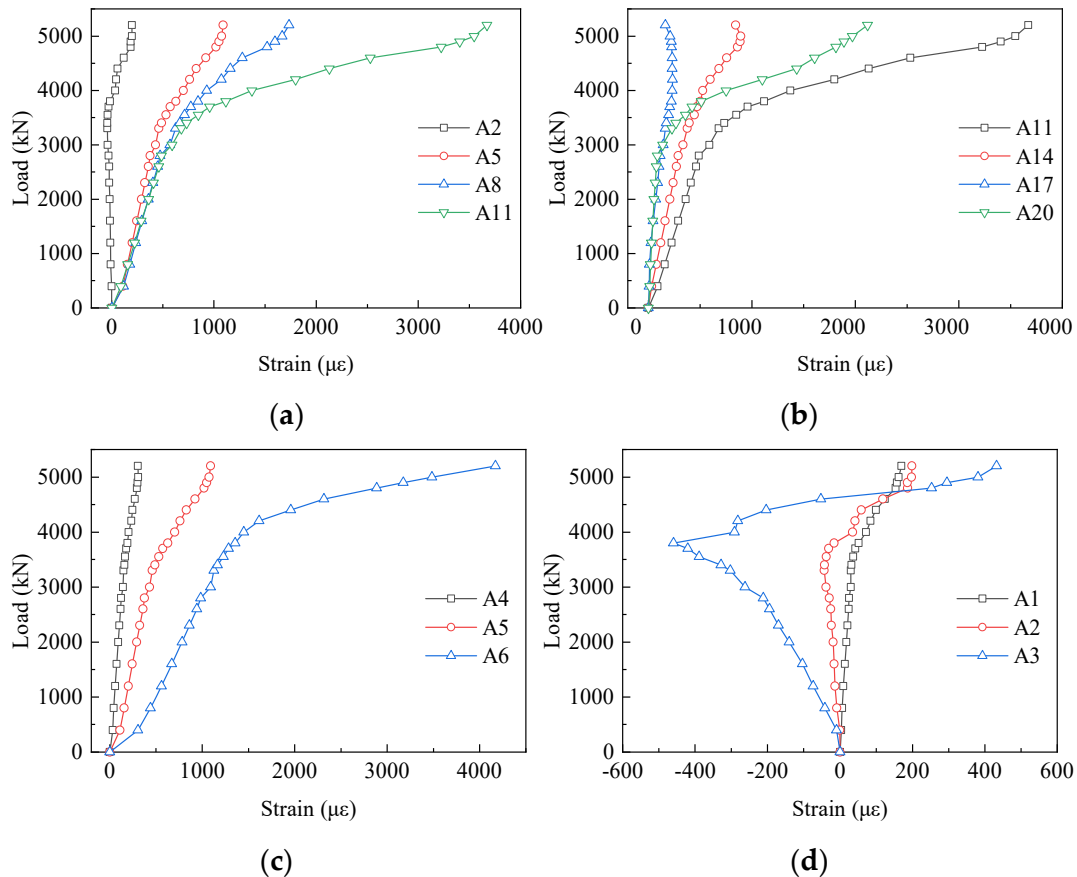
**Figure 9.** Load–strain curves of the embedded gusset plates: (a) A2 to A11 in the second row; (b) A11 to A20 in the second row; (c) the second column of strain gauges; and (d) the first column of the strain gauges.

Figure 9 shows the load–strain curves of the gusset plates which were wrapped by the concrete chord. In the second row, the strain values of A2, A5, A8, A14, and A17 were 6%, 30%, 47%, 25%, and 6% of that of A11 at approximately 5000 kN, respectively. What stands out in Figure 9a and b is the

rapid increase in strains from A2 to A11 and the significant decrease in that from A11 to A20. In other words, the strain results of the embedded gusset plates presented a trend of increasing first and then decreasing along the loading direction. Furthermore, almost all the points did not reach the yield strain ( $2194 \mu\epsilon$ ), except for A11. In the vertical direction, in Figure 9c there was an evident tendency of increasing from A4 to A6 (taking the second column strain gauges as an example). Moreover, the same phenomena occurred in other columns. Exceptionally, in Figure 9d compressive strains occurred at the first column of measuring points, indicating that the front ends of the gusset plates were biased towards compression at the early loading stage.

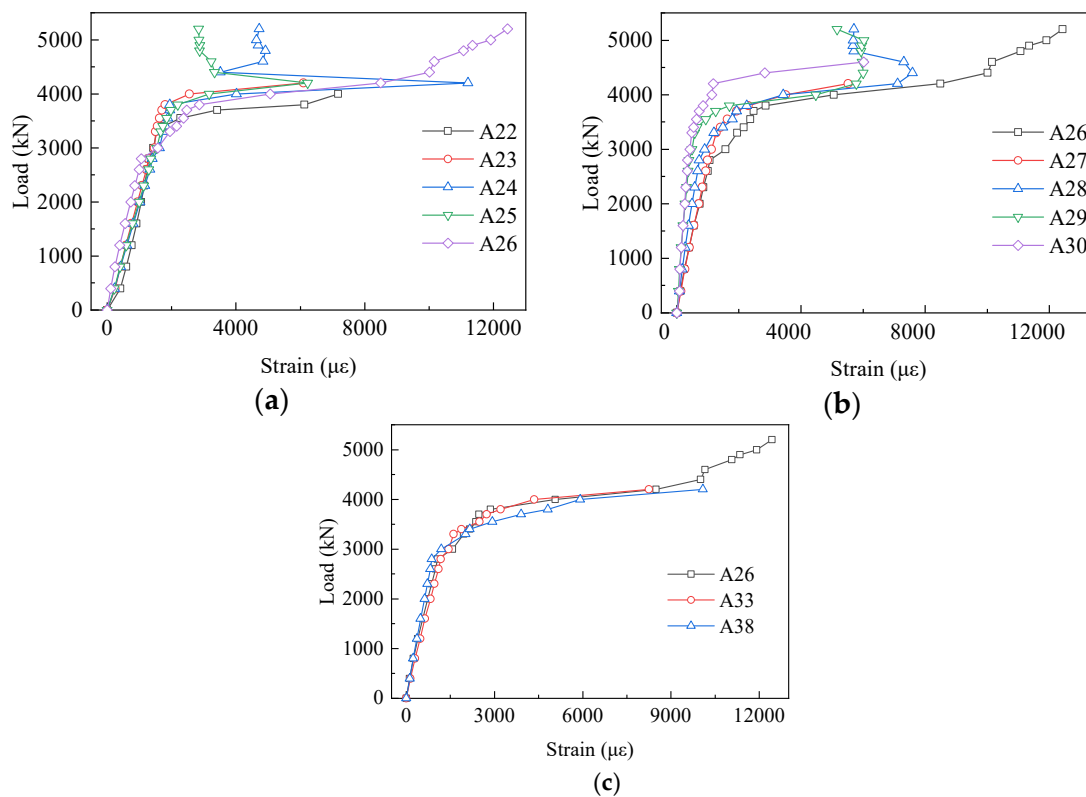
**Figure 10.** Load–strain curves of the exposed gusset plates: (a) A22 to A26 in the fourth row; (b) A26 to A30 in the fourth row; and (c) A26 to A38 in the middle column.

Figure 10 presents the strain results of the gusset plates that were exposed to the air. Different from the strain results of the embedded gusset plates, the exposed gusset plates had a higher strain level. From the results in Figure 10a and b, the strains increased sharply after 3800 kN. Moreover, almost all the strain results of the fourth-row gauges exceeded the yield strain at the load of 4000 kN. Interestingly, the strains of the embedded gusset plates declined gradually from the middle to the edge in the loading direction. In the vertical direction, Figure 10c shows the load–strain curves of the middle row, where no significant variation tendency from A26 to A38 was evident. However, it should be noted that three measuring points were at a high-strain level. The strain of A26, A33, and A38 were bigger than the yield strain, when the load was about 3500 kN. Furthermore, the strain of those three points reached  $8489 \mu\epsilon$ ,  $8249 \mu\epsilon$  and  $10085 \mu\epsilon$ , respectively, at the load of 4200 kN. In addition, the gauges could not function well soon afterward. These results suggest that the exposed part of the gusset plates was a key area for the steel–concrete composite truss joint to exert bearing capacity.

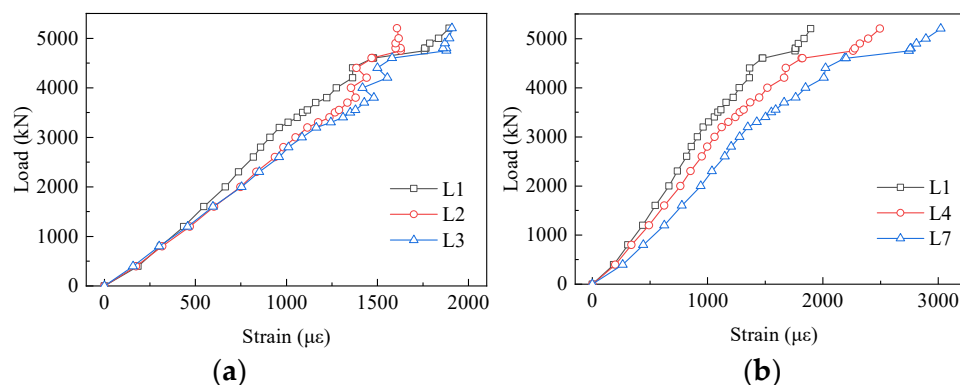
**Figure 11.** Load–strain curves of the tensile truss-web member: (a) L1, L2, L3; and (b) L1, L4, L7; L1: No. 1 strain gauge of tensile truss web.

Figure 11 shows the measured strains of the tensile truss-web members. Almost all the strains of the tensile truss-web members were smaller than the yield strain during the whole loading process. From Figure 11a, b, it can be seen that the strain results at each loading stage and the trend of increasing were different. The slope of the load–strain curves decreased gradually, which showed that the strains of the tensile truss web increased along the loading direction. By contrast with L1, the tensile strain of L2 and L3 increased by 16% and 24% at the load of 3500 kN, respectively. In the vertical direction, Figure 11b shows that the strains increased from L1 to L7 and the growth trend was more obvious. Evidently, what stands out in the Figure is the growth of the strains in both directions.

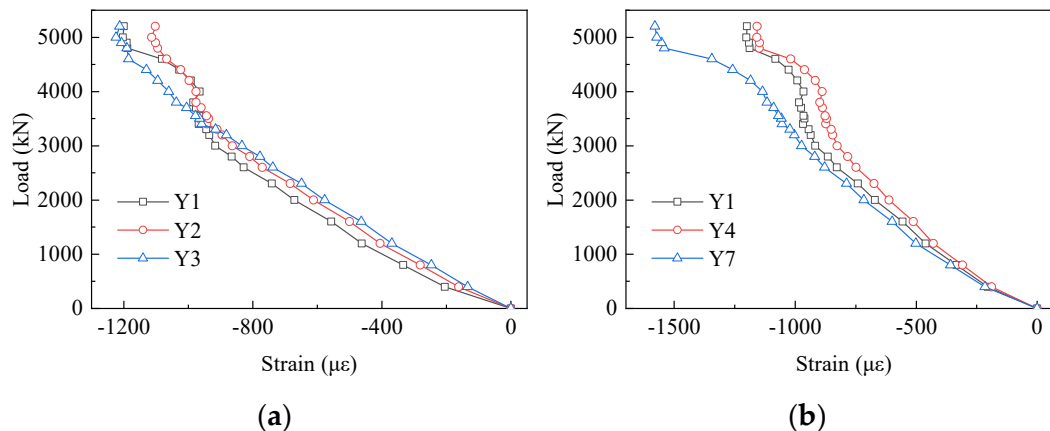
**Figure 12.** Load–strain curves of the compressive truss-web member: (a) Y1, Y2, Y3; and (b) Y1, Y4, Y7; Y1: No. 1 strain gauge of compressive truss web.

The strain results of the compressive truss web are displayed in Figure 12. As shown in Figure 12a, the strain value decreased from Y1 to Y3 along the loading direction, which was contrary to the strain distribution of the tensile truss web. The striking observation to emerge from the strain comparison between the tensile truss web and the compressive truss web was that the area of truss web near the inside of the angle had greater strains. Moreover, the regularity of the strain distribution in the vertical direction was weaker in comparison with the tensile truss web.

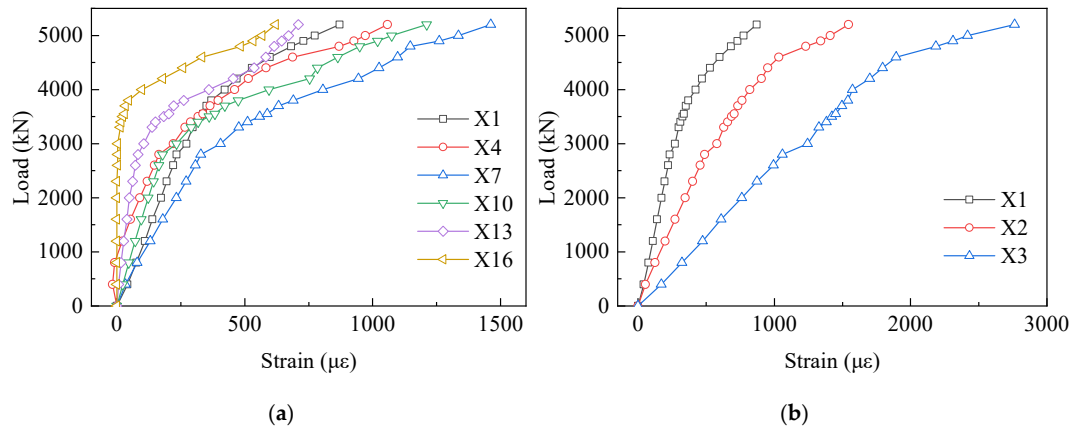
**Figure 13.** Load–strain curves of the perfbond rib (PBL) shear connectors: (a) X1 to X16 in the first row; and (b) X1 to X3 in the first column.

Figure 13 displays the strain results of the PBL shear connectors. From this chart, we can see that no measuring points in the first row exceeded the yield strain during the loading process. Furthermore, there was a visible increase in the strains from X1 to X7 in the first row. Compared with X1, the strain of X7 increased by 71% at the load of 3500 kN. However, on the contrary, the strains decreased from X7 to X16. Compared with X7, the strains of X10, X13 and X16 reduced by 35%, 67% and 96% at the load of 3500 kN, respectively. The strains of the measuring points in the first row increased firstly and then decreased along the loading direction. In the vertical direction, in Figure 13b there was a clear trend of increase in the strain from X1 to X3. The strains of X2 and X3 were about 2.11 and 4.36 times that of X1 at the load of 3500 kN, respectively.

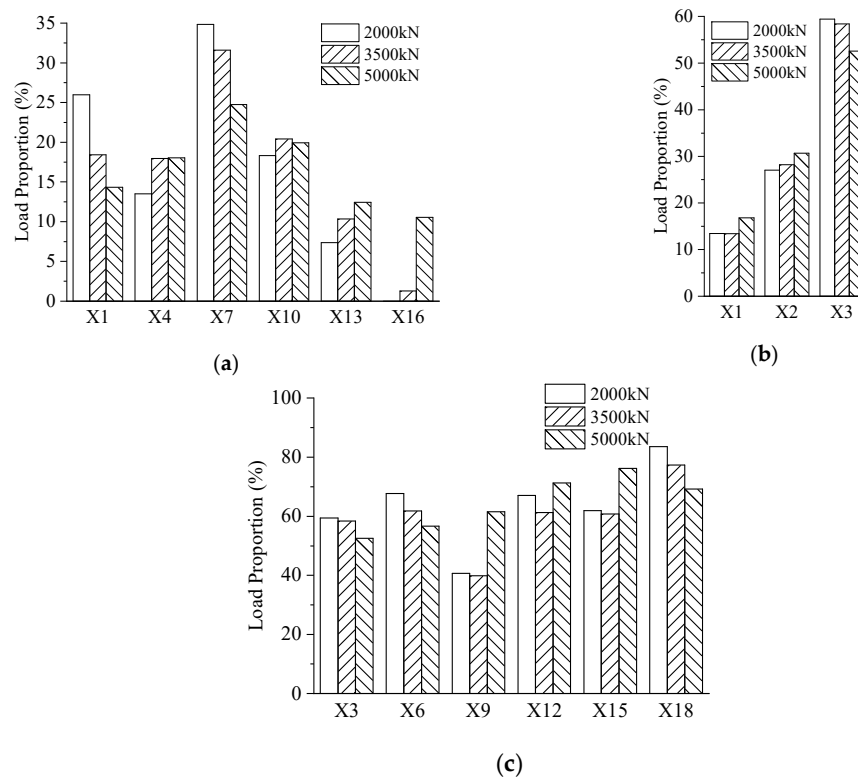
**Figure 14.** Load proportion of the PBL shear connectors: (a) X1 to X16 in the first row; (b) the first column; and (c) the load proportion of the strain gauges in the third row to their respective columns.

Figure 14 shows the load proportion of PBL shear connectors in the same row and the same column with different loads. In the first row, the load proportions from X1 to X16 were 26%, 14%, 35%, 18%, 7% and 0%, respectively, at the load of 2000 kN. The PBL shear connectors in the first row took on 14%, 18%, 25%, 20%, 12%, and 11% of the strains in the first row, when the load reached 5000 kN. Hence, in the same row, it can be seen that the first three PBL shear connectors in the first row bore the vast majority of the load in the initial stage. Moreover, the load proportion of the first three PBL shear connectors decreased gradually with the increase in the load. As shown in Figure 14b, at the load of 2000 kN, the load proportions of X1, X2, and X3 were 14%, 27%, and 59%, respectively. What stands out in Figure 14b is the rapid increase in the load proportion in the vertical direction. Moreover, the load proportion of X3 exceeded 50%. Figure 14c presents the load proportion of the third row of measure points in its column. The load transmitted by the third of points accounted for at least 60% of the total load transmitted by the same row of PBL shear connectors excluding X9. It was suggested that the third row of PBL shear connectors played the vital role in transferring the load between the concrete chord and the gusset plates.
