# The Possibility of Applying Acoustic Emission and Dynamometric Methods for Monitoring the Turning Process

Krzysztof Dudzik \* and Wojciech Labuda

Faculty of Marine Engineering, Gdynia Maritime University, 81-225 Gdynia, Poland;  
w.labuda@wm.umg.edu.pl

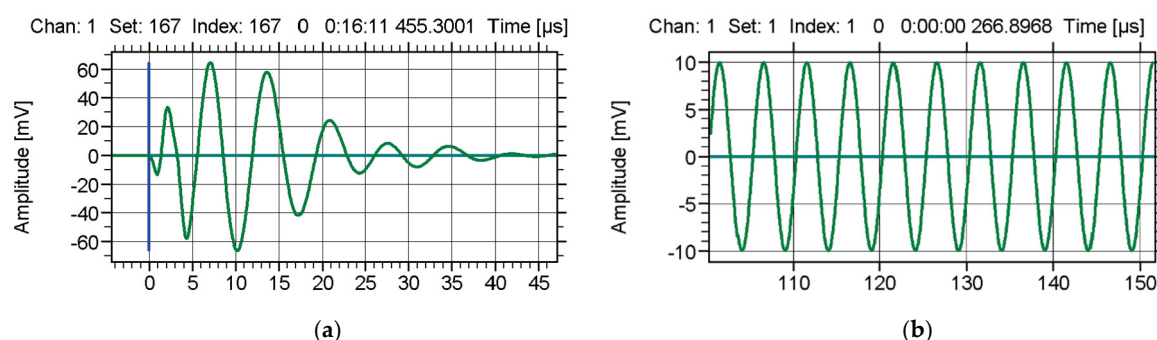
Examples of AE signals are shown in Figure 1.

**Figure 1.** Examples of typical acoustic emission signals: (a) burst signal, (b) continuous signal [24].

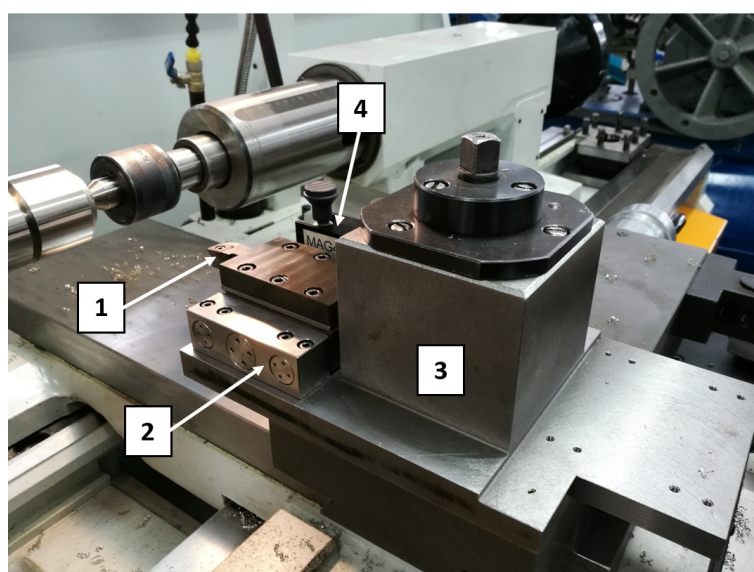
The view of tool and measuring equipment used in research is shown in Figure 2 and the view of shaft is presented in Figure 3.

**Figure 2.** The equipment used in research: 1-tool, 2-dynamometer, 3-dynamometer grip, 4-acoustic emission sensor with holder.

The tool was mounted into Kistler dynamometer (Kistler Instrumente AG, Winterthur, Switzerland). Dynamometer allowed measuring the cutting forces during turning process, both on conventional or CNC lathe machines. It consists of 9119AA2 piezoelectric dynamometer (Kistler Instrumente AG, Winterthur, Switzerland), 5070 charge amplifier and computer with DynoWare software (DynoWare type 2825D-02, Version 2.6.5.1.6, Kistler Group, Winterthur, Switzerland) for acquisition and analysing of the data. This dynamometer allows measuring of dynamic and quasistatic forces:  $F_x$ -radial force,  $F_y$ -feed force and  $F_z$ -cutting force. The range of measured forces is  $-4 \div 4$  kN. The equipment measures the active force, regardless of the application point.

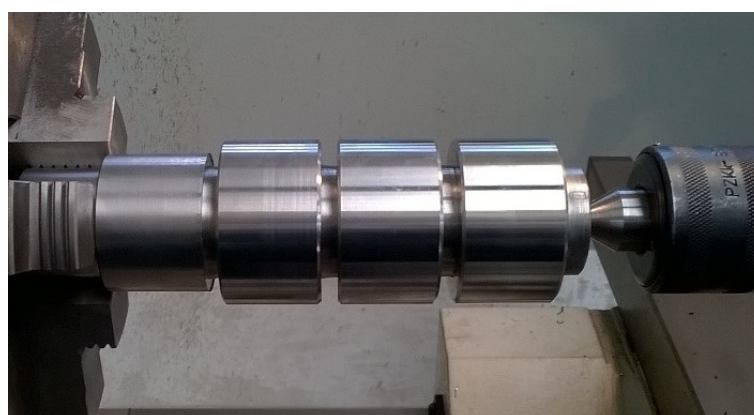
**Figure 3.** The shaft used in research.

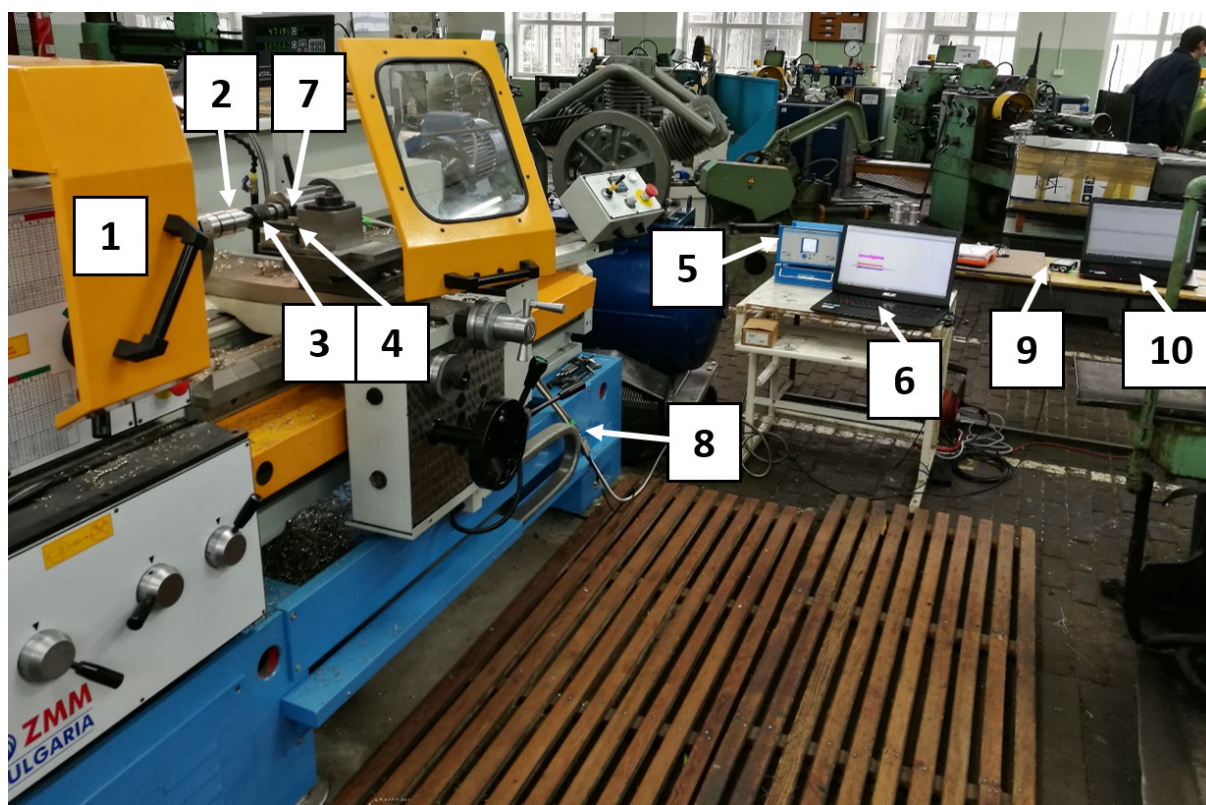
The sensor (VS 150M, Vallen Systeme, Icking, Germany) was fixed to the surface of the dynamometer by means of a MAG4M magnetic holder-designed for that sensor. Silicone grease was used between the sensor and the surface as a coupling fluid. An overall view of the laboratory stand is shown in Figure 4.

**Figure 4.** Laboratory stand: 1–lathing machine, 2–shaft, 3–tool, 4–dynamometer, 5–dynamometer recorder, 6–dynamometer computer, 7–AE sensor, 8–preamplifier, 9–AE recorder, 10–AE computer.

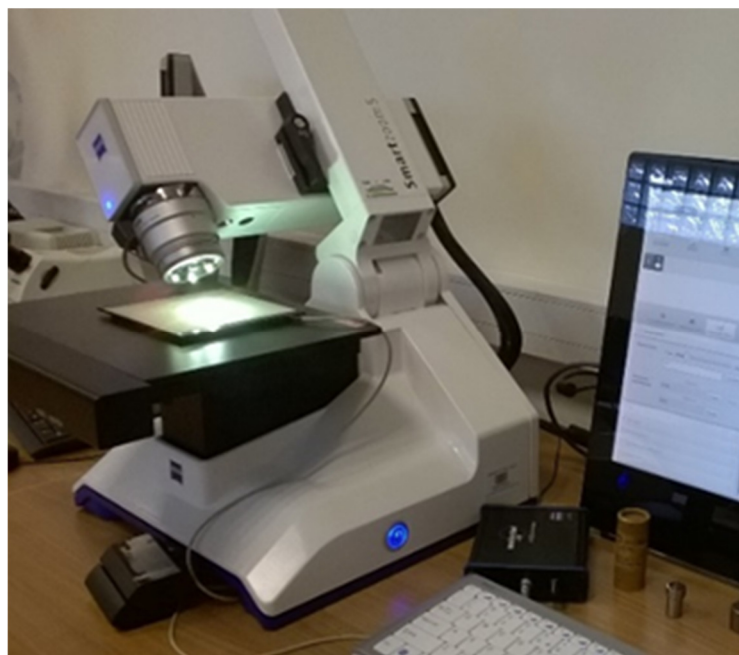
The nose of cutting tool before and after every research stage was observed by digital measuring microscopy (Smartzoom 5, Zeiss, Oberkochen, Germany) Zeiss shown in Figure 5.

**Figure 5.** Measuring microscope used for observing wear degree of cutting insert.

The subsequent stages of the tool cutting edge degradation process were observed by a digital measuring microscope (Zeiss Smartzoom 5). These tests confirmed the suspected degradation of the tool.

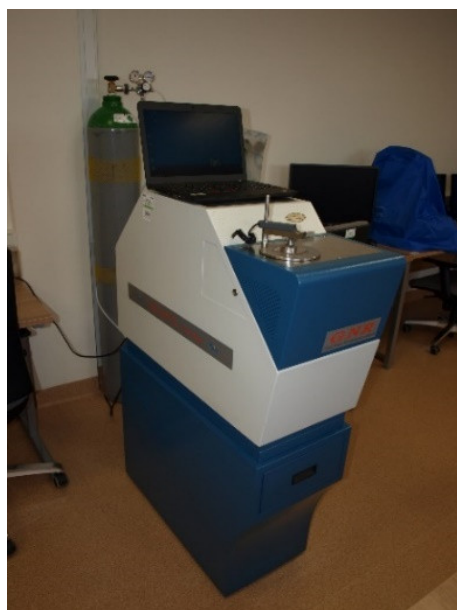
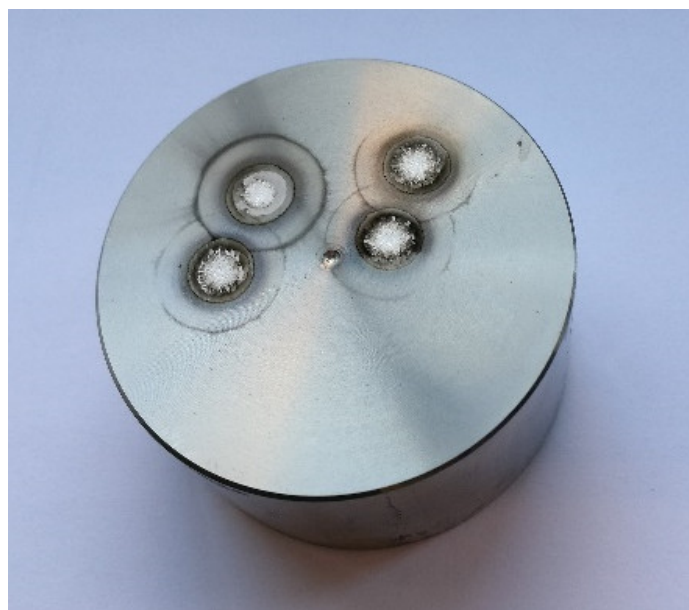
The chemical composition of the shaft material was analysed. It was carried out by an optical emission spectrometer (Solaris-ccd plus, GNR, Novara, Italy) with spark excitation, shown in Figure 6a. The view of the sample after four spark tests is presented in Figure 6b.

**Figure 6.** An optical spectrometer used for chemical composition test (a) and the view of the sample after four spark test (b).

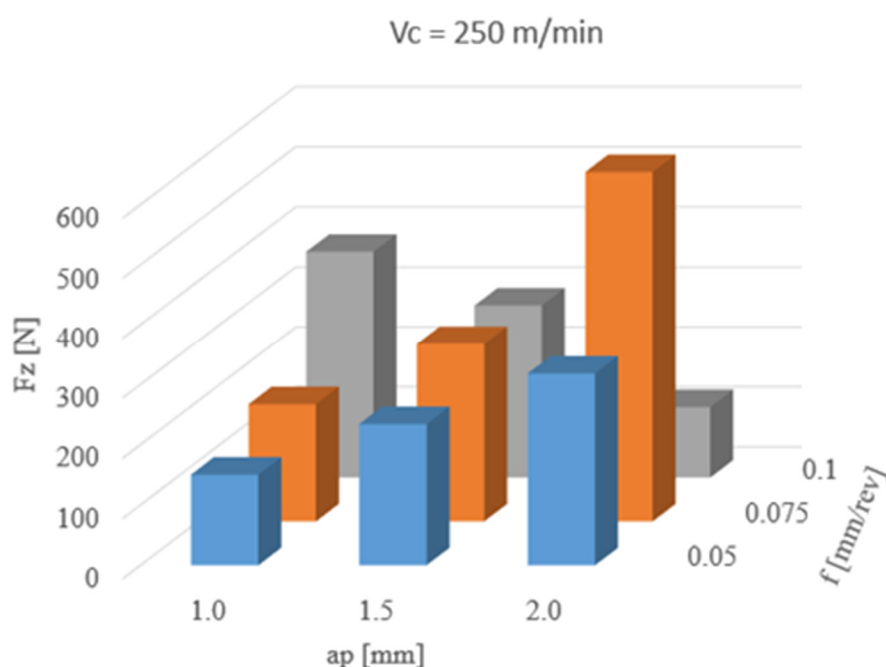
The results of the influence of cutting parameters on the measurement of Fz force are shown in Figure 7. The highest Fz mean value (582 N) was obtained for the following parameters: a cutting depth 2.0 mm and feed 0.075 mm/rev. For feeds of 0.05 and 0.075 mm/rev and an increase of depth of cut in all ranges, the Fz force increases too. For feed 0.1, while ap increases, the Fz force decreases.

**Figure 7.** The results of changing cutting parameters on Fz.

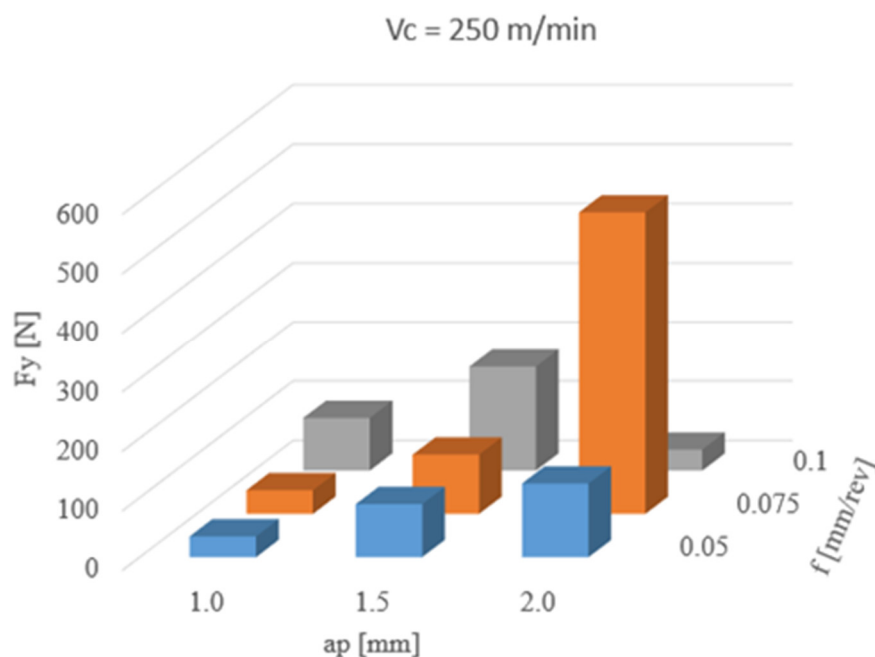
Figure 8 presents the effect of changing such parameters as: ap and f on the feed force Fy. The highest Fy mean value (509 N) was observed for: a cutting depth of 2.0 mm and feed of 0.075 mm/rev. For other depths of cut, the mean values of feed force did not exceed 180 N. A significant increase of feed force testifies to an abrupt change of cutting conditions during the analyzed process.

**Figure 8.** The results of changing cutting parameters on  $F_y$ .

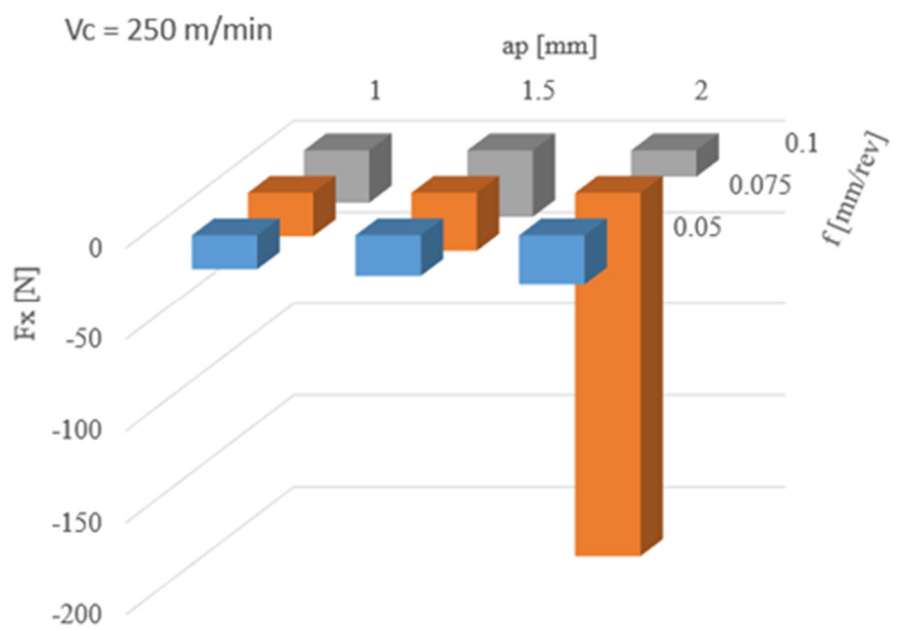
Figure 9 shows the results of the influence of cutting parameter changes on the measurement of  $F_x$  force. The mean value of that force does not exceed  $-36$  N for depth of cut in the range of  $1.0$ – $2.0$  mm. The highest  $F_x$  mean value ( $-198$  N) was obtained for: a cutting depth  $2$  mm and feed  $0.075$  mm/rev. A significant increase of radial force indicates a change in geometry of the cutting insert, and thus its damage or wear. This was confirmed during microscopic examination of the tool's treating zone.

**Figure 9.** The results of changing cutting parameters on  $F_x$ .

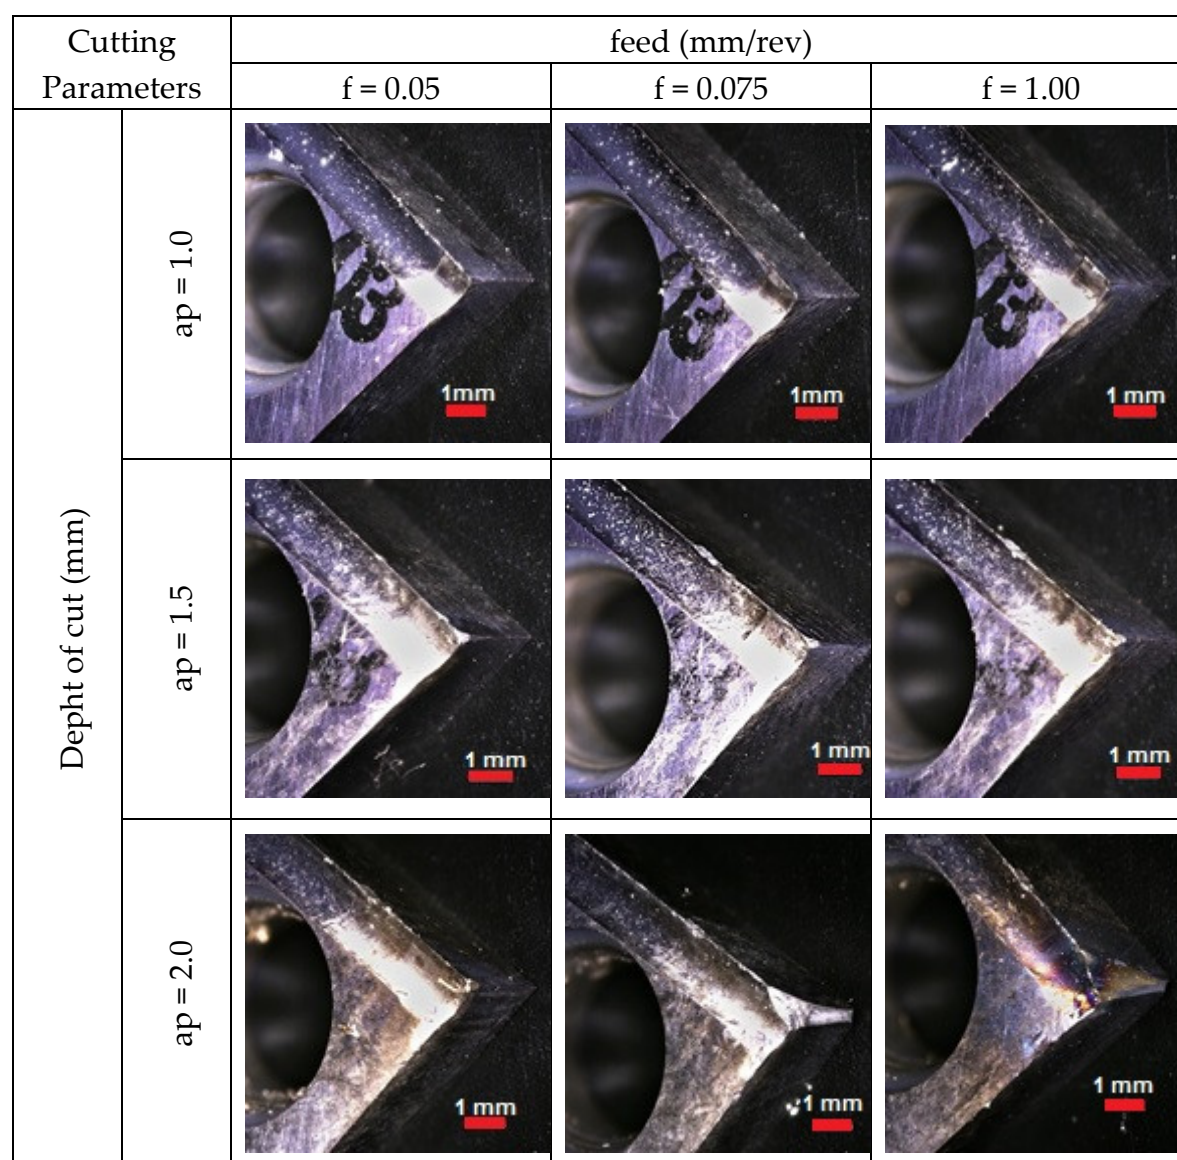
The reason for such a clear increase of forces and their scattering is the damage of the nose of the cutting insert. The view of the cutting edge with different stages of wear can be seen in Figure 10. It shows the images of the rake face of the tool after individual passes.

**Figure 10.** The wear of cutting edge.

In the first stage of cutting shaft pins ( $a_p = 1.0$  mm,  $f = 0.05$ ,  $0.075$  and  $0.1$  mm/rev), only wiping on the surface layer of the cutting insert coating can be observed. The effects of the turning process

can be seen only on the rake face, which corresponds to the depth of cut. Increasing the cutting depth to 1.5 mm at the same feed rates results in an additional loss of material at the corner radius and a slight deformation of the major cutting edge in the area of the rake face and flank face. The highest wear of the cutting tool occurred for the process carried out with  $a_p = 2.0$  mm. For a feed value of 0.05 mm/rev, a line is visible along the major cutting edge, which may indicate a crack in the insert coating on the chipbreaker. Visible damage in the form of abrasion on the flank face and notch, may contribute to faster abrasion of that surface, resulting in poor surface quality or dimensional inaccuracy of the detail. The insert's wear process started when the feed was increased to 0.075 mm/rev. In the zone of the insert taking active part in the cutting process, the cutting edge was damaged along with breaking the entire corner radius with simultaneous wiping of the rake face and the auxiliary and main flank faces. Continued machining with a damaged insert caused the expansion of the degradation zone as well as thermal overheating and thermal cracks. In addition, micro chipping was observed, which also has a negative effect on surface finish and intensive wear of the flank face.

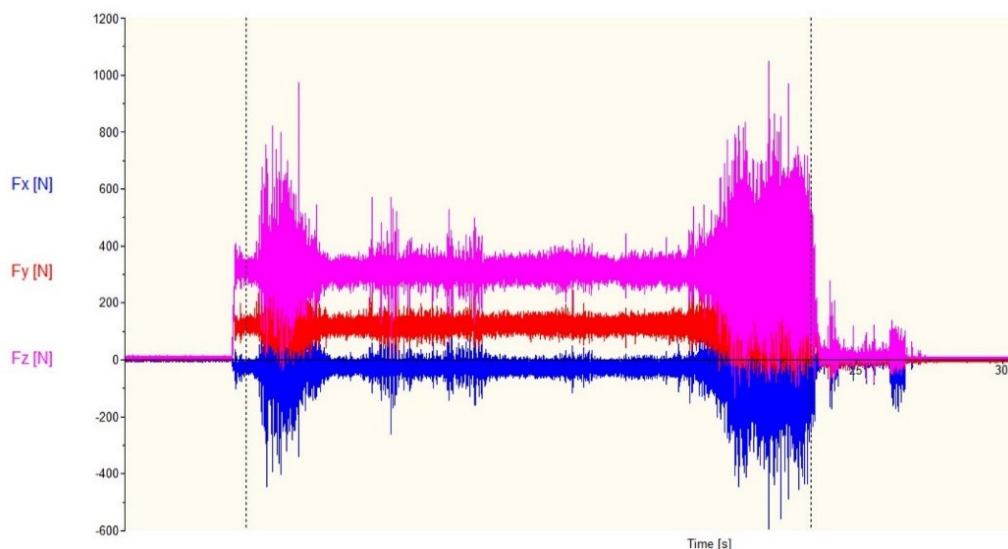
**Figure 11.** Cutting forces during turning with parameters:  $a_p = 2.0$  mm,  $f = 0.05$  mm/rev.

The analysis of forces during the turning process showed that, at the beginning of the cutting edge, the damage process can be observed for machining with cutting parameters  $a_p = 2.0$  mm and  $f = 0.05$  mm/rev (Figure 11). Increasing the feed to 0.075 mm/rev caused damage of the cutting insert nose, in the form of a loss of part of the cutting edge, which affected the change of conditions during the cutting process. Cutting forces registered during the study were shown in Figure 12, while relatively large standard deviation obtained confirm the unstable cutting process. Increasing the feed value with a damaged cutting insert allowed to obtain a fivefold lower value of the  $F_z$  force and a significant reduction of the radial and feed force.

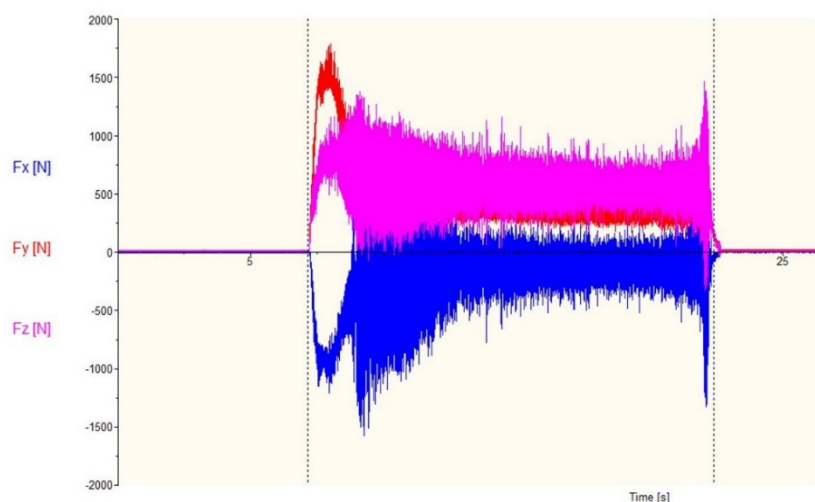
**Figure 12.** Cutting forces during turning with parameters:  $a_p = 2.0$  mm,  $f = 0.075$  mm/rev.

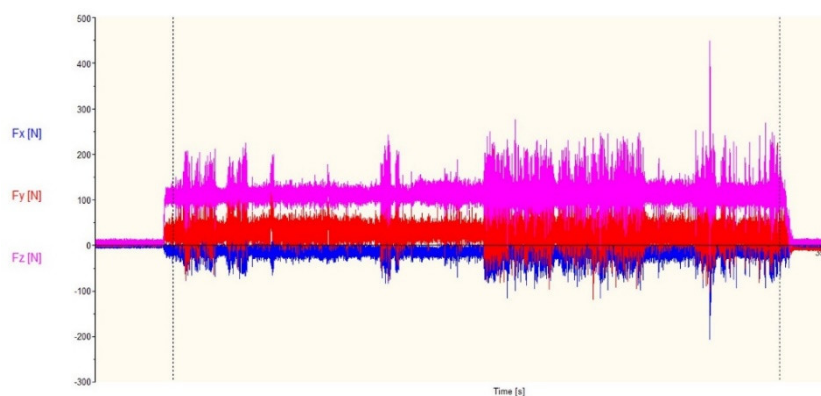
A further cutting process was performed with a cutting depth of 2.0 mm and a feed rate of 0.10 mm/rev, and despite the damage to the cutting insert, the analysed forces did not reach such significant values (Figure 13).

**Figure 13.** Cutting forces during turning with parameters:  $a_p = 2.0$  mm,  $f = 0.10$  mm/rev.

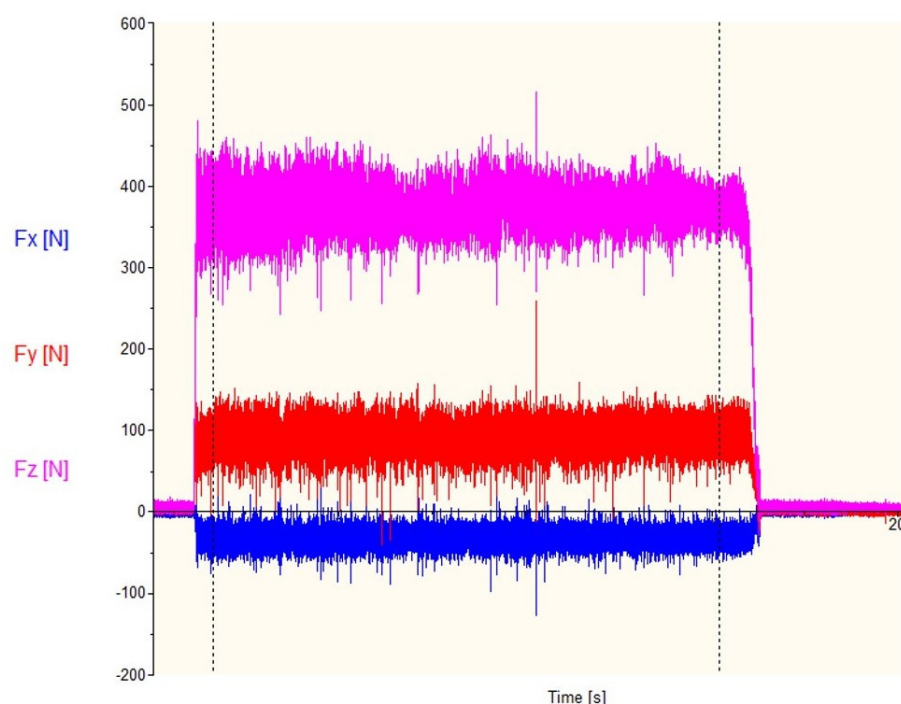
An example of a graph recorded during the study, showing the change of cutting forces over time, is shown in Figure 14. The graph shows cutting forces during turning by a tool with a new cutting insert.

**Figure 14.** Cutting forces during turning by tool with new cutting insert with parameters:  $a_p = 2$  mm,  $f = 0.1$  mm/rev.

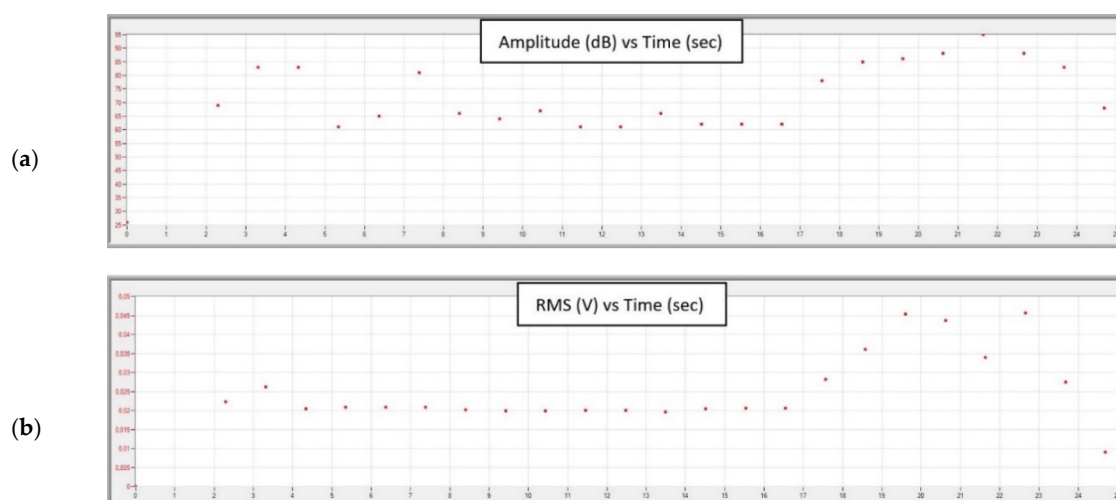
**Figure 15.** Charts of (a) amplitude and (b) RMS changing as a function of time during turning with parameters:  $a_p = 2.0$  mm,  $f = 0.05$  mm/rev.

In the final stage of turning with the parameters  $a_p = 2.0$  mm,  $f = 0.05$  mm/rev, an increase in the amplitude and RMS of the recorded signal is noticeable. The RMS signal rises sharply to  $50 \mu\text{V}$ ; about twice as high compared to turning with a sharp cutting edge. Relatively low frequency of the signal and the increase of its amplitude (Figure 16) indicates a significant increase in its energy. This sudden increase in the energy of the generated AE signal may indicate the beginning of the destruction process of the cutting insert.

An analysis of data recorded during the tests showed that it is possible to observe the beginning of a destruction of the nose of the cutting insert using the acoustic emission method. Figures 15 and 16 show a sudden increase in the amplitude and RMS of the signal in the final stage of turning with the parameters  $a_p = 2$  mm,  $f = 0.05$  mm/rev. The tool failure process was continued while turning with the same insert with the parameters  $a_p = 2$  mm,  $f = 0.75$  mm/rev. A signal with an average RMS value of about 70% higher than in the case of turning with previous parameters was recorded. Increasing the feed to  $f = 0.1$  mm/rev at the same  $a_p = 2$  mm caused an increase in the RMS signal, with mean values being characterized by a large spread, as evidenced by a relatively large standard deviation.

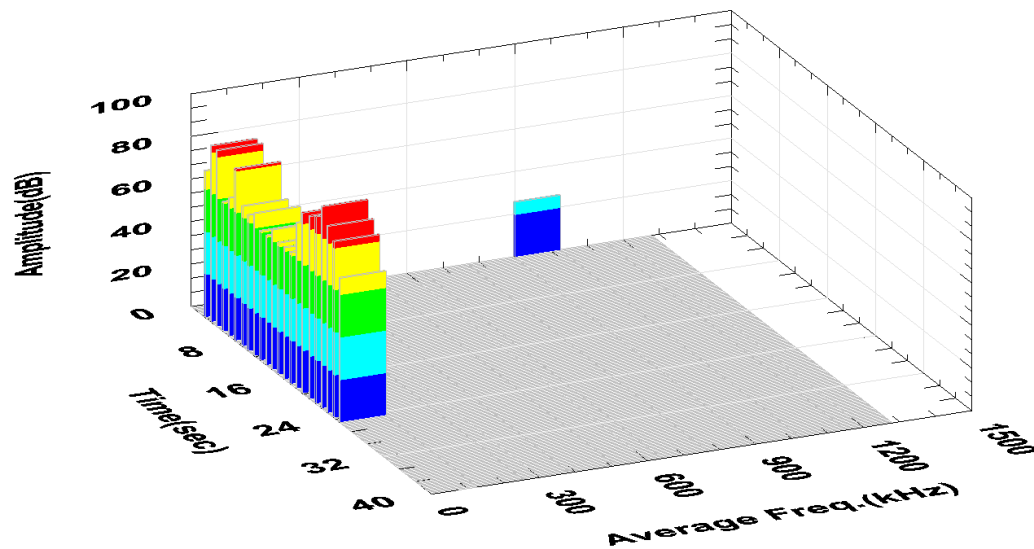
**Figure 16.** Chart of amplitude and average frequency changing as a function of time, during turning with parameters:  $a_p = 2.0$  mm,  $f = 0.05$  mm/rev. Different colours help to observe changes in amplitude-every 20 dB.

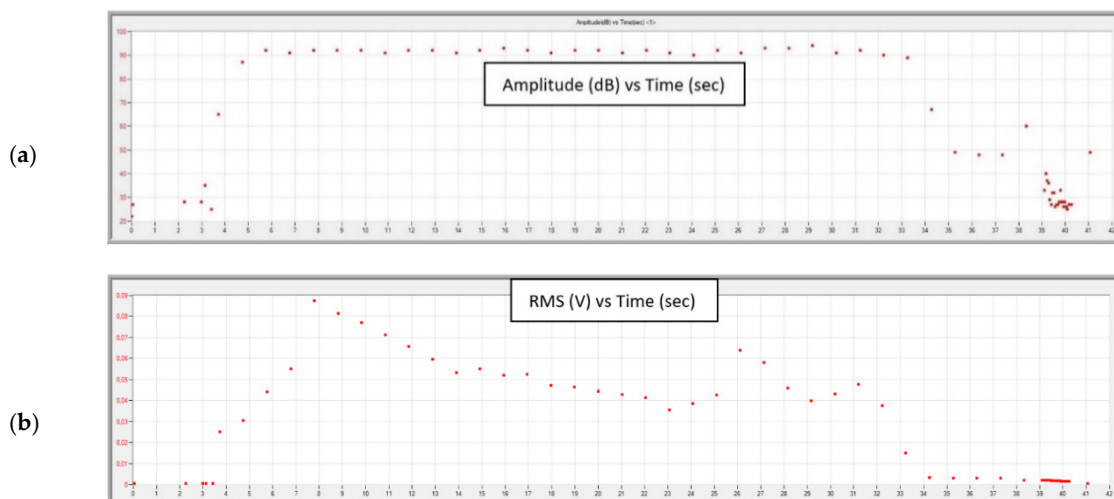
**Figure 17.** Charts of (a) amplitude and (b) RMS changing as a function of time during turning with parameters:  $a_p = 2.0$  mm,  $f = 0.075$  mm/rev.

Figures 17 and 18 show waveforms of signals recorded during turning with a cutting insert has a significant degree of wear. High RMS values (about 40–50  $\mu$ V) of the signal indicate further damage of the insert. It is particularly visible in the initial turning phase with the parameters  $a_p = 2.0$  mm,  $f = 0.1$  mm/rev where the signal RMS was recorded to be about five times higher than the undamaged insert; the maximum value was 111  $\mu$ V. While the turning was performed in a good condition, this parameter was, on average, around 20  $\mu$ V.

A high RMS value and signal amplitude suggest further destruction of the tool. This is particularly evident in Figure 17 in the initial and final turning phases. Despite the significant damage of the nose of the cutting insert, the lathing process was stable. The relatively stable course of the process is evidenced by the decrease in the number of hits of recorded signal.

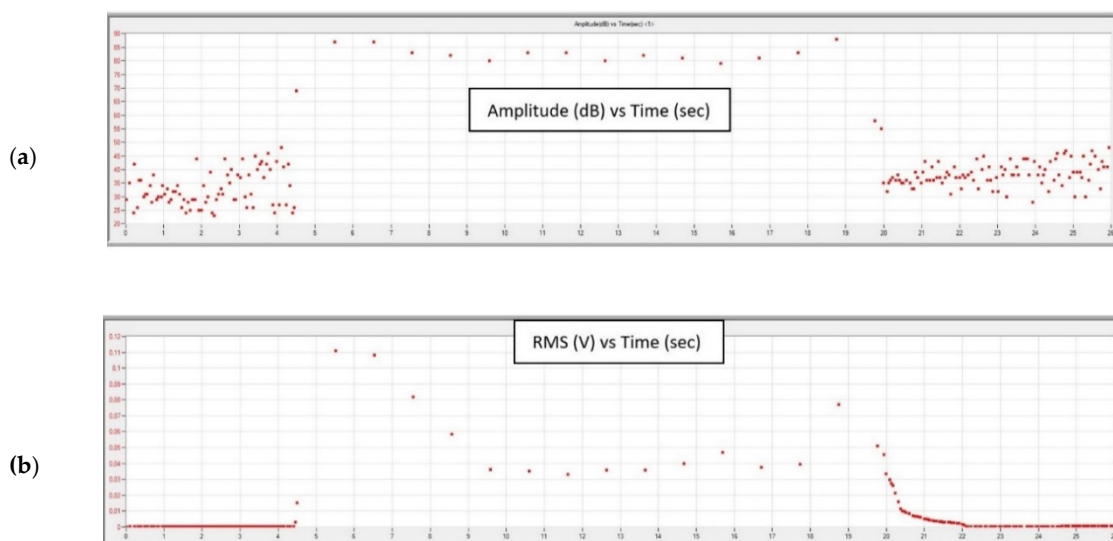
**Figure 18.** Charts of (a) amplitude and (b) RMS changing as a function of time during turning with parameters:  $a_p = 2.0$  mm,  $f = 0.1$  mm/rev.
