Article

The Research of the Rolling Speed Influence on the Mechanism of Strip Breaks in the Steel Rolling Process

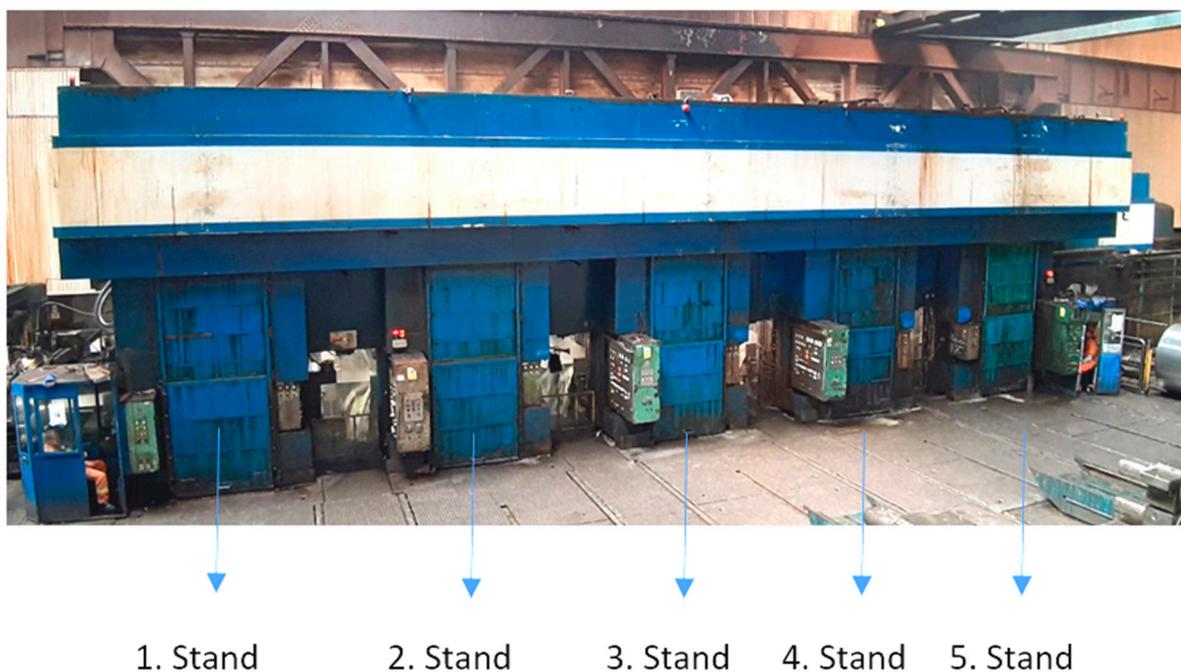
Figure 1. Five-stand cold-rolling tandem mill.

Figure 1 shows a five-stand cold-rolling tandem mill in which the presented research was carried out. Entry maximum thickness of strip is 3.8 mm exit thickness is maximum 1.75 mm, depending on the rolled steel grade. The research was carried out on tinplate steel grades, such as TH620N, TH415, TH550, TS290, TS245, and others. Tinplate grades are the most critical ones due to their very low thickness, around 0.175 mm, i.e., the thickness is comparable to a paper sheet.

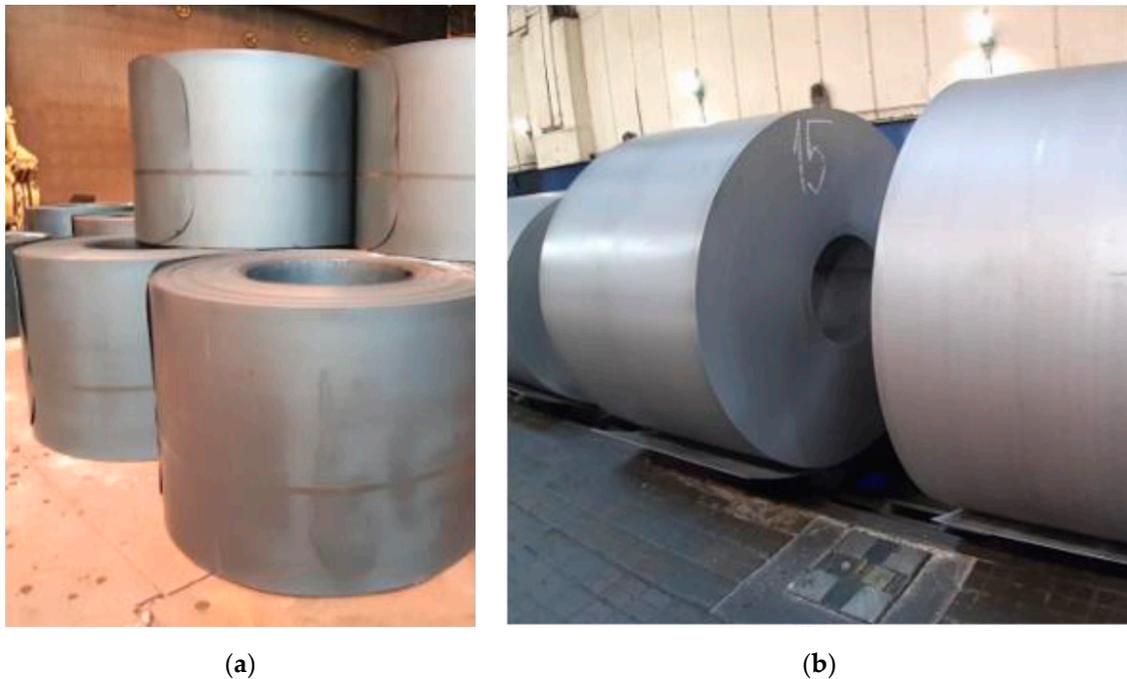
Figure 2. (a) Hot-rolled coils before pickling process; (b) Coils after pickling process.

The cold-rolling process is preceded by pickling. The pickling process is a process when oxides and other foreign materials are removed from the surface of a steel strip using acid solution. Figure 2a shows that the hot-rolled steel strip surface is dark, caused by oxides, and sometimes there is corrosion. Additionally, grease can occur. The cleaning of the strip surface is necessary for further production operations. Figure 2b shows coils with pickled surfaces.

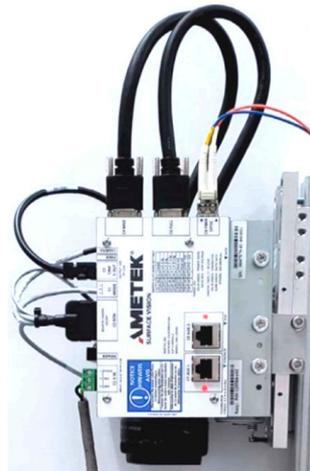
Figure 3. Surface inspection camera.

Figure 3 shows the camera with Camera Link Interface module (AMETEK Surface Vision, Hayward, WI, USA) which is installed at the pickling line. In total, eight cameras were installed at the pickling line: four on the top side and four on the bottom side.

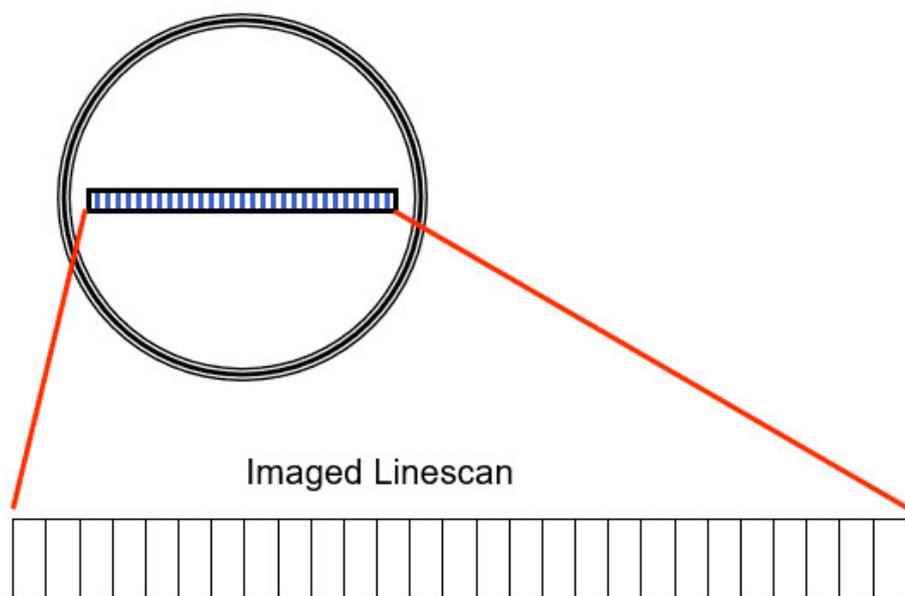
Figure 4. Array of SmartView camera, with single row of pixels.

Some cameras, such as those used in modern digital cameras, have a group of pixels arranged in rows and columns forming a rectangular shape (like the rectangular film of a standard photographic camera). Figure 4 shows SmartView cameras, however, there is a single row of pixels, and the cameras are therefore called linescan cameras because they see (scan) one line at a time.

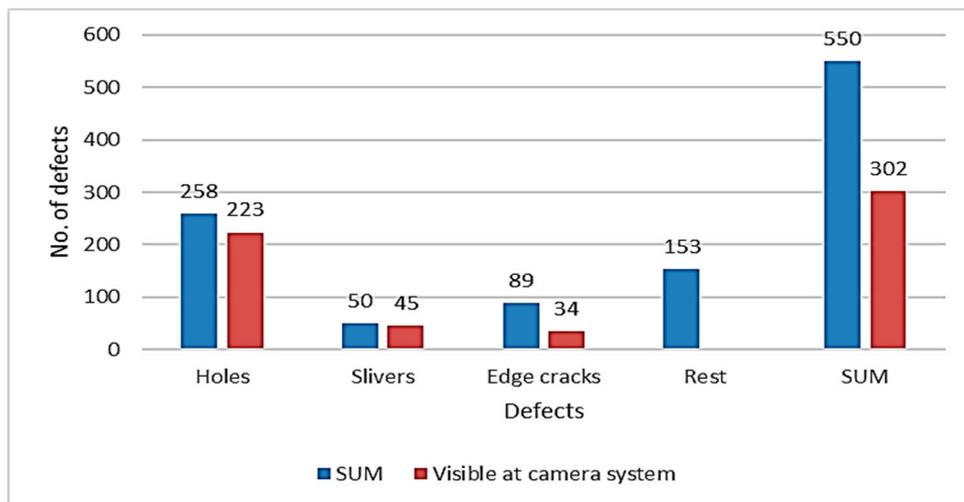
Figure 5. Result of defect verification.

The classification helps determine what defects are critical in the rolling process. System is able to identify defects that are present on strip surface and to predict the risk degree they pose to the rolling process. Figure 5 shows correlation of broken strips and defects visible on strip during pickling was made. There were 550 defects in the database; of that, 302 defects were visible on camera system records. The analysis shows, that preventive actions could have been implemented to prevent an incident during cold-rolling process. The data are displayed in Figure 5. The defects visible on camera records were present on 54.9% of defective coils.

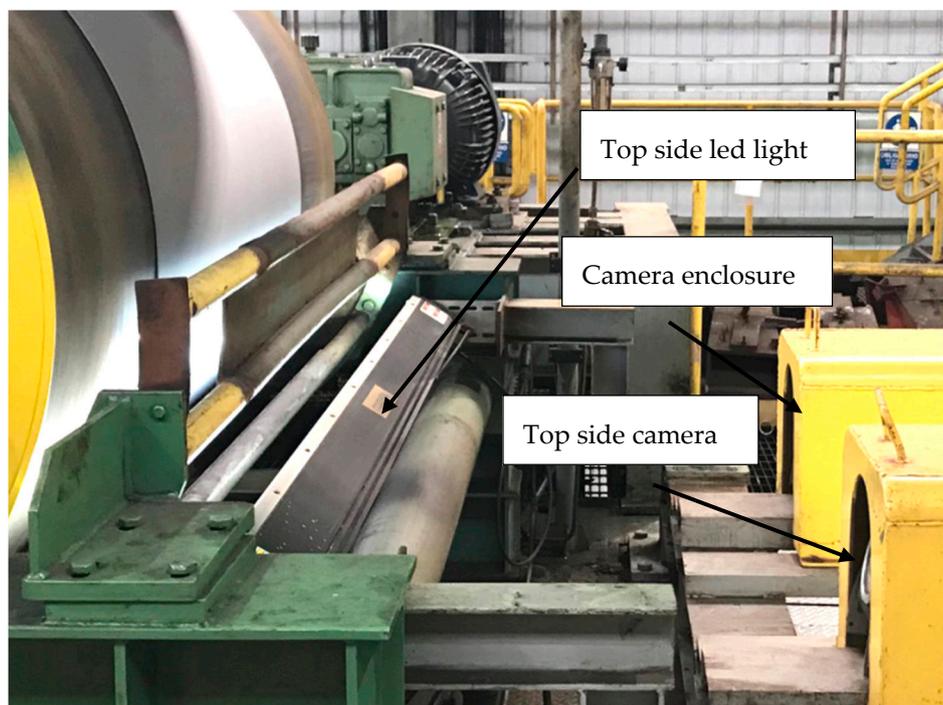
Figure 6. The SmartView system at the end of pickling line.

High-speed cameras were installed at Pickling Line Ametek SmartView®-Surface Inspection system (Hayward, WI, USA) with 6 K cameras; Ametek SmartView®scans the surface of the strip and categorizes the defects. The cameras are mounted in a protective enclosure against damage Figure 6. The surface of the strip lit by an LED light.

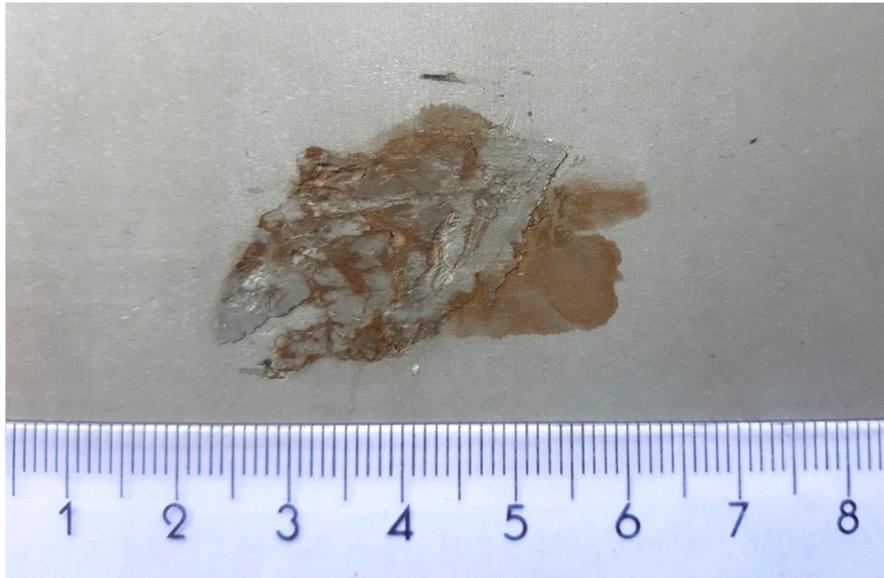
Figure 7. Foreign material inside strip (cm).

Figure 7 shows hot-rolled foreign material rolled on the surface in the hot-rolling process. Those pieces of material from hot-rolling mill fell to the strip surface and were rolled in. This comes from part of the hot-rolling mill and it is critical for the cold-rolling process. The foreign material was detected on the pickling line camera system and the sample was taken for verification.

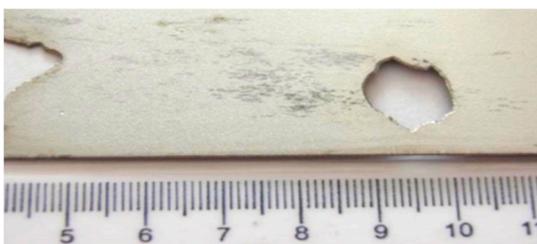
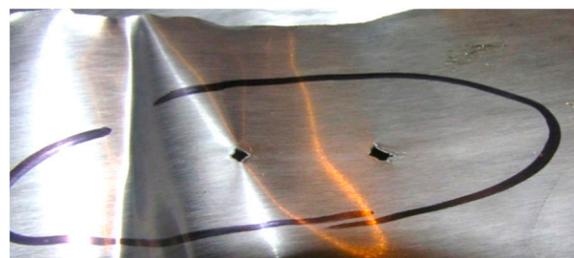
Figure 8. Samples from metallographic analysis (a) Holes in the strip after metallurgical sliver falls out after the rolling process (cm); (b) Holes in the strip after metallurgical sliver falls out after the rolling process.

Further verification was provided after the cold-rolling process. The metallographic analysis confirmed that the root cause of the defect was a metallurgical sliver Figure 8. In the subsurface layers of the steel substrate were linear particles of steelmaking mold flux/cover flux Figure 9. The following elements were found in the particles: Si-Ca-Mg-O, Figure 10, EDS1.

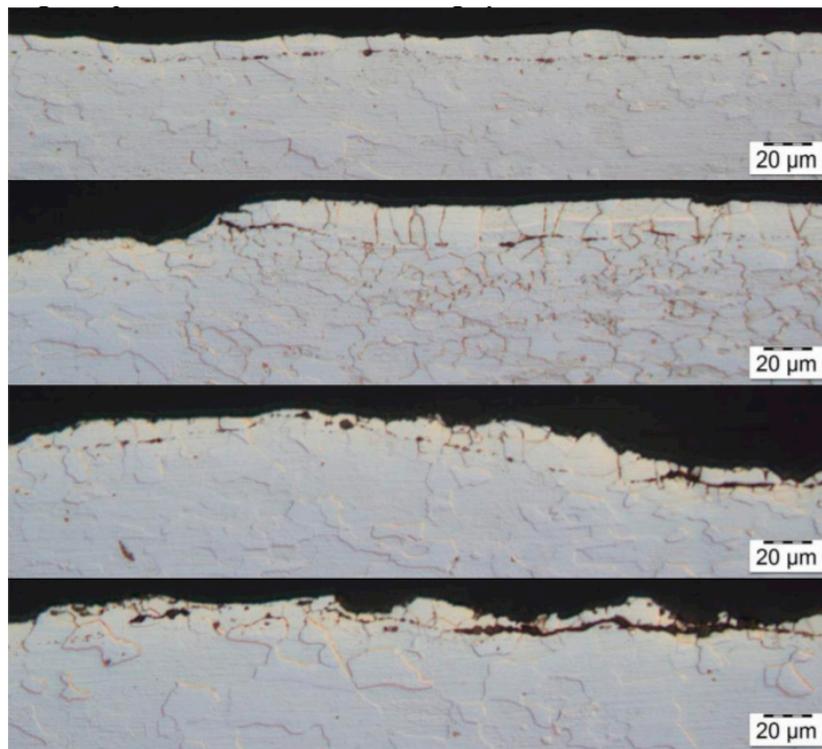
Figure 9. Optical micrographs of metallographic cross-section in the selected defective area.

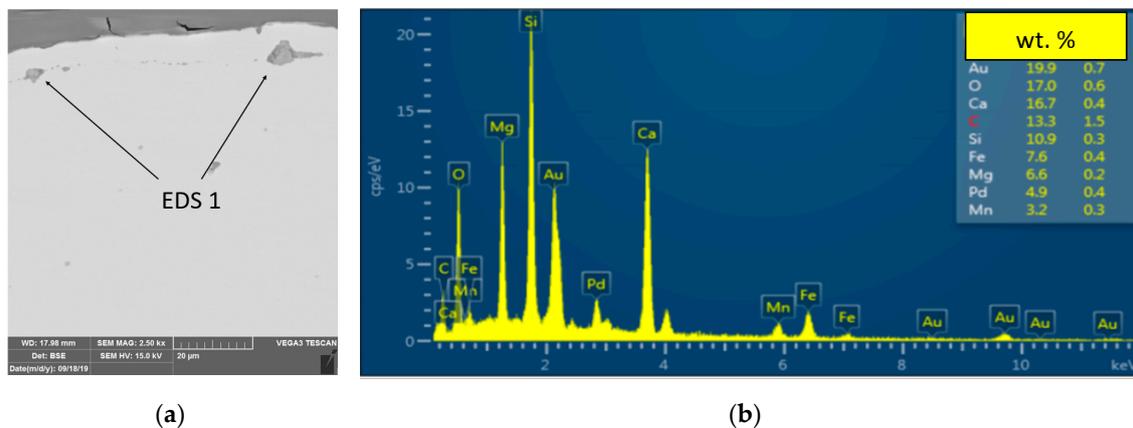
Figure 10. EDS, Energy-dispersive X-ray spectroscopy analyses of foreign fragments of samples: (a) Foreign particles in the steel substrate in the damaged area where the EDS analysis was performed (b) Results of EDS analysis, chemical elements detected by EDS analysis.

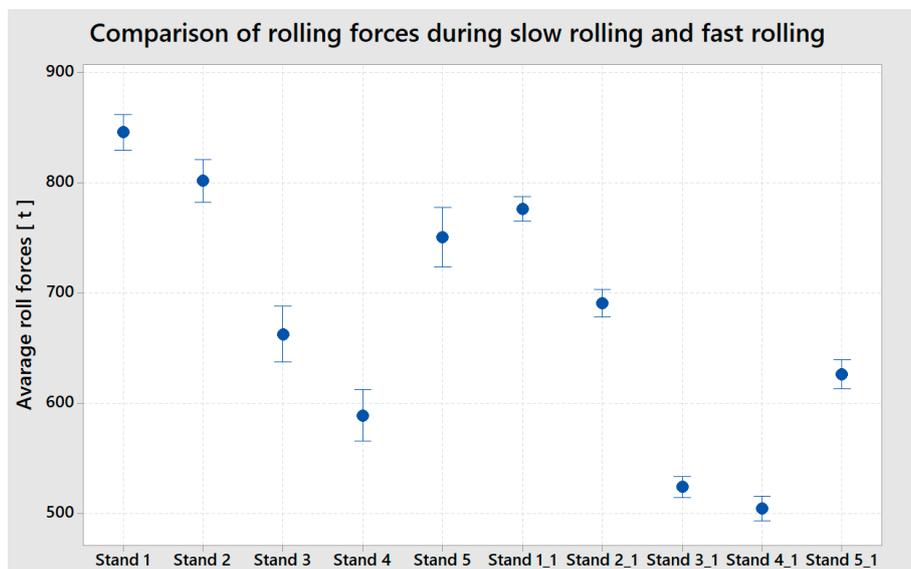
Figure 11. Comparison of rolling forces slow rolling (Stand 1, 2, 3, 4, 5,) and fast rolling (Stand 1_1, 2_1, 3_1, 4_1, 5_1).

The results did not confirm our expectations. Based on the empirical experience, it was expected that through kinetic energy reduction, the forces in the rolling process would also drop, thus reducing the risk of a strip break. The results achieved during the trial are displayed in Figures 11 and 12. The rolling speed reduction did not reduce the forces applied on the critical position in the strip where the simulated defect was located; on the contrary, the values measured in the rolling process were, when the rolling speed was reduced, higher than when the strip was rolled at a higher, stable rolling speed. The inter-stand tensions increased and so did the differential tensions, overall rolling forces, and the Stand 5 tilting was oscillating, and the thickness chart was much more disturbed than at the portion of the strip where the rolling speed was stable. The boxplot chart in Figure 11 shows the rolling force values in tons at each rolling stand at the time when the rolling speed was reduced to 900 m/min (Stand 1, 2, 3, 4, 5) and values in tons at each rolling stand during the stable rolling speed of 1250 m/min. (Stand 1_1, 2_1, 3_1, 4_1, 5_1)

The difference between the two rolling modes is clearly visible. When rolling at the stable speed of 1250 m/min, the rolling forces have a smaller scatter and the rolling process is more stable than when the rolling process slows down. The most significant finding is that the value of the rolling forces, i.e., the factor that most significantly influences the factors that negatively influence the rolled strip from the perspective of the potential destruction of a strip with a critical defect in the rolling process. The overall rolling forces at each stand are significantly higher at a lower rolling speed.

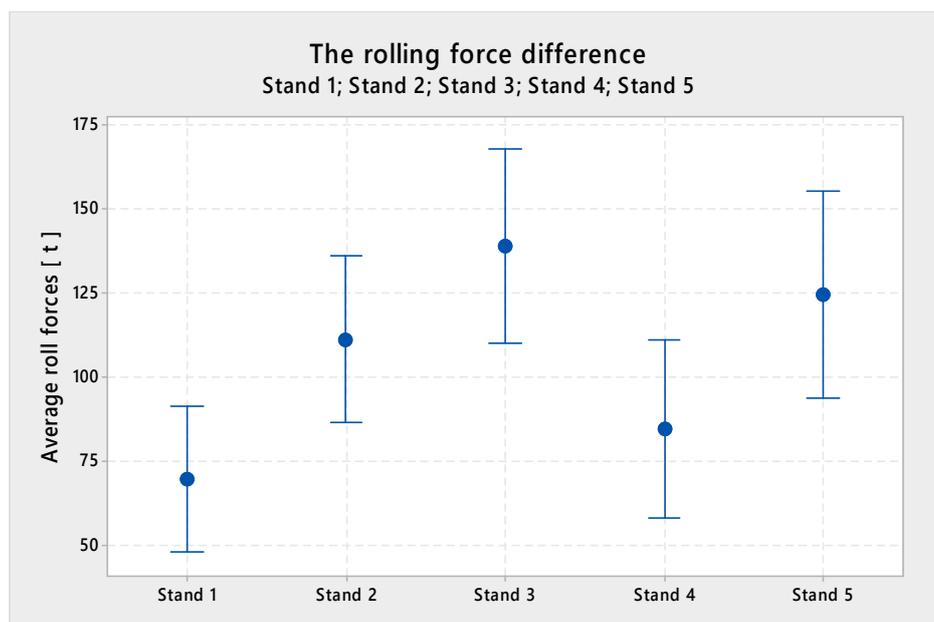
Figure 12. Difference of forces slow and fast rolling.

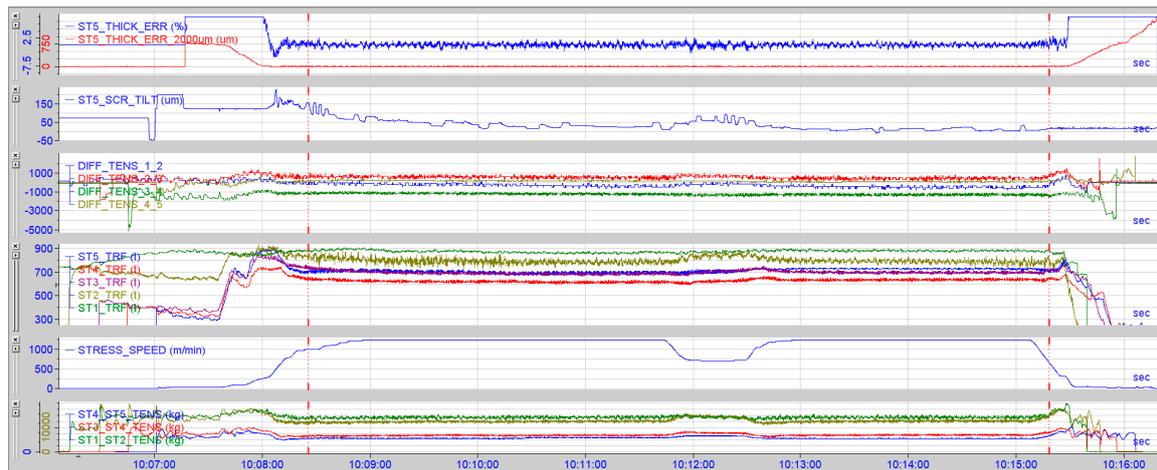
Figure 13. Forces during slow-down of the rolling process.

Figure 13 shows the difference between the average value of total rolling force at each stand at the reduced speed, created with a sample of 100 coils.

- (1) At Stand 1, the value was higher by 69.57 tons
- (2) At Stand 2, the value was higher by 111.21 tons
- (3) At Stand 3, the value was higher by 138.71 tons
- (4) At Stand 4, the value was higher by 84.68 tons
- (5) At Stand 5, the value was higher by 124.59 tons

In Figure 13, one can observe the forces captured by the Iba analyzer during the rolling process when the rolling was reduced; the ST5_THICK_ERR value displays the discrepancy from the requested strip thickness. It is clearly visible that the thickness was oscillating when the speed was reduced. Even though it is within the required limits, gauge oscillation is an unwanted phenomenon. The ST5_SCR_TILT chart displays the values from Stand 5 tilting where the stand was, due to the rolling parameters' change induced by the slow-down, tilting +70 µm. The tilting of the last stand regulates the strip flatness; any unwanted changes of tilting may have a negative impact on the strip flatness. The following charts: DIFF_TENS (different tensions), TRF (total roll force), STX_STY_TENS (tension between stands) display oscillating forces in the rolling process incurred by the rolling speed change.
