# Acoustic Emission and Numerical Analysis of Pine Beams Retrofitted with FRP and Poplar Wood

**Abstract:** Acoustic emission (AE) released by pine beams retrofitted with fiber reinforced plastic (FRP) and poplar planks in bending is analyzed. Basalt fabric (FB), carbon fabric (FC), and carbon pultruded laminate (LC) have been used as FRP. Experimental results and AE behavior are discussed based on an elastoplastic finite-element numerical model. The model demonstrates a strong strain concentration at the end of poplar planks, which causes high AE activity in these areas and acts as a precursor of the delamination of the poplar plank. Based on the experimental results, some AE criteria for predicting the onset of the delamination are tentatively proposed.

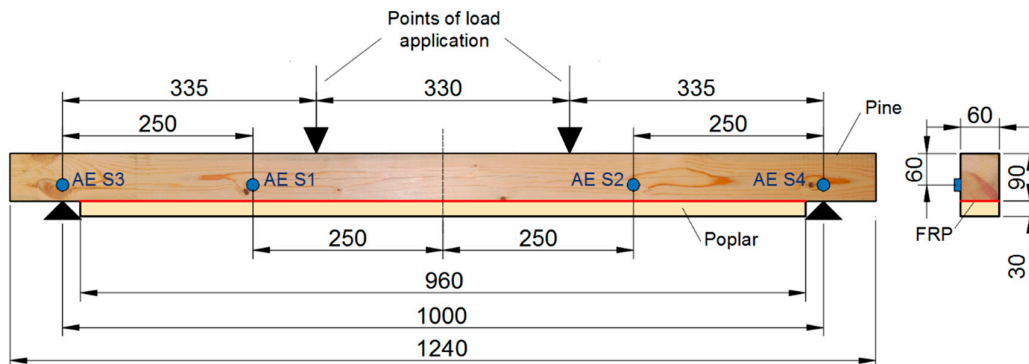
All the four samples were subjected to a four-point bending test, as shown in Figure 1 and described in [17]. The strains at the mid cross-section were measured by gluing six strain gauges as explained in [17]. In order to obtain the MOEst (static modulus of elasticity), the stress-strain slope, with the strain gauge placed on the tension face of the poplar plank, was calculated between 20% and 50% of the maximum stress. Four multiresonant VS45-H piezoelectric sensors (AE sensors, Vallen Systeme, Icking, Germany) were mounted on each specimen, as indicated in Figure 1 [18]. They were acoustically coupled to the specimens by means of silicone grease, and using magnetic holders hooked to flat washers, which were in turn previously glued on the wood surface. The acquisition threshold was 25 dB and the gain 34 dB. The AE signals were acquired with five Msamples/s, a 50 kHz high pass filter, and a 500 low pass filter. Moreover, in order to avoid friction noise, thin Teflon pieces were placed between the wood specimen and the supports. Figure 2 depicts a particular specimen at the testing machine. For each recorded signal, the peak amplitude in dB (A) and the signal strength (SS) were obtained. Moreover, using the hits received for each sensor, a linear location of the AE events was carried out, and 300 cm/ms was used as propagation speed of the specimen along the longitudinal direction (grain direction).

Figure 1. Experimental setup. Distances in mm.

The elastoplastic behavior of the four specimens was analysed by the numerical technique of the finite element method. The geometry of the experimental setup shown in Figure 1 was modeled in AutoCAD 2012 (Autodesk®, San Rafael, CA, United States) [24] CAD software and imported into the open source finite element code Salome Meca® (Code Aster) [25] using the IGES format which allows an easy exchange of information between codes, finally results were drawn with MATLAB® (2013a, Mathworks, Natick, MA, United States) [26]. The constitutive parameters (MOE, Poisson's ratio, elastic limit, and MOR) of pine timber, poplar planks, and FRP were taken from the experiments [17] and shown in Table 3. The points of load shown in Figure 1 were applied as distributed loads in the transverse direction, and the beams were simply supported. Domain was discretized into a finite element mesh composed by 75,000 eight-node hexaedral elements and 91,364 nodes. The average element size was 5 mm, except for the FRP layer. Table 2 shows that the thickness ranges from 0.14 to 1.4 mm. Distributed transverse loads and boundary conditions were transferred into the finite element mesh. Notice that domains of pine beam, FRP layer, and poplar planks are tied by the finite element mesh. The elastoplastic nonlinear analysis was carried out using the linear elastic perfectly plastic model from Salome Meca® (Code Aster, 2018, Électricité de France, Paris, France) [25], where the nonlinear equations were solved with a direct full newton solver. See reference [27] for detailed explanation. Loads are applied incrementally in each step with an increase of 0.001 of the total load. The analysis provides displacements, stresses, strains, and yielding of nodes and elements of the mesh at every step. The set of nodes and elements in the middle of the top and bottom faces and in the position of the gauges described in the previous section are used to compare the finite element results with those provided by the experiments.

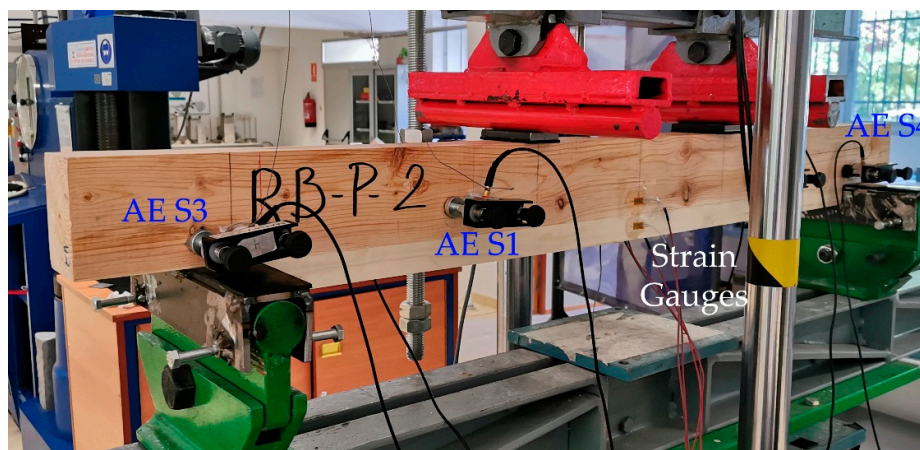
Figure 2. Image of the specimen SP during the bending test.

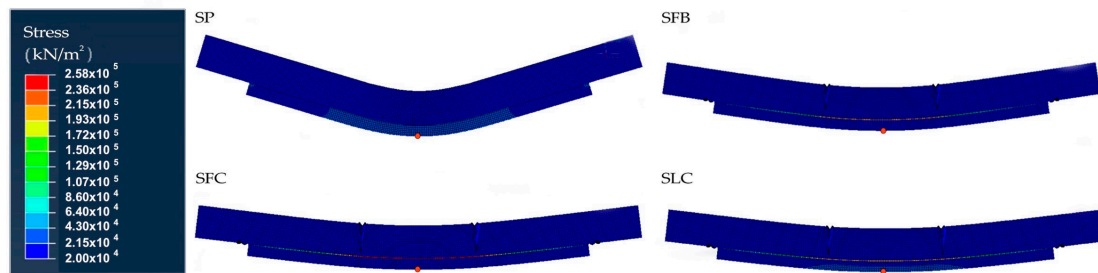
Figures 3 and 4 show the equivalent stress (Von Mises) and equivalent strain distribution numerically obtained for each particular specimen. Using the normal stress and strains distributions, not shown in this paper for simplicity, we can determine the tension and compression areas. As it can be seen in Figure 3, for the SP beam the maximum tensile stress value is reached at the poplar plank, 25 MPa (see the red point in Figure 3). However, for the SFB, SFC, and SLC specimens, the stress is a 28.8%, 40.1%, and 40.2%, respectively, lower compared to the SP beam (see the red point in Figure 3). This fact is mainly caused by the absorption of stresses carried by the FRP element. The strain field is consistent with that expected, being the central area of maximum compressions and tensile stresses the MOEst demanded. For the SP specimen, there is a concentrate strain area with higher values at the upper part of the mid-span of the specimen. Table 4 summarizes the numerical MOE ( $MOE_{num}$ ) obtained for the four beams, as well as the maximum strains obtained for the upper and bottom face (maximum compression and tensile strains, respectively). In this area, the maximum strain value was of 0.12%, highly different to the 0.08%, 0.08%, and 0.07% reached by the SFB, SFC, and SLC specimens, respectively (see the red point in Figure 4). These lower values of strain for the specimens retrofitted with FRP elements, are correlated with the softer distribution of the strain field along the length of the beam. In addition, for all the beams there is a high strain concentration at the support areas (see green points in Figure 4), being critical points to produce a premature delamination. Regarding the different types of FRP, the maximum compression strain for the SLC specimen was 89.9% and 86.1% lower compared to the SFB and SFC beams, respectively, which is

Figure 3. Numerical stress distribution for each specimen.

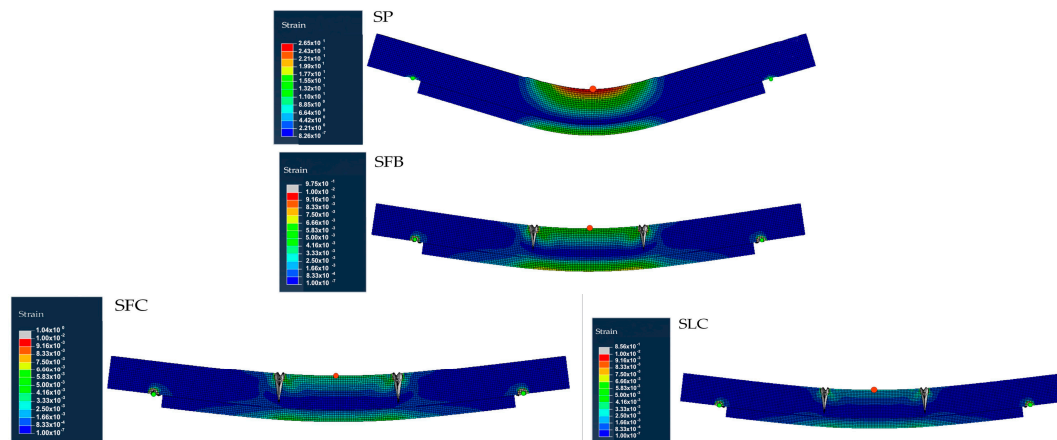
highly correlated with the different stiffness of the FRP materials (see the red point in Figure 4).

Figure 4. Numerical strain distribution for each specimen.

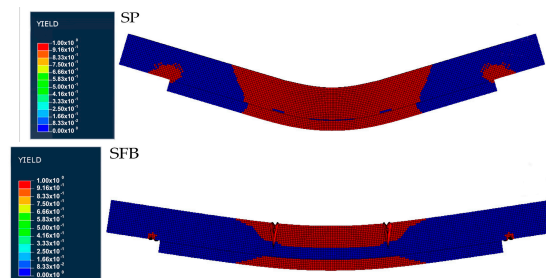
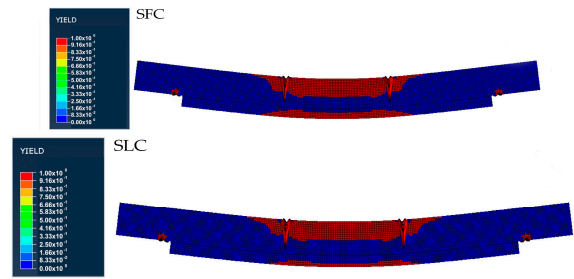
Figure 5 shows the plasticization pattern, demonstrating the previous stress/strain differences between the specimens retrofitted with FRP elements and the SP specimen, as well as the stiffness variations of the different FRP materials. In particular, it can be noticed that the SP specimen reaches the highest plasticization level between the four specimens, with all the mid-part of the specimen plasticized. On the other hand, the SLC specimen is the least plasticized due to the higher stiffness of the CFRP laminate. SFB and SFC ones show a similar behavior.

Figure 5. Numerical plasticization pattern for each specimen.

By means of a FEM elastoplastic analysis of pine beams retrofitted with FRP and poplar planks it has been demonstrated that: (i) FRP absorbs most of the stress and provides a softer distribution of the strains field; (ii) a strong strain concentration is observed in poplar tensile and pine compression areas, but also at the end of the poplar planks (near the support areas), demonstrating that these are the most critical areas to initiate a delamination between FRP and poplar plank, as validated experimentally; (iii) FRP provides a reduction of the maximum deformations with respect to the retrofitting layout using only the poplar plank; (iv) LC layout undergoes the lower maximum deformations than fabric (carbon or basalt) fabric layouts; (v) the specimen without FRP, i.e., only retrofitted with the poplar plank, suffers the largest plasticized area, while the specimen retrofitted with pultruded laminate, SLC, suffers the smallest plasticized area.

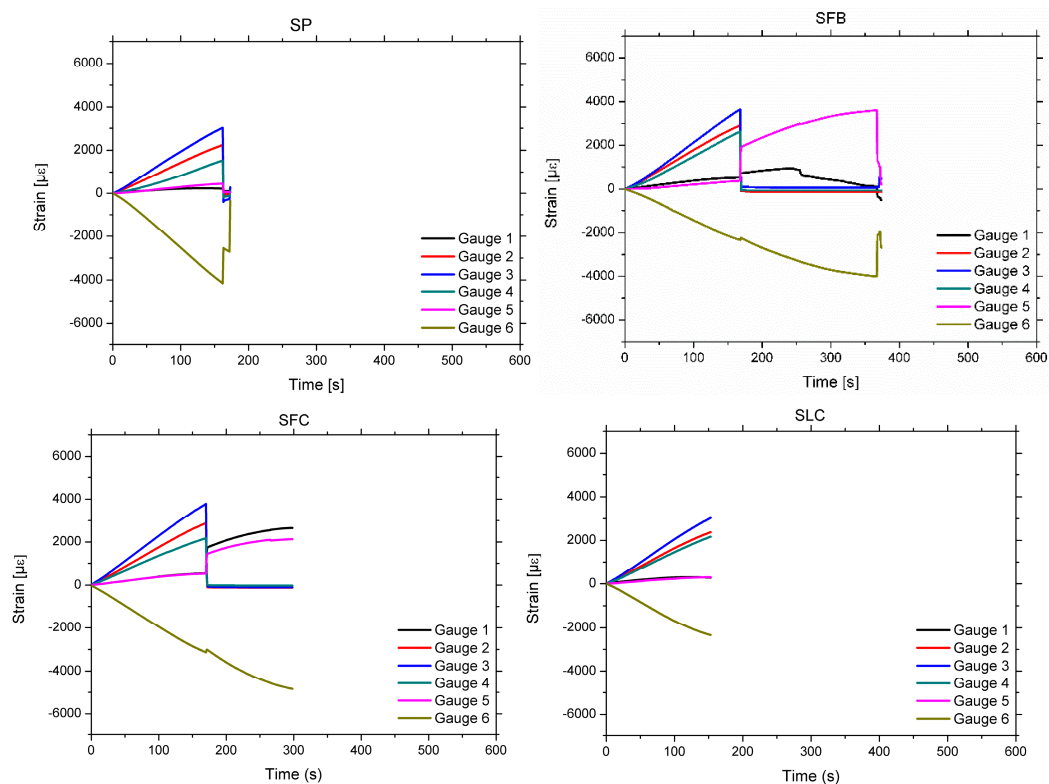
Figure 6 shows the strain-time plots, the strain being measured by the six gauges for all the four specimens. As expected, the maximum strains are obtained at the upper and bottom external faces (gauge 3 for tensile and gauge 6 for compression strains). Similarly, the strain at points 2 and 4, and 1 and 5, are similar to each other. The strain at the poplar plank (2 and 4) are greater than that at the adjacent points at the pine beam (1 and 5), due to the latter being closer to the neutral fiber. Similarly, Figure 7 shows the stress-time plots for all the specimens, while Table 5 shows the experimental  $MO_{Est, exp}$  and MOR.

Figure 6. Experimental strain-time plots for all the specimens. See [17] for the position of the strain gauges.

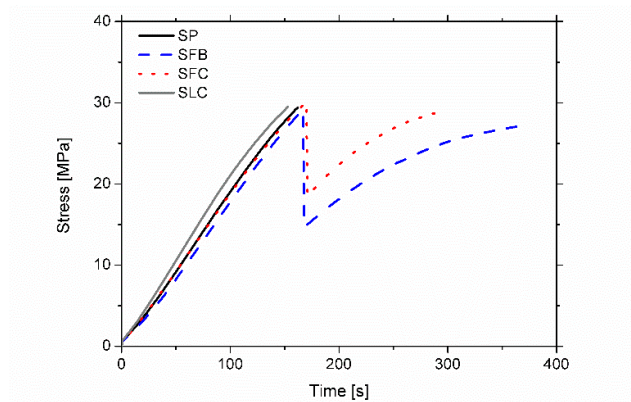
**Figure 7.** Experimental stress-time plot of tensile strain (gauge 3) for all the specimens.

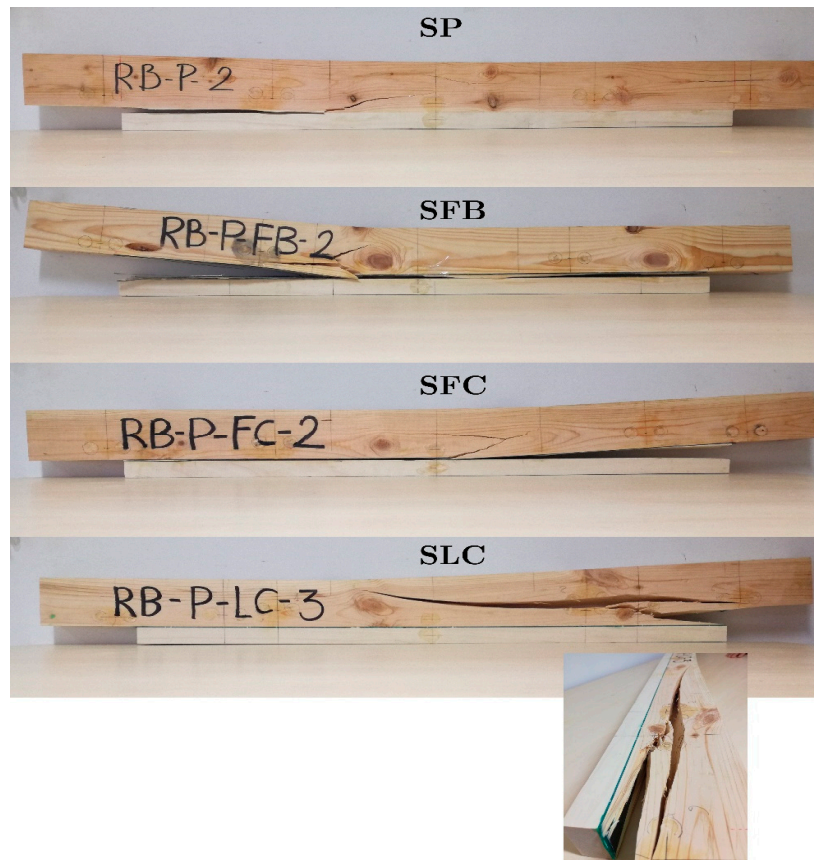
For the case of the SP specimen, it can be observed that the strain increases permanently until the end of the test. In this case, the final failure was caused by a strong pine-poplar delamination starting on the left side of the poplar plank, followed by a mixed brittle tensile/shear fracture of the pine located around the mid-span (tension zone of the pine). However, for the case of specimens retrofitted with the fabric FRP (SFB and SFC), the strain increases permanently up to a particular intermediate load point at which a complete delamination between the FRP fabric and the poplar plank occurs. Moreover, at this point there is a sudden drop of the load and the strain, particularly in the tensile area with the strain at the poplar plank becoming very low because it gets detached. After this drop, a gradual new rise of the load occurs until the final brittle fracture of the pine beam (tensile mode for the SFB specimen and mixed tensile/shear mode for the SFC one), is located at the mid-span of the sample. This ductile behavior of the fracture process is very important in terms of safety. Finally, for the sample with LC retrofitting, the strain increases permanently until the end of the test. Final failure occurred by a very slight pine-FRP delamination at the right side of the poplar plank, followed by a strong brittle shear fracture of the pine, which extended along 2/3 of the length of the specimen. Table 5 summarizes the failure modes of the specimens and Figure 8 shows some pictures of the fracture pattern for each particular sample.

**Figure 8.** Fracture pattern of the specimens.

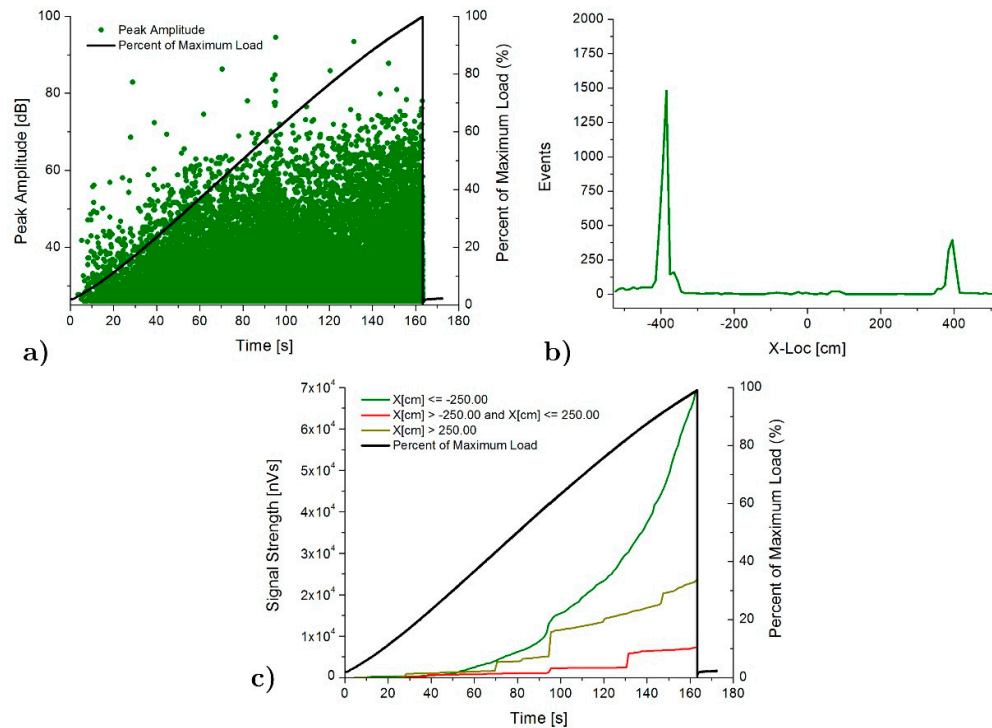
Figure 9 shows the AE results obtained for the SP specimen. Peak amplitude in dB (Figure 9a) shows a gradual increasing as the load increases until the end of the test, demonstrating a progressive deterioration of the specimen. Second plot, Figure 9b, shows the location results of the AE events as a function of position along the specimen. A clear concentration of events is observed at both ends of the poplar planks, which is clearly due to the strain concentration in these areas, demonstrated by the numerical analysis (Figure 4). Higher concentration is observed on the left side, which is in good agreement with placement of the beginning of pine-poplar delamination occurred at this side, experimentally observed (Figure 8). In order to compare the zonal distribution of the AE intensity, Figure 9c shows the AE signal strength located on the left side ( $x < -250$  mm), right side ( $x > 250$  mm), and central area ( $-250 < x < 250$  mm) of the specimen. Few AE is located in the central area in this case, which appeared mainly at the end of the test.

**Figure 9.** AE results for SP specimen: **a)** Peak amplitude vs load history over the time, **b)** Linear location over the specimen and **c)** Signal strength vs load history over the time.

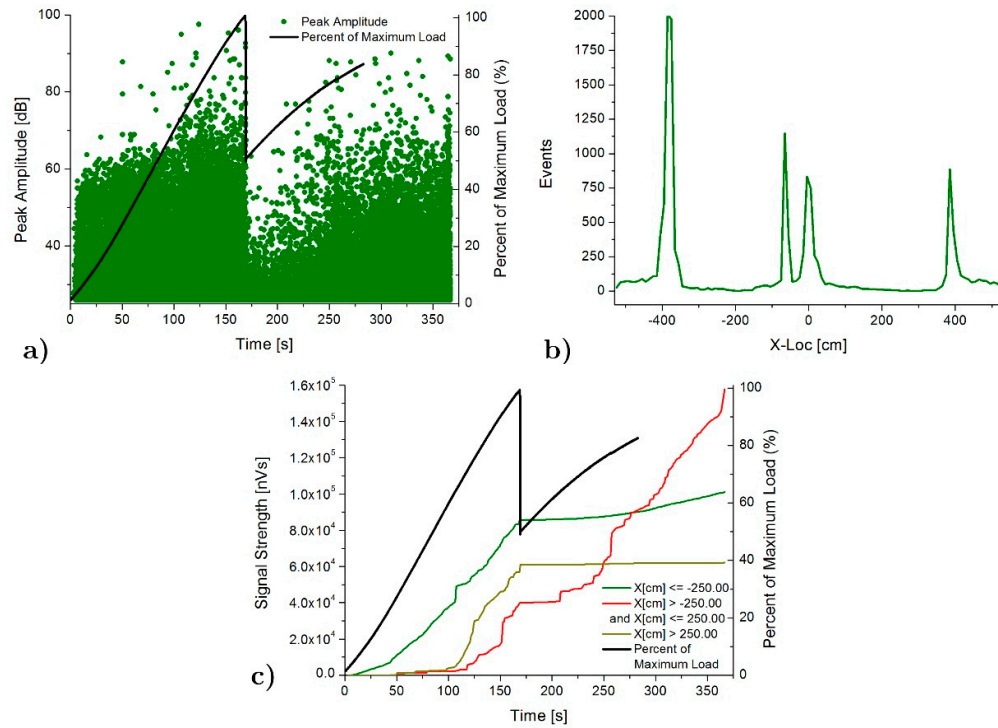
Figures 10 and 11 shows the AE results for the case of SFB and SFC specimens, respectively. Peak amplitude in dB shows a gradual increasing as the load increases until the maximum load, just when the FRP-poplar plank delamination happens. At this point, an important drop of the AE intensity also happens (AE peak amplitude decreases from 90 to 40 dB). An increasing of the peak amplitude until the final breakage demonstrates the progressive increase of the deterioration of the pine beam. AE location results show again a clear concentration of events at both ends of the poplar planks due to the strain concentration in these areas, in accordance again with the numerical analysis results. In this case, higher AE activity and intensity is located in the central area of the specimen, compared with that for the SFB one, which is in good agreement with the fact that the delamination between the poplar and the FRP extended along the entire poplar plank. As for the SP specimen, there is a significant growth of the acoustic emission activity in the central area of the specimen after the delamination (starting at  $t = 210$  s for SFB and at 260 s for SFC sample), due to the stress concentration at the maximum bending moment area of the pine, causing the final failure of the specimen.

**Figure 10.** AE results for SFB specimen: a) Peak amplitude vs load history over the time, b) Linear location over the specimen and c) Signal strength vs load history over the time.

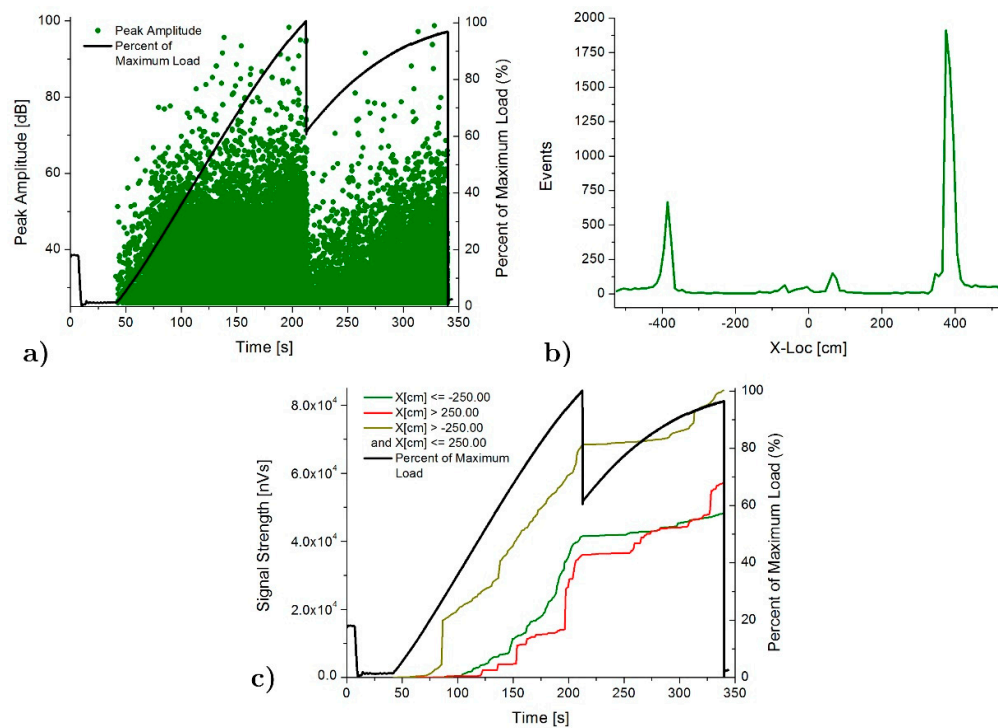
**Figure 11.** AE results for SFC specimen: a) Peak amplitude vs load history over the time, b) Linear location over the specimen and c) Signal strength vs load history over the time.

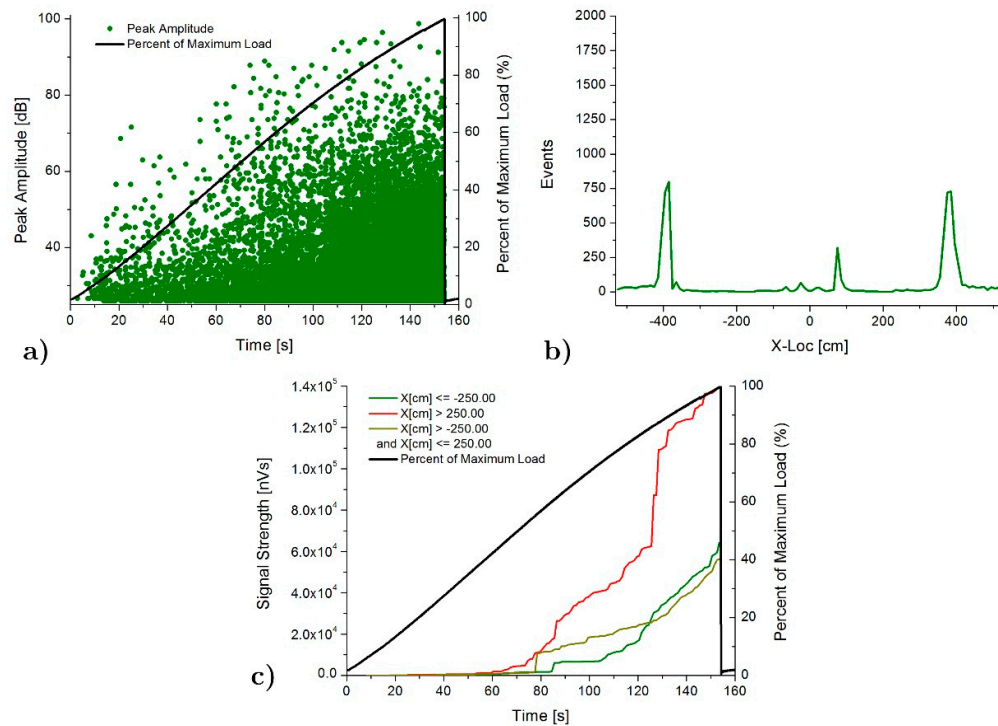
Finally, Figure 12 shows the AE results for the specimen retrofitted with pultruded laminates (SLC). In this case, as happens for the SP specimen, the peak amplitude increases until the end of the test, also demonstrating the evolution of the damage. The location of the acoustic emission also coincides with the high strain areas obtained numerically, that is, the end of the poplar planks and the central area of the specimen. However, unlike the rest of the specimens, the acoustic emission activity in the central zone begins earlier than the acoustic emission at the end of the poplar boards. In addition, the intensity and acoustic emission activity at the end of the poplar planks is lower for this specimen than for the specimens SFB and SFC, in line with the fact that the delamination in this case was very small and the failure final was due to shear fracture of the pine beam.

**Figure 12.** AE results for SLC specimen: **a)** Peak amplitude vs load history over the time, **b)** Linear location over the specimen and **c)** Signal strength vs load history over the time.
