Article

Monitoring of Thermal and Moisture Processes in Various Types of External Historical Walls

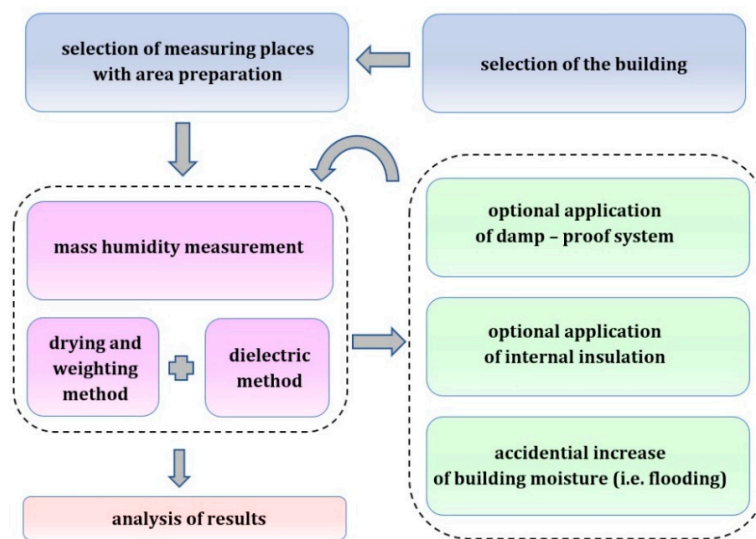
Figure 1. Monitoring and intervention procedure.

The research methodology was proposed below, in Figure 1 describing the monitoring and intervention procedure. Research was based on several selected representative types of historical masonry walls (being a part of public buildings, located in southern Poland) for which material characteristics of particular masonry elements were presented.

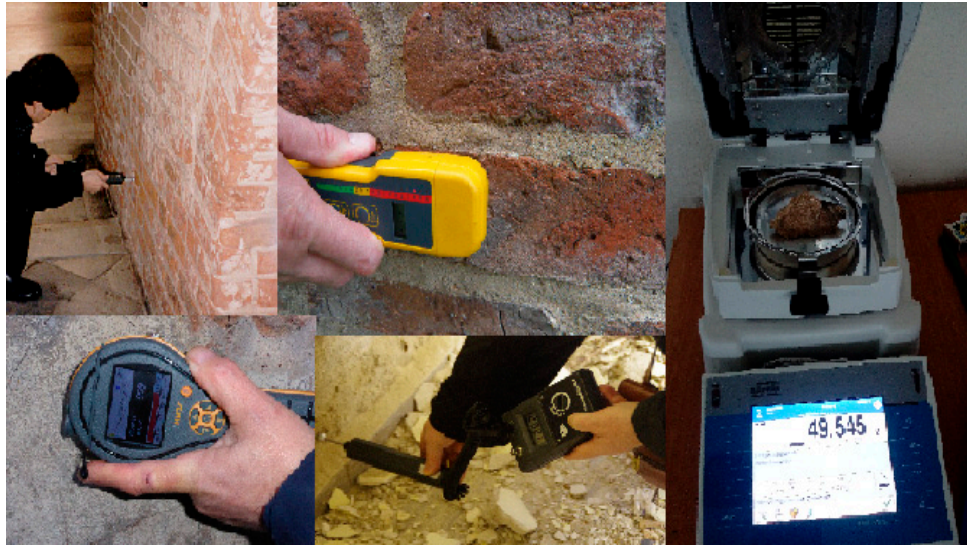
Figure 2. Testing areas and measurement techniques (nondestructive and destructive).

The tests of mass humidity were carried out on four different masonry walls made of solid brick (Figure 2).

In building “A” the first research on the moisture content of walls was carried out in 1997. Next, horizontal damp-proof insulation was made (by chemical barrier–mineral injection). The measurements were repeated in 2004 and then after flooding the cellar interior with water (as a result of a failure of the sewage system) in 2018 (more than 20 years after the first measurement). In building “B” humidity measurements were carried out in 2007. Next, moisture horizontal insulations (by chemical barrier–mineral injection) were made. The measurements were repeated in 2018. In building “C” the measurements were made in 2009. The measurements were repeated in 2019. Anti-humidity and waterproof insulation were not performed in this building. In building “D” the measurements were made in 2016. Next, horizontal damp-proof insulation (by chemical barrier–mineral injection) and internal insulation with a thickness of 5 cm were performed. The measurements were repeated in 2019.

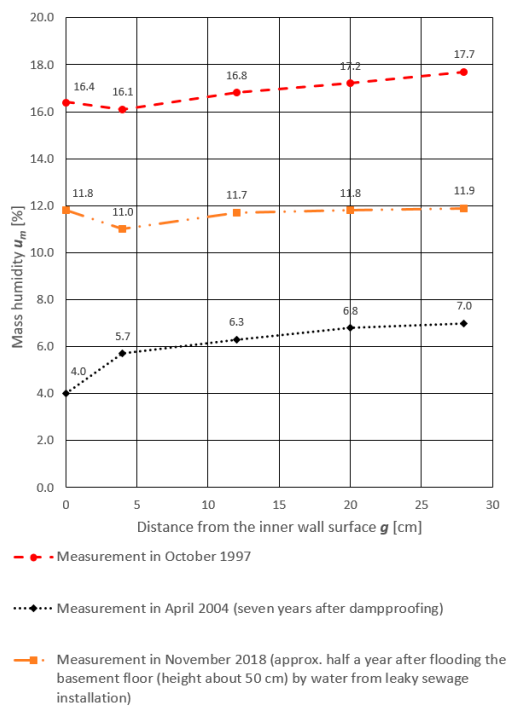
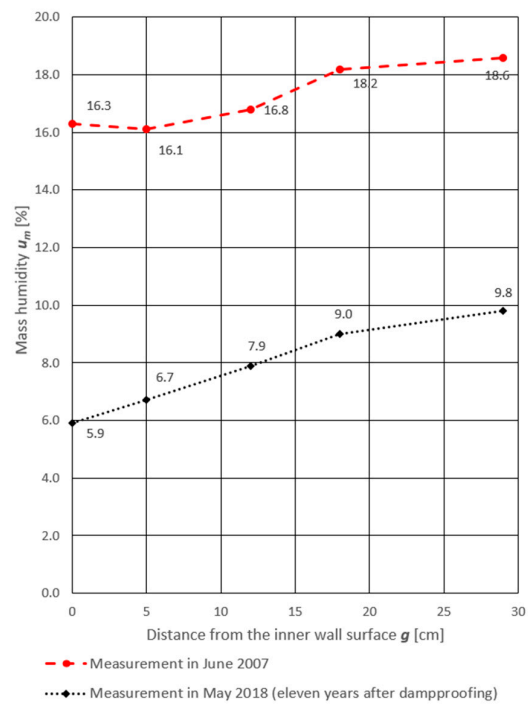
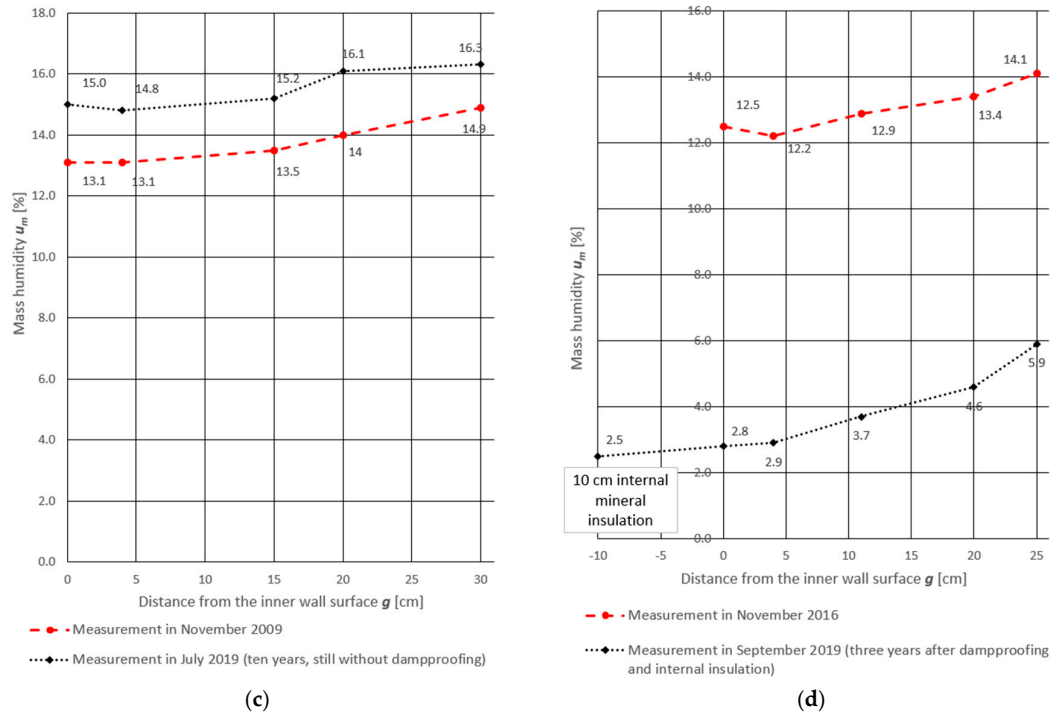
Figure 3. Results of mass moisture measurements on partition thickness in four different masonry walls made of solid brick: (a) Wall of building "A"; (b) wall of building "B"; (c) wall of building "C"; (d) wall of building "D".

The results of mass moisture tests for these four load-bearing masonry walls are shown in Figure 3. In all cases in which the anti-humidity insulation was made, a significant (about 10%) decrease in mass moisture of the walls was observed. In the absence of such insulation, the mass humidity increased slightly during the 10 years of measurements.

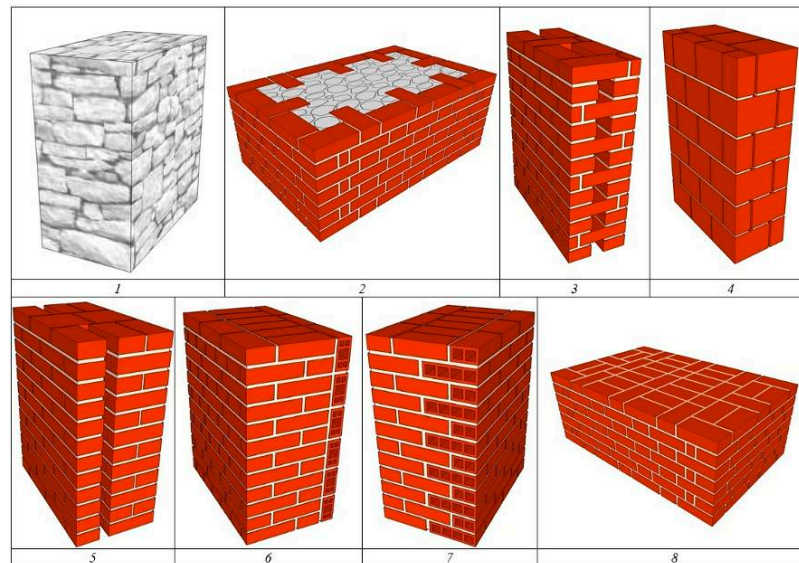
Figure 4. Models of the analyzed types of load-bearing and/or curtain masonry walls.

Models of each analysed type of masonry wall occurring in southern Poland (including those in areas belonging to Germany before World War II) are presented in Figure 4.

An attempt was made to make calculations for as many representative types of walls as could currently be found in historical buildings, as well as those erected in the last 200 years. The following types of walls were adopted:

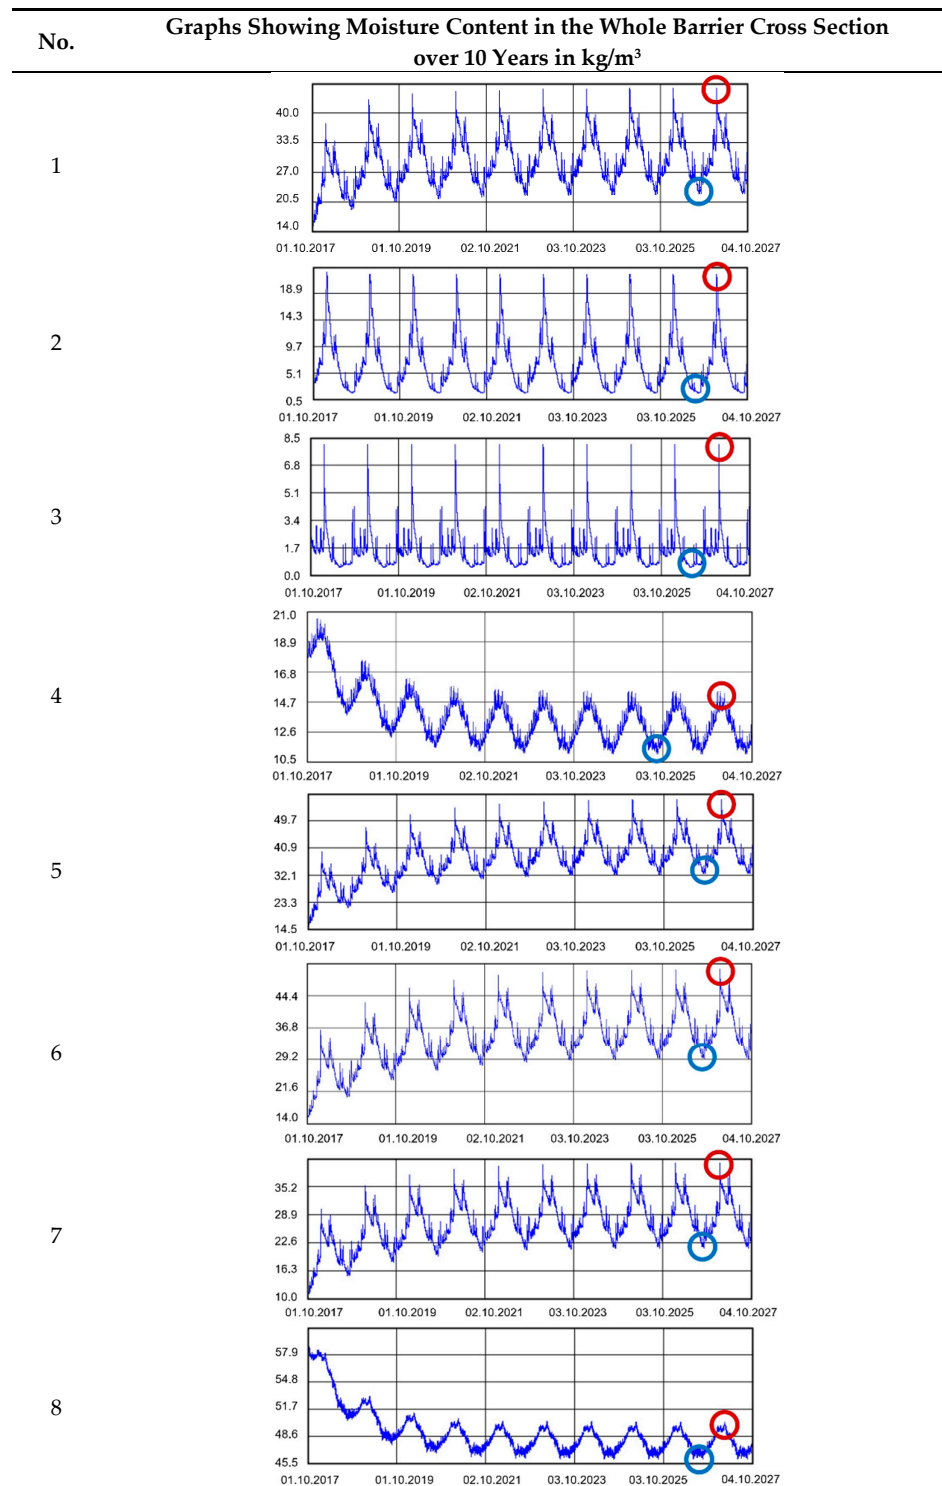
Table 4. Dependence of the degree of barrier moisture on the air exchange rate.

In each of the analyzed partitions, the moisture level stabilizes after about 4–5 years of operation, assuming proper replacement of used and damp indoor air. The service life of partitions 5, 6, 7 during the first 4–5 years results in the increase of moisture inside them. None of the partitions meet the current requirements in terms of thermal insulation.

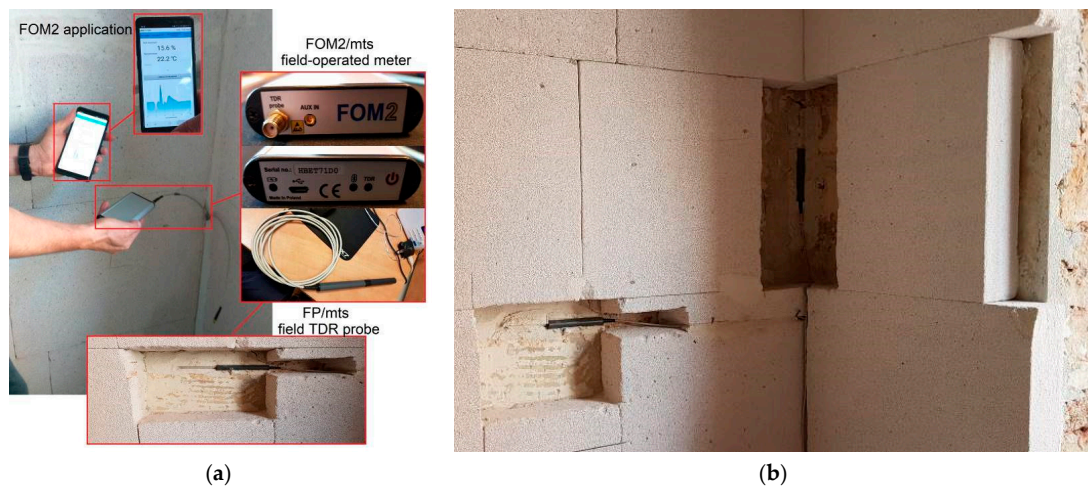
Figure 5. FOM2 measuring system: (a) Elements of the system; (b) probe No. 1 and probe No. 2 installed between the wall and the internal thermal insulation.

The FOM2 system used for measurements is a set consisting of FOM2/mts measuring device and FP/mts probes operating on the basis of TDR (time domain reflectometry) and electrical conductivity. The measurement results can be sent to mobile devices thanks to the use of a Bluetooth connection. Measurement parameters of the FOM2 device are presented in Table 5.

Probe No. 1 was placed on the flat surface of the wall and probe No. 2 in the corner at a height of approximately 1.2 m above the floor level. Both probes were connected with the measuring device FOM2/mts. Before the probe was placed in the wall, it was calibrated using information on the length of cable connections and two dielectric standards of reference: Air and water. After calibration in the air, the probe should be placed in water (preferably pure and deionized at a temperature of about 20 °C) and recalibrated. Only by carrying out the calibration process can you be sure of the results obtained.

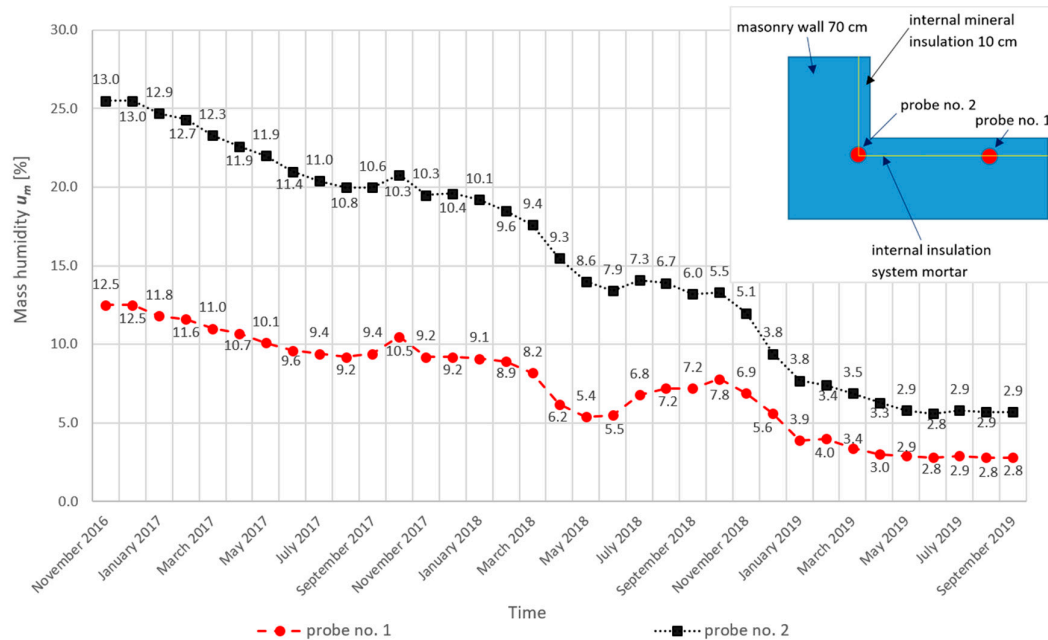
Figure 6. Results of humidity measurements together with a diagram of probes' location in the tested wall.

The results of the humidity measurements together with a diagram of the probe location in the tested masonry wall are presented in Figure 6. The results of temperature measurement (probe No. 1, probe No. 2, indoor temperature, outdoor temperature) are presented in Figure 7.

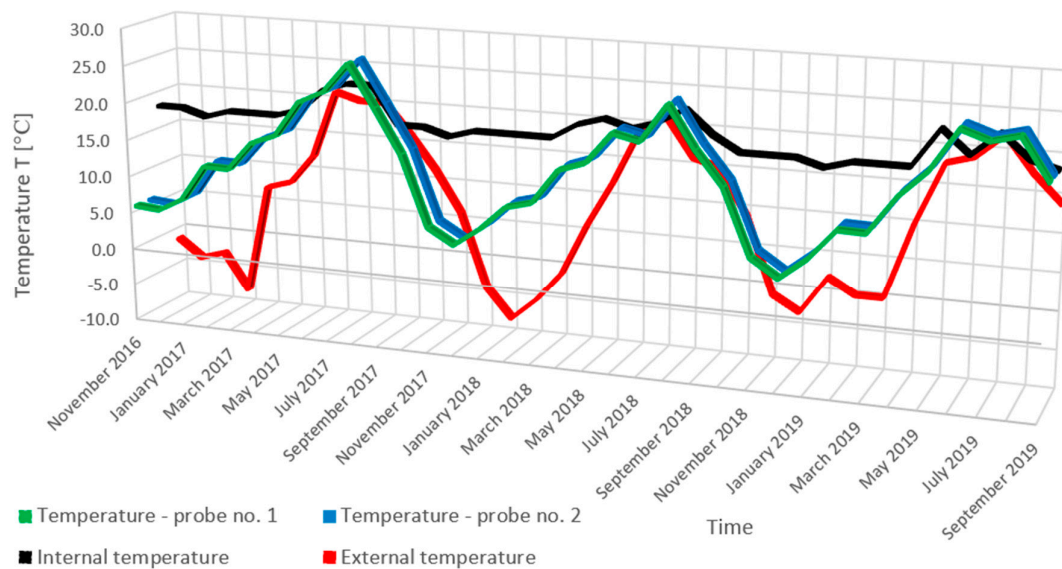
Figure 7. Temperature measurement results (probe No. 1, probe No. 2, indoor temperature, outdoor temperature).

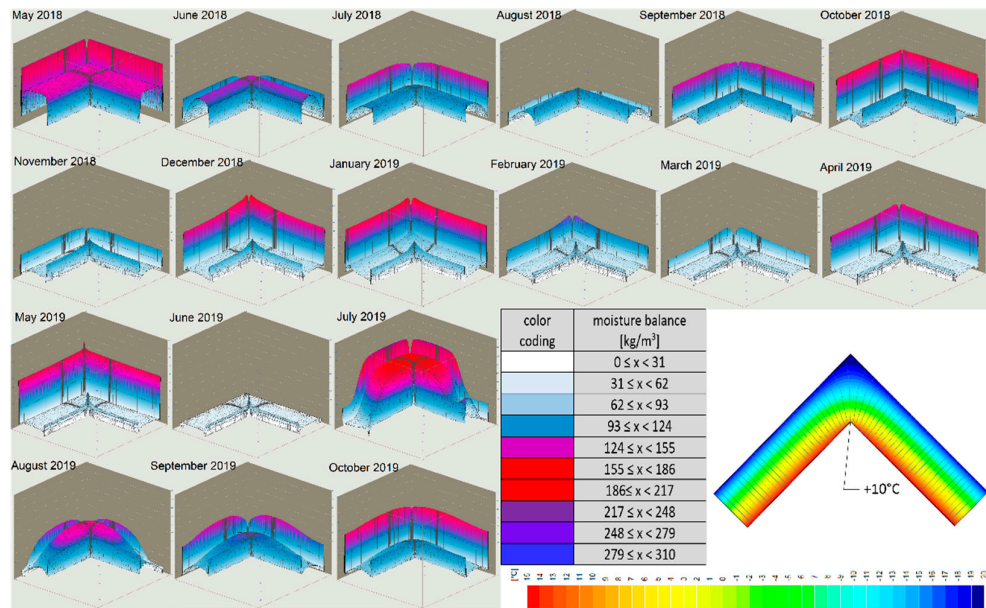
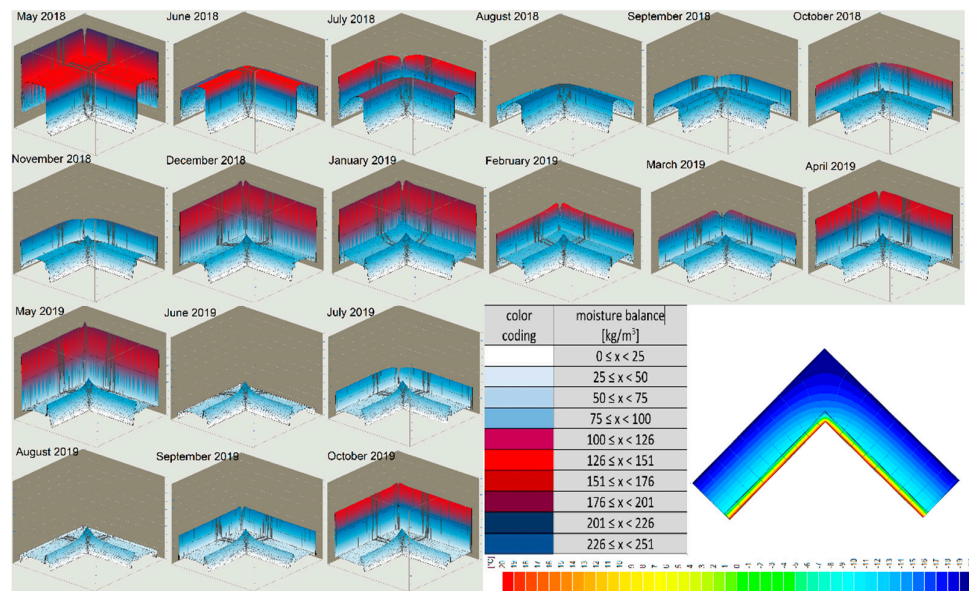
Figure 8. Isothermal distribution of temperature in the corner of the wall: (a) Uninsulated from the inside; (b) insulated from the inside.

Monitoring of hygrothermal parameters was performed by analyzing the data obtained from humidity and temperature measurements and material parameters using WUFI 2D v.3.4 software [37]. When analyzing the state and distribution of temperature isotherms and the adiabat of heat

streams from the last 18 months (Figure 8) in the case of the corner of an uninsulated masonry wall and capillary insulated from the inside with a capillary active mineral layer of 10 cm thickness, it can be stated that a significant decrease in the cooling of the corner is visible. A significant decrease in the water content of the insulated wall was also recorded (Figure 9).

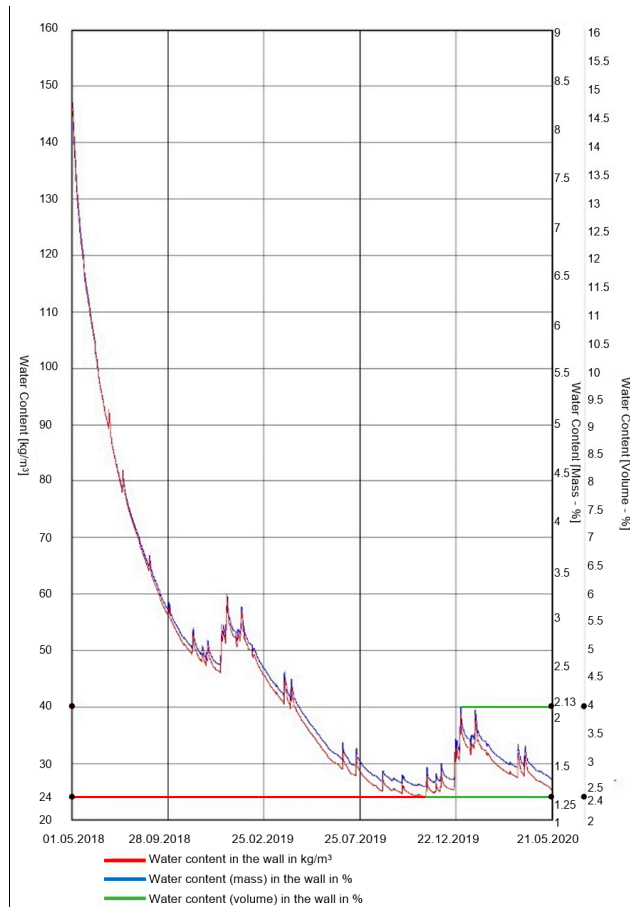
Figure 9. Water content in the insulated wall.
