# The Influence of External Environmental Conditions on Properties of Ceramic Building Materials with Waste Material Additives

**Abstract:** In this paper, we analyze the state of conservation of ceramic building materials (clay masonry units) containing a large share of waste materials in the form of ash and slag from coal combustion and sawdust from wood processing, operated for several decades in facing walls of religious buildings, in external environment conditions. For the purpose of this analysis, comparative tests were carried out on the samples of ceramic materials cut out from facing walls and samples extracted from the same ceramic materials; they were stored in laboratory conditions for the entire time. The following were investigated: initial water absorption, capillary rise, and porosity structure determined with mercury intrusion porosimetry (MIP). The research has shown, among other things, that the ceramic materials exploited in the external environment are characterized by an almost twofold increase in the initial rate of water absorption and by a different size of dominant pores and a pore size distribution in comparison with ceramic materials stored in laborato

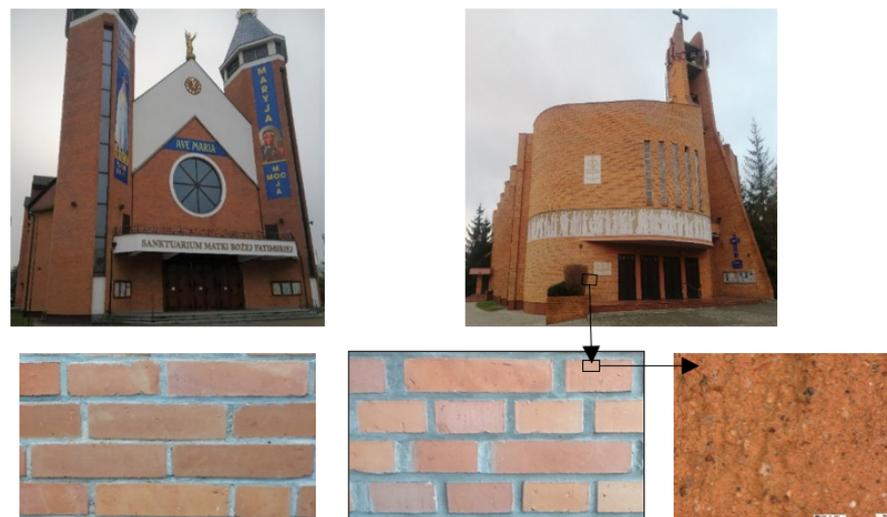
**Figure 1.** Religious buildings from the second half of the XX century with facing walls made of ceramic building materials with waste material additives from which the test samples were taken.

The ceramic materials featured high surface smoothness (Figure 1), small dimensional deviations, and good quality parameters including relatively high strength.

functioning up to this day, without any clear visual signs of destruction, as documented in Figure 1.

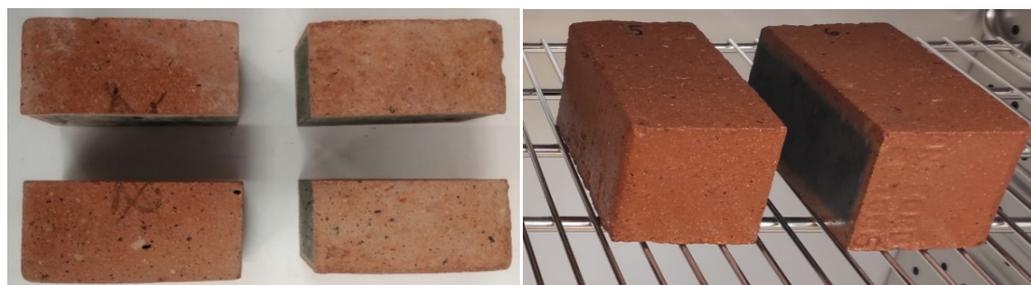
**Figure 2.** Examples of Group A and B samples prepared for testing.

Samples were obtained and tested from two groups of clay masonry units, designated as A and B, shown as examples in Figure 2.

- Group A consisted of brick samples extracted for testing purposes from facing walls of religious buildings shown in Figure 1, operated in natural outdoor environmental conditions for approximately 35 years. The number of tested samples was 18 and they were chosen randomly. The samples were cut from the wall using an angle grinder, then cleaned in laboratory conditions from any mortar residues and cut to the dimensions of 60 × 120 × 65 mm.
- Group B consisted of brick samples extracted from the same batch of masonry units as group A and stored in laboratory conditions for 35 years at 20 °C (±2 °C) and relative

air humidity of 50% ( $\pm 5\%$ ). These masonry units remained in the laboratory as extra units that were obtained during the construction of these buildings in order to perform strength tests. In total, 18 tested samples, also dimensioned as  $60 \times 120 \times 65$  mm, were cut from these units.

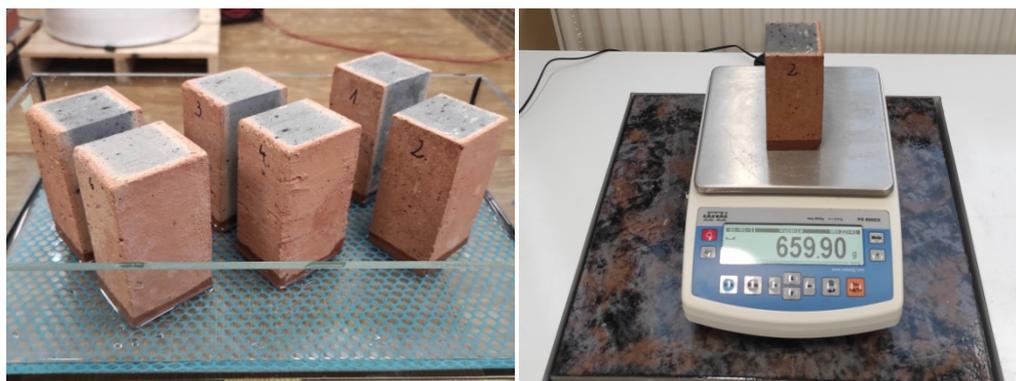
Figure 3. Capillary water rise test stand for samples.

Water absorption by capillary action tests with the samples were carried out according to [29]. The number of tested samples was 18 for each group. The samples were dried to constant weight at  $+40 \text{ }^\circ\text{C} \pm 1 \text{ }^\circ\text{C}$  and then weighed to the nearest 0.1 g. Drying temperature of  $40 \text{ }^\circ\text{C}$  was used to prevent possible microcracks inside the samples. The samples were placed in a tray on a frame. For testing purposes, sample faces were immersed in water at a constant depth of 5 mm ( $\pm 1$  mm) during testing, as shown in Figure 3. After soaking times of 1, 4, 9, 16, 25, 36, 49, and 64 min, the samples were removed, the surface that was immersed in water was wiped, and the samples were weighed (Figure 3).

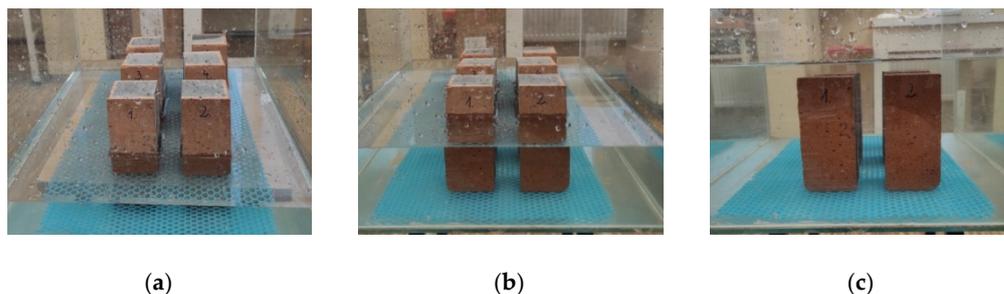
**Figure 4.** Water soaking stages: (a) stage I, (b) stage II, (c) stage III.

The water absorption test was performed according to [30] by immersion of 18 samples from group A and 18 samples from group B. The samples were dried to constant weight at  $+40\text{ }^{\circ}\text{C} \pm 1\text{ }^{\circ}\text{C}$  and then weighed to the nearest 0.1 g. A drying temperature of  $40\text{ }^{\circ}\text{C}$  was used to prevent possible microcracks inside the samples. The samples were placed in a tray with a frame and immersed in water at the temperature of  $20\text{ }^{\circ}\text{C} (\pm 2\text{ }^{\circ}\text{C})$  to about 1/3 of their height. After 3 h, the water level was raised to about 2/3 of the sample height, and after another 3 h, the water was replenished until the samples were fully submerged, as shown in Figure 4.

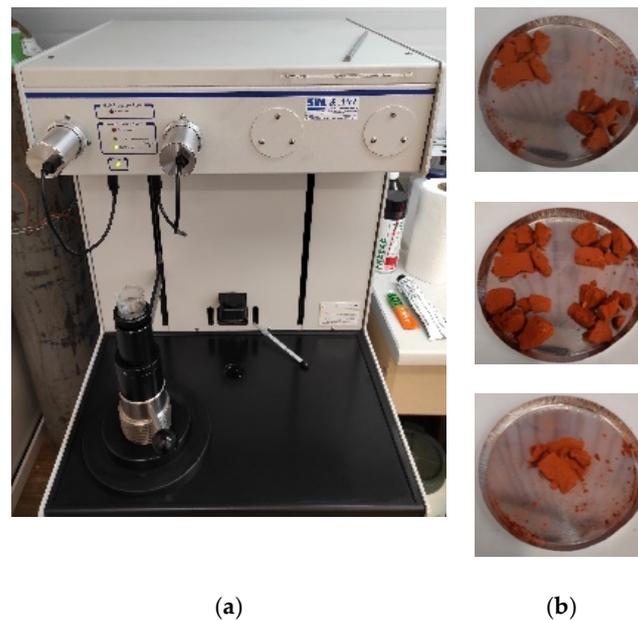
**Figure 5.** Porosimetry test stand: (a) the mercury intrusion porosimeter used in the test, (b) samples selected for the test.

For the porosity test, 18 samples from group A and 18 samples from group B were used after the absorption test performed earlier. Fragments of approximately  $1\text{ cm}^3$  were taken from the facing surface of each sample of both groups. The samples from group A were combined and dried to constant weight at the temperature of  $40\text{ }^{\circ}\text{C} \pm 1\text{ }^{\circ}\text{C}$ . A laboratory sample was selected with the quartering method [31,32] from the obtained material. Quartering consisted of coning the collected and thoroughly mixed material, then flattening and cross-dividing it into four parts. Two diagonal parts were removed, the remaining two parts were remixed, and the selection process was repeated. This procedure was performed three times to obtain laboratory sample volume of about  $5\text{ cm}^3$  that corresponds to the volume of the penetrometer tank shown in Figure 5. The same procedure was used for group B samples.

The test was performed using a 9500 series AutoPore IV mercury intrusion porosimeter equipped with two ports: low and high pressure with a maximum value of 228 MPa, which allows measurements in the range of meso- and macropores from 2 nm to  $360\text{ }\mu\text{m}$  (Figure 5a). Before the actual test, the calibration and “blank test” of the penetrometer used in this test were carried out to determine volume, compressibility, and thermal effect. An equilibrium time of 30 s was determined based on control measurements. As a result of the test, the following parameters of the ceramic building material structure in question were determined: total pore volume, sample volume and its skeletal density, the distribution of the pore volume as a function of the pore diameter as integral cumulative, and differential relation.

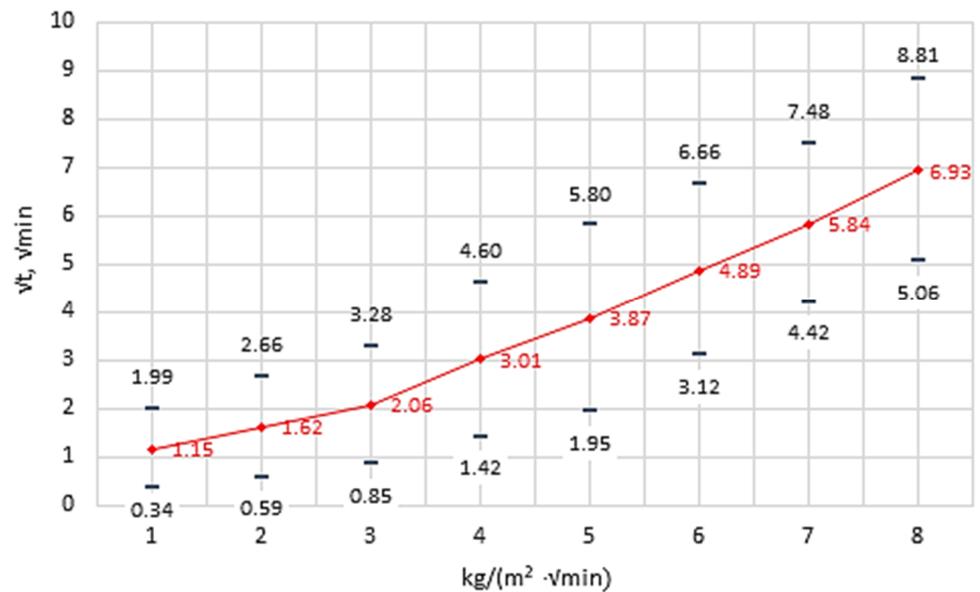
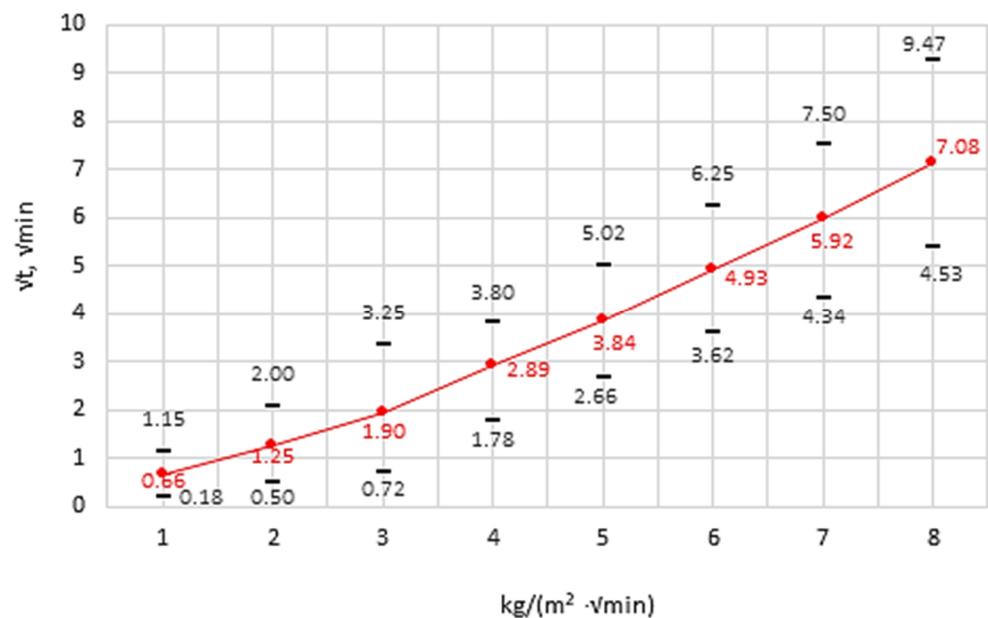
Figure 6. Capillary absorption of tested samples: (a) group A samples, (b) group B samples.

The results of capillary water absorption tests for group A and B samples are shown in Figure 6. They indicate that the dynamics of capillary water absorption by the samples from both groups is similar.

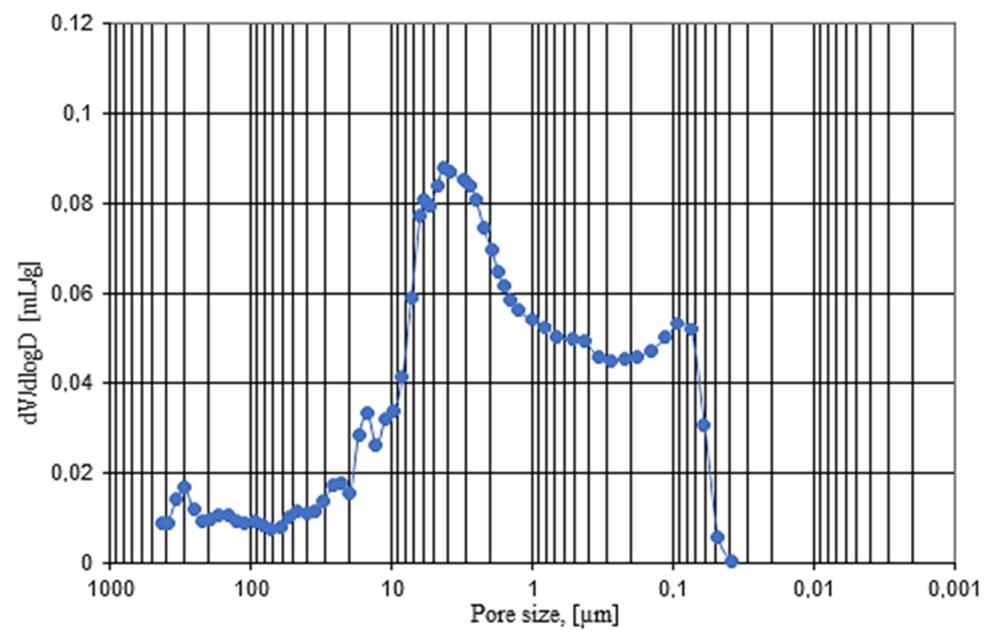
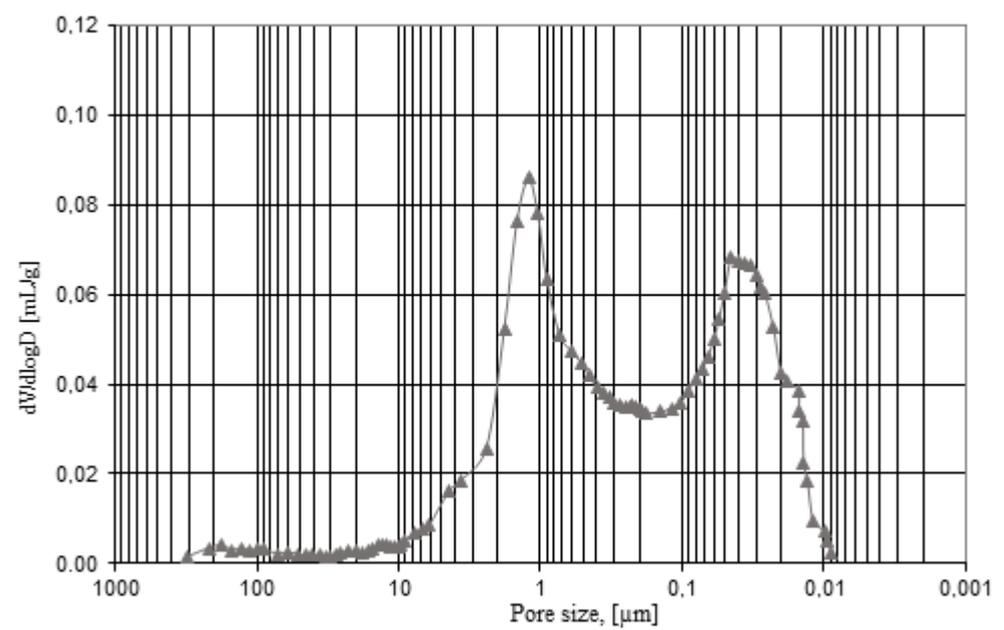
**Figure 7.** Differential curve of pore size distribution: (a) group A samples, (b) group B samples.

Test results, obtained through use of mercury intrusion porosimetry, are given in Table 6 and shown in Figures 7 and 8. The study shows that the samples extracted from masonry units operated for 35 years in outdoor environmental conditions have a total porosity value of 33.35% and a bulk density of 1.668 g/cm<sup>3</sup>. Group B samples stored in laboratory conditions have a similar total porosity value of 33.25% and a bulk density of 1.680 g/cm<sup>3</sup> to group A samples.

Essential factors that differentiate tested samples from group A and B are dominant pore diameter and porosity structure, the results of which are presented in Figures 7 and 8. In group A samples, after 35 years of exposure to environmental factors, there is a bimodal distribution of porosity with dominant pores of diameters of 3.0 µm and 0.09 µm (Figure 7a). Bimodal porosity distribution is also maintained in group B samples stored in laboratory conditions, with dominant diameters of 1.3 µm and 0.045 µm (Figure 7b). Obtained dominant diameters above 3 µm are, according to [11,23], in the range considered safe from the frost damage point of view.

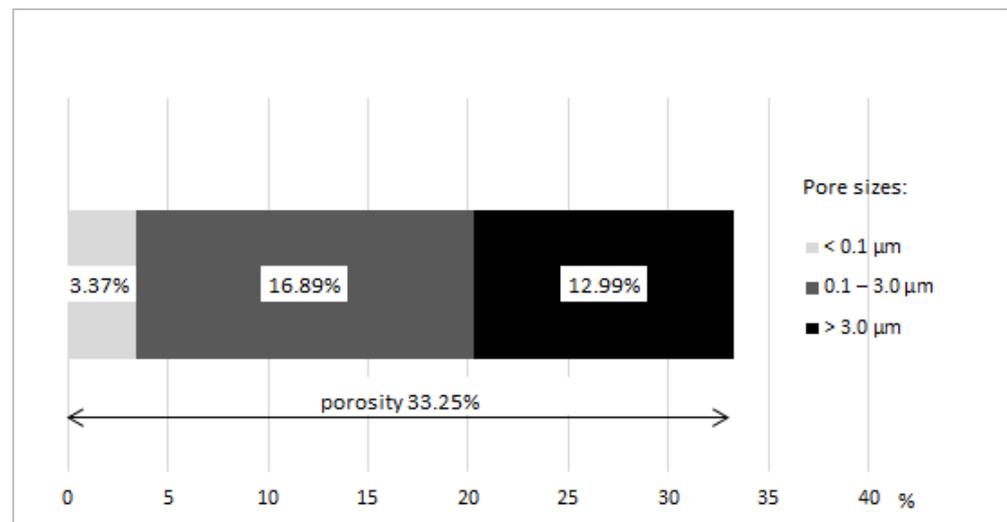
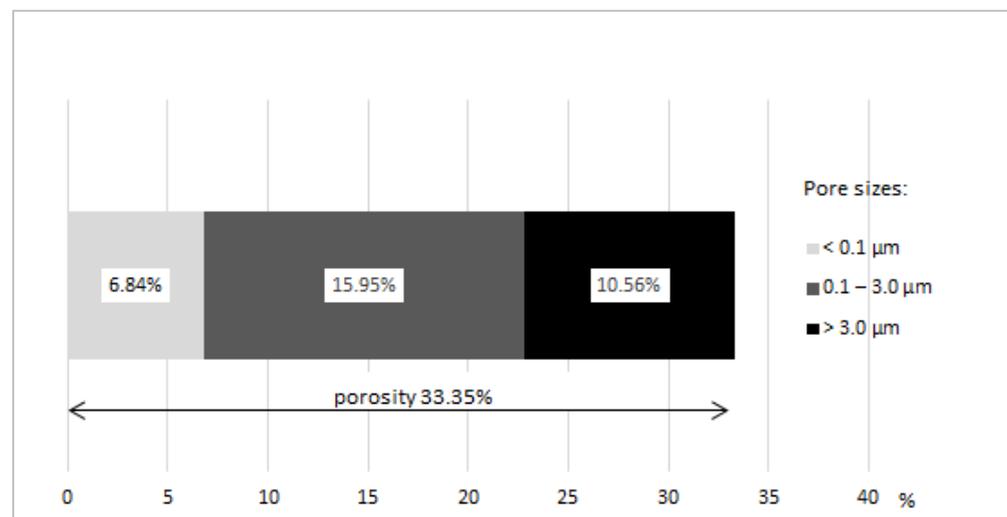
**Figure 8.** Typical porosity ranges: (a) group A samples, (b) group B samples.

As seen in Figure 8, samples extracted from the real building (group A) after 35 years of exposure to environmental factors are characterized by total porosity of 33.25%, and the pore proportion in the range of 0.1 to 3.0 µm is 16.89%, above 3.0 µm—12.99%, and below 0.1 µm—up to 3.37%. In case of group B samples stored in laboratory conditions with similar total porosity value of group A samples, the porosity structure is different. Pore share in the range of 0.1 to 3.0 µm is 15.95%, above 3.0 µm—10.56%, and below 0.1 µm—6.84%. The obtained results show that as a result of many years of operation, due to freeze–thaw cycling in group A ceramic building materials, the pore content >3 µm was increased, which is, however, beneficial from the point of view of its frost damage resistance. The reduction of pore share content <0.1 µm does not affect frost damage. This pore range is considered safe [11,23]. The pore share in the range of 0.1–3.0 µm considered critical from the point of view of frost damage is similar for both groups, A and B. As a result of environmental exposure over a period of about 35 years, the share of critical pores was increased by less than one percentage point, compared to samples stored in laboratory conditions.
