# Technological, Microstructural and Strength Aspects of Welding and Post-Weld Heat Treatment of Martensitic, Wear-Resistant Hardox 600 Steel

Lukasz Konat

Department of Vehicle Engineering, Wrocław University of Science and Technology, 50-370 Wrocław, Poland; lukasz.konat@pwr.edu.pl

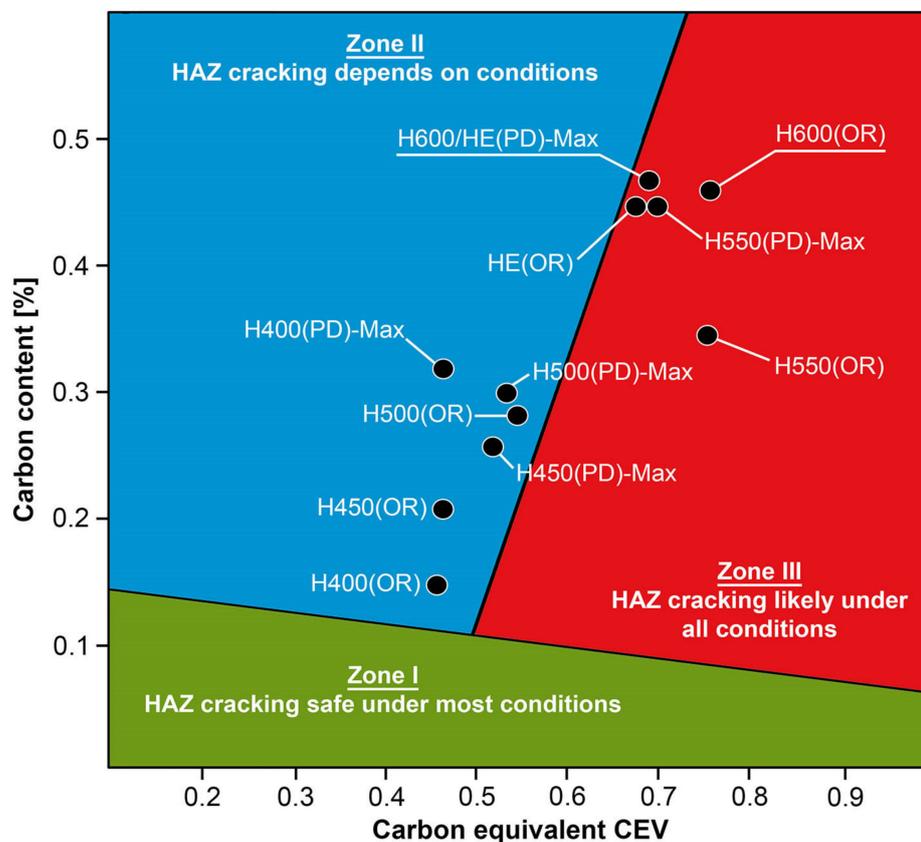
**Figure 1.** Tendency to crack as a function of carbon content and carbon equivalent CEV of welded joints of selected Hardox steels. PD—producer’s data for sheet thicknesses: 8.0–20.0 mm (Hardox 400), 10.0–19.9 mm (Hardox 450), 4.0–13.0 mm (Hardox 500), 8.0–31.9 mm (Hardox 550), 6.0–35.0 mm (Hardox 600), 8.0–19.0 mm (Hardox Extreme); OR—the author’s own tests for sheets with a thickness of 10.0 mm; Max—maximum value. The study is based on the data in Table 2 and refs [23,24].

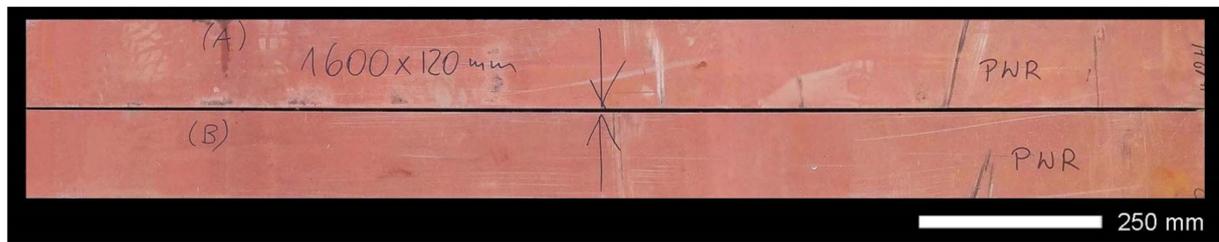
**Figure 2.** Pieces of Hardox 600 sheet for the welding process. The arrows indicate the place of the weld, (A)/(B)—pieces to be welded.

the required dimensions (Figure 2), taking into account the ridges intended for welding, was realized by means of a numerically controlled plasma system HyPerformance.

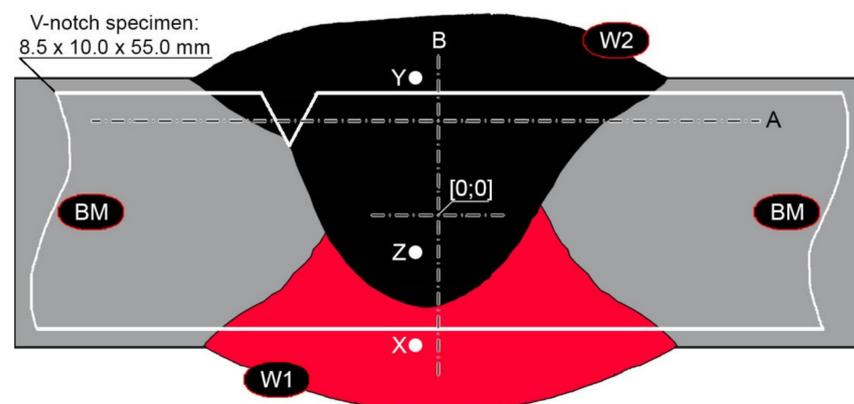
**Figure 3.** General diagram of the welded joints made of Hardox 600 steel. W1/W2—individual layers of the weld according to the sequence of their execution, A/B—lines of performed hardness distributions, BM—base material, X/Y/Z—locations of the chemical analyzes performed, the location of the “V” notch cut on the impact test specimens is shown schematically in white.

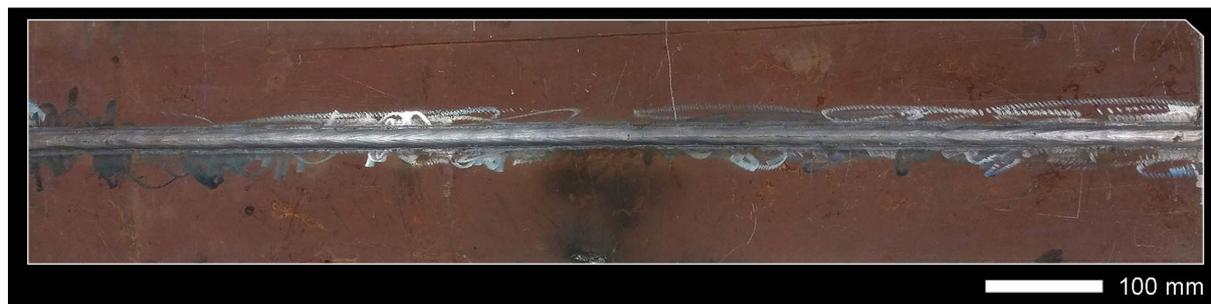
**Figure 4.** A fragment of steel sheets shown in Figure 2 with a welded joint.

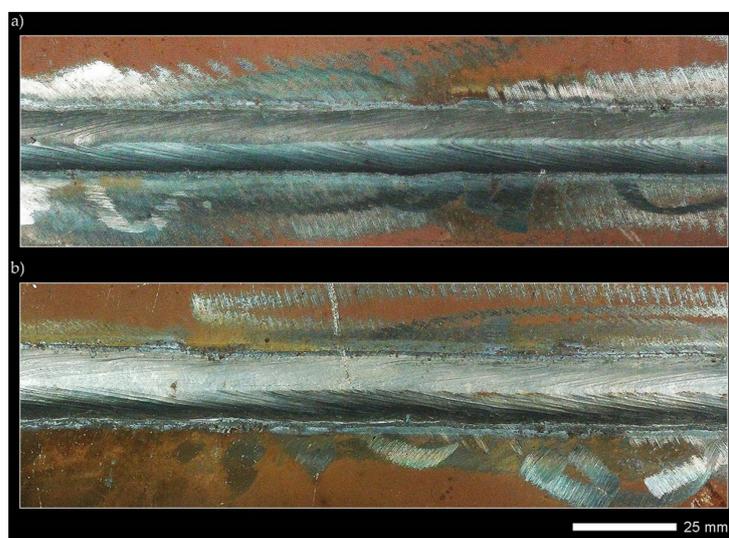
**Figure 5.** Macroscopic image of a fragment of the welded joint shown in Figure 4. (a) View from the front of weld No. 1—made first. (b) View from the front of weld No. 2.

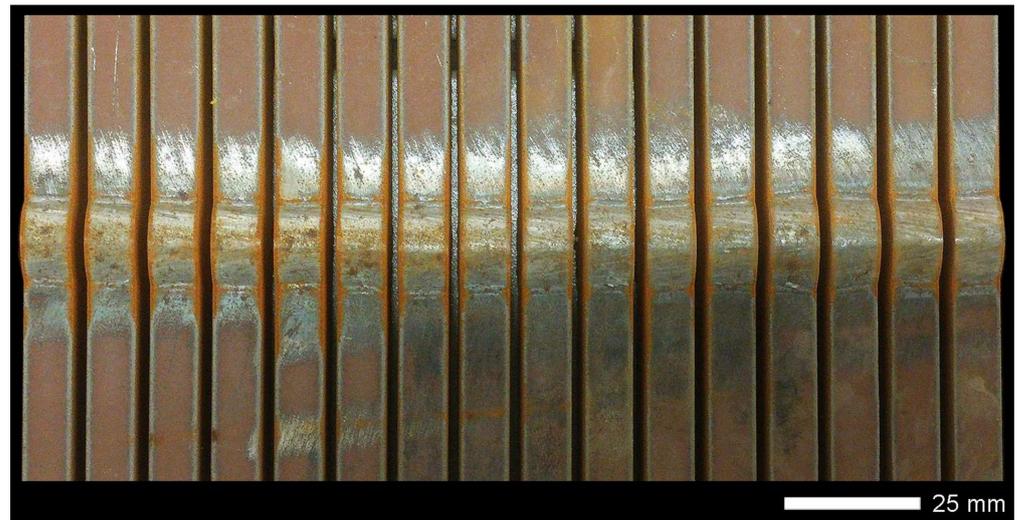
**Figure 6.** A fragment of a welded joint of Hardox 600 steel after the operation of cutting rectangular specimens from the weld area using a high-energy liquid stream with abrasive.

For the purpose of the tests, after welding, cuboid-shaped samples were cut out of the sheets (Figure 6). The machining operations were carried out with the use of a high-energy abrasive water stream and electro-erosion. In subsequent technological operations, some samples of welded joints were subjected to heat treatment, consisting of volumetric quenching in oil or water and low tempering. Before quenching, the samples were additionally normalizingly annealed. The thermal operations were performed in the FCF 12SHM/R gas-tight chamber furnaces by Czylok (CZYLOK Company, Jastrzębie-Zdrój, Poland) using a protective atmosphere of 99.95% argon inert gas. For quenching, Durixol W72 quenching oil with a kinematic viscosity of 21 mm<sup>2</sup>/s, heated to a temperature of  $50 \pm 5$  °C, was used. A water bath consisted of deoxygenated water with a temperature not exceeding 30 °C. The detailed characteristics of the samples used for the tests and the parameters of the thermal treatments performed are presented in Table 5. For the required dimensional tolerances and surface roughness, at the final stage, all specimens were grinded (Figure 7).

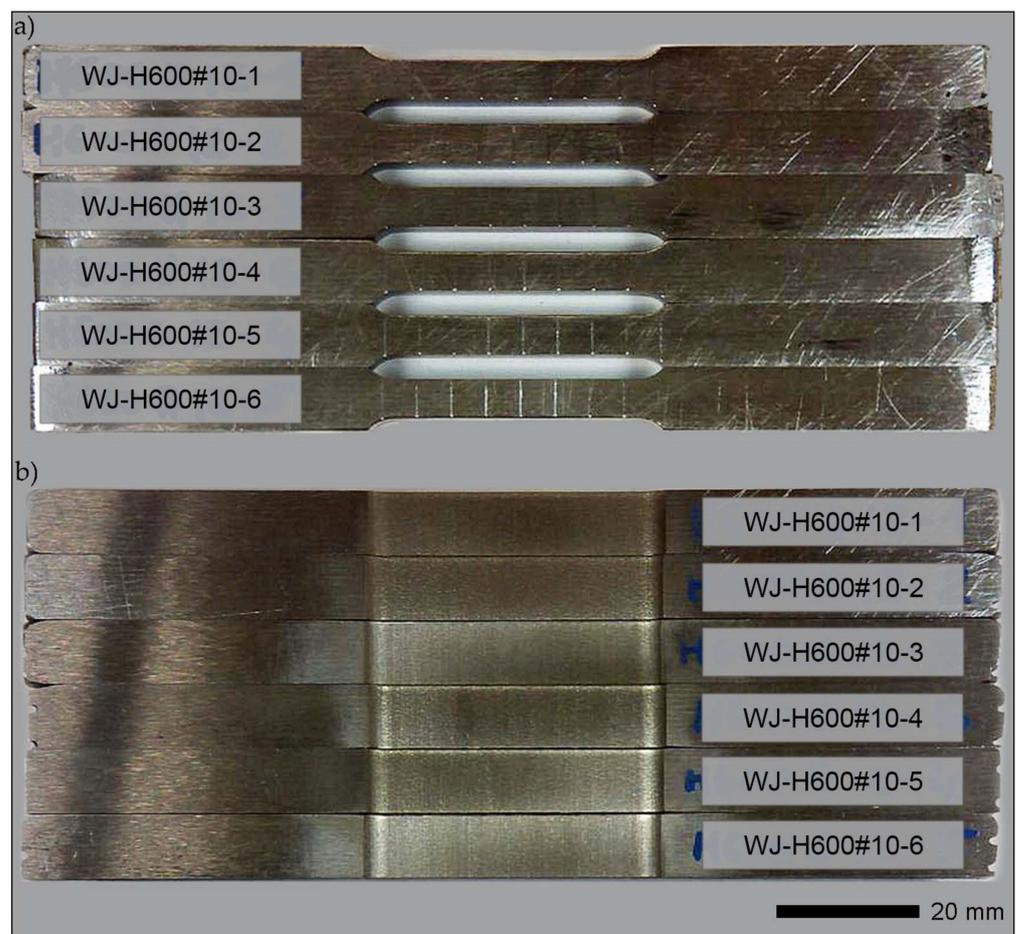
**Figure 7.** Examples of strength samples shown in Figure 6, subjected to a finishing operation. In the heat-affected zone, undercuts were made, constituting a measurement base of the assumed length. The cutting was performed with the electro-erosion method. (a) View of samples from the side of the sheet surface (front weld) with a scale to determine a relative elongation. (b) View of the samples from the side of the sheet cross-section.

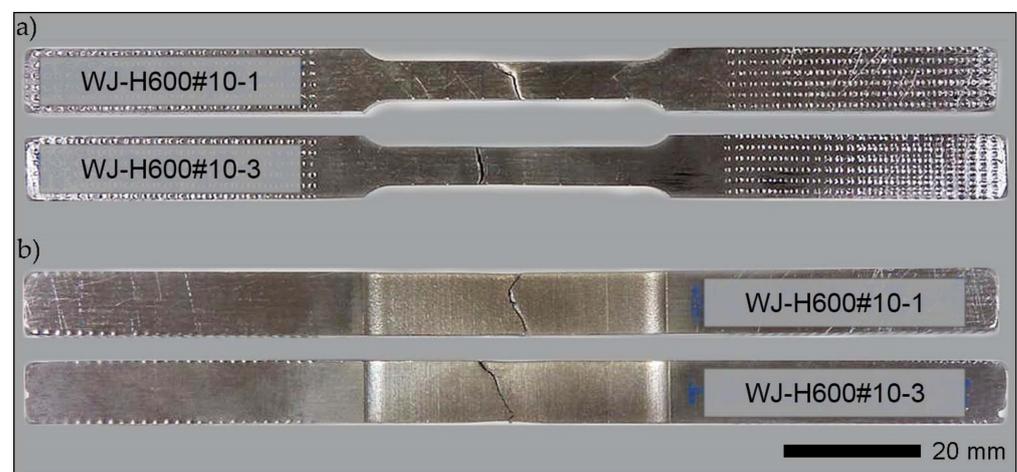
**Figure 8.** Samples subjected to a static tensile test: (a) View from the side of the sheet surface (weld front). (b) View from the side of the sheet cross-section.

Strength tests were conducted in ambient temperature on rectangular, proportional fivefold samples, as per PN-EN ISO 6892-1:2020-05. A material testing system MTS 810 (MTS Headquarters, 14000 Technology Drive, Eden Prairie, MN, USA) was used with an extensometer, measurement base length  $L_0 = 25$  mm. During the tests, the stretching rate was controlled by the stress increase rate. Next, the following were determined for each sample: Young's modulus ( $E$ ), elastic limit ( $R_{p0.05}$ ), yield strength ( $R_{p0.2}$ ), tensile strength ( $R_m$ ), the percentage reduction of area ( $Z$ ) and percentage elongation ( $A_5$ ) after tear. The final strength indexes were an arithmetic mean of the results obtained from at least five samples for each measuring point. Additionally, based on the test results obtained for individual samples, measurement errors in the form of standard deviation were calculated. Examples of samples subjected to strength tests are shown in Figures 8 and 9.

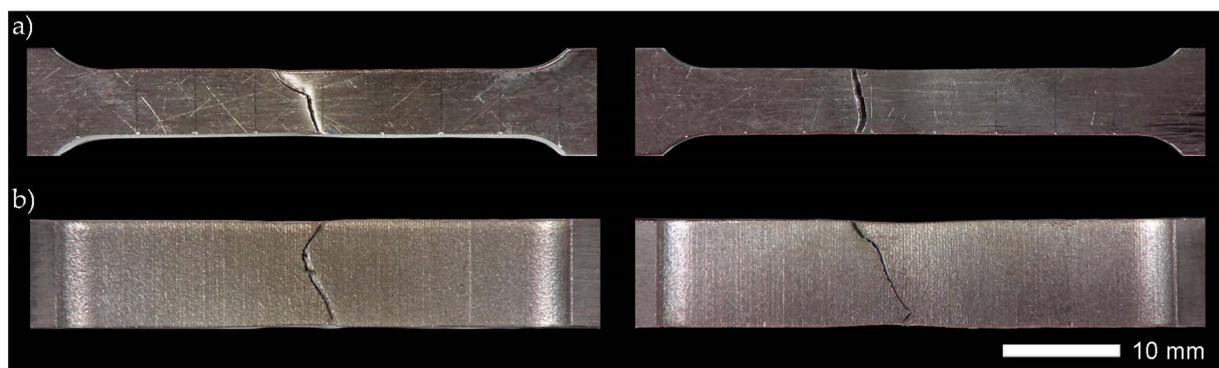
**Figure 9.** Enlarged macroscopic images of the databases of the samples shown in Figure 8: (a) View of the sample measurement base from the side of the sheet surface (weld front). (b) Sample measurement base view from the sheet cross-section side.

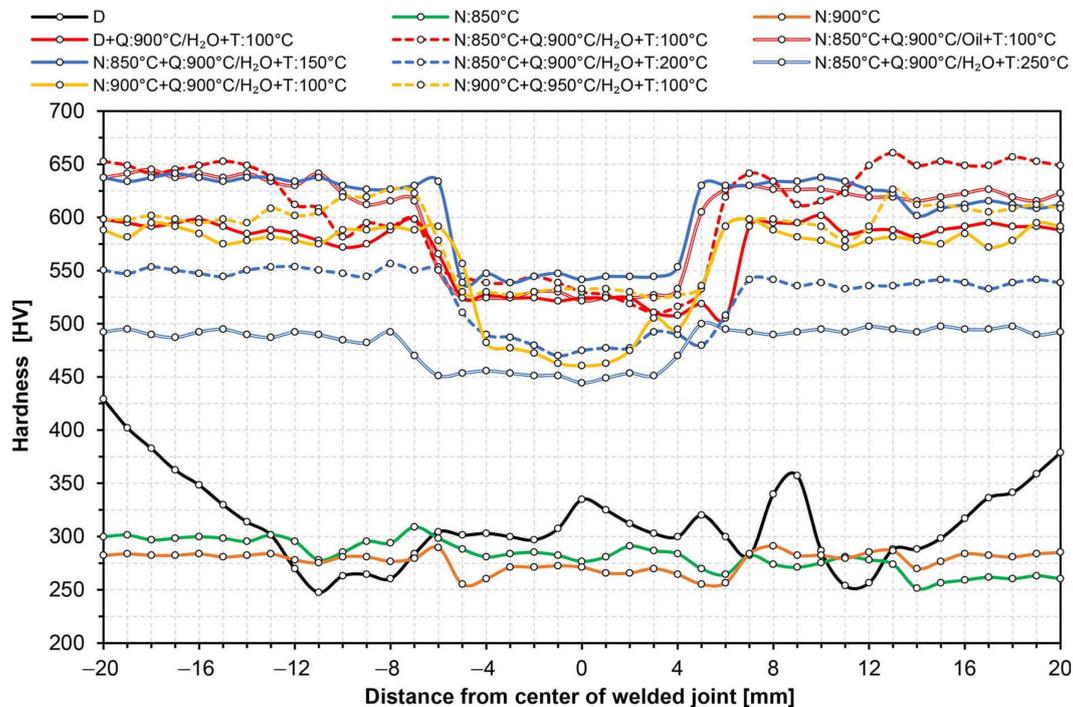
Figure 10. Distribution of the hardness of the welded joint Hardox 600 along the line A marked in Figure 3, subjected to various heat treatments, summarized in Table 6. D—delivery condition (without heat treatment), N—normalization, Q—quenching, T—tempering.

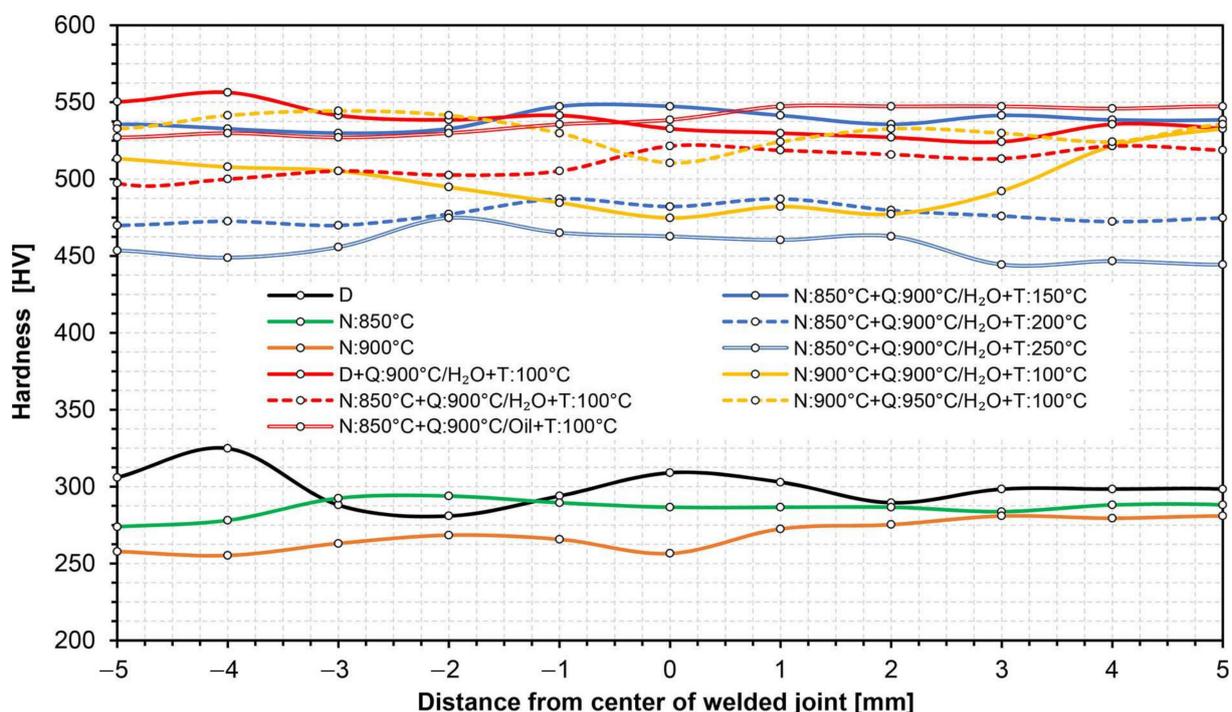
**Figure 11.** Distribution of the hardness of the welded joint Hardox 600 along the line B marked in Figure 3, subjected to various heat treatments, summarized in Table 6. D—delivery condition (without heat treatment), N—normalization, Q—quenching, T—tempering.

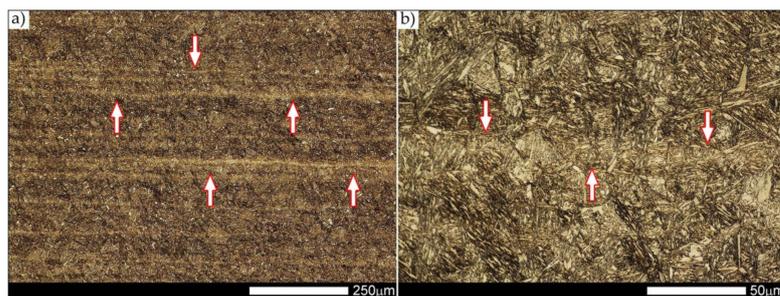
**Figure 12.** Micro-structure of Hardox 600 as delivered from a steelworks (before welding)—longitudinal direction for plastic working [4]. (a) A general view of the micro-structure with banding features clearly visible. (b) Enlarged fragment of the central zone shown in (a). Structure of tempering martensite with bands of quenching martensite. The arrows indicate the strands of unremoved martensite running in the direction of thermomechanical rolling. Light microscopy, etched with 3%  $\text{HNO}_3$  in ethyl alcohol.

Micro-structure of the heat-affected zone and the base material, marked respectively as HAZ and BM in Figure 29, showed no significant differences as a result of the thermal treatments performed. In both cases, a similar structure is observed, consisting of tempering martensite with numerous bands of unremoved martensite structure (MQ designation in Figures 35 and 36). The presence of these bands is a direct result of producing Hardox 600 sheets technology—thermomechanical rolling—which were not “removed” during the applied post-welding thermal treatments. It is also worth mentioning here that the structural properties of the zones in question, especially the BM zone shown in Figure 36, are very similar to the properties of the base material supplied directly from the steelworks, shown in Figure 12.

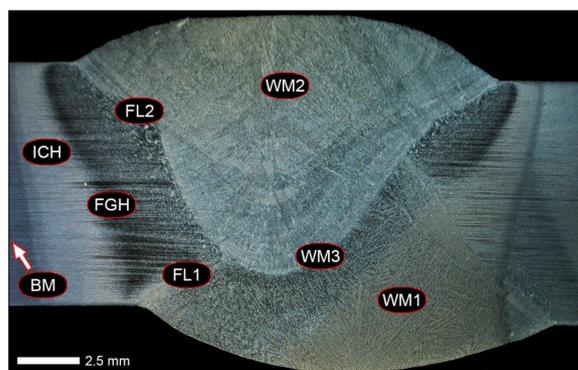
**Figure 13.** Macroscopic view of the weld joint cross section of Hardox 600 as delivered. WM—weld metal zone, FL—fusion line, BM—base material zone, FGH(AZ)—fine-grained zone (normalization and re-crystallization), ICH(AZ)—inter-critical zone (incomplete normalization). Stereoscopic microscopy, etched with 3%  $\text{HNO}_3$  in ethyl alcohol and Adler’s reagent.

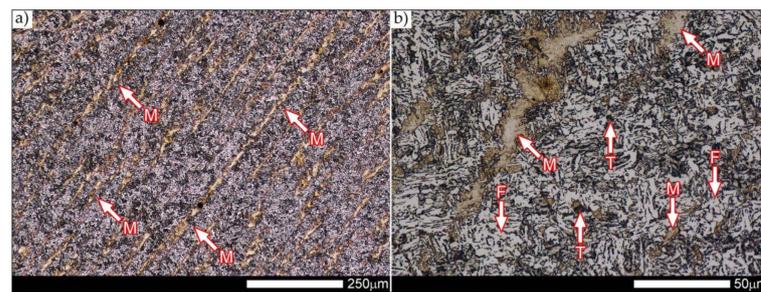
**Figure 14.** Micro-structure of a welded joint of Hardox 600 as delivered in the area marked WM1 in Figure 13: (a) General view of the micro-structure with clear banding features. (b) Enlarged central area of the structure shown in (a). A very diverse structure, mainly consisting of banded martensite against the background of non-equilibrium ferrite. The presence of troostite colonies is also locally observed. M—martensite, F—ferrite, T—troostite. Light microscopy, etched with 3% HNO<sub>3</sub> in ethyl alcohol.

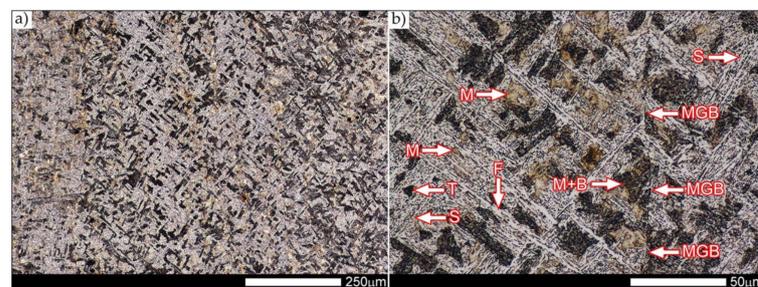
**Figure 15.** Micro-structure of the welded joint of Hardox 600 as delivered in the area marked as WM2 in Figure 13: (a) General view of a dendritic structure of a morphologically very diverse structure. (b) Enlarged central area of the structure shown in (a). Micro-structure consisting of martensite and lower bainite and a few colonies of troostite against the background of quenching sorbite. M—martensite, F—ferrite, T—troostite, S—sorbite, B—lower bainite, MGB—migrated grain boundary. Light microscopy, etched with 3% HNO<sub>3</sub> in ethyl alcohol.

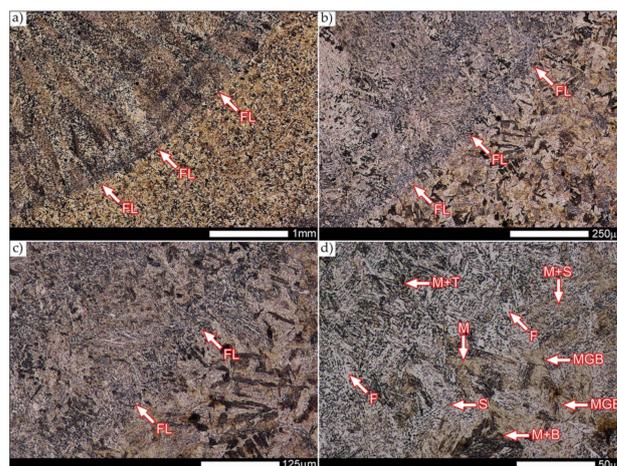
**Figure 16.** Micro-structure of a welded joint of Hardox 600 as delivered in the area marked WM3 in Figure 13—different magnification scales: (a) ~25×; (b) ~100×; (c) ~200×; (d) ~500×. A clearly visible fusion line with a very diverse micro-structure. The quenching sorbite structure is observed along the entire length of the fusion line, as is the sorbitic–martensitic and troostitic–martensitic structure. In the zones directly adjacent to the fusion line, there are areas of quenching martensite and lower bainite, locally separated by migrated boundaries. FL—fusion line, M—martensite, F—ferrite, T—troostite, S—sorbite, B—lower bainite, MGB—migrated grain boundary. Light microscopy, etched with 3% HNO<sub>3</sub> in ethyl alcohol.

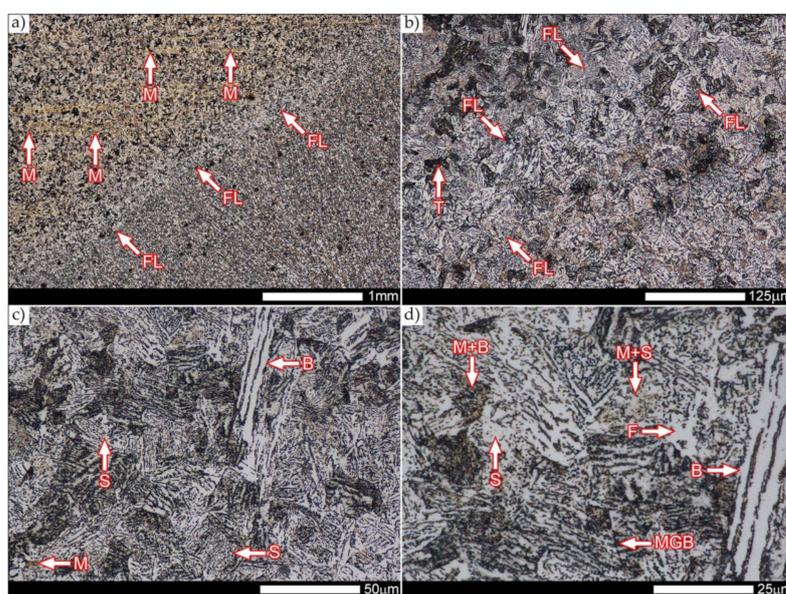
Figure 17 shows structural changes within the fusion line occurring during the execution of the first layer of the weld (FL1 area in Figure 13). In the case of the above zone, it can be stated that it is dominated by a sorbitic structure with distinct features of post-martensitic orientation. This state of affairs indicates thermal processes that are characteristic of tempering within a fusion line. The regions of martensite or lower bainite in the discussed zone are observed relatively sparse, which seems to confirm the earlier statement. On the other hand, the presence of bainitic ferrite plates (designation B in Figure 17c,d), thickness of which is 3–5  $\mu\text{m}$  (length  $\sim 60 \mu\text{m}$ ), is slightly more numerous. The presence and large size of this phase indicates local (heterogeneous) growth of austenite during welding and also indicates a possibility that, during crystallization of this zone, phase transformations could take place in isothermal conditions. The type of structure described above, in relation to the heat-affected zone of welded joints, most often manifests itself in a significantly reduced brittleness threshold, observed even at ambient temperature.

**Figure 17.** Micro-structure of a welded joint of Hardox 600 as delivered in the area marked as FL1 in Figure 13—different magnification scales: (a)  $\sim 25\times$ ; (b)  $\sim 200\times$ ; (c)  $\sim 500\times$ ; (d)  $\sim 1000\times$ . A clearly visible fusion line (FL) with a very diverse micro-structure. Quenching sorbite (S), martensitic–sorbitic (M+S) structure, areas of quenching martensite and lower bainite (M+B) are observed along the entire length of the fusion line. Locally, the formation of structurally free quenching martensite (M) and quenching troostite (T) as well as upper bainite (B) are observed. There are also migrated grain boundaries (MGB). Light microscopy, etched with 3%  $\text{HNO}_3$  in ethyl alcohol.

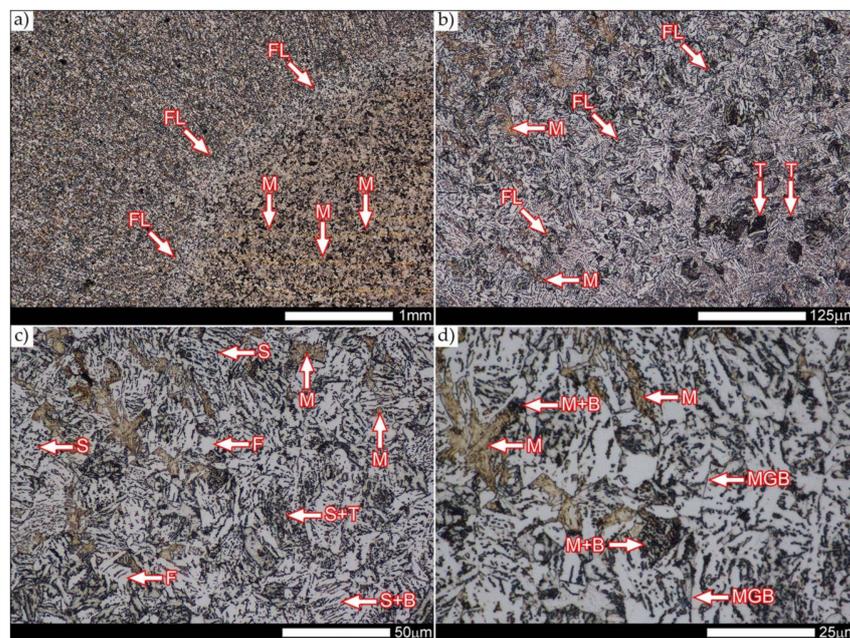
In the case of the zone of the tested welded joint marked as FL2 in Figure 13, it can be stated that it consists predominantly of a ferritic–sorbitic structure and a strip-like arrangement—in the direction of crystallization—of quenching martensite (Figure 18). Secretions of lower bainite and troostite are also locally observed. The lack of clear features of the post-martensitic orientation of the sorbite formed and a fairly significant amount of block ferrite allow us to conclude that the pattern of changes taking place on the fusion line during the execution of the second layer of the weld was characteristic of those observed during partial or isothermal quenching. The described type of construction on the fusion line may also indirectly result from the dendritic structure remaining after directional crystallization, which, in the FCC or BCC crystal lattices, most often runs along the  $\langle 100 \rangle$  direction [28]. High rate of crystal growth is also associated with a high dendritic segregation index of the chemical composition. Hence, very often on the fusion line of welded joints and surfaced layers there are observed structures indicating lower carbon content than it would result from the chemical composition of the base material and an

**Figure 18.** Micro-structure of a welded joint of Hardox 600 as delivered in the area marked FL2 in Figure 13—different magnification scales: (a) ~25×; (b) ~200×; (c) ~500×; (d) ~1000×. A clearly visible fusion line (FL) with a very diverse micro-structure. Along the entire length of the fusion line and in the zones adjacent to it, the structure of quenching sorbite (S), sorbitic–bainitic (S+B), sorbitic–troostitic (S+T), areas of quenching martensite and lower bainite (M+B) banded—structurally free—quenching martensite (M) are observed. The secretions of quenching troostite (T) as well as block ferrite (F) are locally observed. MGB—migrated grain boundary. Light microscopy, etched with 3% HNO<sub>3</sub> in ethyl alcohol.

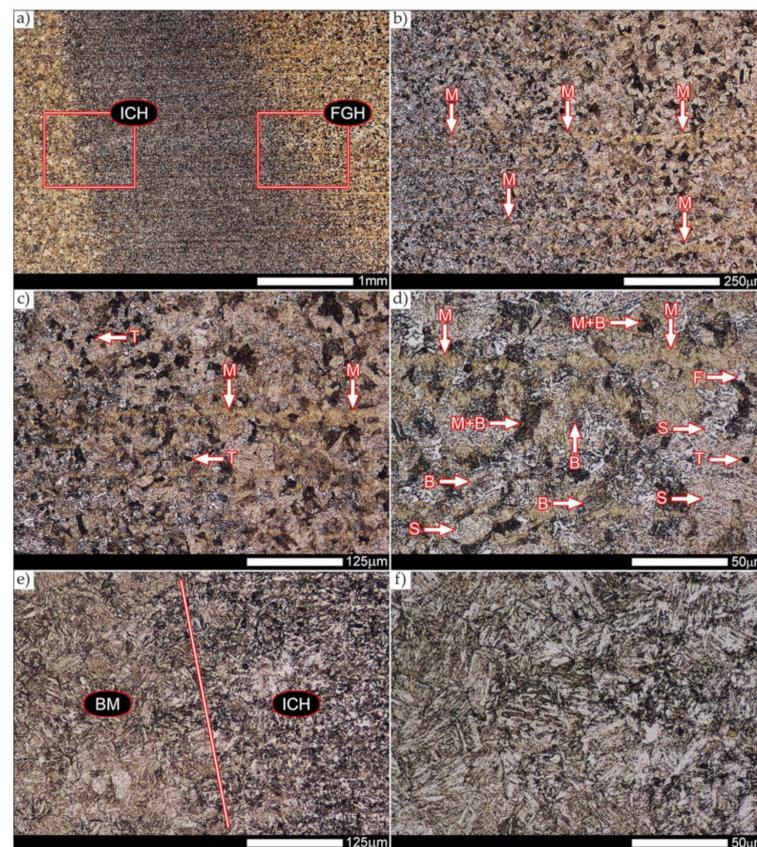
**Figure 19.** Micro-structure of the welded joint of Hardox 600 steel in the delivered condition in the area of the heat-affected zone, marked as FGH and ICH in Figure 13. (a) General view of the heat-affected zone. (b–d) Enlarged areas of the micro-structure marked by frame FGH in (a). (e,f) Enlarged areas of the micro-structure marked with frame ICH in (a). In the whole area of the zone of warm influence, the presence of martensitic structure bands (M) is observed. The following structures can be distinguished in the FGH zone: quenching martensite with lower bainite (M+B), upper bainite (B), quenching sorbite (S), quenching troostite (T) and block ferrite (F). The ICH zone consists mainly of a post-martensitic structure, i.e., tempered sorbite (ICH in (e)) and tempered martensite (BM in (e)). Light microscopy, etched with 3% HNO<sub>3</sub> in ethyl alcohol.

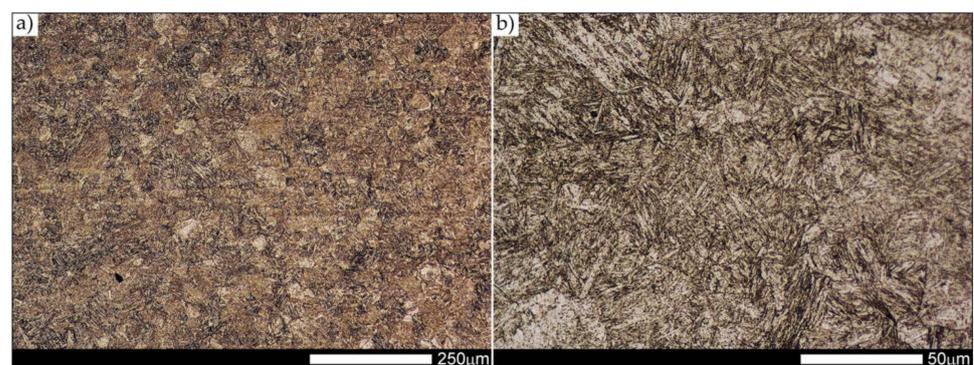
**Figure 20.** Micro-structure of the base material of the weld joint of Hardox 600 in the as welded condition—area BM in Figure 13. (a) General view of the micro-structure with very little banding features. (b) Enlarged central area of the structure shown in (a). In terms of a structure, the micro-structure is similar to that of fine-lath tempering martensite. Light microscopy, etched with 3% HNO<sub>3</sub> in ethyl alcohol.

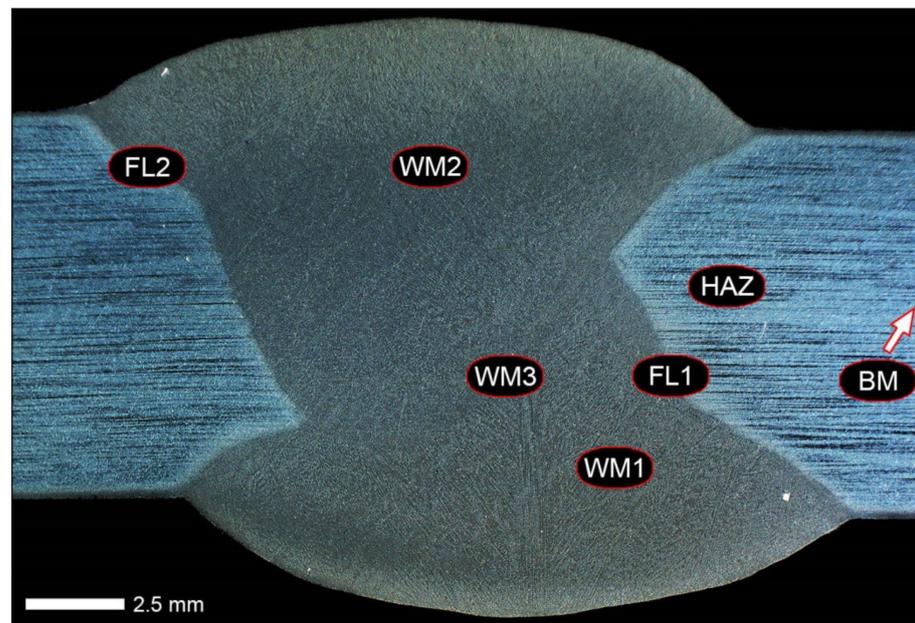
Figure 21 shows a macroscopic image of the considered welded joint after performed normalizing annealing. In such a state of heat treatment (immediately after welding), the same zones of the welded joint were subjected to structural analysis as in the case of the delivered condition. Nevertheless, due to high degree of uniformity of the structure in the area between the FL1/FL2 fusion lines and the base material BM (Figure 21), in relation to this zone, the tests were generally carried out for the entire heat-affected zone (HAZ designation in Figure 21).

**Figure 21.** Macroscopic view of the welded joint cross section of Hardox 600 in normalized state—process No. 3 shown in Table 6. WM—weld metal zone, FL—fusion line, BM—base material zone, HAZ—heat-affected zone. Stereoscopic microscopy, etched with 3% HNO<sub>3</sub> in ethyl alcohol.

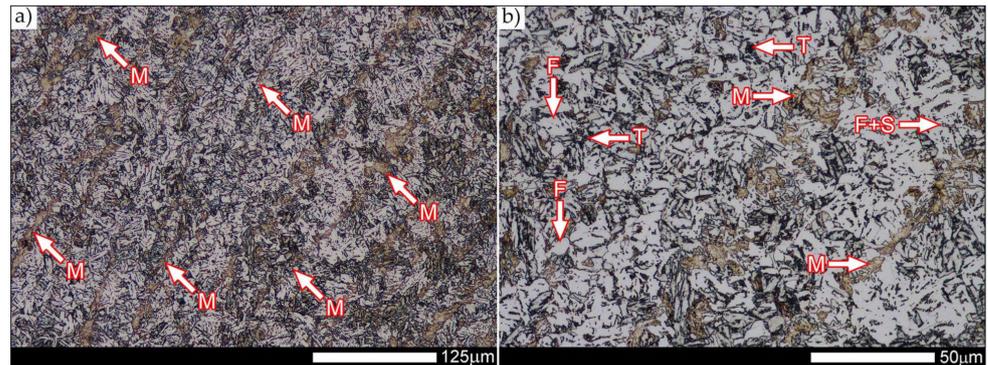
**Figure 22.** Micro-structure of the welded joint of Hardox 600 in normalized state in the area marked as WM1 in Figure 21. (a) General view of the micro-structure with clear banding features. (b) Enlarged central area of the structure shown in (a). Structure diversified in terms of structure characteristic for incompletely hardened state. Banded development of martensite against the background of non-equilibrium ferrite and sorbite are observed. The presence of quenching troostite colonies is also locally observed. M—martensite, F—ferrite, T—troostite, S—sorbite. Light microscopy, etched with 3% HNO<sub>3</sub> in ethyl alcohol.

In the zones of the weld metal, marked as WM1 and WM2 in Figure 21 (in terms of chemical composition, points X and Y in Figure 3 and Table 5), the normalization procedure caused very similar structural changes (Figures 22 and 23). In both cases, the obtained structure was characteristic of incomplete quenching treatments. It consisted mainly of non-equilibrium ferrite grains, locally with the features of upper bainite, with a significant volume of a quenching sorbite structure. The presence of a martensitic structure is observed in the carbon-enriched zones, in the form of micro-structural bands running in the direction of weld crystallization during welding. In a few zones, the presence of the quenching troostite structure can also be indicated.

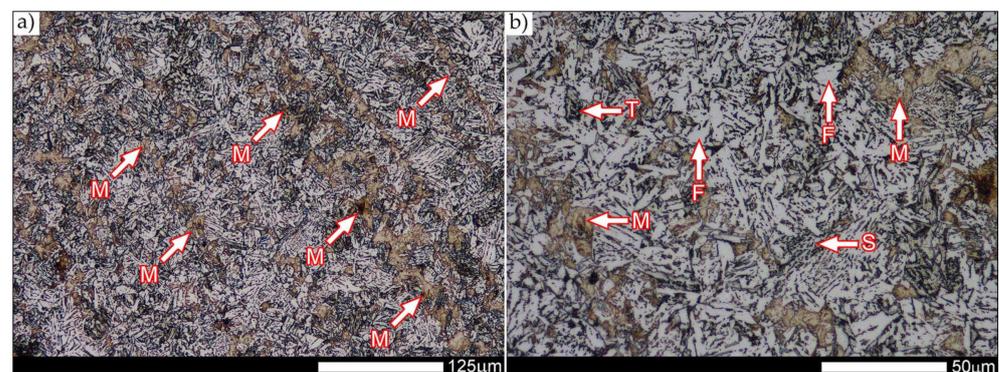
**Figure 23.** Micro-structure of the welded joint of Hardox 600 in normalized state in the area marked as WM2 in Figure 21. (a) General view of the micro-structure with distinct banding features. (b) Enlarged central area of the structure shown in (a). Differentiated structure characteristic for incompletely hardened state. Band-like development of martensite is observed—in the direction of the weld crystallization—against the background of non-equilibrium ferrite and quenching sorbite. In terms of structure, the ferritic phase is very similar to the upper bainite. The presence of quenching troostite colonies is also locally observed. M—martensite, F—ferrite, T—troostite, S—sorbite. Light microscopy, etched with 3% HNO<sub>3</sub> in ethyl alcohol.

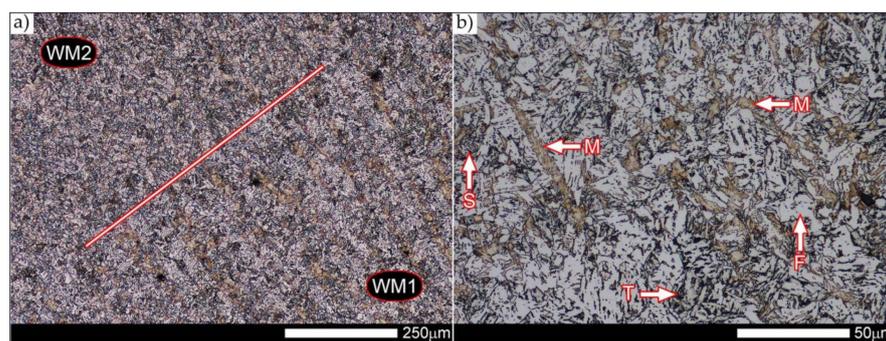
**Figure 24.** Micro-structure of the welded joint of Hardox 600 steel in the normalized state in the area marked as WM3 in Figure 21. (a) General view of the micro-structure—the line shows a slightly outlined fusion line. (b) The enlarged area of the structure on the fusion line shown in (a). Relatively homogeneous, phase-different structure characteristic of an incompletely hardened state. The presence of non-equilibrium ferrite grains is observed—for the most part—locally with the features of upper bainite, with quenching sorbite and with isolation martensite precipitates and in the form of bands running in the direction of crystallization. The presence of quenching troostite colonies can also be observed in a small amount. WM1/WM2—weld material No.1 and No.2, M—martensite, F—ferrite, T—troostite, S—sorbite. Light microscopy, etched with 3% HNO<sub>3</sub> in ethyl alcohol.

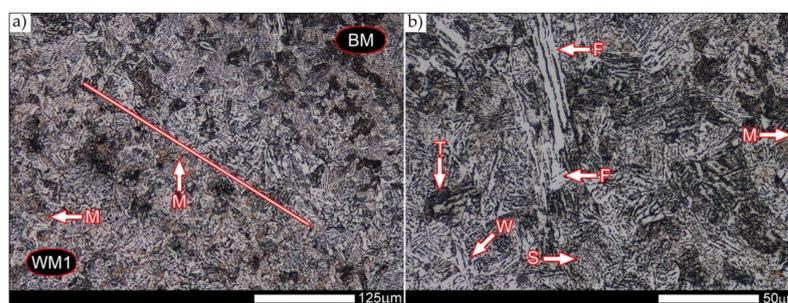
**Figure 25.** Micro-structure of the welded joint of Hardox 600 steel in a normalized state in the area marked as FL1 in Figure 21. (a) General view of the micro-structure—the line shows a slightly indicated fusion line. (b) Enlarged area of the structure on the fusion line shown in (a). In terms of construction, the structure is characteristic for isothermal quenching—quenching sorbite (S) with the features of the upper bainite. In addition, the presence of non-crystallized ferrite (F), significant amounts of quenching troostite colonies (T), martensite (M) locally transforming into lower bainite and individual areas with Widmanstätten (W) structure features can be indicated. WM1—weld material No.1, BM—base material. Light microscopy, etched with 3% HNO<sub>3</sub> in ethyl alcohol.

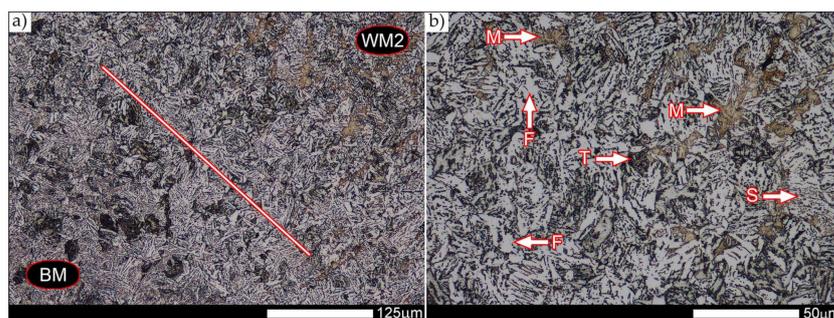
In the case of the zone marked as FL2 (Figure 26), it can be stated that in the normalized state it is characteristic of the state after incomplete quenching, and, in terms of structure, it is very similar to the WM3 zone. The zone of weakly outlined fusion line (symbolically marked in Figure 26a) mainly consists of non-equilibrium ferrite grains, as well as quenching sorbite and quenching troostite. Directly on the fusion line, practically no precipitation of the martensitic structure, which has a much larger share in the zones deeper towards the weld metal, is observed. The discussed type of structure primarily results from the significant dendritic segregation of the chemical composition during welding.

**Figure 26.** Micro-structure of the welded joint of Hardox 600 steel in the normalized state in the area marked as FL2 in Figure 21. (a) General view of the micro-structure—the line shows a slightly outlined fusion line. (b) The enlarged area of the structure on the fusion line shown in (a). Relatively homogeneous, differentiated in terms of phase structure, the structure characteristic for the incompletely hardened state. Against the background of non-equilibrium ferrite grains (F) and quenching sorbite (S), visible bands of the martensitic structure (M) and troostite colonies (T). WM2—weld material No. 2, BM—base material. Light microscopy, etched with 3% HNO<sub>3</sub> in ethyl alcohol.

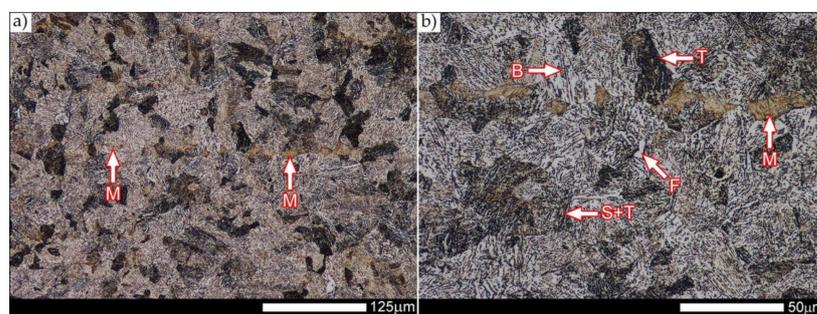
**Figure 27.** Micro-structure of a welded joint of Hardox 600 in the normalized state in the area marked as HAZ in Figure 21. (a) General view of the micro-structure with marked banding features. (b) The enlarged central area of the structure shown in (a). The structure characteristic for isothermal cooling—on the background of quenching sorbite structure (S) and quenching troostite (T), band-like precipitation of martensite (M), locally changing into the structure of upper bainite (B). In a few zones, the presence of structurally free ferrite (F) is also observed. Light microscopy, etched with 3% HNO<sub>3</sub> in ethyl alcohol.

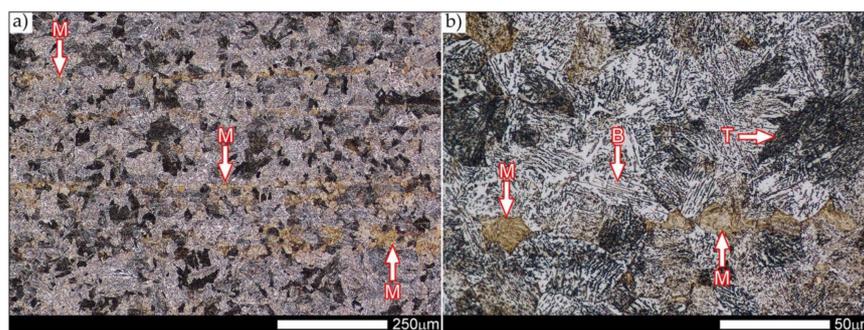
**Figure 28.** Micro-structure of the base material of the welded joint of Hardox 600 steel in normalized state—area BM in Figure 21. (a) General view of the micro-structure with streaked areas of quenching martensite. (b) Enlarged central area of the structure shown in (a). In terms of structure, the structure is characteristic of isothermal cooling—on the background of quenching sorbite and quenching troostite visible precipitation of banded martensite. Upper bainite crystallizing from the grain boundaries of the former austenite is locally observed. M—martensite, B—bainite, T—troostite. Light microscopy, etched with 3% HNO<sub>3</sub> in ethyl alcohol.

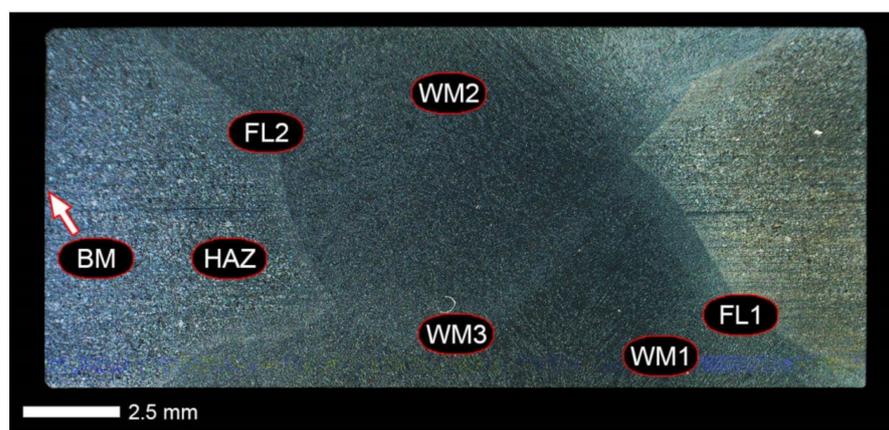
Figure 29 shows a macroscopic image of a welded joint of Hardox 600 steel after comprehensive heat treatment, according to the diagram No. 9 shown in Table 6. As in the previous cases (as delivered and normalized), the welded joint was subjected to structural tests in selected zones, symbolically marked in the macro-photograph, below. Figures 30–36 present an overview of the structural structure in the characteristic zones of the tested welded joint. Regardless of the zone under consideration, it can be stated that the implemented thermal treatments caused very similar structural changes in the entire area of the butt weld. In practically every case under consideration, the welded joint was characterized by a fine-lathed tempering martensite structure with areas of quenching martensite. The above statement seems to be correct both for the zone of the base material and the weld metal and for the structural properties observed on the fusion lines.

**Figure 29.** Macroscopic image of the welded joint cross-section of Hardox 600 in the heat-treated state according to the diagram No. 9 shown in Table 6. WM—weld metal zone, FL—fusion line, BM—base material zone, HAZ—heat-affected zone. Stereoscopic microscopy, etched with 3% HNO<sub>3</sub> in ethyl alcohol.

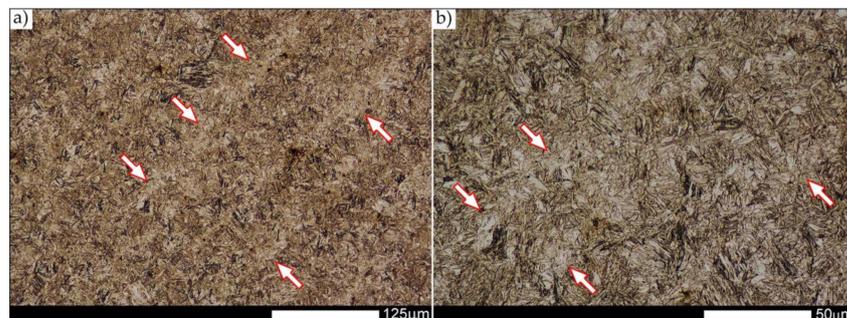
**Figure 30.** Micro-structure of the welded joint of Hardox 600 in the heat-treated condition according to the diagram No. 9 shown in Table 6, in the area labeled WM1 in Figure 29. (a) General view of the micro-structure with slight banding features. (b) Enlarged central area of the structure shown in (a). The structure of fine-lath tempering martensite with quenching martensite separated along the strips (in the direction of the weld crystallization) (undermined martensite—marked with arrows). Light microscopy, etched with 3% HNO<sub>3</sub> in ethyl alcohol.

The weld metal zones marked as WM1 and WM2 presented in Figures 30 and 31 show almost identical structural features, which is largely due to the same chemical composition in these areas (points X and Y in Figure 3 and Table 5). In both cases, it consists of fine-lath tempering martensite with banded quenching martensite—untempered martensite. These bands run in the direction of the primary crystallization of the weld, caused by the welding process. Locally, apart from these bands—in the zones depleted in carbon—

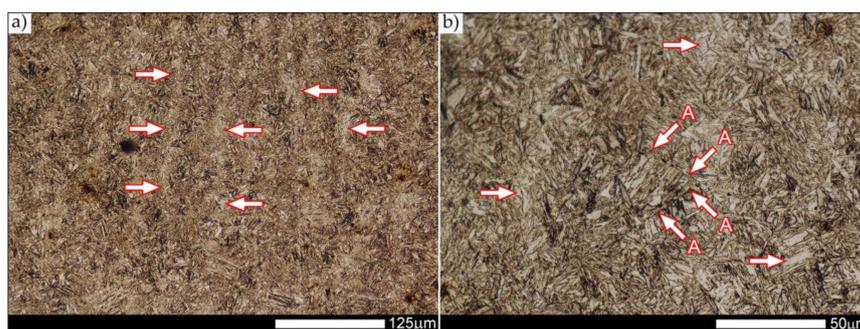
**Figure 31.** Micro-structure of a welded joint of Hardox 600 in the heat-treated condition as shown in Diagram No. 9 shown in Table 6 in the area labeled WM2 in Figure 29. (a) General view of the micro-structure with slight banding features. (b) Enlarged central area of the structure shown in (a). Structure of fine-lath tempering martensite with banded quenching martensite (indicated by arrows). Arrows (A) mark the grain boundary of the former austenite, inside which martensite arranged in the form of packages is observed, which is also characterized by a low degree of the crystallographic orientation's variability. Light microscopy, etched with 3% HNO<sub>3</sub> in ethyl alcohol.

martensite with a packet and block structure is observed, characterized by a low variability of the crystallographic orientation of individual packets within the boundaries of the former austenite grains (arrows A in Figure 31b). This condition is typical of hardened low-carbon steels.

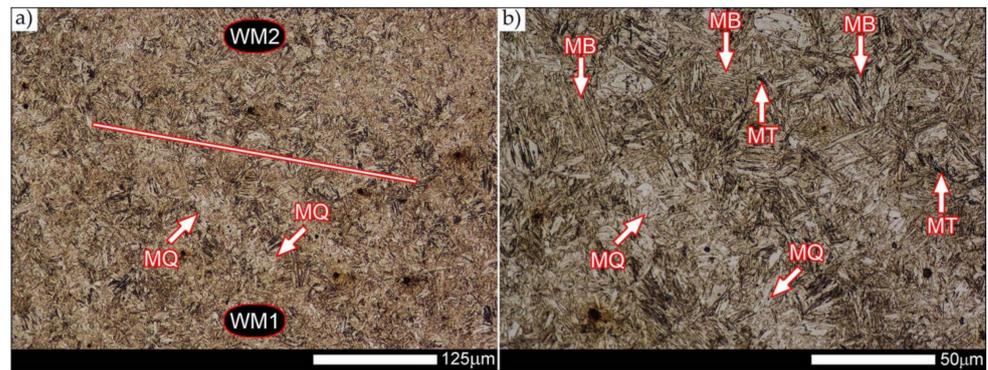
A slightly larger volume of the block martensite structure can be indicated on the fusion line between the weld metal materials (Figure 32). Almost along the entire length of the very poorly defined fusion line, marked as WM3 in Figure 29 (in terms of chemical composition, point Z in Figure 3 and Table 5), the presence of low-carbon, fine-lath block martensite is observed (MB designation in Figure 32b). This state of affairs is dictated by the depletion of this area in carbon, resulting in reduced hardenability and resistance to tempering processes. Hence, in sporadic cases, the presence of highly tempered structures with post-martensitic orientation is noted (marking MT in Figure 32b). It is worth mentioning that removal of the described changes would require additional homogenizing annealing, which, due to the properties of the base material, is inadvisable, as well as technologically difficult and economically unjustified.

**Figure 32.** Micro-structure of the welded joint of Hardox 600 steel in the heat-treated state according to the diagram No. 9 shown in Table 6, in the area marked as WM3 in Figure 29. (a) General view of the micro-structure—the line symbolically marks the fusion line. (b) Enlarged central area of the structure at the fusion line shown in (a). For the most part, a structure consisting of fine-lathed tempering martensite with banded quenching martensite (MQ). Along the entire length of the fusion line, martensite of block structure (MB) is present, characterized by a small variation in the crystallographic orientation within the former austenite grains. The arrows (MT) indicate single precipitations of highly tempered martensite, which crystallized first. WM1/WM2—weld material No. 1 and No. 2. Light microscopy, etched with 3% HNO<sub>3</sub> in ethyl alcohol.

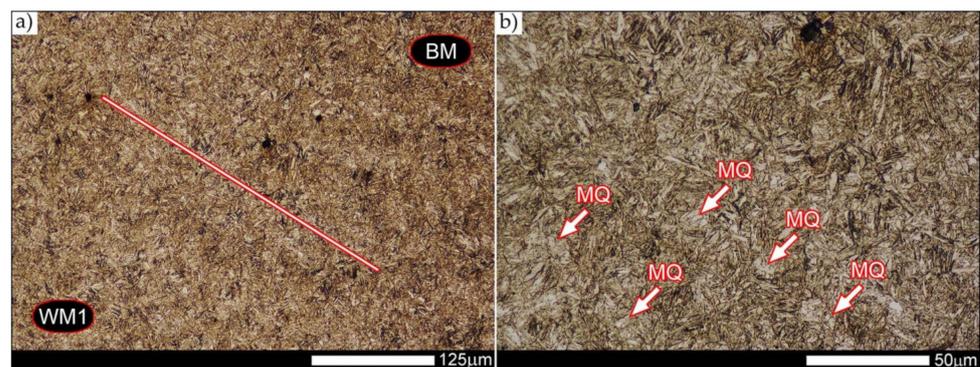
**Figure 33.** Micro-structure of the welded joint of Hardox 600 in the heat-treated condition according to the diagram No. 9 shown in Table 6, in the area marked as FL1 in Figure 29. (a) General view of the micro-structure—the fusion line is symbolically marked with a straight line. (b) Enlarged central area of the structure at the fusion line shown in (a). Throughout the fusion line, the structure, for the most part, consists of tempering martensite with very little banding characteristics formed by undemanding martensite (MQ). WM1—weld material No. 1, BM—base material. Light microscopy, etched with 3% HNO<sub>3</sub> in ethyl alcohol.

Referring to the structural properties recorded on individual FL1 and FL2 fusion lines of the welded joint under consideration (Figures 33 and 34), it should be noted that the comprehensive heat treatment procedures carried out led to an almost complete homogenization of the structure in these zones. As a result, the structure of fine-lathed, medium-carbon tempering martensite with few zones of quenching martensite was obtained (marking MQ in Figure 33). It is also worth adding that there are relatively few areas of the martensite structure with block morphology in this case, which indicates a similar percentage of carbon in these areas.

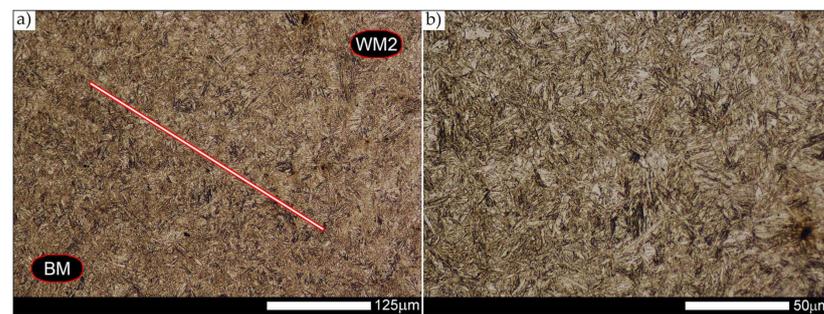
**Figure 34.** Micro-structure of the welded joint of Hardox 600 steel in the heat-treated condition according to the diagram No. 9 shown in Table 6, in the area marked as FL2 in Figure 29. (a) General view of the micro-structure—the fusion line is symbolically marked with a straight line. (b) Enlarged central area of the structure at the fusion line shown in (a). Throughout the fusion line, the structure predominantly consists of tempering martensite with very few areas of quenching martensite. There are no clear banding features in the structure. WM2—weld material No. 2, BM—base material. Light microscopy, etched with 3% HNO<sub>3</sub> in ethyl alcohol.
