# Technological, Microstructural and Strength Aspects of Welding and Post-Weld Heat Treatment of Martensitic, Wear-Resistant Hardox 600 Steel

Lukasz Konat

Department of Vehicle Engineering, Wrocław University of Science and Technology, 50-370 Wrocław, Poland; lukasz.konat@pwr.edu.pl

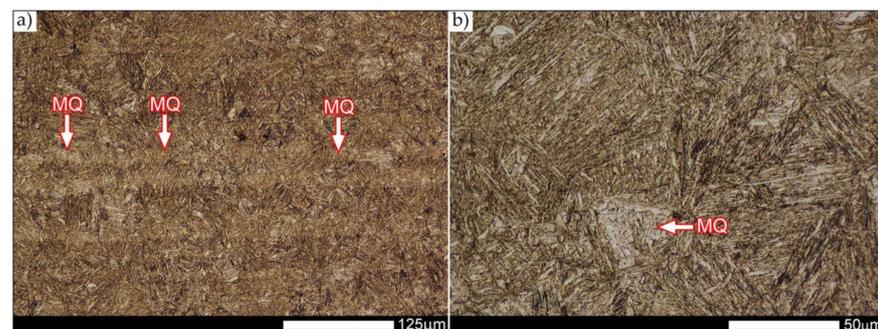
**Figure 35.** Micro-structure of the welded joint of Hardox 600 in the heat-treated state according to the diagram No. 9 shown in Table 6, in the area marked as HAZ in Figure 29. (a) General view of the micro-structure—the arrows indicate small banding features of the structure, created by the presence of undetermined martensite (quenching martensite—MQ). (b) Enlarged central area of the structure shown in (a). Structure mainly consists of fine-lathed tempering martensite. Light microscopy, etched with 3% HNO<sub>3</sub> in ethyl alcohol.

Micro-structure of the heat-affected zone and the base material, marked respectively as HAZ and BM in Figure 29, showed no significant differences as a result of the thermal treatments performed. In both cases, a similar structure is observed, consisting of tempering martensite with numerous bands of unremoved martensite structure (MQ designation in Figures 35 and 36). The presence of these bands is a direct result of producing Hardox 600 sheets technology—thermomechanical rolling—which were not “removed” during the applied post-welding thermal treatments. It is also worth mentioning here that the structural properties of the zones in question, especially the BM zone shown in Figure 36, are very similar to the properties of the base material supplied directly from the steelworks, shown in Figure 12.

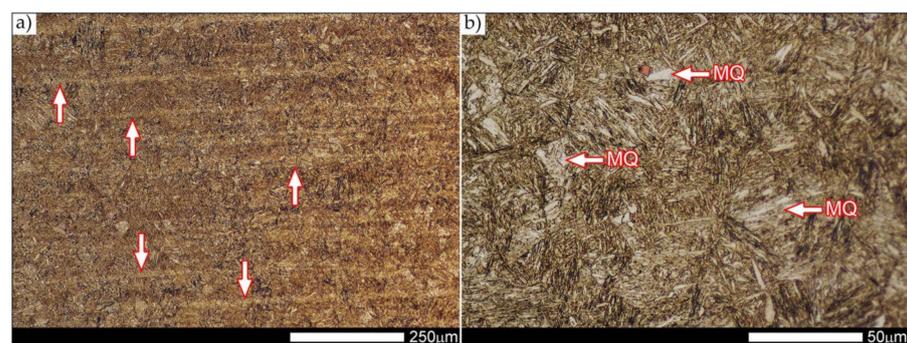
**Figure 36.** Micro-structure of the base material of the welded Hardox 600 steel in the heat-treated state according to the diagram No. 9 shown in Table 6—the BM area in Figure 29. (a) General view of the micro-structure—arrows indicate clear banding features created by underexposed martensite (quenching martensite)—MQ). (b) The enlarged central area of the structure shown in (a). The micro-structure of fine-lathed tempering martensite, characterized by a large variation of the crystallographic orientation within the block structure it creates. Light microscopy, etched with 3% HNO<sub>3</sub> in ethyl alcohol.

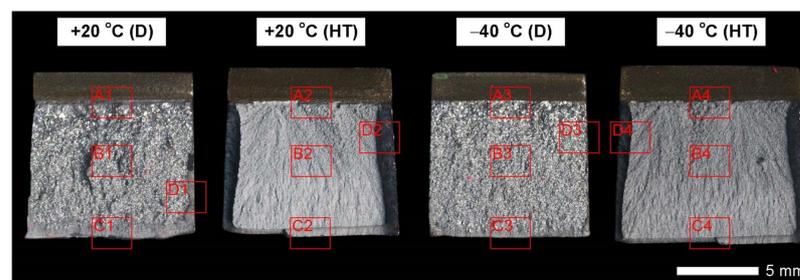
Figure 37 presents macroscopic images of the fracture surfaces of welded joints representative samples, subjected to impact toughness tests at +20 °C and −40 °C. As a result of the fractographic analysis, very significant differences in the overall structure of fractures between the analyzed series of samples can be identified. Regardless of the test temperature, the fractures of welded joints samples as delivered (immediately after welding) do not show a significant share of plastic side zones. At the temperature of +20 °C, the share of the plastic zone occurring only locally does not exceed 2% of the total fracture area (frame D1 in Figure 37). In the case of samples subjected to the impact test at −40 °C, these shares do not exceed 1% (frame D3 in Figure 37); therefore, their presence can be described as marginal. The above-described state of affairs proves the expenditure of very little energy during the formation of fractures, which also confirms the obtained very low impact indexes of the welded joint in the delivered condition. In the case of fractures of welded joint samples subjected to complex heat treatment, in the entire temperature range of impact tests, they show significant shares of plastic side zones. At a temperature of +20 °C, these shares can be estimated at 20% (frame D2 in Figure 37) and about 12% for the Charpy test carried out at 40 °C (frame D4 in Figure 37). The clear presence of relatively wide plastic side zones on the fracture surfaces of heat-treated samples indicates formation of fractures over a longer period of time, with the simultaneous expenditure of considerable energy. The above statement seems to be justified by the values of impact indices obtained (Table 6). In addition, the macroscopic analysis performed showed that the fractures of the samples in the delivered condition are characterized by a different topography, resulting from the presence of fractures almost on the entire surface (except for the fracture zones marked with frames C1 and C3 in Figure 37), a coarse-grained structure on the fusion line. On the other hand, of the welded joint surfaces of the fractures subjected to additional heat treatment can be considered fine-grained, homogeneous, characterized by roughness, running in the direction of crystallization during welding. In order to identify the structure of the fracture surfaces individual zones in question, all samples were subjected to further examination using SEM electron microscopy.

**Figure 37.** Macroscopic image of the fracture surfaces of representative samples of welded joints made of Hardox 600 after the impact test. D—delivery condition (after welding), HT—condition after comprehensive heat treatment according to diagram No. 9 shown in Table 6. The frames indicate: A—under-notch zone, B—central zone, C—final-fracture zone, D—side zone. Stereoscopic microscopy, non-etching condition.

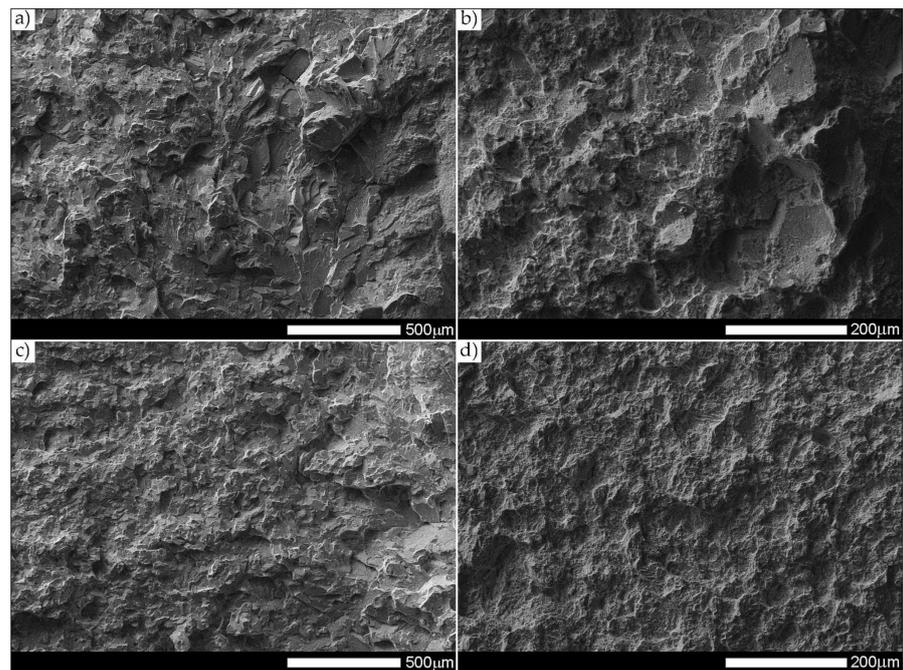
**Figure 38.** Images of the fracture surfaces of the welded joint Hardox 600, marked with the appropriate frames “A” in Figure 37: (a) A1, delivery condition, +20 °C, ~50×; (b) A2, heat-treated condition, +20 °C, ~150×; (c) A3, delivered condition, −40 °C, ~50×; (d) A4, heat-treated condition, −40 °C, ~150×. SEM, non-etching condition.

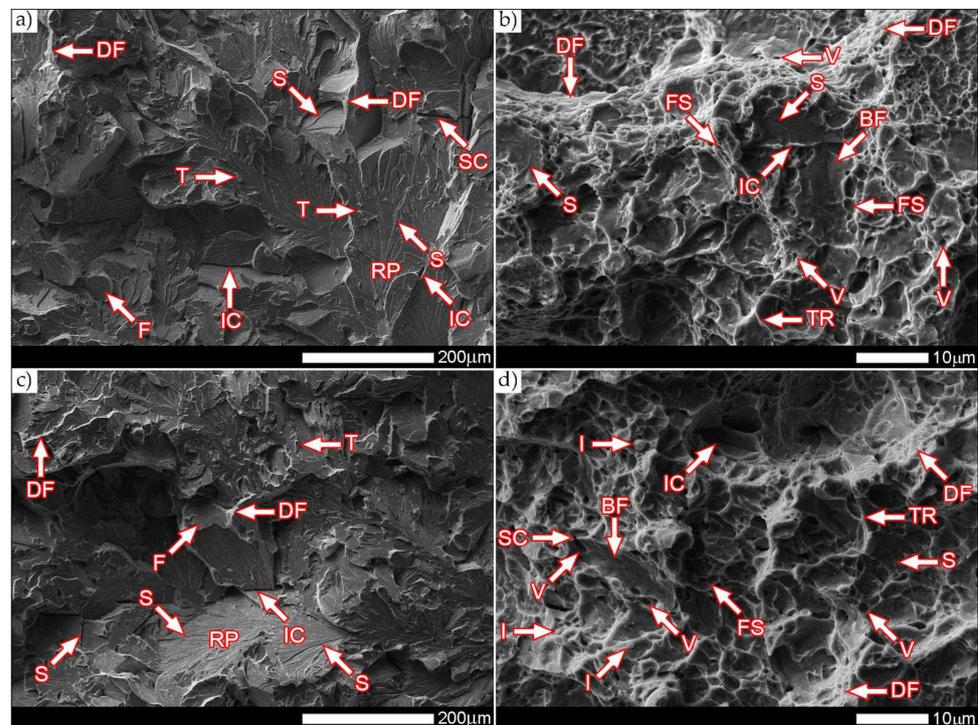
**Figure 39.** Enlarged images of the fracture surfaces shown in Figure 38: (a) A1, delivered condition, +20 °C, ~150×; (b) A2, heat-treated condition, +20 °C, ~1500×; (c) A3, delivered condition, −40 °C, ~150×; (d) A4, heat-treated condition, −40 °C, ~1500×. DF—ductile fracture, BF—brittle fracture, SC—secondary fracture, IC—inter-crystalline fracture, RP—“river” pattern, S—steps, T—tongues, F—facets, V—micro-voids, FS—fish scales, I—inclusions, TR—tear ridges. SEM, non-etching condition.

Figure 39b,d show the characteristic fracture zones of the analyzed heat-treated samples. The fractures obtained at both ambient and low temperature are characterized by the presence of voids of very different sizes. The discussed feature is particularly visible in the fracture zones with high plastic deformation (DF), where the presence of extremely small voids (V) is observed. The remaining areas are dominated by larger, shallow voids in which no phase precipitation is observed. Such a situation results directly from the state of heat treatment, which, in the final stage, included tempering operation at a fairly low temperature (100 °C), i.e., much below the temperature favorable to the precipitation processes. In some areas of the revealed fracture surfaces—especially at −40 °C—single non-metallic inclusions (I) are visible, which are fine slags formed directly in the welding process, most likely resulting from the presence of corrosion products on the ridges of the welded sheet. On the fracture surfaces, one can also observe a characteristic “fish scale” structure (FS) approximately running in the direction of the crack development (especially at ambient temperature). This is confirmed by the fact that the fracture process is initiated by plastic deformation within the voids, while the fracture itself takes place similarly to brittle fracture by cutting the walls separating them. In addition, the presence of the so-called “tear ridges” (TR) that indicate the presence of a quasi-fracture. Such a fracture is created by joining many local fractures, usually formed on the same crystallographic plane [29], resulting in material's decohesion, preceded by a strong plastic deformation. The presence of steps can also be indicated on the considered fracture surfaces—in brittle zones (BF). Nevertheless, their course is rather flat, without formation of the characteristic structure of “river pattern”, so it can be concluded that their contribution to energy absorption during destruction was marginal.

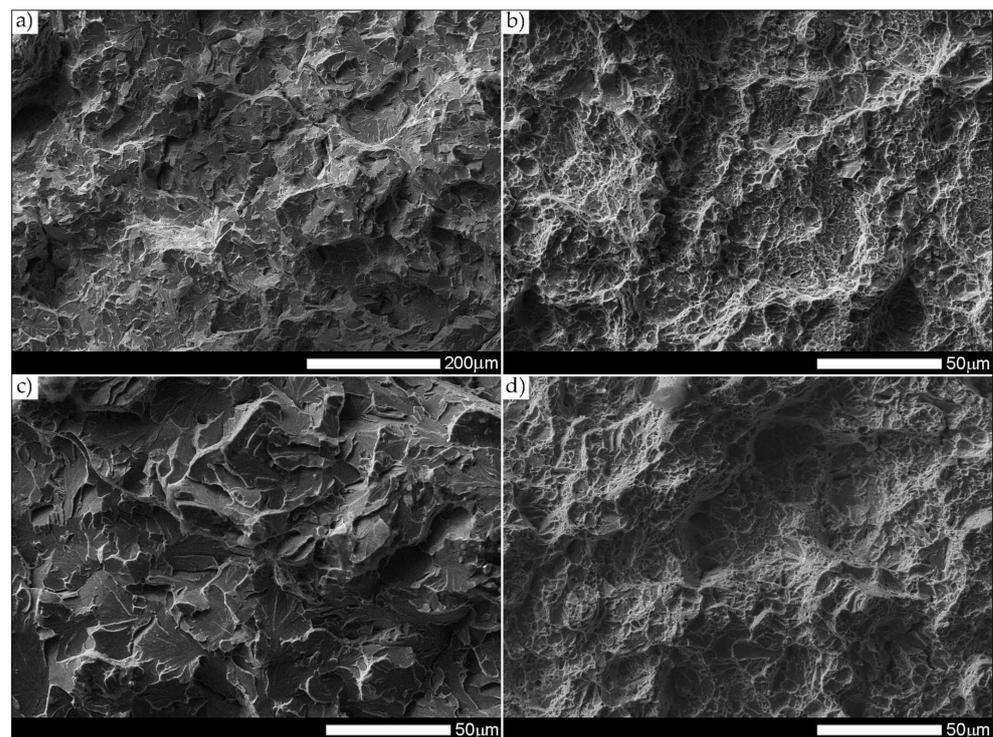
**Figure 40.** Images of the fracture surfaces of the welded joint Hardox 600, marked with the appropriate frames “B” in Figure 37: (a) B1, delivery condition, +20 °C, ~150×; (b) B2, heat-treated condition, +20 °C, ~500×; (c) B3, delivered condition, −40 °C, ~500×; (d) B4, heat-treated condition, −40 °C, ~500×. SEM, non-etching condition.

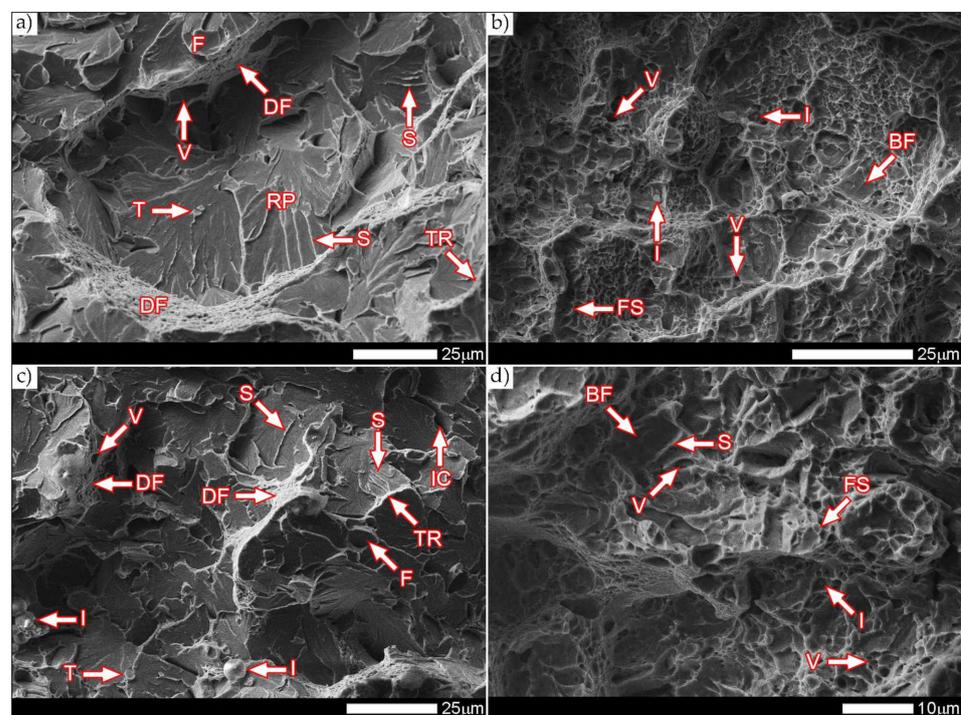
**Figure 41.** Enlarged images of the fracture surfaces shown in Figure 40: (a) B1, delivery condition, +20 °C, ~700×; (b) B2, heat-treated condition, +20 °C, ~1000×; (c) B3, delivered condition, −40 °C, ~750×; (d) B4, heat-treated condition, −40 °C, ~1500×. DF—ductile fracture, BF—brittle fracture, IC—inter-crystalline fracture, RP—“river” pattern, S—steps, T—tongues, F—facets, V—micro-voids, FS—fish scales, I—inclusions, TR—tear ridges. SEM, non-etching condition.

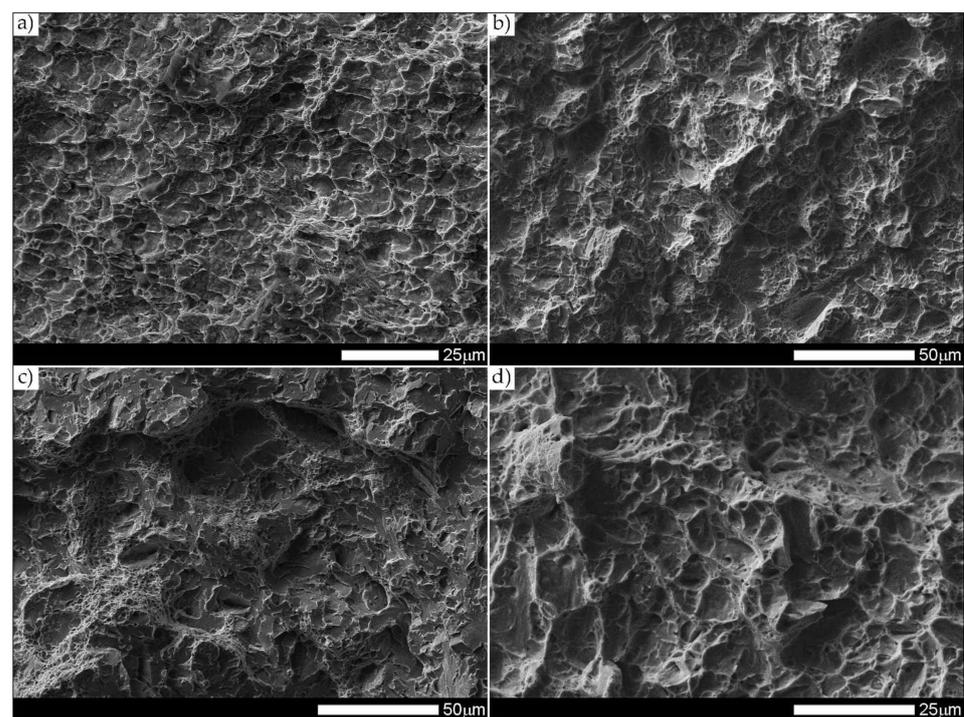
**Figure 42.** Images of the fracture surfaces of the welded joint Hardox 600, marked with the appropriate “C” frames in Figure 37: (a) C1, delivery condition,  $+20\text{ }^{\circ}\text{C}$ ,  $\sim 800\times$ ; (b) C2, heat-treated condition,  $+20\text{ }^{\circ}\text{C}$ ,  $\sim 500\times$ ; (c) C3, delivered condition,  $-40\text{ }^{\circ}\text{C}$ ,  $\sim 500\times$ ; (d) C4, heat-treated condition,  $-40\text{ }^{\circ}\text{C}$ ,  $\sim 1000\times$ . SEM, non-etching condition.

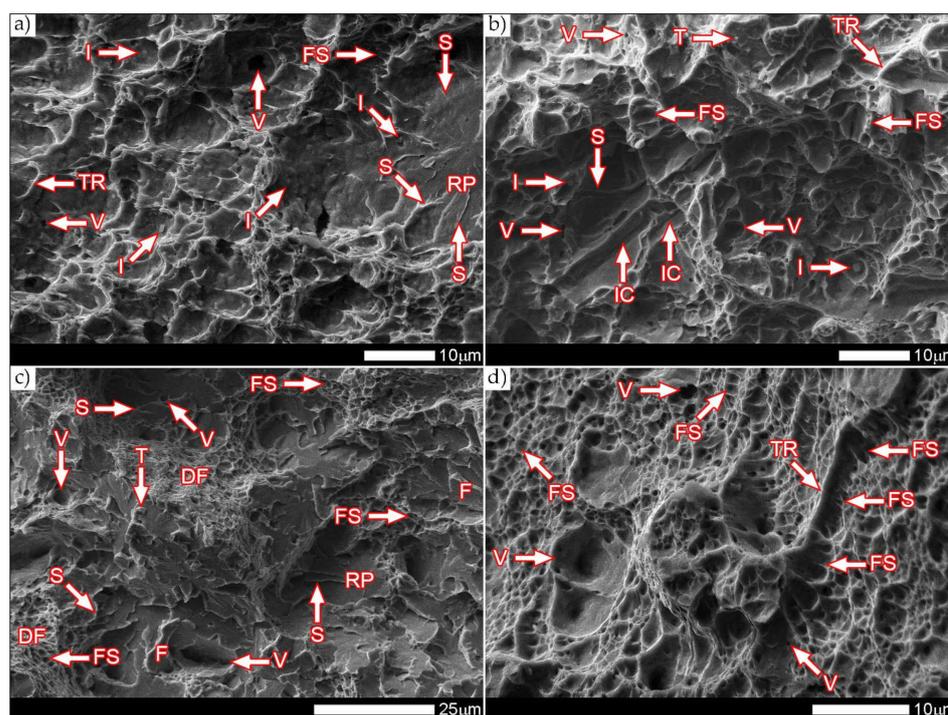
**Figure 43.** Enlarged images of the fracture surfaces shown in Figure 42: (a) C1, delivery condition, +20 °C, ~1500×; (b) C2, heat-treated condition, +20 °C, ~1500×; (c) C3, delivered condition, −40 °C, ~1000×; (d) C4, heat-treated condition, −40 °C, ~2000×. DF—ductile fracture, IC—inter-crystalline fracture, RP—“river” pattern, S—steps, T—tongues, F—facets, V—micro-voids, FS—fish scales, I—inclusions, TR—tear ridges. SEM, non-etching state.

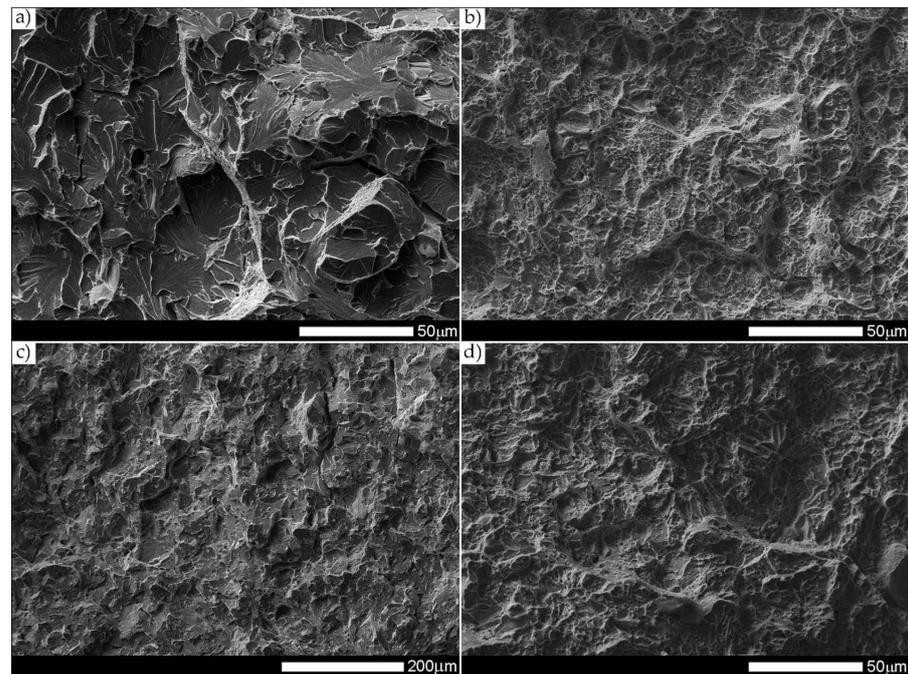
**Figure 44.** Images of the fracture surfaces of the welded joint Hardox 600, marked with the appropriate “D” frames in Figure 37: (a) D1, delivered condition, +20 °C, ~500×; (b) D2, heat-treated condition, +20 °C, ~500×; (c) D3, delivered condition, −40 °C, ~150×; (d) D4, heat-treated condition, −40 °C, ~500×. SEM, non-etching condition.

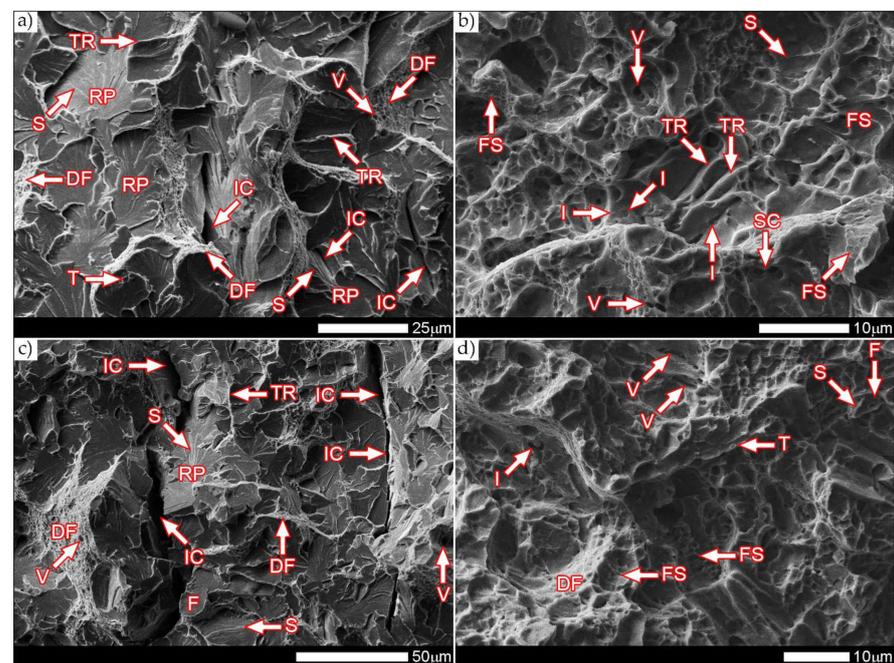
**Figure 45.** Enlarged images of the fracture surfaces shown in Figure 44: (a) D1, delivered condition, +20 °C, ~800×; (b) D2, heat-treated condition, +20 °C, ~2000×; (c) D3, delivered condition, −40 °C, ~500×; (d) D4, heat-treated condition, −40 °C, ~1500×. DF—ductile fracture, IC—inter-crystalline fracture, RP—“river” pattern, S—steps, T—tongues, F—facets, V—micro-voids, FS—fish scales, I—inclusions, TR—tear ridges. SEM, non-etching state.
