Material Origins of the Accelerated Operational Wear of RD-33 Engine Blades

Abstract: The structural and strength analysis of the materials used to construct an important engine element such as the turbine is of great significance, at both the design stage and during tests and training relating to emergency situations. This paper presents the results of a study on the chemical composition, morphology, and phased structure of the metallic construction material used to produce the blades of the high- and low-pressure turbines of the RD-33 jet engine, which is the propulsion unit of the MiG-29 aircraft. On the basis of an analysis of the chemical composition and phased structure, the data obtained from tests of the blade material allowed the grade of the alloy used to construct the tested elements of the jet engine turbine to be determined. The structural stability of the material was found to be lower in comparison with the engine operating conditions, which was shown by a clear decrease in the resistance properties of the blade material. The results obtained may be used as a basis for analyzing the life span of an object or a selection of material replacements, which may enable the

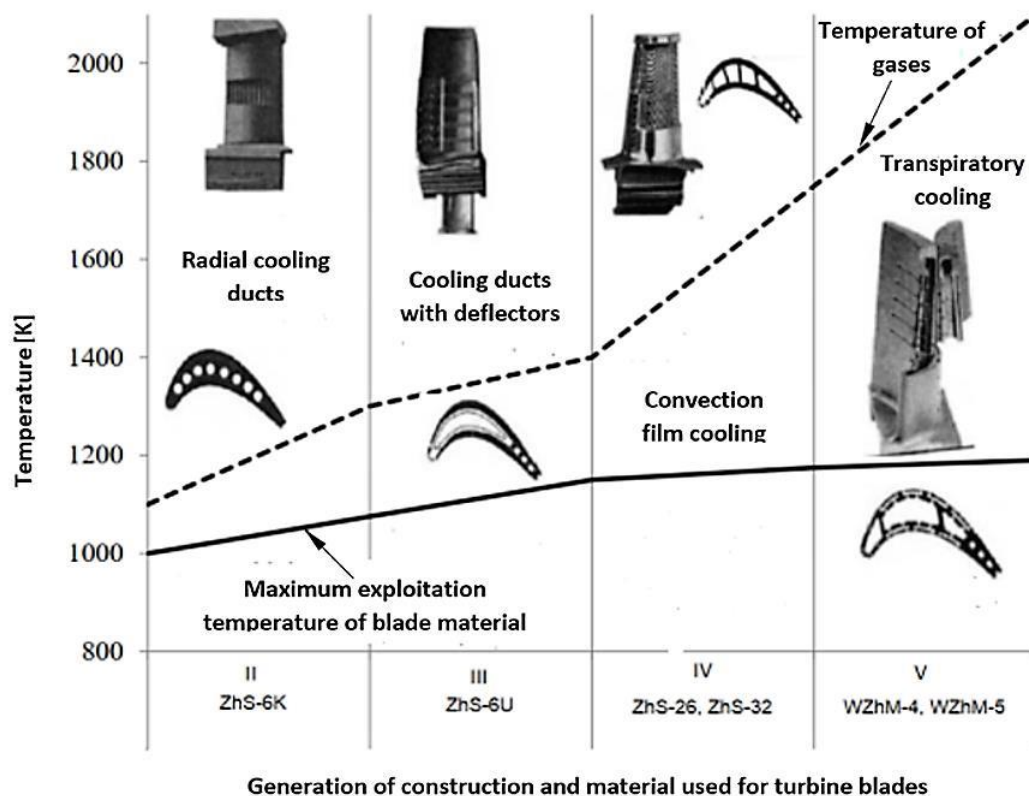
Figure 1. Development of the cooling technology and change in materials used to construct Russian turbine jet engines [3].

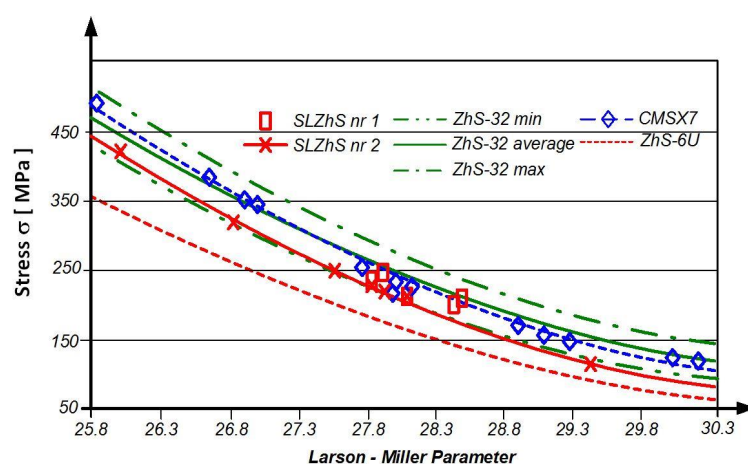
Figure 3. Influence of temperature and exploitation time on the exploitation stress of ZhS alloys used in the construction of RD-33 engine turbine blades, as defined by the Larson–Miller parameter P [3].

The scope of application of the alloys used to construct the blades of the RD-33 engine and, in particular, the creep resistance, depending on the temperature and duration of its long-term impact on the material, are best represented by the Larson–Miller parametric coordinates, as defined by Formula (1) (Figure 3):

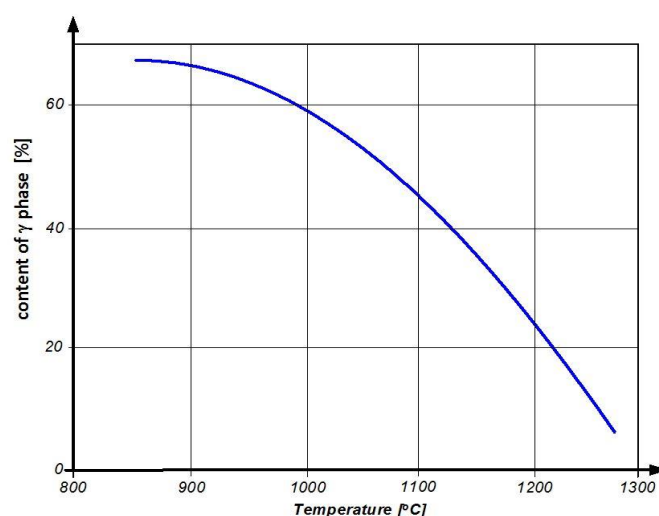
Figure 4. Influence of exploitation temperature on the share of phase γ' in the structure of the ZhS-32 alloy [14].

Ta additives, which increase the temperature of the solidus from 1240 °C (ZhS-6U) up to 1310 °C (ZhS-32) [15]. It is obvious that the long-drawn process of exploitation, linked with the high-temperature influence of exhaust gases, causes the grain coarsening and decrease of the phase γ' content in the blade material structure (Figure 4).

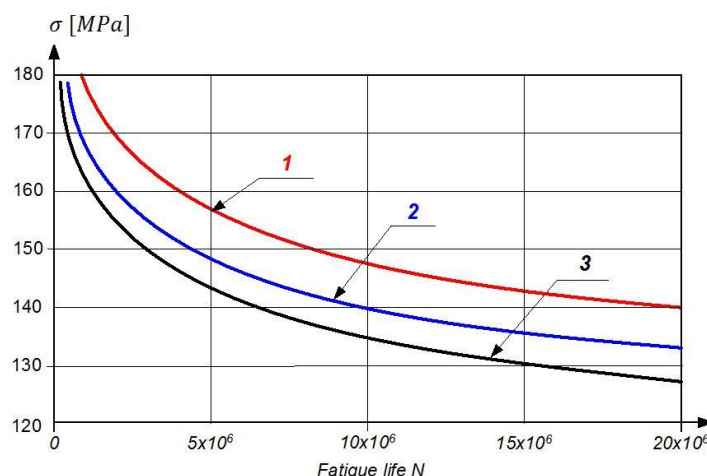
Figure 5. The fatigue curves of turbine blades made of EI-437B, where the working time $t = 0$ h (1), $t = 200$ h (2), and $t = 400$ h (3) [15].

These phenomena result in a decrease in strength parameters in nickel-based super-alloys, manifested by a significant decrease in the fatigue strength of the blade material (Figure 5).

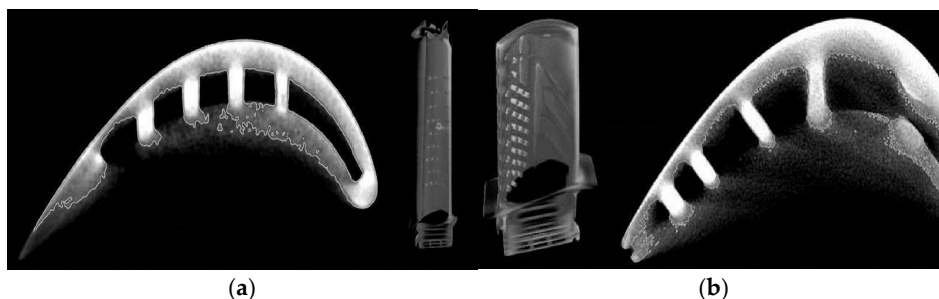
Figure 6. The shape of the LPT blade (a) and the HPT blade (b), with visible cooling channels, obtained by the computer-based micro-tomography CT.

The mass loads and, in particular, the heat loads of the turbine blades caused by the exhaust gas stream from the combustion chamber (1560 K) require cooling of this engine component. In the RD-33 motor, under analysis, the blades of both the LPT and HPT are cooled by means of internal channels (Figure 6), and the blades of the HPT, due to the higher gas temperature, also have channels for cooling the trailing edge.

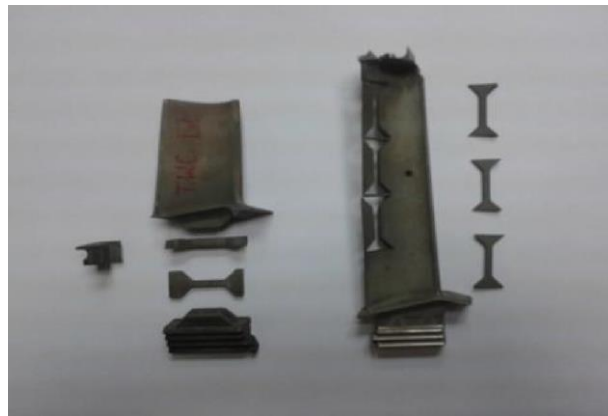
Figure 7. View of specimens cut out (using the electro-discharge method) of a material of the LPT blade and view of specimens for static tensile testing cut out of the material of the HPT blade and LPT blade.

This blade design poses serious problems relating to the selection of a place to take the strength test specimens in order to properly perform a static tensile test. Therefore, taking into account the nature of the mechanical loads carried by the material of the component tested, it was assumed that the specimens for the static tensile tests will be cut along the blade feather of the LPT, i.e., in the direction of the centrifugal forces and, in the case of the HPT, from the lock material, i.e., the component subjected to the highest mass loads (Figure 7).

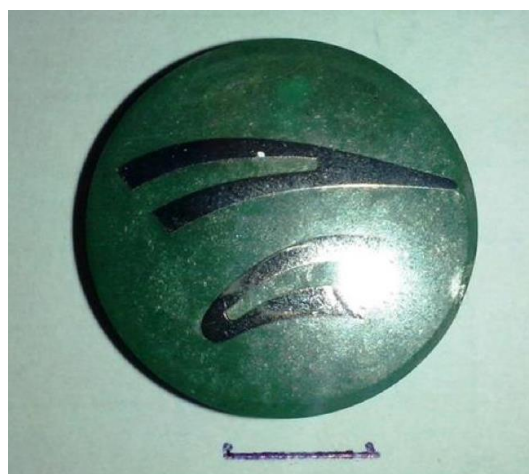
Figure 8. Metallographic specimen of the material of the LPT blade.

In order to make microscopic observations to reveal the grain structure of the blade material, metallographic samples were prepared (Figure 8). They were prepared, first, by mounting them in a conductive resin and then grinding them with abrasive papers of varying granulations in the range of 100–1000 and, second, by a final polishing with a diamond slurry of polishing powder using the Struers polishing machine.

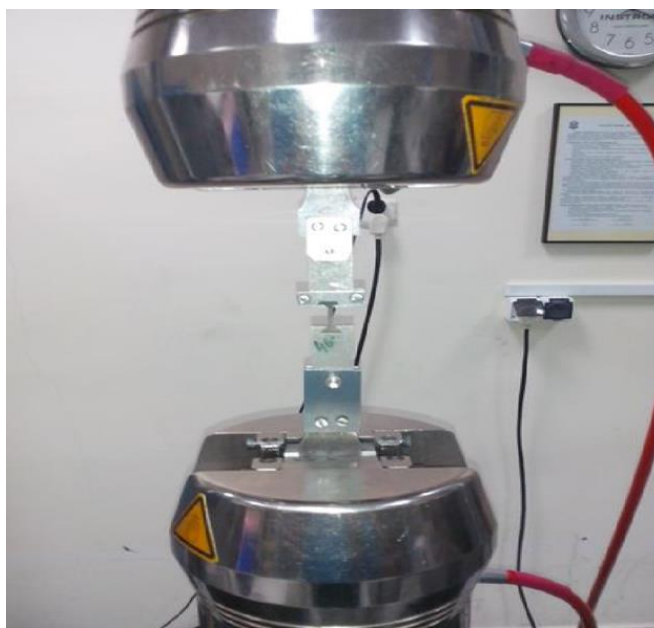
Figure 9. View of the test sample in specially designed holders.

A static tensile test, considered a destructive test, was carried out with the Instron 8501 Plus universal testing machine in accordance with the PN-EN ISO 6892-1:2010 standard. Due to the non-standardized, small dimensions of the strength specimens obtained (Figure 7), in order to execute the static tensile test, it was necessary to design and manufacture special holders to give the test a proper performance (Figure 9).

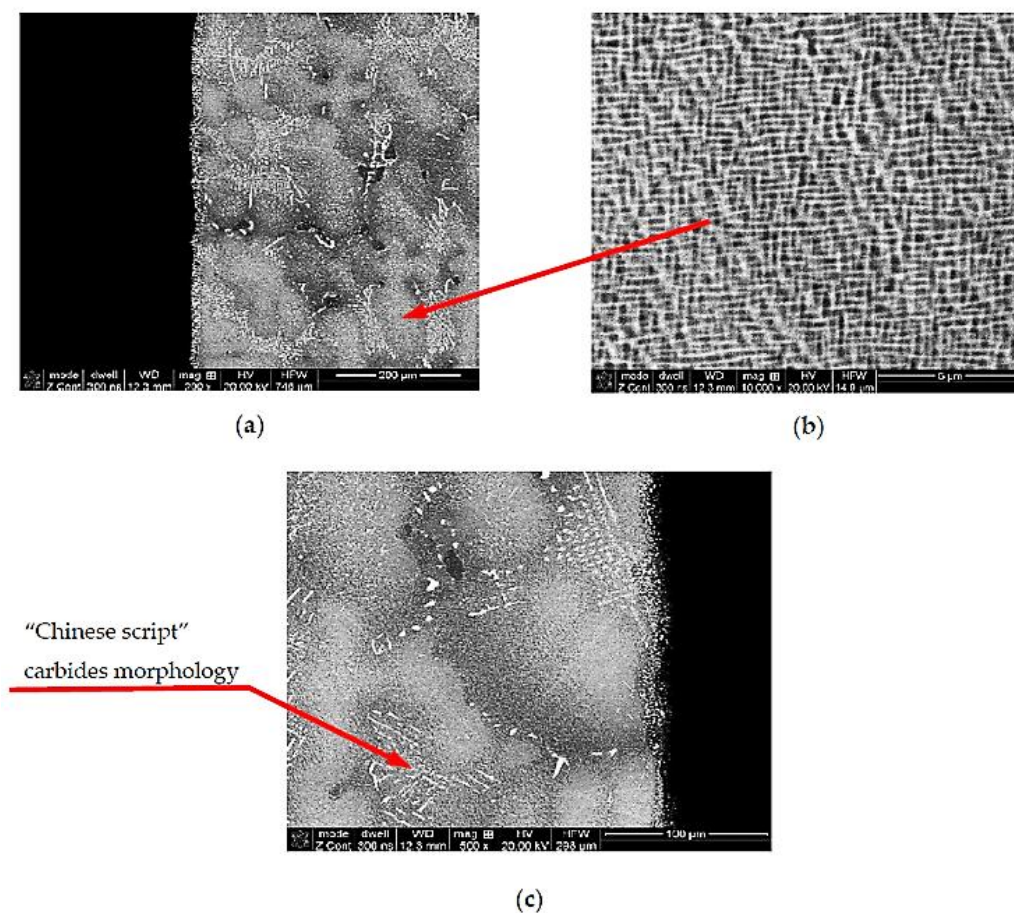
Figure 10. Multiphase structure of the TWC blade material built on the matrix of the γ phase (a), with cuboidal precipitates of the intermetallic phase γ' (b) and reinforcing carbide precipitates (c).

The microscopic observations carried out at magnifications of 100–10,000 \times (Figure 10) showed that the TWC blade material is characterized by a multiphase structure typical for nickel-based heat-resistant alloys. After the supersaturation and aging process, it consists of the primary, dendritic structure, resulting from the crystallization of the alloy (Figure 10a); the solid solution γ , formed during supersaturation; cuboid intermetallic precipitates of the γ' phase, released during the aging process (Figure 10b); and reinforcing carbides, with a “Chinese script” morphology (Figure 10c).

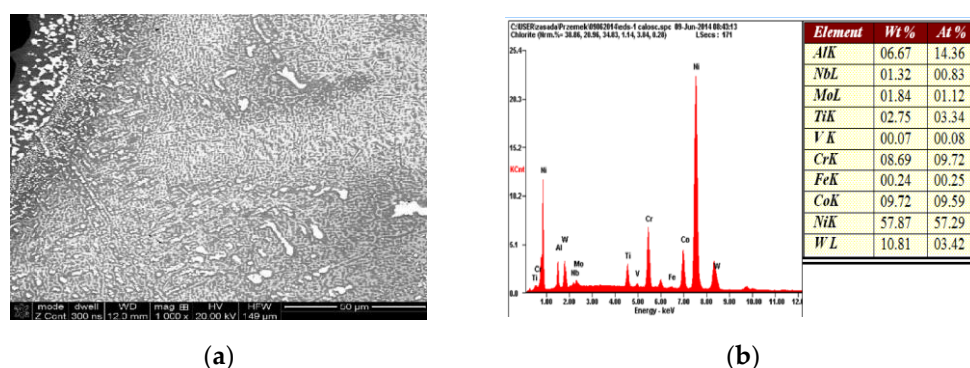
Figure 11. Result of the microanalysis of the chemical composition of the material of the HPT blade. The area subject to microanalysis (a), the spectrum of identified elements (b).

Nevertheless, the microanalysis of the chemical composition of the multi-phase blade structure allowed for the identification of significant discrepancies, mainly in terms of the content of chromium and titanium, between the tested material and the ZhS-32 and ZhS-26 alloys. The chemical composition of the analyzed material of the blades suggests that they are made of an alloy with a chemical composition corresponding to the heat-

resistant nickel-based superalloy, MAR-M 200 [16], which also corresponds to the chemical composition of the Russian ZhS-6U alloy [17] (Figure 11) (Table 2.).

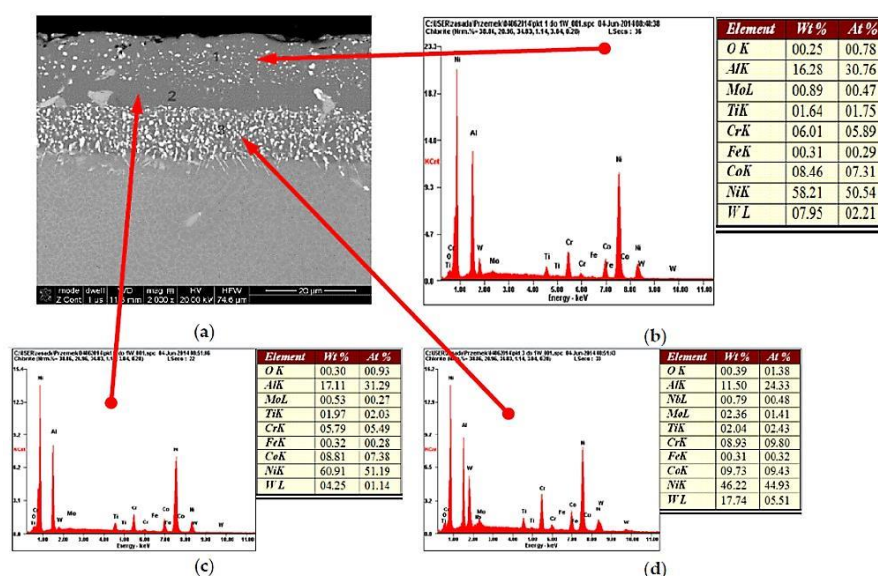
Figure 12. Three-layer barrier nickel aluminides (NiAl), with the coating diffusively applied to the TWC blade material (a), and the results of the microanalysis of the chemical composition in individual areas (b–d).

This process has led to the constitution on the surface of the blade material of a three-layer heat-resistant coating of NiAl intermetallic phase protecting the blade material from overheating.

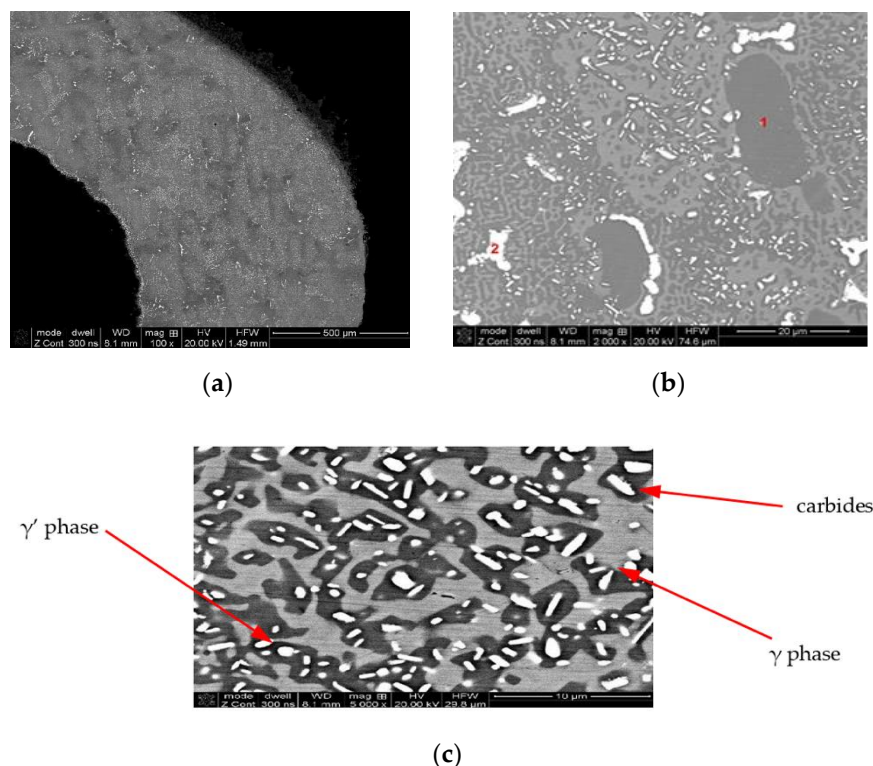
Figure 13. Damaged barrier coating at the leading edge of the HPT blade (a) and the effect of the anomalous growth of the γ' phase (b) and increase in the share of carbides in the matrix of the core material (c) due to overheating.

Nevertheless, in spite of the material of the core of the HPT blade being protected against the temperature influence of exhaust gases, the barrier coating was damaged at the leading edge, which, due to temperature increase, led to changes in the grain structure of the blade at the overheating point (Figure 13a). In addition to a small but noticeable growth of the grains of the γ matrix from 80 up to 95 μm , an anomalous selective growth and coagulation of the precipitations of the γ' phase (area 1 Figure 13b) growth and coagulation (area 2 Figure 13b) and an increase in the content of the carbides in the structure are also observed (Figure 13c), which may lead to a decrease of the creep resistance of the blade material.

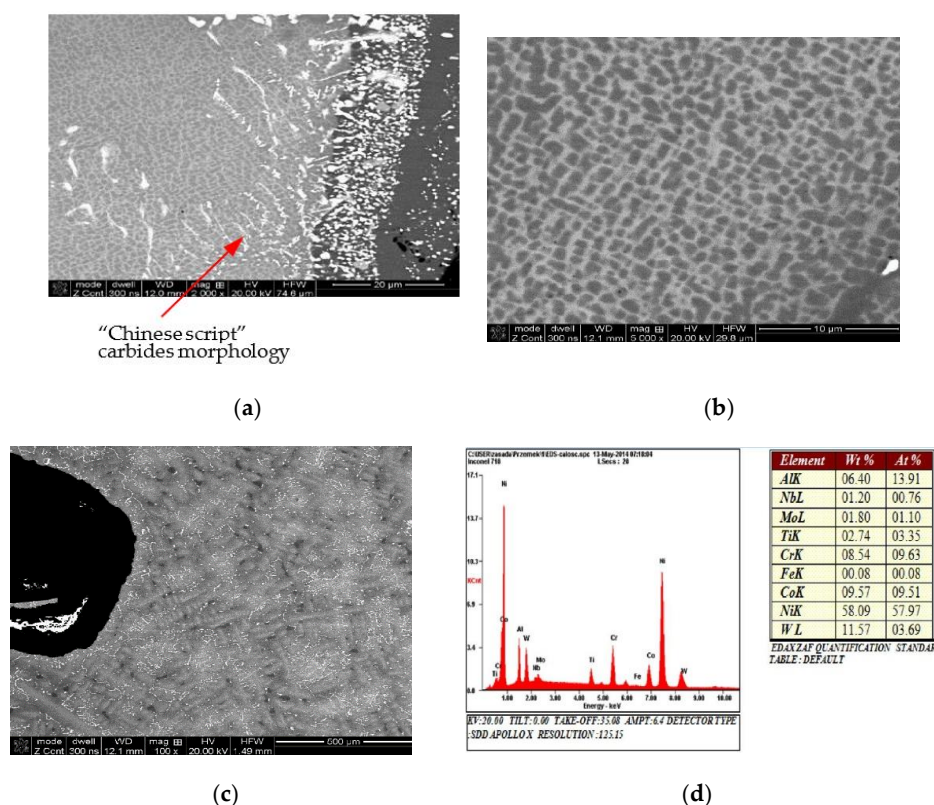
Figure 14. View of the structure of the LPT blade with the barrier coating (a), characteristic grain of the cuboidal phase γ' (b), and uniformly distributed reinforcing precipitations of carbides (c). The result of the microanalysis of the chemical composition of the core material (d).

A microanalysis of the chemical composition suggests that a similar phased composition to that of the material of the HPT blade is the result of a similar chemical composition, suggesting that the same alloy was used for the material of the LPT blade, as in the case of the HPT blade (Figure 14) and (Table 3).

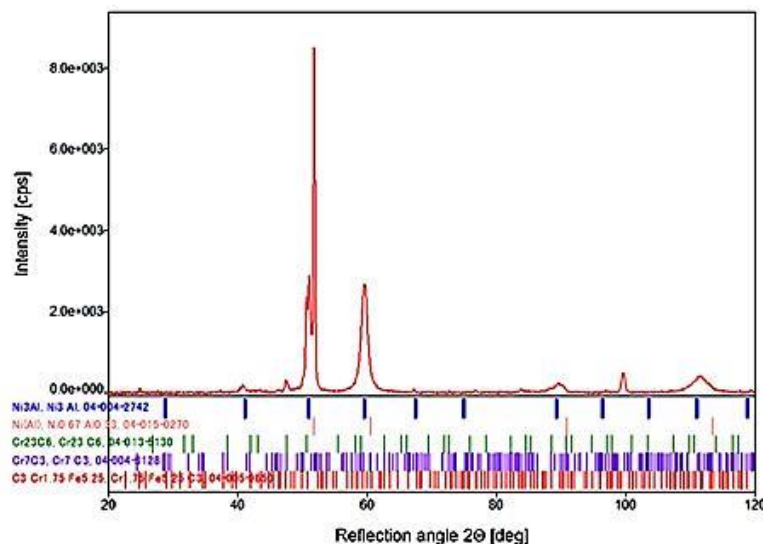
Figure 15. X-ray diffraction (XRD) pattern of the blade material with the identified phases.

The microscopic observations were confirmed by the XRD analysis. Based on the X-ray phase analysis measurements, by analyzing the positions of the obtained reflections, it was possible to unequivocally confirm the multi-phase structure of the blade material observed during the microscopic observations (Figure 15).

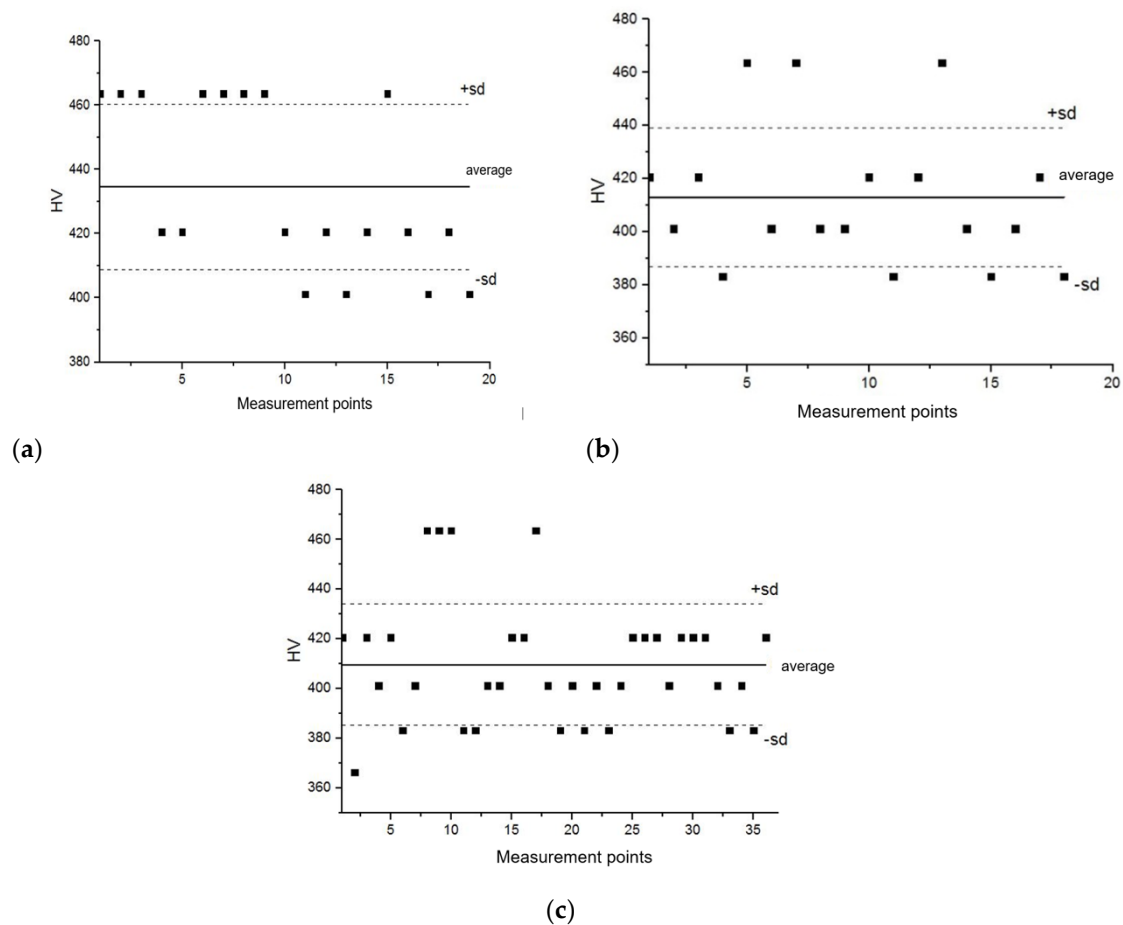
Figure 16. Statistical distribution of the microhardness of the material of the HPT blade in the overheated zone (a), in the non-overheated zone (b), and in the material of the LPT blade (c).

These tests were carried out with the semi-automatic microhardness tester, SHIMADZU-DORERNST M, and the obtained results were subjected to statistical analysis, which confirmed the structural homogeneity of the analyzed material areas, characterized by an average value of microhardness at a statistically uniform level within the range of 410–430 HV 0.025 (Figure 16).

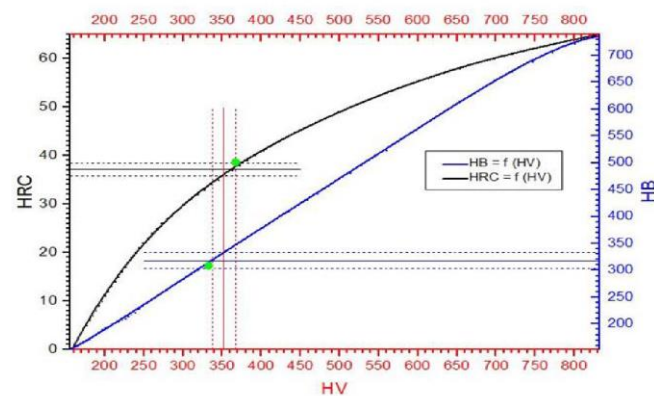
Figure 17. Comparison of the hardness measurements obtained with the Rockwell PW 106 hardness tester and the Wolpert Wilson Testor 751 universal hardness tester.

The observed structural changes were reflected in the strength parameters of the alloy used for the construction of the tested blades. As can be seen in Figure 17, where the hardness values obtained are marked with the determined standard deviation, the intersection points (marked in green) of the hardness obtained are located on the curves, which represent the dependency between the Brinell and Rockwell hardness as a function of the Vickers hardness (curves $\text{HB} = f(\text{HV})$ and $\text{HRB} = f(\text{HV})$), which clearly proves the correctness of the measurements carried out. It also proves the high homogeneity of the tested material, caused by the refinement of the grain structure, despite its multiphase nature.

However, the average hardness value of the analyzed material, after its exploitation, decreased to the level of 350 HV10, compared to 450 HV10, which is typical in the case of a correctly structured ZhS-6U alloy. It should also be noted that the hardness (Figure 17) and microhardness (Figure 16) values measured by the same Vickers method differ significantly, reaching 70 HV hardness units in extreme cases. However, the observed phenomenon, the indentation size effect (ISE), is in accordance with the variable hardness law, which describes the influence of elastic deformation on the value of the obtained results, i.e., the smaller the load, the greater the influence of elastic deformation and thus the greater the

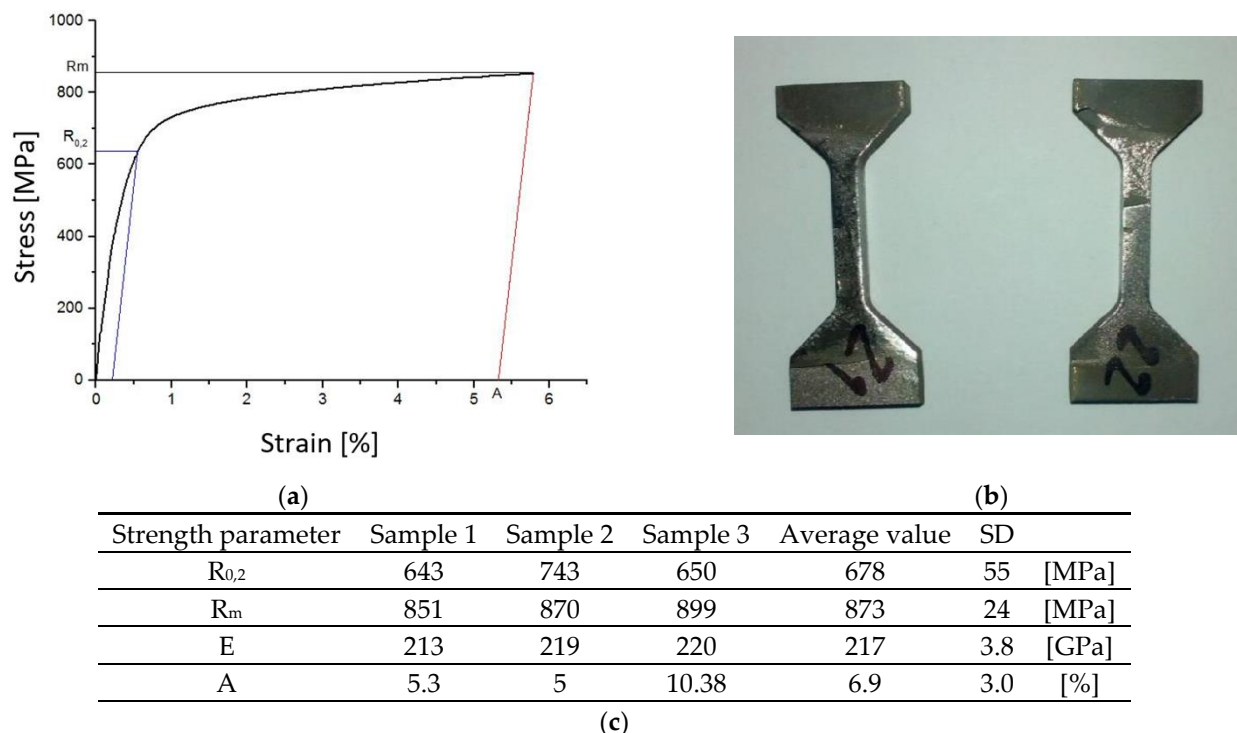
Figure 18. Tensile curve of the blade material (a), view of specimens before and after the tensile test (b), and the determined strength parameters (c).

hardness value. At this point, it should be recalled that the load for the microhardness measurements was 25 g, and for the hardness measurements, it was 10 kg. The decrease in the strength properties is confirmed by the results of the static tensile test (Figure 18).

In accordance with the Hall–Petch relationship, the decrease in the share of the γ' phase in the material structure and the growth there caused a decrease in the yield point from the original level of 770 MPa for the ZhS-6U alloy to 678 MPa for the material of the tested blade (Table 5).

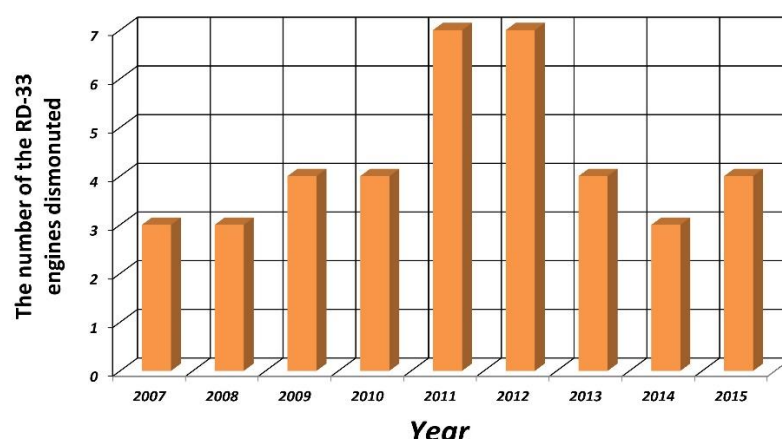
Figure 19. The number of RD-33 engines dismantled from airplanes due to damage to the high-pressure turbine in one of the air bases in Poland during the years 2007–2015 [4].
