Article

The Effect of Deposited Dust on SCC and Crevice Corrosion of AISI 304L Stainless Steel in Saline Environment

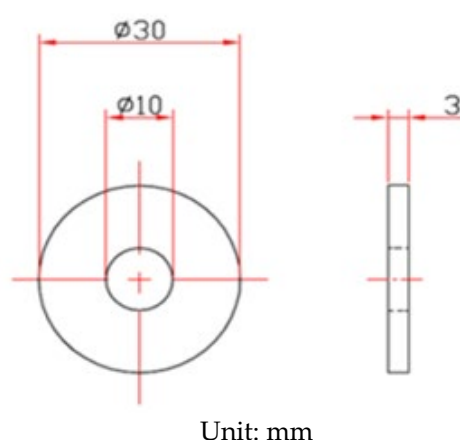
Figure 1. Dimensions of the specimen used for crevice corrosion test.

The shape and dimensions of the test specimens are presented in Figure 1. White emery was adopted in this work to simulate the dust accumulated on the as-machined specimen surface. The as-machined surface roughness (R_a) of the specimen was $4.9\ \mu\text{m}$. The chemical compositions of the AISI 304L steel used in the work are listed in Table 1. The test samples were manufactured from AISI 304L austenitic stainless steel, and white emery was made from alumina. Duplicate tests were conducted for each experimental condition.

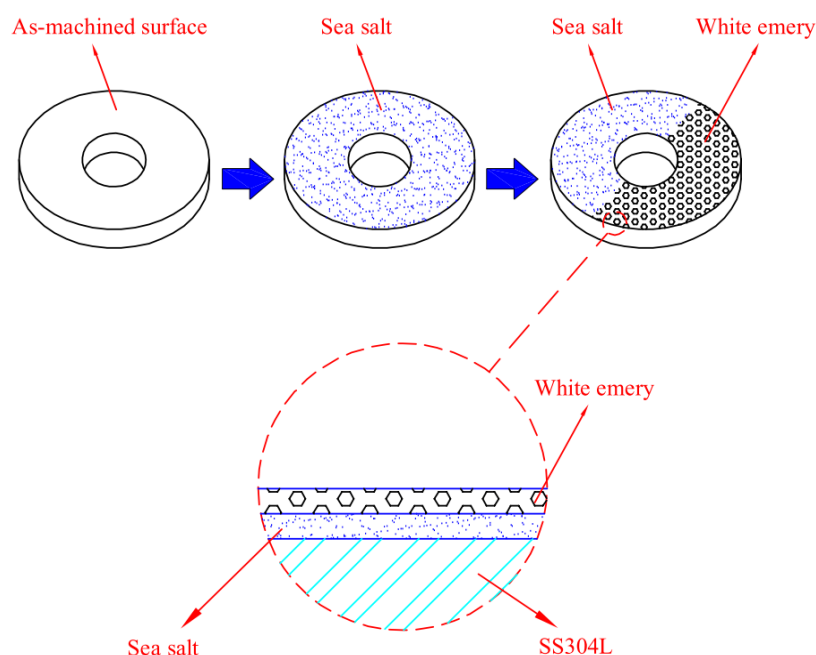
Figure 2. Schematic diagram of the specimen sprayed with synthetic sea water and white emery.

The chemical composition of sea salt used in the present study, based on ASTM D 1141-98 (13) Formula a, are listed in Table 2. A schematic diagram of the test specimen sprayed with synthetic sea water and white emery is presented in Figure 2. First of all, the samples were sprayed with synthetic sea water of 3.5 wt.% and subsequently dried on a hot plate at $65\ ^\circ\text{C}$ for 20 min. After the specimens were dried, the mass change of specimens was measured to calculate the salt loadings in g/m^2 . The concentration of chloride for the samples was $0.1\ \text{g}/\text{m}^2$ and $1\ \text{g}/\text{m}^2$. Finally, 0.5 g of white emery was sprayed uniformly in a semicircle of the sample. The constant humidity and temperature chambers

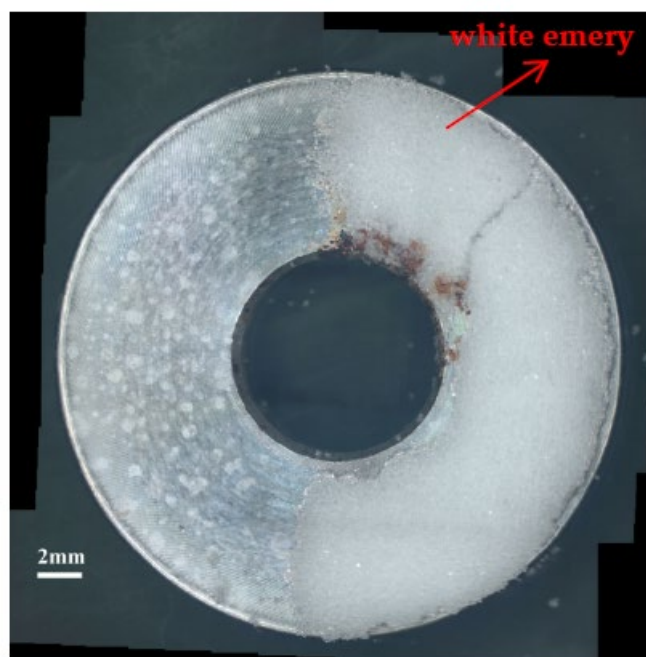
Figure 3. Macrographs of the specimens with a 1 g/m^2 chloride concentration after 7000 h of testing a relative humidity (RH) of 70%.

Figure 3 and Figure 4 illustrate macrographs of the AISI 304L steel samples with a 1 g/m² concentration of chloride after testing for 7000 h at a relative humidity of 70%. Figure 3 reveals that significant crevice corrosion occurred in corroded areas. Figure 4a illustrates that obvious crevice corrosion was only observed in the regions deposited with white emery, while Figure 4b demonstrates a clear image of the crevice corrosion after the specimen was cleaned. Figure 5 reveals macrographs of the AISI 304L stainless steel samples with a 0.1 g/m² chloride concentration at three different relative humidity levels. A trace of crevice corrosion was discerned with the specimens. The rusted areas of the specimens at a relative humidity of 70% seem to be larger than the specimens at relative humidities of 45% and 55%. Figure 6 shows SEM micrographs of the samples deposited with a chloride

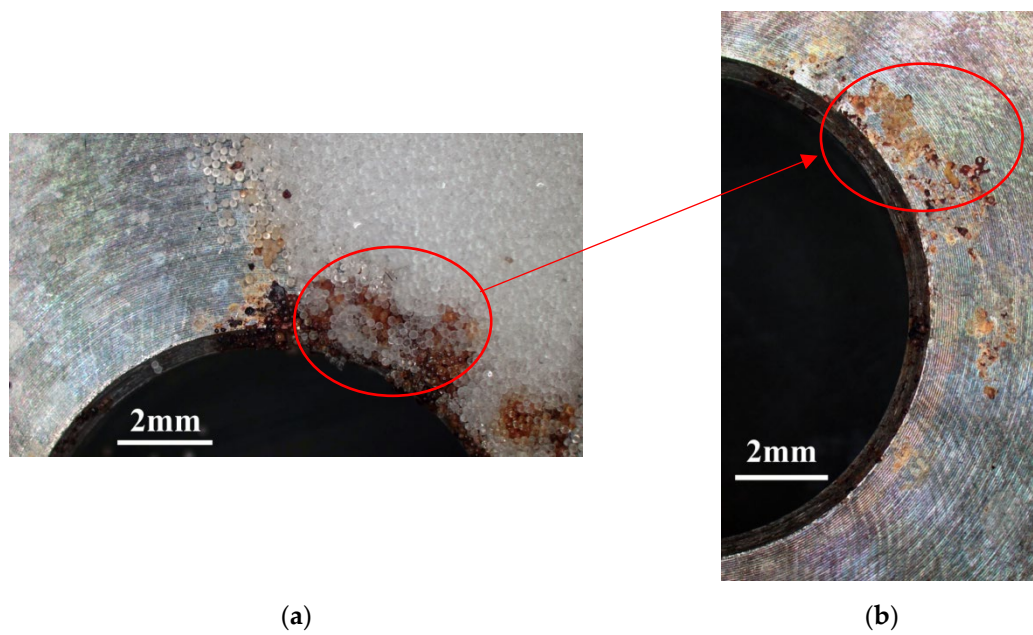
Figure 4. Macrographs of the corrosion regions of those samples with a chloride concentration of 1 g/m² at RH = 70%: (a) Specimen before cleaning and (b) specimen after cleaning.

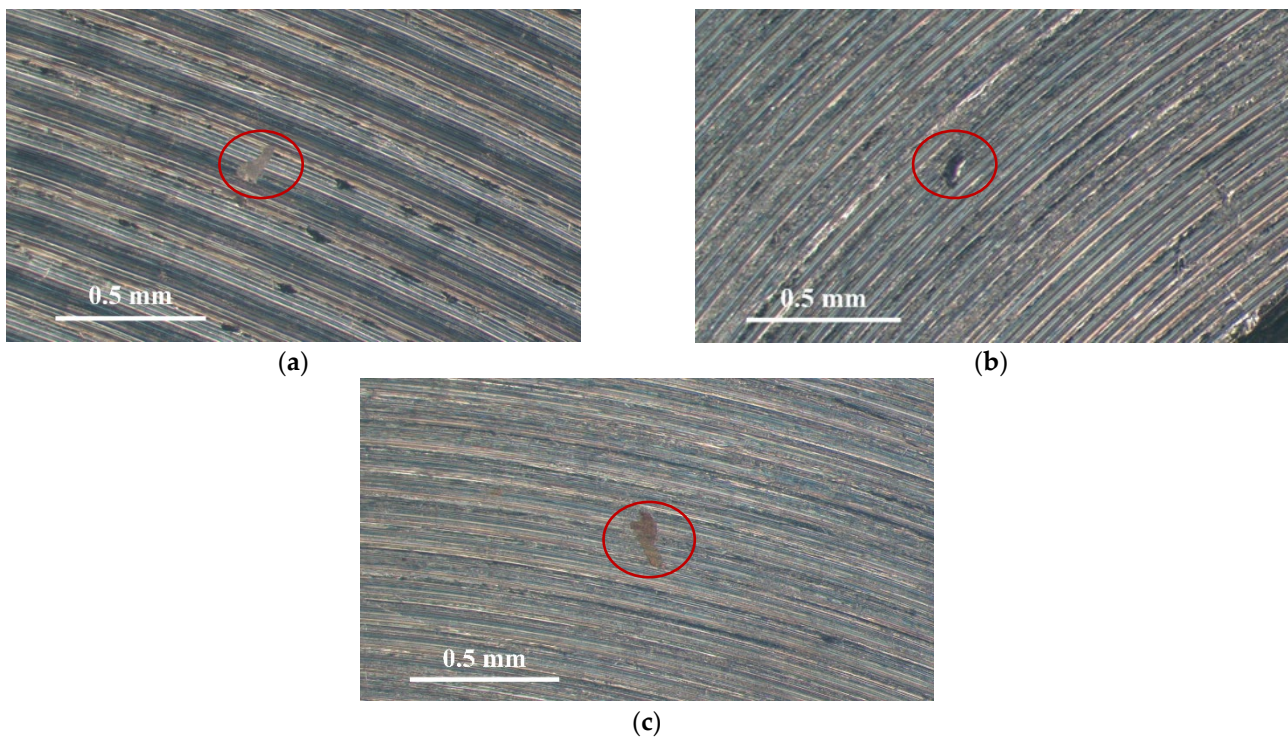
Figure 5. Macrographs of the corrosion regions of those samples with a 0.1 g/m² chloride concentration at: (a) Relative humidity = 45%, (b) relative humidity = 55%, and (c) relative humidity = 70%.

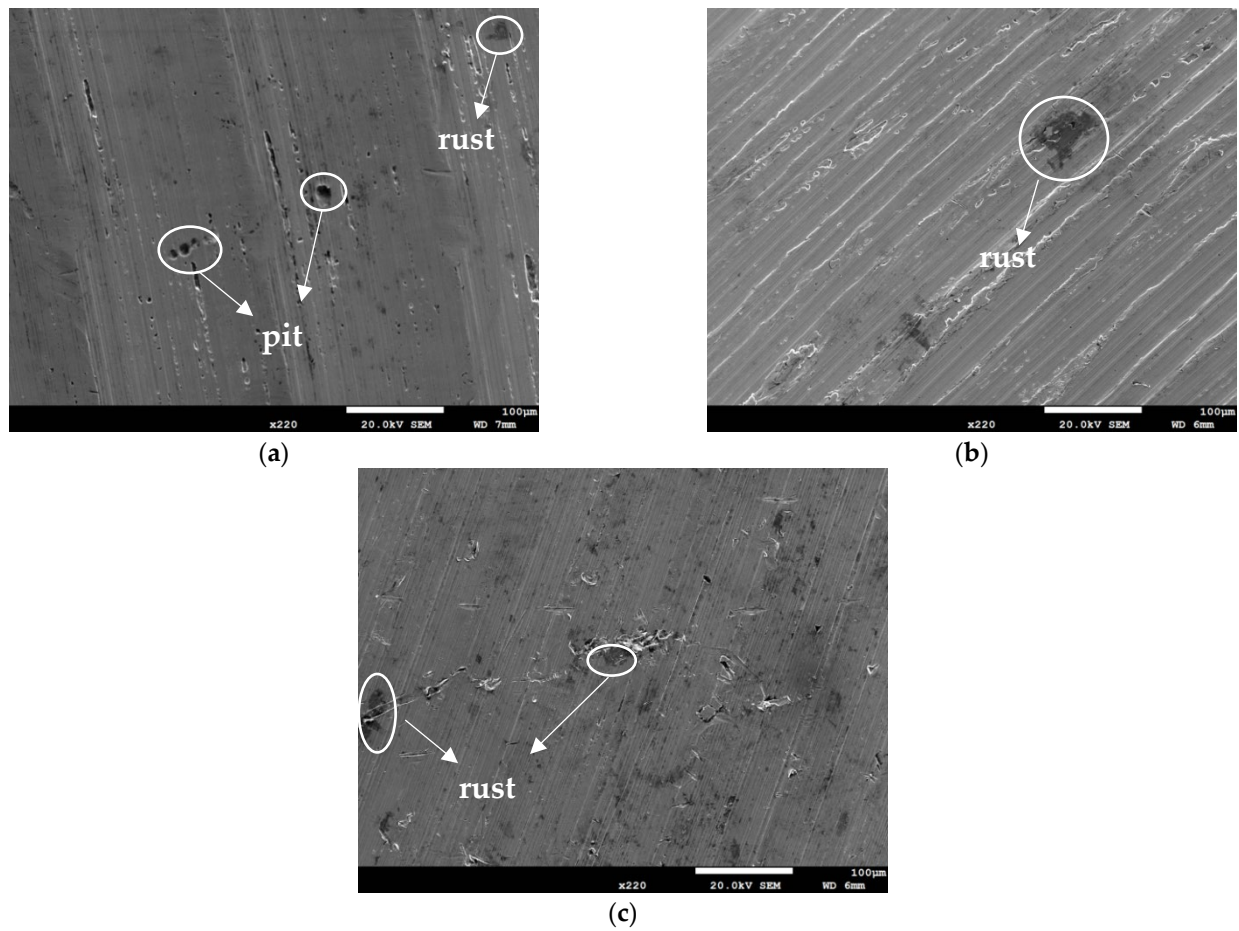
Figure 6. SEM micrographs of those specimens with a 0.1 g/m² chloride concentration at: (a) Relative humidity = 45%, (b) relative humidity = 55%, and (c) relative humidity = 70%.

concentration of 0.1 g/m^2 at various levels of relative humidity for 7000 h. The rust observed on the specimens presents proof of crevice corrosion, which was induced by chloride. The morphologic features of the crevice corrosion changed with RH. Figure 6a reveals some small corrosion pits on the specimens. Furthermore, there are some rust spots on the specimens shown in Figure 6b,c, with shallow corrosion existing beneath the rust spots. Figure 6c shows that the specimens subjected to a relative humidity of 70% present slightly more corrosion than those exposed to relative humidities of 45% and 55%, as shown in Figure 6a,b. Figure 7 demonstrates macrographs of the AISI 304L steel samples deposited with a chloride concentration of 1 g/m^2 at three different relative humidity levels. Figure 7a–c demonstrates that there is no obvious dissimilarity in the corroded regions on the samples at relative humidities of 45% and 55%. However, the corroded areas increased significantly at a relative humidity of 70%. In addition, the samples with a chloride concentration of 1 g/m^2 , shown in Figure 7, reveal more severe corrosion at all three RH levels than that with a chloride concentration of 0.1 g/m^2 , as illustrated in Figure 5. Figure 8 reveals SEM micrographs of the samples deposited with a chloride concentration of 1 g/m^2 at various levels of RH for 7000 h. As for those samples deposited with a chloride concentration of 0.1 g/m^2 , the rust on the samples with a chloride concentration of 1 g/m^2 is proof of crevice corrosion, which was induced by chloride. Figure 8a–c illustrate several rust spots that occurred on the specimen and shallow corrosion beneath the rust spots. The samples subjected to a relative humidity of 70% (Figure 8c) reveal more serious corrosion than those exposed to relative humidities of 45% and 55% (Figure 8a). Moreover, those samples with a chloride concentration of 1 g/m^2 , as illustrated in Figure 8, reveal more serious corrosion at all three RH levels than those with a chloride concentration of 0.1 g/m^2 , as shown in Figure 6.

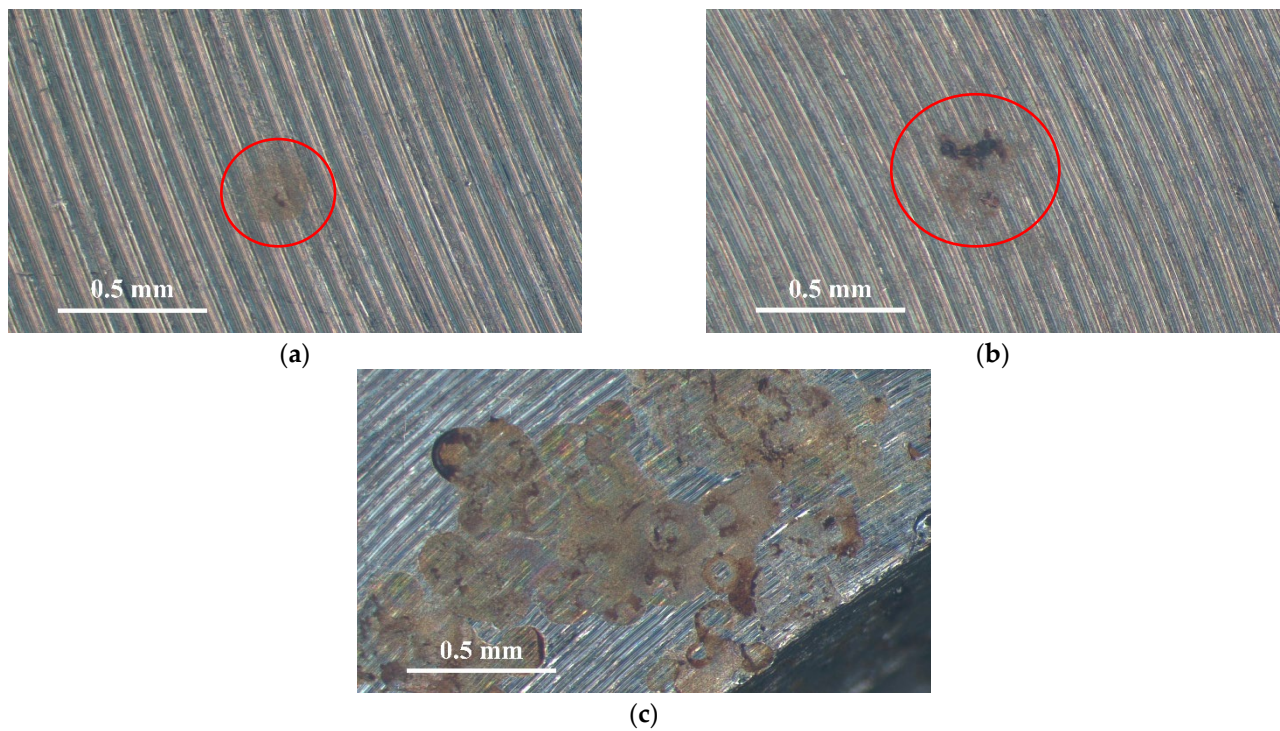
Figure 7. Macrographs of the corroded regions of those samples with a 1 g/m² chloride concentration at: (a) Relative humidity = 45%, (b) relative humidity = 55%, and (c) relative humidity = 70%.

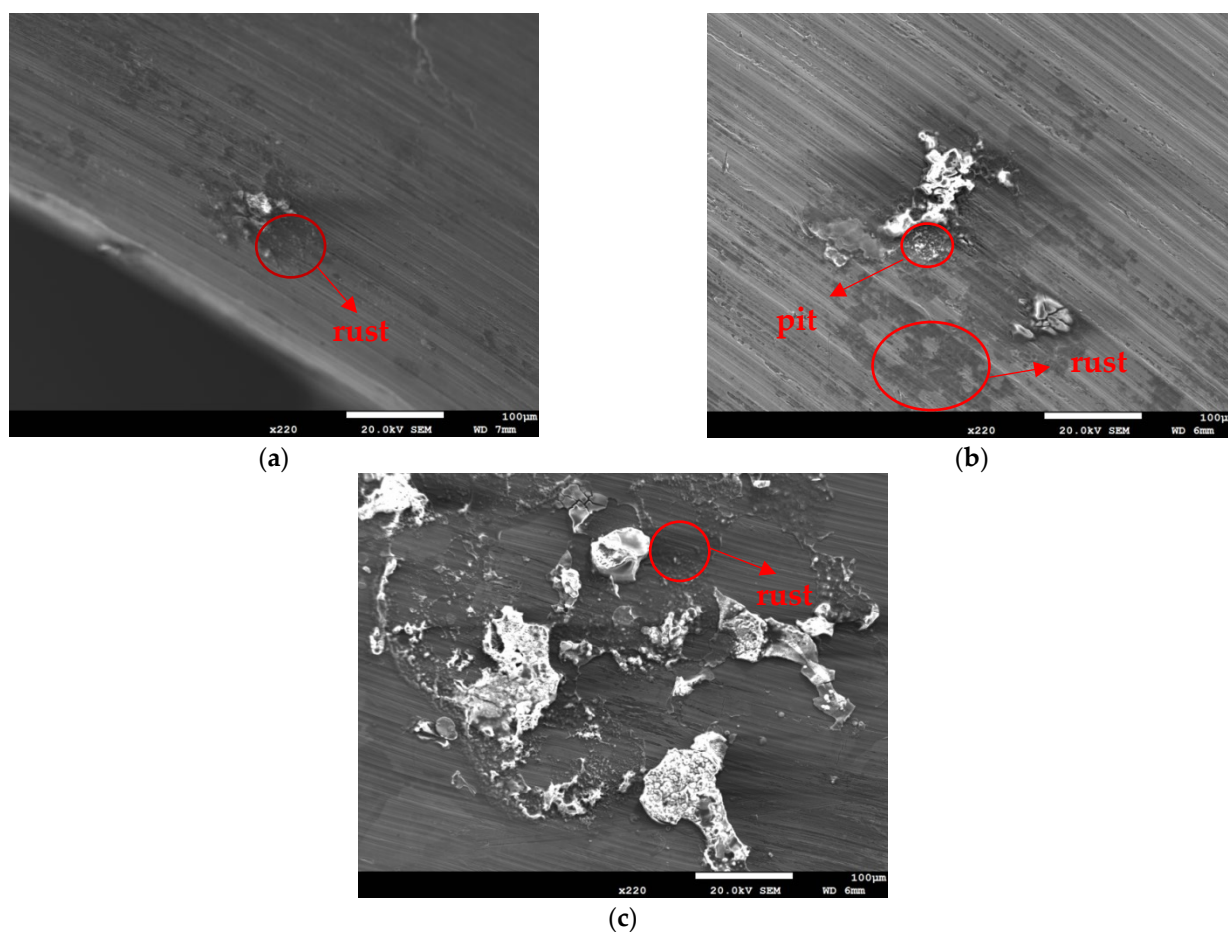
Figure 8. SEM micrographs of those samples with a chloride concentration of 1 g/m² after 7000 h of testing at: (a) RH = 45%, (b) RH = 55%, and (c) RH = 70%.

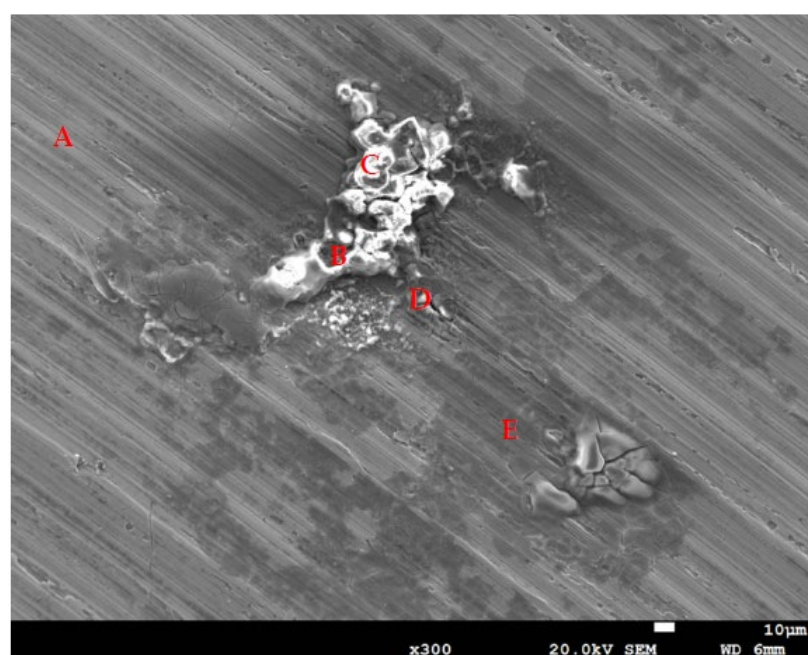
Figure 9. Energy dispersive X-ray spectrometry (EDS) analysis of the corroded regions on those specimens with a 1 g/m^2 chloride deposit after testing at 55% relative humidity for 7000 h.

Figure 9 depicts EDS examinations of the corroded regions on test specimens deposited with a chloride concentration of 1 g/m² at 55% RH. The results of the EDS analysis of the corroded regions are shown in Table 3, revealing that the sulfur and chlorine contents of Point A, which is the matrix of stainless steel, were so low that they could not be detected. Points B, C, and D, located in the corrosion products, were inspected to have higher contents of sulfur and chlorine, and the rust at Point E contained trace amounts of sulfur and chlorine. Furthermore, Points B, C, D, and E had higher contents of sulfur in comparison to Point A, which is probably explained by the sulfates contained in the synthesized sea water.

Cl^- ions are indispensable for the initiation of crevice corrosion. The CCS mechanism, owes the initiation of crevice corrosion to the accumulation of the aggressive ions, particularly Cl^- in the crevice, brings about the appearance of highly aggressive localized corrosion that destroys the passive film of stainless steel [29]. Point B has a higher content of iron but a lower content of oxygen compared to Points C and D, which indicates that the oxide product was peeled off to expose the metal surface. Moreover, Point E, located in the rust region, has a higher Fe content but lower Cl and O contents compared to Points B, C, and D.

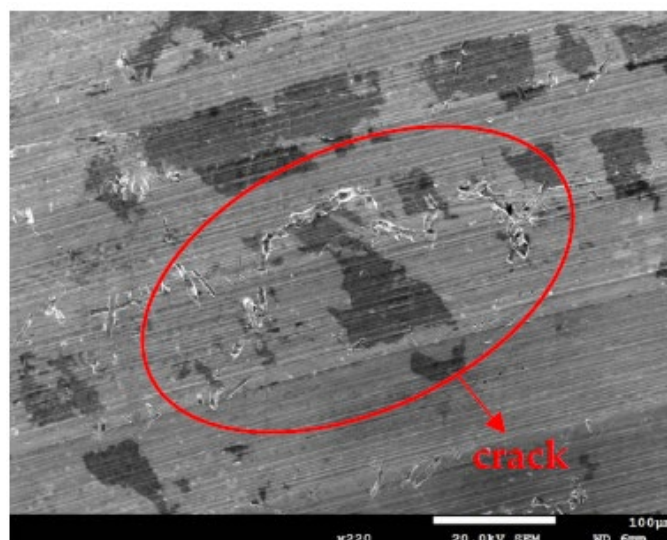
Figure 10. SEM morphology of the SCC in those samples with 0.1 g/m^2 of chloride deposited after 7000 h of testing at RH = 70%.

Figures 10 and 11 are SEM micrographs demonstrating the morphology of the SCC of the samples deposited with chloride concentrations of 0.1 g/m^2 and 1 g/m^2 at various RH levels, respectively. For samples deposited with a 0.1 g/m^2 chloride concentration, no SCC cracks were observed on those specimens exposed to the 45% and 55% relative humidities, as shown in Figure 6a,b, whereas Figure 10 demonstrates discontinuous SCC cracks on those specimens tested at a 70% relative humidity. For samples deposited with a 1 g/m^2 chloride concentration, no SCC cracks were observed on those specimens exposed to a 45% relative humidity, as exemplified in Figure 8a. Meanwhile, Figure 11a shows discrete SCC cracks on those samples exposed to a 55% RH, whereas Figure 11b reveals continuous SCC cracks on the specimens tested at a 70% relative humidity. Shoji et al. demonstrated that MgCl_2 is the sea salt constituent responsible for promoting low-temperature atmospherically induced SCC in AISI 316L and 304L steel. They inspected the phenomenon of atmospherically induced SCC of samples deposited with a 25 g/m^2 chloride concentration using sea water [19]. Prosek and coworkers investigated the phenomenon of atmospherically induced SCC of AISI 316L and 304 stainless steel with a 260 g/m^2

chloride concentration acquired by MgCl_2 droplets [23]. The maximum 1 g/m^2 chloride concentration used in this research is much lower compared to that reported in the literature [19,22,23]. Figures 10 and 11a demonstrate short and shallow cracks on those samples deposited with 0.1 g/m^2 of chloride at a 70% RH and 1 g/m^2 of chloride at a 55% RH, respectively, as opposed to Figure 11b, in which long and deep cracks appear on those specimens deposited with 1 g/m^2 of chloride at a relative humidity of 70%. It is conjectured that microcracks nucleate discontinuously at favorable sites in the first place and, under some favorable situations, microcracks grow and then coalesce by means of breaking ligaments between them to connect into one main crack [26–28,30]. On the basis of this hypothesis, some of the shallow and short cracks present on those samples with a 0.1 g/m^2 chloride concentration at a 70% RH and a 1 g/m^2 chloride concentration at a 55% RH could be attributed to finite amounts of Cl^- ions transmitted to the crevice sites of the samples. As a result of the low concentration of chloride of the samples tested, it is essential to have higher RH environments to promote the transmission of adequate amounts of Cl^- to crevice sites for promoting crack nucleation. The Cl maps obtained by EDS mapping are proof of the aforementioned argument. There was no SCC at RH = 45% and 55% whereas specimens exposed at RH = 70%, the highest RH of the three, cracked with those specimens deposited with a chloride concentration of 0.1 g/m^2 , as shown in Figures 6a,b and 10. This is probably because the chloride concentration of 0.1 g/m^2 was so low that it could not initiate stress corrosion cracking in the specimens tested at lower levels of relative humidity (RH = 45% and 55%). Moreover, when the chloride concentration for the specimens was increased to 1 g/m^2 , there were still no SCC cracks with specimens exposed to RH = 45% whereas those exposed to RH = 55% and 70% cracked, as illustrated in Figures 8a and 11a,b. This can be possibly interpreted as finite chloride transmitted into crevice sites at the lowest relative humidity (relative humidity = 45%) in the specimens deposited with 1 g/m^2 of chloride. Therefore, the synergistic effect of the chloride concentration and relative humidity could account for the SCC initiation of the 304L stainless steel. From the experimental results of the work, it can be concluded that the relative humidity threshold for the SCC initiation of AISI 304L stainless steel with an as-machined surface deposited with a chloride concentration of 0.1 g/m^2 at 45°C is between 55% and 70% RH, whereas the relative humidity threshold for those specimens deposited with a chloride concentration of 1 g/m^2 is between 45% and 55% RH. The increased volume of corrosion products possibly creates localized stress beneath white emery, which acts like a crevice former, leading to the occurrence of SCC. Furthermore, with the increase in relative humidity, the length of the cracks was observed to increase when comparing Figure 11a to Figure 11b.

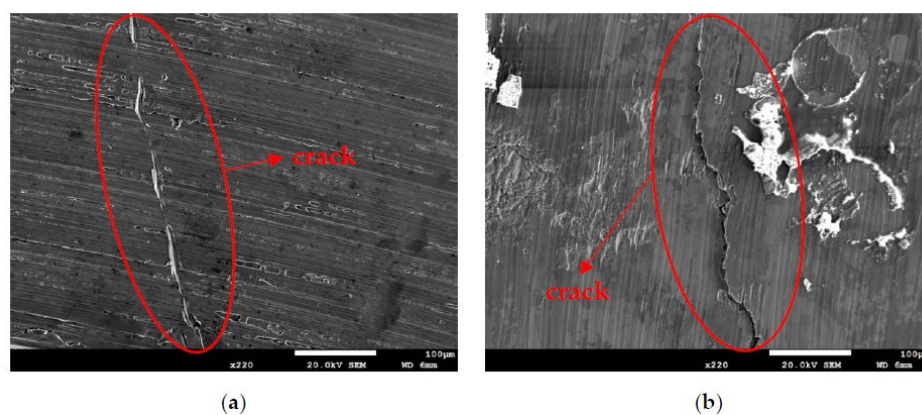
Figure 11. SEM morphology of the SCC in those samples with a chloride concentration of 1 g/m² after 7000 h of testing at: (a) RH = 55% and (b) RH = 70%.

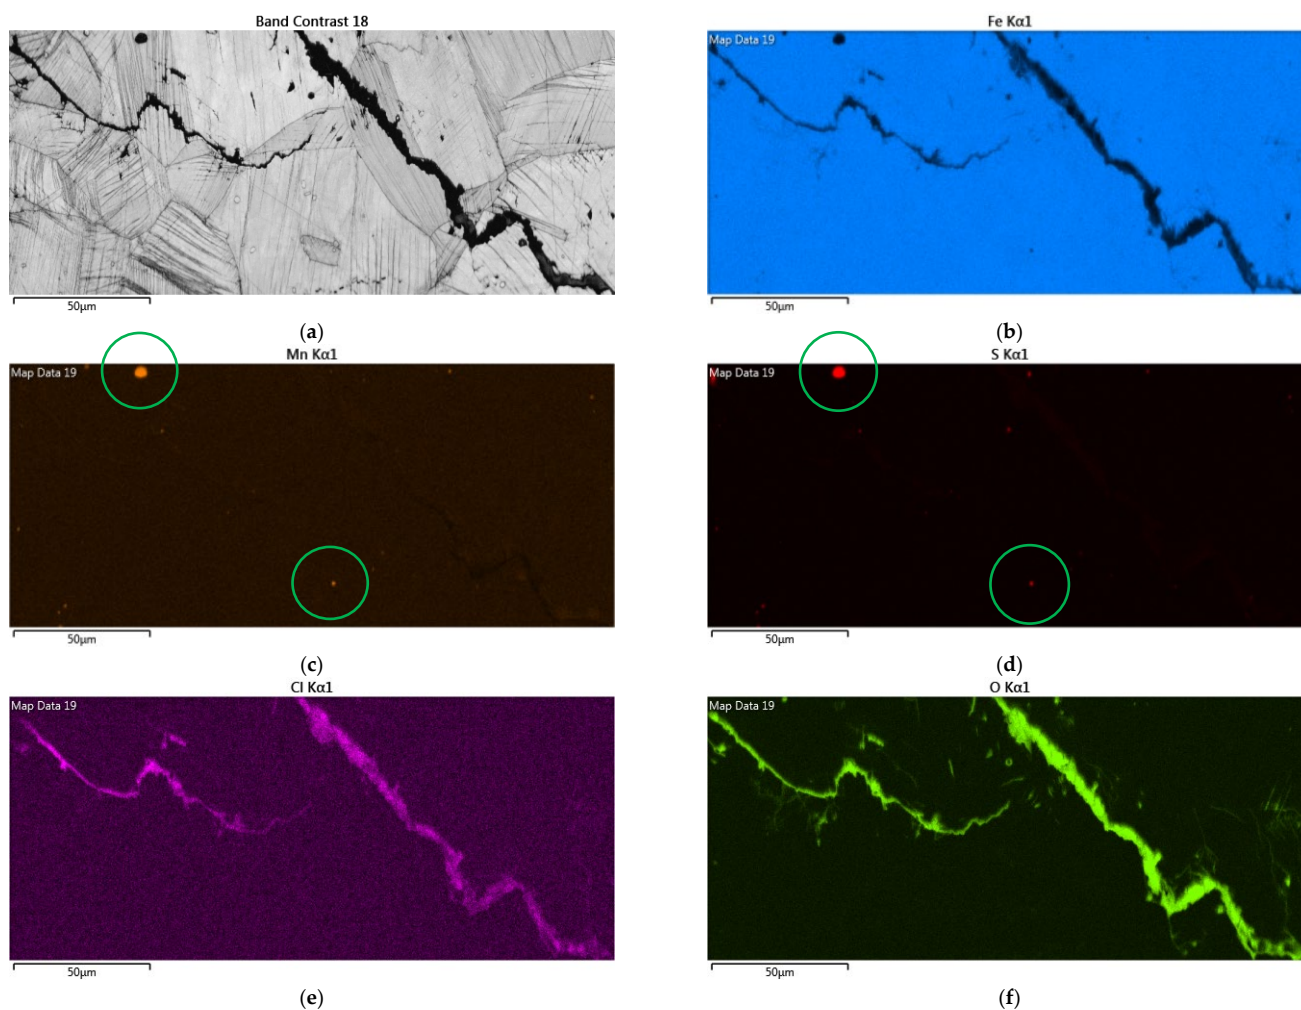
Figure 12. EDS mapping for the crack regions of those samples with a chloride concentration of 1 g/m² tested for 7000 h at a relative humidity of 70%: (a) Band contrast image, (b) Fe mapping, (c) Mn mapping, (d) S mapping, (e) Cl mapping, and (f) O mapping.

Figure 12 demonstrates EDS mapping for the crack regions of those samples deposited with a 1 g/m² chloride concentration tested at a 70% RH. The crack region is obviously enriched with chlorine and oxygen, as respectively demonstrated by Figure 12e,f, but depleted with iron, as manifested in Figure 12b. Figure 12c,d reveal enriched manganese and sulfur, respectively, on the center bottom and left top of the figure.

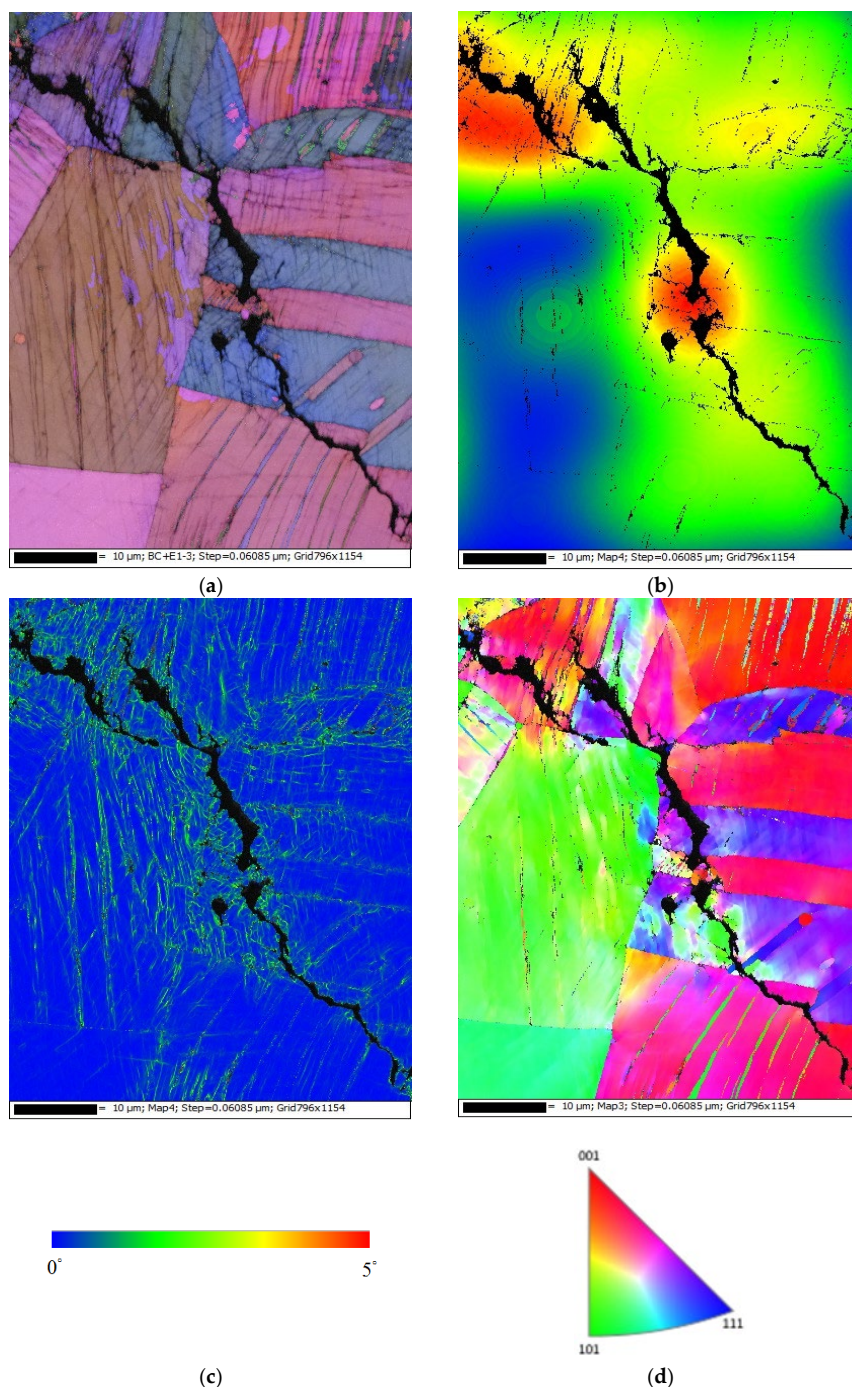
Figure 13. Electron back scatter diffraction (EBSD) maps for the crack region of the specimens deposited with a 1 g/m² chloride concentration tested for 7000 h at 70% RH: (a) Euler map, (b) strain counteracting map, (c) kernel average misorientation (KAM) map, and (d) inverse pole figure (IPF) map.

Figure 13 demonstrates EBSD maps for the crack regions of those specimens deposited with 1 g/m² of chloride at a 70% RH. Figure 13a,d present samples cracked by a transgranular stress corrosion cracking (TGSCC) mode, which is in good agreement with those findings on transgranular stress corrosion cracking of stainless steel induced by chlorides when the temperature was above 50 °C [10]. The strain counteracting map for the specimens tested (Figure 13b) illustrates that the stress is more concentrated around the crack regions. Moreover, the kernel average misorientation (KAM) map for the specimens tested (Figure 13c) demonstrates that the high plastic strain, located around the crack regions, is probably linked to the plastic strain at the crack tip.
