Physical and Chemical Characterisation of the Pigments of a 17th-Century Mural Painting in the Spanish Caribbean

Keywords: Caribbean; Cathedral of Santo Domingo; 17th century; UV-VIS-NIR; Raman spectroscopy; XRD; SEM/EDX; pigment; mural painting; dating

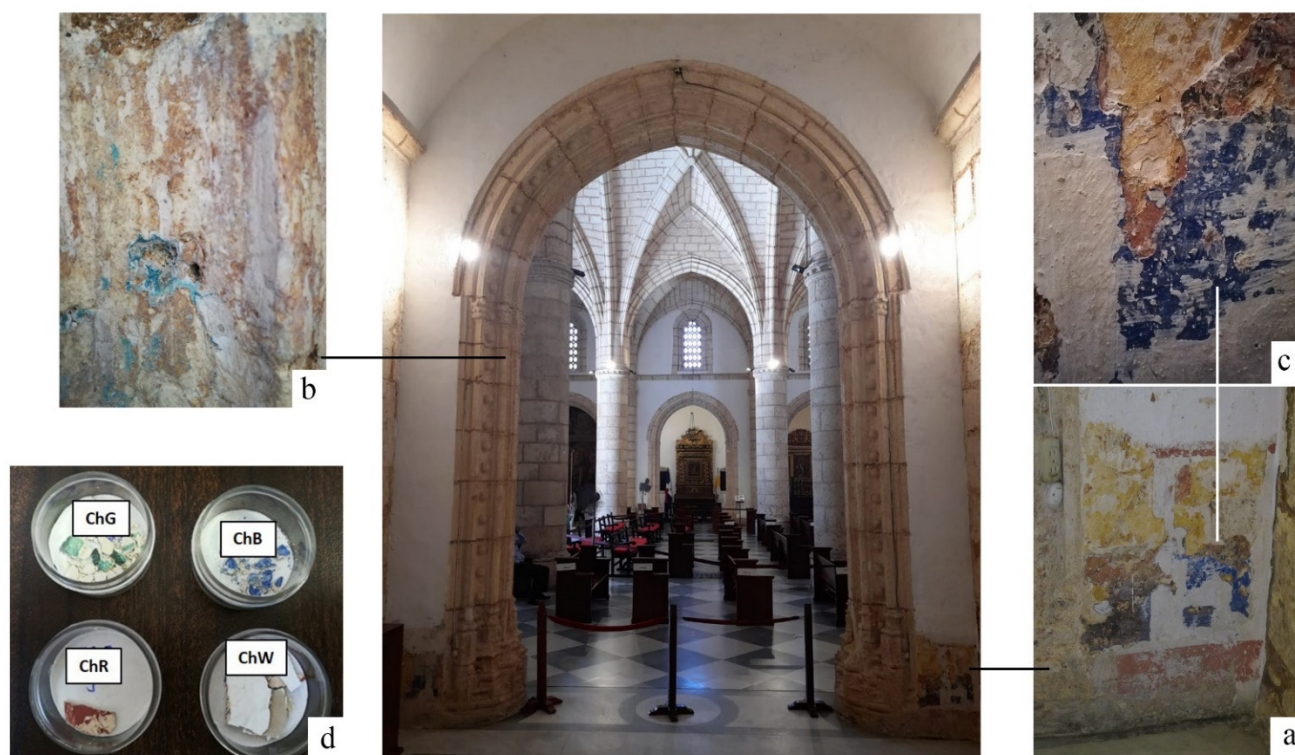
Figure 1. Remains of mural painting of Our Lady of Mercy Chapel; (a–c) zones from which the samples were taken; (d) analysed samples.

The chapel was built in two stages. In the first stage, which was at the beginning of the 17th century, the chapel was much smaller than its current form and was approximately 2 m deep. In the second stage, circa the 18th century, the chapel was enlarged to approximately 7 m deep, because the number of brotherhoods increased with the arrival of the Spaniards [29]. At the beginning of 2019, restoration work was carried out in the Chapel prior to the installation of Our Lady of Mercy. At that time, remains of a mural painting appeared that correspond to the initial stage in which the chapel was managed by the brotherhood of the Candelaria. Samples were selected taking into account different coloration, position and stratigraphy (Figure 1).

Samples of the four identified pigments were transported to laboratories to complete the physical and chemical characterisation of the mural painting. The pigments selected were green (ChG), red (ChR), blue (ChB) and white (ChW) (Figure 1). A number of samples were obtained from detached fragments of the mural painting. The ochre pigment was directly applied to the stone and its extraction required the use of tools that could damage the stone, so it was only analysed in situ.

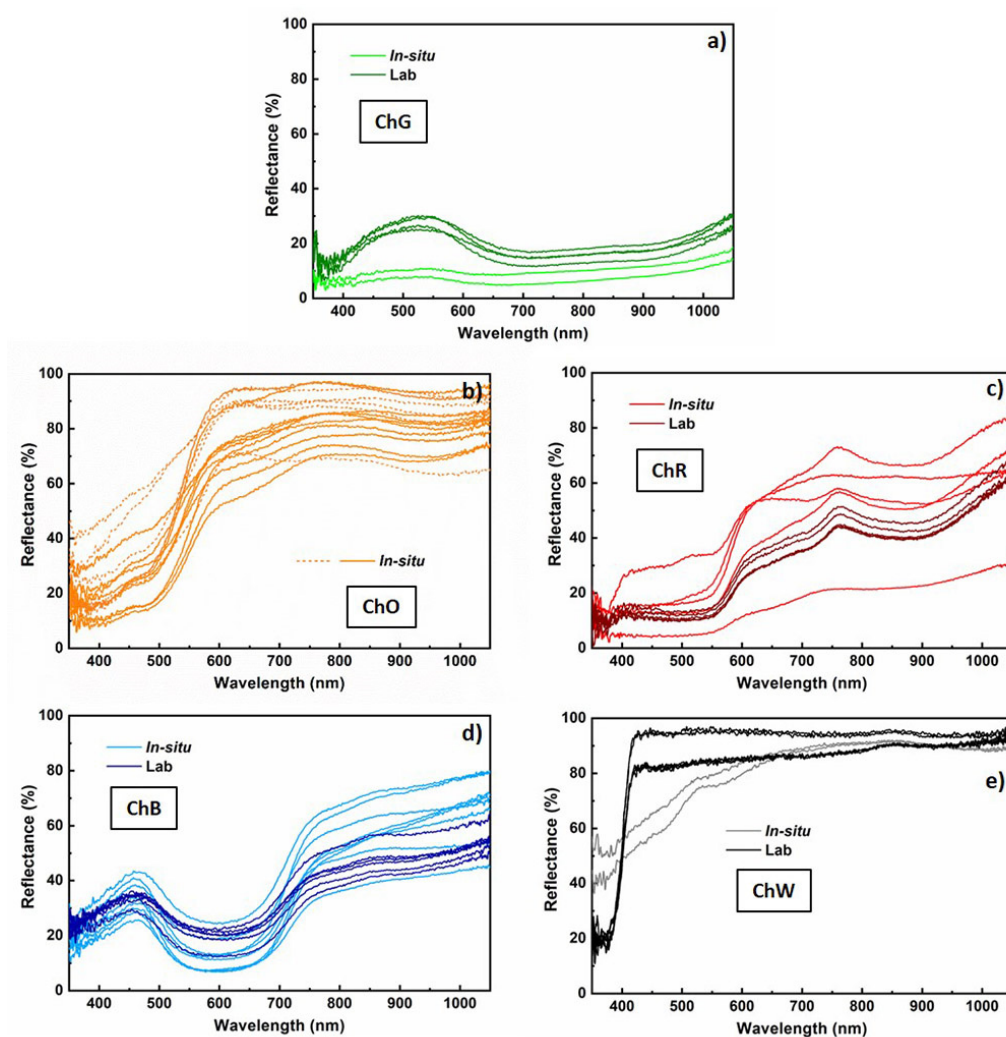
Figure 2. Reflectance spectra obtained from mural painting both in situ and in the laboratory. (a) green (ChG); (b) ochre (ChO); (c) red (ChR); (d) blue (ChB) and (e) white (ChW).

However, in all the spectra depicted in solid lines (Figure 2b light ochre), a wide relative maximum in wavelength, about 790 nm, was observed, with reflectance values varying between 71% and 85%. This behaviour is characteristic of pigments based on Fe, namely yellow ochre ($\text{FeO}(\text{OH}) \cdot n\text{H}_2\text{O}$) and goethite ($\alpha\text{-FeO}(\text{OH})$) compounds. Absorption due to ligand field transitions of the Fe^{3+} ion causes decreases in reflectance by approximately 650 nm and 920 nm. The relative minimum observed at 480 nm is also characteristic of the charge transfer transitions of the Fe–O bond in these compounds [30,31]. Because of the significant differences in the spectra, the values of the colour coordinates obtained exhibit a high dispersion.

Similarly, the spectra obtained on the red layer (ChR) present very different levels of reflectance (Figure 2c light red), which are consistent with the different shades of this layer, and which result in a high dispersion in the values of the L^* coordinate. However, all these curves show common and specific characteristics of pigments based on anhydrous Fe oxides. These may be hematite ($\alpha\text{-Fe}_2\text{O}_3$) or red ochre, which is a natural product coloured by the presence of anhydrous iron oxide Fe_2O_3 produced by the loss of water from yellow ochre [31,32]. The increase in reflectance starts at 550 nm and shifts to longer wavelengths with respect to those of the spectra measured in the ochre layer. The maximum reflectance is more pronounced in this red layer, varying between 21% and 73%, and was observed at a wavelength of approximately 765 nm, which is associated with the red colour of the surface being analysed. In the b^* -versus- a^* representation (Figure 3), the results for this layer are consistently below the bisector of the first quadrant.

All reflectance spectra measured on the blue layer (Figure 2d light blue) (ChB) have a maximum and minimum in the visible range. The maximum is almost symmetrical and occurs at approximately 465 nm, with appreciable variations in width and reflectance (between 26% and 43%). The minimum is at approximately 610 nm, with a variation in reflectance values between 7% and 25%. This behaviour is characteristic of an ultramarine-

The reflectance curves of the green sample (Figure 2a dark green) show a wide maximum with a reflectance between 25% and 30% at a wavelength in the order of 530 nm. This value of maximum reflectance in the visible range corresponds to the green colour that

Spectra of the red sample (ChR) show a nearly constant reflectance on the order of 12% for wavelengths below 550 nm (Figure 2c dark red). The reflectance increases to a well-defined maximum, with a value of 44–51%, at approximately 765 nm, followed by a minimum, with a reflectance of 39–45%, at approximately 880 nm. As revealed through the analysis of the in situ measurements, these spectra may correspond to iron-oxide-based pigments. These results are consistent with those for the hematite phase (α -Fe₂O₃) [31,32].

The reflectance curves of the blue sample (ChB) present characteristics already observed in the in situ characterisation, demonstrating a wide maximum, with values between 26 and 43% at 465 nm, within the range associated with its blue colour (450–495 nm) (Figure 2d dark blue). As indicated previously, the spectra are similar in terms of the visible range to that of the ultramarine-blue pigment, with a generic composition of (Na,Ca)₈(AlSiO₄)₆(SO₄,S,Cl)₂ [33].

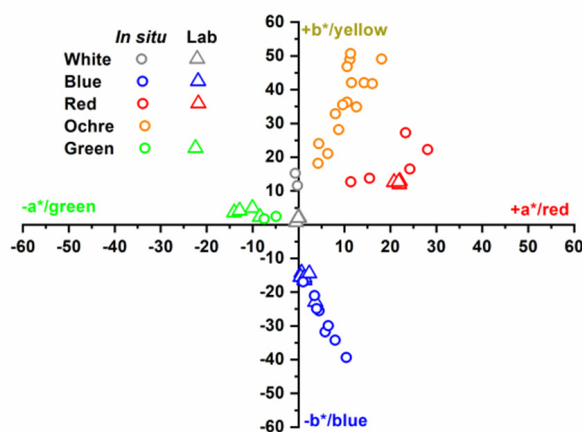
Figure 3. Colour coordinates of mural painting.

blue pigment, which is composed mainly of the mineral lazurite [33]. For the blue-layer spectra, an average L^* coordinate of 46.3 ± 8.0 was obtained (Table 2), whereas the points in the b^* -versus- a^* representation extend below the bisector of the fourth quadrant (Figure 3).

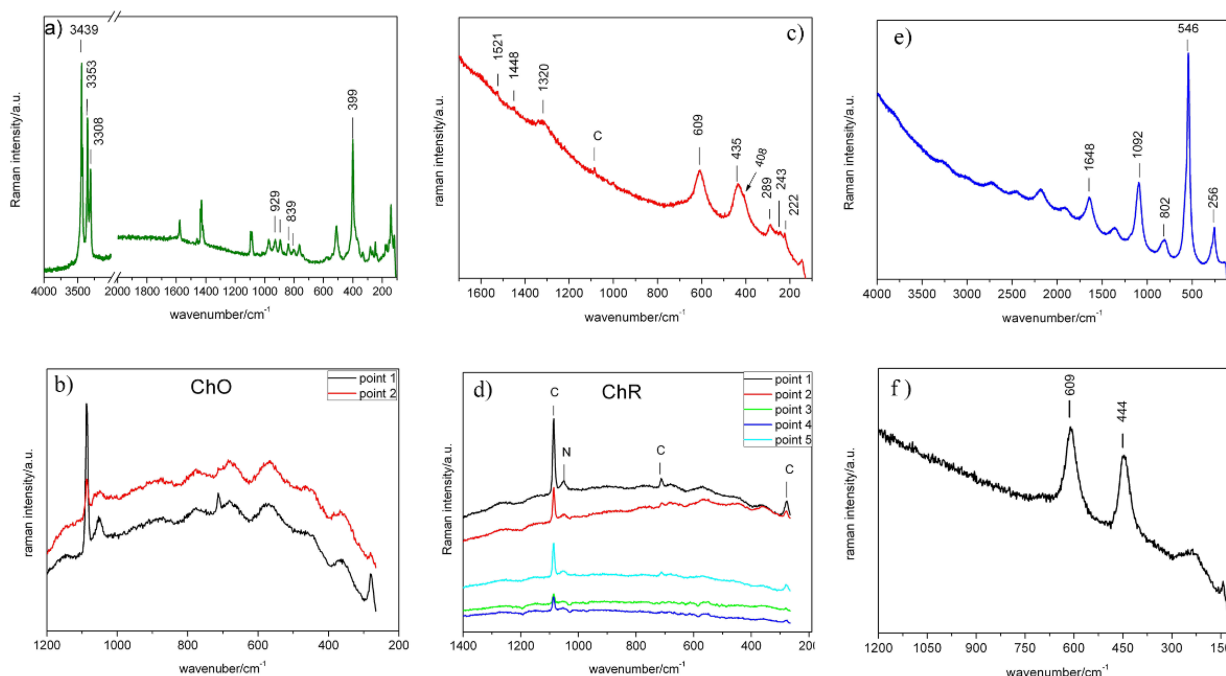
Figure 4. Raman spectra of the samples. Green sample (ChG) in laboratory (a) Ochre sample (ChO) in situ (b); red sample (ChR) in laboratory (c) and in situ (d); blue sample (ChB) in laboratory (e) and white sample (ChW) in laboratory (f).

Because of the high fluorescence of the micro-Raman spectrum of the red pigment (ChR), only the signals at frequencies below 600 cm^{-1} could be identified (Figure 4c, in laboratory). In this range, signals at 609, 435, 408, 289, 243 and 222 cm^{-1} , which are associated with hematite iron oxide (Fe_2O_3), were identified [42]. On the other hand, the signals at 606 and 435 cm^{-1} frequencies may also be due to the presence of TiO_2 as rutile [43]. Other areas of the sample included white deposits, whose micro-Raman spectrum shows a strong signal at 143 cm^{-1} , indicating the presence of anatase TiO_2 . The addition of this white pigment is usually associated with mixing for a lighter dye. The Raman spectrum on the back of the ChR sample indicates that the base of the paint was probably lime [34], as in the previous samples.

The micro-Raman spectrum of the ChB sample (Figure 4e in laboratory) shows the characteristic vibration signals of lazurite, $\text{Na}_3\text{Ca}(\text{Si}_3\text{Al}_3)\text{O}_{12}\text{S}$ [44–46], the main component of the mineral lapis lazuli. Its most intense Raman signal was observed at 546 cm^{-1} (symmetrical stress, $\nu_1\text{ S}^{3-}$), together with another of medium intensity, with maximum at 256 cm^{-1} (ν_2 , strain vibration S^{3-}). Another series of signals were observed; these signals were identified to be harmonics, characteristic of the resonant Raman effect (Figure 4e in laboratory) [47]. These bands appear at double frequency (1092 cm^{-1}) and triple frequency (1648 cm^{-1}) of the most intense frequency (546 cm^{-1}), and at other frequencies (802 cm^{-1}) by combinations of the signals at 256 and 546 cm^{-1} . Analysis of the back of the sample via micro-Raman spectroscopy revealed, as in the two previous samples, that the pigment was probably applied on a lime base.

Finally, the micro-Raman spectrum of the white ChW sample (Figure 4f, in laboratory) shows two intense signals with maxima at 609 and 444 cm^{-1} due to vibrations of the Ti–O link of rutile TiO_2 [40]. As was performed for the rest of the samples, the back of the ChW sample was analysed, and the spectrum, despite showing a high level of fluorescence, made it possible to identify the presence of CaCO_3 [34].

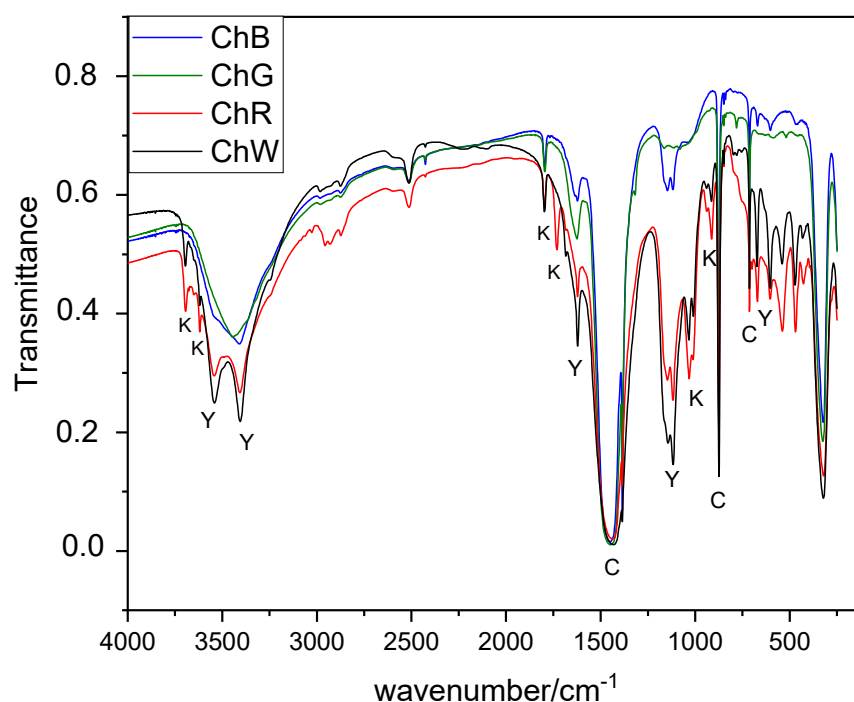
Figure 5. FTIR results of samples: C = calcite (CaCO_3); Y = gypsum ($\text{CaSO}_4 \cdot 2\text{H}_2\text{O}$); K = kaolinite ($\text{Al}_2\text{Si}_2\text{O}_5(\text{OH})_4$).

FTIR spectra of the pigments (Figure 5) allow to identify the presence of calcite by the bands at 1449 cm^{-1} (ν_3), 875 cm^{-1} (ν_2) and 712 cm^{-1} (ν_4); the presence of gypsum by the bands corresponding to water at 3550, 3492, 3405 cm^{-1} (ν_{water}) and 1692, 1627 cm^{-1} (δ_{water}) and to sulphate at 1111 cm^{-1} (ν_3) and 669, 600 cm^{-1} (ν_4), as well as the presence of anhydrite (1153 cm^{-1}) in all of them. The spectrum shows, as well, bands in the range $3000\text{--}2800\text{ cm}^{-1}$ due to symmetric and asymmetric C–H stretching of CH_3 and CH_2 groups [48]. These signals are due to the presence of organic matter and are more intense in the ChR sample with a higher kaolinite content, so it can be associated with this mineral. A sharp signal of medium intensity with a maximum at 2513 cm^{-1} is also observed, which some authors associated to vibrations of CO_3^{2-} in calcite and minerals of the calcite and dolomite groups [49].

Only some signals that could correspond to the pigments were identified in the case of sample ChR (signal at 536 cm^{-1} from hematite) and sample ChW (signal at 517 cm^{-1} from TiO_2). In these same samples, kaolinite was also identified [50].

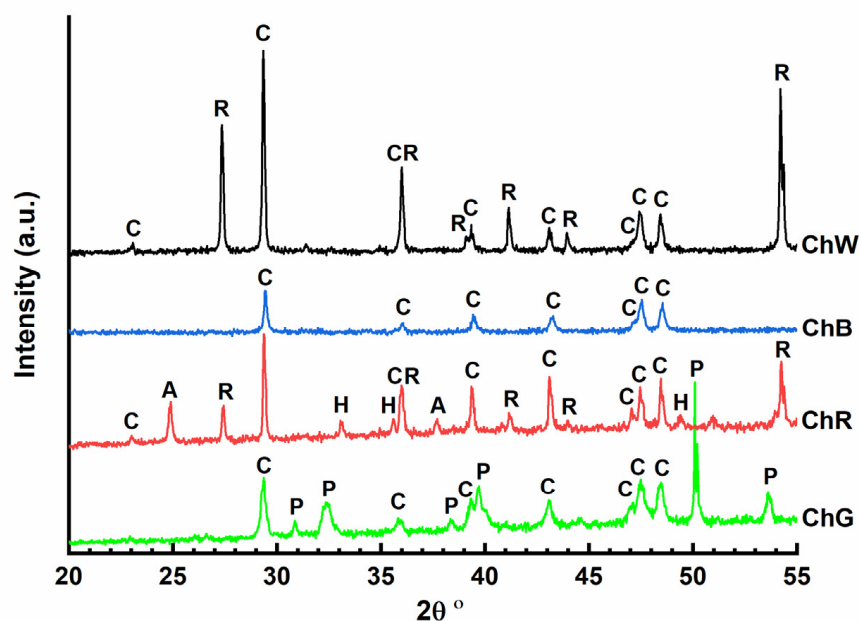
Figure 6. X-ray diffraction results of samples: C-calcite (CaCO_3); R-rutile (TiO_2); A-anatase (TiO_2); H-hematite ($\alpha\text{-Fe}_2\text{O}_3$); P-paratacamite ($\text{Cu}_2\text{Cl}(\text{OH})_3$).

X-ray diffractograms were obtained for the four samples analysed in the laboratory (Figure 6). In all the cases, the presence of calcite crystalline phase (CaCO_3) (C) can be identified, with a maximum intensity peak at $2\theta\ 29.45^\circ$. In the case of the green sample (ChG), the diffractogram shows low-intensity signals. The most intense peaks are characteristic of the paratacamite phase, one of the four polymorphic structures of copper oxychloride ($\text{Cu}_2\text{Cl}(\text{OH})_3$) that corresponds with the strong signals observed in Raman spectroscopy attributed to the vibrations of $\text{Cu}_3\equiv\text{O}-\text{H}-\text{Cl}$. The red-sample diffractogram (ChR) confirms the presence of hematite ($\alpha\text{-Fe}_2\text{O}_3$) which provides the red colour. Diffraction peaks characteristic of anatase ($2\theta\ 25.69^\circ$) and rutile ($2\theta\ 27.44^\circ$) polymorphs of titanium oxide (TiO_2) could be detected in this diffractogram that it is in accordance with the micro-Raman spectrum that shows a strong signal at 143 cm^{-1} , indicating the presence of anatase. This white phase could have been added to lighten the red colour of hematite. In addition, the calcite phase was the only phase observed in the diffractogram of the blue sample (ChB), suggesting that the pigment used in this case has an amorphous character. Finally, the diffractogram of the white sample (ChW) confirmed the presence of rutile TiO_2 , with two maximum intensity peaks at $2\theta\ 27.44^\circ$ and 54.32° , which was also inferred from its micro-Raman spectra at 609 cm^{-1} and 444 cm^{-1} .

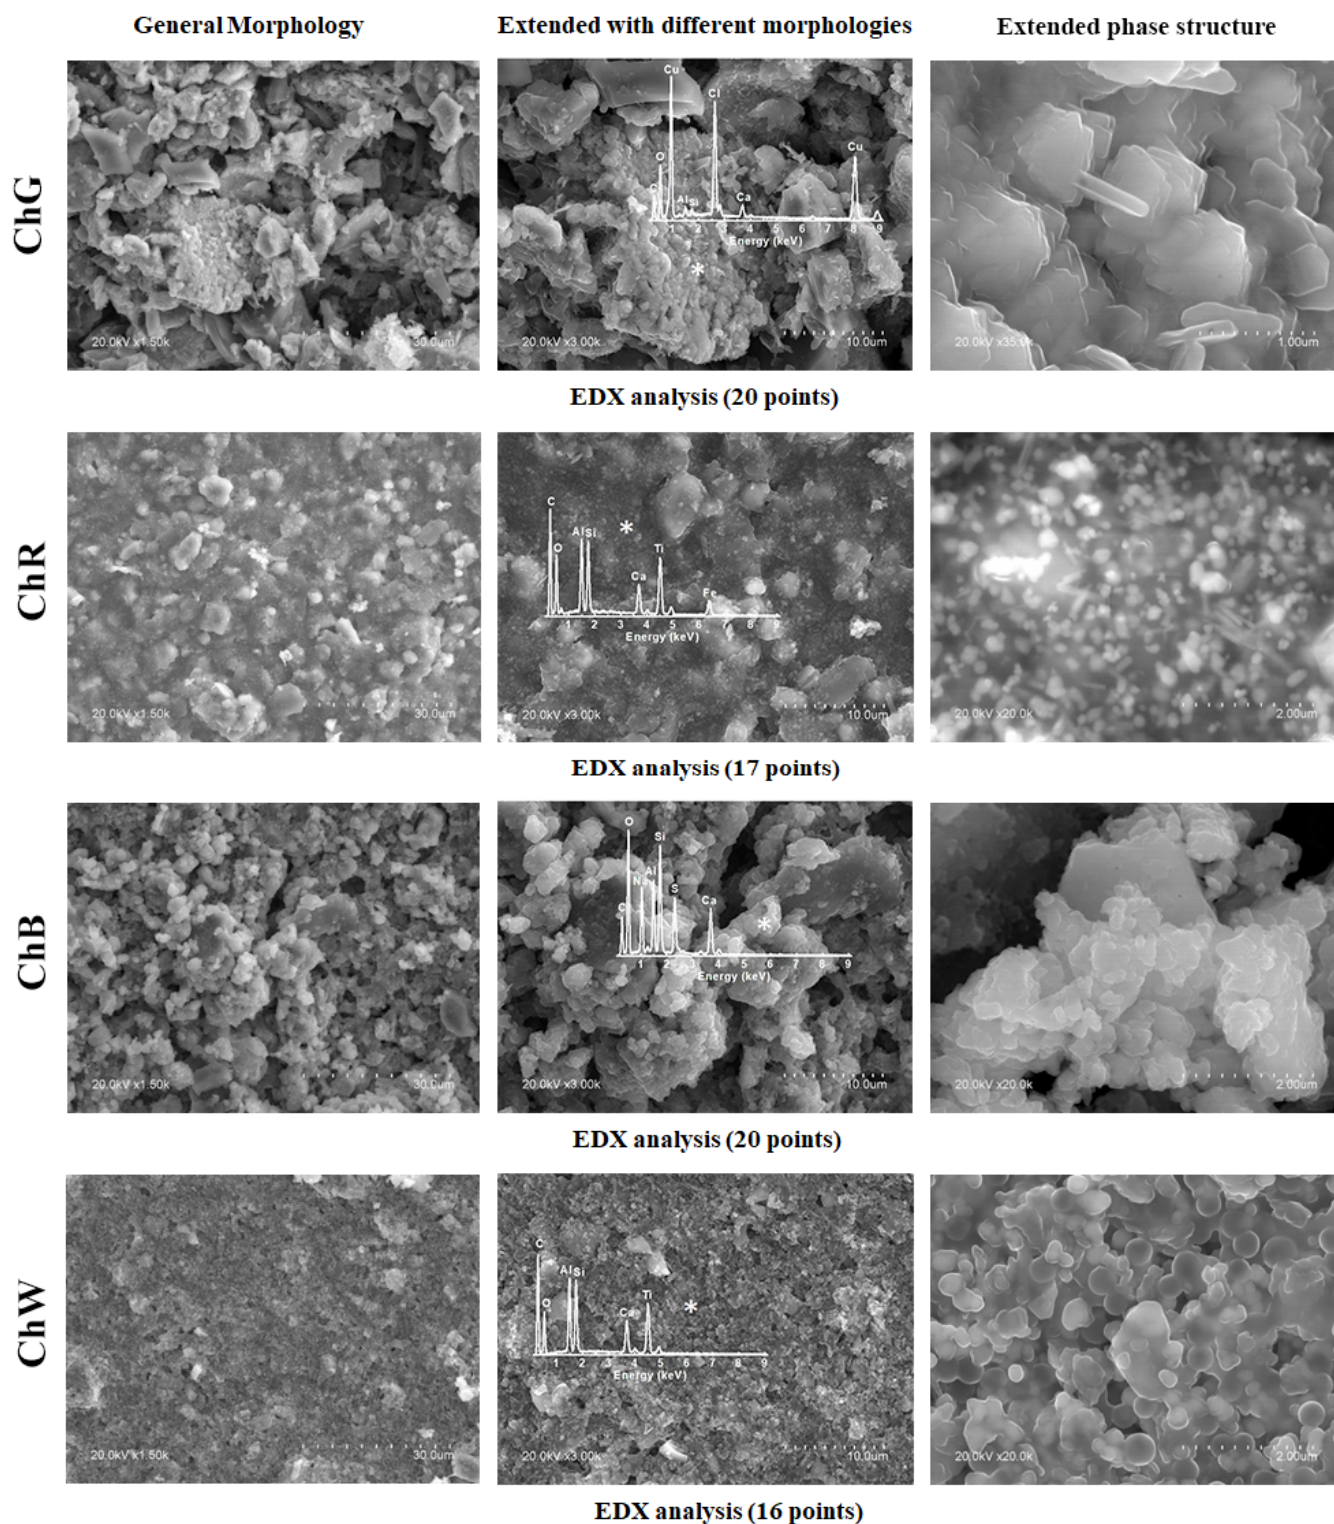
Figure 7. Microstructural analysis of samples via SEM/EDX.

The morphology, microstructure and composition of each sample were analysed via SEM–EDX. Figure 7 shows three images of each sample: the general morphology observed at $1500\times$ magnification, magnified image with the different morphologies identified and details of the predominant microstructure with the characteristic EDX spectrum.

In the green sample (ChG), the predominant structure is formed by crystals in the form of flat plates with a characteristic edge length on the order of 730 nm, and thickness on the order of 125 nm. The majority of signals in the EDX spectra measured on these plates correspond to Cu and Cl, and thus the composition is indicative of copper oxychloride ($\text{Cu}_2\text{Cl}(\text{OH})_3$), which has been identified in the sample analysis via Raman spectroscopy and XRD.

By contrast, the predominant morphology in the red sample (ChR) was smoother than that in the green sample. The strongest signals in the EDX spectra correspond to Fe and Ti, which are consistent with the chemical compositions iron and titanium oxides determined via the other techniques performed on this sample. In addition, a number of crystals of different sizes were observed, among which Al and Si predominate in some cases, and calcium in other cases.

The blue sample (ChB) shows a granular morphology with rounded holes and few differentiated crystals. The EDX spectrum of the predominant morphology shows majority of the signs of Na, Ca, Si, Al and S, consistent with the presence of lazurite in the sample. On the other hand, the crystals present a predominant signal of Ca, which indicates the calcite phase CaCO_3 , the only crystalline phase identified via XRD.

Finally, the predominant morphology in the white sample (ChW) was relatively smooth and had rounded holes. The composition obtained via EDX comprises Ti, Si and Al as the majority elements. Similar to those for the previous samples, the most intense signal of this EDX spectrum indicates the presence of Ca, which is associated with the calcite phase.
